NASA/TP-2009-214769

A Summary of NASA and USAF Hypercolic Propellant Related Spills and Fires

*B. M. Nuffer
Kennedy Space Center, Florida*

June 2009

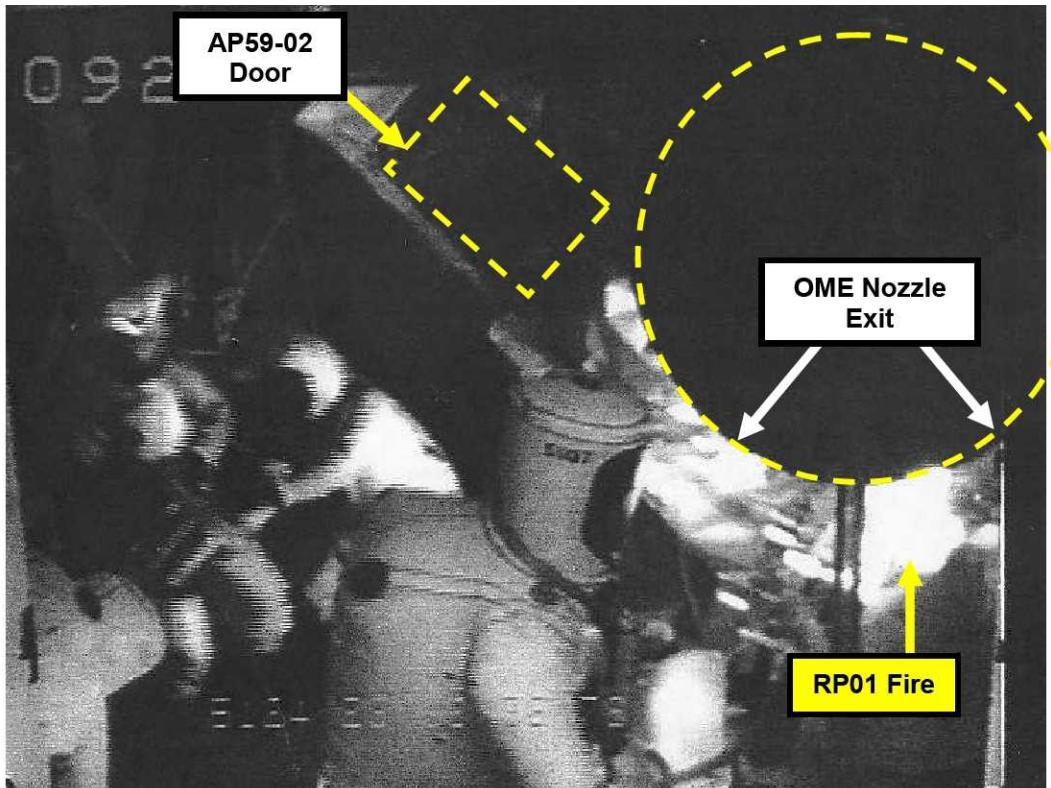
Figure 33-1: Still Photograph from Video of RP01 Fire

During the STS-69 OV-105 flow, while performing a thruster R1A removal and replacement, a fire broke out in the Space Shuttle right OMS pod stinger area. The fire burned strongly for about 30 seconds and a smaller flame burned for about one minute and 45 seconds. The size of the flame was estimated to be approximately 15 inches x 11 inches x 11 inches with a damage region of approximately 22 inches x 14 inches x 14 inches in the stinger. The materials that burned included several ounces of fuel, a shop light, and the Orcofilm spill protection (flame retardant covering films). Figure 32-1 is a still image from the video recording during the fire and Figure 33-2 is a clearer color photograph of the same area for reference.

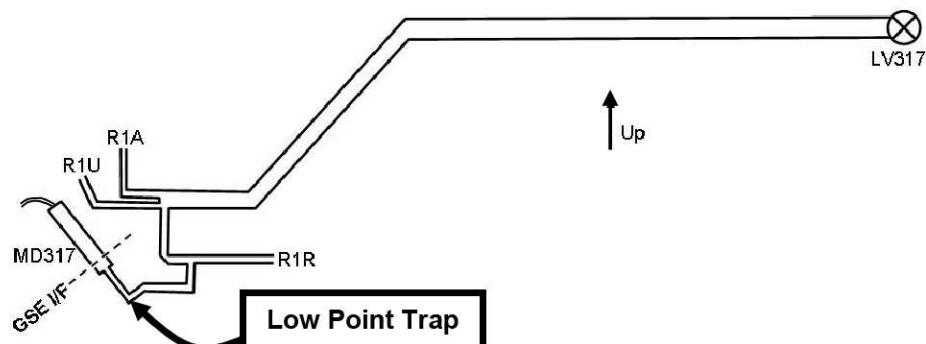
Figure 33-3: Approximate Manifold 1 Layout Schematic

Another possible scenario (not included in the formal mishap report) for the pressure increase was put forth stating the pulse purges were unable to remove all the liquid MMH as a result of a low point trap present in the manifold near the MD317 (manifold 1 drain/purge QD) AHC interface. Figure 33-3 shows the basic layout and low point in fuel manifold 1 in the right pod stinger area. It is believed that during the purge, gas was unable to enter the line through the MD317 QD to displace the liquid MMH out of the manifold. This was a result of a small bubble that had formed in the low point as a result of helium coming out of the liquid MMH/helium solution. The helium slowly coming out of solution may have been the source of the pressure rise in the manifold rather than a leaking manifold isolation valve. Once the fire started, it heated the area thus increasing the pressure and pushing additional fuel out of the fuel feedline that was trapped. In both scenarios (leaking manifold isolation valve or helium coming out of solution), liquid MMH was present in the manifold line just prior to and during the fire and the manifold pressure increase went unnoticed.

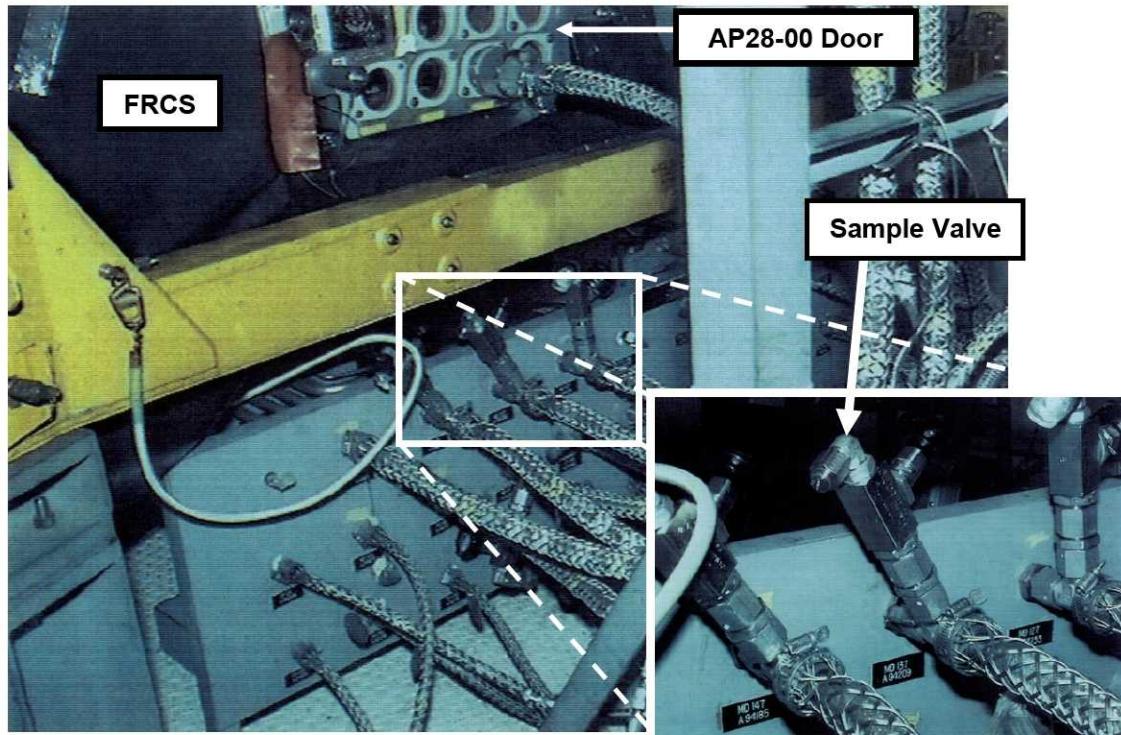
Figure 36-1: MD137 Flexhose Sample Valve

One technician powered up the aspirator and then began to remove the sampling valve outlet cap from the MD137 flexhose (see Figure 36-1 for a close-up view of the sampling valve). A TVC of the area was then performed with a resulting reading of 0.0 ppm. The technician laid the aspirator hose on the side of the rack, which was not a suitable position to capture any liquid or vapor that may be released from the valve outlet as the procedure stated.

The technicians were then at the point in the procedure where the valve was to be opened. The procedure was written to imply that there may be some vapor released from the valve when it was opened. Liquid MMH was not expected, but, as it turns out, there was a liquid release once the valve was opened. MMH splashed out of the sample valve and onto one technician's left arm, the glove of the other technician, and the surrounding area. It is estimated that approximately $\frac{3}{4}$ -cup of liquid MMH spilled from the valve. The technician immediately closed the valve and began to evacuate the test cell along with the other technicians. He exited the test cell and located a safety shower, which he began to use. A medical and fire team were immediately dispatched to the scene and the engineers on console notified the proper authorities. The technician did receive chemical burns on his arm for which he was treated at the OHF. He was released within a few hours.

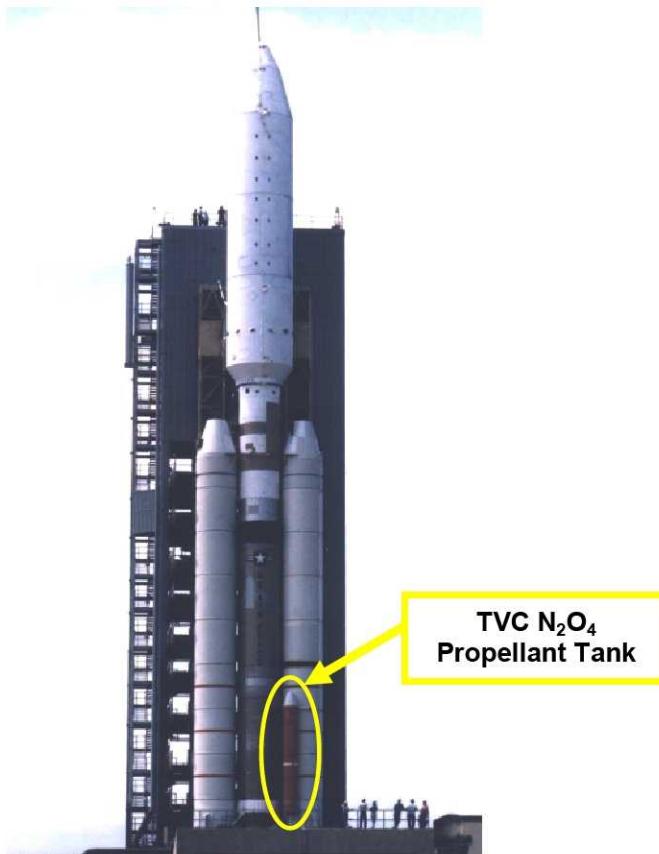
Figure 37-1: Titan IV A on Launch Pad

On July 16, 1997 engineers at VAFB SLC-4E were remotely pressurizing the two N₂O₄ propellant tanks, one each on the two Titan IV A's SRM TVC systems. Reference Figure 31-2 for a diagram of the TVC system. The propellant tank servicing was completed without incident about nine days prior to the pressurization. Each tank contained about 8,400 lbs (702 gallons) of liquid N₂O₄. The rocket was being prepared for a planned mid-July 1997 launch on a Department of Defense mission to replace an aging reconnaissance satellite. Figure 37-1 shows a Titan IV A configuration at its launch pad and points out the location of the N₂O₄ tank.

About 20 minutes after initiating the propellant tank pressurization, liquid N_2O_4 was observed to be streaming out of the aft skirt heat shield region on *both* SRMs. There were no reported injuries and the flight hardware had minimal collateral damage (mainly on the SRM nozzles). At the time of the observed N_2O_4 release (likely initially noticed by the signature brownish-orange NO_2 vapors characteristic of an N_2O_4 spill) the propellant tanks were at a pressure of about 830 psi. The target pressure was about 1,040 psi. The engineers quickly began to depressurize the propellant tanks, which had the immediate affect of decreasing the rate of propellant release. The tanks were vented from their initial pressure of about 830 psi to a final pressure of 38 psi, at which time the N_2O_4 release ceased. At that time, all systems were secured and the operation terminated. It was decided to offload all of the propellant from the subject tanks, so about eight hours later, the engineers and technicians began the offloading procedure. This operation was completed without incident. Following the offload and evacuation of the TVC N_2O_4 system and tubing, the total amount of propellant transferred was estimated. About 1,160 gallons of N_2O_4 was re-captured as a result of the drain-back. This logically implies that about 244 gallons of N_2O_4 was released to the atmosphere.

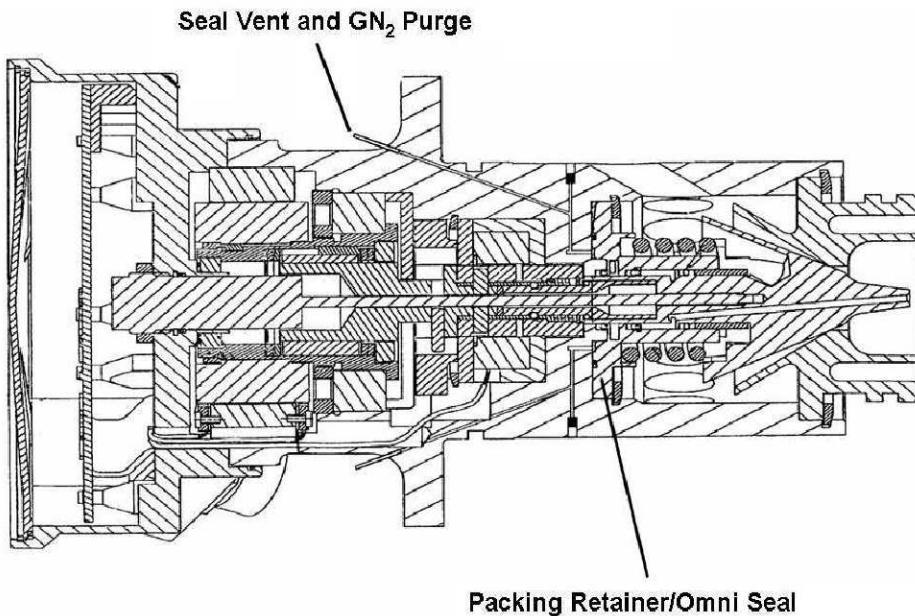
Figure 37-2: Titan IV A TVC FCV Cutaway View

The source of the leak was found to be the electronic compartment purge ports on two flow control valves (FCVs) on SRM #1 and one FCV on SRM #2. A cutaway view of the FCV is shown in Figure 37-2. These valves (along with the one remaining valve that did not leak) were removed and sent to the manufacturer for failure analysis. Upon disassembly of the three failed valves, evidence of combustion was noted at the electrical compartment's omniseal. The omniseal had been extruded through the sealing surface and the retainer ring had been ejected. The degradation of the omniseal resulted in liquid N_2O_4 flowing into the FCV's electronics compartment and out the purge port. There were no leaks found within the TVC propellant tank or the associated system plumbing.

Failure analysis determined that the proximate cause of the seal degradation was traced to a chemically reactive incompatibility of N_2O_4 with the cleaning agent, Bio T-200A, used on the FCVs during manufacturing at that time. Freon had long been the industry standard for oxidizer component cleaning; however, in 1987 the international scientific community endorsed the Montreal Protocol Treaty which phased out the use of halogenated hydrocarbons (including Freon) due to their proven role in ozone depletion. In early 1994, the Titan IV program adopted a policy to phase-out the use of Freon for cleaning of components and simultaneously phase-in the use of a trade product, Bio T-200A.

In June of 1994, a subcontractor was commissioned by the FCV manufacturer to test the compatibility of liquid Bio T-200A with N₂O₄. Tests showed that N₂O₄ reacted violently with Bio T-200A after about five hours of exposure (at ambient pressure and temperature). As a result of this finding, precautions were added in the EMV (and later the FCV) manufacturing process that included a drying out the components via a baking process since it was known that a *dry film* of Bio T-200A is compatible with N₂O₄. The manufacturer used a 30-minute bake at 100 °F, believing that these conditions were sufficient to remove all the liquid Bio T-200A. However, Bio T-200A has a relatively low vapor pressure and thus requires a comparatively long time for complete evaporation. Following the K-18 N₂O₄ spill, an investigation identified that the FCV manufacturing process indeed left a wet residue of Bio T-200A under the packing retainer (shown in Figure 37-2).

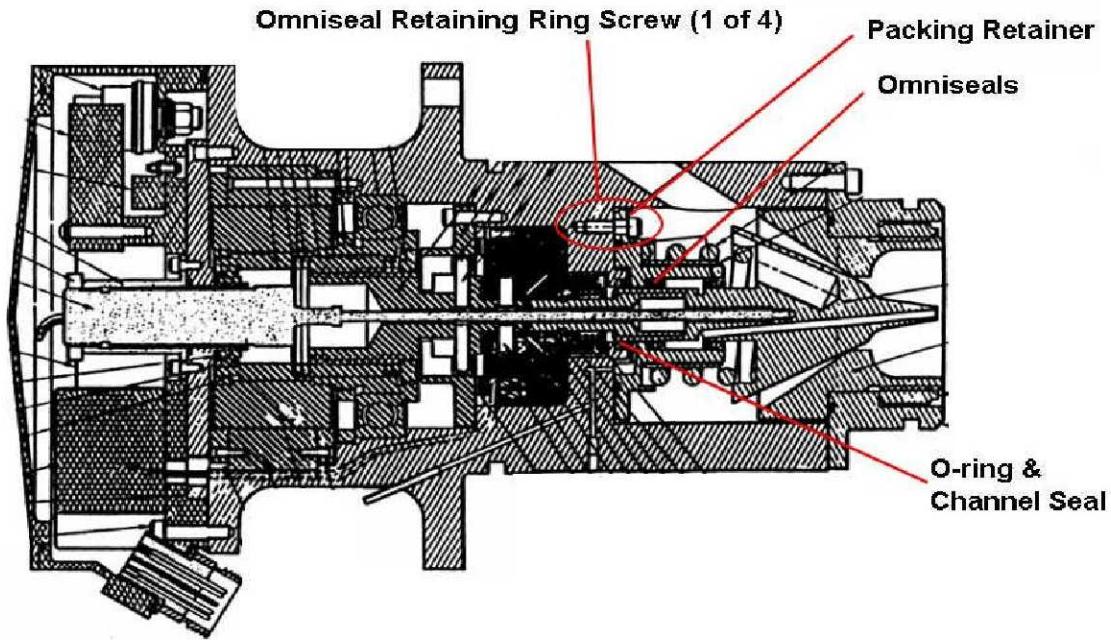
Figure 37-3: Titan IV A TVC EMV Cutaway View

The component design change was driven by the difficulty in manufacturing the EMVs, as well as some of its internal components becoming obsolete. A cutaway view of the EMV is shown in Figure 37-3. The intent of the valve redesign was to make as few changes as possible to allow for consistent manufacturing, part machining, and part procurement, as well as using the same outer housing of the valve to allow the new FCV to essentially be "dropped in" without any TVC system modifications. There are several noted differences between the two valve designs. One significant difference is their method of fastening the packing retainer to the omniseals. Both designs utilize an omniseal to isolate the N_2O_4 from the valve's electronic compartment. However, the original EMV design fastened the omniseal and packing retainer using four screws, whereas the superseding FCV design employed a snap-ring to fasten the retainer. The four mechanical screws on the EMVs left a much smaller gap (if any) between the component surfaces, whereas the FCVs snap ring design, while sufficient for its launch duty, had a large enough gap between the component surfaces that the liquid Bio T-200A cleaning solvent was able to accumulate on the omniseal spring.

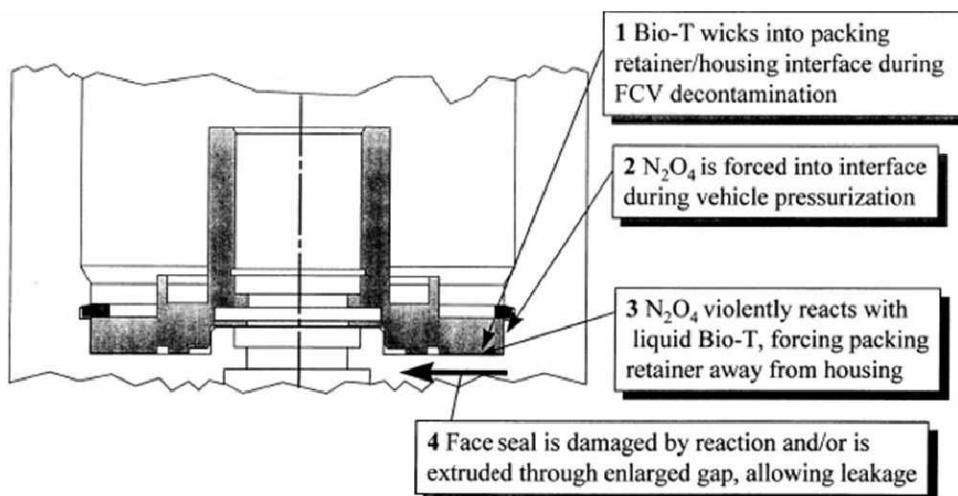
Figure 37-4: Titan IV A FCV Failure Description

1. By the completion of the TVC N₂O₄ propellant tank loading, the cavity adjacent to the packing retainer filled with liquid N₂O₄
2. The liquid N₂O₄ vaporized and migrated into the packing retainer crevice
3. During the tanks' pressurization, the trapped N₂O₄ vapor re-condensed into a liquid and reacted with the residual Bio T-200A in the packing retainer crevice (see Figure 37-4)
 - o The energy of this reaction damaged the packing seal
 - o The force of the increased system pressure overcame the remaining, compromised integrity of the seal components and thus flowed past the seals to atmosphere.

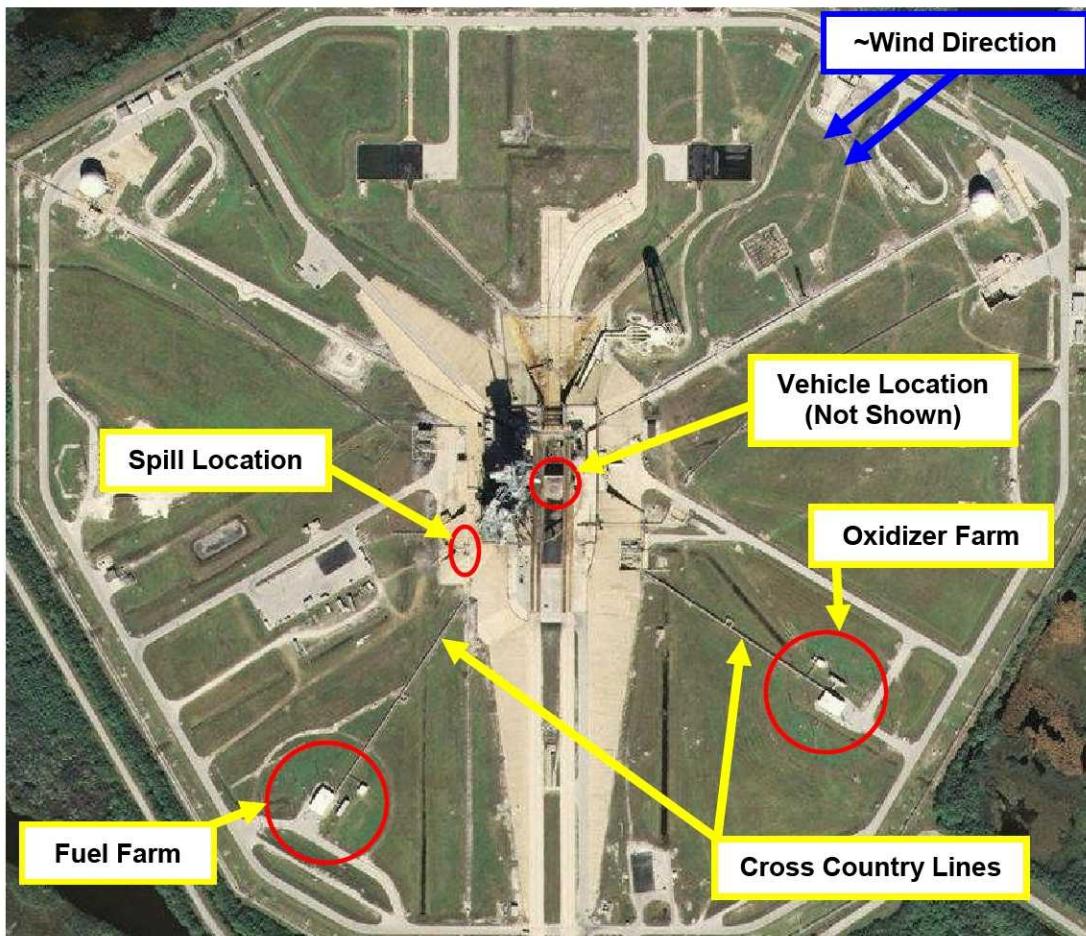
Figure 38-1: Geographic Layout of Launch Pad 39B

The SCAPE van driver was the first to detect the spill when he smelled oxidizer in the area of the fuel farm (see Figure 38-1 for a geographic layout of Pad 39B). Safety officials at the launch pad perimeter noted the source of the oxidizer vapors was the Pad 39B west slope. Three technicians in SCAPE were directed to proceed to the general area of the vapor source from their location on launch pad tower 107-foot level. Upon arrival, the technicians noted that heavy N₂O₄ (NO₂) vapors were leaking from both the inlet and outlet flanges of the return cross-over valve. They also noted that there were still several

gallons of liquid N₂O₄ on the ground near the flanges and at the bottom of the slope in a grassy area. Sparks were seen shortly after the arrival of the technicians; therefore, two of the three evacuated. Some of the liquid N₂O₄ that had flowed down the slope incline contacted the electrical conduits routed along the ground that supplied power to nearby lighting. The technicians were unaware that the N₂O₄ had dissolved some of the cabling insulation.

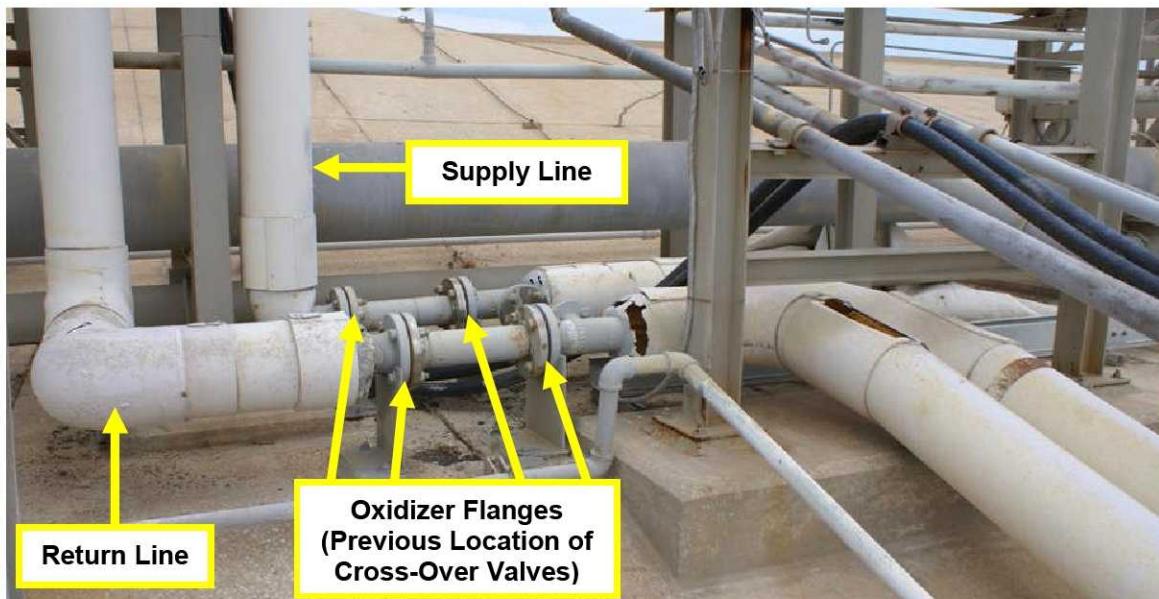
Figure 38-2: Former Site of Oxidizer Cross-Over Valve Complex at Pad 39B

About two months prior to the spill, an operation was completed on the cross-over valve complex in which the flange gaskets had to be replaced. This operation was a result of noted leaks at the cross-over valve complex return valve as a result of (it was assumed) an alignment problem with the valve flanges. The valve mounts were removed to correct the misalignment issue. The mount removal was completed without authorizing the out of configuration condition as it was against what was required per the cross-over valve drawings.

During the repair procedure, the flange gaskets were replaced; however, there was a discrepancy in the Pad 39B drawing for the flange. An engineering order had been issued in 1978 to the Pad 39A drawings to require the installation of American National Standards Institute (ANSI) sized gaskets. The Pad 39B drawings were never corrected; therefore, an undersized gasket was installed. It was also found through a detailed analysis of the flange gasket installation procedures that the flanges were not leak tested with GN₂ following the 24-hour retorque of the flange bolts. This could have led to a change in the gasket clamping force. The combination of the undersized gasket and an inherent preload from an inadequate support structure under the valve complex (improper configuration management) were the root causes of this incident. The problem report closure statement for the spill stated the following:

"The flange gaskets which leaked were of the white gar lock material and cut to the dimensions specified per [the Pad 39A cross-country line] drawing. An investigation revealed the material of the gaskets was compatible and acceptable for oxidizer use. The apparent problem was with the dimensions specified for 150 lb flange gaskets. The internal diameter was too large, reducing the sealing surface, and a slight gasket failure led to the leak. A walkdown of the pad B [hypergol tubing] was performed and all white 150 lb gaskets were identified and replaced with gaskets cut using the new dimensions released per the [Pad 39B cross-country line] drawing...All subsequent [helium] leak checks and propellant flows showed no signs of further oxidizer leakage."

Following this incident, the Pad 39B drawings were updated to require the installation of the proper flange seals. All the cross-over valves were removed and replaced with flanged pipe as they were no longer needed for hypergolic propellant loading. This reduced processing time on the valves and greatly reduced the risk of a leak at the valve flanges. Figure 38-2 is a photograph of the location where the cross-over valve complex was previously located at Pad 39B and Figure 38-3 is a photograph of the location of the Pad 39B fuel cross-over valve complex with the fuel farm and Vehicle Assembly Building in the background.

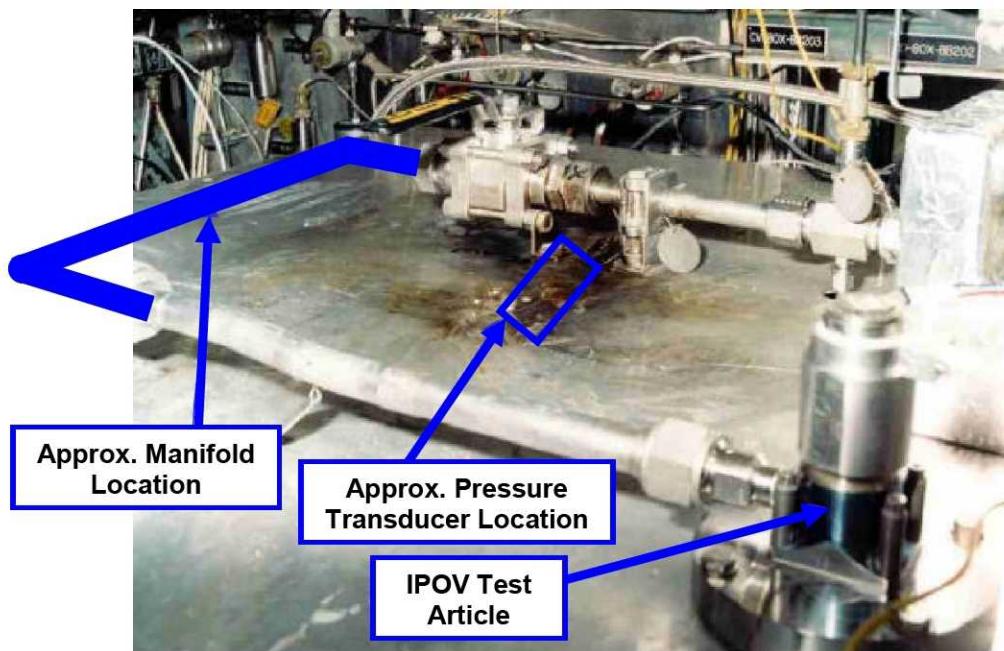
Figure 42-1: IPOV Test Setup

The IPOV was in the process of being validated following some modifications that were made to the valve. The operating pressure at the valve inlet was approximately 276 psia. The test was simply flowing liquid N₂O₄ from one tank into another by cycling the valve. The pressure transducer was in the system to monitor this inlet pressure. Approximately 36,000 (of the planned 80,000) cycles of the valve, with a flow duration of approximately 80 ms and a maximum flowrate of 1.91 lb/sec, had been completed when the explosion occurred. The proper emergency procedures were immediately implemented following the incident. These procedures included securing the test cell and deactivating the air handler for both the test cell and the attached building. There was no reported fire following the explosion.

Initial inspections of the pressure transducer indicated that the transducer failed as a result of one of the following: over-pressurization, inadequate design, or cyclic fatigue at a highly stressed location. Since the pressure transducer failed, data from it at around the time of the failure may be suspect; therefore, the investigation included a detailed inspection of the nearby system tubing to determine if there was an over-pressurization event. Close inspection of the pressure transducer itself would indicate if the transducer failed from cyclic fatigue or was subject to a ductile failure from a single overload event.

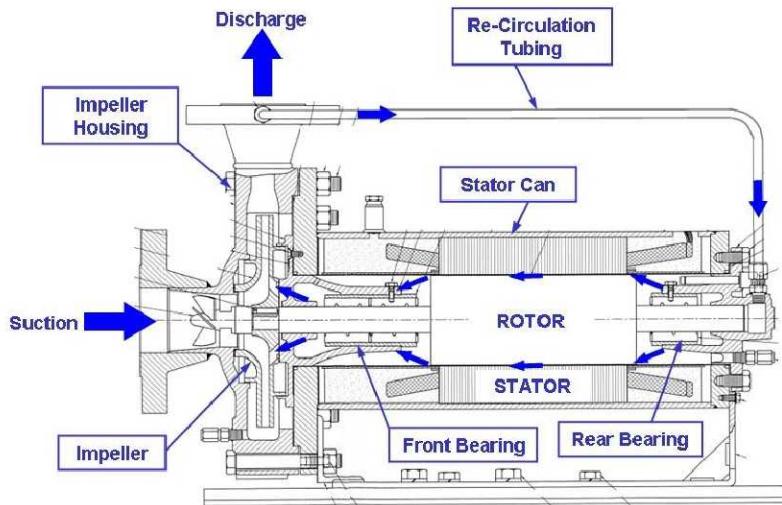
Figure 43-3: Pump Schematic

The incident failure analysis concluded, according to Crass, that there was a “cooling anomaly at the [carbon graphite journal] bearings...leading to [an explosion] in the stator can winding area.” It was found that the most likely contributor to this was a clogged filter in the pump recirculation loop that circulates liquid through the rotor cavity to cool the front and rear bearings as illustrated in Figure 43-3. Data analysis showed that the upstream and downstream temperature transducers indicated an increase in temperature of 8 °F across the pump. The low flow rate of 40 gpm and high ambient temperatures (high of 86 °F for 8/12/2003) accelerated the failure of the pump. At these flow conditions, the pump was not

able to be properly lubricated as a result of the high vapor pressure of liquid N₂O₄ (these particular pumps are designed to be lubricated with the liquid that they are pumping). The excessive bearing wear led to damage to the stator liner can, allowing oxidizer to leak onto the hot copper windings. The N₂O₄ reacted with the copper winding insulation and caused the coil wire to short, which was the proximate cause of the explosion.

Following the explosion, there were some design changes made to the pumps since an improper pump design was a root cause, these changes include the following:

- Machining of the pump from a single billet of stainless steel rather than casting them
- Serrations were added on the impellor housing and rear bearing housing for improved sealing capability
- The addition of a thermowell for thermocouple monitoring rather than the old thermoswitch which proved to be unreliable

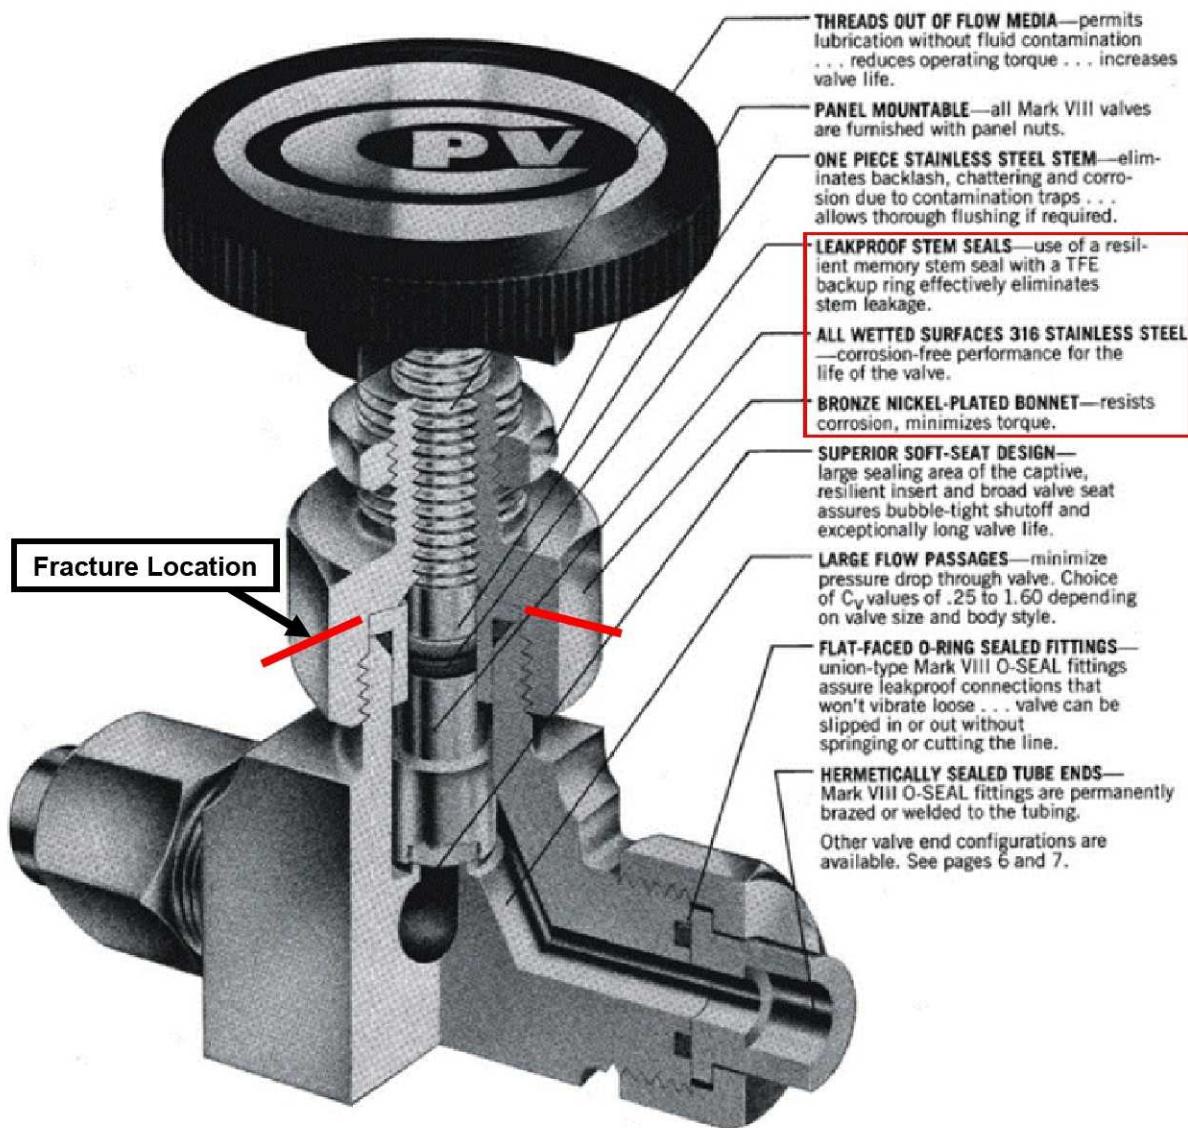
Figure 45-2: Schematic of Failed Manual Valve

The failure began as an intergranular crack in the nickel-plated, aluminum bronze bonnet threads (fracture surface shown in Figure 45-1). It is believed that the crack began as a result of the ethylene propylene rubber and Teflon soft seals allowing corrosive agents to slowly leak into the thread region. Figure 45-2 shows a cross-section cutaway of the manual valve. The Teflon soft seals can be seen clearly near the middle of the threaded shaft. The corrosive agents reacted with ammonia, which came from the decomposition of N_2H_4 ($N_2H_4 \rightarrow 1/3 N_2 + 4/3 NH_3$). This accelerated the local corrosion and cracking. This was the first failure for this type of valve since they were procured and installed in several hypergolic systems at WSTF in 1994.

The valve had been cycled roughly 380 times and seen approximately 177 pressure cycles at around 400 psia (the last 42 cycles were in 2005) since its installation in September of 1994. In 2005 testing began on the IAPU system using high-purity N_2H_4 (rather than monopropellant grade N_2H_4) to determine if there were any significant differences in the corresponding catalyst bed temperatures. High-purity hydrazine is defined as 99.5% pure N_2H_4 . Monopropellant grade N_2H_4 has a purity of 98.3%. During the testing, an internal leak was discovered in the system. The workaround of this internal leak was to alter the system valve configuration. The new configuration had the soon-to-be failed ½-inch manual valve in-line with the main catch tank and the bypass catch tank which resulted in a pressure of 50-psia on the manual valve that subsequently failed. While in this static configuration, the manual valve bonnet fractured and was ejected from the valve into the test cell, spilling the N_2H_4 . The altering of the nominal configuration could be considered a root cause, along with the improper design (primarily material incompatibility) of the manual valve, itself.

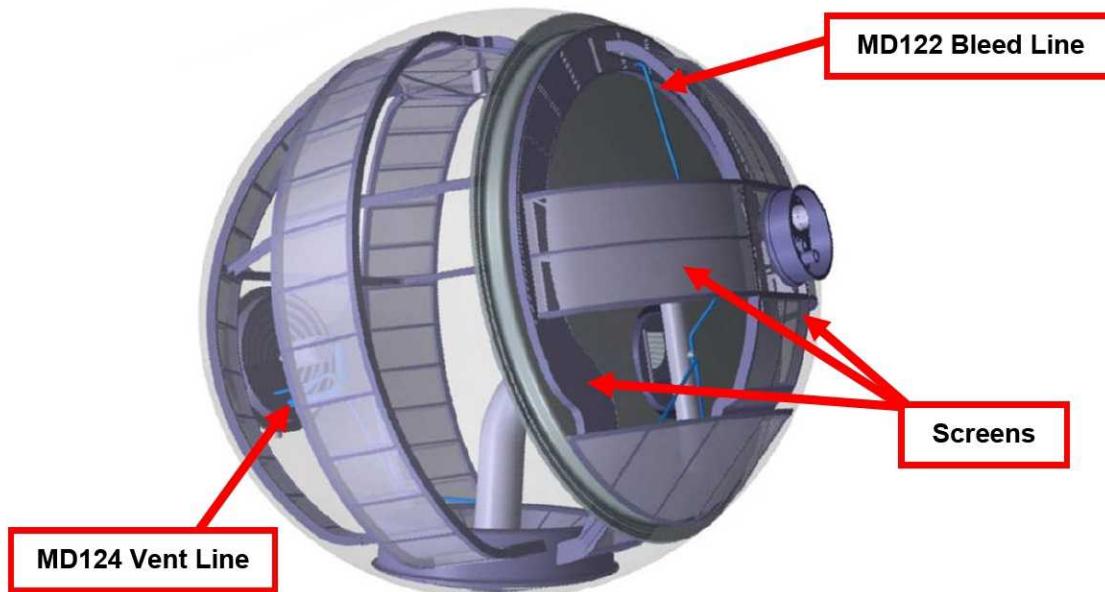
Figure 46-1: Solid Model of RCS Propellant Tank in (Roughly) the Horizontal Orientation

With the vehicle in a horizontal orientation, the MD122 line runs from the high point of the oxidizer tank lower compartment channel, through an interface at the tank outlet flange, and out to an AHC located in an externally accessible door on the FRCS outer mold line (AP28-00 door). It is known through pressure measurements that the MD122 and MD120 connected GSE lines were clear of any liquid immediately following the two, five-minute purges; however, it is not known if the propellant acquisition system channel in the lower compartment was broken down (i.e. it did not contain any liquid). If the screen was not completely broken down, it is possible that liquid oxidizer “wicked” up the screen following the purges to the point where MD122 connects to the acquisition screens. See Figure 46-1 for visual aid of the propellant acquisition system screens and the MD122 line. The absence of liquid in the lines can be confirmed by noting that there was not any significant pressure increase in the lines. The tank was *not* in thermal equilibrium. The tank shell (skin) temperature rose from 49 °F, when tank venting was complete, to 58 °F, when MD124 GSE vent valve was opened for the emergency vent through MD124 in the upper compartment of the tank. When the two purges were complete the tank shell temperature was 54 °F. From the time of the spill to the emergency MD124 vent, the tank shell temperature rose from 57 °F to 58 °F. The fluid and gas temperatures likely rose by a degree or two during this time.

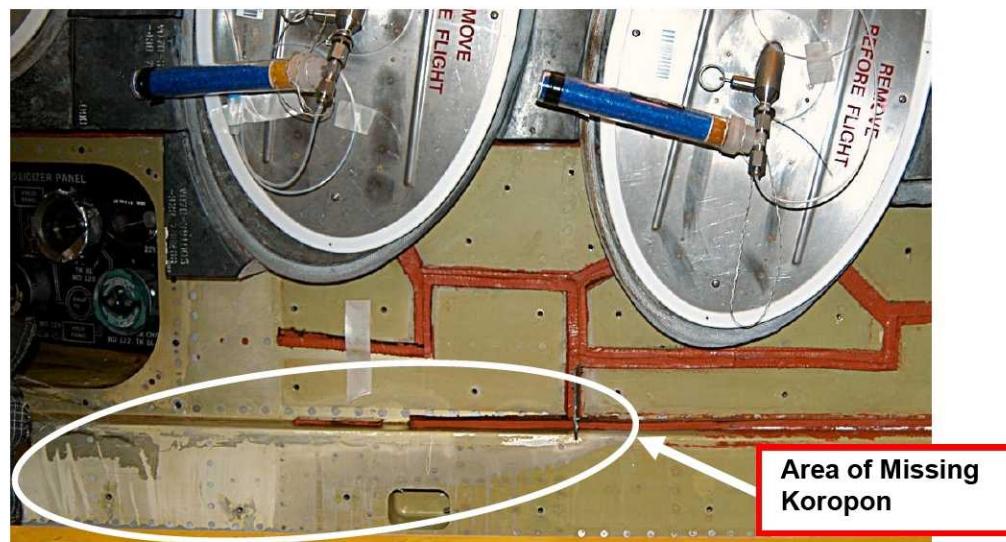
Figure 46-3: View Looking at R/H Side Down-Firing Thrusters (F2D & F4D)

The spilled oxidizer appears to have reacted with Koropon, RTV, and silver plating (nutplates and barrel nut elements). The oxidizer vapors reacted with the Koropon and removed a large area, as shown in Figure 46-3, and passed through the nutplate holes and around the perimeter of the phenolic QD service panel into the interior of the FRCS module, as shown in Figure 46-4, causing damage to the Koropon on the interior side of the FRCS module.
