## HYPERGOLIC PROPELLANTS: THE HANDLING HAZARDS AND LESSONS LEARNED FROM USE

B. Nufer

NASA Kennedy Space Center, Engineering Directorate, Fluids Division, Hypergolic and Hydraulic  
Systems Branch  
Kennedy Space Center, FL 32899

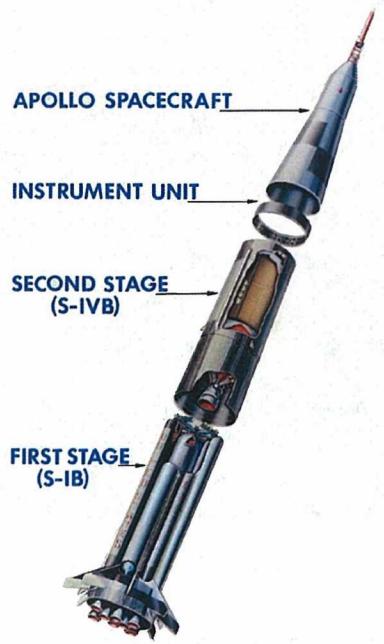
**Figure 4: Saturn 1B Launch Vehicle**

The N<sub>2</sub>O<sub>4</sub> spill occurred when a vacuum was applied to the Command Module Reaction Control System (RCS) propellant tank prior to the second dry-run servicing test. It was later determined that a quick disconnect (QD) servicing valve had become blocked during the initial dry-run test (proximate cause). When the vacuum pump was brought online for the second dry run, oxidizer was pulled into the pump's oil sump and then subsequently released out of the oil sump tank vent port. Technicians used the standard procedure at the time, which was to dilute the propellant using water. This, unfortunately, resulted in the formation of nitric acid. Approximately 400 gallons of water were used to dilute the N<sub>2</sub>O<sub>4</sub> which ultimately ran down the side of the launch vehicle and into the instrument unit ring, as seen in Figure 4 in the Saturn 1B cutaway view.

The damage to the vehicle was extensive and the delay was several weeks. The cleanup on the ground level of LC-34 took several days. A de-stack was completed to remove the instrument unit ring for repair. Most of the wiring in the instrument unit was removed and cleaned. Four cables were replaced and five connectors were rebuilt. Three of the outside antennas were also replaced along with the Saturn IB fin #4 and liquid oxygen bay three door. The forward skirt was removed from the Saturn IV B segment to allow for access inside the launch vehicle. The primary concern for the vehicle was long term corrosion. The vehicle design organization eventually became comfortable with proceeding to launch following several tests. This incident led to the following process and design changes:

- Following use, every QD was disassembled, cleaned, and all soft good were replaced
  - An inadequate maintenance plan was considered the root cause of this incident

- All subsequent GSE tests were performed using a referee fluid such as Freon or alcohol

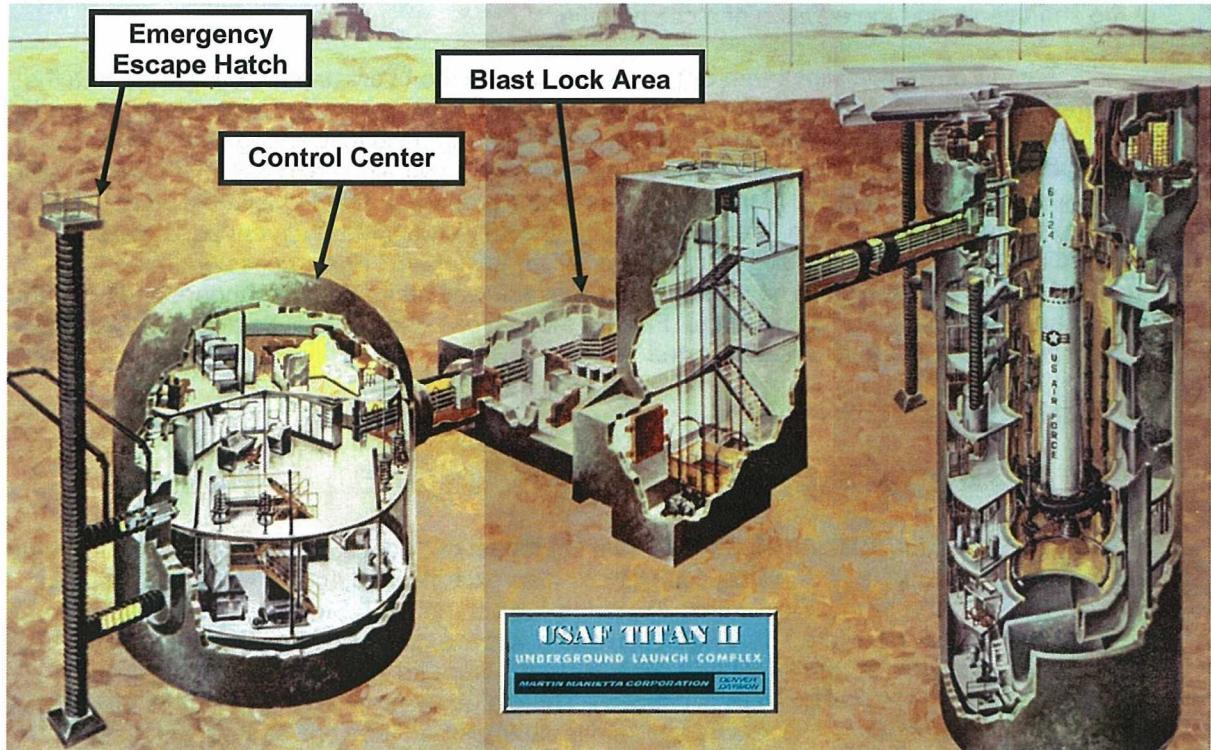
Figure 7: Underground Titan II Missile Complex

Very high concentrations of NO<sub>2</sub> vapors traveled from the silo into the connecting cableway to the blast lock area, which was located just outside of the control center where several personnel were located (see Figure 7). All the personnel located in the blast lock area managed to escape the vapors by exiting through the access portal at ground level. The personnel in the control center would normally be isolated from the silo; however, two technicians involved in the spill opened the airlock door to try and obtain assistance for their supervisor who was in need of immediate medical attention. The two technicians and four other control center personnel then evacuated through the emergency escape hatch, once they realized the immediate danger of the situation. The nearby town of Rock, Kansas had to evacuate about 100 people as a result of the vapors that were escaping from the silo (see Figure 8).

It was later discovered that the suit of the supervisor had failed, introducing him to dangerous levels of N<sub>2</sub>O<sub>4</sub> (NO<sub>2</sub>) vapors, which was ultimately fatal to him within minutes of being

- Proper configuration control of GSE components, in this case the filter, is highly important in the handling of toxic chemicals, especially hypergols (root cause of the incident)
- Emergency procedures and safing must always be reviewed, practiced, and ingrained in the minds of personnel working with toxic chemicals
- Procedural oversight may have been beneficial
- Proper isolation of bulk propellant should be inherently designed into any rocket propulsion system and used accordingly during loading operations
- Personal protective equipment (PPE) should be inspected prior to every use

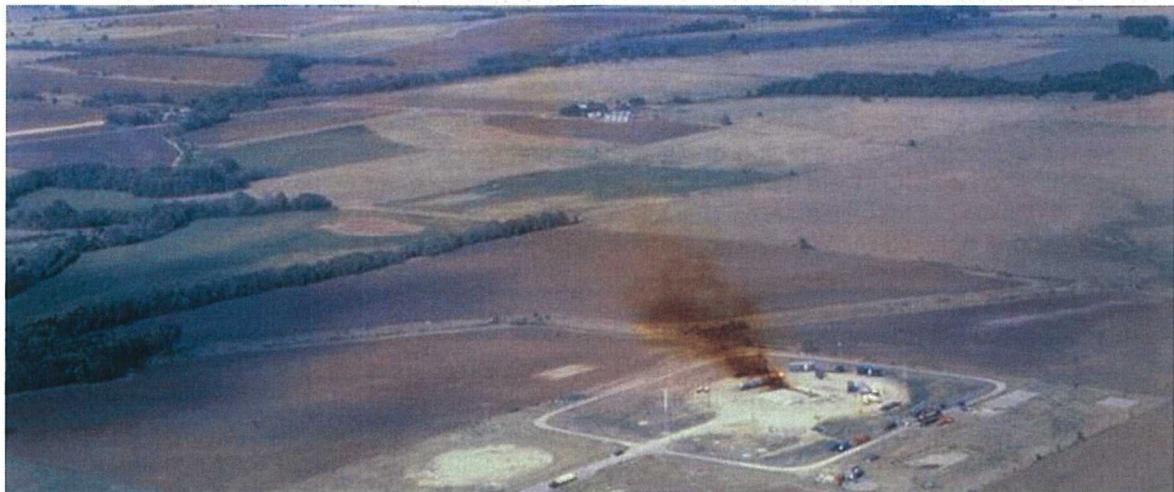
Figure 8: Arial View of  $N_2O_4$  Vapor Cloud Coming from Missile Silo 533-7

On August 24, 1978, at McConnell AFB southeast of Wichita, Kansas, the worst reported unintentional N<sub>2</sub>O<sub>4</sub> spill in U.S. history took place. Approximately 13,450 gallons of liquid N<sub>2</sub>O<sub>4</sub> spilled into the underground missile silo. Two members of the 381<sup>st</sup> Strategic Missile Wing were killed and 25 more were injured from N<sub>2</sub>O<sub>4</sub> liquid and vapor exposure. The silo also suffered extensive damage. The Titan II first and second stages were an A-50/N<sub>2</sub>O<sub>4</sub> bi-propellant propulsion system. The loading operations were completed using a holding tanker located above ground. Recall that N<sub>2</sub>O<sub>4</sub> (NO<sub>2</sub>) vapors are heavier than air and they boil at approximately 70 °F at ambient pressure.

Once the N<sub>2</sub>O<sub>4</sub> loading of the rocket's first and second stages had been completed, all that remained was disconnecting the QDs from the rocket air half couplings (AHC). The technicians wearing Rocket Fuel Handler Coverall Outfits (RFHCOs) were unaware that a Teflon o-ring seal had dislodged from an upstream location, moved through the filter assembly (of which there were no filter elements installed), through the QD, and wedged itself in between the poppet of the AHC and its primary sealing surface on the Titan II (proximate cause) of the spill. This prevented the isolation of the bulk propellant in the first stage oxidizer tanks once the QD was removed. The RFHCOs were similar to SCAPE suits that are used by the Space Shuttle Program. When the technician mechanically separated the QD from the AHC, approximately 13,450 gallons of liquid N<sub>2</sub>O<sub>4</sub> poured out of the AHC and into the missile silo.

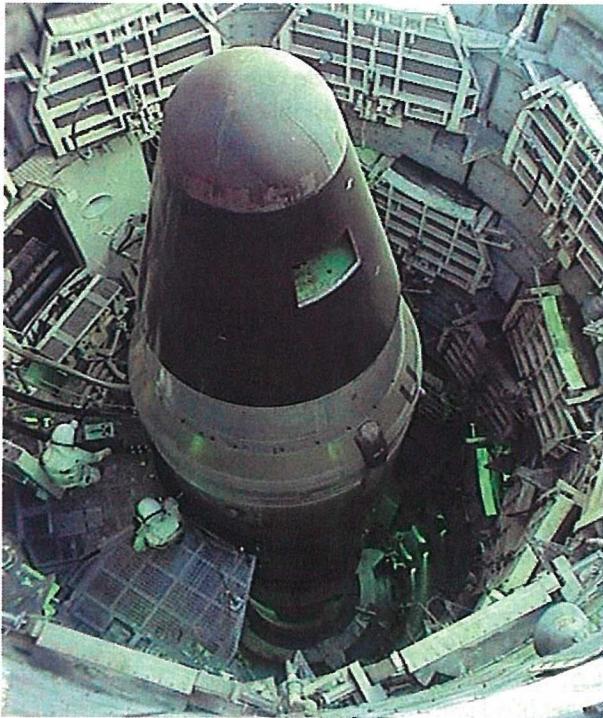
**Figure 9: Technicians Working on Fold-Down Platform in Titan Silo Level 2**

At about 6:30 PM on September 18, 1980, an airman was conducting a maintenance operation on level two (see Figure 9) of the underground silo when he accidentally dropped a large wrench socket. The standing platforms were hydraulically-controlled, flip-down structures with a rubber boot mounted between the platform and the rocket. The socket fell hitting the standing level two platform and bounced in the direction of the rocket where it slipped through the small gap between the rubber boot (which had become pliable over the years) and the Titan II rocket. It fell about 70 feet before hitting the thrust mount near the base of the rocket. The socket then bounced into and ruptured the stage one fuel tank (proximate cause). Approximately 11,140 gallons of A-50 drained into the bottom of the silo. Fuel vapors heated up the silo and caused the pressures in the non-ruptured propellant tanks to rise substantially.

- All workers should wear a belt with lanyards to attach tools
  - Operational human error is, therefore, the root cause
- Cloths should be placed on the platforms to prevent tools from bouncing off the metal

- The Titan II missile silo platforms should be renovated to increase safety
- The training and qualification program was insufficient prior to the incident (a root cause)

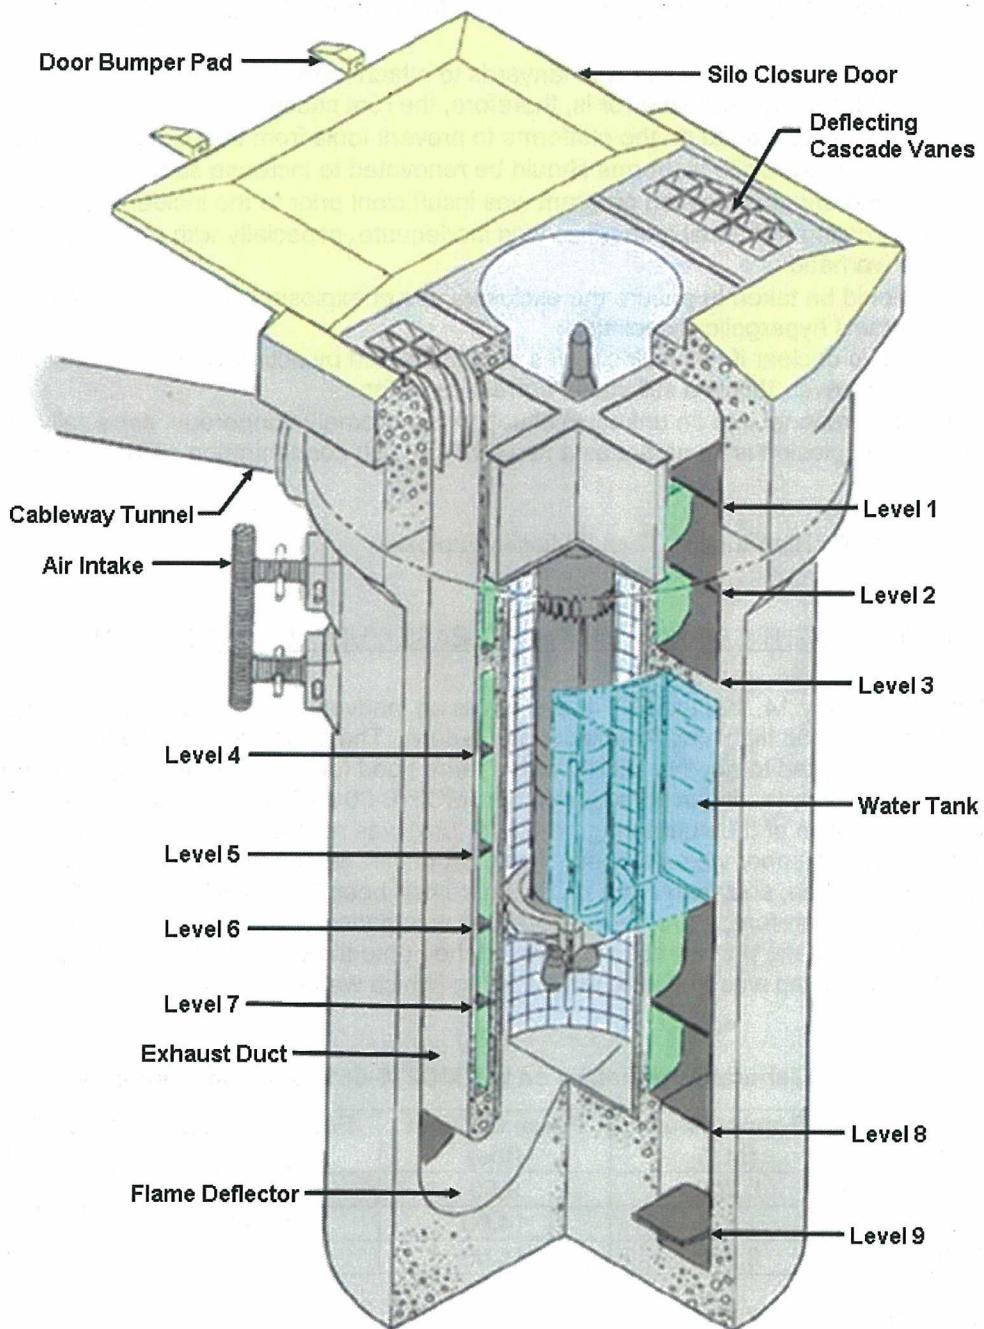
**Figure 10: Titan II Missile Silo**

It was reported that the explosion blew the 740-ton reinforced concrete and steel silo door (see Figure 10 for a depiction of the Titan II missile silo) 200 feet into the air and 600 feet from the silo. The rocket's second stage, with the W53 thermonuclear warhead attached, was launched out of the silo following the explosion of the first stage. The second stage then supposedly blew up in midair, (it contained about 1,730 gallons of A-50 and 3,120 gallons of  $\text{N}_2\text{O}_4$ ) sending the undetonated warhead several hundred feet from the silo. The W53 warhead had a mass of 8,136 lb and a yield of 9,000 kilotons (the Hiroshima bomb "Little Boy" was estimated at about 15 kilotons). Luckily the warhead's safety features operated as they were designed. There was no reported loss of radioactive material.

- Communication with local authorities was inadequate, especially with reference to the nuclear warhead
- Care should be taken to ensure the exclusive use of explosion proof hardware in a facility that contains hypergolic propellants

- It is unclear if this incident was indeed caused by activating the exhaust fans; however, this is a still viable corrective action
- Sending personnel into an unknown situation is extremely dangerous, especially one in which an explosion is imminent as a result of the high concentration of fuel vapors

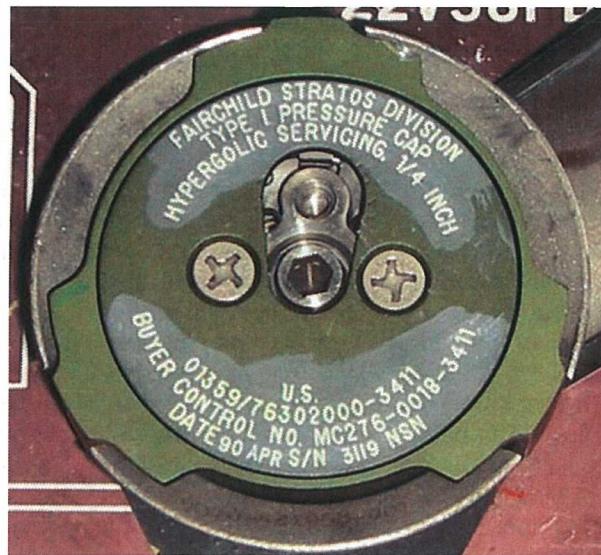
**Figure 11: Fairchild 1/2-inch Flight Cap**

On roughly July 14, 1981 in OPF1, there was an inadvertent release of N<sub>2</sub>O<sub>4</sub> (NO<sub>2</sub>) vapors during the MD338 flight cap installation procedure. The cap was removed from MD338 on June 15, 1981 and routed to another facility with a fume hood for refurbishment. During the refurbishment procedure the incorrect part number (MC276-0018-2411, a ¼-inch flight cap, see Table 1 for a description of the numbering nomenclature) was recorded for the cap and a parts tag with the incorrect number was attached. The correct part number was MC276-0018-2811 (a ½-inch oxidizer flight cap, shown in Figure 11). There had been issues with oxidizer flight caps becoming corroded; therefore, a problem report (PR) was generated to clean the caps. During the cleaning procedure the part number that was etched onto the cap was sanded off and all that was left to identify the cap was the attached parts tag (which was incorrect).

During the MD338 flight cap installation procedure, on roughly July 14, 1981, the work step correctly called for the installation of a 1/2-inch cap (part number MC276-0018-2811) onto the AHC. The cap that was staged for installation was the misidentified 1/4-inch cap. When a 1/4-inch cap is placed onto a 1/2-inch AHC, the dimensions of the stem allow for the actuation of the 1/2-inch AHC poppet (reference Figure 30 for an illustration of this) if the proper force is applied to the cap and poppet. This is exactly what happened. An oxidizer vapor release was reported when the technician tried to install the 1/4-inch cap (proximate cause). The root causes are human error, improper configuration management, and improper vehicle design. The original flight cap design should not have enabled this type of incident to occur. The technician received minor injuries from exposure to NO<sub>2</sub> vapors. Close attention needs to be paid to the identification of flight caps and other hardware to prevent an event like this from occurring again (which it does on November 4, 1992 at WSTF).

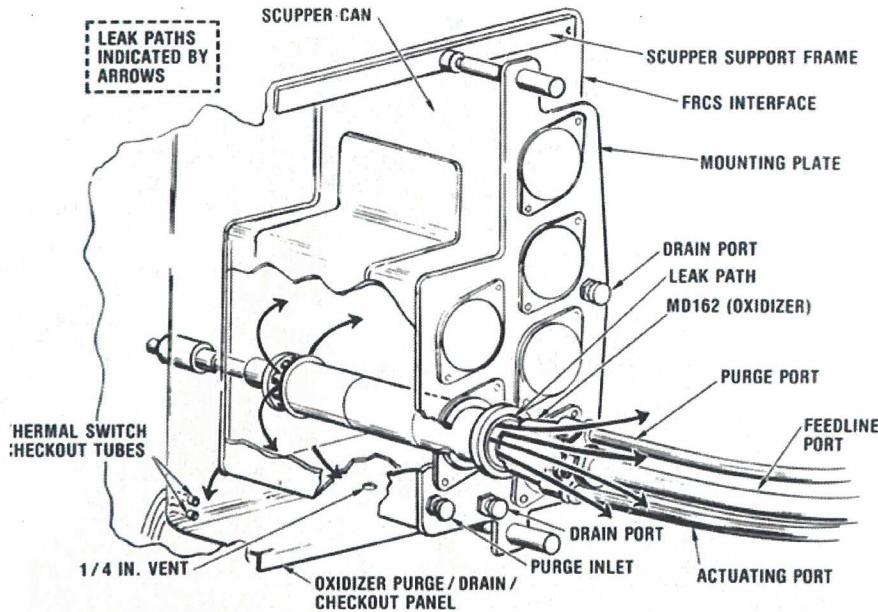
**Figure 12: Drawing of AP28-12 Door and Failed MD162 GHC**

At 1:13 AM on September 22, 1981 an N<sub>2</sub>O<sub>4</sub> spill occurred at Pad 39A. The proximate cause of the spill was a failed ground half coupling (GHC), MD162, at the AP28-12 door (shown in Figure 12) on FRC2 of OV-102 (Columbia). Failure of the GHC was a result of iron nitrate build-up between the probe and the dynamic head of the GHC along with the tight tolerances of the GHC. See Figure 13 for a description of the AHC and GHC and also the failure location. Between 15 to 20 gallons of oxidizer was released into the attached scupper, which subsequently overflowed onto the vehicle. Damage to thermal tile adhesive resulted in the removal of 370 tiles (shown in orange in Figure 14). The photograph in Figure 15 shows the thermal tiles and the underlying vehicle structure along with the scupper and QD flexhoses going into the AP28-00 door (second FRCS oxidizer servicing door just beneath the AP28-12 door when the vehicle is in the vertical orientation).

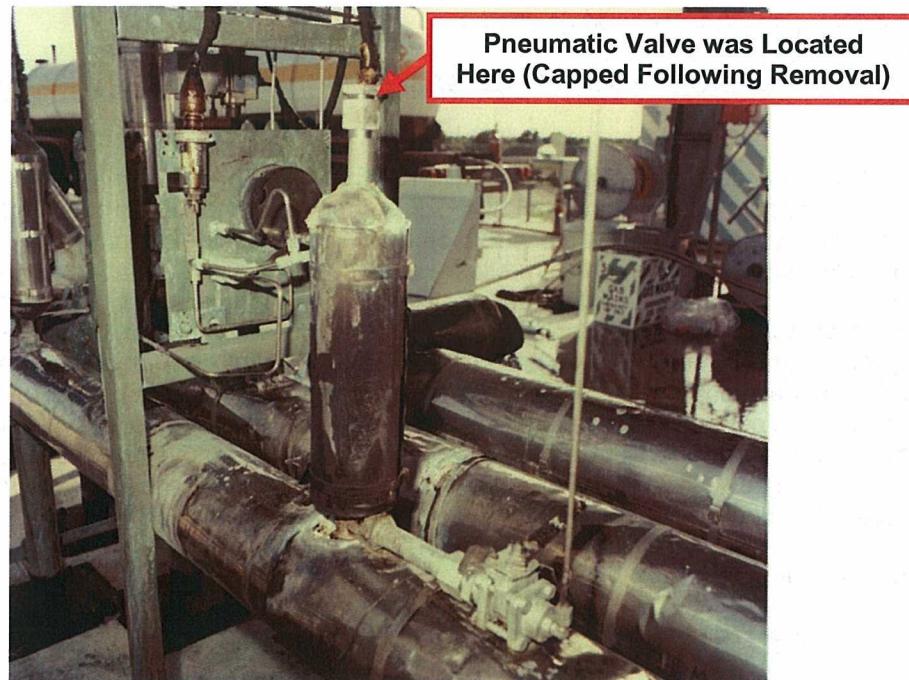
Figure 16: Photograph of Fuel Farm Following Fire

- The procedure was not written or reviewed by an experienced engineer prior to the task
- The engineer on console was making changes to the procedure real-time while monitoring another task in parallel
  - Improper adherence to the procedure and the procedure approval process are also root causes of this incident
- There was only one engineer on console supporting the hazardous operation
  - The engineer had to leave the communications channel to talk to the test conductor and in doing this missed some reports from the personnel at the fuel farm
- There was not a charged water line nearby when the fire occurred

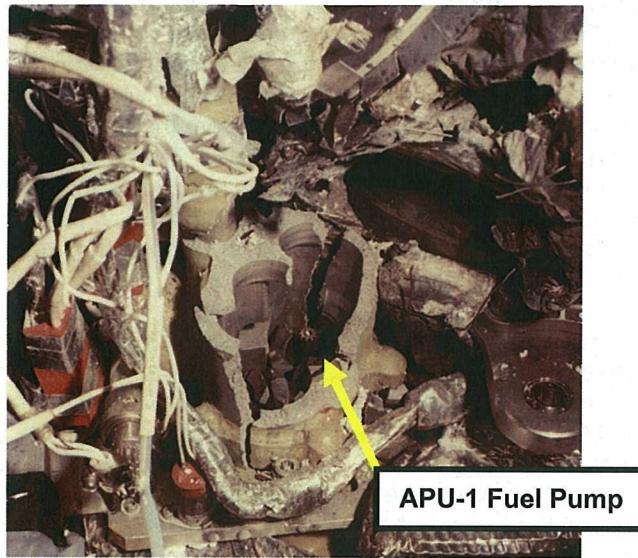
Figure 18: APU 1 Fuel Pump Explosion Following STS-9

*The APU failures most probably resulted from a crack in the injector stem caused by corrosion of the sensitized inside diameter surface. The corrodant is probably carbazic acid or some similar substance which can be derived from air, moisture, CO<sub>2</sub>, hydrazine and/or ammonia. The corrosion is time dependent and the crack progressed under sustained stress levels from the inner diameter surface toward the outer diameter surface until mechanical or thermal fatigue conditions could [complete] the crack rupture."*

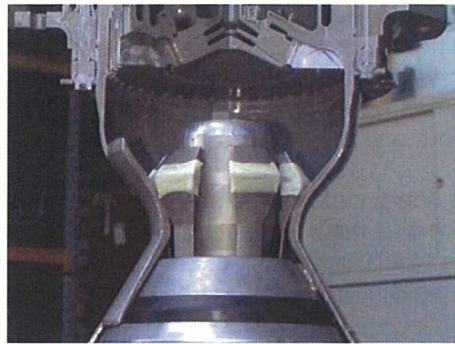
Figure 20: Space Shuttle Thruster Chamber Cutaway with Purge Adapter Installed

On May 24, 1985, while preparing for the removal of R4D (down-firing thruster on the Space Shuttle right pod) from OV-099, there was an MMH spill in OPF1 on the 10-foot level west side. R4D was being removed as a result of an in-flight anomaly related to a heater failure on the thruster. The manifold had been drained of its propellant and it was thought that a purge through the MD348 line (which connects to the manifold) and out the thruster nozzle purge adapter was sufficient to remove the liquid and most of the fuel vapors. Figure 20 shows a purge adapter in a cutaway of a primary thruster nozzle. During the part of the procedure where the purge adapter was being removed, approximately one cup of liquid MMH spilled from the thruster and down onto the body flap (which is illustrated relative to thruster R4D in Figure 21). The body flap was partially covered with spill protection sheets. The OPF1 hypergol exhaust fans were activated and the facility was immediately evacuated. It was recorded that some of the liquid MMH had saturated the body flap tile filler bar. It is unknown if the tile had to be removed. Unlike N<sub>2</sub>O<sub>4</sub>, which was known to breakdown Koropon primer (from the STS-2 N<sub>2</sub>O<sub>4</sub> spill mentioned previously), the effect of MMH on Koropon was not well known in 1985.

There are three possible proximate causes to this spill. A combination of two or more of the following causes is also possible. The first involves an improper configuration in which the flexhose that was being used for the procedure had previously been utilized for a similar operation on the left pod thruster L1U's manifold. This flexhose was several feet longer than the flexhose that was normally used for the right pod manifold evacuations. It was routed from the R4D thruster purge adapter to the 19-foot level above, then down to the eductor on the 10-foot level. This excessive length in hose may have allowed for a "u-shaped" low point trap to be formed in which liquid MMH could have collected. The second possible proximate cause involved a procedural error made by the engineers on console. The evacuation could have created a pressure differential across the liquid MMH. When the eductor was deactivated and removed, this pressure differential may have pushed the liquid into the thruster chamber. The third possible proximate cause was the liquid had collected in the thruster chamber (see Figure 20) and the purge was of insufficient duration to remove all the liquid MMH or the liquid trap may have

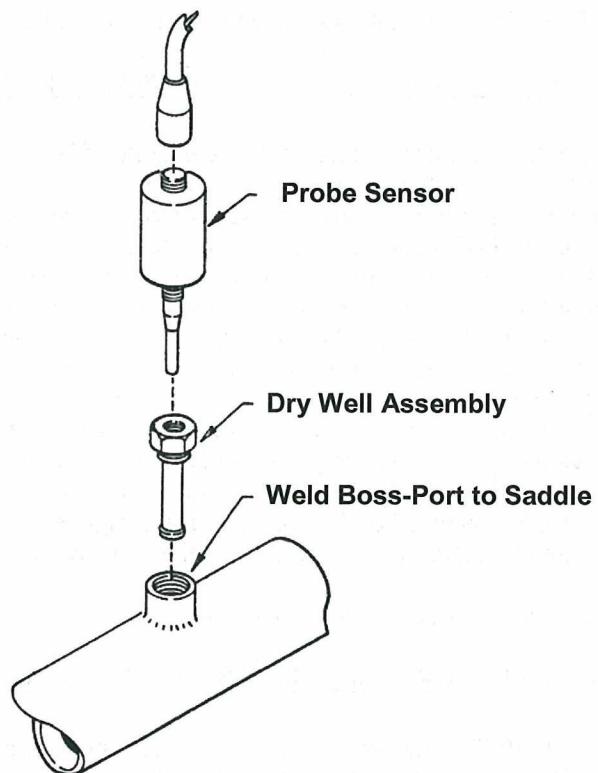
**Figure 22: Transducer and Dry Well Assembly**

*"The LSOC hypergolic mechanical technician actually performing the task of transducer removal used incorrect shop practice and loosened the wrong nut. Instead of using a one-inch wrench to retain the dry well in place while loosening the transducer lock nut that threads into the dry well, he used the wrench to loosen the dry well. He then used his hand to unscrew the transducer thinking he was extracting the transducer from the dry well while he was actually unscrewing the transducer dry well assembly from the three-inch MMH line. A mixture of fluid and vapor MMH immediately erupted from the line sending a column 10 to 12 feet in the air."*

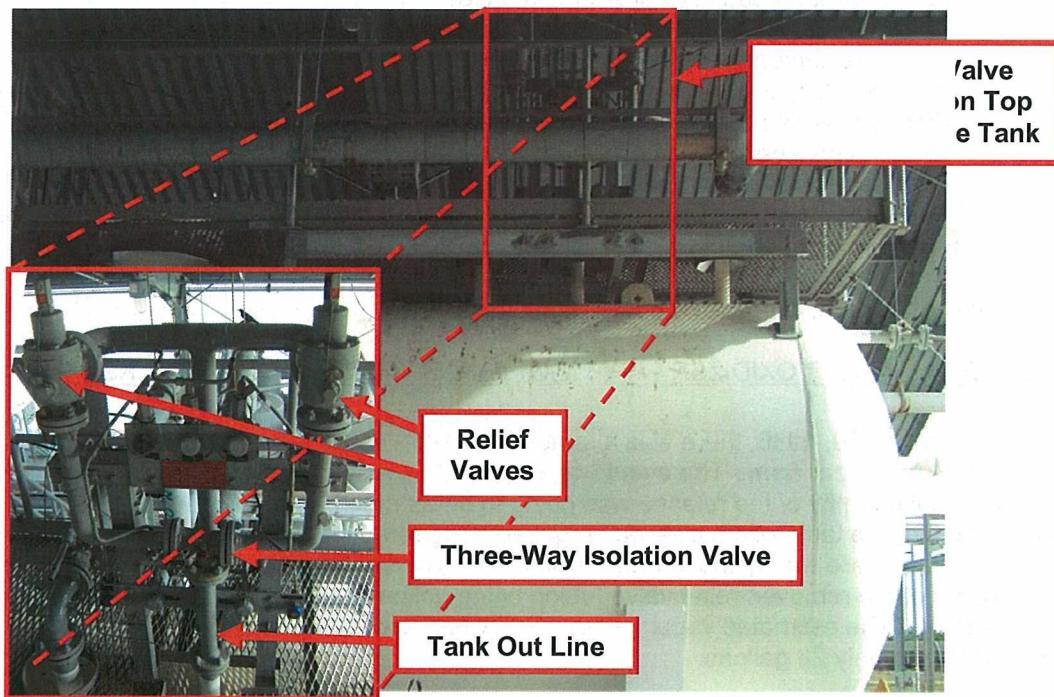
Figure 23: Dual Relief Valve Modification Location

An improper GSE design and operational human error were the root causes of this incident. About ten months prior to this relief valve removal and replacement operation, a formal request had been submitted by engineering to install a dual relief valve system onto the storage tank with a three-way isolation valve to prevent a vapor release during component removal. This request was denied. Following the large vapor release, the modification was implemented at both launch pads, greatly reducing the possibility of any future hazard. This dual relief valve modification allowed for isolation during the relief valve annual maintenance. The modification was also implemented on the fuel storage tanks at both launch pads. Figure 23 is a photograph of the relief valve locations on the top of the N<sub>2</sub>O<sub>4</sub> storage tank with a close-up photograph of the relief valve three-way isolation valve modification.

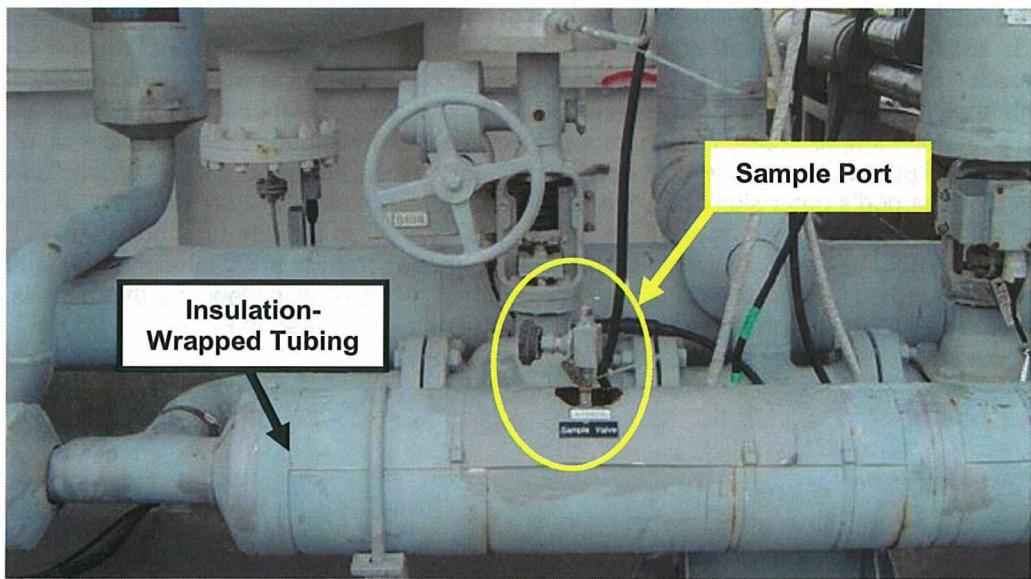
Figure 24: Photograph of Sample Port

On May 25, 1988, at the Pad 39B oxidizer farm, technicians were completing an N<sub>2</sub>O<sub>4</sub> sampling operation. During the operation, the technicians detected a small leak at the interface between the sampling valve and the tubing (see Figure 24). The sampling operation was delayed until the leak could be fixed. The repair was finally scheduled to be worked about a month later during the afternoon of June 23, 1988. The removal of some local insulation was required to fix the leak along with re-torquing the fitting that connected the sample valve to the tubing. This was all completed that afternoon.

At about 10:30 PM on June 23, 1988, the sampling operation was successfully repeated. This was followed by the disconnection of the sampling flexhose from the sample port. When the flexhose was removed, liquid N<sub>2</sub>O<sub>4</sub> spilled (about two tablespoons) into the small well surrounding the sample port. It was not uncommon to have a small amount of residual N<sub>2</sub>O<sub>4</sub> remaining in the sample flexhose when it was disconnected. The spilled N<sub>2</sub>O<sub>4</sub> reacted with the adhesive used for the attachment of the insulation to the tubing and ignited (proximate cause of the fire). The fire burned itself out in about 10 to 15 seconds before the technicians in SCAPE could return with a fire hose. There were no injuries to the personnel working the operation and the only hardware damage was to the insulation, which was replaced.

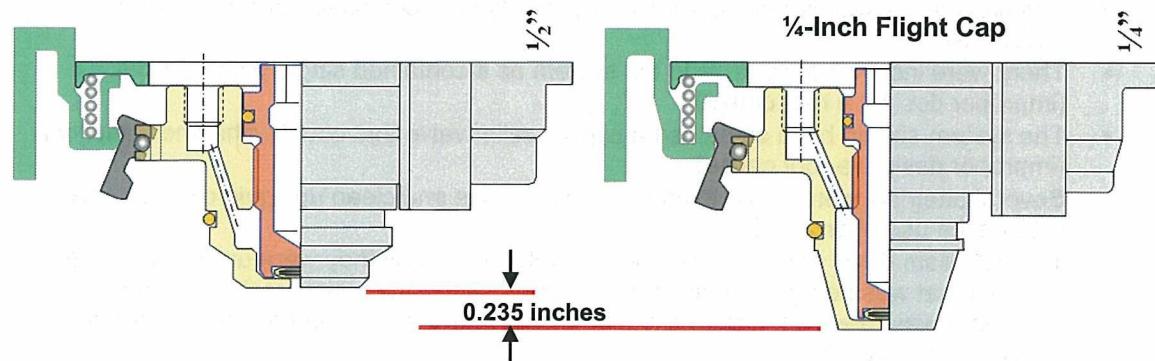
Figure 30:  $\frac{1}{4}$ -inch and  $\frac{1}{2}$ -inch Hypergolic Flight Cap Cutaway View

- The appearance of a  $\frac{1}{4}$ -inch AHC cap is such that it could be mistaken for a  $\frac{1}{2}$ -inch AHC cap to an untrained technician
  - The technician was undergoing on the job training under the direct supervision of an experienced technician, but the distinction between a  $\frac{1}{4}$ -inch cap and a  $\frac{1}{2}$ -inch cap was not explained to him
- Age and wear made part number identification on the AHC cap difficult
- Work instructions should be written to include positive identification of interface equipment
- AHC cap mating should not be considered a benign activity; therefore, PPE should be used to protect the employees from credible releases of propellants
- Future designs should consider keying of AHC caps to preclude incorrect size/commodity installation

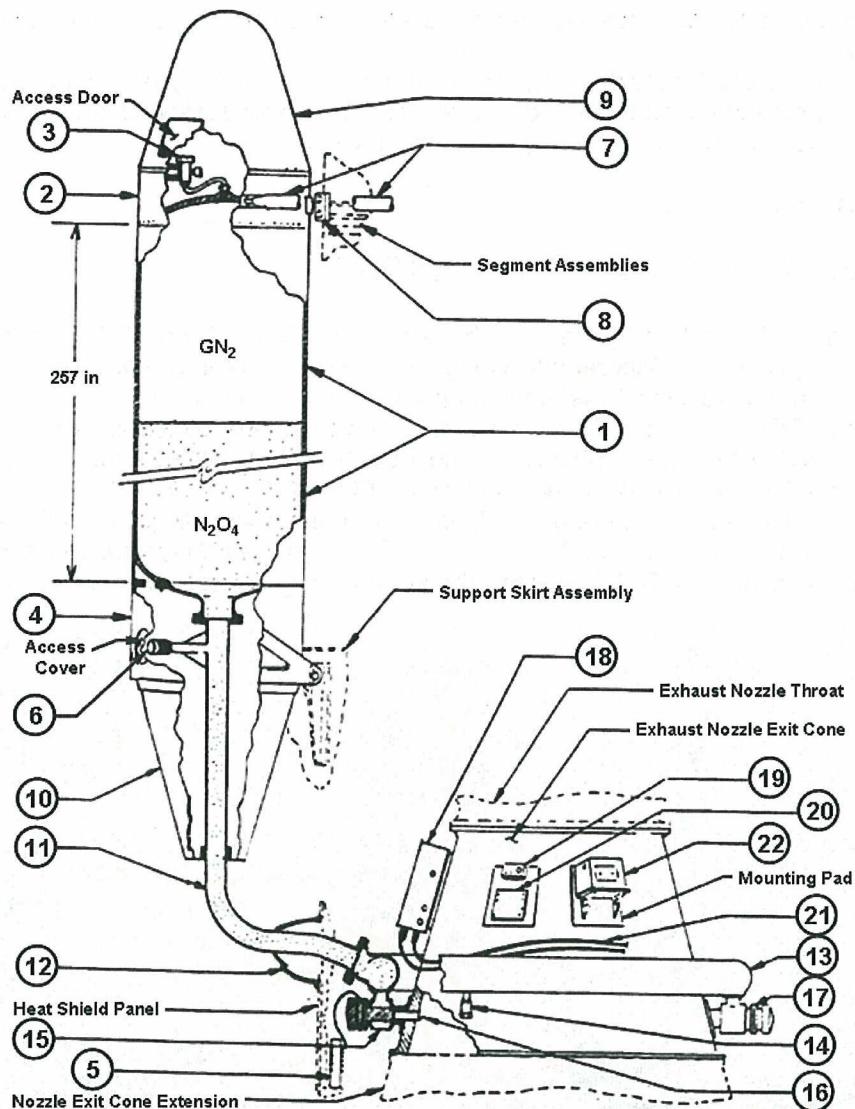
Figure 32: Titan IV A TVC System Schematic (see Table 2 for references)

On August 20, 1994, at Space Launch Complex 41 (SLC-41) on CCAFS there was a large release of liquid N<sub>2</sub>O<sub>4</sub>. Oxidizer was being loaded into the Titan IV A's solid rocket motor (SRM) thrust vector control (TVC) system in preparation for the launch of the National Reconnaissance Office's Mercury Electronic Intelligence or ELINT satellite on August 27, 1994. The N<sub>2</sub>O<sub>4</sub> was used to alter the combustion in the Titan IV A SRM nozzle and, therefore, provide TVC. A photograph of the SLC-41 launch pad with a Titan IV A is shown in Figure 31. A diagram of the Titan IV A's TVC system is shown in Figure 32 with the numbered callouts listed in Table 2. The incident occurred about three and a half hours after sunrise when the solar heat caused the pressure to increase in the N<sub>2</sub>O<sub>4</sub> tubing while the system was in a static configuration.

The pressure increase went unnoticed by the engineers and technicians. Remote data monitoring was available on the launch vehicle, but not on the propellant transfer systems (GSE). Local dial gauges likely showed the increase in pressure; however, there were no technicians monitoring these particular gauges. The pressure rise eventually caused a weld seam to fail at the base of the transfer system (proximate cause). This portion of the N<sub>2</sub>O<sub>4</sub> servicing GSE lacked a relief valve, thus allowing the propellant in the tubing to become "liquid locked" since a drain-back and purge had not been completed (improper design; a root cause). There was no damage to the GSE (excluding the ruptured tubing) or vehicle hardware and there were no reported injuries.

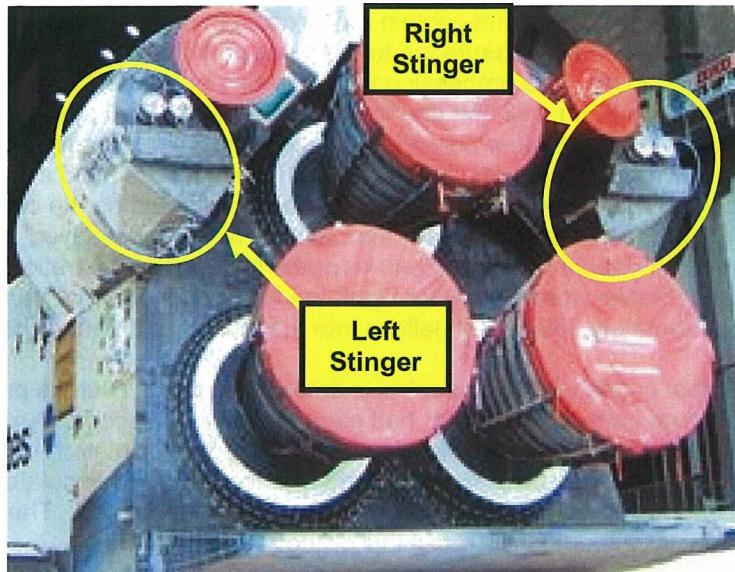
**Figure 33: Stinger Locations on Orbiter**

During the STS-69 OV-105 flow, while performing a thruster L3D removal and replacement, an MMH flame was reported in the Space Shuttle left OMS pod stinger area (see Figure 33 for the relative location of the stingers). The technician in SCAPE was preparing to inspect the dynatube (approximately an hour after the thruster was removed) with a mirror when he reported a small flame on the MMH thruster feedline dynatube. Another technician was unable to find any water to put out the fire and mistakenly picked up an alcohol bottle and sprayed the flame which produced a small flash near the feedline, igniting the residual MMH inside it. It is believed that the technician thought the spray bottle was Freon. It was reported that the flame was extinguished by the technician placing his SCAPE glove over the dynatube end. This was probably not the best idea since MMH can react exothermically in a rigid volume and burn in an atmosphere 2.5% to 98% by volume in air.

Prior to the reported fire, the technician removed the Aclar (plastic film) bag from the open end of the thruster feedline dynatube fitting. This fitting connects the manifold to the thruster. When he did this, he noted that there was an exceptionally large amount of fuel vapor present and some liquid MMH was dripping from the open line. The technician proceeded to place the aspirator directly on the feedline dynatube (the procedure and known practice was to place the aspirator perpendicular to the dynatube exit). This was likely the proximate cause of the fire. The engineer on console then noted that the manifold pressure dropped from 16 psia indicated to 6 psia indicated in about five seconds (the transducer had a 2 psi offset). The manifold pressure stabilized to 16 psia indicated after a couple minutes. At this point, the technician was instructed by the engineer to remove the aspirator from the dynatube. He did this and then left the area to find a mirror to aid in the dynatube inspection. When he approached the dynatube with the mirror he noted a "cream/yellowish color" flame and "heat waves." As previously mentioned, he proceeded to put out the flame with his glove after the other technician doused the area with alcohol.

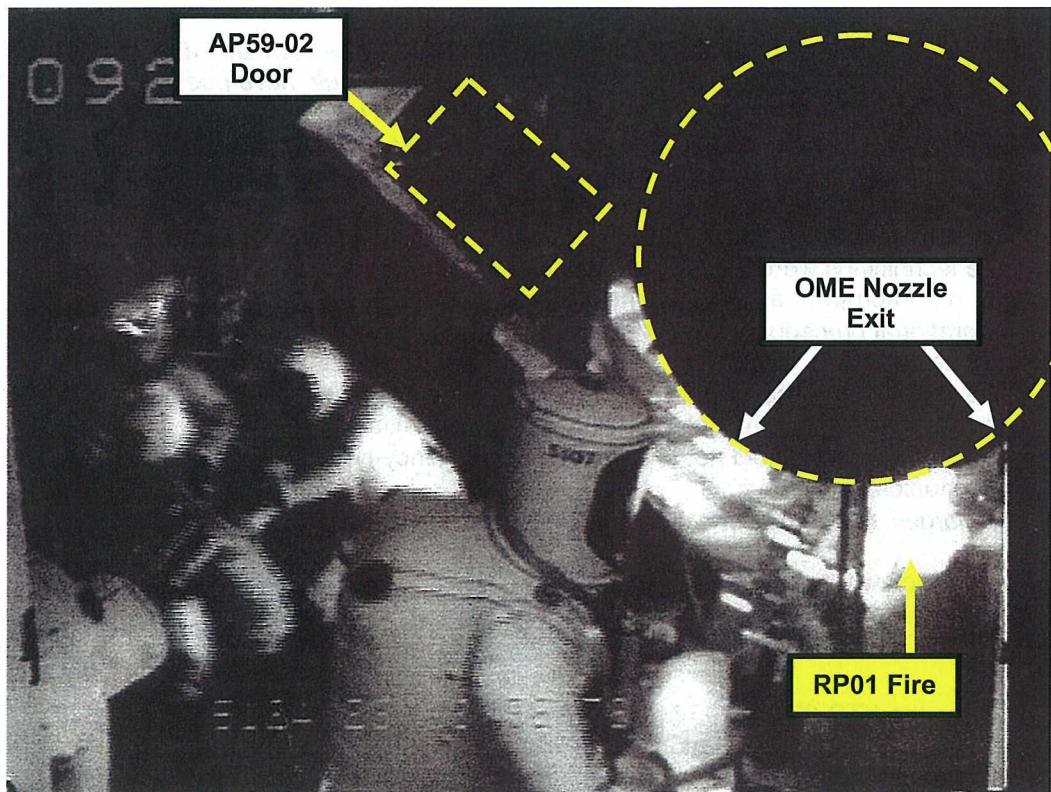
Figure 34: Still Photograph from Video of RP01 Fire

The technicians managed to put the fire out with a parts rinse bucket nearby, which they had to refill several times with water in the safety shower. Apparently, there was not a charged water line in the vicinity. Once the fire had been reduced in size from a large flame to a small flame at the open end of the dynatube, a technician cupped the end of the dynatube with his SCAPE suit glove and placed the aspirator in the flame, which immediately put out the fire.

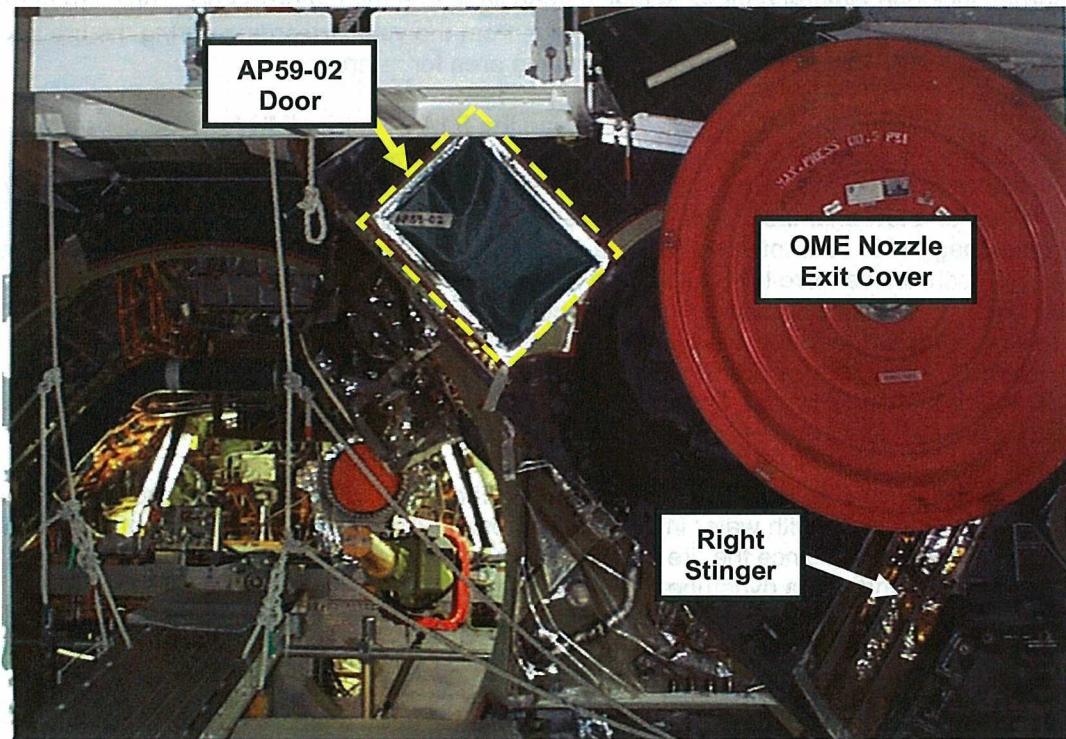
Figure 35: Color Photograph of Right Pod and Orbiter Aft

During the STS-69 OV-105 flow, while performing a thruster R1A removal and replacement, a fire broke out in the Space Shuttle right OMS pod stinger area. The fire burned strongly for about 30 seconds and a smaller flame burned for about one minute and 45 seconds. The size of the flame was estimated to be approximately 15 inches x 11 inches x 11 inches with a damage region of approximately 22 inches x 14 inches x 14 inches in the stinger. The materials that burned included several ounces of fuel, a shop light, and the Orcofilm spill protection (flame retardant covering films). Figure 34 is a still image from the video recording during the fire and Figure 35 is a clearer color photograph of the same area for reference.

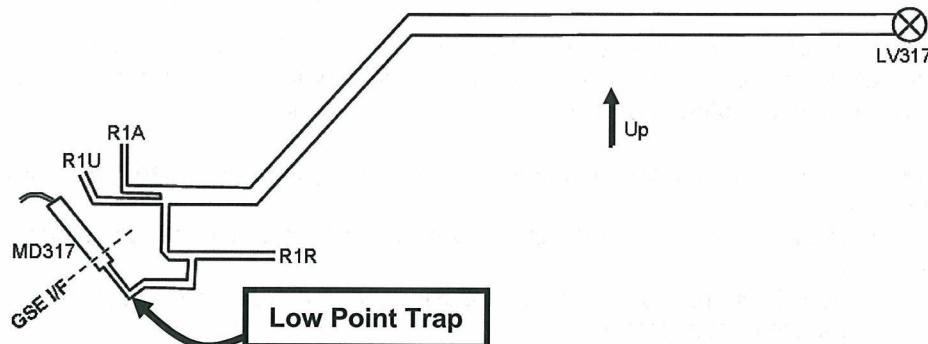
Figure 36: Approximate Manifold 1 Layout Schematic

Another possible scenario (not included in the formal mishap report) for the pressure increase was put forth stating the pulse purges were unable to remove all the liquid MMH as a result of a low point trap present in the manifold near the MD317 (manifold 1 drain/purge QD) AHC interface. Figure 36 shows the basic layout and low point in fuel manifold 1 in the right pod stinger area. It is believed that during the purge, gas was unable to enter the line through the MD317 QD to displace the liquid MMH out of the manifold. This was a result of a small bubble that had formed in the low point as a result of helium coming out of the liquid MMH/helium solution. The helium slowly coming out of solution may have been the source of the pressure rise in the manifold rather than a leaking manifold isolation valve. Once the fire started, it heated the area thus increasing the pressure and pushing additional fuel out of the fuel feedline that was trapped. In both scenarios (leaking manifold isolation valve or helium coming out of solution), liquid MMH was present in the manifold line just prior to and during the fire and the manifold pressure increase went unnoticed.

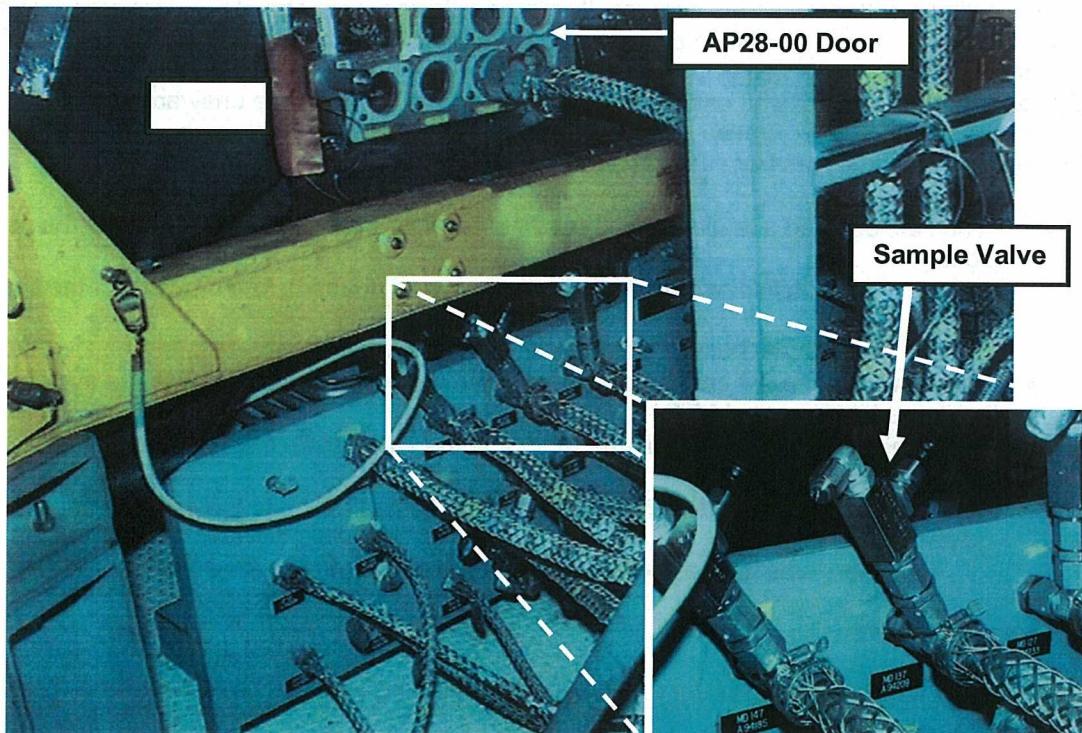
**Figure 37: MD137 Flexhose Sample Valve**

One technician powered up the aspirator and then began to remove the sampling valve outlet cap from the MD137 flexhose (see Figure 37 for a close-up view of the sampling valve). A TVC of the area was then performed with a resulting reading of 0.0 ppm. The technician laid the aspirator hose on the side of the rack, which was not a suitable position to capture any liquid or vapor that may be released from the valve outlet as the procedure stated.

The technicians were then at the point in the procedure where the valve was to be opened. The procedure was written to imply that there may be some vapor released from the valve when it was opened. Liquid MMH was not expected, but, as it turns out, there was a liquid

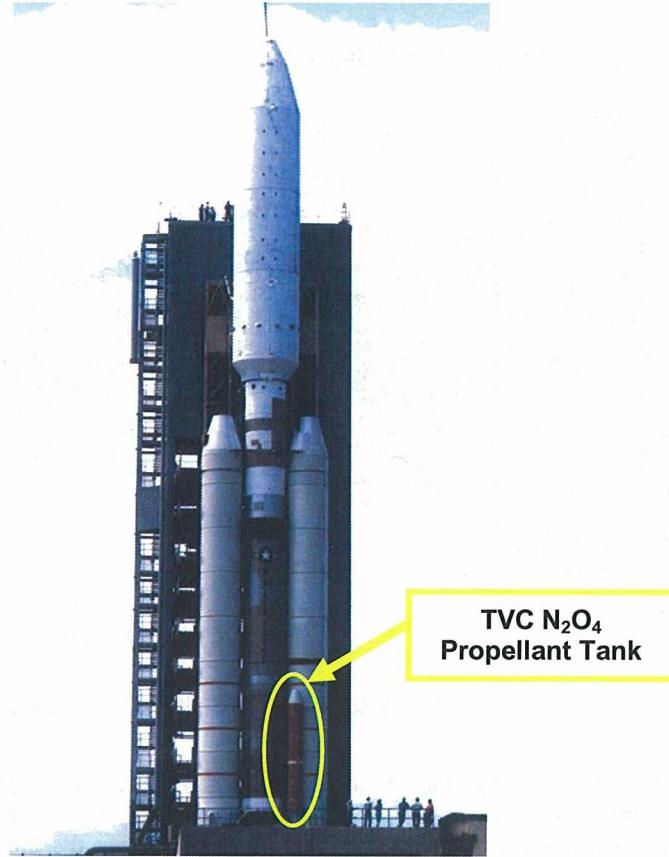
Figure 38: Titan IV A on Launch Pad

satellite. Figure 38 shows a Titan IV A configuration at its launch pad and points out the location of the N<sub>2</sub>O<sub>4</sub> tank.

About 20 minutes after initiating the propellant tank pressurization, liquid N<sub>2</sub>O<sub>4</sub> was observed to be streaming out of the aft skirt heat shield region on *both* SRMs. There were no reported injuries and the flight hardware had minimal collateral damage (mainly on the SRM nozzles). At the time of the observed N<sub>2</sub>O<sub>4</sub> release (likely initially noticed by the signature brownish-orange NO<sub>2</sub> vapors characteristic of an N<sub>2</sub>O<sub>4</sub> spill) the propellant tanks were at a pressure of about 830 psi. The target pressure was about 1,040 psi. The engineers quickly began to depressurize the propellant tanks, which had the immediate effect of decreasing the rate of propellant release. The tanks were vented from their initial pressure of about 830 psi to a final pressure of 38 psi, at which time the N<sub>2</sub>O<sub>4</sub> release ceased. At that time, all systems were secured and the operation terminated. It was decided to offload all of the propellant from the subject tanks, so about eight hours later, the engineers and technicians began the offloading procedure. This operation was completed without incident. Following the offload and evacuation of the TVC N<sub>2</sub>O<sub>4</sub> system and tubing, the total amount of propellant transferred was estimated. About 1,160 gallons of N<sub>2</sub>O<sub>4</sub> was re-captured as a result of the drain-back. This logically implies that about 244 gallons of N<sub>2</sub>O<sub>4</sub> was released to the atmosphere.

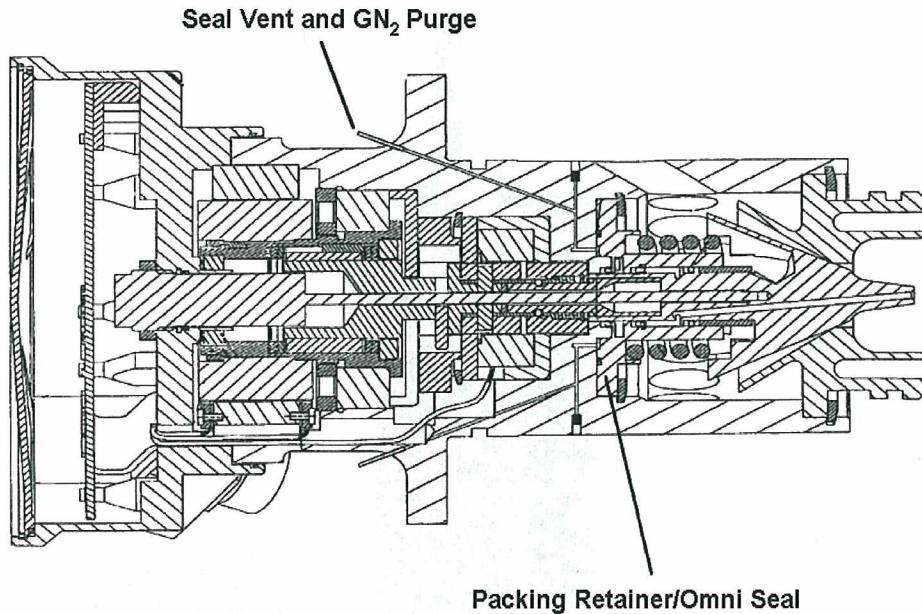
**Figure 39: Titan IV A TVC FCV Cutaway View**

The degradation of the omniseal resulted in liquid N<sub>2</sub>O<sub>4</sub> flowing into the FCV's electronics compartment and out the purge port. There were no leaks found within the TVC propellant tank or the associated system plumbing.

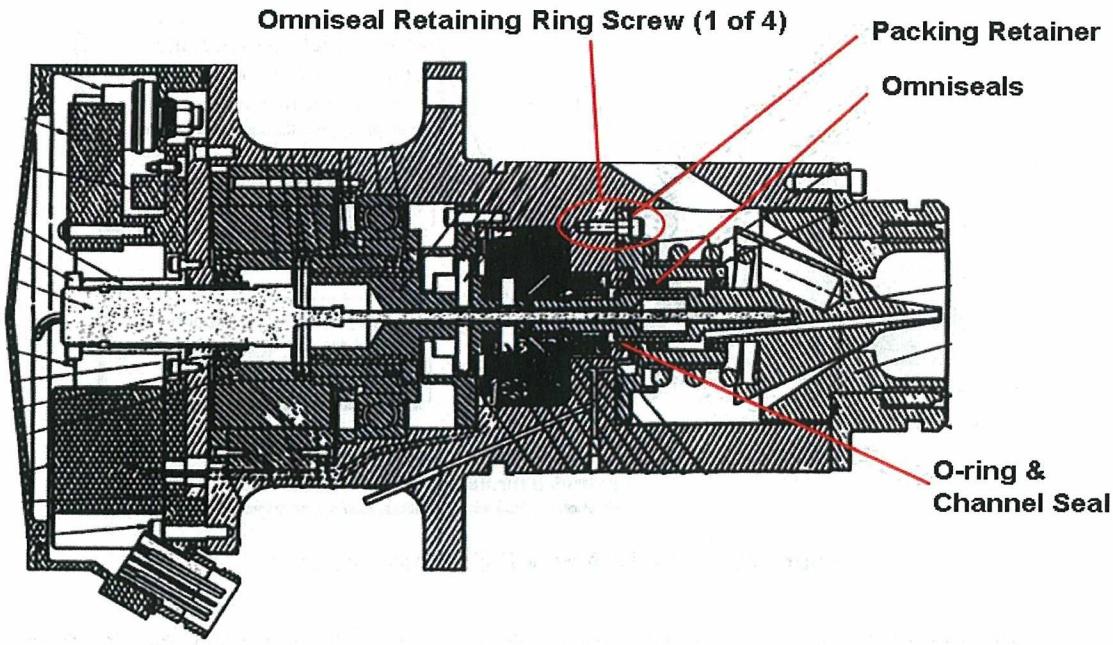
Figure 40: Titan IV A TVC EMV Cutaway View

The component design change was driven by the difficulty in manufacturing the EMVs, as well as some of its internal components becoming obsolete. A cutaway view of the EMV is shown in Figure 40. The intent of the valve redesign was to make as few changes as possible to allow for consistent manufacturing, part machining, and part procurement, as well as using the same outer housing of the valve to allow the new FCV to essentially be "dropped in" without any TVC system modifications. There are several noted differences between the two valve designs. One significant difference is their method of fastening the packing retainer to the omniseals. Both designs utilize an omniseal to isolate the N<sub>2</sub>O<sub>4</sub> from the valve's electronic compartment. However, the original EMV design fastened the omniseal and packing retainer using four screws, whereas the superseding FCV design employed a snap-ring to fasten the retainer. The four mechanical screws on the EMVs left a much smaller gap (if any) between the component surfaces, whereas the FCVs snap ring design, while sufficient for its launch duty, had a large

enough gap between the component surfaces that the liquid Bio T-200A cleaning solvent was able to accumulate on the omniseal spring.

A total of 74 EMVs which had been cleaned with Bio T-200A successfully flew in the Titan IV A TVC system. The Titan IV program accepted the use of Bio T-200A as the cleaning agent for the new FCVs by analysis, ground test, and similarity to the cleaning agent's use on the EMVs. The failure of three of the four FCVs on this one rocket, compared to the success of 74 EMVs on successfully launched rockets, suggests that the method of qualifying the FCVs was flawed.
