## HYPERGOLIC PROPELLANTS: THE HANDLING HAZARDS AND LESSONS LEARNED FROM USE

B. Nufer

NASA Kennedy Space Center, Engineering Directorate, Fluids Division, Hypergolic and Hydraulic  
Systems Branch  
Kennedy Space Center, FL 32899

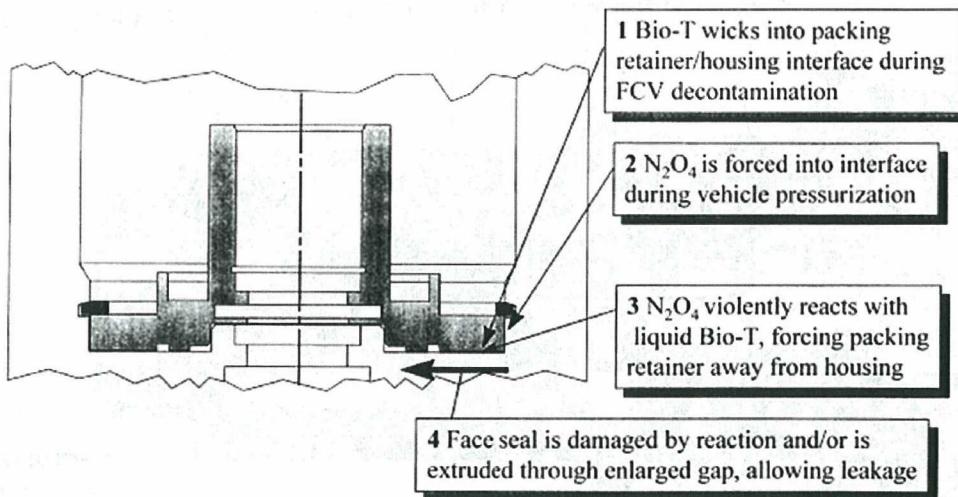
**Figure 41: Titan IV A FCV Failure Description**

- The force of the increased system pressure overcame the remaining, compromised integrity of the seal components and thus flowed past the seals to atmosphere.

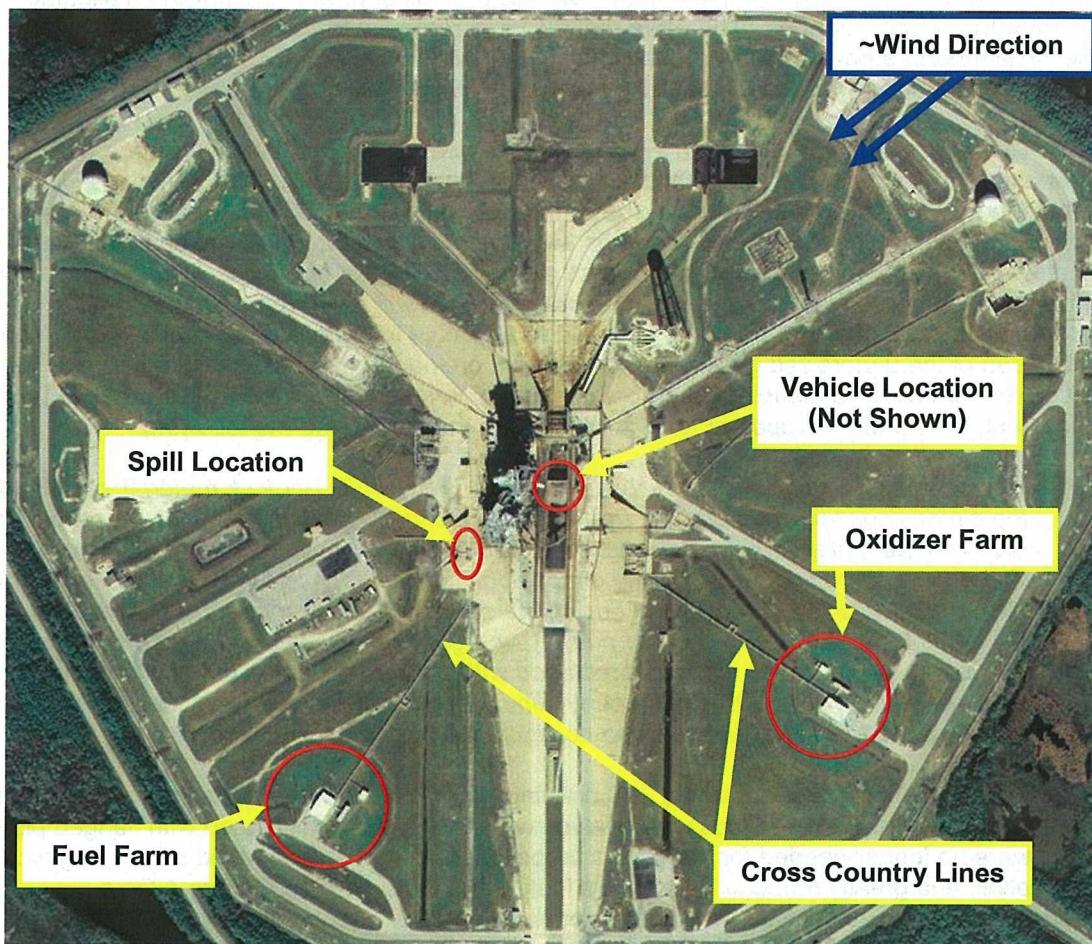
**Figure 42: Geographic Layout of Launch Pad 39B**

During the N<sub>2</sub>O<sub>4</sub> GSE drain down following OV-102's oxidizer servicing, the cross-over valves were closed. A water hammer effect from the liquid column in the GSE lines opened a gap at the cross-over valve flanges (inlet and outlet). This gap enabled liquid oxidizer to leak out onto the launch pad slope (the concrete incline from ground level to the base of the launch tower).

The SCAPE van driver was the first to detect the spill when he smelled oxidizer in the area of the fuel farm (see Figure 42 for a geographic layout of Pad 39B). Safety officials at the launch pad perimeter noted the source of the oxidizer vapors was the Pad 39B west slope. Three technicians in SCAPE were directed to proceed to the general area of the vapor source from their location on launch pad tower 107-foot level. Upon arrival, the technicians noted that heavy N<sub>2</sub>O<sub>4</sub> (NO<sub>2</sub>) vapors were leaking from both the inlet and outlet flanges of the return cross-over valve. They also noted that there were still several gallons of liquid N<sub>2</sub>O<sub>4</sub> on the ground near the flanges and at the bottom of the slope in a grassy area. Sparks were seen shortly after the arrival of the technicians; therefore, two of the three evacuated. Some of the liquid N<sub>2</sub>O<sub>4</sub> that had flowed down the slope incline contacted the electrical conduits routed along the ground that supplied power to nearby lighting. The technicians were unaware that the N<sub>2</sub>O<sub>4</sub> had dissolved some of the cabling insulation.

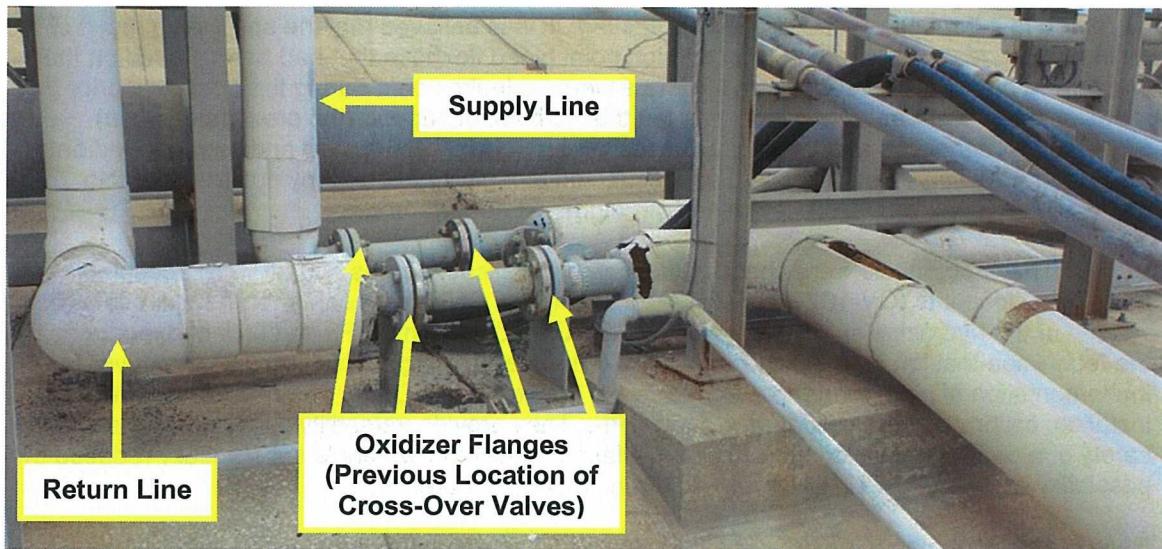
Figure 43: Former Site of Oxidizer Cross-Over Valve Complex at Pad 39B

*"The flange gaskets which leaked were of the white gar lock material and cut to the dimensions specified per [the Pad 39A cross-country line] drawing. An investigation revealed the material of the gaskets was compatible and acceptable for oxidizer use. The apparent problem was with the dimensions specified for 150 lb flange gaskets. The internal diameter was too large, reducing the sealing surface, and a slight gasket failure led to the leak. A walkdown of the pad B [hypercold tubing] was performed and all white 150 lb gaskets were identified and replaced with gaskets cut using the new dimensions released per the [Pad 39B cross-country line] drawing...All subsequent [helium] leak checks and propellant flows showed no signs of further oxidizer leakage."*

Following this incident, the Pad 39B drawings were updated to require the installation of the proper flange seals. All the cross-over valves were removed and replaced with flanged pipe as they were no longer needed for hypergolic propellant loading. This reduced processing time on the valves and greatly reduced the risk of a leak at the valve flanges. Figure 43 is a photograph of the location where the cross-over valve complex was previously located at Pad 39B and Figure 44 is a photograph of the location of the Pad 39B fuel cross-over valve complex with the fuel farm and Vehicle Assembly Building in the background.

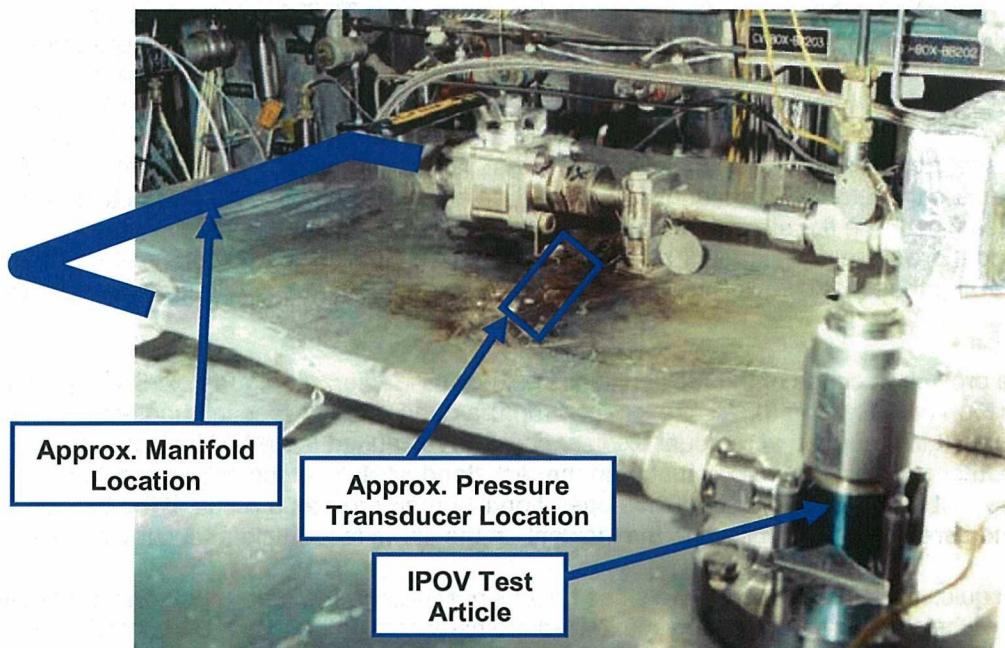
Figure 45: IPOV Test Setup

On March 25, 2003, in Test Cell 831 at WSTF, during the life cycle testing of an N<sub>2</sub>O<sub>4</sub> Improved Pilot Operating Valve (IPOV), there was an explosion. Following the explosion, there was an N<sub>2</sub>O<sub>4</sub> vapor release (approximately three quarts) into the test cell. There were no reported injuries since the cell was vacated prior to starting the test. It was found that a pressure transducer had catastrophically failed as a result of a material incompatibility within the pressure transducer (proximate cause). Figure 45 is a photograph of the test setup following the explosion with the relative location of the pressure transducer prior to the explosion.

The IPOV was in the process of being validated following some modifications that were made to the valve. The operating pressure at the valve inlet was approximately 276 psia. The test was simply flowing liquid N<sub>2</sub>O<sub>4</sub> from one tank into another by cycling the valve. The pressure transducer was in the system to monitor this inlet pressure. Approximately 36,000 (of the planned 80,000) cycles of the valve, with a flow duration of approximately 80 ms and a maximum flowrate of 1.91 lb/sec, had been completed when the explosion occurred. The proper emergency procedures were immediately implemented following the incident. These procedures included securing the test cell and deactivating the air handler for both the test cell and the attached building. There was no reported fire following the explosion.

Initial inspections of the pressure transducer indicated that the transducer failed as a result of one of the following: over-pressurization, inadequate design, or cyclic fatigue at a highly stressed location. Since the pressure transducer failed, data from it at around the time of the failure may be suspect; therefore, the investigation included a detailed inspection of the nearby system tubing to determine if there was an over-pressurization event. Close inspection of the pressure transducer itself would indicate if the transducer failed from cyclic fatigue or was subject to a ductile failure from a single overload event.

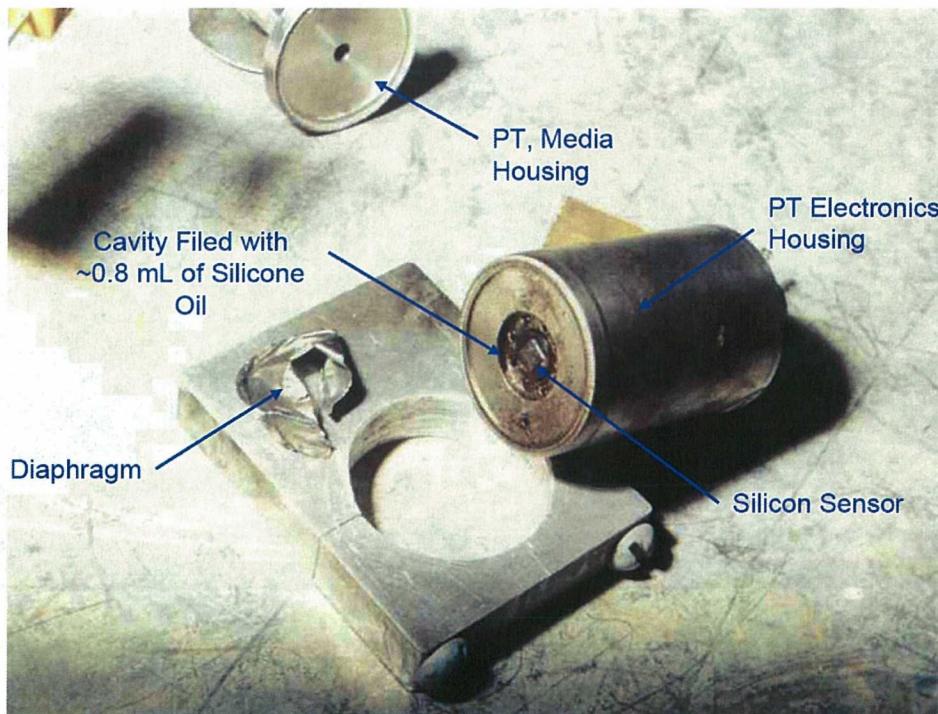
**Figure 46: Failed Pressure Transducer**

The presence of the silicone oil was not mentioned in the pressure transducer specification from the manufacturer. This is the case for many pressure transducers of this specific design. Close scrutiny of specifications during hypergol component procurement is extremely important. This incident was difficult to prevent since the WSTF personnel did not know that there was silicone oil in the pressure transducer, but an improper GSE design (component procurement) is designated as the root cause. The wind corridor was also assessed and, as a result of this incident, it was altered to reduce the risk to the surrounding buildings from an oxidizer vapor release.

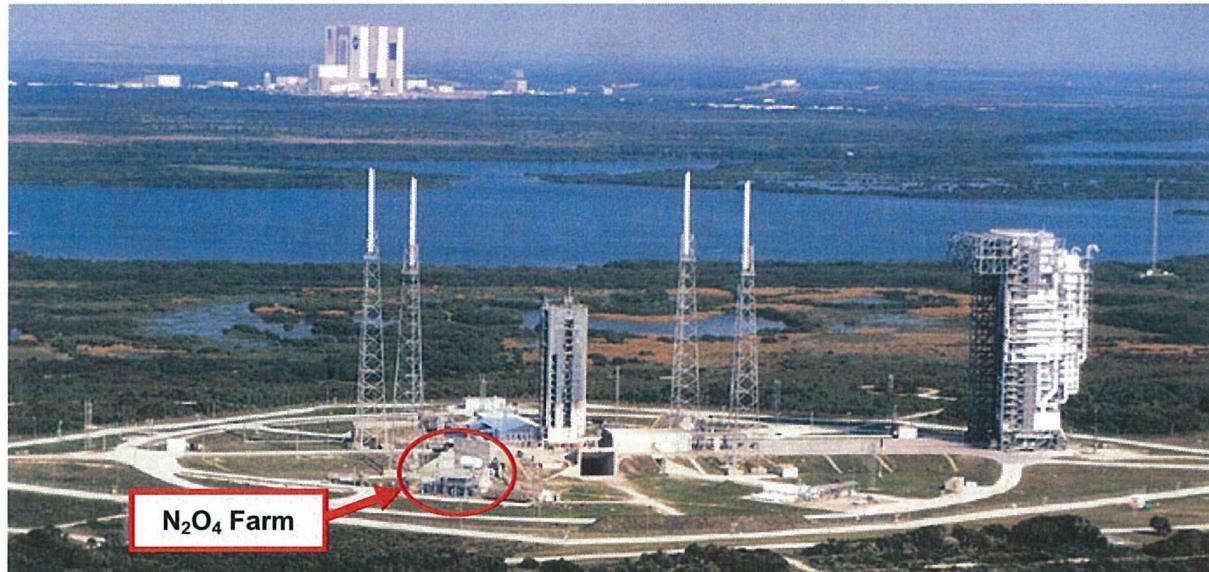
Figure 47: LC-40 at CCAFS

On August 12, 2003, at CCAFS launch Pad LC-40 (shown in Figure 47) during the bleed-in operation for the B36 Stage II (Titan IV) propellant load, the oxidizer centrifugal pump exploded (proximate cause of the N<sub>2</sub>O<sub>4</sub> spill). The Titan IV launch vehicle was being loaded in preparation for the September 9, 2003 launch of the National Reconnaissance Office's payload. Along with the liquid N<sub>2</sub>O<sub>4</sub> release of approximately 40 gallons, the explosion created a large amount of shrapnel which caused significant damage to the surrounding GSE. The pump was completely destroyed as shown in Figure 48. Fourteen people reported to an on site health facility. They were all later released without injury. The storage tank holding several thousand gallons of liquid N<sub>2</sub>O<sub>4</sub> remained intact with minimal damage. An extensive investigation was initiated as a result of the Space Shuttle Program using these same pumps at Pads 39A and 39B (eight pumps in four locations) along with the Titan program which used them at LC-40.

The engineers had noticed a decrease in the oxidizer pump flow rate (34-50 gpm versus 200 gpm) during the 18,600 gallon loading of the Stage I N<sub>2</sub>O<sub>4</sub> tanks. A meeting was held to discuss this reduction in flow rate in which the contractor and government team chose to continue on with the Stage II load. The consensus of the meeting was that an internal filter had become partially clogged at the oxidizer farm. The personnel had seen this sort of occurrence previously. Operational human error is considered a root cause as a result of the loading team not investigating the decreased flow rate issue further.

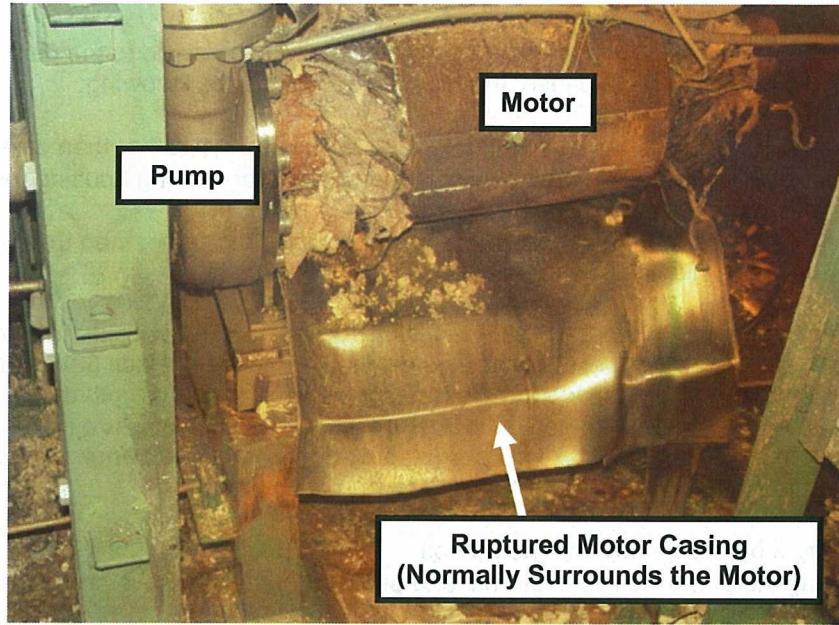
**Figure 48: Pump and Motor After Explosion**

The incident failure analysis concluded, according to Crass, that there was a “cooling anomaly at the [carbon graphite journal] bearings...leading to [an explosion] in the stator can winding area.” It was found that the most likely contributor to this was a clogged filter in the pump recirculation loop that circulates liquid through the rotor cavity to cool the front and rear bearings as illustrated in Figure 49. Data analysis showed that the upstream and downstream temperature transducers indicated an increase in temperature of 8 °F across the pump. The low flow rate of 40 gpm and high ambient temperatures (high of 86 °F for 8/12/2003) accelerated the failure of the pump. At these flow conditions, the pump was not able to be properly lubricated as a result of the high vapor pressure of liquid N<sub>2</sub>O<sub>4</sub> (these particular pumps are designed to be lubricated with the liquid that they are pumping). The excessive bearing wear led to damage to the stator liner can, allowing oxidizer to leak onto the hot copper windings. The N<sub>2</sub>O<sub>4</sub> reacted with the copper winding insulation and caused the coil wire to short, which was the proximate cause of the explosion.

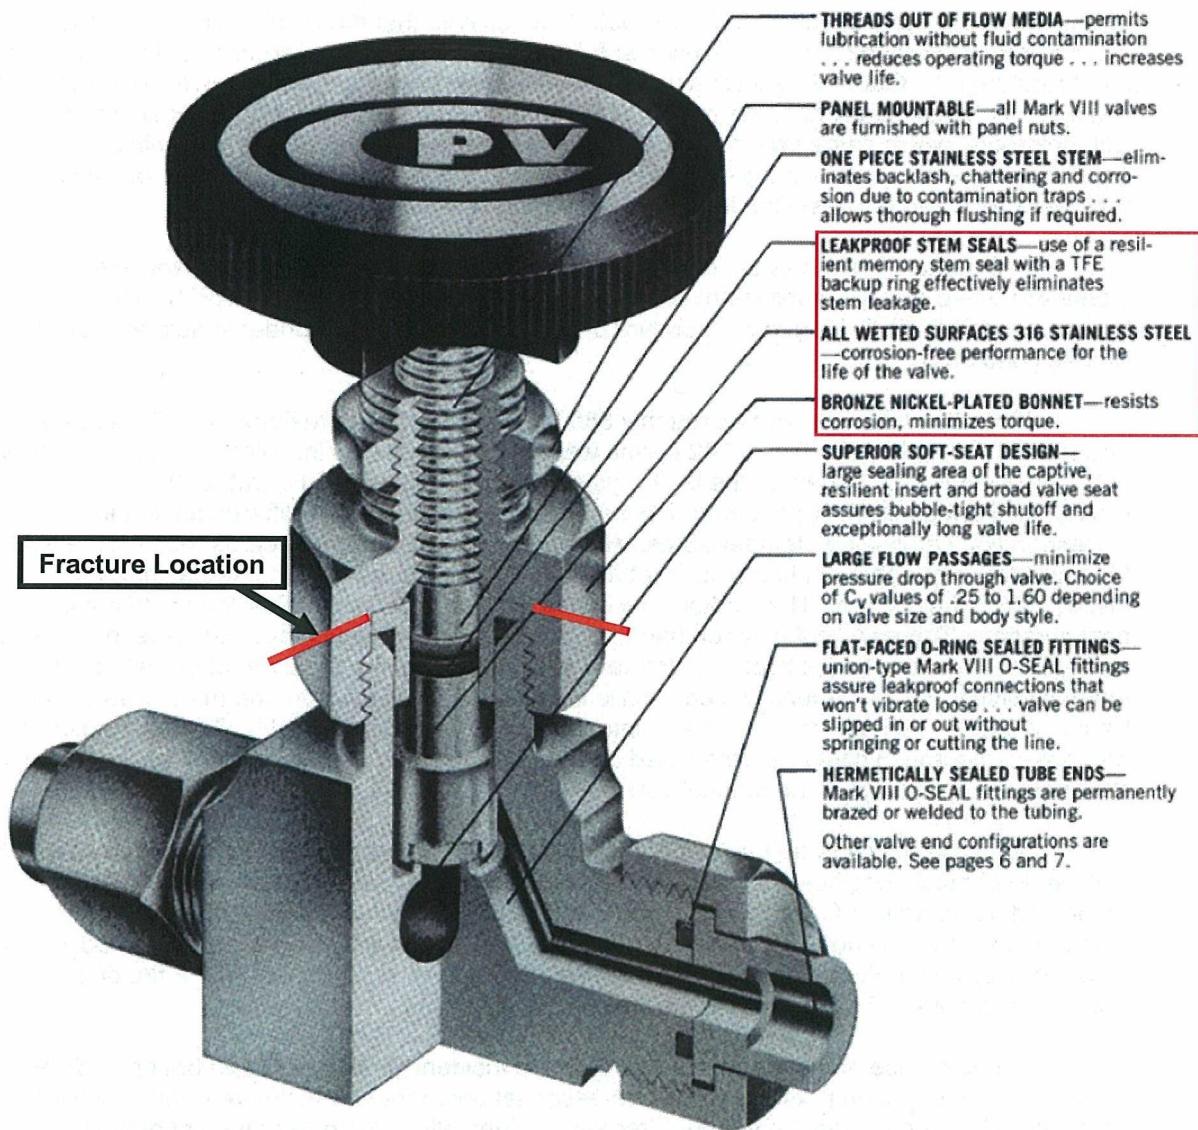
Figure 51: Schematic of Failed Manual Valve

The failure began as an intergranular crack in the nickel-plated, aluminum bronze bonnet threads (fracture surface shown in Figure 50). It is believed that the crack began as a result of the ethylene propylene rubber and Teflon soft seals allowing corrosive agents to slowly leak into the thread region. Figure 51 shows a cross-section cutaway of the manual valve. The Teflon soft seals can be seen clearly near the middle of the threaded shaft. The corrosive agents reacted with ammonia, which came from the decomposition of N<sub>2</sub>H<sub>4</sub> (N<sub>2</sub>H<sub>4</sub> → 1/3 N<sub>2</sub> + 4/3 NH<sub>3</sub>). This accelerated the local corrosion and cracking. This was the first failure for this type of valve since they were procured and installed in several hypergolic systems at WSTF in 1994.

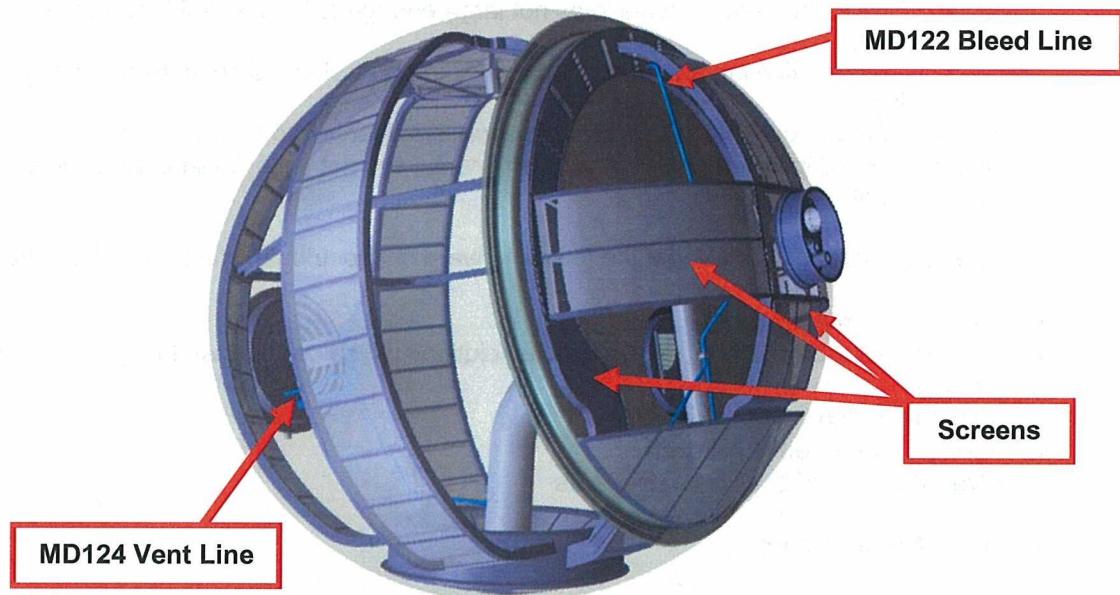
**Figure 52: Solid Model of RCS Propellant Tank in (Roughly) the Horizontal Orientation**

With the vehicle in a horizontal orientation, the MD122 line runs from the high point of the oxidizer tank lower compartment channel, through an interface at the tank outlet flange, and out to an AHC located in an externally accessible door on the FRCS outer mold line (AP28-00 door). It is known through pressure measurements that the MD122 and MD120 connected GSE lines were clear of any liquid immediately following the two, five-minute purges; however, it is not known if the propellant acquisition system channel in the lower compartment was broken down (i.e. it did not contain any liquid). If the screen was not completely broken down, it is possible that liquid oxidizer “wicked” up the screen following the purges to the point where MD122 connects to the acquisition screens. See Figure 52 for visual aid of the propellant acquisition system screens

and the MD122 line. The absence of liquid in the lines can be confirmed by noting that there was not any significant pressure increase in the lines. The tank was *not* in thermal equilibrium. The tank shell (skin) temperature rose from 49 °F, when tank venting was complete, to 58 °F, when MD124 GSE vent valve was opened for the emergency vent through MD124 in the upper compartment of the tank. When the two purges were complete the tank shell temperature was 54 °F. From the time of the spill to the emergency MD124 vent, the tank shell temperature rose from 57 °F to 58 °F. The fluid and gas temperatures likely rose by a degree or two during this time.

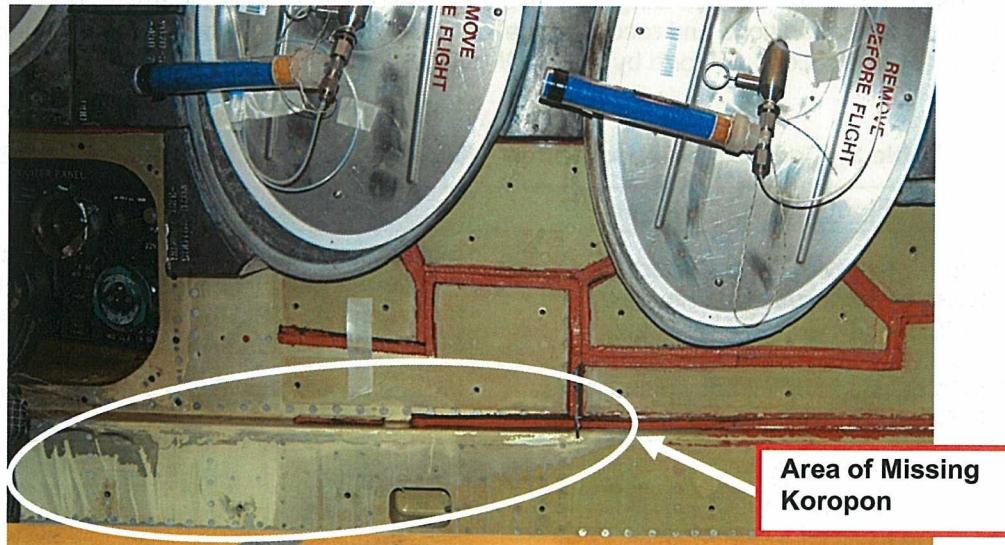
Figure 54: View Looking at R/H Side Down-Firing Thrusters (F2D & F4D)

The spilled oxidizer appears to have reacted with Koropon, RTV, and silver plating (nutplates and barrel nut elements). The oxidizer vapors reacted with the Koropon and removed a large area, as shown in Figure 54, and passed through the nutplate holes and around the perimeter of the phenolic QD service panel into the interior of the FRCS module, as shown in Figure 55, causing damage to the Koropon on the interior side of the FRCS module.

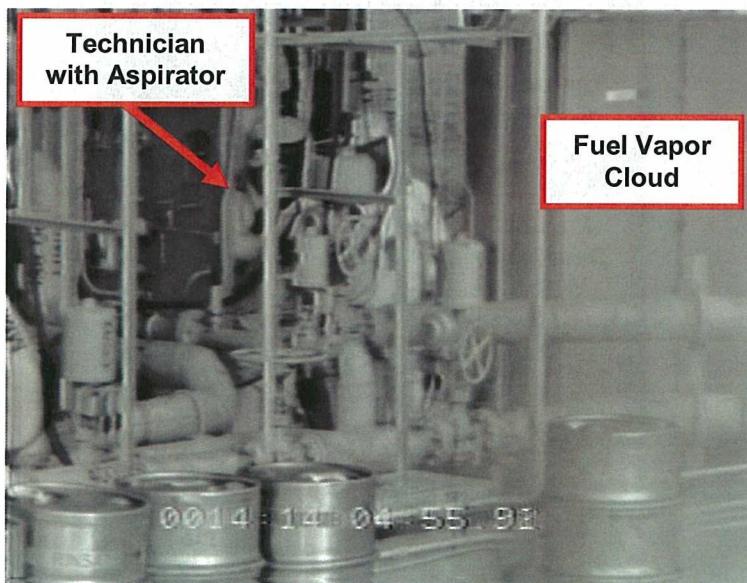
Figure 56: Screen Capture of Video during Spill

On the morning of January, 14, 2010 during the fuel servicing operation for the Space Shuttle mission STS-130, about 1 gallon of MMH was spilled onto the ground from an open line where a pressure transducer had been removed. Several more gallons were contained in the toxic vent system by utilizing a vacuum aspirator below the spilling MMH. There were no injuries and no hardware damage. The pressure transducer was discovered as failed shortly after the computer autosequencer was activated from the LCC to fill the GSE tubing with liquid. Once the lines are filled with liquid at the fuel farm, the two series centrifugal pumps are brought online to initiate the flow to the launch tower.

In preparation for the component removal, the tubing was purged to clear out residual liquid MMH and fuel vapors. All the necessary valves were closed to isolate the particular section of the servicing system tubing. Once a spare component was obtained, the pressure transducer was removed from its ¼-inch lines that connect to the three-inch fuel supply pipe that runs to the launch tower at launch pad 39A. A few drops of fuel were noted when the pressure transducer was removed. During inspection by the SCAPE technicians, it was found that they had the incorrect connection fittings. The technicians relocated to their work bench several dozen feet away to swap the connection fittings from the old pressure transducer to the new one. Console operators in the LCC began to notice “smokiness” on their closed circuit, black and white video monitors. This was not reported to the technicians who relocating back to the removal site. When they arrived, the SCAPE technicians reported a steady stream of liquid MMH coming from the ¼-inch tube from which the pressure transducer was removed. One technician immediately placed an aspirator below the line to collect the liquid (shown in Figure 56) while the other began to douse the area with water from a nearby fire hose. Direction was given by the console engineers to use a manual overdrive wheel on an upstream valve in attempt to isolate the liquid source. The leak was stopped by this action.

Normally, when this component is replaced the system is dry as a result of weeks without use. However, in this case, the system had just been wetted and then purged. It is well known that it takes a few days for the propellant to completely drain back into the storage tank from the servicing distribution system tubing. The liquid accumulated in the tubing (and subsequently spilled out the ¼-inch line) as a result of a leaking upstream pneumatically operated flow control valve, which is shown in Figure 57.

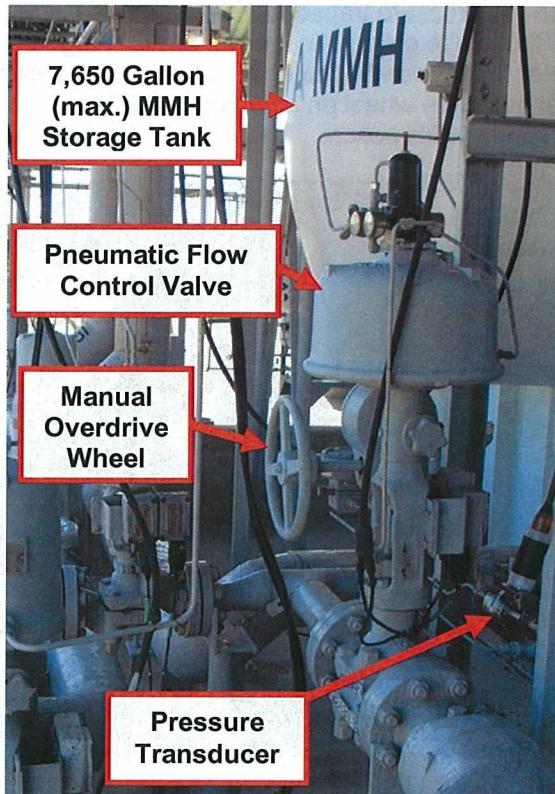
**Figure 57: Pad 39A Fuel Farm Pressure Transducer Location**

The pneumatically operated flow control valve also has a manual override hand wheel to use in the event of loss of pneumatic pressure. The valve is designed to be normally open to allow liquid to flow from the launch tower back into the storage tank. Prior to the spill, it was known by some of the test team that this particular valve required manually driving it closed to fully seat the internal seals. This was not performed prior to opening the system for the pressure transducer replacement (the proximate cause).

The root cause of this incident was improper training. Following the spill the engineering and technician team met and identified the following four primary lessons learned:

- Prior to removal of the pressure transducer, the proper fittings were not identified resulting in the technicians having to improvise and use the fittings from the old transducer.
- The open port from which the pressure transducer was removed was left unattended for several minutes. Technicians should be trained to make every effort to avoid leaving an open system unattended.
- The leak path through the pneumatic flow control valve was not known by the entire console test team. This is easy to say in hindsight, but if the entire team was aware of this characteristic of the valve, the spill may not have occurred.
- Reporting of the spill did not follow the approved KSC environmental procedures.
