The 1928 St. Francis Dam Failure and Its Impact on American Civil Engineering

J. David Rogers

THE 1928 ST. FRANCIS DAM DISASTER

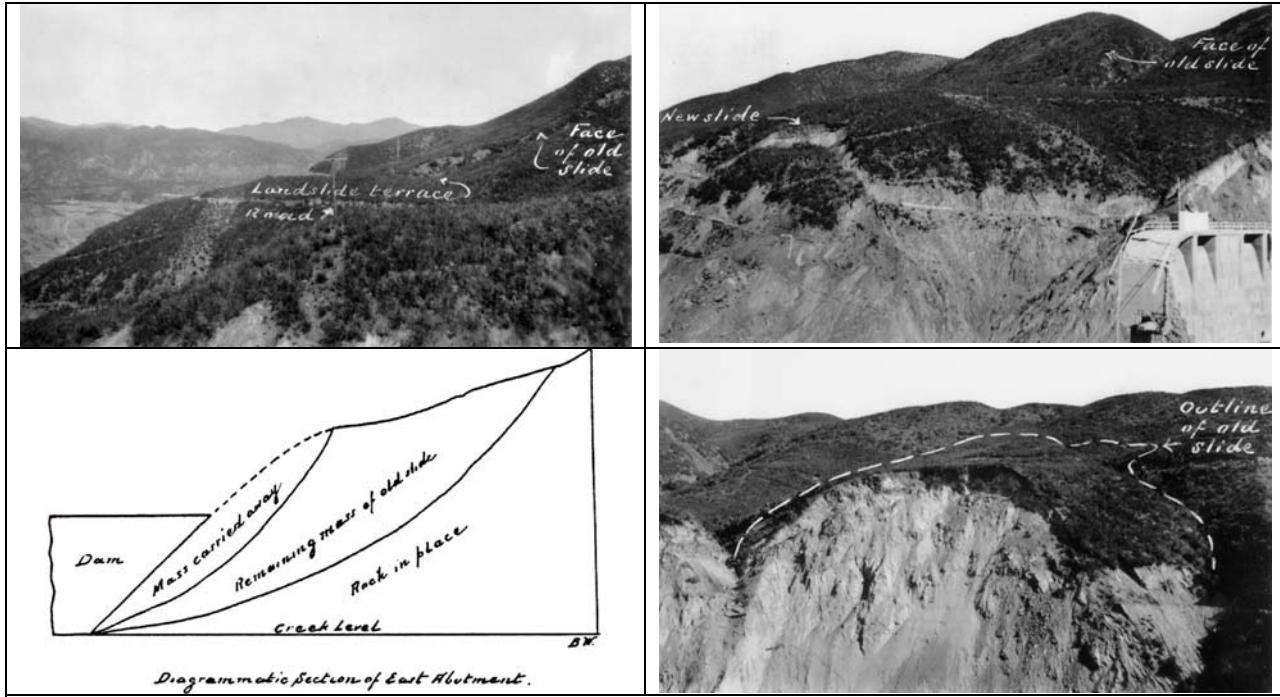
Figure 43. Some of the key figures from Willis June 1925 article in Western Construction News. The upper left image shows the old landslide terrace developed in the Pelona Schist above the reservoir area. The image at upper right shows one of the landslides that slipped into the reservoir due to rapid drawdown. The lower images show a hypothesized cross section through the east abutment landslide (left), suggesting that most of the pre-existing bedrock slide forming the dam's left abutment was not mobilized in the failure (photos courtesy of the Grunsky family).

Willis' assertions came from employing classical theorems about terraces; asking which mechanisms were responsible for creating the many prominent terraces exhibited within the Pelona schist along a strike-controlled dip slope. Several of Willis' key figures are reproduced in Fig. 43. He asserted that the east abutment slide was simply the partial reactivation of a much larger paleolandslide developed in the schist sometime during the Pleistocene epoch. Some of these slumps slid a short distance into the reservoir area, likely triggered by rapid drawdown of the reservoir as it drained, as sketched in Fig. 44. Note how the greater volume of these dormant landslide features were not reactivated in 1928, just as Willis alleged.

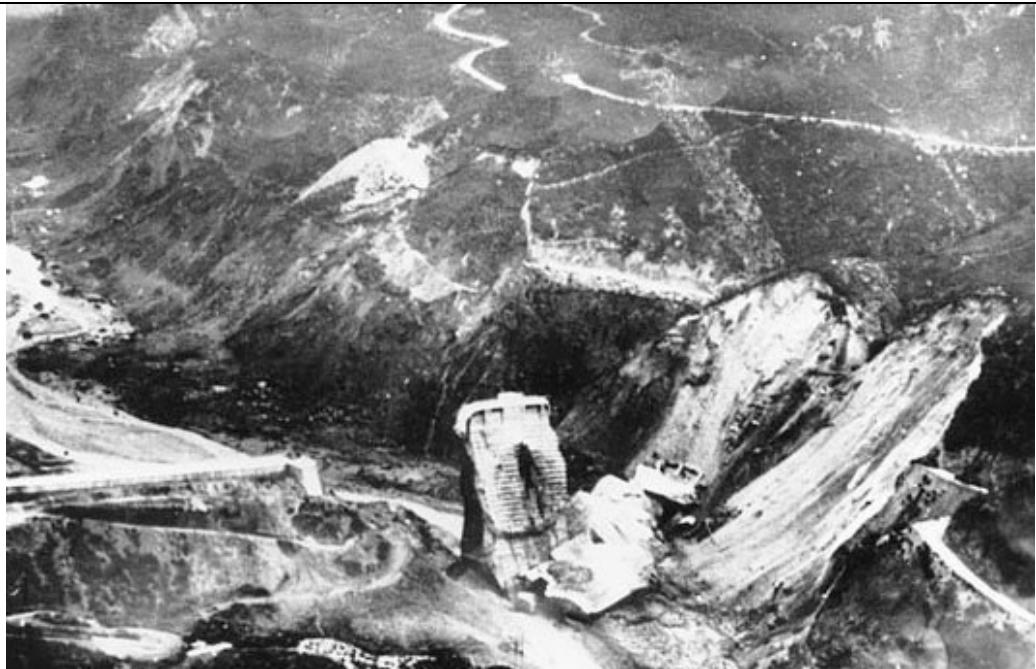
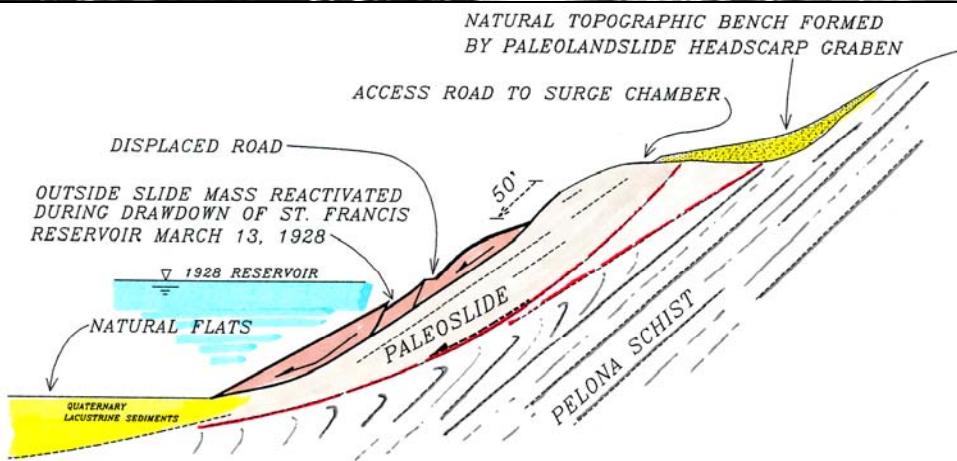
Figure 44. Upper image shows the large slump block that dropped into the reservoir upstream of the dam, due to rapid drawdown of the reservoir (from UCLA Spence Collection). Lower figure from Rogers (1992) shows a cross section through this slump block based on field reconnaissance. It appears to be a retrogressive translational block glide that moved about 50 feet. Note how only a small fraction of the parent slide mass was involved.

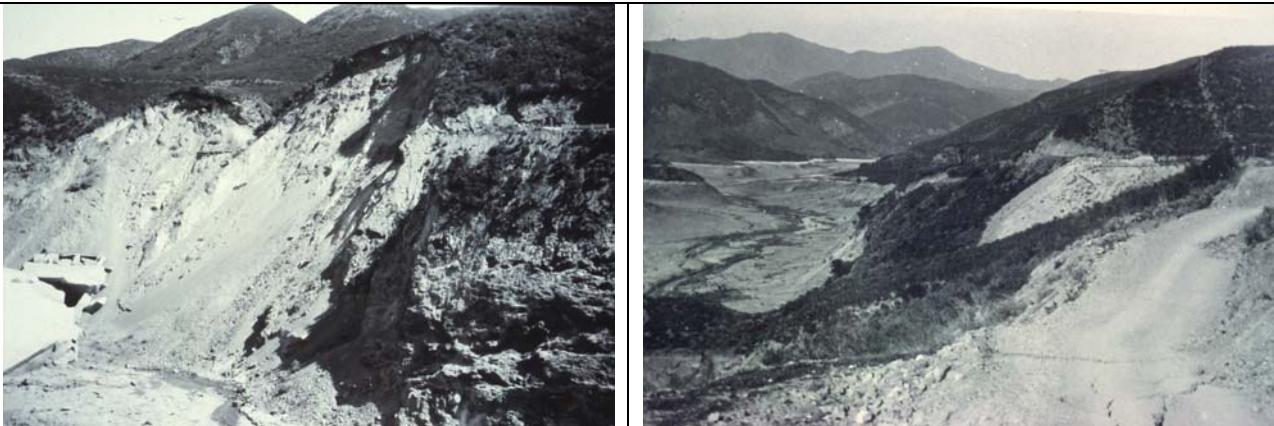
There is a good deal of physical evidence to support Willis' assertions. DWP's Bee Canyon power line road ran parallel to the reservoir's southeastern shoreline, about 300 feet above the valley floor (Figs. 28, 29, 44, and 45). Inspection of this road after the failure revealed large tension cracks at either end of a broad depression, about 300 feet above the dam's left abutment, as shown in Fig. 45 right. The entire slope appears to have dropped two to nine feet, well above the ragged headscarp of the east abutment slide.

Figure 45. Left photo shows exposed scarp of the east abutment landslide extending well above old San Francisquito Cyn. Rd. Image at right shows gross ground deformations along the Bee Highline Road, about 300 feet above the dam's left abutment. The slope dropped two to nine feet above the east abutment slide. Both photos from Ventura County Museum of History & Art.

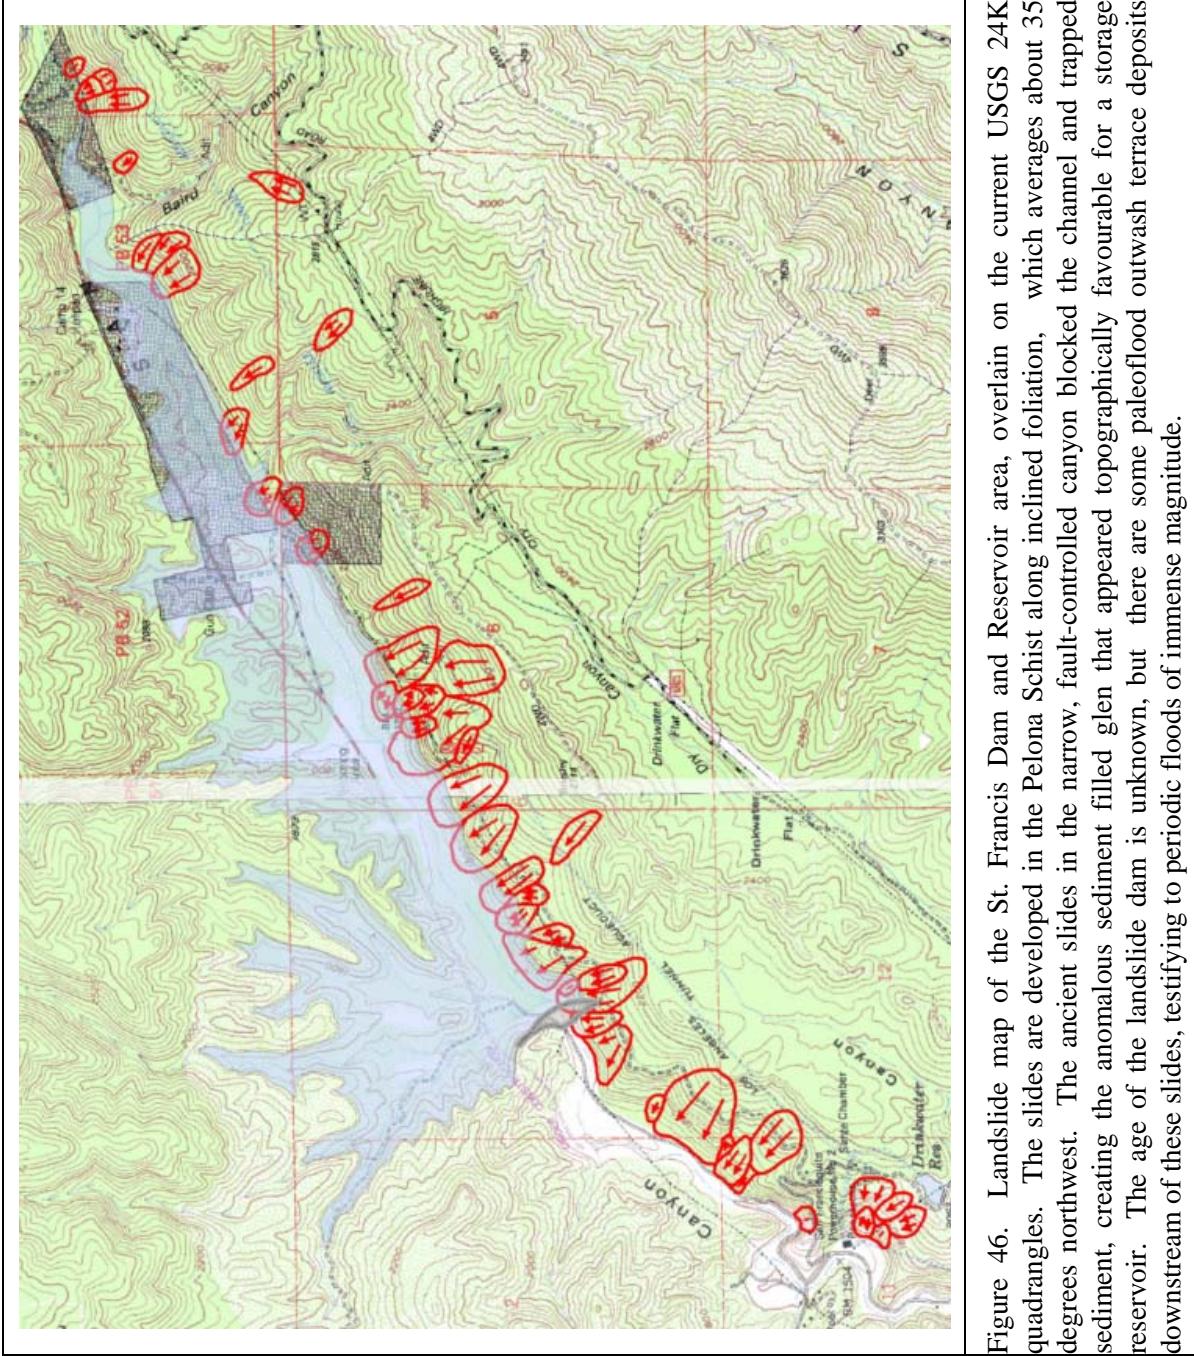
Figure 46. Landslide map of the St. Francis Dam and Reservoir area, overlain on the current USGS 24K quadrangles. The slides are developed in the Pelona Schist along inclined foliation, which averages about 35 degrees northwest. The ancient slides in the narrow, fault-controlled canyon blocked the channel and trapped sediment, creating the anomalous sediment filled glen that appeared topographically favourable for a storage reservoir. The age of the landslide dam is unknown, but there are some paleoflood outwash terrace deposits downstream of these slides, testifying to periodic floods of immense magnitude.

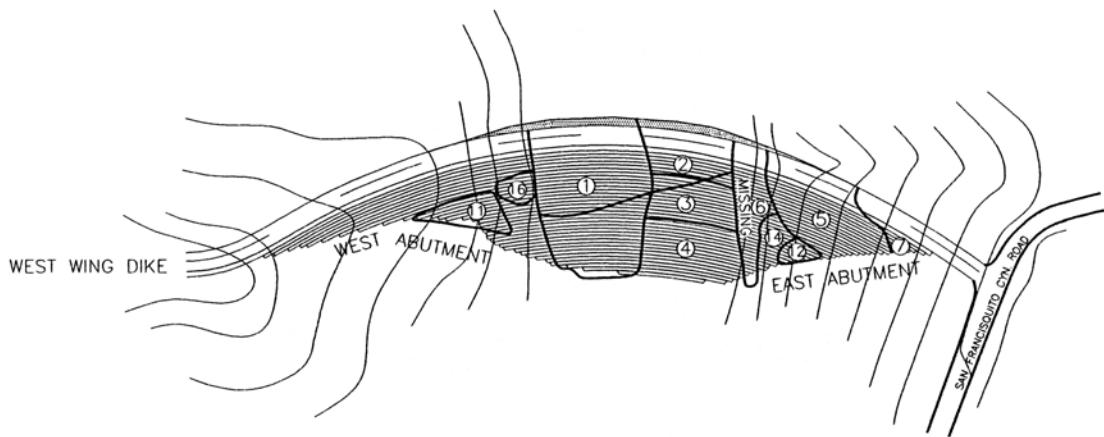
PLAN VIEW OF ST FRANCIS DAM
AS DESIGNED

Figure 47. Plan view of the main dam, as originally designed. Diagonal lines and numbers delineate dam blocks with the State's nomenclature (as presented in Fig. 38). The dam's vertical steps were each 5 feet high, but the horizontal distances varied from 5.5 feet at the bottom to 1.5 feet near the top.

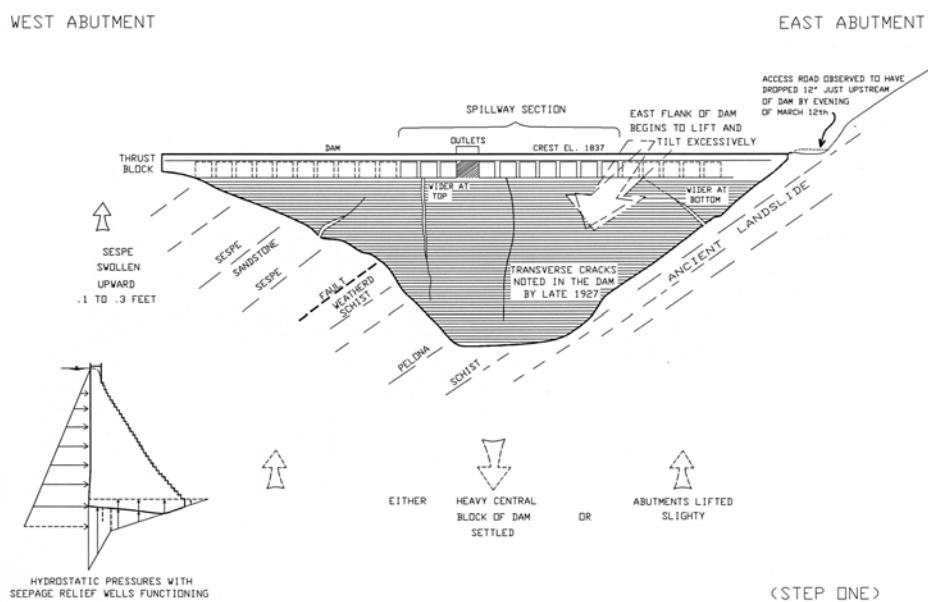
significant thermal stresses and shrinkage of the mass concrete. 130,446 cubic yards of concrete were placed at St. Francis in just 16 months, without any attempt at cooling the concrete. As a consequence, some rather large contraction cracks formed in the monolith, which were plugged with oakum (dry wedges of oak wood, pounded into the cracks) in 1926-27 (those positions on the downstream face are portrayed in Fig. 49).

Figure 48. Schematic elevation view of the dam with transverse cracks which appeared on the downstream face of the dam a year previous to the failure. The dam was built without contraction joints. Some hydrostatic pressure relief was afforded the central core of the dam, as shown at lower left. This portion of the dam did not fail, only the sloping abutments failed.

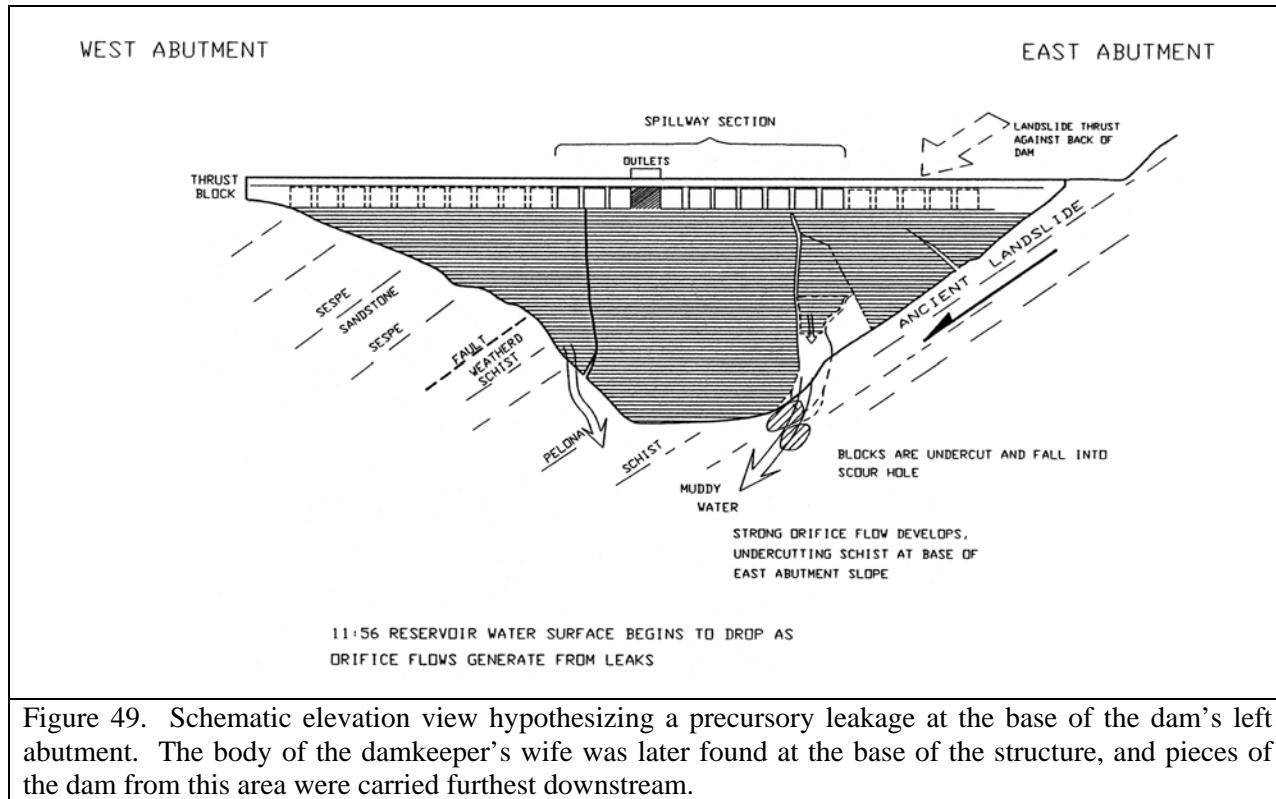
Figure 49. Schematic elevation view hypothesizing a precursory leakage at the base of the dam's left abutment. The body of the damkeeper's wife was later found at the base of the structure, and pieces of the dam from this area were carried furthest downstream.

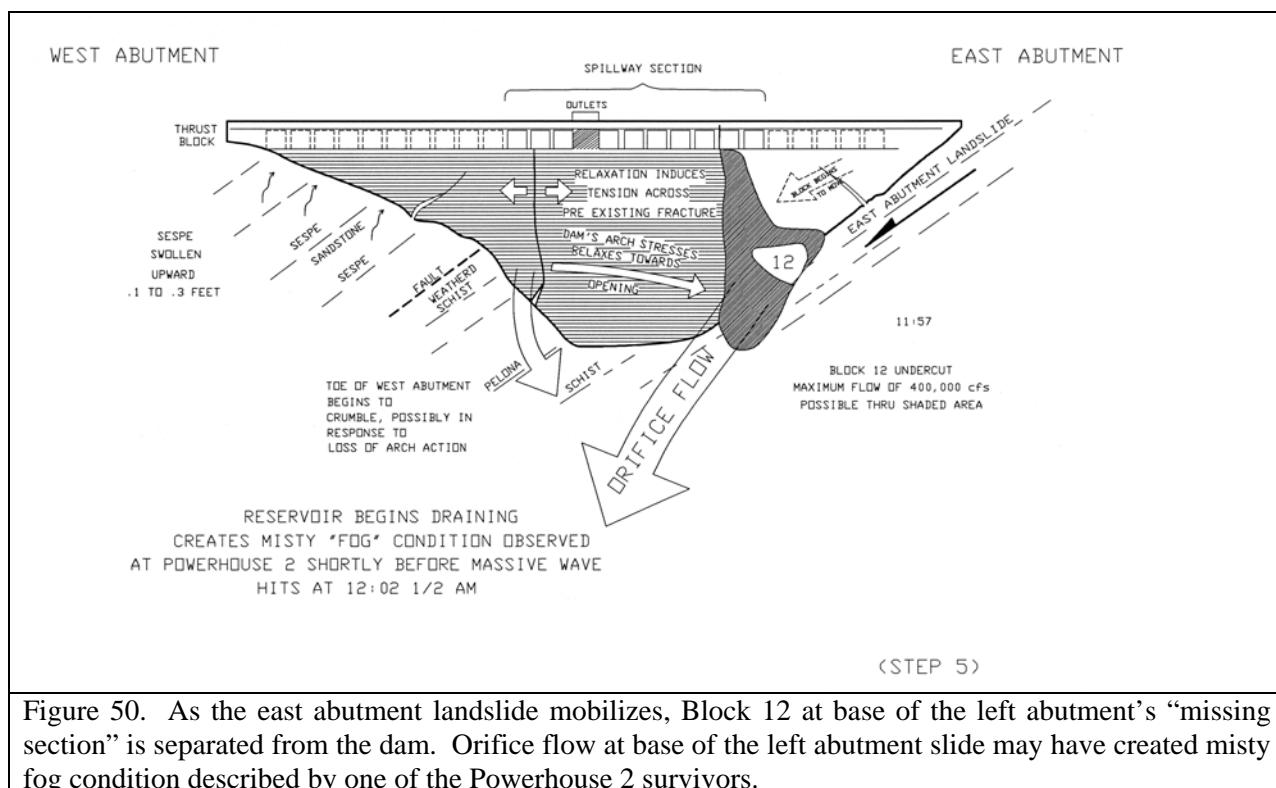
Figure 50. As the east abutment landslide mobilizes, Block 12 at base of the left abutment's "missing section" is separated from the dam. Orifice flow at base of the left abutment slide may have created misty fog condition described by one of the Powerhouse 2 survivors.

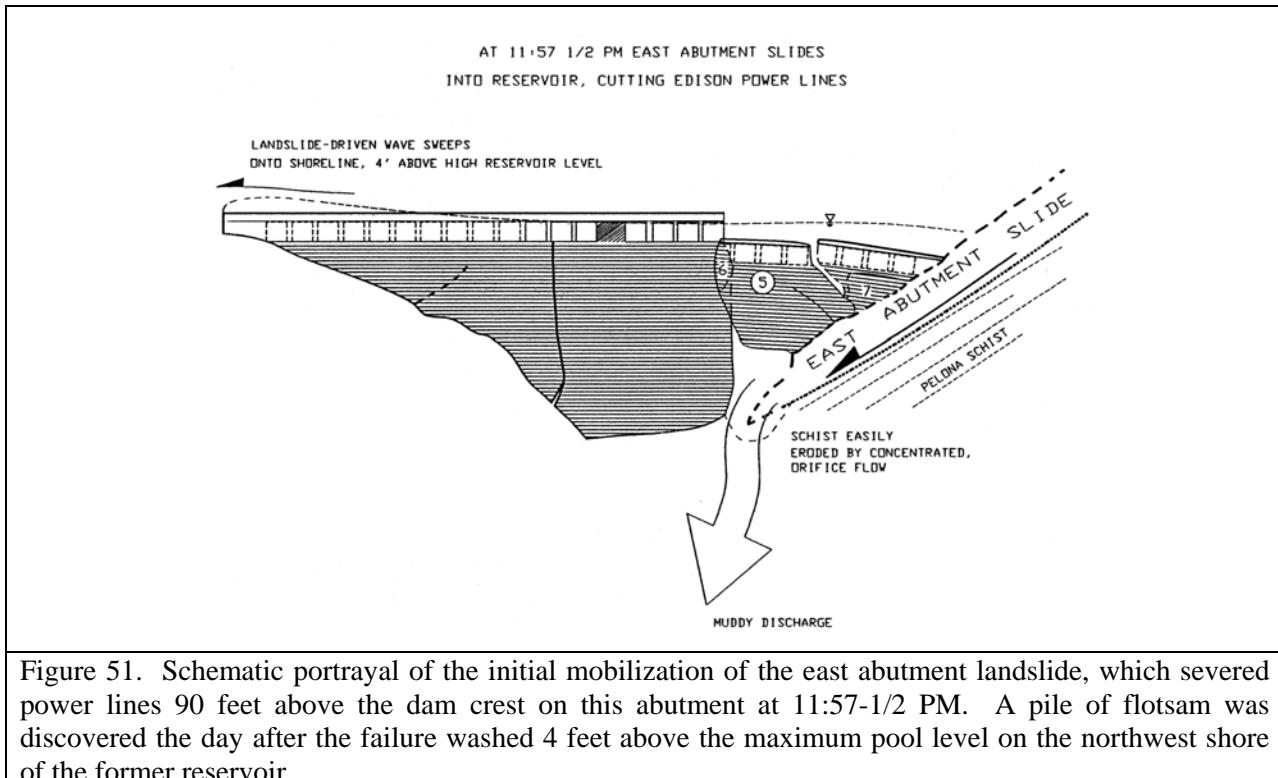
Figure 51. Schematic portrayal of the initial mobilization of the east abutment landslide, which severed power lines 90 feet above the dam crest on this abutment at 11:57-1/2 PM. A pile of flotsam was discovered the day after the failure washed 4 feet above the maximum pool level on the northwest shore of the former reservoir.

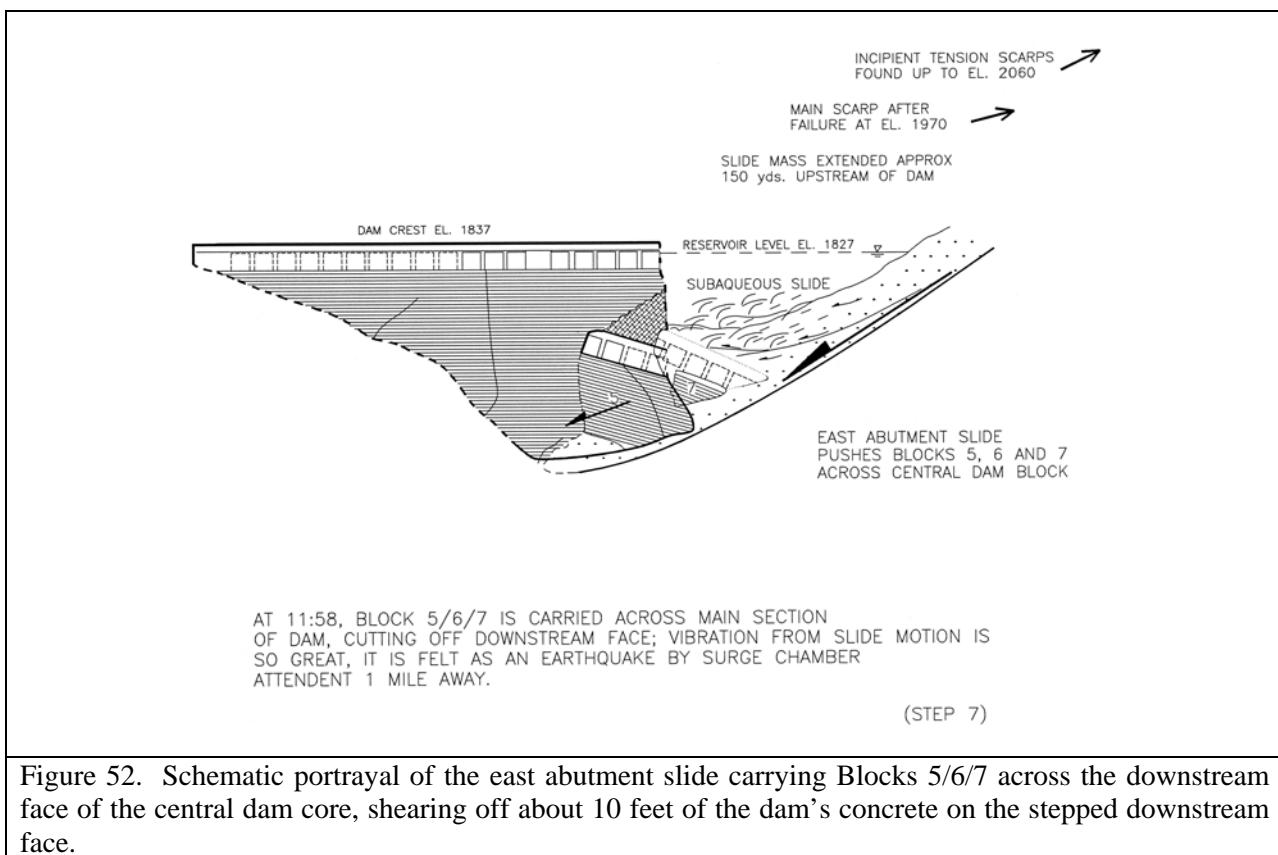
Figure 52. Schematic portrayal of the east abutment slide carrying Blocks 5/6/7 across the downstream face of the central dam core, shearing off about 10 feet of the dam's concrete on the stepped downstream face.

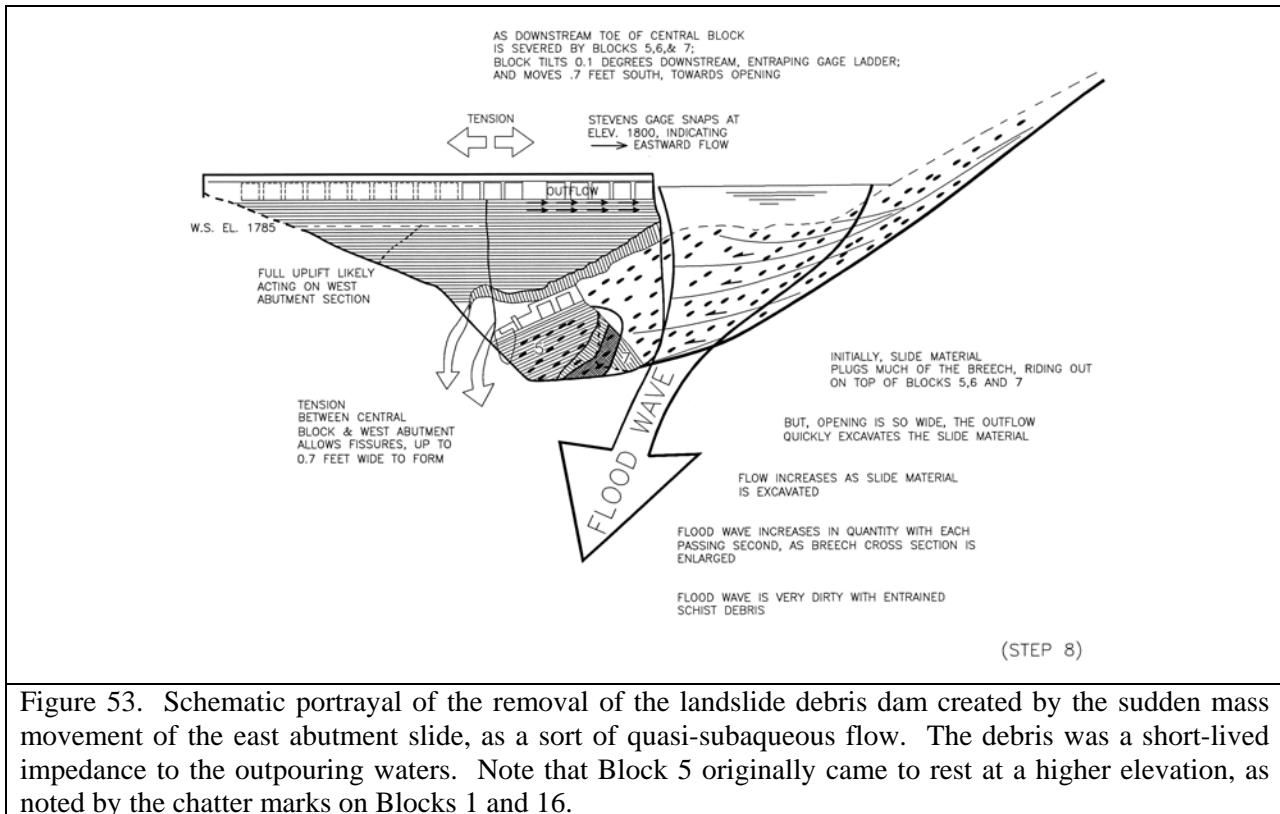
Figure 53. Schematic portrayal of the removal of the landslide debris dam created by the sudden mass movement of the east abutment slide, as a sort of quasi-subaqueous flow. The debris was a short-lived impedance to the outpouring waters. Note that Block 5 originally came to rest at a higher elevation, as noted by the chatter marks on Blocks 1 and 16.

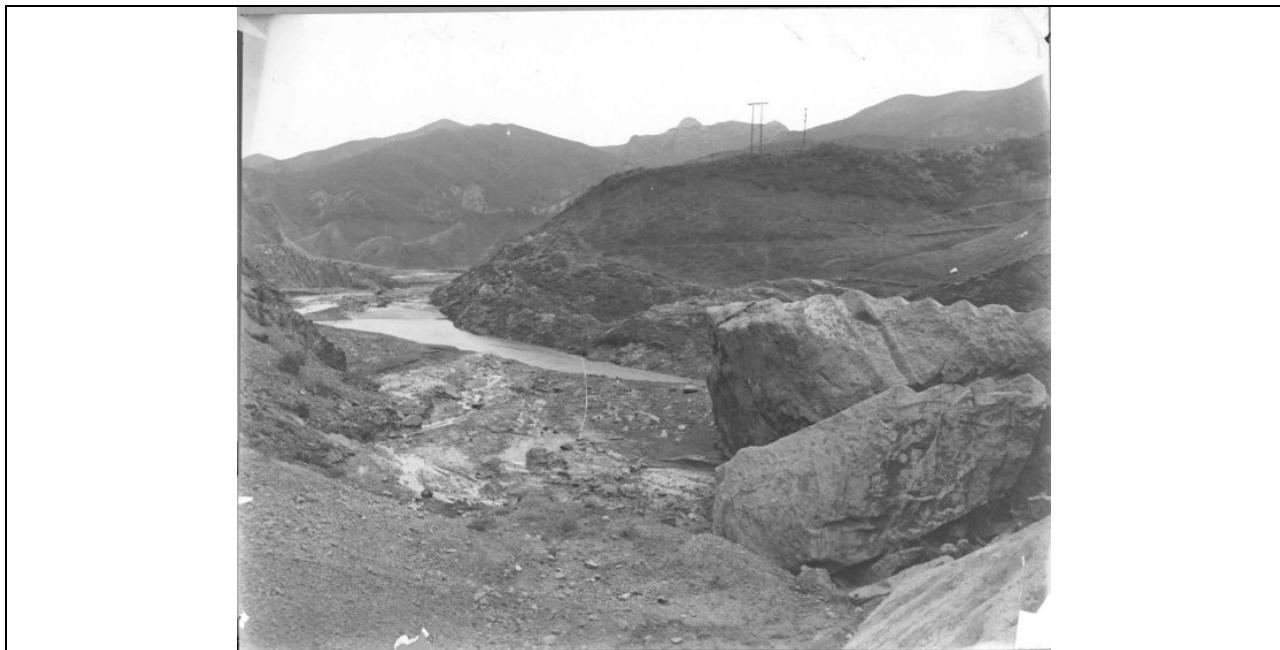
Figure 54. View from left abutment looking downstream at Block 7 wedged in behind Block 5. Note the accumulation of talus shed off the east abutment landslide scarp, which was 450 ft high. Photo by H. Wildey, from the author's collection.

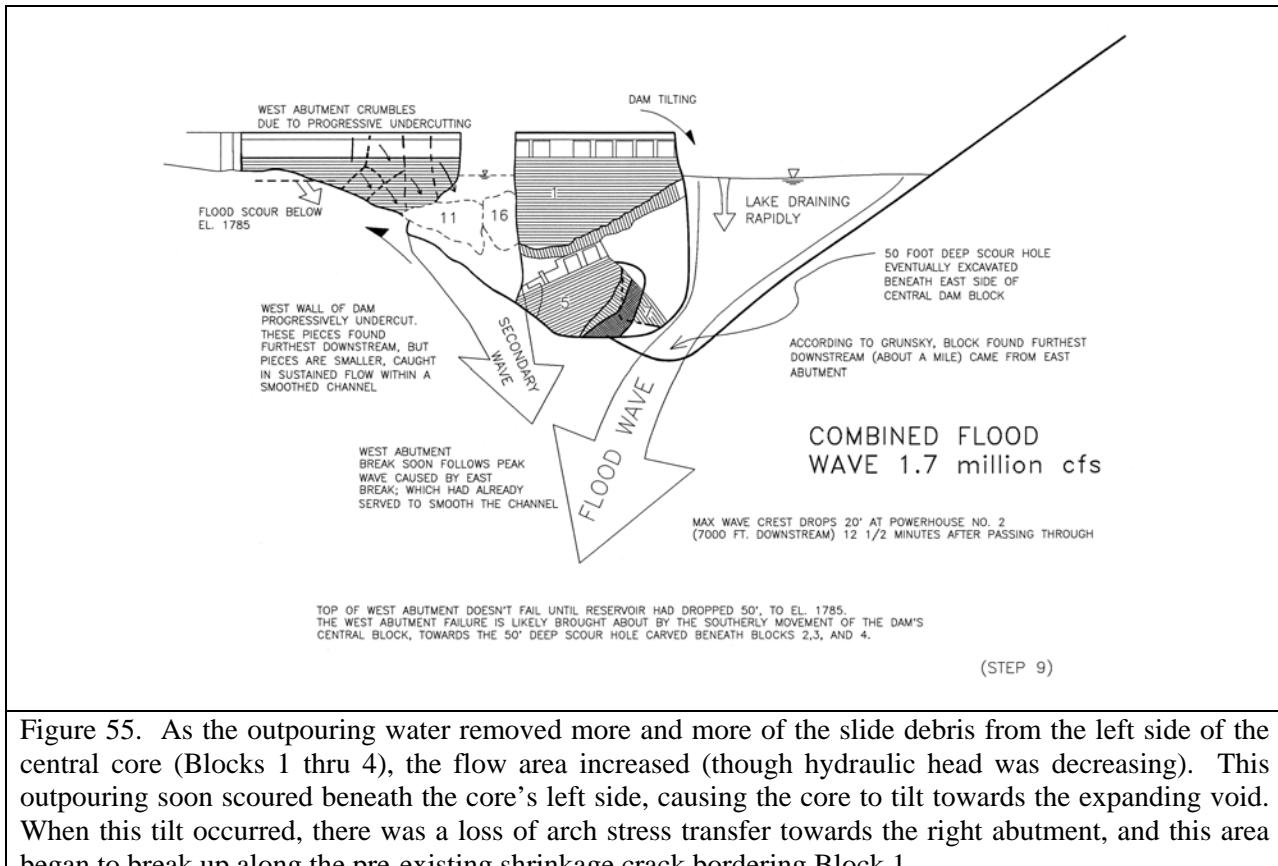
Figure 55. As the outpouring water removed more and more of the slide debris from the left side of the central core (Blocks 1 thru 4), the flow area increased (though hydraulic head was decreasing). This outpouring soon scoured beneath the core's left side, causing the core to tilt towards the expanding void. When this tilt occurred, there was a loss of arch stress transfer towards the right abutment, and this area began to break up along the pre-existing shrinkage crack bordering Block 1.

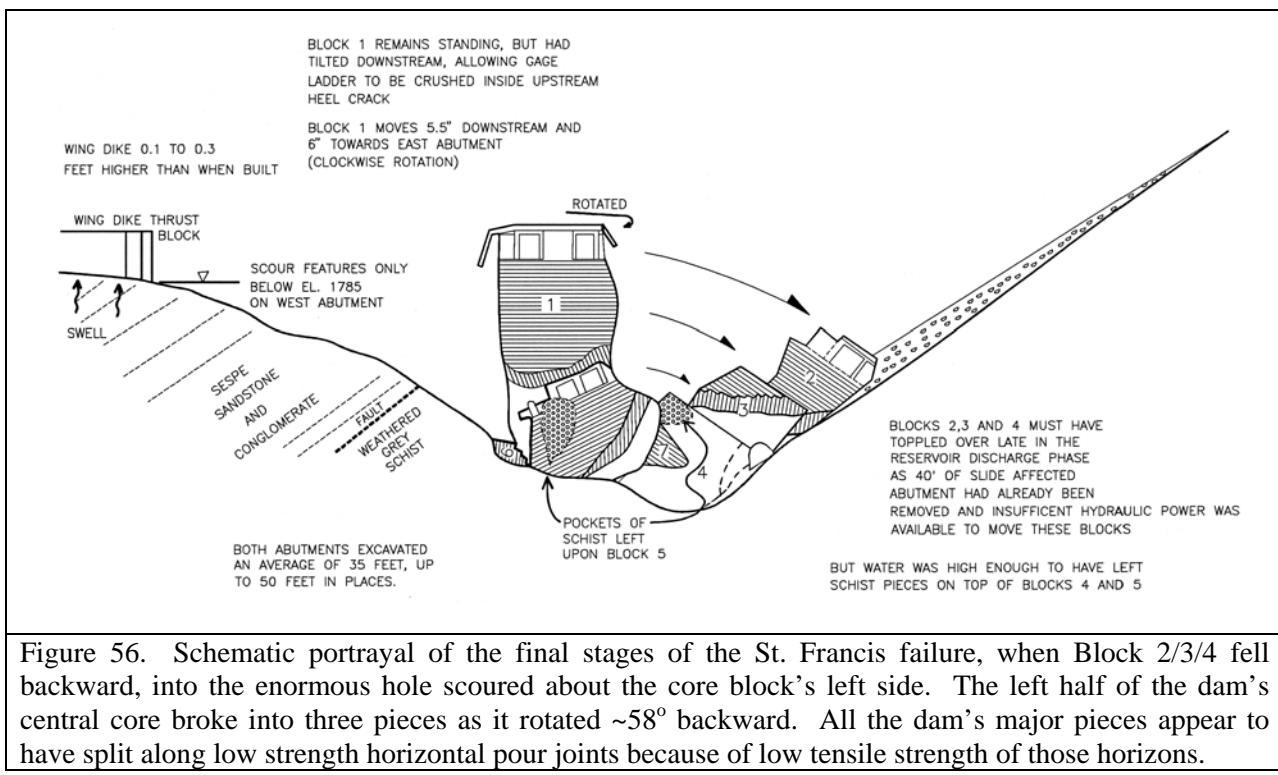
Figure 56. Schematic portrayal of the final stages of the St. Francis failure, when Block 2/3/4 fell backward, into the enormous hole scoured about the core block's left side. The left half of the dam's central core broke into three pieces as it rotated ~58° backward. All the dam's major pieces appear to have split along low strength horizontal pour joints because of low tensile strength of those horizons.

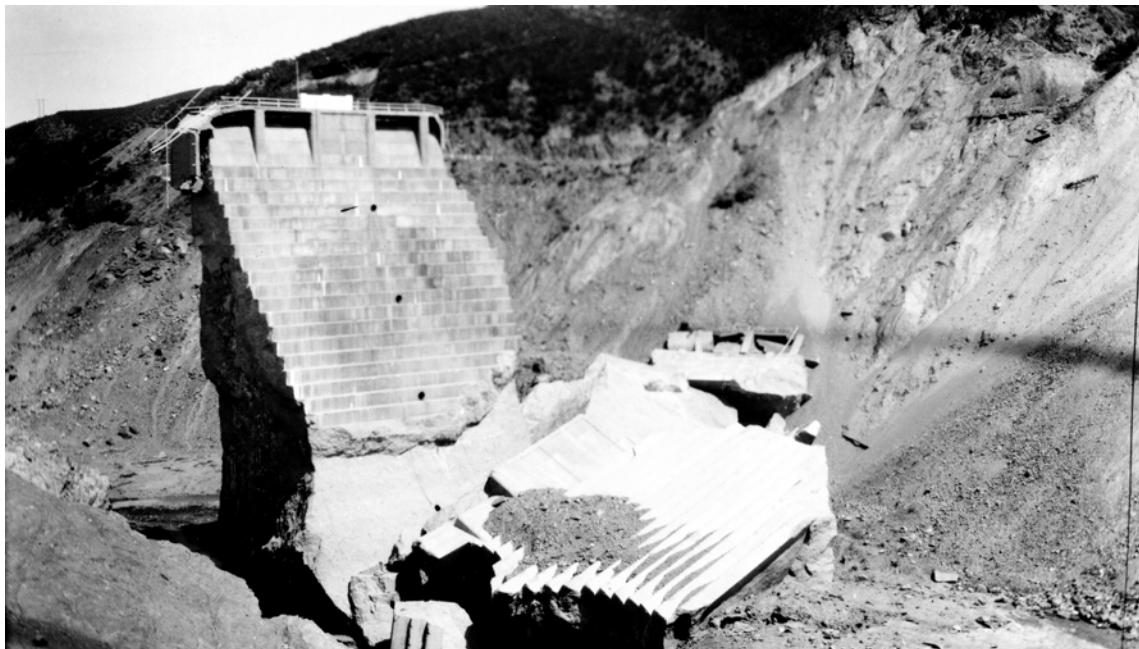
Figure 57. Upstream view of Block 5 sitting in front of Block 1 after the failure. Note the quantity of schist detritus sitting atop Block 5, testifying to its having been carried down slope in a slurry of disaggregated schist. Note the chatter marks on Block 1 cut by Block 5 and the latter's final resting position, about 30 feet lower. The material originally supporting Block 5 was likely swept away when the right abutment subsequently failed. Photo from the Lee collection, U.C. water Resources Center Archives.

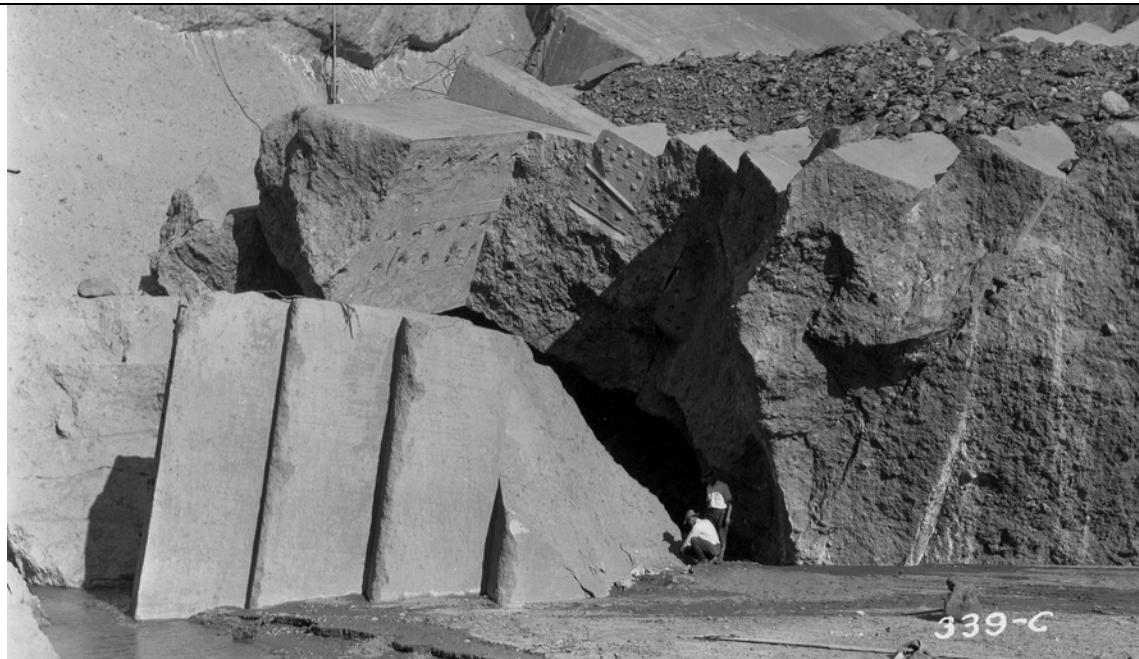
Figure 58. State survey party examining Block 6, which fell off of Block 5. Note the schist detritus infilling the 5 foot high steps of Block 5, 25 to 30 feet above the channel in foreground. Photo by H. Wilday, from author's collection.

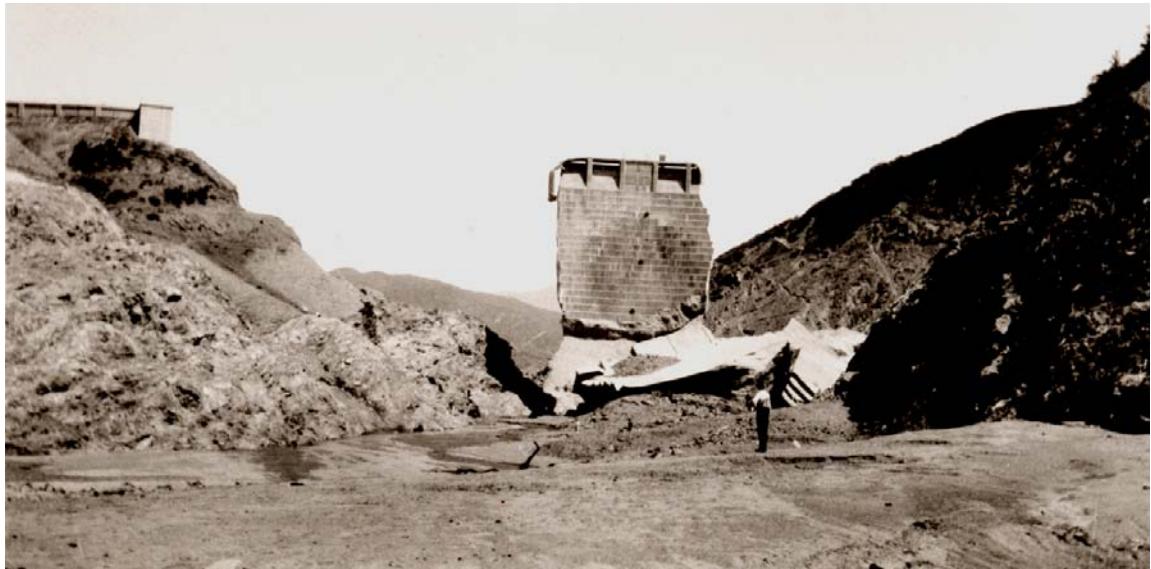
Figure 59. View looking upstream at the imposing monolith of Block 1. As in the previous photos, the gap between Block 5 and the chatter mark cut into Block 1 is noticeable, as is the clean character of the right abutment, swept clean of all debris in the later stages of the failure. Photo from the W.L. Huber Collection of the U.C. Water Resources Center Archives.

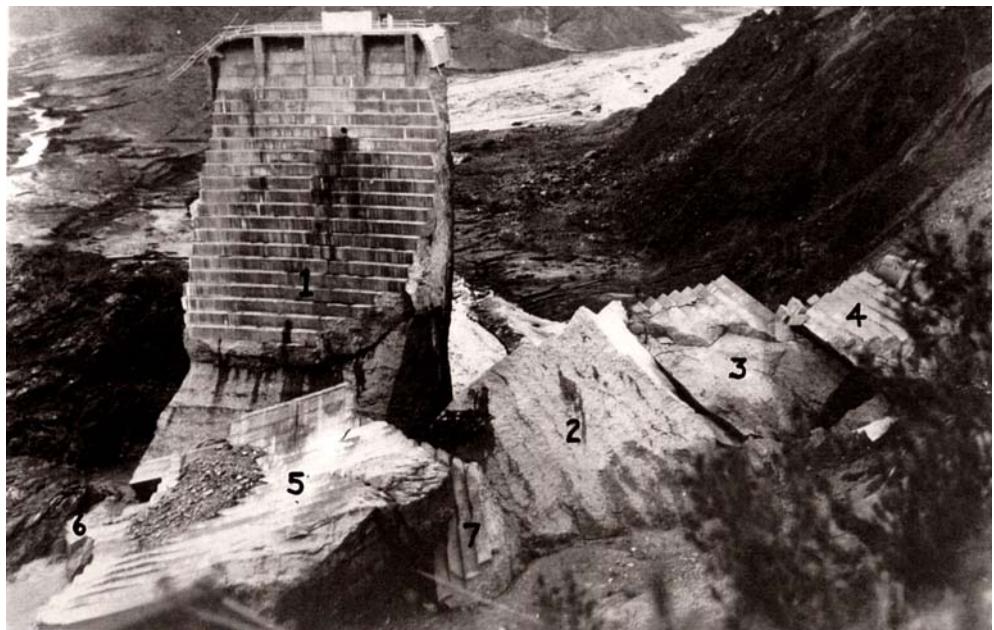
Figure 60. Upstream view of Blocks 1, 5 and 6 and those of Block 2, 3, 4, which rotated backward into a deep scour hole cut around the core's left side. Note the broken surface of Block 2 and most of Block 3, where the dam's downstream steps have been sheared off. Historian Charles Outland unravelled this puzzle while he was writing *Man Made Disaster* in the early 1960s. Photo from L.A. Dept. of Water & Power.

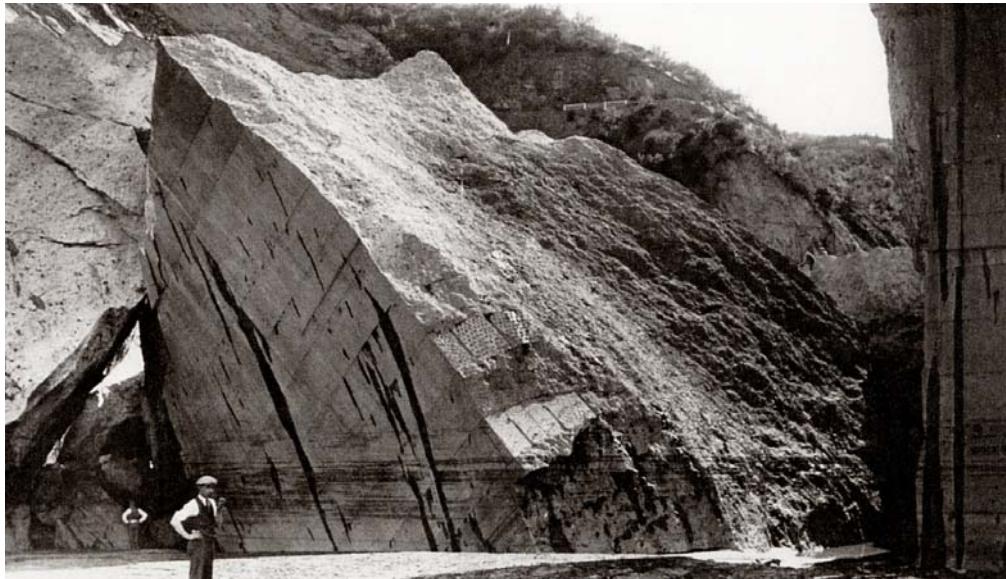
Figure 61. Ground view of Block 2 and a portion of 3, taken after the failure from upstream of Block 1. The horizontal scour marks across the inclined block testify to the reservoir stage when Block 2/3/4 toppled over. The reservoir was only about 17.5 feet deep, or nearly drained, when the left half of then dam's central core fell over. Photo from then W.L. Huber Collection of the U.C. Water Resources Center Archives.

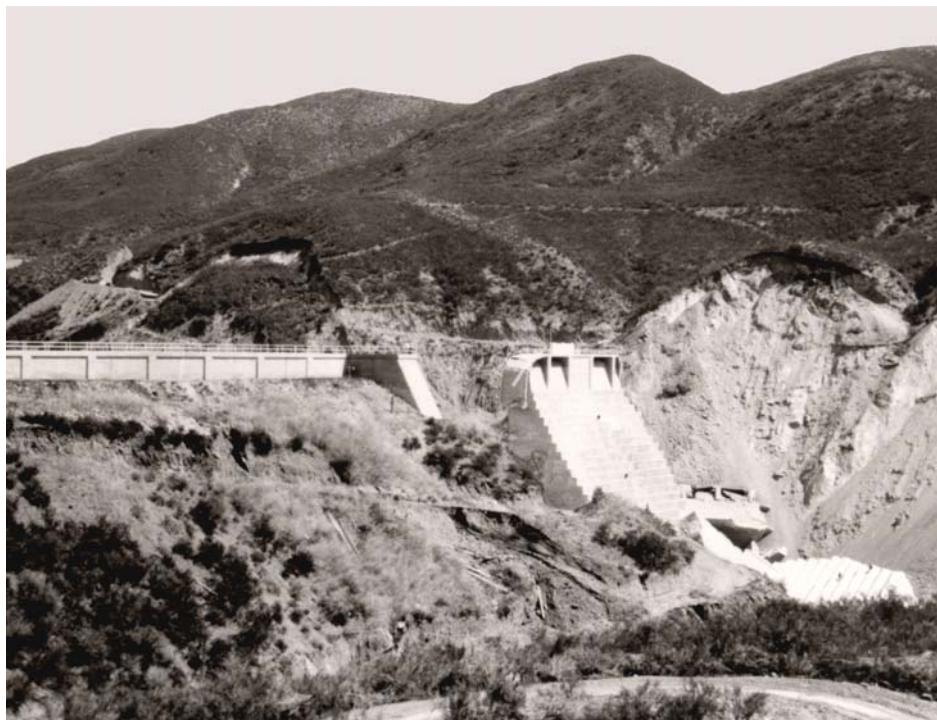
The reservoir was about two-thirds empty by the time the right abutment gave way, as evidenced by the low scour line on the right abutment (Fig. 62). This section likely gave way as Block 1 moved towards the gap on the left abutment side, the motion increasing as the flood volume diminished, lessening the lateral restraint. That Blocks 16/44 and 11/43 were transported so far is likely ascribable to their having been carried on a bed of fluidized debris, which had been deposited by the left abutment landslide and protected where it had piled up on the upstream face of the right abutment (this is why the chatter marks on Blocks 1 and 16 were so far above the final position of Block 5). So, the right abutment blocks were carried away in a debris slurry which represented a secondary mobilization of what remained of the left abutment slide debris (Fig. 55).

Figure 62. Ground view of the right abutment, just downstream of the dam following the failure. The intact nature of all vegetation on the dam's right abutment to an elevation at least 75 feet below the dam's crest suggests that the reservoir was 2/3 drained before the right abutment of the dam gave way (also see Fig. 29).

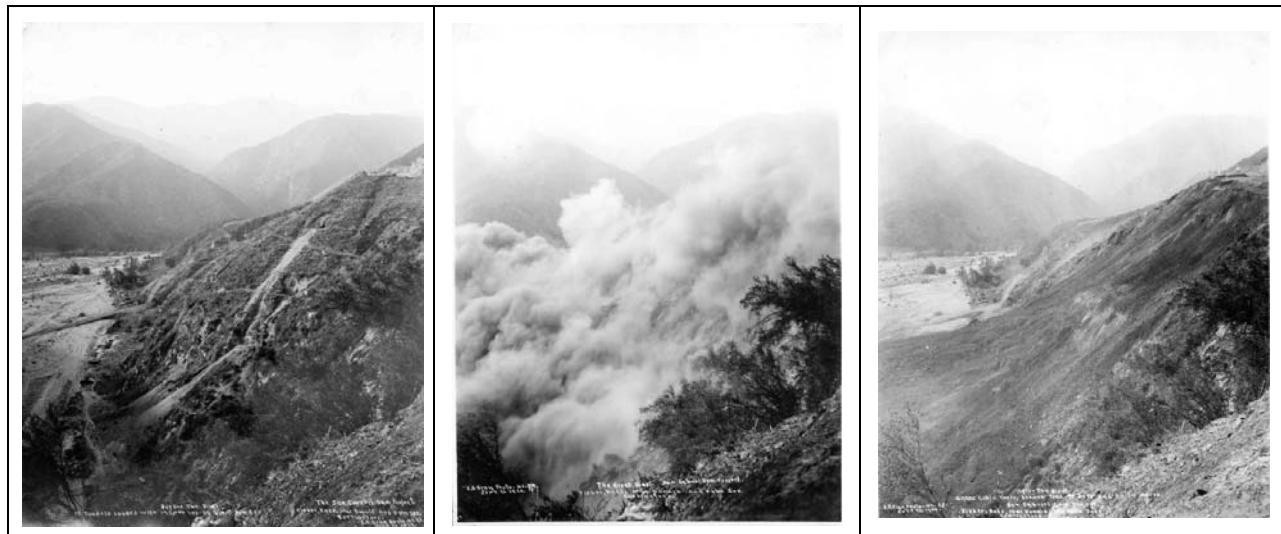
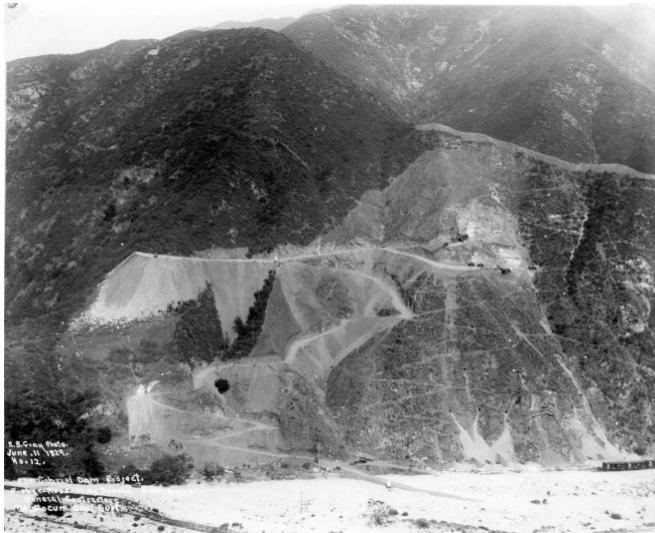
Figure 64. Ten times the size of St. Francis, San Gabriel Dam at The Forks site would have become the largest dam in the world if the State of California had not cancelled the project. This review authority over non-Federal dams by the state was established in the wake of the St. Francis disaster. These images show the excavation activities and landsliding that occurred on the right abutment in 1929. Photos from US Bureau of Reclamation.

The original San Gabriel Dam was intended to be a record breaker. It was laid out to be 500 feet high with a crest length of 2,300 feet and a concrete volume of 3.8 million yds³ (even larger than Hoover Dam, completed 7 years later). The owner was the Los Angeles County Flood Control District, which had already spent \$3 million of the \$25 million contract, awarded in September 1928. During excavation of the dam's right abutment in June 1929, the contractor loaded coyote tunnels with 193,000 lbs of powder, bringing down 160,000 yds³ of rock, but over-blasting the abutment left the rock severely fractured. On September 16th a massive landslide involving more than 200,000 yds³ slid down into the canyon, halting further construction. The three images in upper panel of Fig. 64 show, from left, the right abutment before excavation, during the detonation in June 1929, and after the large rock slide in August 1929. The lower image in Fig. 64 is an elevation view looking at the right abutment before the blast of June 26, 1929.
