The 1928 St. Francis Dam Failure and Its Impact on American Civil Engineering

J. David Rogers

THE 1928 ST. FRANCIS DAM DISASTER

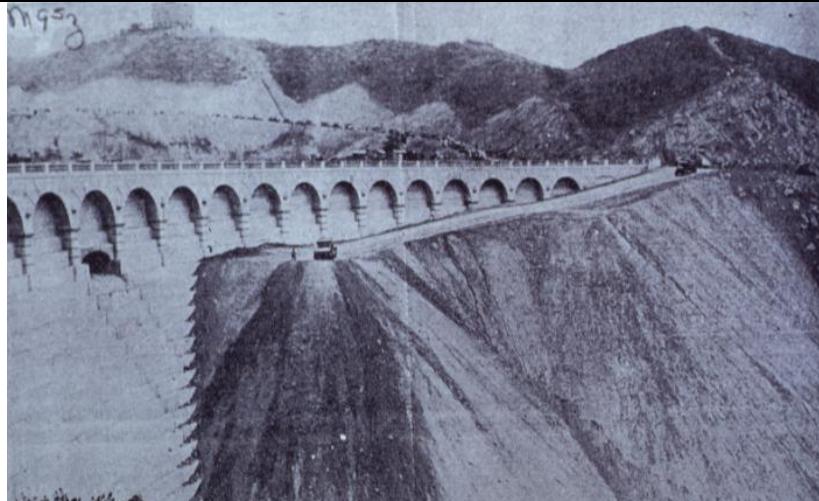
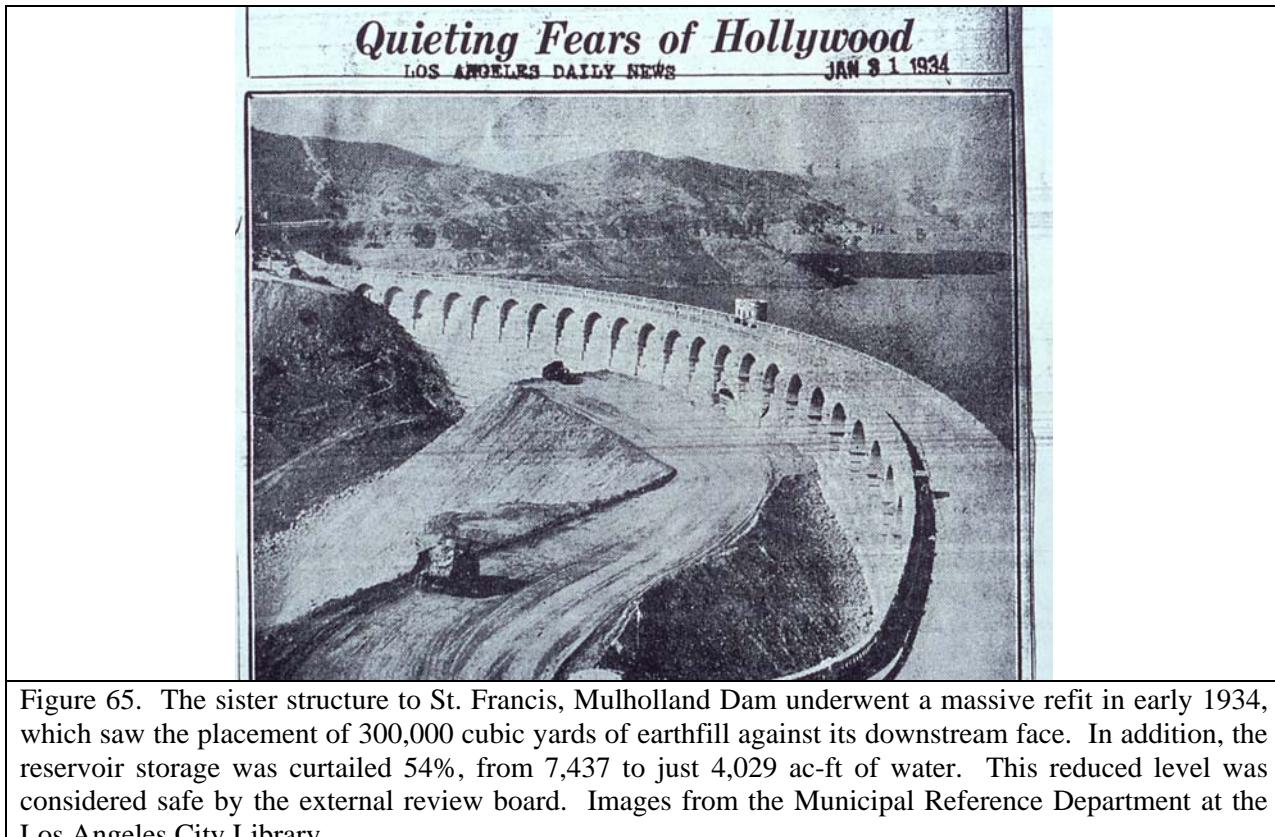
Figure 65. The sister structure to St. Francis, Mulholland Dam underwent a massive refit in early 1934, which saw the placement of 300,000 cubic yards of earthfill against its downstream face. In addition, the reservoir storage was curtailed 54%, from 7,437 to just 4,029 ac-ft of water. This reduced level was considered safe by the external review board. Images from the Municipal Reference Department at the Los Angeles City Library.

All of the review panels, even that chaired by BWWS's own Harvey Van Norman in 1930, concluded that Mulholland Dam had insufficient control of hydraulic uplift and underseepage to be stable in overturning under full reservoir pressure, more especially so, during an earthquake. They recommended drawing the reservoir down to elevation 715 feet, 36 feet below the dam crest, to bring the resultant thrust inside the middle third of the structure. The reservoir pool had been drawn down 50% in 1929 as a precaution to placate concerned Hollywood residents while the dam was analyzed. The Van Norman panel recommended placing an enormous earthen buttress against the dam's downstream face to heighten its safety factor against possible failure in the event of a major earthquake and placate public concerns.

After considering the increased stability engendered by the downstream embankment fill, the city concluded that the reservoir pool could be maintained no higher than 54% of the maximum level (4,028.7 ac-ft), and this is where it has remained since 1931. The reservoir is normally operated at a pool level between 715 and 721 feet, which is a conspicuous 35+ feet below the dam's crest elevation of 756 feet. In January and February of 1934 the City quietly supervised the placement of over 300,000 cubic yards of earth against the downstream face of Mulholland Dam to provide a massive buttress (Fig. 65). Today this slope is covered with eucalyptus trees, obscuring the concrete parapets of a once famous concrete dam that still bears the name of the City's famed waterworks engineer. Mulholland Dam retains Hollywood Reservoir, which local residents refer to as "Lake Hollywood."

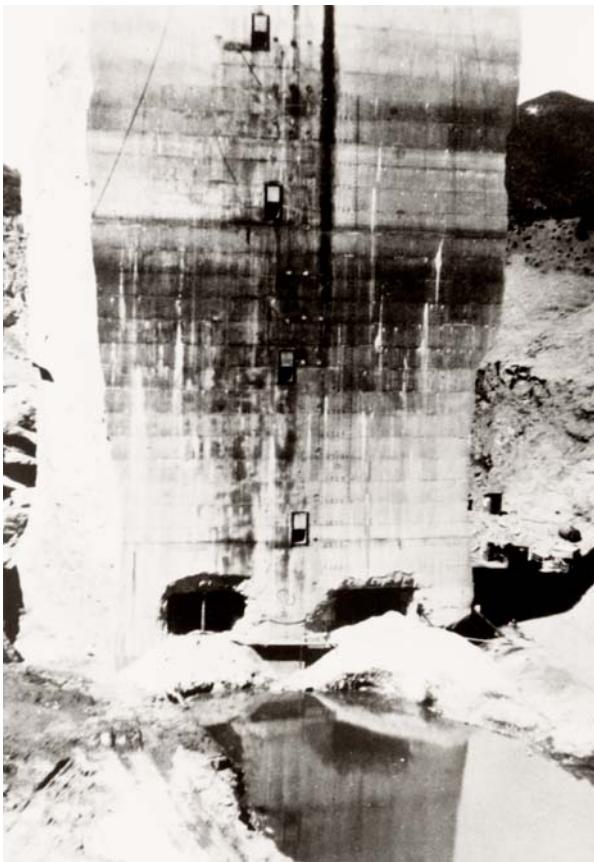
Figure 66. View looking at upstream heel of Block 1 in mid-1929, when the City was engaged in demolition work at the damsite. These adits in the upstream heel of Block 1 were loaded with dynamite and detonated, blowing the block backward, just like Blocks 2/3/4. Block 1 toppled backward and split into five discernable pieces. As in the case for Blocks 2/3/4, the concrete separated along undulatory cold pour joints, due to the weak tensile strength along these horizons, coated with a high water content laitance layer.
