Hydro-geomorphic hazards and impact of man-made structures during the catastrophic flood of June 2000 in the Upper Guil catchment (Queyras, Southern French Alps)

Gilles Arnaud-Fassetta*, Etienne Cossart, Monique Fort

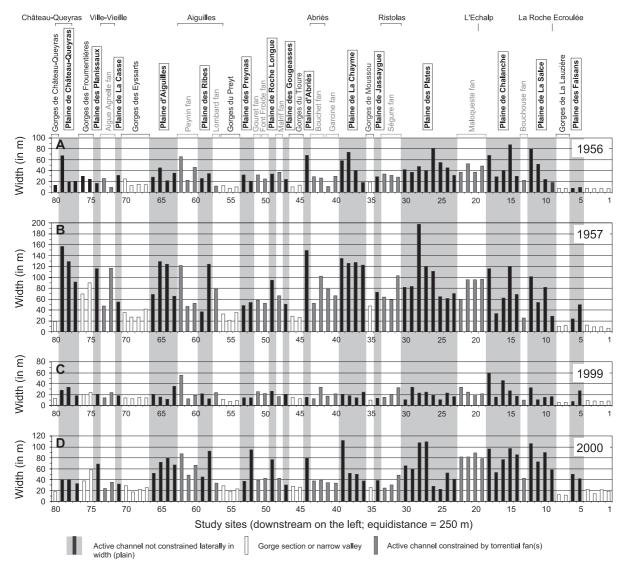
Fig. 6. Comparison of the active channel width of the Guil River before and after the June 1957 and June 2000 events (active channel width measured on IGN aerial photographs dated from 1956, 1957, 1999 and 2000). The amplitude of variations in active channel width depends on the section type (constrained or not by the presence of rocky outcrops and/or tributary fans). Upstream of La Roche Ecroulée (site 9), the impacts of both events are comparable, and the June 2000 event might even be larger. Downstream, the active channel width in 2000 was only about 40% of the 1957 channel width; yet locally (upstream of short gorge sections), the width was similar during both events.

One major impact of the flood was the enlargement of the active channel and the generalised bank erosion observed regardless of the section considered (Arnaud-Fassetta and Fort, 2004) (Fig. 6). In the wider areas, river banks collapsed and retreated, thus reinjecting a large volume of sediment into the active channel. Very locally, the "1957 flood terraces" (Tricart, 1974) were eroded as well. In the narrower sections, bank undercutting triggered many landslides, to the detriment of colluvial, morainic or weathered bedrock slopes (Fig. 7A). Artificial channel segments were also affected, with deterioration or partial destruction of dikes, gabions, concrete or blocky-armoured walls. For instance, the gabions and earthy dike protecting the camping ground of Le Chardonnet (Ristolas) were seriously undermined, and directly threatened the safety of campers (Koulinski, 2001). Also, most of the wooden footbridges used for hiking or cross-country skiing were washed away.

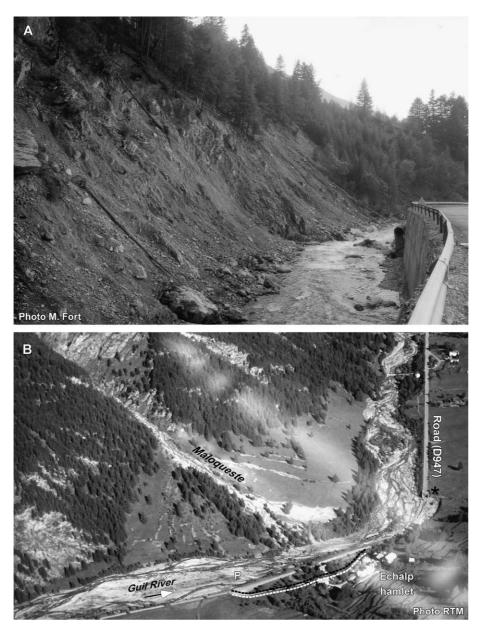
Fig. 7. (A) In the Preyt gorges, upstream of Aiguilles, the Guil channel is narrowed by the concrete wall and road embankment (right bank). Adjustments to fluctuations of discharge can only be accommodated on the left bank (landslides affecting the weathered slaty bedrock). Additionally, the concrete wall deflects the flow onto the opposite (left) bank with minimum loss of energy, reinforcing the destabilisation of the bank. (B) Aerial view of the confluence between the Guil River and the Maloqueste Torrent after the 2000 flood. Sediment and water transported by the Maloqueste Torrent deflected the Guil River onto its right bank. In addition, the Guil River enlarged its active channel to the detriment of the flood plain (change of a single-thread channel to braided channels). Both processes produced combined effects, with destruction along the right bank [parking area washed away (P), a 300-m-long stretch of the D947 road eroded (*), re-opening, right in front of the Echalp houses, of a former channel closed by the road embankment (double dashed line)] (RTM photograph).

Reduced channel capacity arising from anthropogenic structures may also affect gorge sections. In 2000, the water intake (for Aiguilles hospital) and the dam built in the Aiguilles (Preyt) gorge had the effect of narrowing the channel even more, and thus increased artificially the rise in water levels upstream, aggravating the submersion of the camping ground of Le Gouret. In the same narrow gorge, the retaining concrete wall of the D947 road caused deflection of the flow on to the opposite (left) bank, thus exacerbating landsliding and supplying the Guil River with abundant gravelly and finer sediments (Fig. 7A). The resulting increase in flow rate gave rise to supersaturated pulses, causing rapid destruction of the riparian forest and excessive dumping of bed-material load where the Guil River entered the Plaine des Ribes in Aiguilles (Figs. 8D and 9A,B).

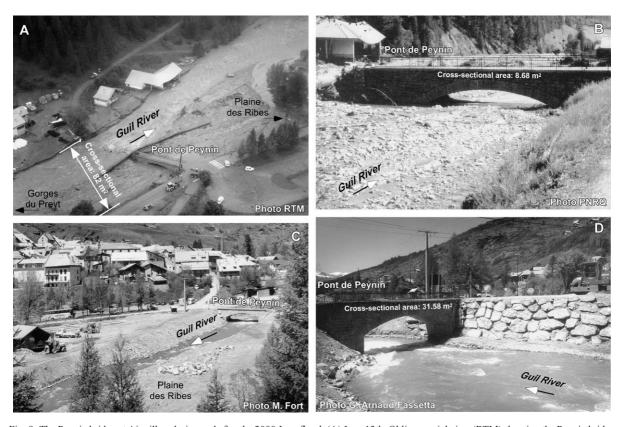
Fig. 9. The Peynin bridge at Aiguilles, during and after the 2000 June flood. (A) June 13th. Oblique aerial view (RTM) showing the Peynin bridge nearly buried by sediment and the new channel opened by the Guil River on its left bank. The cross-sectional area was 82 m². (B) June 14. Detail of the Peynin bridge, blocked by sediment (PNRQ). The cross-sectional area is reduced to 8.68 m². (C) July 2000. The Guil channel has been dug out, and the gravels removed have been piled on both banks as levees to re-establish one single channel flowing under the Peynin bridge. (D) May 2002. The upstream-progressing erosion subsequent to the dredging of the Guil riverbed has undermined the base of the bridge piles. Concrete stone armouring has been built in order to protect the right bank and the hospital downstream, whereas the left bank has been left unmanaged.

One generalised action (along both natural and urbanised reaches) was the narrowing of channel crosssectional area by artificial levees, built with loose gravels taken up directly from the river channel (Fig. 9C). These stone dikes, stretching parallel to the low water channel, were meant to restrict the braiding river course within one channel as had been the case before the flood, and to force the river to incise its alluvial floor, thus indirectly reducing the frequency of overbank floods. However, we speculate that this approach is illusory. First, bed armouring prevents channel incision during annual floods, so that the channel capacity remains insufficient for a 10- to 30-year flood event. Strong riverbed degradation (armour removal) increases the critical height of the levees for planar/slab failure. Second, during extreme events, these artificial levees offer little resistance to erosion because the channel competence during flood is greater than the resistance offered by the grain-size of the material constituting the artificial levees. In these conditions, the channel tends to widen and to be infilled, causing a higher flood risk in the flood plain (Fig. 15A).

Other measures adopted have included rebuilding bridges, at the same places and sometimes of the same size as before the flood. Although, following its destruction, the bridge connecting the road to the Peynin cone, downstream of Aiguilles, was rebuilt with a wider roadbed (30 m instead of 16 m), and so able to absorb the effects of higher river discharges, the same rather small cross-sectional area was retained in the case of the intact Peynin bridge. In fact, because of the cost of such a structure, it was decided to wait until another major flood destroys the bridge, so that a new, larger bridge will then be constructed, and the left bank protected (handicraft zone). So far, the left bank has been left unmanaged as the lesser evil, for the flooding of the handicraft zone is considered less of a disaster than the flooding of the hospital (concrete rockarmouring rebuilt on the right bank; Fig. 9D).

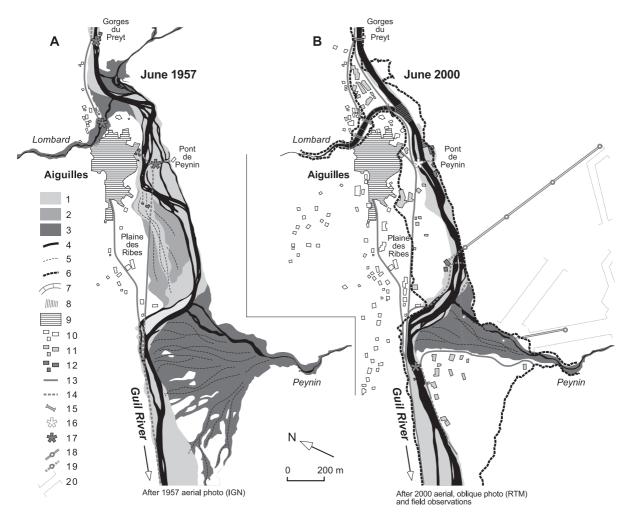
Fig. 10. Comparative maps showing flood impacts and land-use changes that took place in the Plaine des Ribes (Aiguilles village) between 1957 and 2000. Obviously, the vulnerability of this village has increased, due to the many buildings and activities sited in the former 1957 active channel of the Guil River and on the Peynin fan. 1=1957 active channel; 2=floodplain; 3=zone of aggradation (torrential fan); 4=main channel; 5=secondary channels; 6=1957 flood plain extent; 7=flood control structure: concrete embankment and weirs; 8=channel degradation control structure: concrete bed armouring; 9=village; 10=building away from the 1957 flood plain; 11=building sited on the 1957 flood plain, not flooded in 2000; 12=damaged building; 13=road; 14=damaged or destroyed road; 15=bridge; 16=aggraded bridge; 17=damaged or destroyed bridge; 18=ski pylon; 19=damaged or destroyed ski pylon; 20=ski run.

spread over the left bank, in the handicraft zone, thus reoccupying their former (pre-1957) channel course (Fig. 10). The two buildings of the carpenter's

workshop, one civil engineering company building, and a small house were damaged. Overbank flow also occurred on the right bank downstream of the
