Fire Risk Assessment

| General Information | | | | | | | | | | |
|---|--|---|---|---|---|---|---|---|---|--|
| Address of premises: | | | 8 Osborne Villas, Bristol, BS2 8BP | | | | | | | |
| Date of fire risk assessment: | | | November 2023 | | | | | | | |

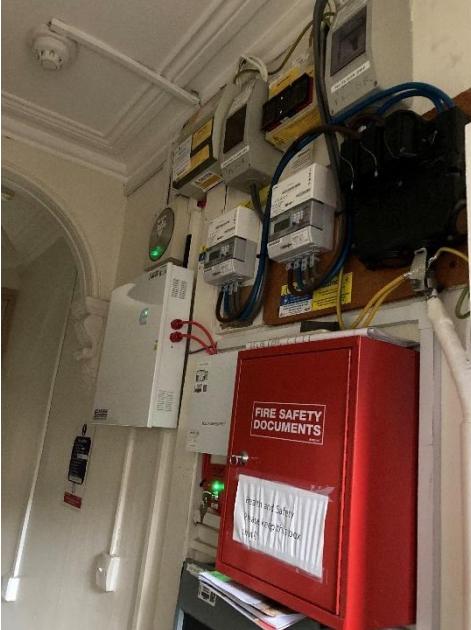
| IGNITION SOURCES (d) Electrical | COMMENTARY Record any findings within the building ensuring you identify potential fire hazards and risk areas within the premises | EXISTING CONTROL MEASURES Record systems and procedures in place including training and information given. If action is needed record this in the action log. | FIRE RISK Control/condition satisfactory? |
|--|--|--|---|
| <p>Items to consider:</p> <ul style="list-style-type: none"> Is wiring in good condition? Is there evidence of overloading including use of multi-block adapters? Trailing leads Are electrical intake areas clear of combustible materials? To what standard was the electrical system installed | <p>The electrical installation was tested in January 2021. The meters and distribution boards are situated in the entrance corridor at high level.</p> <p>No evidence of overloading or poor cable management was found.</p> <p>The electrical intake and meters are all on the wall of the single means of escape next to the final exit. This presents a hazard to the single means of escape and although there is early warning through the fire alarm system, this risk should be either boxed in completely removed from the hallway.</p> | <p>Occupiers are responsible for arranging PAT testing and should arrange re-visits according to the risks and amount of use electrical items get.</p> <p>Visual inspection of appliances at time of FRA does not raise any concerns, but PAT test would need to be arranged for certainty.</p> <p>Smoke detection in areas of greatest risk (kitchen, hallway) offers early detection and evacuation.</p> <p>Very low occupancy numbers with only GF and 1st floor rooms occupied.</p> <p>All occupiers will know the escape route and any visitors will be directed to the single means of escape.</p> <p>All areas are within required travel distances to the final exit.</p> | <p>Moderate 20</p> |

The electrical meters/intake within the GF corridor is a particular hazard that needs addressing to ensure the single means of escape is not compromised.

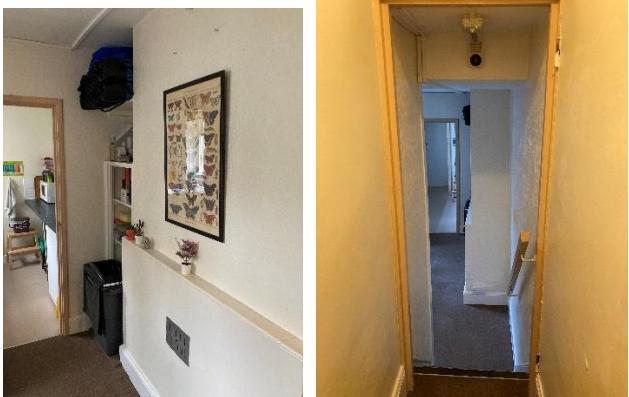
| EMERGENCY ROUTES AND EXITS | | | |
|---|---|---|--|
| <p>Items to consider:</p> <p>Are they covered by automatic detection or fire resisting construction and fire doors?</p> | <p>Record any findings within the building ensuring you identify potential fire hazards and risk areas within the premises</p> <p>The building is essentially a residential property, now adapted for office use. The building remains in a residential layout with rear extension housing a small kitchen and dining area that has been adapted as a seating area for waiting clients. There are no hobs within the kitchen – only electrical appliances.</p> <p>The rear GF extension creates a situation where three small rooms adjoin one another with a very short set of stairs to the main corridor that leads towards the exit. To escape from the rear room (a WC), evacuation can only be achieved in one direction. There is a door that leads to the rear garden, but offers no means of escape to an ultimate place of safety, despite having EML outside of the bolted door.</p> <p>There is what appears to be 'nominal fire door' between the GF entrance corridor and the 3 rear rooms on the GF (kitchen area and bathroom), however, the building is treated as one compartment.</p> | <p>Record systems and procedures in place including training and information given.</p> <p>If action is needed record this in the action log.</p> <p>Smoke / Heat detection within the 2 access rooms (kitchen and small waiting area). No SD in WC where risk is lowest.</p> <p>Occupancy is very low – max of around 10/11 people, (but usually lower) might be in the building at one time, if each counsellor were to have a client on site.</p> <p>EML on the escape route.</p> <p>Occupiers are familiar with building layout, and will direct clients to the front exit.</p> <p>Building is only generally occupied 3 days a week.</p> <p>Although the kitchen and waiting area are technical separate rooms on plans, they are treated as one space and due to close proximity, smoke or flame would be quickly identified if in either space if in the area.</p> <p>Very low risk building activities.</p> | <p>Control/condition satisfactory?</p> <p>Moderate 20</p> |

| EMERGENCY ROUTES AND EXITS | | | |
|--|--|---|---|
| | Further measures should be sought to reduce the risk to occupiers using the WC that would need to escape through the kitchen to a place of safety. | | |

| Issue | Risk Level / location | Issue description | Proposed solution | Person responsible | Job reference number | Expected completion (date) | Checked as complete (names & date) |
|---|---|---|--|---|---|---|---|
| 4 | Tolerable | Door to kitchen (inner room condition) prevents visibility to adjoining room. | Remove internal door to create one space with clear visibility and access to the fire exit route. Inner room condition removed. Dead end condition will remain but with | FM – via Helpdesk request | 1072143 | | |

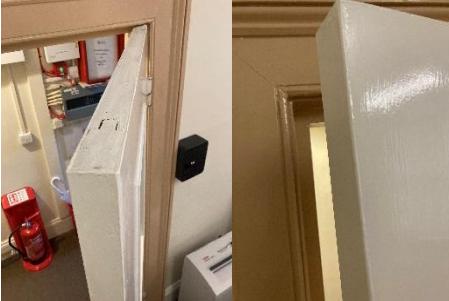
| EMERGENCY ROUTES AND EXITS | | | |
|---|--|--|---|
| <p>Items to consider:</p> <ul style="list-style-type: none"> Are all exits and staircases protected from ingress of smoke and fire? Is escape route protected for a minimum of 30 minutes? Is the integrity of fire resisting compartments maintained? Are fire doors in good condition, functioning correctly and not wedged open? Do you have a testing regime for approved hold open devices on fire doors? | <p>Record any findings within the building ensuring you identify potential fire hazards and risk areas within the premises</p> <p>The exit routes from the GF and 1F are offered a degree of protection from ingress of smoke and fire by nominal fire doors only. Doors onto the GF corridor appear to have qualities of a fire doors, such as Georgian Glass, at least 44mm thick, and some are fitted with door closers. It is assumed that these doors are nominal fire doors, but will not be certified fire doors to today's standards.</p> <p>The 1st floor rooms (x2) do not have door closers, but should be added to improve the conditions and ability to reduce/limit fire and smoke spread.</p> <p>The construction of the walls cannot be assumed to be fire resisting materials due to the age of the building and lack of information to indicate otherwise.</p> <p>The extent of this non-intrusive FRA has not extended into voids or cavities that are not easily accessible.</p> | <p>Record systems and procedures in place including training and information given.</p> <p>If action is needed record this in the action log.</p> <p>There are no certified fire doors in the building. The doors to all the rooms are generally kept closed and at the end of the day all doors are shut.</p> <p>Doors onto the escape routes appear to be nominal fire doors, which are generally over 44mm thick, appear to be of solid construction, have door closers and Georgian glass (not all)...but they cannot be considered fully functional fire doors to today's standards.</p> <p>The building is treated as a single compartment, however, the corridors appear to be offered a degree of protection by virtue of the doors being notional fire doors. In this small building, this would be sufficient to enable staff to evacuate in good time.</p> <p>Detection covers all rooms and corridor, except the two WCs and the 2 1F offices. Door closers should be added to improve the function of these doors when limiting smoke/fire spread.</p> <p>General activity in this building is very low risk.</p> | <p>Control/condition satisfactory?</p> <p>Tolerable 5</p> |

| EMERGENCY ROUTES AND EXITS | |
|---|---|
| | <p>To improve the safety of the escape route, consideration should be given to replace all doors to the escape route with modern, certified fire doors, or if this is financially prohibitive, modifications by a suitably qualified person to install necessary fire rated door furniture and intumescent strips and smoke seals and door closers to improve their ability to maintain a full 30 minutes of protection to the escape routes.</p> |

| Issue | Risk Level / location | Issue description | Proposed solution | Person responsible | Job reference number | Expected completion (date) | Checked as complete (names & date) |
|---|---|---|--|---|---|---|---|
| 3 | Substantial | All doors on corridors are not FD30s – Ther are notional fire doors. Additional smoke seal required to all doors to fill any small gaps. Both 1 st floor rooms also have no door closers. | Add smoke seals and strips and any other fire rated door furniture as required uograd doors, or ideally replace with fire rated door sets to latest standards. | Asset Maintenance | 1073536 | TBC | |
