Fire Risk Assessment

General Information											
Address of premises:			Goldney Hall, Lower Clifton Hill, Bristol, BS8 1BH								
Assessor / job title:			Mr J.L.A. Singleton-Campbell – MIFSM, Fire Compliance Southwest								
Date of fire risk assessment:			13th January 2026								
Date of previous fire risk assessment:			3rd – 4th November 2025								
Suggested date of next review: (based on risk level indicator)			12th July 2026								
Building risk profile (A, B, Ci, Cii)			Cii								
Risk Level Indicator											
0-99		100 – 399		400 – 699		700 – 999		1000+			
(a) Hazard(s) total =		Trivial	0	Tolerable	1	Moderate	18	Substantial	5	Intolerable	
(b) Points award		1 point		5 points		20 points		50 points		100 points	
Points total (a x b)		0		5		360		250			
615

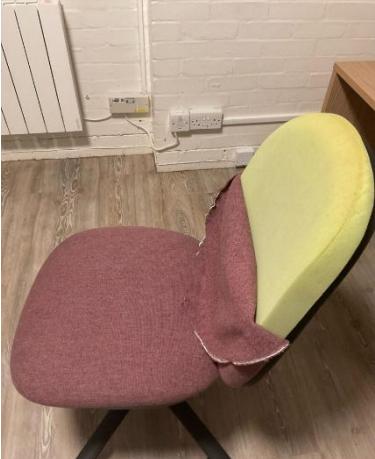
Figure 1

A damaged upholstered chair with exposed foam core was observed within block a, room 0.5.

Issue	Risk Level	Issue description and location	Proposed solution	Person responsible	Job reference number	Expected completion (date)	Checked as complete (names & date)
1 <i>Fig 1</i>	3	A damaged upholstered chair with exposed foam core was observed within Block A, Room 0.5. The presence of damaged soft furnishings can present an increased fire load and potential for rapid fire spread due to the exposed combustible material.	Remove the damaged chair from use and dispose of it appropriately. Any replacement furniture should be certified as fire-retardant in accordance with the Furniture and Furnishings (Fire) (Safety) Regulations 1988 (as amended). Ensure regular inspections of upholstered furniture are undertaken to identify and remove any future damaged items.	Jemima Moulton-Hawkins	N/A	December 2025	Complete: Chair replaced 09/12/2025
2 <i>Fig 2</i>	3	Whilst University of Bristol-supplied electrical appliances are PAT tested at the appropriate frequencies, a number of student-owned electrical appliances were identified within kitchens with no evidence of PAT testing. No test labels or records were available to confirm that these appliances had been subject to inspection.	The University already provides sessions for students to present personal appliances to the Facilities team for PAT testing. It is recommended that routine kitchen checks continue, and that any student-owned appliances identified without evidence of testing are referred for PAT testing at the next available opportunity.	Andrew Langford / Tawanda Chibaya	N/A	December 2025	Complete: Current testing regime deemed sufficient, no further action required

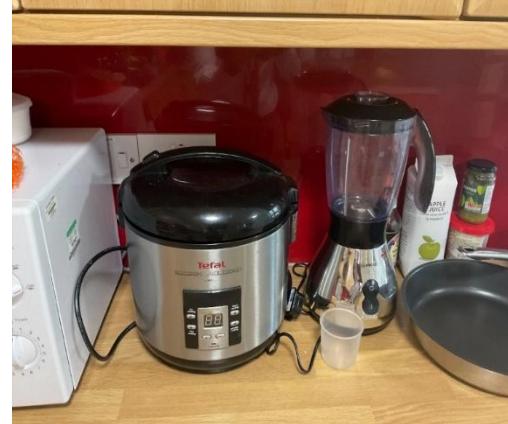
Figure 2

Privately owned student electrical appliances without evidence of PAT testing were observed within kitchen areas at the time of assessment.

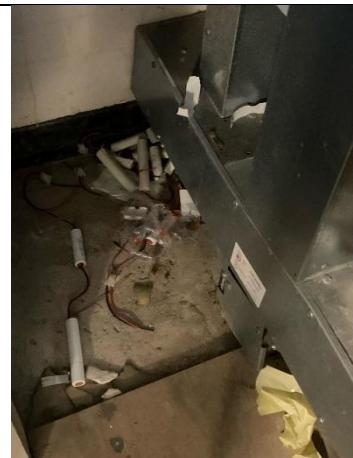
Figure 5

Disused Ni-Cad batteries were observed on the floor within the electrical intake cupboard serving flat B1.

3	4	<p><i>Fig 3 To Fig 11</i></p> <p>Combustible materials and disused Ni-Cad batteries were observed stored within multiple electrical riser cupboards and plant areas throughout the premises. These areas are designed solely to accommodate electrical infrastructure and should not be used for general storage. The presence of combustible materials within electrical or plant areas increases the risk of ignition, fire spread, and may obstruct safe access to essential electrical equipment.</p> <ul style="list-style-type: none"> • Electrical cupboard serving Flat A1 • Electrical cupboard serving Flat B0. • Electrical cupboard serving Flat B1. • Electrical cupboard serving Flat B2. • Electrical cupboard serving Flat F0. • Electrical cupboard serving Flat G0. • Electrical cupboard serving Flat H0. • Electrical cupboard serving Flat H2. • Electrical cupboard serving Flat J0. • Boiler room located to the rear of Block L 	<p>Remove all combustible items and disused Ni-Cad batteries from electrical riser cupboards and plant rooms immediately. Implement a strict housekeeping regime to ensure these areas remain clear of storage and regularly inspected. Any redundant batteries should be disposed of safely in accordance with hazardous waste regulations, and Estates or local management should incorporate periodic checks into routine maintenance procedures.</p>	<p>Joe Collins / Jemima Moulton- Hawkins</p>	<p>1508862. 00</p>	<p>December 2025</p>	<p>Complete: Maintenance Services completed clear out of all electrical cupboards 16/12/2025 Cupboards checked by JMH 08/01/2026 Ongoing spot checks of cupboards to be included in monthly H&S audits.</p>

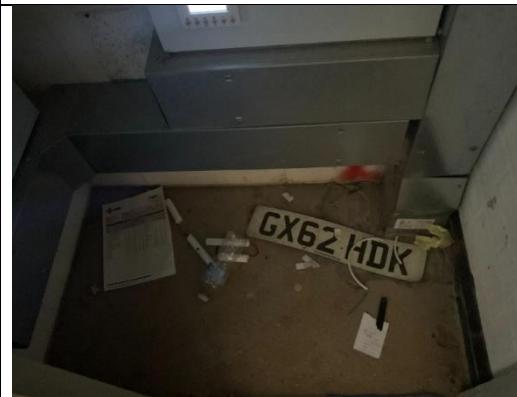
Figure 6

Disused Ni-Cad batteries and combustible waste were observed on the floor within the electrical cupboard serving flat B2.

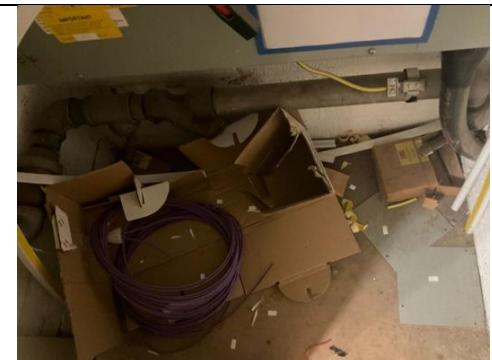
Figure 8

Combustible materials and disused Ni-Cad batteries were observed on the floor within the electrical cupboard serving Flat H0.	Combustible materials and disused Ni-Cad batteries were observed on the floor within the electrical cupboard serving Flat H2.	Combustible materials and disused Ni-Cad batteries were observed on the floor within the electrical cupboard serving Flat J0	Disused Ni-Cad batteries were observed on the floor within the boiler room located to the rear of Block L.
---	---	--	--

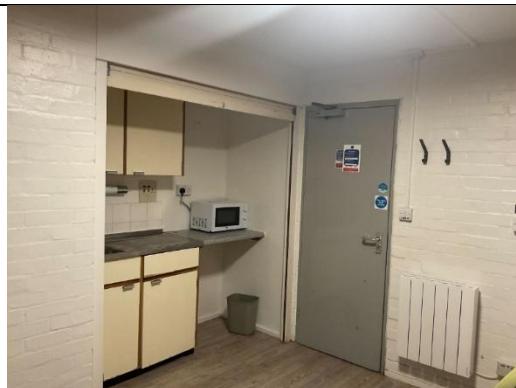
Figure 13

Kitchenette located within Flat A – Room 0.5, positioned directly adjacent to the primary escape route (flat entrance door).	Final exit door fitted with thumb-turn lock lacking signage to indicate direction of operation.	Electrical distribution cupboard within Flat B0 fitted with non-fire-resisting doors requiring replacement with FD30S door sets.	Electrical distribution cupboard within Flat B1 fitted with non-fire-resisting doors requiring replacement with FD30S door sets.
--	---	--	--

4 <i>Fig 13</i>	3	<p>Access was obtained to Flat A – Room 0.5, which was vacant at the time of assessment. A kitchenette is installed directly adjacent to the flat entrance door, forming part of the escape route from the room. A roller shutter is provided to enclose the kitchenette; however, it is not interlinked to the fire alarm system to automatically close in the event of fire and is therefore likely to remain in the open position when the kitchenette is in use.</p> <p>University staff advised that these rooms are typically allocated to postgraduate students. When allocated to non-postgraduate students, the roller shutter is kept in the lowered and locked position, preventing use of the kitchenette and thereby removing the cooking risk. Conversely, when the room is allocated to a postgraduate student, the kitchenette is made available and the roller shutter remains unlocked and raised, which introduces the risk that a fire originating within the kitchenette area could compromise the means of escape via the entrance door.</p> <p>Although a secondary door provides potential alternative egress to a small enclosed external space, use of this route</p>	<p>A review should be undertaken to identify all student bedrooms that incorporate kitchenette facilities and to confirm their position relative to the primary entrance door. Where a kitchenette is positioned immediately adjacent to the flat entrance door, this arrangement should be considered unsuitable due to the potential for a fire in that area to compromise the escape route.</p> <p>The University should implement a management control whereby any kitchenette positioned beside the entrance door is maintained in the lowered and locked position by default, preventing its use unless the room is specifically allocated to a postgraduate student under controlled conditions. Where the kitchenette is made available for use, a fire-resisting roller shutter should be installed and interlinked to the fire alarm system so that it automatically closes upon activation of the alarm or loss of power, and the activation of the shutter should simultaneously isolate all electrical supplies serving the kitchenette.</p> <p>If these measures cannot reasonably be achieved, or where no suitable alternative means of escape exists that does not require passing the kitchenette, the kitchenette should either be removed or relocated so that its position does not compromise the escape route. A fire blanket should be provided within each kitchenette, and clear instructions issued to occupants regarding safe use of appliances and the prohibition of unattended cooking.</p> <p>Where reliance is placed on a secondary door providing access to an enclosed</p>	Jemima Moulton-Hawkins / Joe Collins	1524887.00	February 2026	<p>Started - Partial Completion: JMH emailed Student Accom Team to remove offering of kitchenette in room, change room profile on StarRez 07/01/2026</p> <p>1524887.00 - job raised to lock off shutter to kitchenette 07/01/2026</p> <p>Further Action: Raise job in Easter to carry out complete removal of kitchenettes in A0.5, C0.5 and E0.5 over summer 2026.</p>

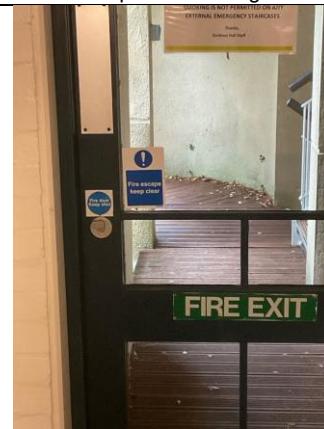
Figure 14

5 <i>Fig 14</i>	2	<p>A number of final exit doors throughout the premises are fitted with thumb-turn locks. However, the direction of operation and method of use for these locks are not clearly indicated by appropriate signage. In an emergency, particularly in low lighting or when used by unfamiliar persons, the absence of clear indication could delay</p>	<p>Provide clear, durable, and pictorial signage adjacent to all final exit doors fitted with thumb-turn locks, indicating the direction of turn and method of operation to release the door. Signage should comply with BS 5499-4 and be of a size and format easily visible in low-light conditions.</p>	Jemima Moulton-Hawkins	N/A	December 2025 08/12/2025	Complete: JMH installed photoluminescent thumb turn signage to all final exits 08/12/2025

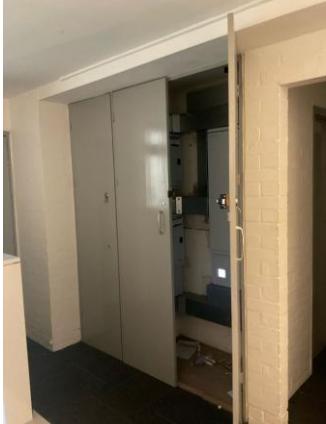
Figure 18

Electrical distribution cupboard within Flat C0 fitted with non–fire-resisting doors requiring replacement with FD30S door sets.

egress or lead to confusion in operating the device.				
6 <i>Fig 15 To Fig 33</i>	4	<p>A number of doors installed to electrical distribution cupboards within flats were observed to be non-fire-resisting in construction. These enclosures contain electrical equipment which represents a potential ignition source and therefore require adequate fire separation from the surrounding accommodation. The current lightweight doors would not provide sufficient resistance to the spread of smoke or fire in the event of an electrical fault or equipment fire.</p> <ul style="list-style-type: none"> • Block B • Block C • Block D • Block F • Block G • Block H • Block J 	All electrical cupboard doors located within flats should be replaced with new FD30S fire-resisting door sets, constructed and installed in accordance with BS 8214 and the manufacturer's certification. Doors should be fitted with suitable locks to ensure they remain closed when not in use and provided with appropriate signage stating "Fire door – Keep locked shut".	Awaiting Quote from Shield 13/01/2026	Planon ref 1548831 Raised 12.2.26	May 2026

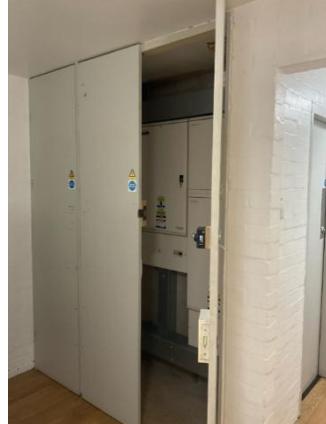
Figure 19

Electrical distribution cupboard within Flat C1 fitted with non–fire-resisting doors requiring replacement with FD30S door sets.

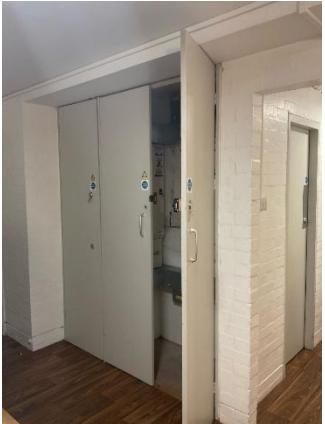
Figure 20

Electrical distribution cupboard within Flat C2 fitted with non–fire-resisting doors requiring replacement with FD30S door sets.

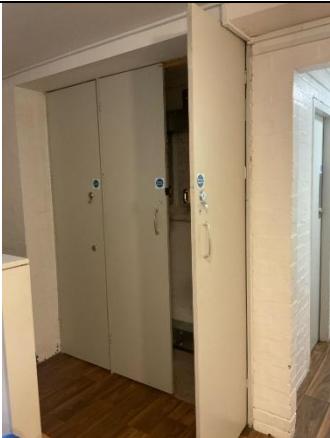
Figure 22

Electrical distribution cupboard within Flat D3 fitted with non–fire-resisting doors requiring replacement with FD30S door sets.

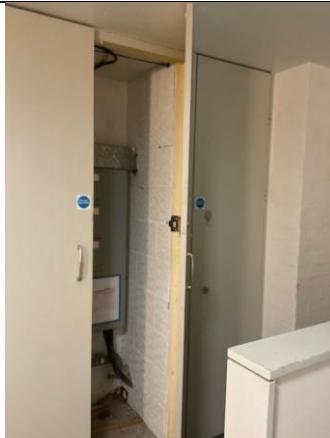
Figure 23

Electrical distribution cupboard within Flat F0 fitted with non–fire-resisting doors requiring replacement with FD30S door sets.

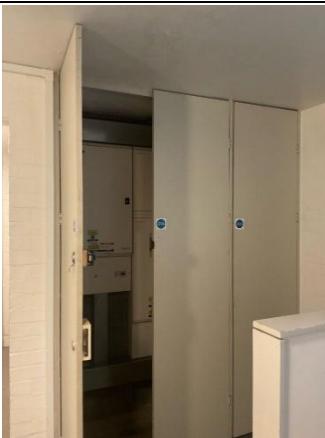
Figure 24

Electrical distribution cupboard within Flat F0 fitted with non–fire-resisting doors requiring replacement with FD30S door sets.

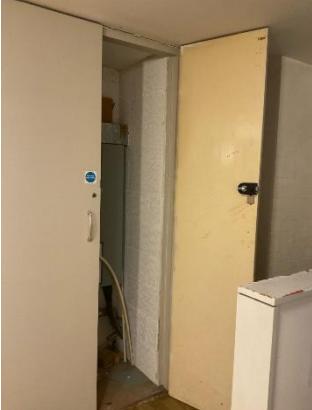
Figure 26

Electrical distribution cupboard within Flat C0 fitted with non–fire–resisting doors requiring replacement with FD30S door sets.

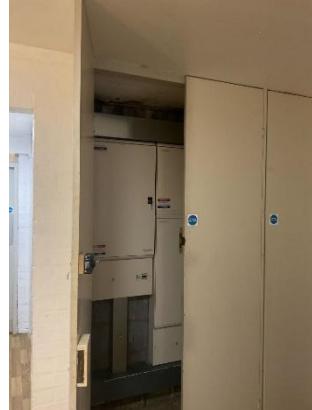
Figure 27

Electrical distribution cupboard within Flat C1 fitted with non–fire–resisting doors requiring replacement with FD30S door sets.

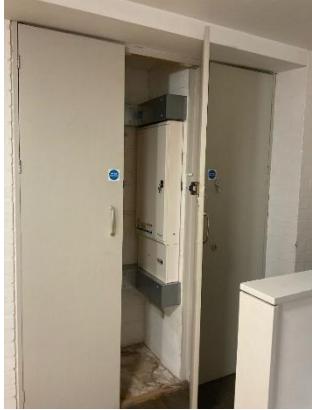
Figure 28

Electrical distribution cupboard within Flat C2 fitted with non–fire–resisting doors requiring replacement with FD30S door sets.

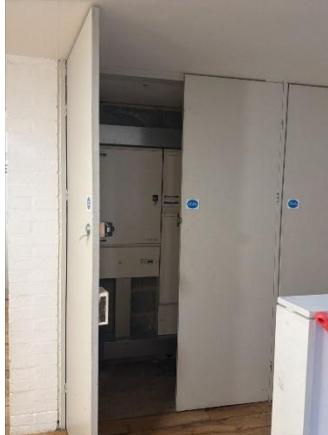
Figure 30

Electrical distribution cupboard within Flat H1 fitted with non–fire–resisting doors requiring replacement with FD30S door sets.

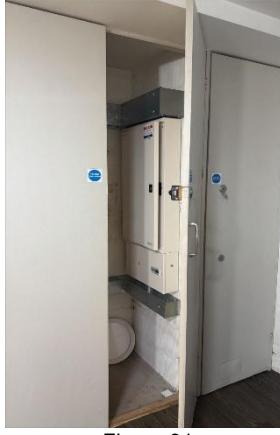
Figure 31

Electrical distribution cupboard within Flat H2 fitted with non–fire–resisting doors requiring replacement with FD30S door sets.

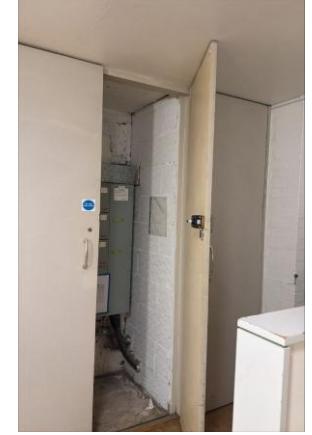
Figure 32

Electrical distribution cupboard within Flat J0 fitted with non–fire–resisting doors requiring replacement with FD30S door sets.

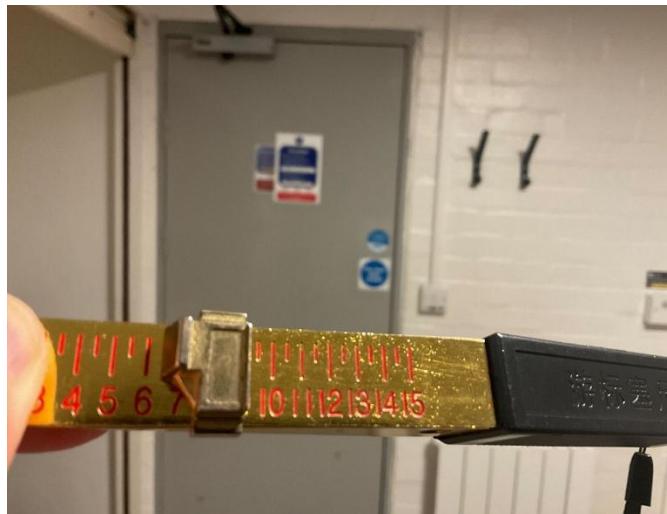
Figure 34

Excessive perimeter gap to fire door protecting Room A0.5.

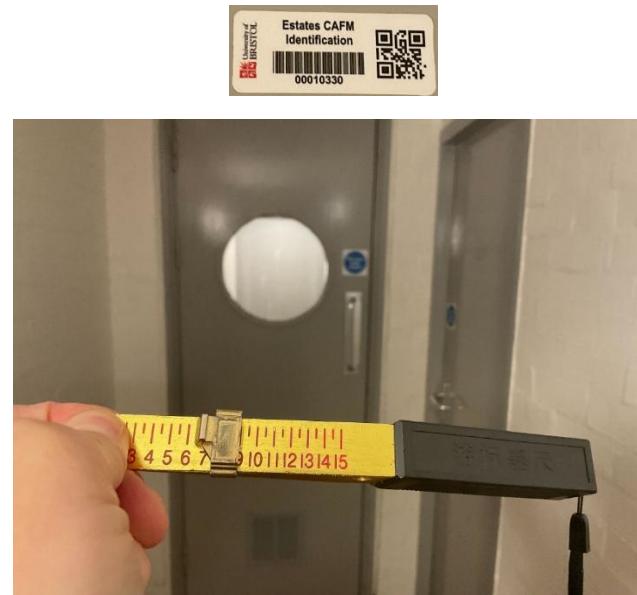
Figure 35

Excessive perimeter and threshold gaps to cross-corridor fire door adjacent to Room A0.1.

10	4	<p><i>Fig 34 To Fig 104</i></p> <p>A representative sample of fire doors was inspected during the assessment (refer to Appendix A). Although routine inspection and maintenance records are reported to be maintained, the general condition of fire doors throughout the premises is poor, with widespread evidence of non-compliance with current fire-resisting standards.</p> <p>Common defects observed include:</p> <ul style="list-style-type: none"> • Excessive and inconsistent perimeter and threshold gaps. • Missing or surface-mounted intumescent and cold smoke seals. • Doors and frames warped, damaged, or crudely repaired. • Glazing systems lacking intumescent seals or sealed with non-fire-resisting silicone. • Doors failing to close fully to latch due to defective or absent self-closing devices. • Worn, leaking or non-fire-rated hinges. • Missing doorstops and unsatisfactory frame interfaces. • Combustible materials fixed over vision panels, obscuring visibility. 	<p>A comprehensive fire door survey should be carried out by a competent and qualified fire door inspector (e.g. FDIS or equivalent) to confirm the condition, certification and suitability of all fire-resisting door sets throughout the building.</p> <p>All identified defects should then be rectified through a structured programme of repair, upgrade or replacement in accordance with:</p> <ul style="list-style-type: none"> • BS 8214 – Timber-based Fire Door Assemblies; • Manufacturer certification data for each door set. <p>New or replacement door sets should be third-party certificated FD30S fire-resisting doors, installed by competent installers under a recognised certification scheme, and fitted with:</p> <ul style="list-style-type: none"> • Rebated intumescent and cold smoke seals; • CE/UKCA-marked hinges (grade 11 minimum); • Self-closing devices adjusted to fully latch; and correct signage - <i>"Fire door – Keep shut"</i> <p>Or</p> <ul style="list-style-type: none"> • Fitted with secure locks and signage stating <i>"Fire door – Keep locked shut"</i> (as applicable). 	Dean Finch	153626 2.00	May 2026

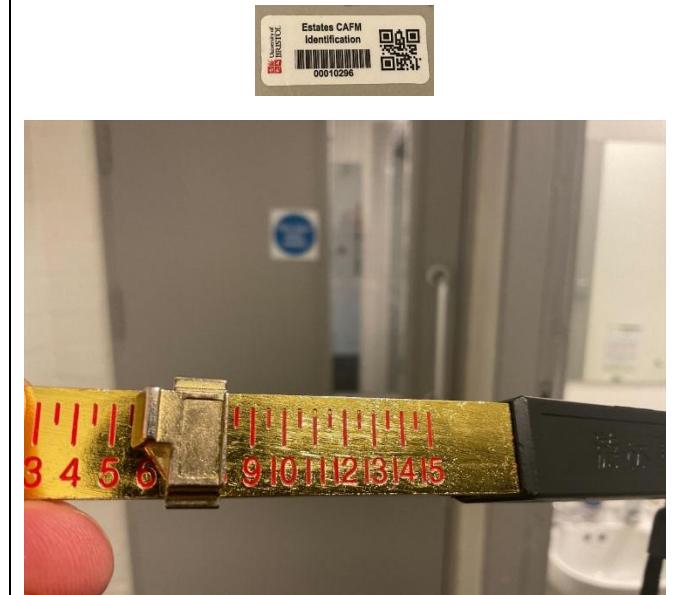
Figure 36

Excessive perimeter gaps and missing cold smoke seals to cross-corridor fire door at entrance to Flat A1.

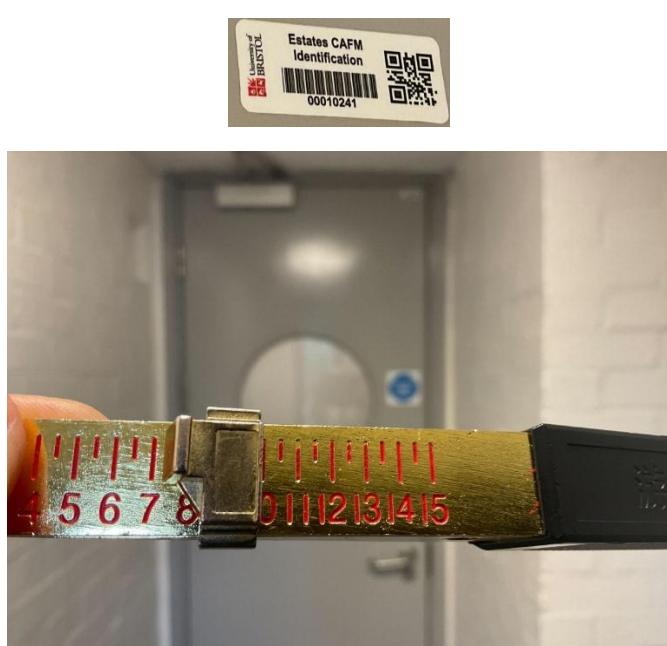
Figure 37

Excessive perimeter gap to entrance fire door protecting Flat A2.

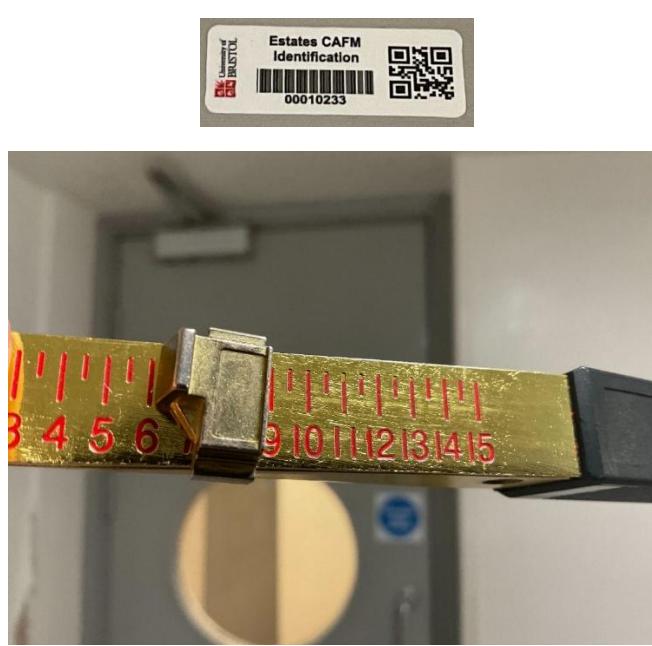
Figure 38

Excessive perimeter gap to fire door protecting kitchen within Flat A2.

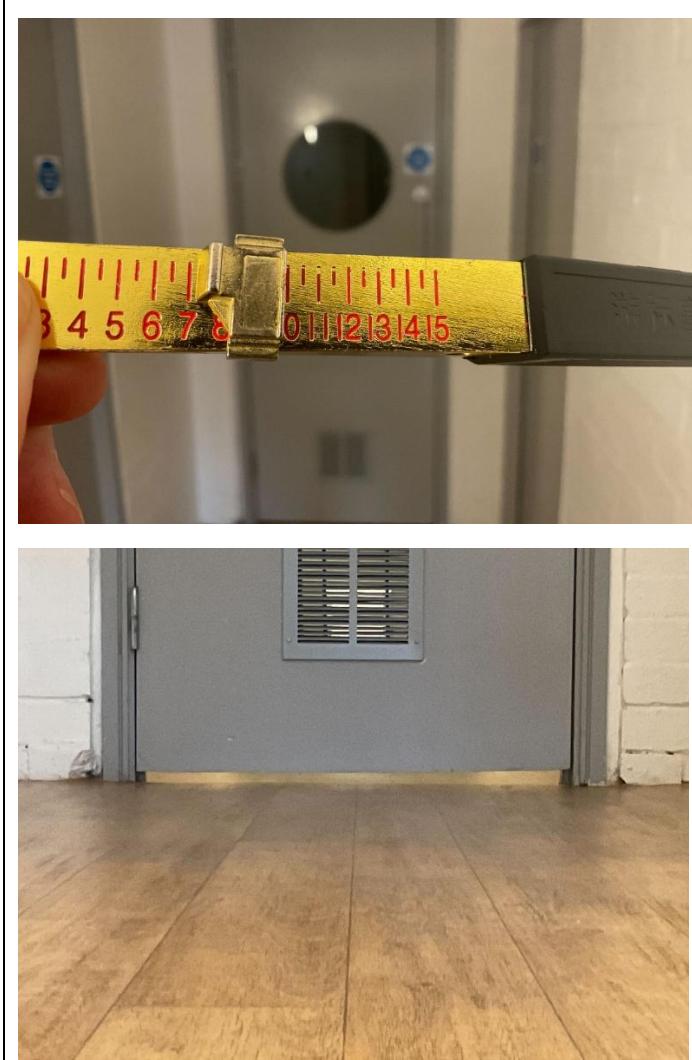
Figure 39

Excessive perimeter and threshold gaps to cross-corridor fire door adjacent to Room A2.1.

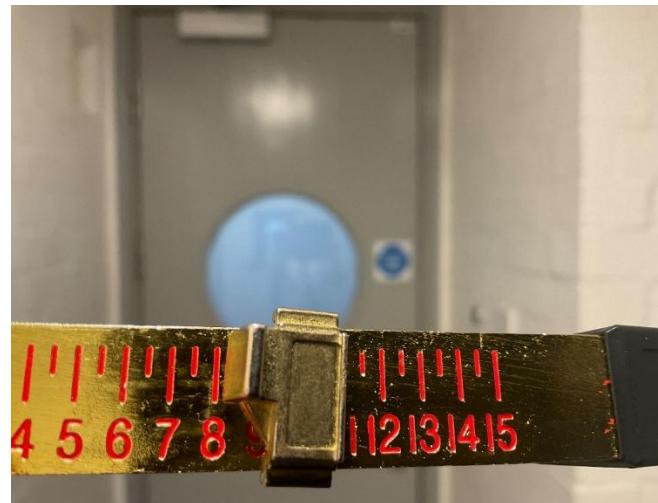
Figure 40

Highly excessive perimeter gaps to entrance fire door protecting Flat A2.

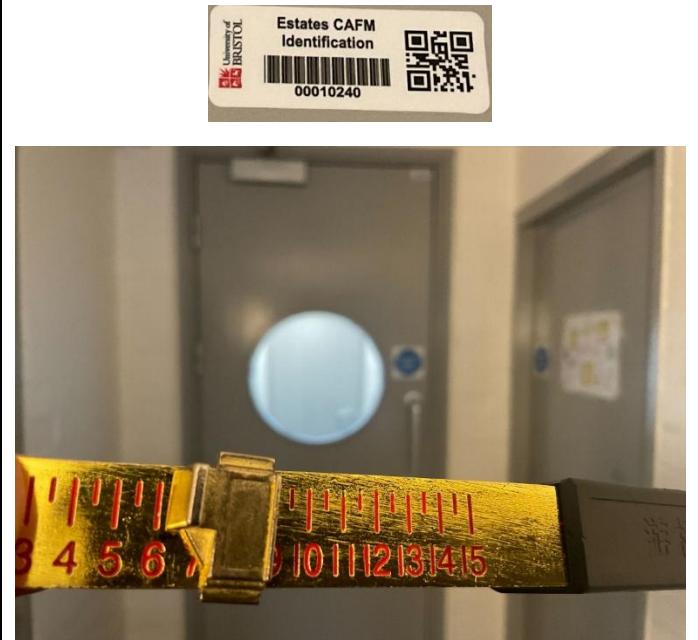
Figure 42

Excessive perimeter gap to cross-corridor fire door adjacent to Room A3.1.

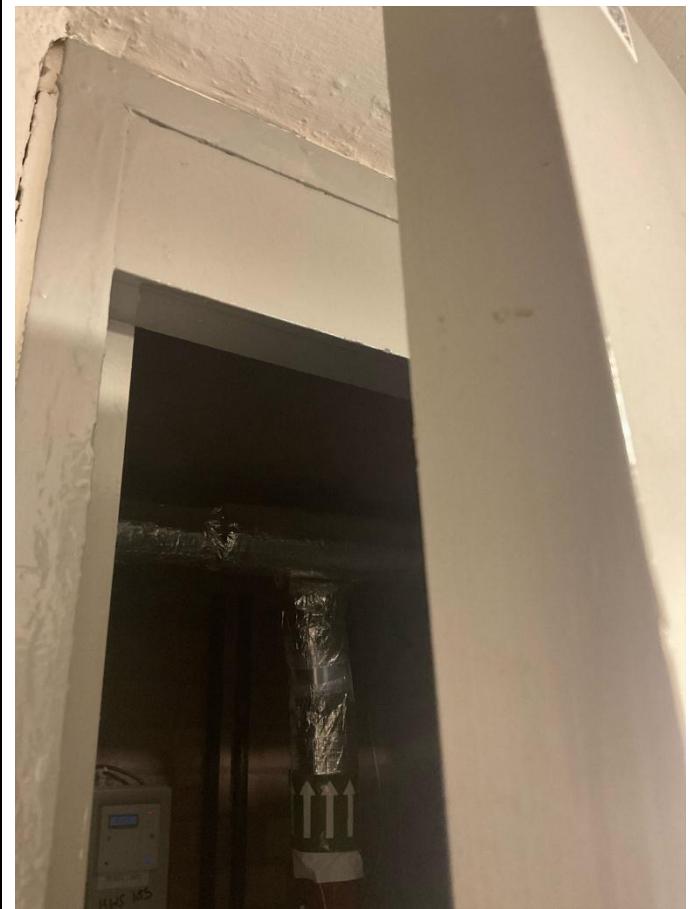
Figure 44

Excessive perimeter gap to fire door protecting boiler cupboard leading from stairwell opposite Flat B0.

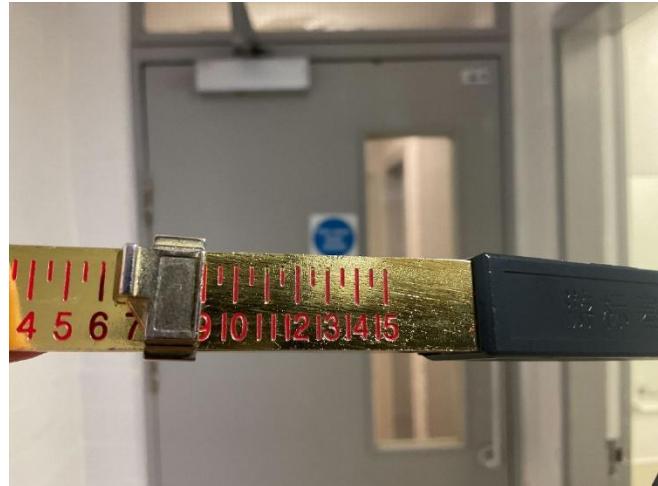
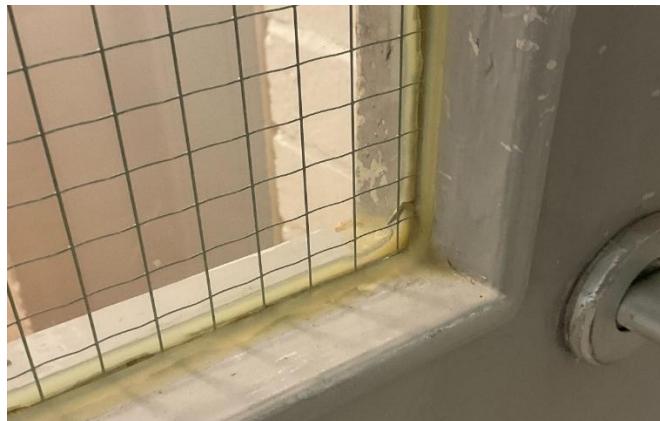
Figure 45

Excessive perimeter gaps and glazing sealed with silicone to cross-corridor fire door opposite kitchen within Flat B0.

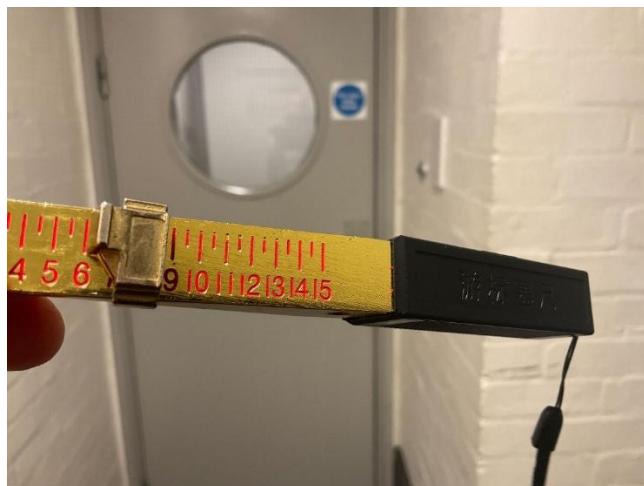
Figure 46

Excessive perimeter gap to entrance fire door protecting Flat B1.

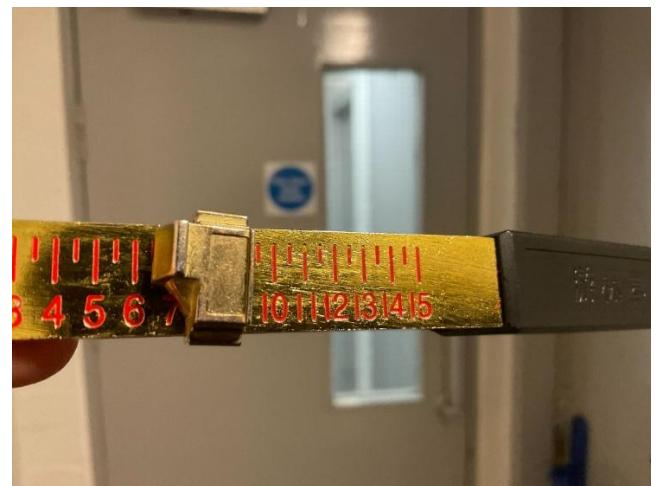
Figure 47

Excessive threshold gap and warping to cross-corridor fire door opposite kitchen within Flat B1; door set requires replacement.

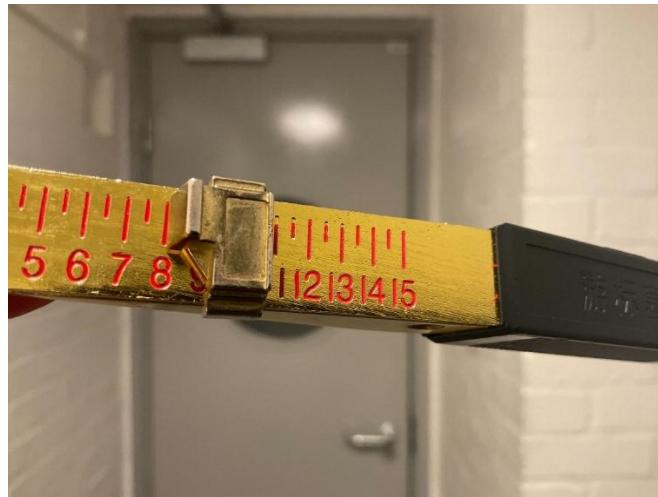
Figure 48

Highly excessive perimeter gaps to entrance fire door protecting Flat B2.

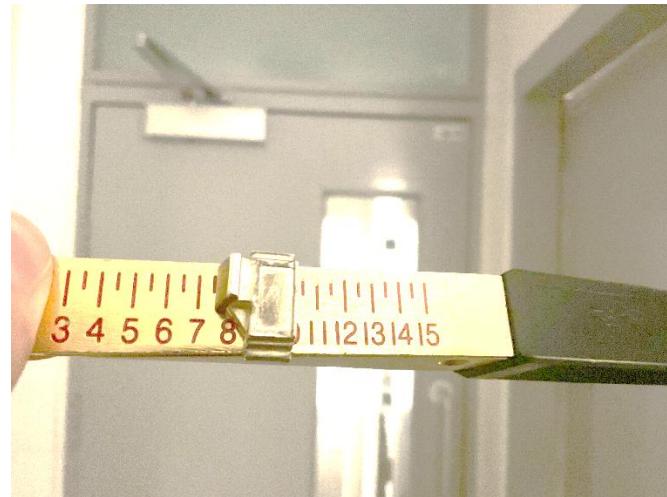
Figure 49

Excessive perimeter gap to cross-corridor fire door opposite kitchen within Flat B2.

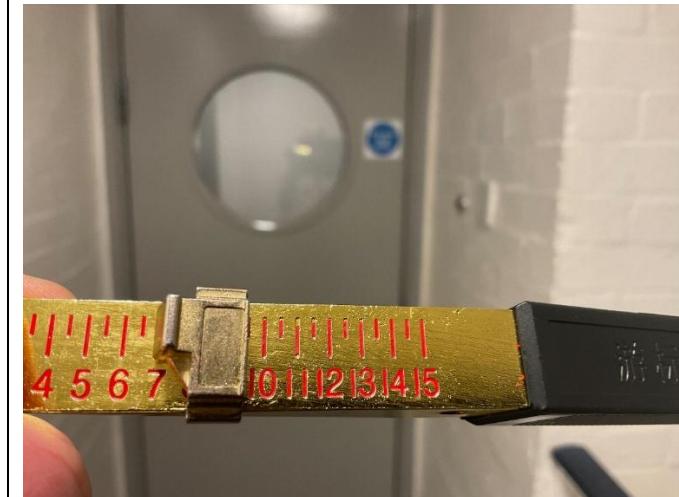
Figure 50

Excessive perimeter gap to entrance fire door protecting Flat B3.

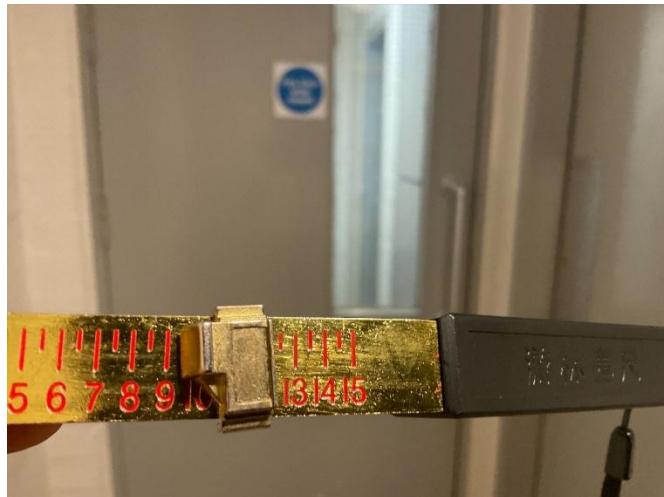
Figure 51

Excessive perimeter gap to cross-corridor fire door opposite kitchen within Flat B3.

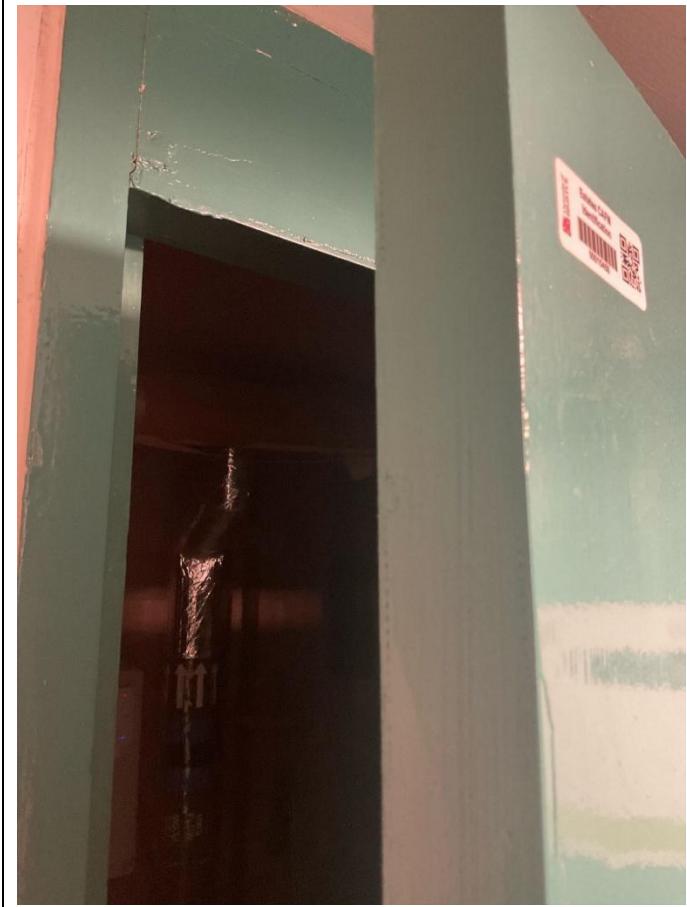
Figure 53

Fire door protecting boiler cupboard of Block C opposite Flat C0 not fitted with intumescent or cold smoke seals and missing upper doorstop.

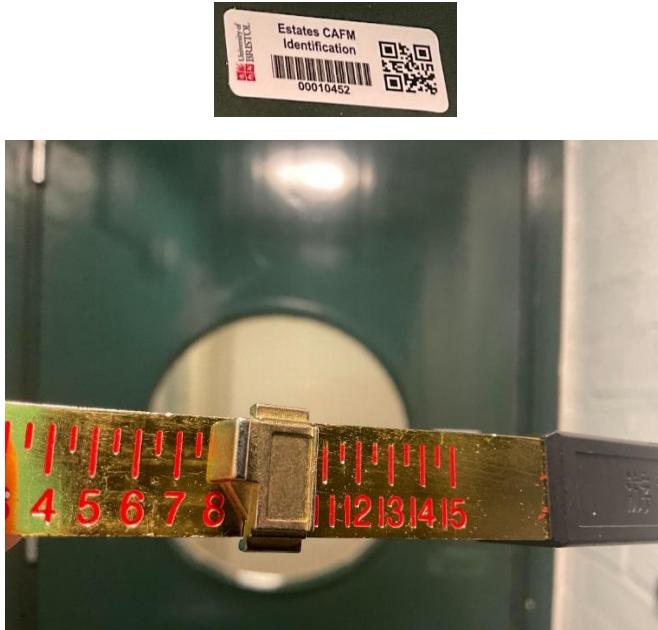
Figure 54

Excessive perimeter gap to entrance fire door protecting Flat C0.

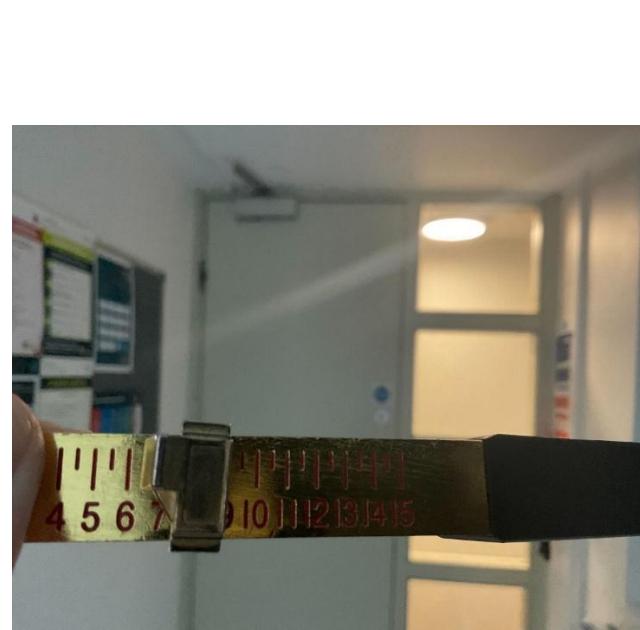
Figure 55

Excessive perimeter head gap to fire door protecting kitchen within Flat C0.

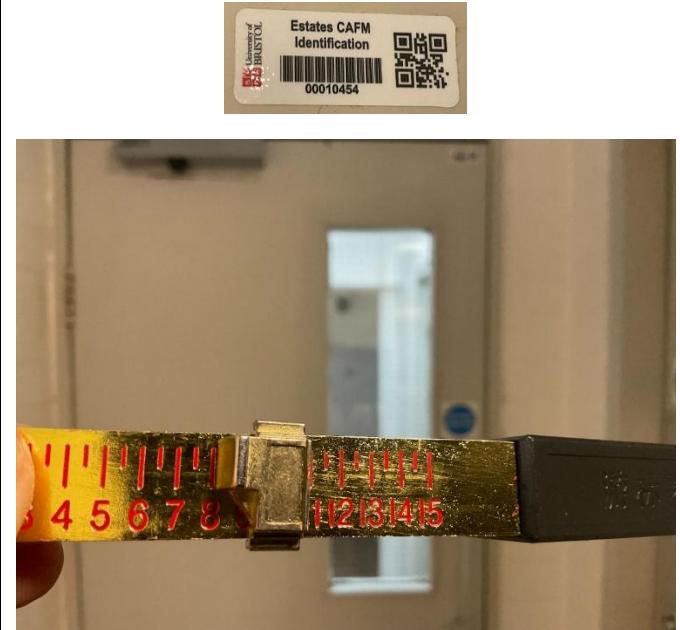
Figure 56

Excessive perimeter gap to cross-corridor fire door opposite kitchen within Flat C0.

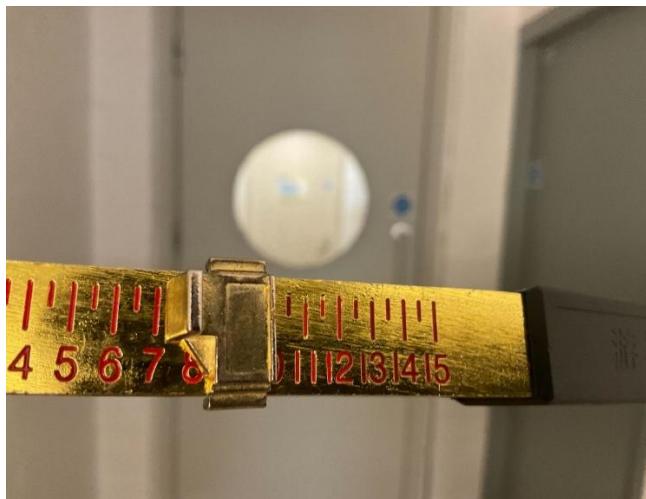
Figure 60

Excessive perimeter gap to inter-corridor fire door adjacent to Room 1.1 within Flat C1.

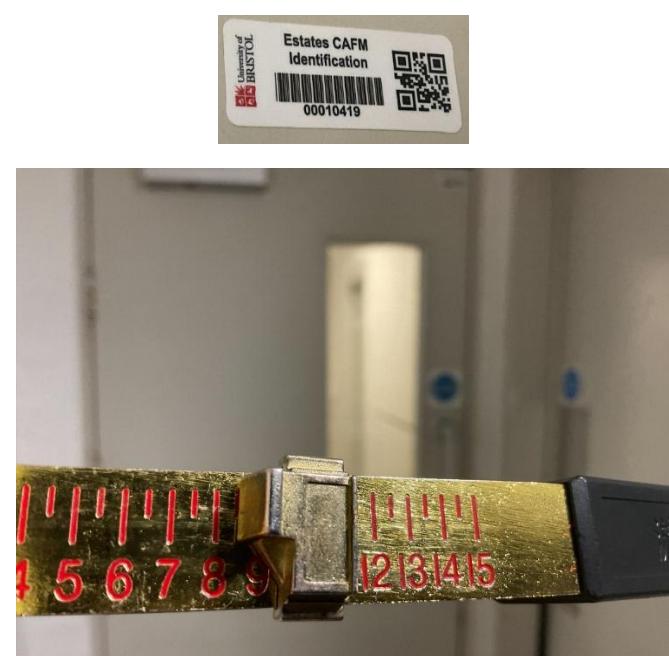
Figure 61

Excessive perimeter gap to entrance fire door protecting Flat C2.

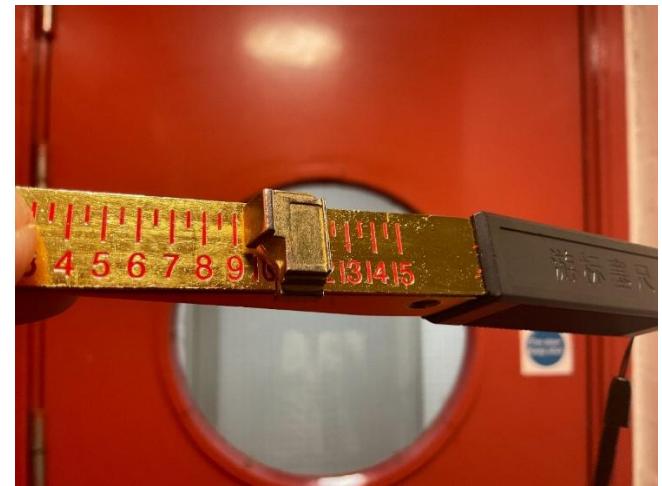
Figure 68

Highly excessive perimeter gaps to entrance fire door protecting Flat D0.

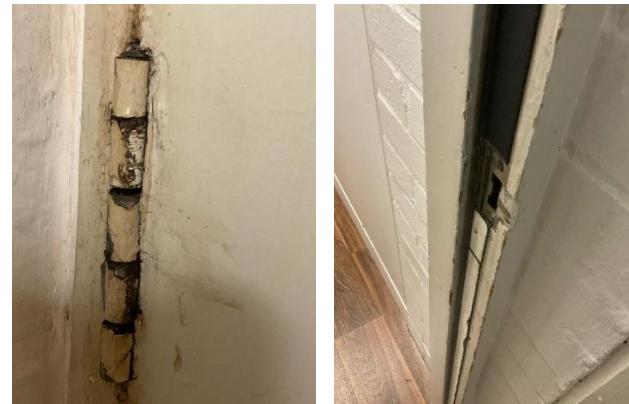
Figure 70

Typical cross-corridor fire doors opposite kitchens within flats with excessive perimeter gaps, worn hinges, and surface-mounted intumescent strips; representative of multiple doors in similar condition throughout the premises.

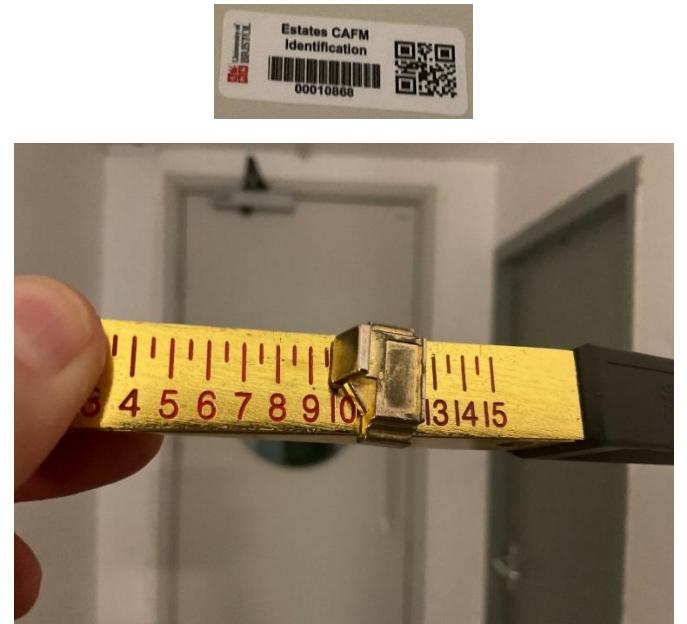
Figure 71

Excessive perimeter gap to cross-corridor fire door adjacent to Room 0.1 within Flat D0.

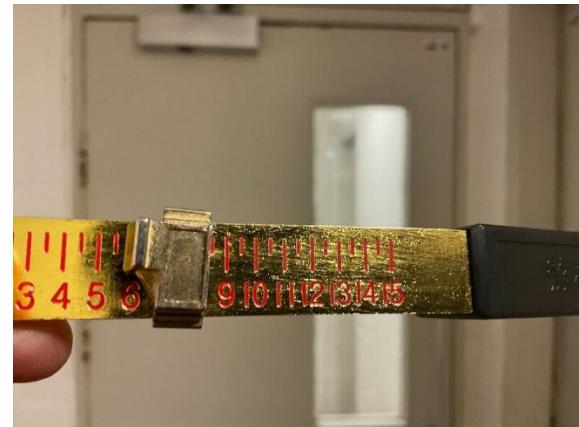
Figure 72

Excessive perimeter gaps and combustible paper affixed to vision panel glazing on entrance fire door protecting Flat D1.

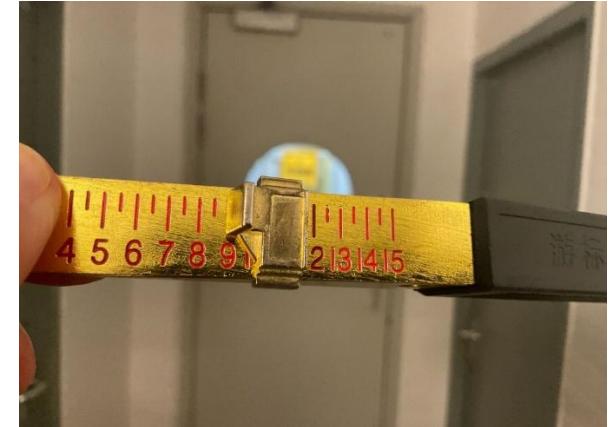
Figure 73

Excessive perimeter gap to cross-corridor fire door within kitchen of Flat D1.

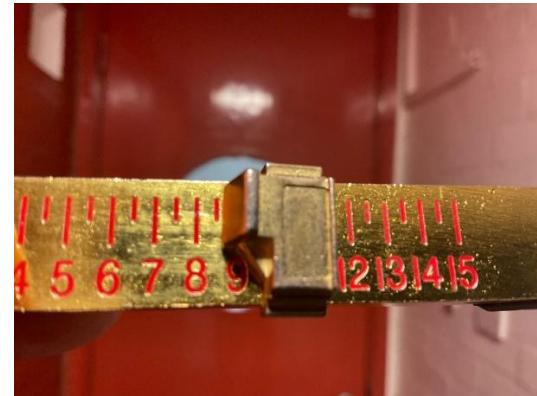
Figure 75

Highly excessive perimeter gaps and combustible paper affixed to vision panel glazing on entrance fire door protecting Flat D2.

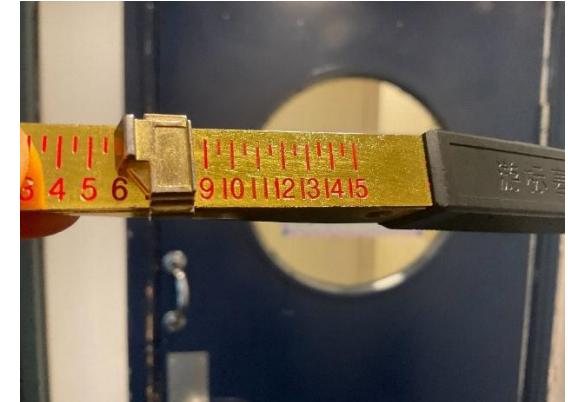
Figure 76

Highly excessive perimeter gaps to entrance fire door protecting Flat D3.

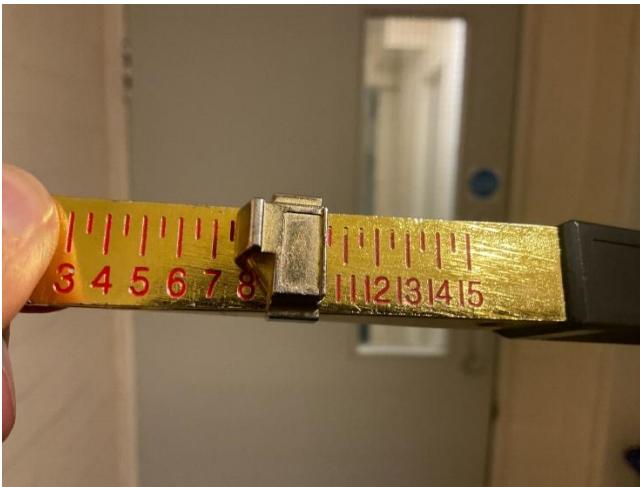
Figure 77

Excessive perimeter gaps and combustible paper affixed to vision panel glazing on entrance fire door protecting Flat E0.

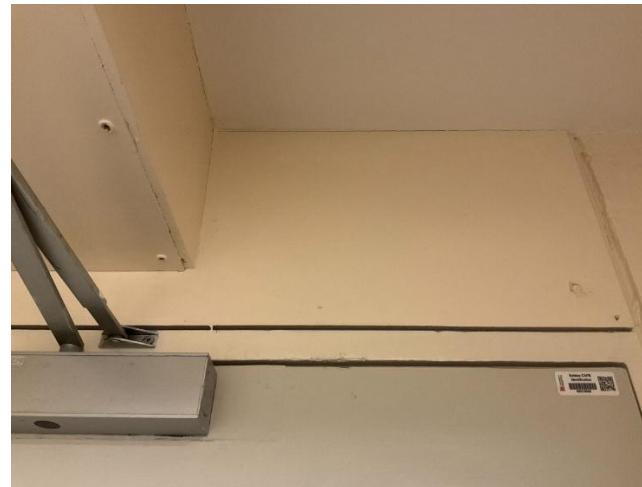
Figure 78

Excessive perimeter gap to cross-corridor fire door opposite kitchen within Flat E0.

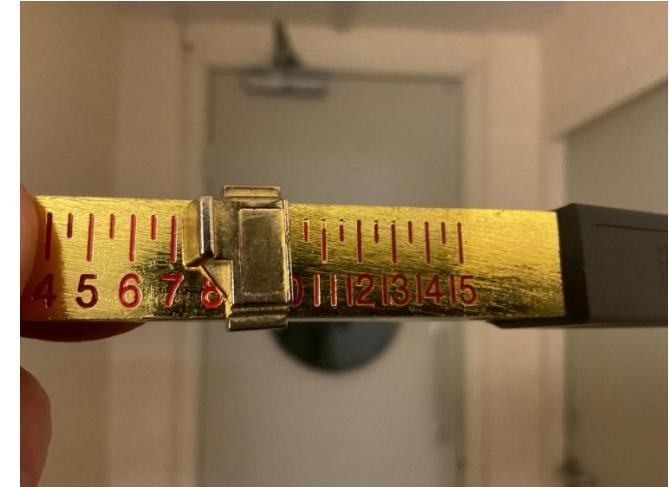
Figure 79

Transom panel above cross-corridor fire door opposite kitchen within Flat E0 does not appear to be fire-resisting in construction.

9 <i>Fig 79</i>	3	The transom panel above the cross-corridor fire door opposite the kitchen within Flat E0 does not appear to be fire-resisting in construction. The integrity of this panel forms part of the fire-resisting barrier intended to maintain compartmentation between the alternate escape routes.	The fire-resisting performance of the transom panel above the cross-corridor fire door opposite the kitchen within Flat E0 should be confirmed by a competent contractor. If this cannot be confirmed, the transom replaced or upgraded using certified fire-resisting materials and methods to achieve a minimum of 30 minutes' integrity and smoke resistance, consistent with the adjoining wall and door set.	Awaiting Quote from Shield 13/01/2026	Planon ref 1359477	May 2026

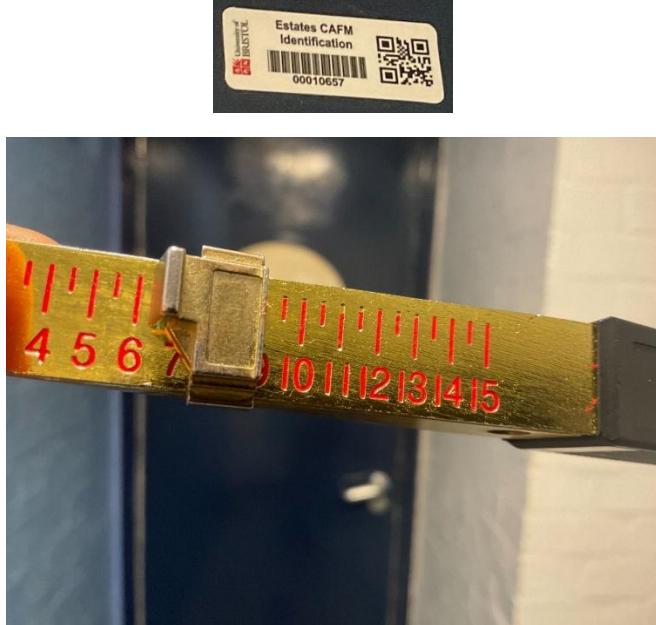
Figure 80

Excessive perimeter gap to cross-corridor fire door adjacent to Room 0.1 within Flat E0.

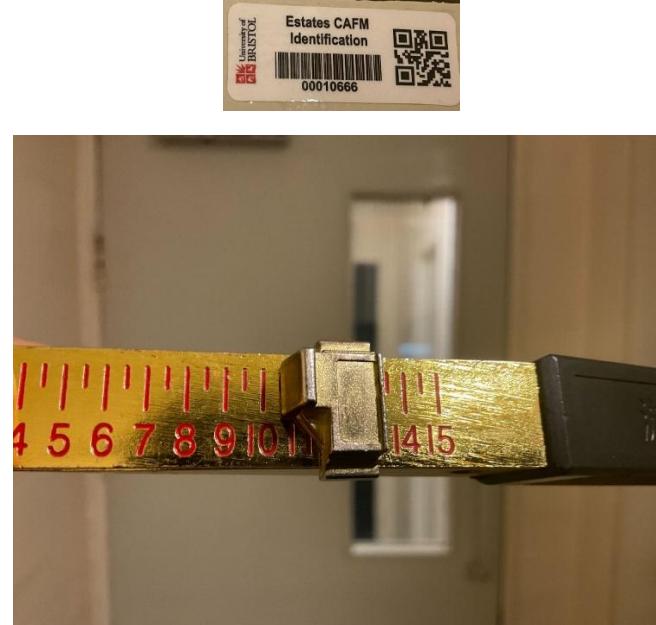
Figure 81

Excessive perimeter gap to entrance fire door protecting Flat E1.

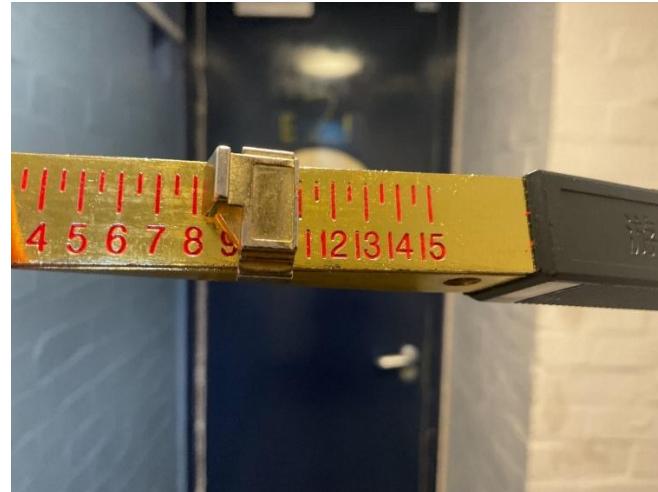
Figure 84

Excessive perimeter gap to cross-corridor fire door adjacent to Room 1.1 within Flat E1.

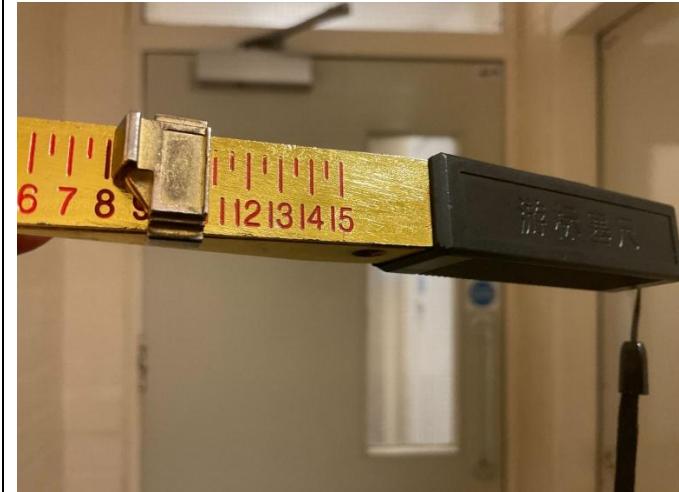
Figure 85

Highly excessive perimeter gaps to entrance fire door protecting Flat E2.

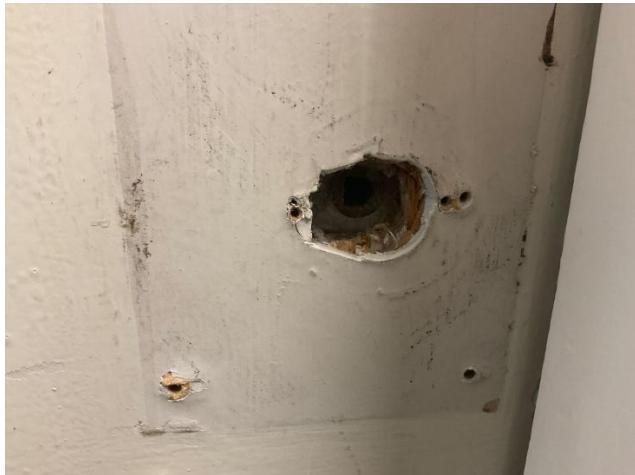
Figure 86

Highly excessive perimeter gaps to cross-corridor fire door opposite kitchen within Flat E2.

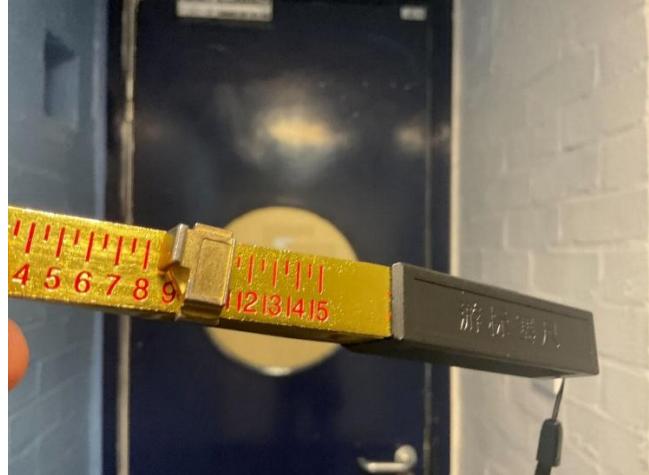
Figure 87

Penetrations through door leaf to fire door protecting linen cupboard within Flat E2.
