Fire Risk Assessment

General Information											
Address of premises:			Goldney Hall, Lower Clifton Hill, Bristol, BS8 1BH								
Assessor / job title:			Mr J.L.A. Singleton-Campbell – MIFSM, Fire Compliance Southwest								
Date of fire risk assessment:			13th January 2026								
Date of previous fire risk assessment:			3rd – 4th November 2025								
Suggested date of next review: (based on risk level indicator)			12th July 2026								
Building risk profile (A, B, Ci, Cii)			Cii								
Risk Level Indicator											
0-99		100 – 399		400 – 699		700 – 999		1000+			
(a) Hazard(s) total =		Trivial	0	Tolerable	1	Moderate	18	Substantial	5	Intolerable	
(b) Points award		1 point		5 points		20 points		50 points		100 points	
Points total (a x b)		0		5		360		250			
615

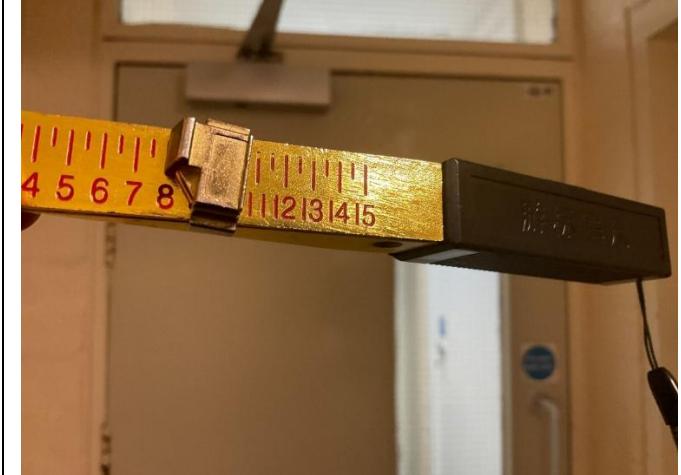
Figure 88

Highly excessive perimeter gaps to entrance fire door protecting Flat E3.

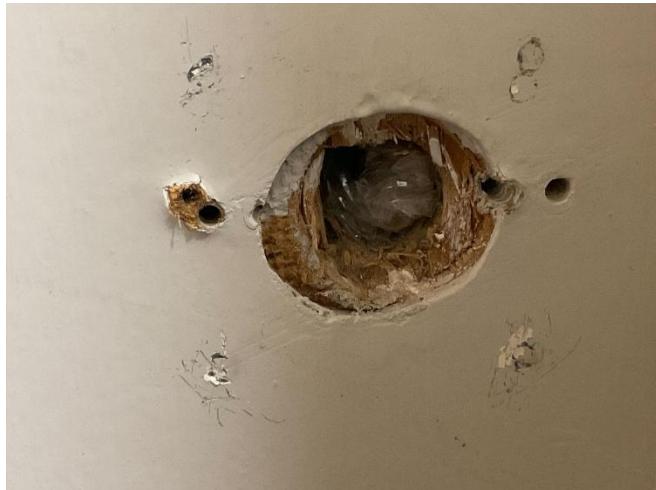
Figure 89

Excessive perimeter gap to cross-corridor fire door opposite kitchen within Flat E3.

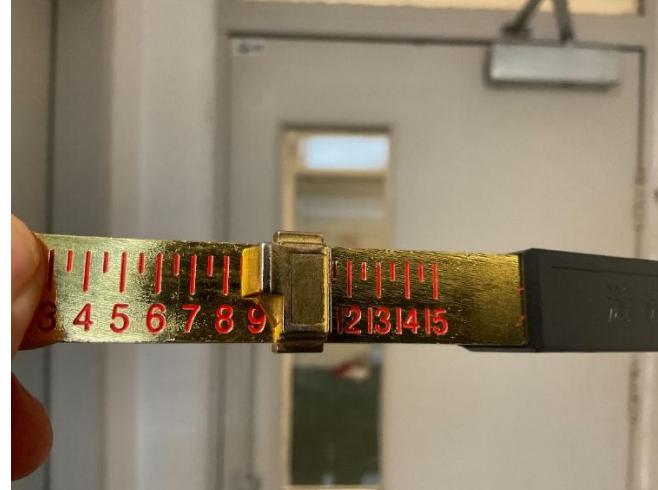
Figure 91

Excessive perimeter head gap and damaged surface-mounted intumescent strip to cross-corridor fire door at entrance to Flat F2.

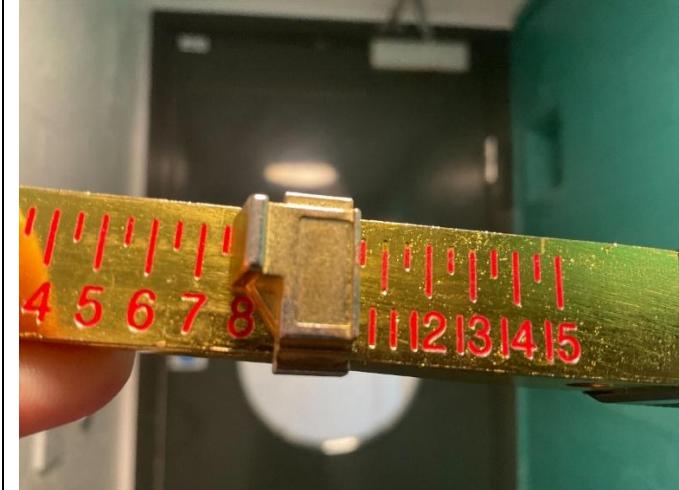
Figure 92

Highly excessive perimeter gaps to entrance fire door protecting Flat F1.

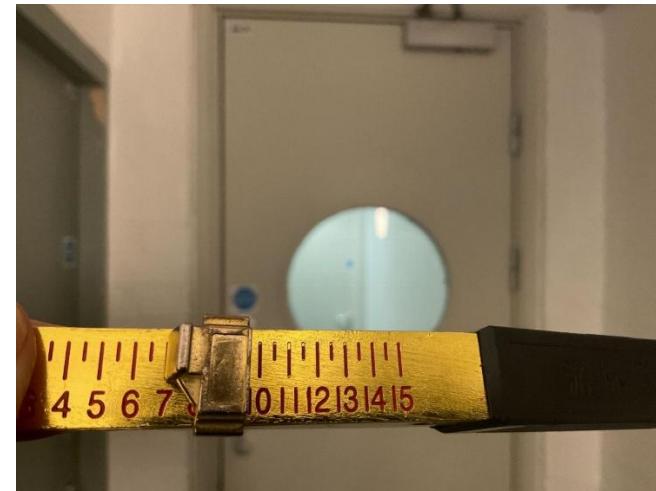
Figure 93

Excessive perimeter head gap to fire door protecting kitchen within Flat F1.

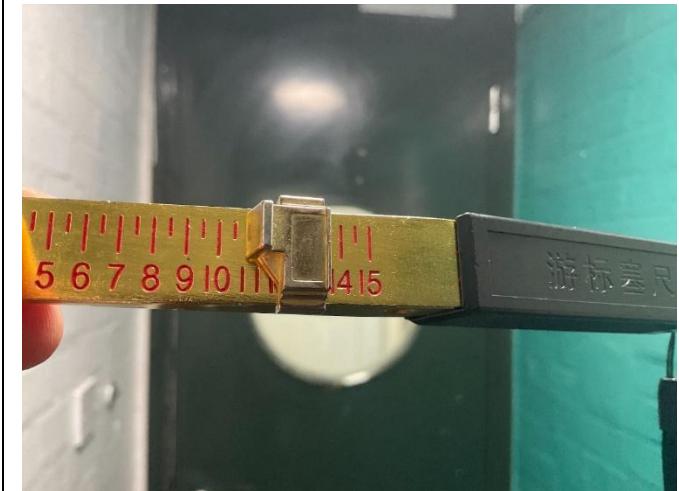
Figure 94

Excessive perimeter gap to cross-corridor fire door adjacent to Room 1.1 within Flat F1.

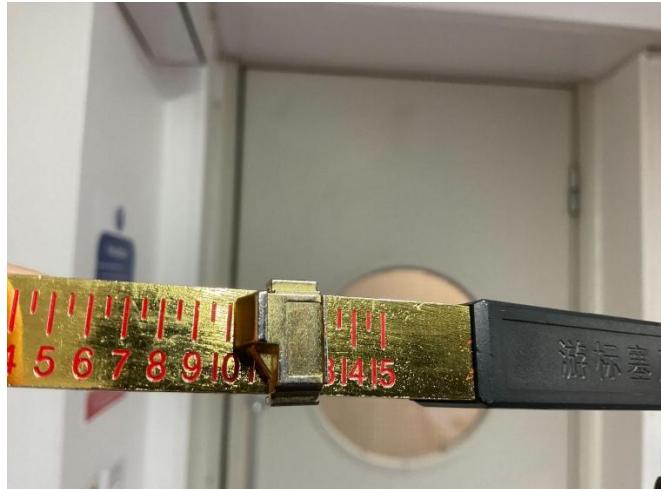
Figure 98

Excessive perimeter gap to entrance fire door protecting Flat G0.

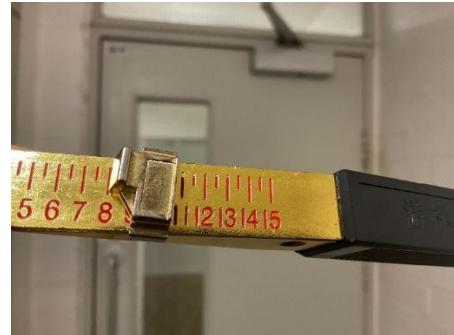
Figure 100

Highly excessive perimeter gaps and missing intumescent glazing seals to cross-corridor fire door opposite kitchen within Flat G0.

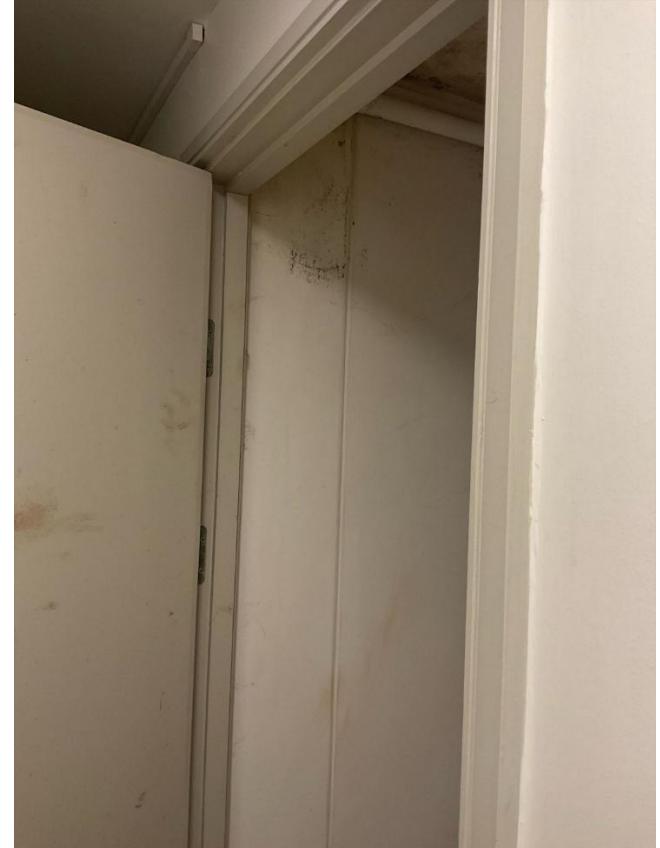
Figure 101

Fire door protecting storage cupboard within dead-end corridor adjacent to Room 0.8 not fitted with intumescent or cold smoke seals.

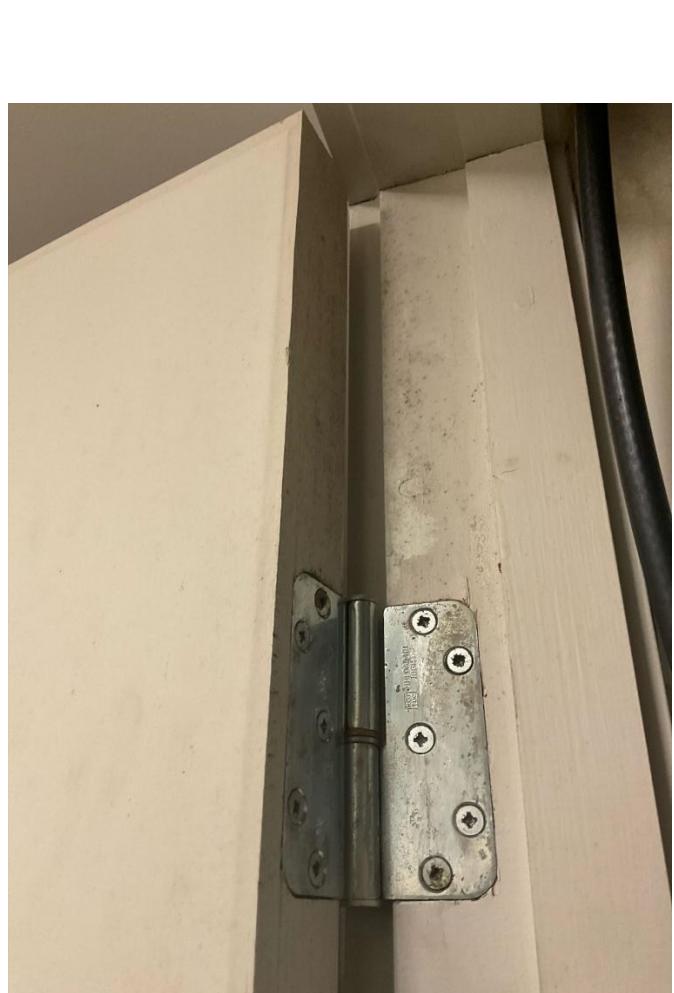
Figure 104

Excessive perimeter gaps and combustible paper affixed to vision panel glazing on entrance fire door protecting Flat G1.

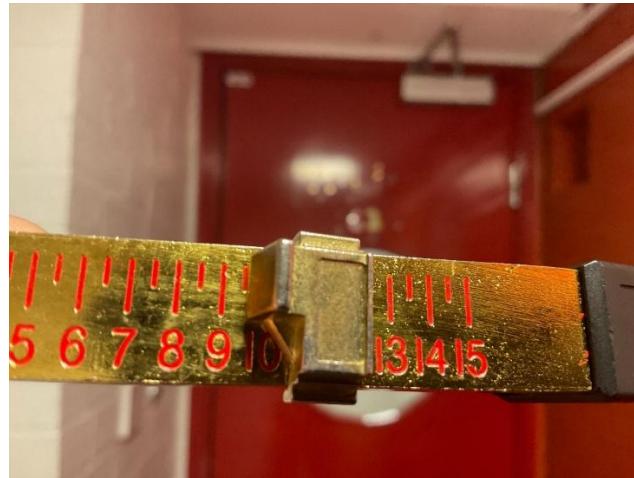
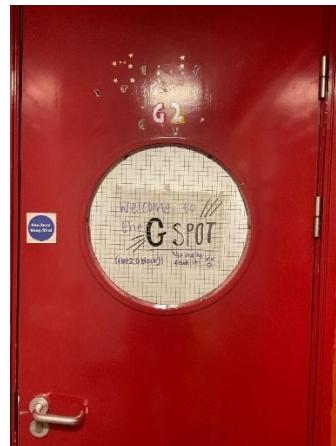
Figure 105

Highly excessive perimeter gaps and combustible paper affixed to vision panel glazing on entrance fire door protecting Flat G2.

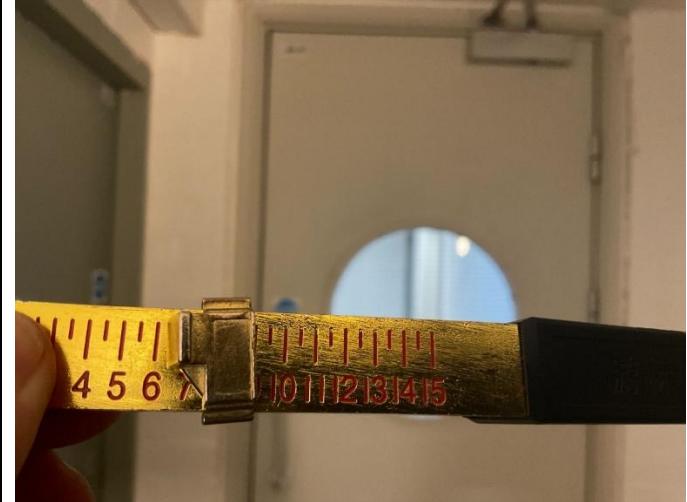
Figure 106

Highly excessive perimeter head gap to cross-corridor fire door opposite kitchen within Flat G2.

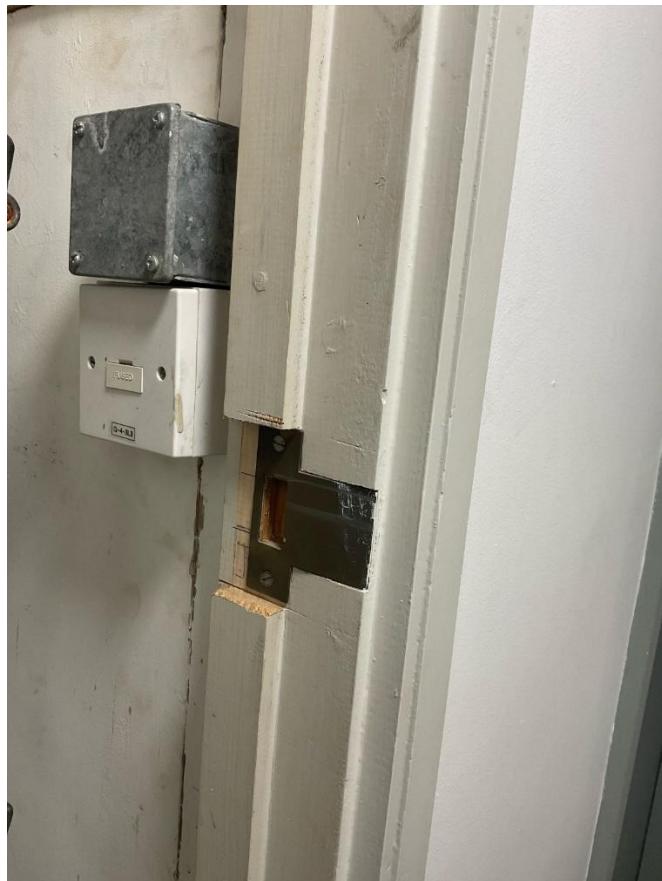
Figure 108

Fire door protecting immersion boiler cupboard within Flat G2 adjacent to Room 2.8 not fitted with intumescent or cold smoke seals and missing section of doorstop.

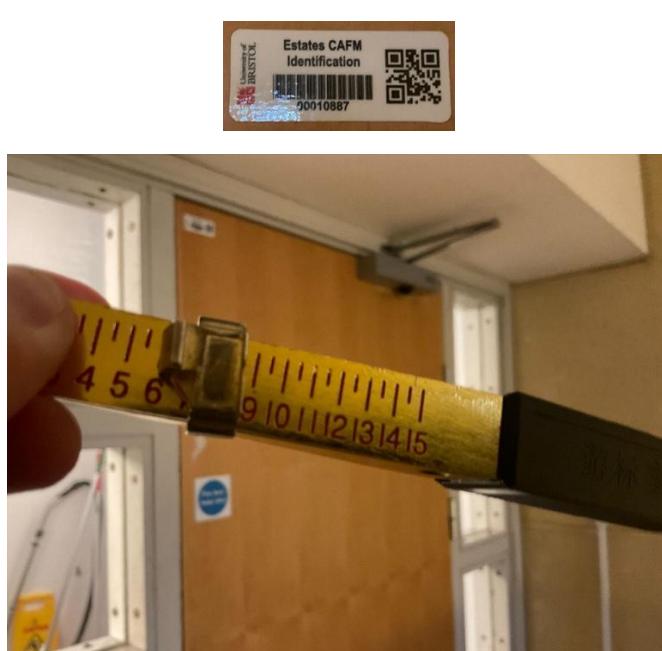
Figure 109

Excessive perimeter gap to fire door at head of staircase leading to Flat K1.

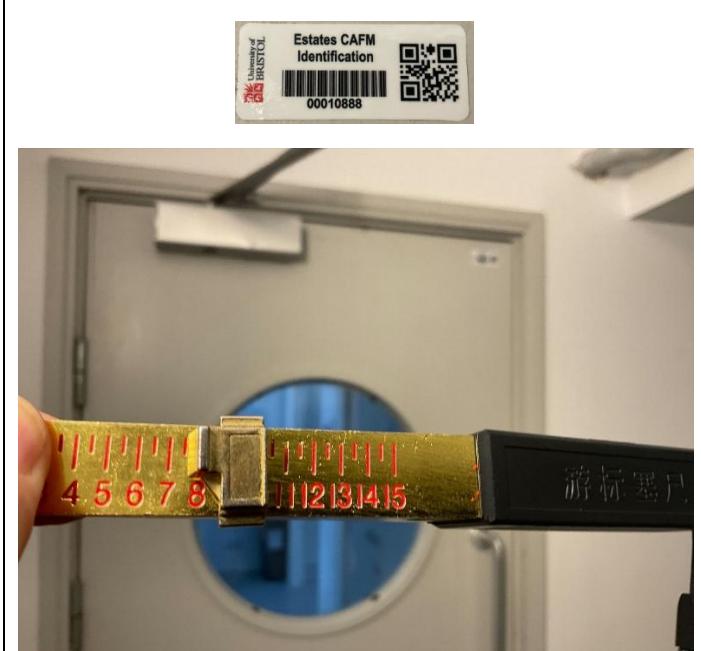
Figure 110

Excessive perimeter head gap to fire door protecting kitchen within Flat K1.

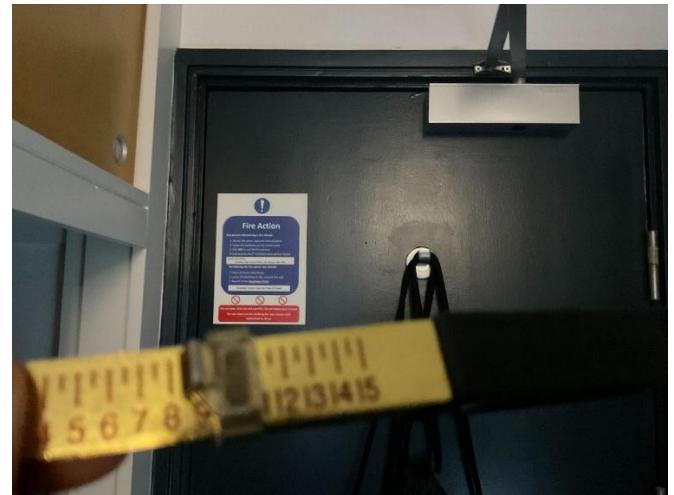
Figure 113

Excessive perimeter head gap to fire door protecting Room 0.4 within Flat K0.

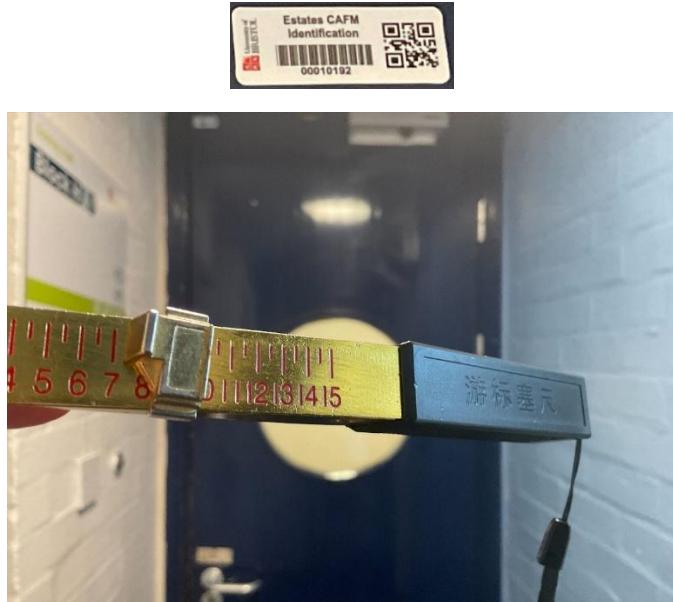
Figure 114

Excessive perimeter gap to entrance fire door protecting Flat H0.

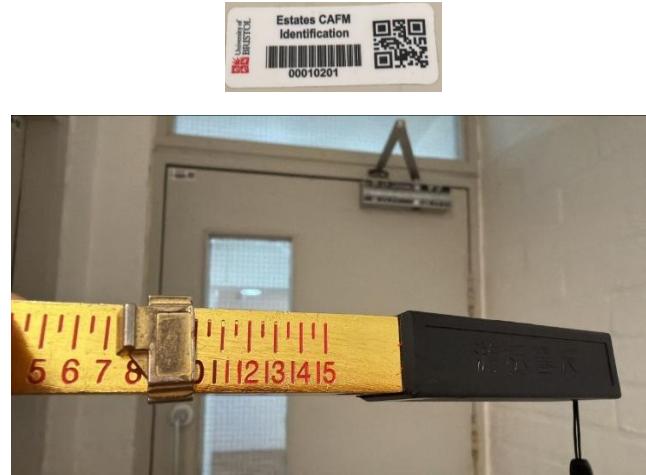
Figure 115

Excessive perimeter gaps, surface-mounted intumescent strips, and badly worn hinges to cross-corridor fire door opposite kitchen within Flat H0.

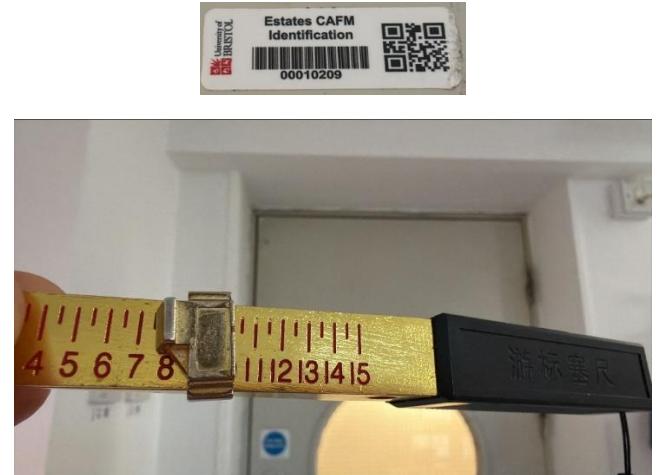
Figure 116

Excessive perimeter gap to fire door protecting kitchen within Flat H1.

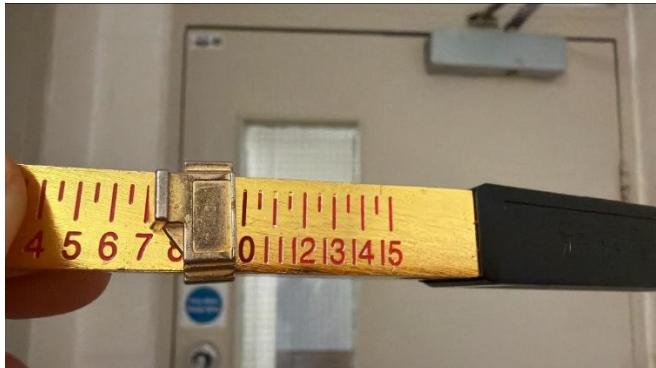
Figure 117

Excessive perimeter gaps and surface-mounted intumescent strips to cross-corridor fire door opposite kitchen within Flat H1.

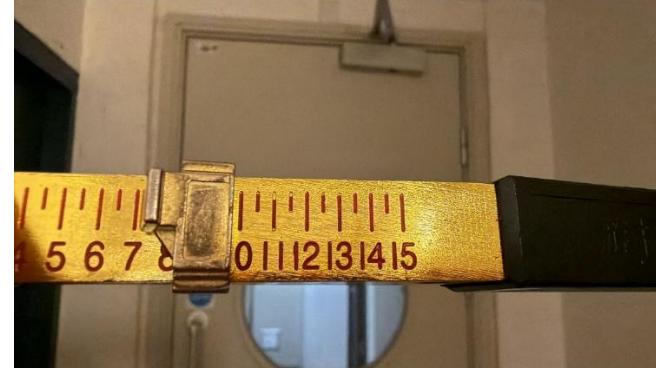
Figure 118

Excessive perimeter gap to cross-corridor fire door adjacent to Room 1.1 within Flat H1.

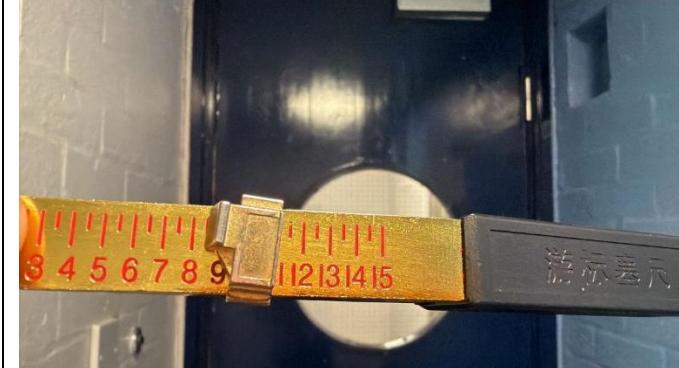
Figure 119

Excessive perimeter gap to entrance fire door protecting Flat H2.

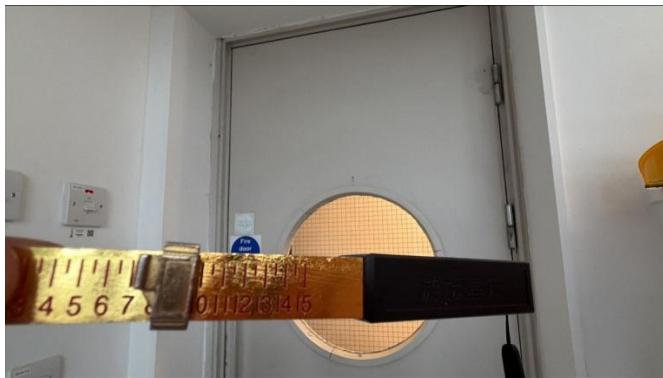
Figure 120

Excessive perimeter gap to fire door protecting kitchen within Flat H2.

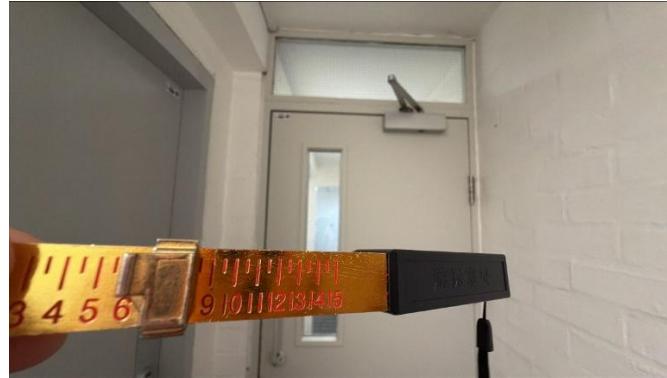
Figure 121

Excessive perimeter gap to cross-corridor fire door opposite kitchen within Flat H2.

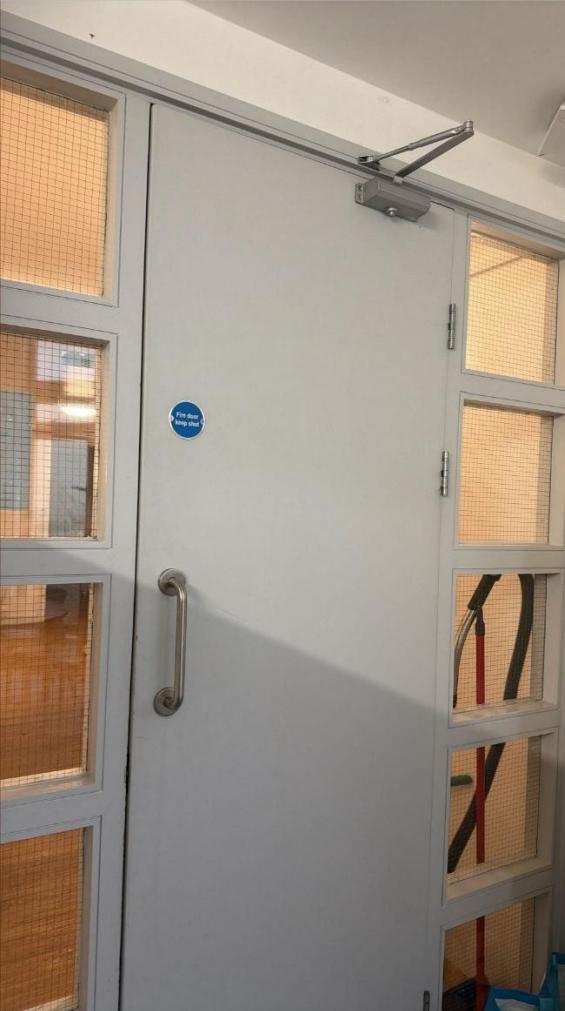
Figure 123

Fire door protecting kitchen within Flat J0 not closing fully to latch.

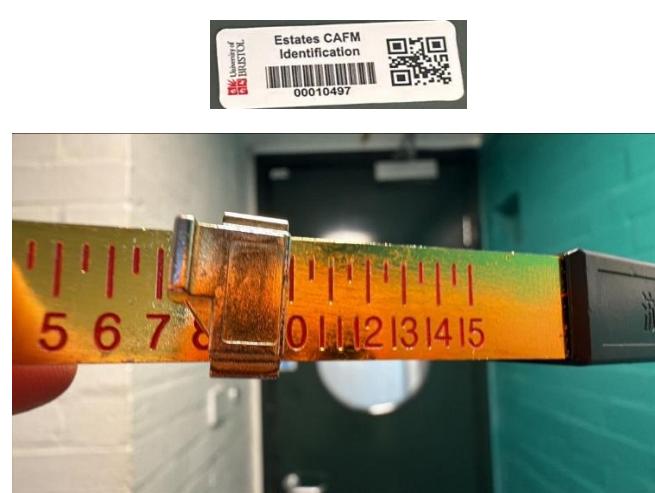
Figure 124

Excessive perimeter gap to entrance fire door protecting Flat J1.

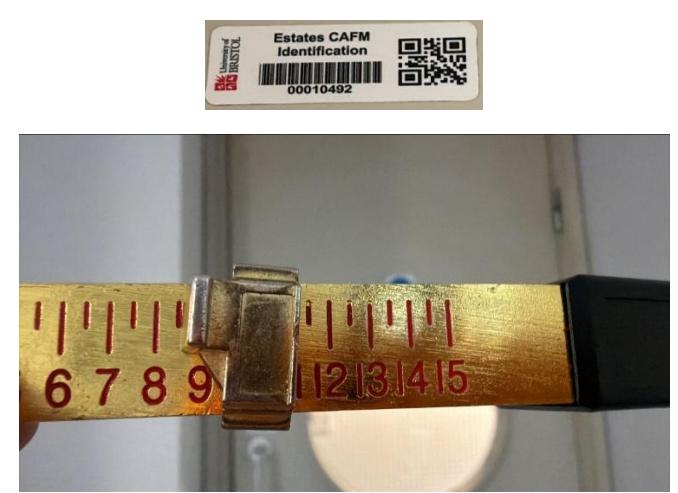
Figure 125

Excessive perimeter gap to fire door protecting kitchen within Flat J1.

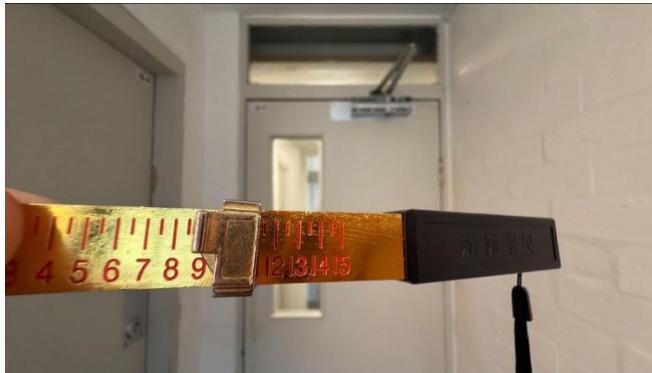
Figure 126

Excessive perimeter gaps and surface-mounted intumescent strips to cross-corridor fire door opposite kitchen within Flat J1.

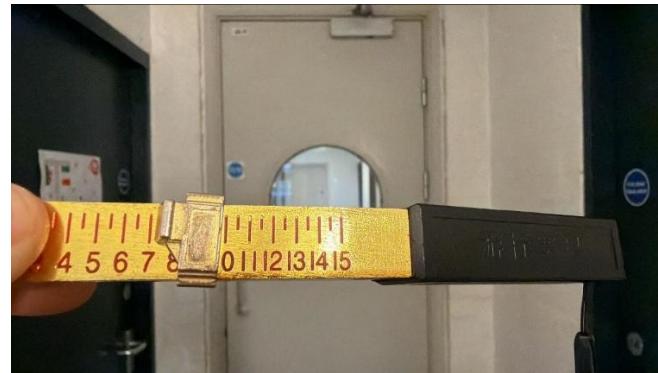
Figure 127

Excessive perimeter gap to cross-corridor fire door adjacent to Room 1.1 within Flat J1.

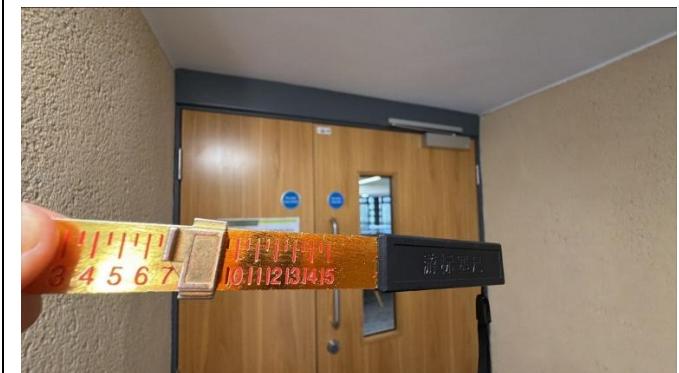
Figure 128

Excessive perimeter gap to fire door leading from common room and study area onto end stairwell of Block L.

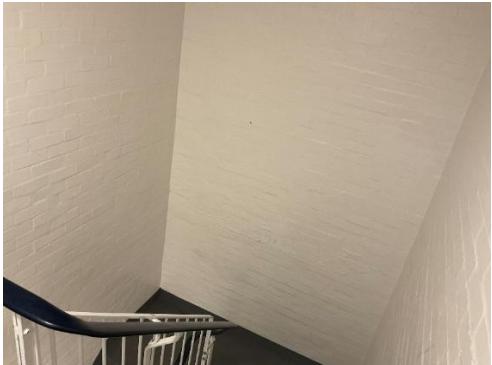
Figure 129

Insufficient directional escape signage within staircases; intermediate and landing signs missing or inconsistently positioned

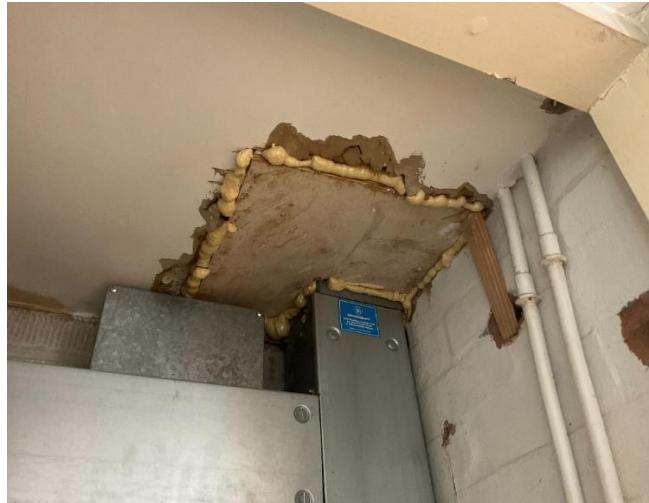
Figure 130

Compartmentation breaches observed within the electrical cupboard of Flat C1.

Given the extent and variety of issues observed, a comprehensive compartmentation survey is recommended to verify the continuity of fire separation and to identify all required remedial works—particularly within high-risk areas such as boiler rooms, electrical intake cupboards, and plant spaces.

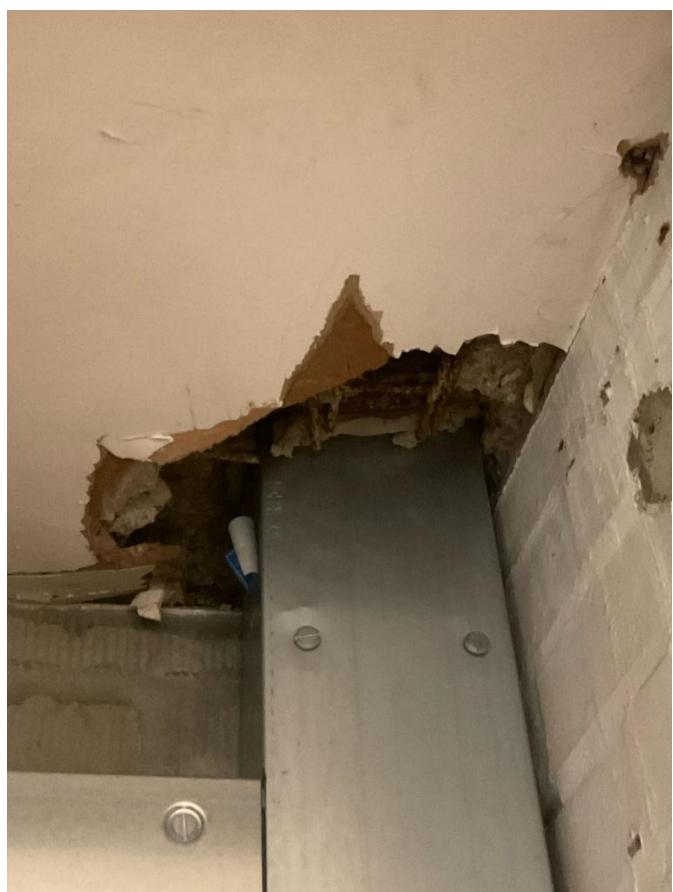
Figure 132

Compartmentation breaches observed within the electrical cupboard of Flat D1.

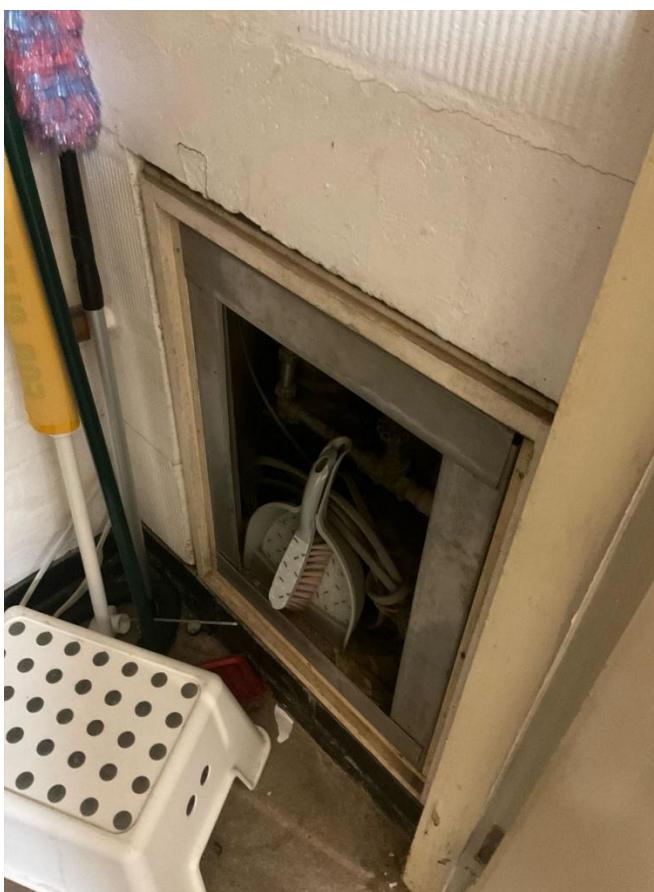
Figure 133

Fire-resisting hatch missing within the cleaners' cupboard of Flat E0.

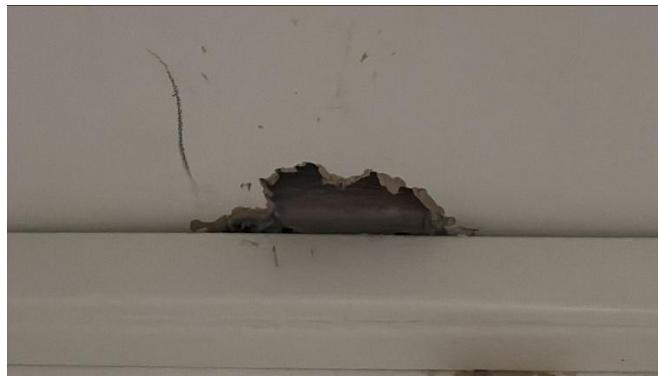
Figure 135

Compartmentation breaches observed within the storage cupboard opposite Flat H Room 0.7.

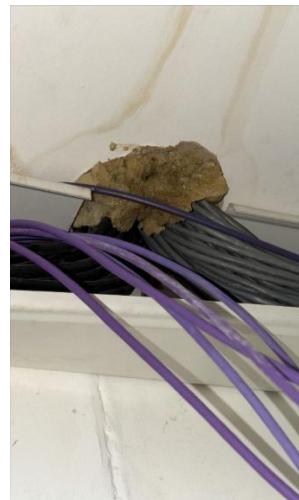
Figure 136

Compartmentation breaches observed within the IT cupboard of Flat J1 opposite Room 1.7.

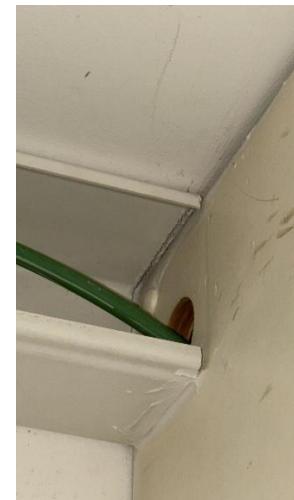
Figure 137

Compartmentation breaches observed within the boiler room to the rear of Block L.

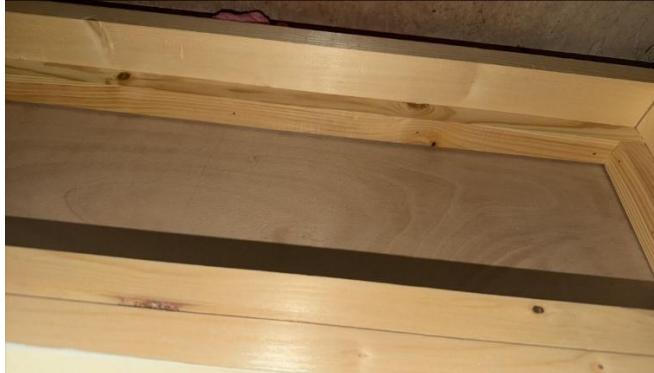
Figure 138

Transom panel above the boiler room fire door within the stairwell of Block A not of fire-resisting construction.

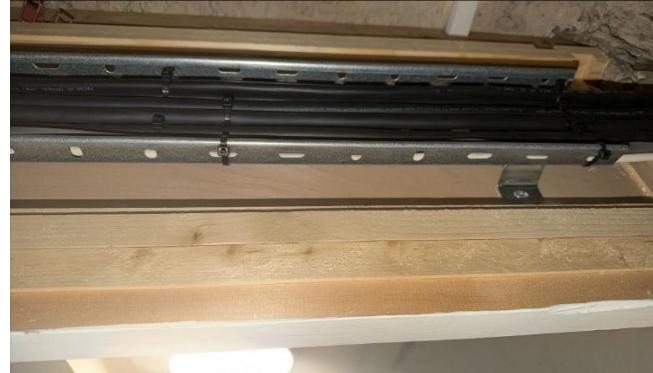
Figure 139

Transom panel above the boiler room fire door within the stairwell of Block E not of fire-resisting construction.

21 <i>Fig 139</i>	3	The transom panel above the boiler room fire door within the stairwell of Block E does not appear to be of fire-resisting construction.	Confirm the fire-resisting performance of the transom panel above the boiler room fire door within the stairwell of Block E. Where it cannot be confirmed to provide a minimum of 30 minutes' fire resistance, replace or upgrade the panel using certified fire-resisting materials in accordance with BS 8214 and the manufacturer's guidance to maintain the compartment's integrity.	Jemima Moulton-Hawkins / Dean Paterson	N/A	February 2026	Complete: Shield confirmed transoms to be of fire resisting construction 13/01/2026 following initial installation of door set in 2022
22	4	Compartmentation breaches were observed in several areas throughout the premises, indicating potential widespread deficiencies in compartment integrity.	A full compartmentation survey should be undertaken by a competent fire-stopping specialist to confirm the adequacy of compartment lines throughout the premises, particularly within high-risk areas such as boiler rooms, electrical distribution cupboards, service risers, and escape routes. Any defects identified should be recorded, risk-assessed, and appropriately remediated to maintain the building's fire-resisting compartmentation.		Planon ref 149390 4	May 2026	AL to raise project requesting fire compartmentation survey

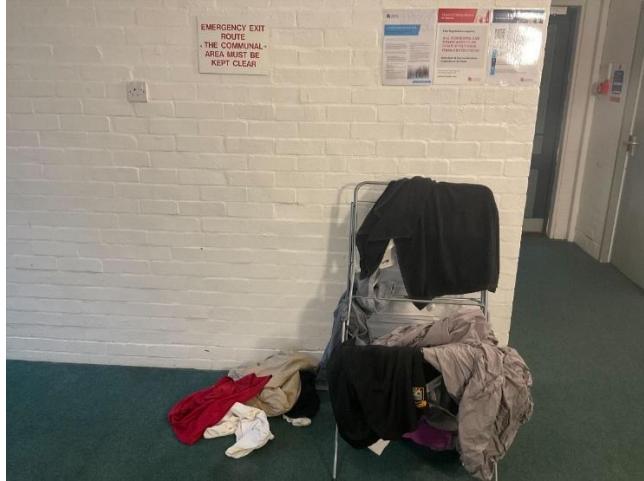
Figure 141

Clothing and personal items being dried within the escape corridor of Flat F2, increasing the fire load and compromising the sterility of the escape route.

23 <i>Fig 140 To Fig 142</i>	3	Personal items and combustible materials, including clothing being dried and coat hooks, were observed within escape corridors serving the flats. Of particular note, clothes drying was observed within the escape corridors of Flats D2, F2, and H2. The presence of such items increases the fire load within the escape routes and could compromise the safety of occupants in the event of a fire. The Fire and Rescue Service has previously highlighted that escape routes should be maintained as sterile areas, free from storage, doormats, and other obstructions.	All personal items, clothing, and combustible materials should be removed from escape corridors immediately. Escape routes must be maintained as sterile areas, free from storage or obstructions. Residents should be reminded that coat hooks, doormats, and clothes drying within these areas are not permitted.	Jemima Moulton-Hawkins	N/A	December 2025	Complete: Coat hooks and door mats removed from communal areas 05/12/2025. Regular inspections in place to ensure escape routes remain clear, obstructions removed where found.

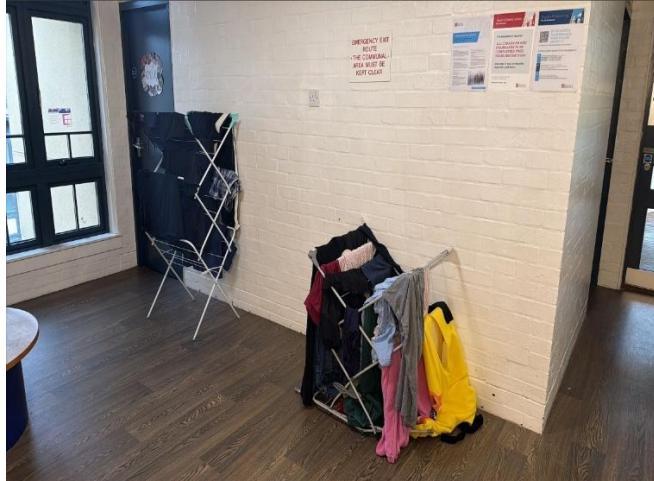
Figure 142

Clothes drying noted within the escape corridor of Flat H2, contrary to the requirement for escape routes to be maintained as sterile areas free from combustible materials.

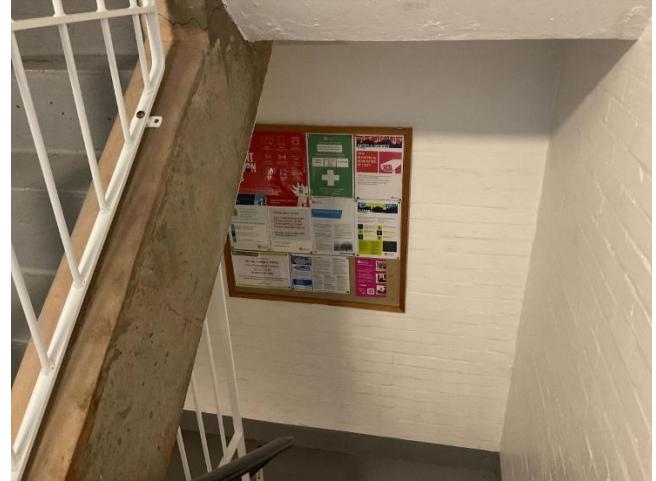
Figure 143

Combustible noticeboard of open design observed within protected stairwell, introducing unnecessary fire load within the means of escape.

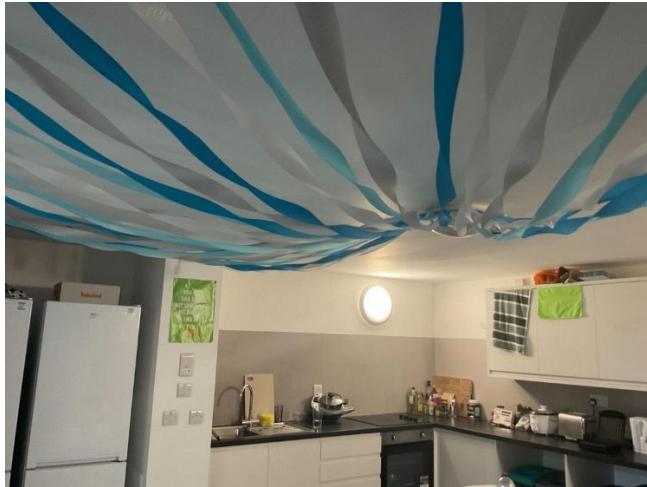
Figure 144

Combustible crepe paper decorations suspended from ceiling within kitchen of Flat F0, presenting an increased fire load above cooking appliances and lighting.

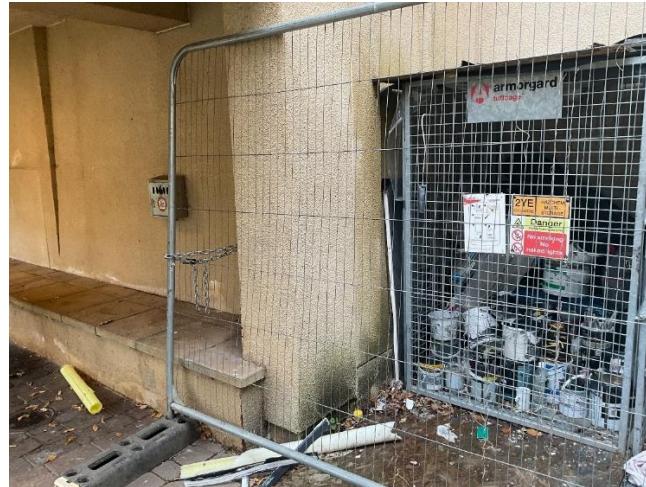
Figure 145

- Temporary Hazardous Storage Cage: A temporary hazardous storage cage was observed outside the Trunk Room, positioned directly adjacent to the designated smoking area. The cage displayed warning signage stating "No Smoking / No Naked Lights", yet the proximity to the smoking shelter introduces a potential ignition hazard.

Temporary hazardous materials storage cage containing flammable substances positioned adjacent to designated smoking area, contrary to safety signage and increasing ignition risk.

The hazardous storage cage should be relocated to a secure, suitably separated position, remote from ignition sources and smoking areas.

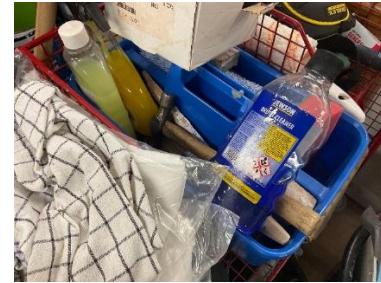
Figure 146

- Storage of Highly Flammable Liquids and Aerosols: The Trunk Room (maintenance workshop) was found to contain quantities of highly flammable liquids and aerosols that were not stored within a purpose-designed flammable liquids cabinet. The area also contained spare domestic appliances and general clutter, contributing to an elevated fire load.

Highly flammable liquids and aerosols stored in the trunk room without a suitable fire-resisting cabinet, alongside poor housekeeping and excess fire load.

It is recommended that a certified highly flammable liquids cabinet be provided, and that housekeeping standards within this area be improved to reduce the overall fire risk.

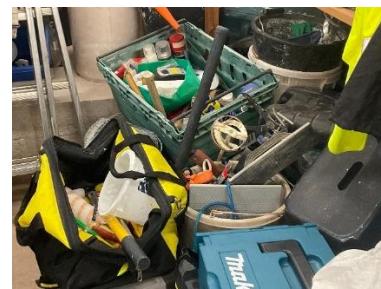
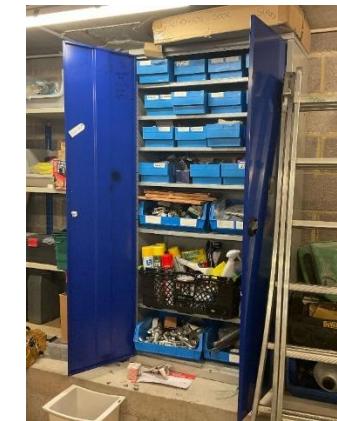
27 <i>Fig 146</i>	3	The Trunk room, used as a maintenance workshop, contains a range of spare appliances (including heaters, refrigerators, and microwaves) and is also used for the storage of quantities of highly flammable liquids and aerosols. These substances are not stored within a purpose-designed, fire-resisting flammable liquids cabinet. Housekeeping within this area was also found to be poor, contributing to an elevated fire load and increased risk of fire spread.	Provide a suitably sized, lockable, fire-resistant cabinet designed for the safe storage of highly flammable liquids and aerosols in accordance with HSG71 Storage of Flammable Liquids in Containers. Ensure all such materials are transferred into the cabinet when not in use. Improve general housekeeping standards within the trunk room to reduce the accumulation of combustible waste and maintain clear access routes.	Jemima Moulton-Hawkins	N/A	December 2025	Started - Partial Completion: Chemical cabinet ordered £449 - 04/12/2025 Trunk room cleared by maintenance operative - 22-23/12/2025 Delivery issues with chemical cabinet, chased supplier for resolution 09/01/2026

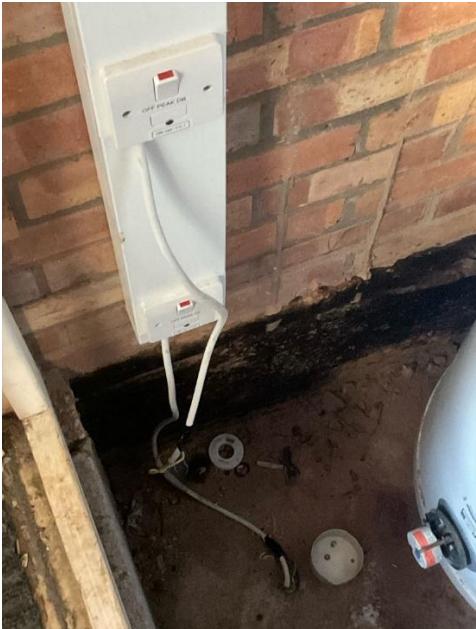
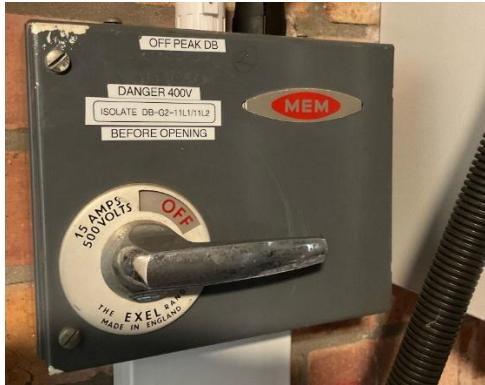
Figure 147

Redundant live cables and unfused spurs observed within immersion heater cupboard of Block G. Isolator in the 'off' position but not locked off, presenting a potential fire and electrical hazard.

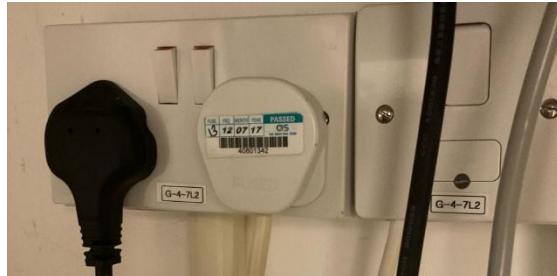
Figure 148

Examples of IT and electrical equipment within utility/IT cupboards (flats G1 and H1) with no evidence of recent portable appliance testing or inspection.

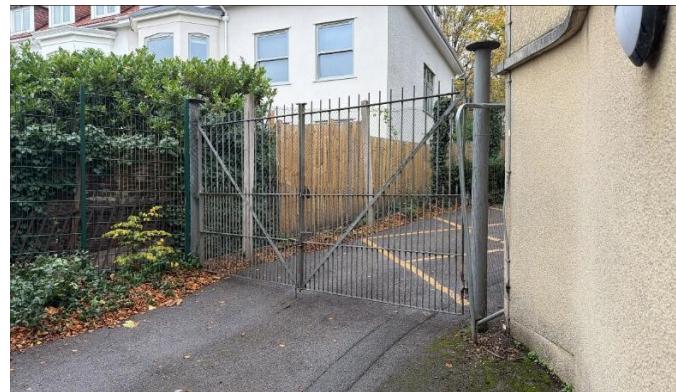
Figure 151

Main vehicle access gates to the side of the premises secured with a padlock, potentially restricting Fire and Rescue Service access in an emergency.

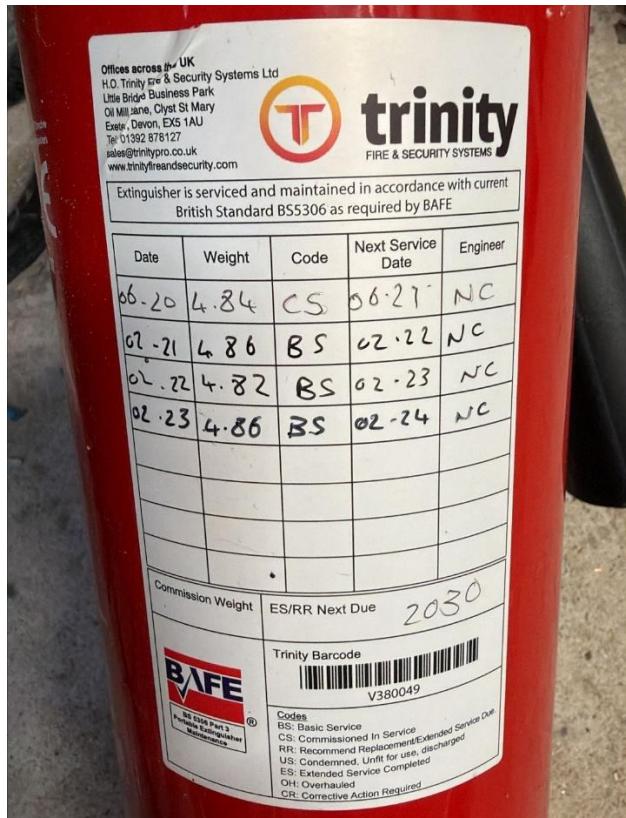
Figure 153

Carbon dioxide fire extinguisher within the boiler plant room to the rear of Block L showing an out-of-date service label (last serviced February 2023).

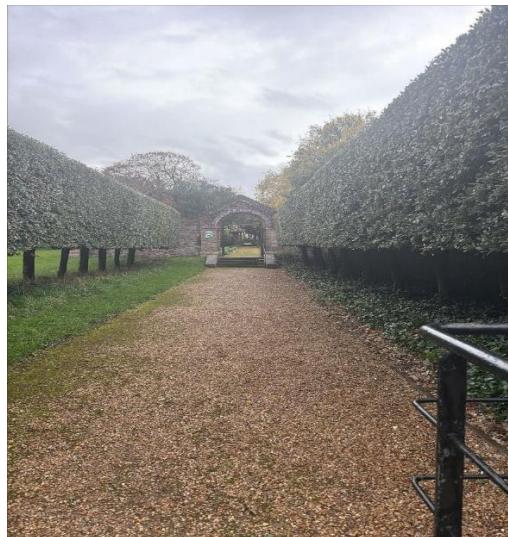
Figure 154

External escape route leading towards the emergency assembly point not provided with emergency lighting, including unlit steps and level changes.

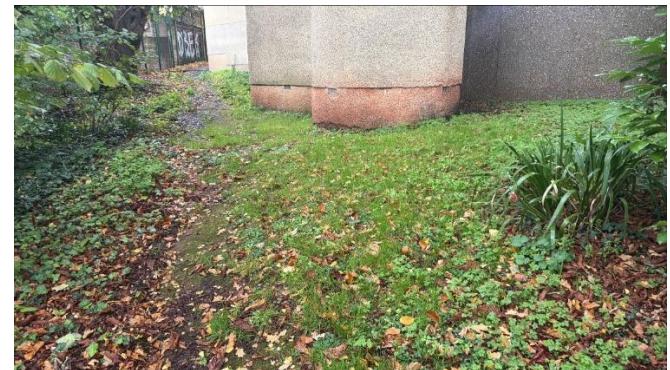
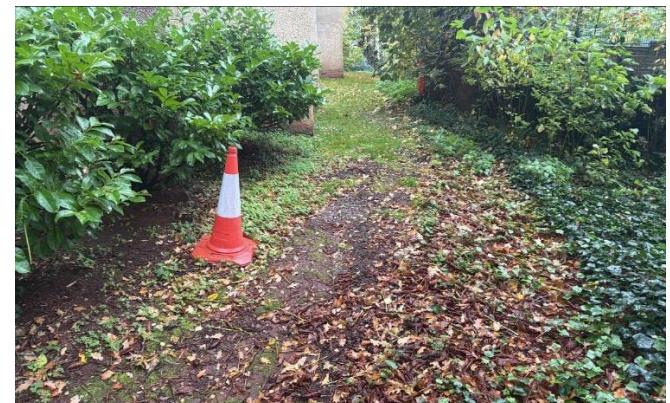
Figure 155

Uneven and unlit external escape routes at the base of emergency staircases, increasing trip and fall risk during evacuation in low-light conditions.

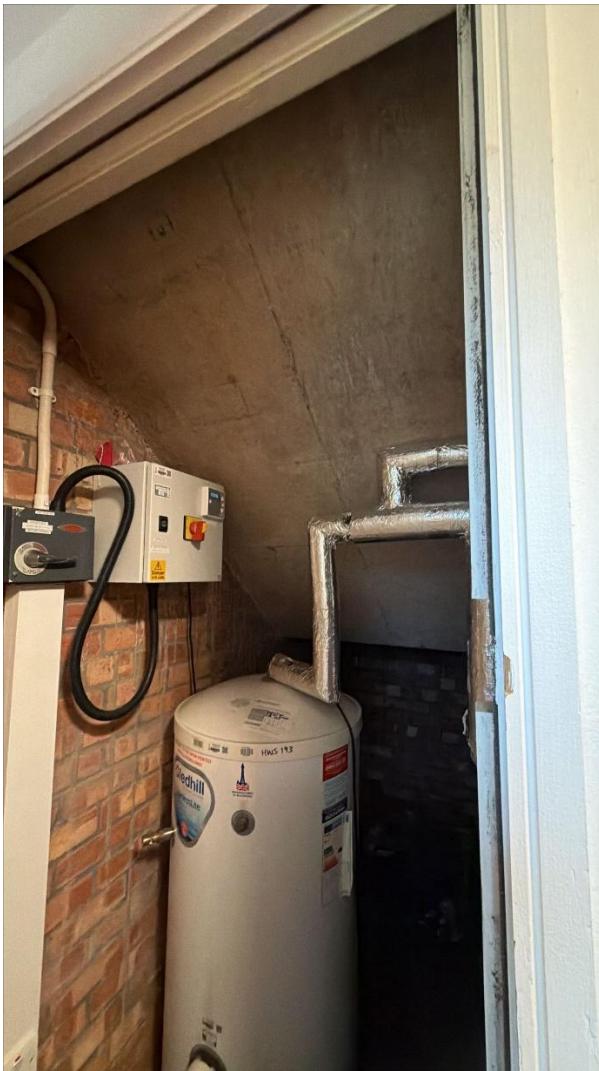
Figure 156

Cupboards, boiler rooms, and plant areas not provided with automatic fire detection, confirming that the current system does not achieve Category L1 coverage in accordance with BS 5839-1.

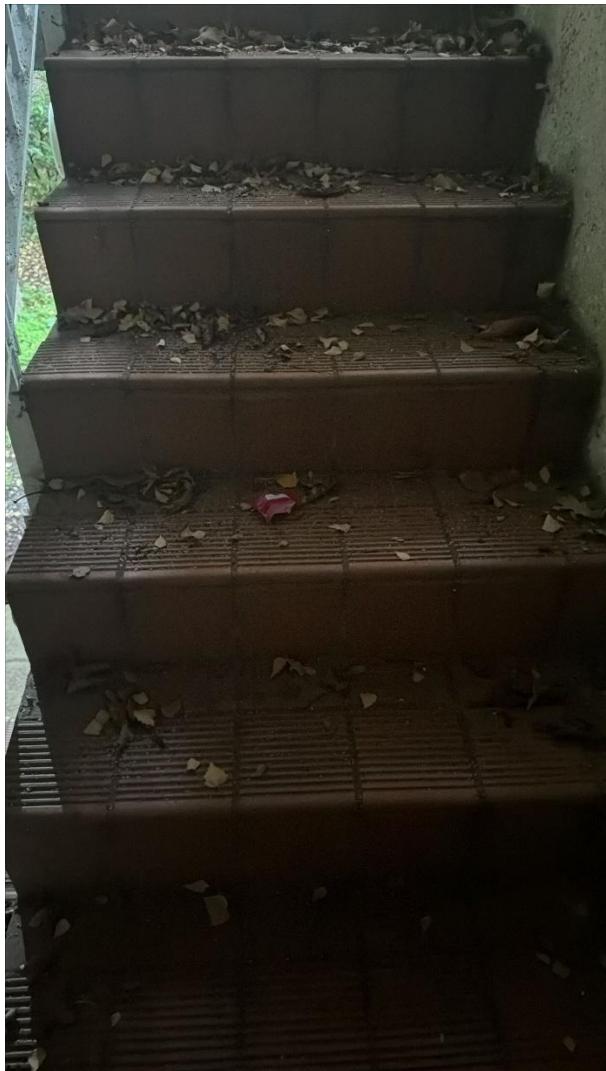
Figure 157

Accumulation of litter and leaves observed on treads and landings of external escape staircases, presenting slip and trip hazards.
