# MK-312BT Failure 20

MK312BT Firmware and function issues (Failure 20), debug suggestions?

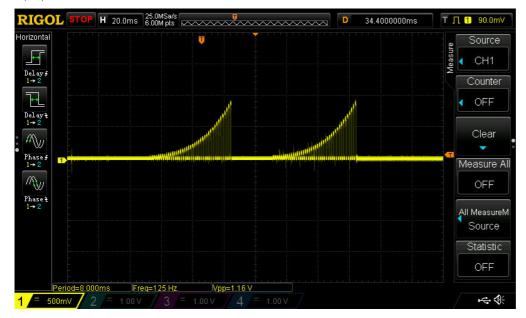
During initialisation the processor will send increasing pulses to both outputs.

These pulses cause voltage spikes across the current shunt (R30) which are measured by PA0 (pin 40).

If PA0 measures nothing or unexpected values you will see Failure 20.

The probe is connected to PA0:

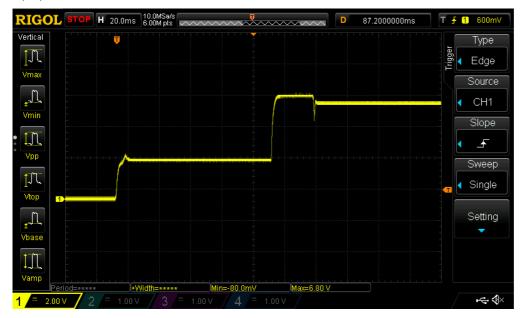
Both IRF fets (Q3 and Q6 look normal to me. Gate ~6.1V, Drain and Source 8,9V

(looks similar on both so i post just one of them)

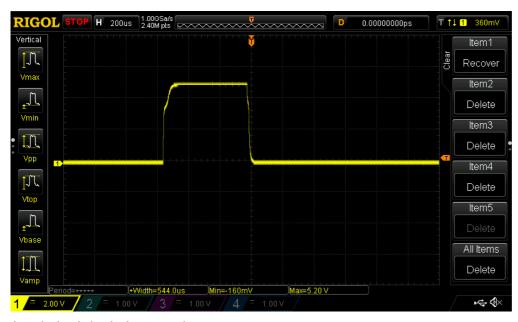
520N Q2 and Q1 (for Channel 1) seems to be also normal (?)

(again both look the same)

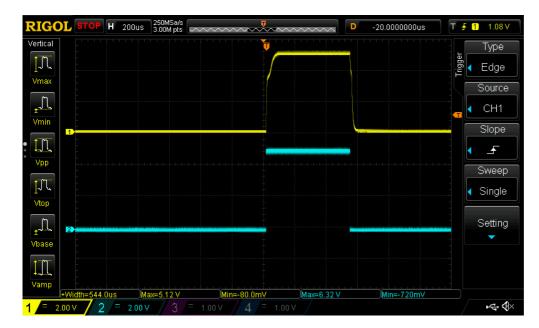
So next im measured the PB Line/Pin on the Atmega and the Gate of the 520N together Channel A example like Q3 (yellow) and PB2 (blue)

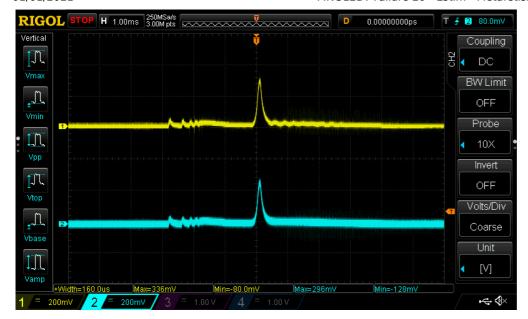
Channel B example of Q5 (yellow) and PB1

That signal is so low and short that i'm not even sure it's a real output of the Atmega

So now I'm really confused. If Channel A works as intended (which I guess, but don't know), why don't i get any signal from PB0 and PB1 to the mosfet gates of Channel B?

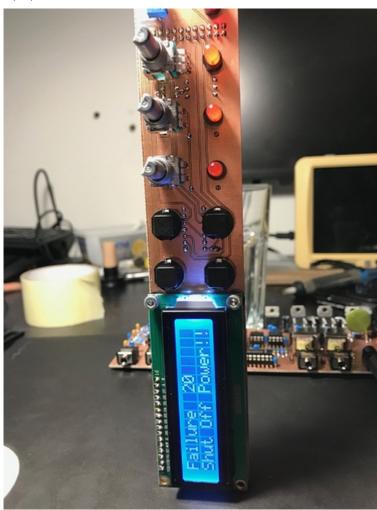
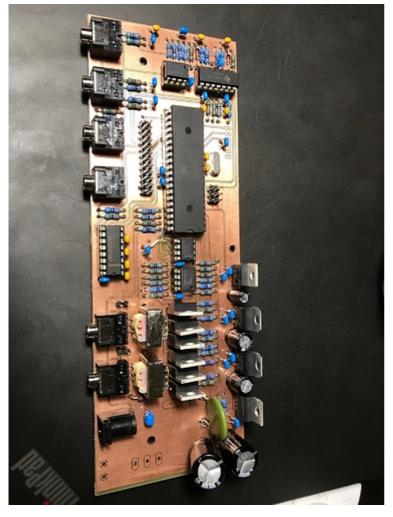
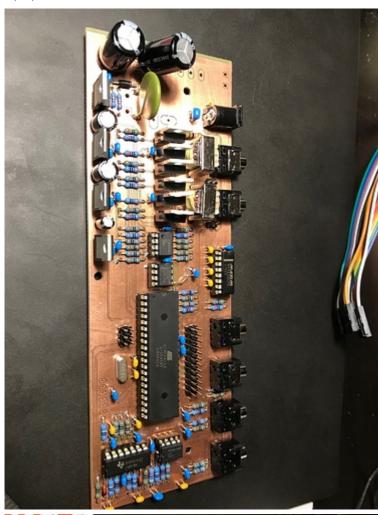
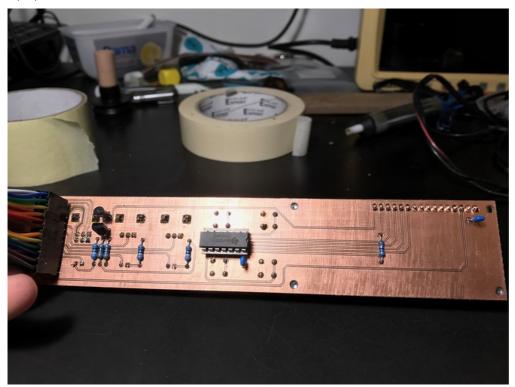
Hi Nestor, pictures are below. My PCB is homemade = no professional production but I checked all connections and parts and looks OK. When I switch it ON, I have error Failure 20 and on PA0 pin is not visible signal with tree test pulses - nothint. I checked output from ATMEGA and LM359 to

MOSFETS and nothink - no signal after switcing on. All voltages from regulator OK, only on output of LM2941 in 14 volts and not 12. I tested it with 12V on batery input with the same result. Display is showing message, but backlight is blinking in interval around 10 seconds = Short backlight ON and than 10 second without backlight. The same situation with blinking is on LED Output A and Output B.

You use a wrong DAC. With the current firmware you should use the LTC part not the MAXIM.
