# COMPRESSION BENDING FINDINGS

CANDIDO LEYBA BRANDON MARLBOROUGH

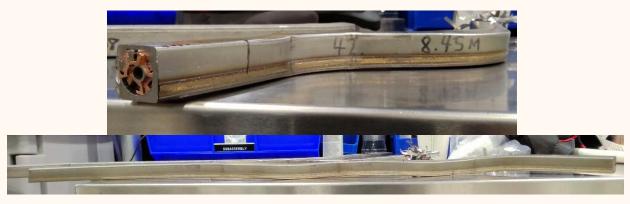
SAMPLE 2

The denser the cable the more bending and twisting of the z axis happens when compressed at the same PSI for all sample pieces, see images below.

Warping is another concern directly affecting the cable from compression bending. As the images show very clearly the method CFS is currently using for compression bending may be the reason for breaks in fiber.
