SEWER INSPECTION REPORT  
PSI-DEMO-20260730-001

4827 Sample Grove Lane, Indianapolis, IN 46239

# Inspection Summary

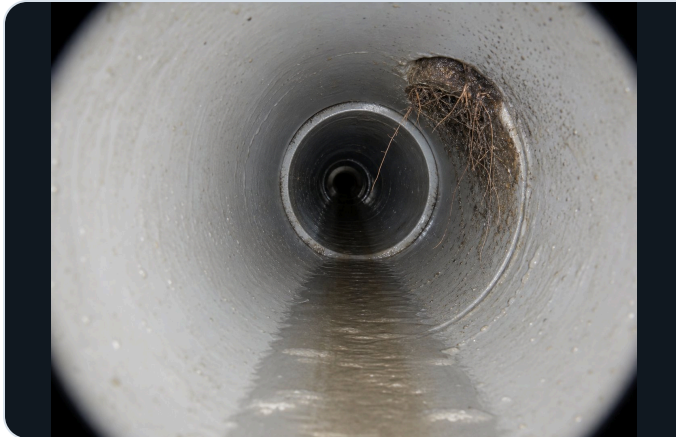
GENERATED CAMERA EVIDENCE · APPROX. 48 FT

A localized root intrusion and shallow standing water were visible at one joint. The center remained passable, and the camera reached the public connection at approximately 96 ft.

## Localized root intrusion and shallow water

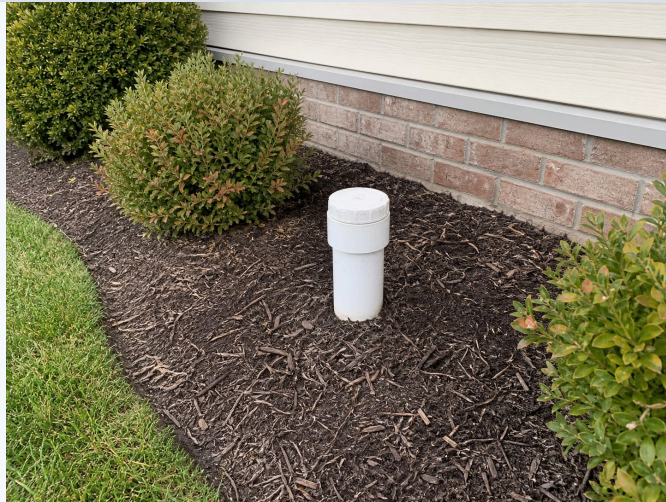
## Exterior cleanout access

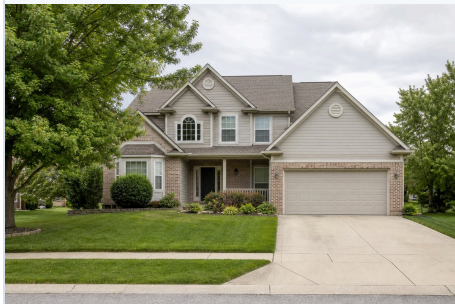
Generated exterior view illustrating the cleanout used as the demonstration access point.
