FABMETRICS AI — AUTOMATED WAFER YIELD INSPECTION REPORT

# Industrial Semiconductor Cleanroom Defect Analysis & Patent Audit

Inspector Profile: admin (Lead Semiconductor Engineer) | Batch Size: 10 Wafer Maps | Date: 2026-08-06 16:53:32 IST

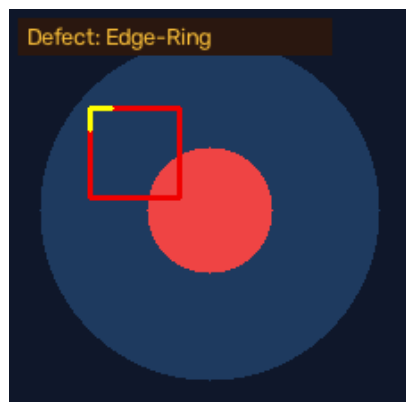
| Seq | Substrate Filename | Predicted Defect Mode | Confidence | Risk Status |
|---|---|---|---|---|
| 4 | wafer_sample_00003.png | Edge-Ring | 98.0% | FAIL (Defect) |

Sample #4:  
wafer\_sample\_00003.png  
Class: **Edge-Ring** (98.0%)  
Defect Clusters: 1

| Defect Mode | Physical Description | Cleanroom Root Cause | Preventive Engineering Action |
|---|---|---|---|
| Edge-Ring | Continuous boundary ring of failing dies along extreme wafer edge. | Plasma etch gas velocity drop-off or magnetic field distortion near outer wafer boundary. | Tune focus ring RF power bias and replace eroded edge focus rings in plasma chamber. |

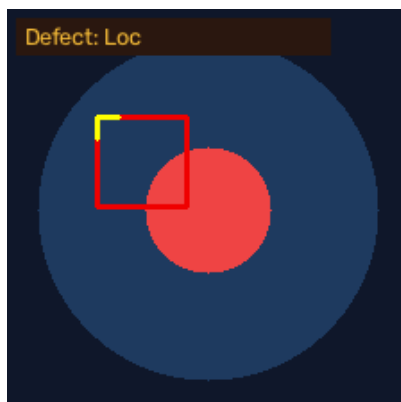
| Seq | Substrate Filename | Predicted Defect Mode | Confidence | Risk Status |
|---|---|---|---|---|
| 5 | wafer_sample_00004.png | Loc | 99.0% | FAIL (Defect) |

Sample #5:  
wafer\_sample\_00004.png  
Class: **Loc** (99.0%)  
Defect Clusters: 1

| Defect Mode | Physical Description | Cleanroom Root Cause | Preventive Engineering Action |
|---|---|---|---|
| Loc | Concentrated localized cluster spot on active die area. | Airborne cleanroom micro-particulate contamination landing during mask exposure. | Perform HEPA filter laminar flow audit and clean stepper reticle mask surface. |

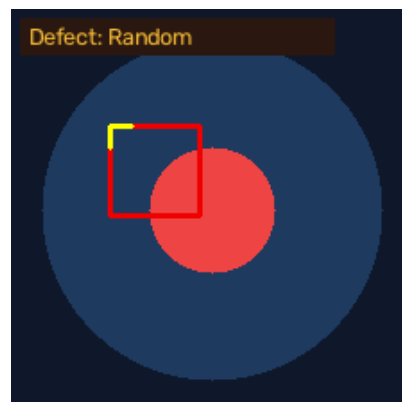
| Seq | Substrate Filename | Predicted Defect Mode | Confidence | Risk Status |
|---|---|---|---|---|
| 6 | wafer_sample_00005.png | Random | 95.0% | FAIL (Defect) |

Sample #6:  
wafer\_sample\_00005.png  
Class: **Random** (95.0%)  
Defect Clusters: 1

| Defect Mode | Physical Description | Cleanroom Root Cause | Preventive Engineering Action |
|---|---|---|---|
| Random | Scattered point anomaly distribution across silicon disk. | Silicon substrate crystal lattice dislocation or raw material wafer bulk defect. | Reject silicon ingot lot and perform high-resolution X-ray diffraction (XRD) ingot inspection. |
