# Industrial Semiconductor Cleanroom Defect Analysis & Patent Audit

Inspector Profile: admin (Lead Semiconductor Engineer) | Batch Size: 10 Wafer Maps | Date: 2026-08-06 16:23:27 IST

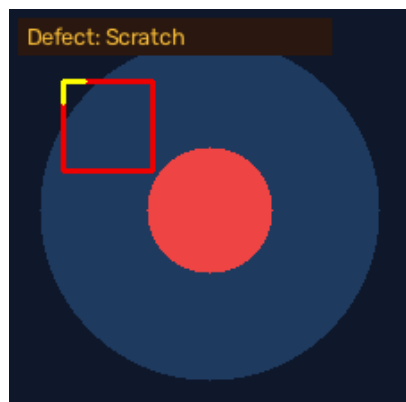
| Seq | Substrate Filename | Predicted Defect Mode | Confidence | Risk Status |
|---|---|---|---|---|
| 1 | wafer_sample_00000.png | Scratch | 95.0% | FAIL (Defect) |

Sample #1:  
wafer\_sample\_00000.png  
Class: **Scratch** (95.0%)  
Defect Clusters: 1

| Defect Mode | Physical Description | Cleanroom Root Cause | Preventive Engineering Action |
|---|---|---|---|
| Scratch | Linear defect track caused by mechanical abrasion across wafer surface. | Robot transfer arm misalignment, cassette slider friction, or automated handler pin contact. | Re-align 6-axis wafer transfer robot end-effector and inspect vacuum pick pins. |

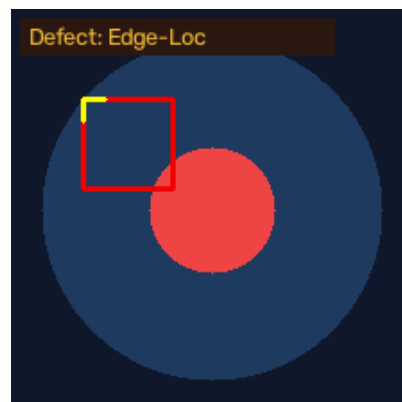
| Seq | Substrate Filename | Predicted Defect Mode | Confidence | Risk Status |
|---|---|---|---|---|
| 3 | wafer_sample_00002.png | Edge-Loc | 97.0% | FAIL (Defect) |

Sample #3:  
wafer\_sample\_00002.png  
Class: **Edge-Loc** (97.0%)  
Defect Clusters: 1

| Defect Mode | Physical Description | Cleanroom Root Cause | Preventive Engineering Action |
|---|---|---|---|
| Edge-Loc | Grouped localized flaw blob hugging the outer wafer perimeter. | Edge bead removal (EBR) solvent splash or vacuum chuck clamp edge friction. | Adjust EBR solvent dispense angle and clean robotic wafer transport edge grippers. |

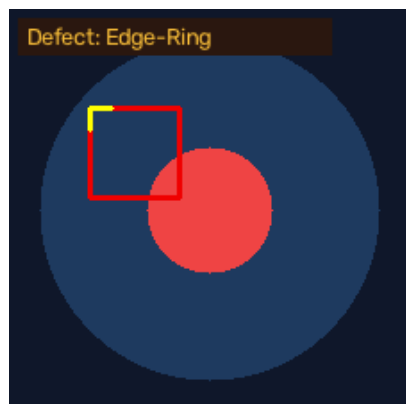
| Seq | Substrate Filename | Predicted Defect Mode | Confidence | Risk Status |
|---|---|---|---|---|
| 4 | wafer_sample_00003.png | Edge-Ring | 98.0% | FAIL (Defect) |

Sample #4:  
wafer\_sample\_00003.png  
Class: **Edge-Ring** (98.0%)  
Defect Clusters: 1

| Defect Mode | Physical Description | Cleanroom Root Cause | Preventive Engineering Action |
|---|---|---|---|
| Edge-Ring | Continuous boundary ring of failing dies along extreme wafer edge. | Plasma etch gas velocity drop-off or magnetic field distortion near outer wafer boundary. | Tune focus ring RF power bias and replace eroded edge focus rings in plasma chamber. |

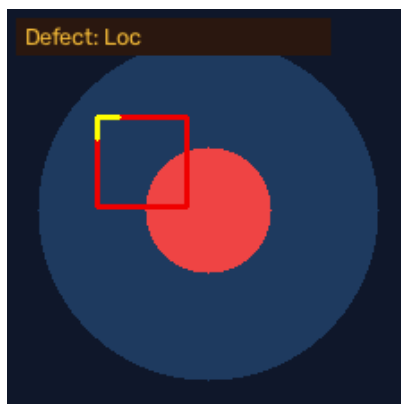
| Seq | Substrate Filename | Predicted Defect Mode | Confidence | Risk Status |
|---|---|---|---|---|
| 5 | wafer_sample_00004.png | Loc | 99.0% | FAIL (Defect) |

Sample #5:  
wafer\_sample\_00004.png  
Class: **Loc** (99.0%)  
Defect Clusters: 1

| Defect Mode | Physical Description | Cleanroom Root Cause | Preventive Engineering Action |
|---|---|---|---|
| Loc | Concentrated localized cluster spot on active die area. | Airborne cleanroom micro-particulate contamination landing during mask exposure. | Perform HEPA filter laminar flow audit and clean stepper reticle mask surface. |

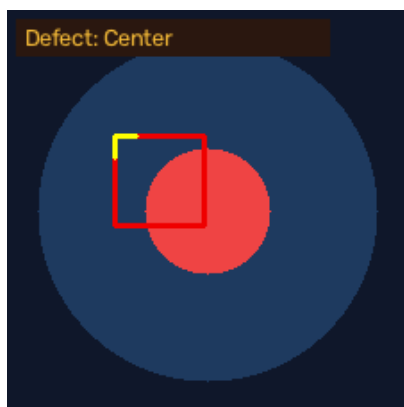
| Seq | Substrate Filename | Predicted Defect Mode | Confidence | Risk Status |
|---|---|---|---|---|
| 7 | wafer_sample_00006.png | Center | 96.0% | FAIL (Defect) |

Sample #7:  
wafer\_sample\_00006.png  
Class: **Center** (96.0%)  
Defect Clusters: 1

| Defect Mode | Physical Description | Cleanroom Root Cause | Preventive Engineering Action |
|---|---|---|---|
| Center | Concentric defect cluster situated at wafer disk center. | Uneven photoresist spin-coating or center nozzle spray pressure fluctuation during photolithography. | Calibrate spin-coater dispense nozzle and adjust rotational acceleration profiles. |

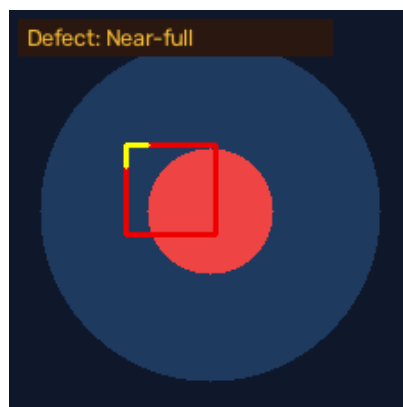
| Seq | Substrate Filename | Predicted Defect Mode | Confidence | Risk Status |
|---|---|---|---|---|
| 8 | wafer_sample_00007.png | Near-full | 97.0% | FAIL (Defect) |

Sample #8:  
wafer\_sample\_00007.png  
Class: **Near-full** (97.0%)  
Defect Clusters: 1

| Defect Mode | Physical Description | Cleanroom Root Cause | Preventive Engineering Action |
|---|---|---|---|
| Near-full | Widespread array damage covering majority of wafer surface. | Catastrophic chemical bath acid over-etching, total gas valve failure, or power surge. | Immediate emergency shutdown of wet bench etch bay and recalibrate thermal flow sensors. |

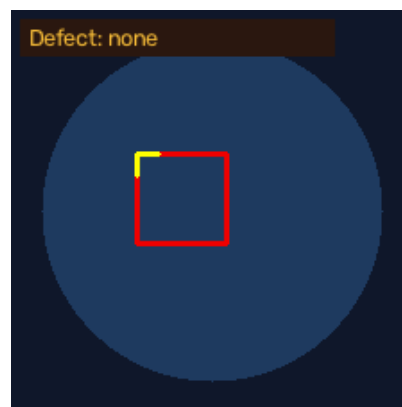
| Seq | Substrate Filename | Predicted Defect Mode | Confidence | Risk Status |
|---|---|---|---|---|
| 9 | wafer_sample_00008.png | none | 98.0% | PASS (Clean) |

Sample #9:  
wafer\_sample\_00008.png  
Class: **none** (98.0%)  
Defect Clusters: 1

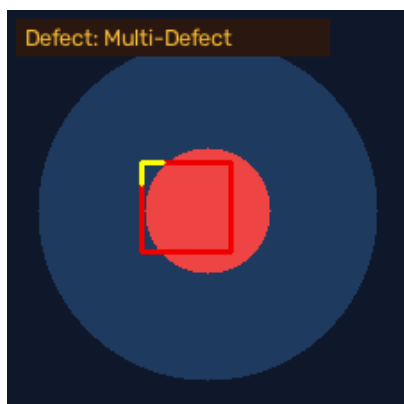
| Seq | Substrate Filename | Predicted Defect Mode | Confidence | Risk Status |
|---|---|---|---|---|
| 10 | wafer_sample_00009.png | Multi-Defect | 99.0% | FAIL (Defect) |

Sample #10:  
wafer\_sample\_00009.png  
Class: **Multi-Defect** (99.0%)  
Defect Clusters: 1

| Defect Mode | Physical Description | Cleanroom Root Cause | Preventive Engineering Action |
|---|---|---|---|
| Multi-Defect | Complex dual-defect superimposed wafer maps (e.g. Scratch + Donut). | Multiple process step failures across photolithography and CMP transport stages. | Perform root-cause cross-correlation audit across wet etching and transport handling bays. |
