# Industrial Semiconductor Cleanroom Defect Analysis & Patent Audit

PATENT PENDING • REGISTRATION US-2026-FABMETRICS-AI • CONFIDENTIAL AUDIT REPORT

Inspector Profile: admin (Lead Semiconductor Engineer) | Batch Size: 10 Wafer Maps | Date: 2026-08-06 17:30:17 IST

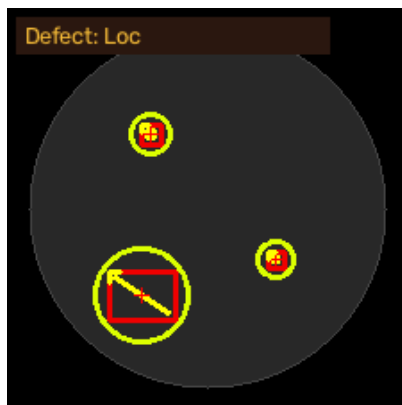
| Seq | Substrate Filename | Predicted Defect Mode | Confidence | Risk Status |
|---|---|---|---|---|
| 7 | wafer_matrix_sample_07.png | Loc | 72.0% | FAIL (Defect) |

Sample #7:  
 wafer\_matrix\_sample\_07.png  
 Class: **Loc** (72.0%)  
 Defect Clusters: 3

| Defect Mode | Physical Description | Cleanroom Root Cause | Preventive Engineering Action |
|---|---|---|---|
| Loc | Concentrated localized cluster spot on active die area. | Airborne cleanroom micro-particulate contamination landing during mask exposure. | Perform HEPA filter laminar flow audit and clean stepper reticle mask surface. |

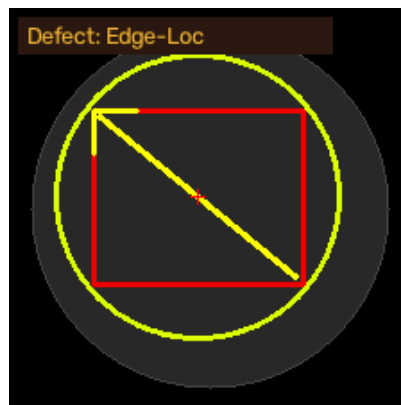
| Seq | Substrate Filename | Predicted Defect Mode | Confidence | Risk Status |
|---|---|---|---|---|
| 8 | wafer_matrix_sample_08.png | Edge-Loc | 57.5% | FAIL (Defect) |

Sample #8:  
 wafer\_matrix\_sample\_08.png  
 Class: **Edge-Loc** (57.5%)  
 Defect Clusters: 1

| Defect Mode | Physical Description | Cleanroom Root Cause | Preventive Engineering Action |
|---|---|---|---|
| Edge-Loc | Grouped localized flaw blob hugging the outer wafer perimeter. | Edge bead removal (EBR) solvent splash or vacuum chuck clamp edge friction. | Adjust EBR solvent dispense angle and clean robotic wafer transport edge grippers. |

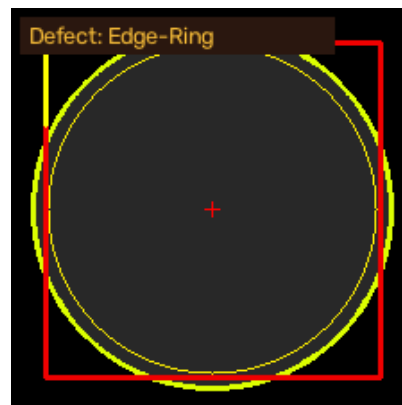
| Seq | Substrate Filename | Predicted Defect Mode | Confidence | Risk Status |
|---|---|---|---|---|
| 9 | wafer_matrix_sample_09.png | Edge-Ring | 67.9% | FAIL (Defect) |

Sample #9:  
 wafer\_matrix\_sample\_09.png  
 Class: **Edge-Ring** (67.9%)  
 Defect Clusters: 1

| Defect Mode | Physical Description | Cleanroom Root Cause | Preventive Engineering Action |
|---|---|---|---|
| Edge-Ring | Continuous boundary ring of failing dies along extreme wafer edge. | Plasma etch gas velocity drop-off or magnetic field distortion near outer wafer boundary. | Tune focus ring RF power bias and replace eroded edge focus rings in plasma chamber. |

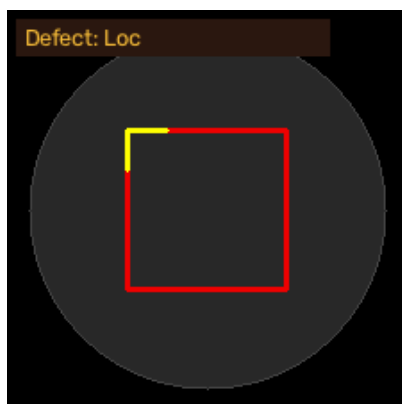
| Seq | Substrate Filename | Predicted Defect Mode | Confidence | Risk Status |
|---|---|---|---|---|
| 10 | wafer_matrix_sample_10.png | Loc | 72.7% | FAIL (Defect) |

Sample #10:  
 wafer\_matrix\_sample\_10.png  
 Class: **Loc** (72.7%)  
 Defect Clusters: 1
