# Industrial Semiconductor Cleanroom Defect Analysis & Patent Audit

Inspector Profile: admin (Lead Semiconductor Engineer) | Batch Size: 10 Wafer Maps | Date: 2026-08-06 22:11:50 IST

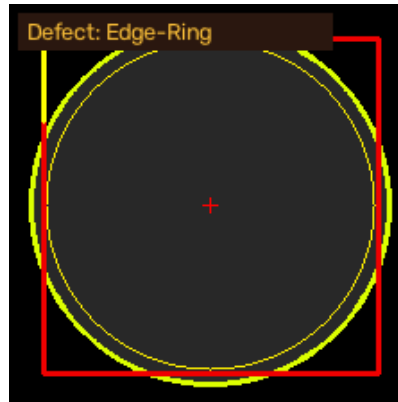
| Seq | Substrate Filename | Predicted Defect Mode | Confidence | Risk Status |
|---|---|---|---|---|
| 2 | wafer_matrix_sample_02.png | Edge-Ring | 67.9% | FAIL (Defect) |

Sample #2:  
wafer\_matrix\_sample\_02.png  
Class: **Edge-Ring** (67.9%)  
Defect Clusters: 1

| Defect Mode | Physical Description | Cleanroom Root Cause | Preventive Engineering Action |
|---|---|---|---|
| Edge-Ring | Continuous boundary ring of failing dies along extreme wafer edge. | Plasma etch gas velocity drop-off or magnetic field distortion near outer wafer boundary. | Tune focus ring RF power bias and replace eroded edge focus rings in plasma chamber. |

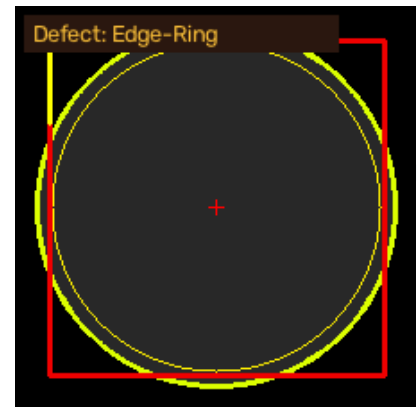
| Seq | Substrate Filename | Predicted Defect Mode | Confidence | Risk Status |
|---|---|---|---|---|
| 9 | wafer_matrix_sample_09.png | Edge-Ring | 67.9% | FAIL (Defect) |

Sample #9:  
wafer\_matrix\_sample\_09.png  
Class: **Edge-Ring** (67.9%)  
Defect Clusters: 1
