# Industrial Semiconductor Cleanroom Defect Analysis & Patent Audit

Inspector Profile: admin (Lead Semiconductor Engineer) | Batch Size: 10 Wafer Maps | Date: 2026-08-06 16:33:19 IST

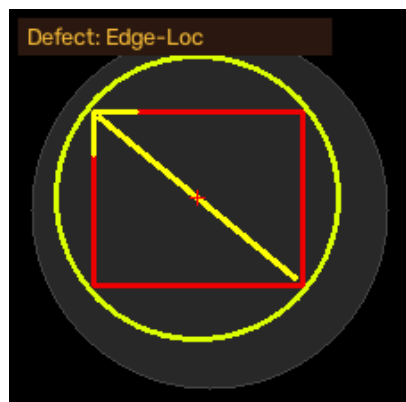
| Seq | Substrate Filename | Predicted Defect Mode | Confidence | Risk Status |
|---|---|---|---|---|
| 1 | wafer_matrix_sample_01.png | Edge-Loc | 57.5% | FAIL (Defect) |

Sample #1:  
wafer\_matrix\_sample\_01.png  
Class: **Edge-Loc** (57.5%)  
Defect Clusters: 1

| Defect Mode | Physical Description | Cleanroom Root Cause | Preventive Engineering Action |
|---|---|---|---|
| Edge-Loc | Grouped localized flaw blob hugging the outer wafer perimeter. | Edge bead removal (EBR) solvent splash or vacuum chuck clamp edge friction. | Adjust EBR solvent dispense angle and clean robotic wafer transport edge grippers. |

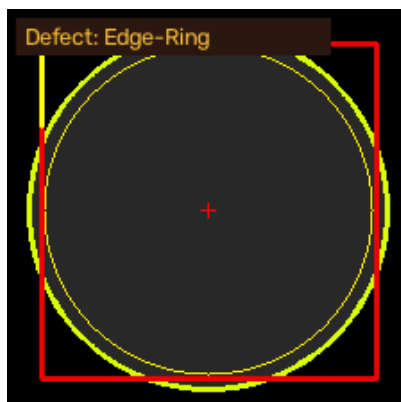
| Seq | Substrate Filename | Predicted Defect Mode | Confidence | Risk Status |
|---|---|---|---|---|
| 2 | wafer_matrix_sample_02.png | Edge-Ring | 67.9% | FAIL (Defect) |

Sample #2:  
wafer\_matrix\_sample\_02.png  
Class: **Edge-Ring** (67.9%)  
Defect Clusters: 1

| Defect Mode | Physical Description | Cleanroom Root Cause | Preventive Engineering Action |
|---|---|---|---|
| Edge-Ring | Continuous boundary ring of failing dies along extreme wafer edge. | Plasma etch gas velocity drop-off or magnetic field distortion near outer wafer boundary. | Tune focus ring RF power bias and replace eroded edge focus rings in plasma chamber. |

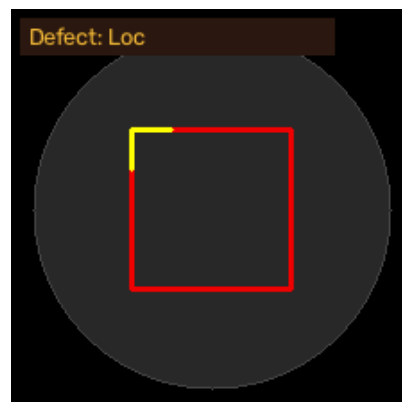
| Seq | Substrate Filename | Predicted Defect Mode | Confidence | Risk Status |
|---|---|---|---|---|
| 3 | wafer_matrix_sample_03.png | Loc | 72.7% | FAIL (Defect) |

Sample #3:  
wafer\_matrix\_sample\_03.png  
Class: **Loc** (72.7%)  
Defect Clusters: 1

| Defect Mode | Physical Description | Cleanroom Root Cause | Preventive Engineering Action |
|---|---|---|---|
| Loc | Concentrated localized cluster spot on active die area. | Airborne cleanroom micro-particulate contamination landing during mask exposure. | Perform HEPA filter laminar flow audit and clean stepper reticle mask surface. |

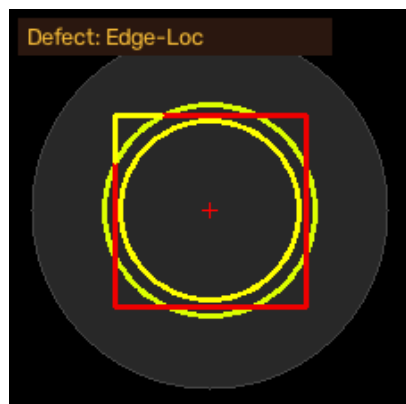
| Seq | Substrate Filename | Predicted Defect Mode | Confidence | Risk Status |
|---|---|---|---|---|
| 4 | wafer_matrix_sample_04.png | Edge-Loc | 48.8% | FAIL (Defect) |

Sample #4:  
wafer\_matrix\_sample\_04.png  
Class: **Edge-Loc** (48.8%)  
Defect Clusters: 1

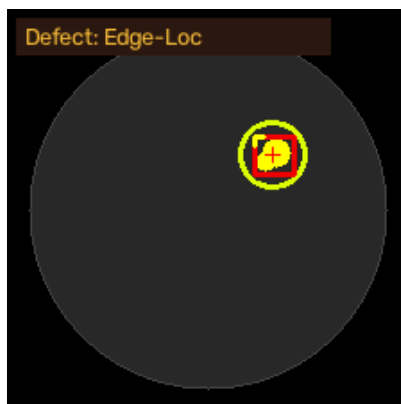
| Seq | Substrate Filename | Predicted Defect Mode | Confidence | Risk Status |
|---|---|---|---|---|
| 5 | wafer_matrix_sample_05.png | Edge-Loc | 54.9% | FAIL (Defect) |

Sample #5:  
wafer\_matrix\_sample\_05.png  
Class: **Edge-Loc** (54.9%)  
Defect Clusters: 1

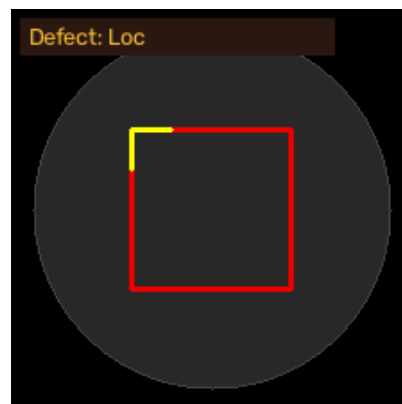
| Seq | Substrate Filename | Predicted Defect Mode | Confidence | Risk Status |
|---|---|---|---|---|
| 6 | wafer_matrix_sample_06.png | Loc | 72.7% | FAIL (Defect) |

Sample #6:  
wafer\_matrix\_sample\_06.png  
Class: **Loc** (72.7%)  
Defect Clusters: 1

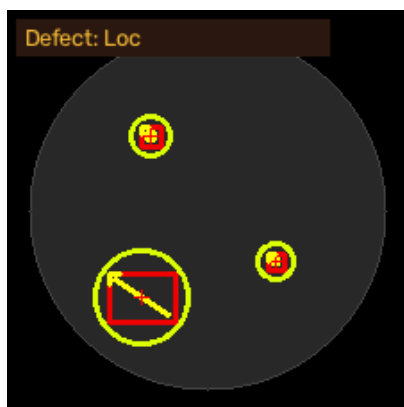
| Seq | Substrate Filename | Predicted Defect Mode | Confidence | Risk Status |
|---|---|---|---|---|
| 7 | wafer_matrix_sample_07.png | Loc | 72.0% | FAIL (Defect) |

Sample #7:  
wafer\_matrix\_sample\_07.png  
Class: **Loc** (72.0%)  
Defect Clusters: 3

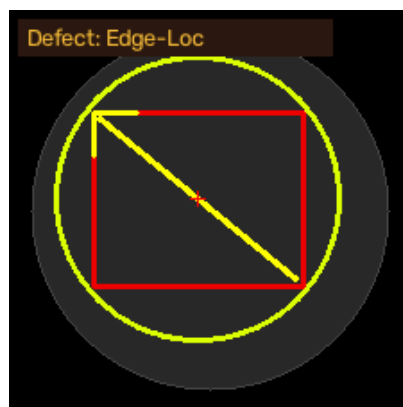
| Seq | Substrate Filename | Predicted Defect Mode | Confidence | Risk Status |
|---|---|---|---|---|
| 8 | wafer_matrix_sample_08.png | Edge-Loc | 57.5% | FAIL (Defect) |

Sample #8:  
wafer\_matrix\_sample\_08.png  
Class: **Edge-Loc** (57.5%)  
Defect Clusters: 1

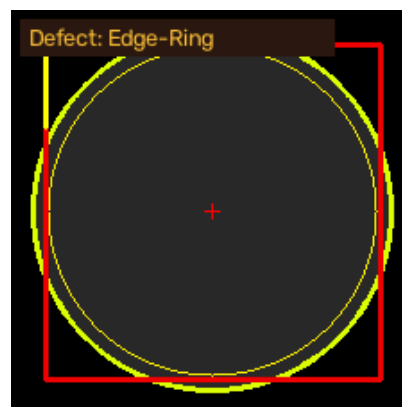
| Seq | Substrate Filename | Predicted Defect Mode | Confidence | Risk Status |
|---|---|---|---|---|
| 9 | wafer_matrix_sample_09.png | Edge-Ring | 67.9% | FAIL (Defect) |

Sample #9:  
wafer\_matrix\_sample\_09.png  
Class: **Edge-Ring** (67.9%)  
Defect Clusters: 1

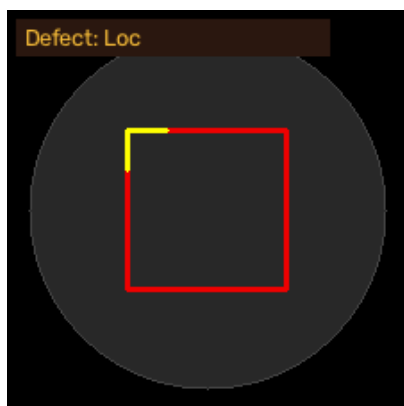
| Seq | Substrate Filename | Predicted Defect Mode | Confidence | Risk Status |
|---|---|---|---|---|
| 10 | wafer_matrix_sample_10.png | Loc | 72.7% | FAIL (Defect) |

Sample #10:  
wafer\_matrix\_sample\_10.png  
Class: **Loc** (72.7%)  
Defect Clusters: 1
