# Industrial Semiconductor Cleanroom Defect Analysis & Patent Audit

Inspector Profile: admin (Lead Semiconductor Engineer) | Batch Size: 10 Wafer Maps | Date: 2026-08-06 17:14:38 IST

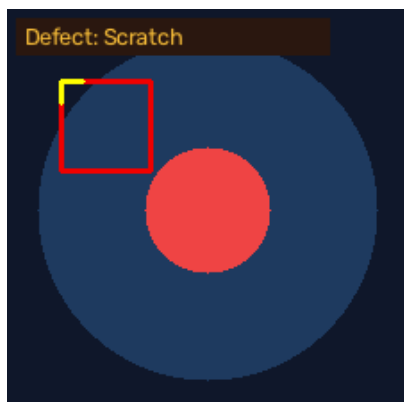
Sample #1:  
wafer\_sample\_00000.png  
Class: **Scratch** (95.0%)  
Defect Clusters: 1

| Defect Mode | Physical Description | Cleanroom Root Cause | Preventive Engineering Action |
|---|---|---|---|
| Scratch | Linear defect track caused by mechanical abrasion across wafer surface. | Robot transfer arm misalignment, cassette slider friction, or automated handler pin contact. | Re-align 6-axis wafer transfer robot end-effector and inspect vacuum pick pins. |

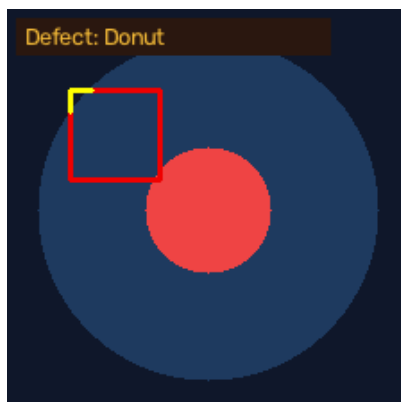
Sample #2:  
wafer\_sample\_00001.png  
Class: **Donut** (96.0%)  
Defect Clusters: 1

| Defect Mode | Physical Description | Cleanroom Root Cause | Preventive Engineering Action |
|---|---|---|---|
| Donut | Ring-shaped defect formation inside interior silicon die space. | Thermal gradient non-uniformity during rapid thermal annealing (RTA) or CMP slurry drying. | Inspect heating lamp arrays and balance Chemical Mechanical Planarization (CMP) slurry flow. |

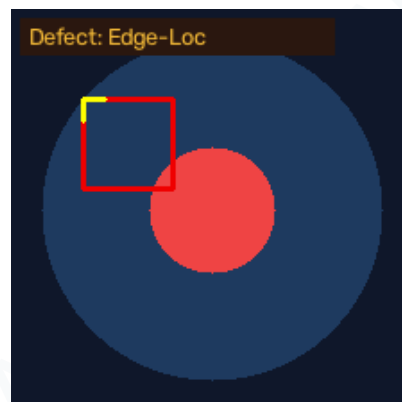
Sample #3:  
wafer\_sample\_00002.png  
Class: **Edge-Loc** (97.0%)  
Defect Clusters: 1

| Defect Mode | Physical Description | Cleanroom Root Cause | Preventive Engineering Action |
|---|---|---|---|
| Edge-Loc | Grouped localized flaw blob hugging the outer wafer perimeter. | Edge bead removal (EBR) solvent splash or vacuum chuck clamp edge friction. | Adjust EBR solvent dispense angle and clean robotic wafer transport edge grippers. |

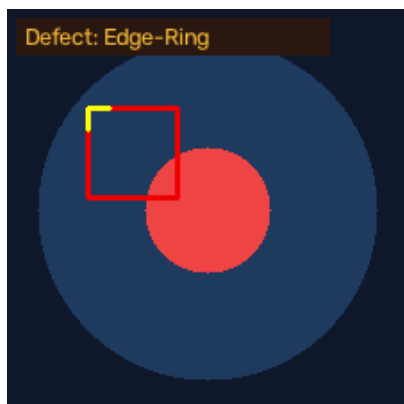
Sample #4:  
wafer\_sample\_00003.png  
Class: **Edge-Ring** (98.0%)  
Defect Clusters: 1

| Defect Mode | Physical Description | Cleanroom Root Cause | Preventive Engineering Action |
|---|---|---|---|
| Edge-Ring | Continuous boundary ring of failing dies along extreme wafer edge. | Plasma etch gas velocity drop-off or magnetic field distortion near outer wafer boundary. | Tune focus ring RF power bias and replace eroded edge focus rings in plasma chamber. |

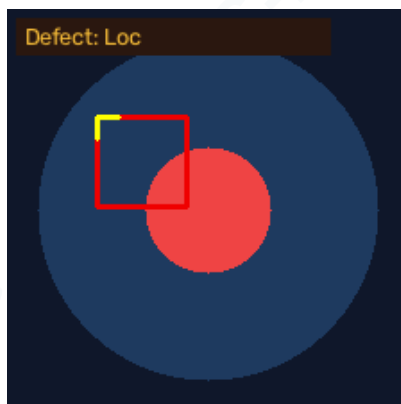
Sample #5:  
wafer\_sample\_00004.png  
Class: **Loc** (99.0%)  
Defect Clusters: 1

| Defect Mode | Physical Description | Cleanroom Root Cause | Preventive Engineering Action |
|---|---|---|---|
| Loc | Concentrated localized cluster spot on active die area. | Airborne cleanroom micro-particulate contamination landing during mask exposure. | Perform HEPA filter laminar flow audit and clean stepper reticle mask surface. |

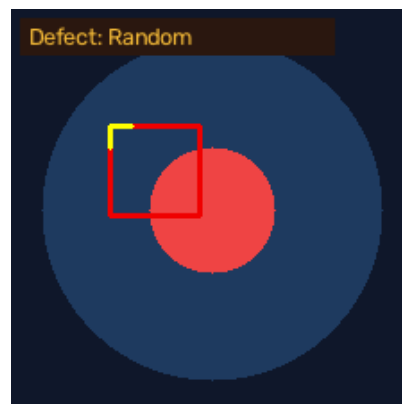
Sample #6:  
wafer\_sample\_00005.png  
Class: **Random** (95.0%)  
Defect Clusters: 1

| Defect Mode | Physical Description | Cleanroom Root Cause | Preventive Engineering Action |
|---|---|---|---|
| Random | Scattered point anomaly distribution across silicon disk. | Silicon substrate crystal lattice dislocation or raw material wafer bulk defect. | Reject silicon ingot lot and perform high-resolution X-ray diffraction (XRD) ingot inspection. |

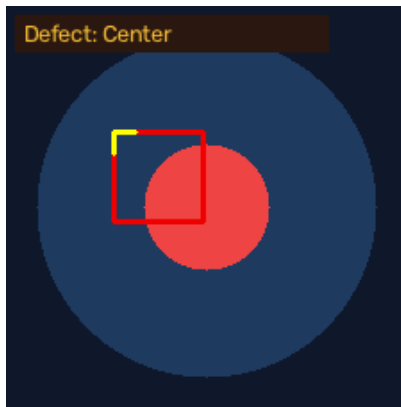
Defect: Center

Sample #7:  
wafer\_sample\_00006.png  
Class: **Center** (96.0%)  
Defect Clusters: 1

| Defect Mode | Physical Description | Cleanroom Root Cause | Preventive Engineering Action |
|---|---|---|---|
| Center | Concentric defect cluster situated at wafer disk center. | Uneven photoresist spin-coating or center nozzle spray pressure fluctuation during photolithography. | Calibrate spin-coater dispense nozzle and adjust rotational acceleration profiles. |

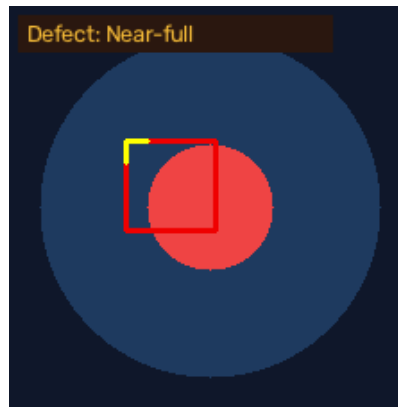
Defect: Near-full

Sample #8:  
wafer\_sample\_00007.png  
Class: **Near-full** (97.0%)  
Defect Clusters: 1

| Defect Mode | Physical Description | Cleanroom Root Cause | Preventive Engineering Action |
|---|---|---|---|
| Near-full | Widespread array damage covering majority of wafer surface. | Catastrophic chemical bath acid over-etching, total gas valve failure, or power surge. | Immediate emergency shutdown of wet bench etch bay and recalibrate thermal flow sensors. |

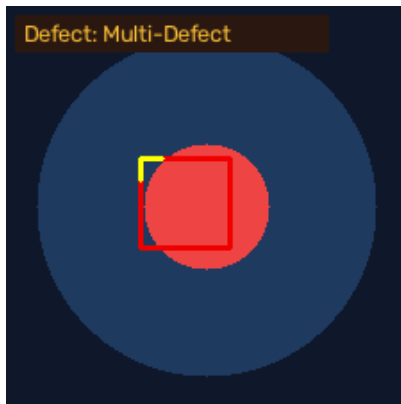
Defect: Multi-Defect

Sample #10:  
wafer\_sample\_00009.png  
Class: **Multi-Defect** (99.0%)  
Defect Clusters: 1

| Defect Mode | Physical Description | Cleanroom Root Cause | Preventive Engineering Action |
|---|---|---|---|
| Multi-Defect | Complex dual-defect superimposed wafer maps (e.g. Scratch + Donut). | Multiple process step failures across photolithography and CMP transport stages. | Perform root-cause cross-correlation audit across wet etching and transport handling bays. |
