Destructive impact of successive high magnitude earthquakes occurred in Türkiye's Kahramanmaraş on February 6, 2023

Aylin Demir¹ · Erkan Celebi¹ · Hakan Ozturk¹ · Zeki Ozcan¹ · Askin Ozocak¹ · Ertan Bol¹ · Sedat Sert¹ · F. Zehra Sahin¹ · Eylem Arslan¹ · Zeynep Dere Yaman¹ · Murat Utkucu² · Necati Mert¹

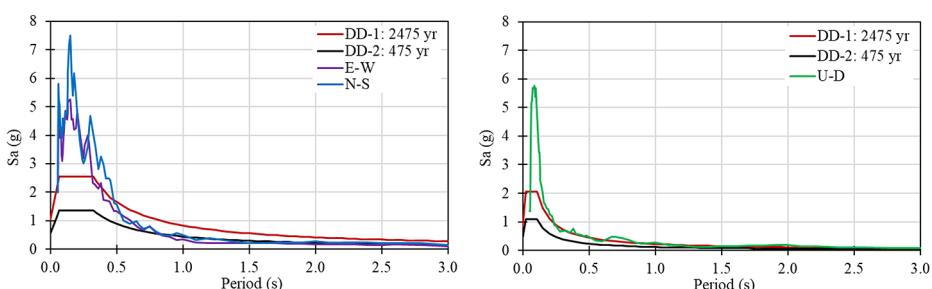
Upon the horizontal and vertical elastic design spectra are investigated, it is observed that the elastic design spectrum, created for an earthquake risk having a return period of 475 years (corresponding to earthquake level DD-2 in TBEC 2018) was exceeded in the locations of Karamanmarsa, Hatay, Gaziantep, and Adiyaman during the Pazarcık Earthquake ($M_w = 7.7$). However, the elastic design spectrum created for an earthquake risk having a return period of 2475 years (corresponding to earthquake level DD-1 in TBEC 2018) was only exceeded in Karamanmarsa and Hatay provinces. Moreover, during the

**Fig. 2** Pazarcık Earthquake ($M_w = 7.7$), Station 4614 (Kahramanmaraş/Pazarcık), Response Spectra ($\xi=5\%$, $V_{s,30} = 541$ m/s, Soil class: ZC)

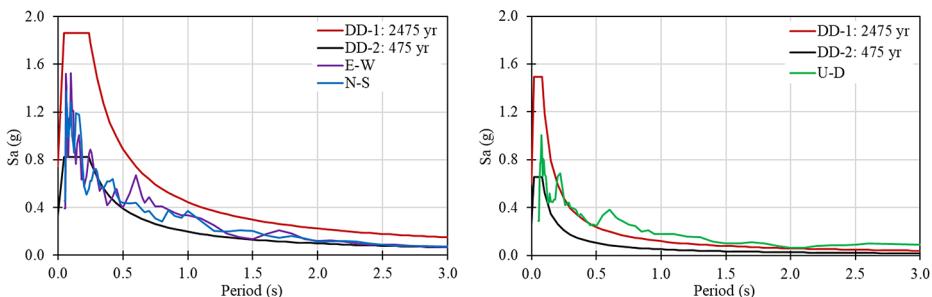
Fig. 3 Elbistan Earthquake ($M_w = 7.6$), Station 4406 (Malatya/Akçadağ), Response Spectra ($\xi=5\%$, $V_{s,30} = 815 \text{ m/s}$, Soil class: ZB)

Elbistan Earthquake ($M_w = 7.6$), while the design spectrum created for DD-2 was exceeded only in Malatya and Karamanmaraş, the design spectrum of DD-1 earthquake level was not exceeded in the region except at station 4612 in Elbistan for the periods higher than 1.2 s. The design spectra have not been exceeded in other places in the area.

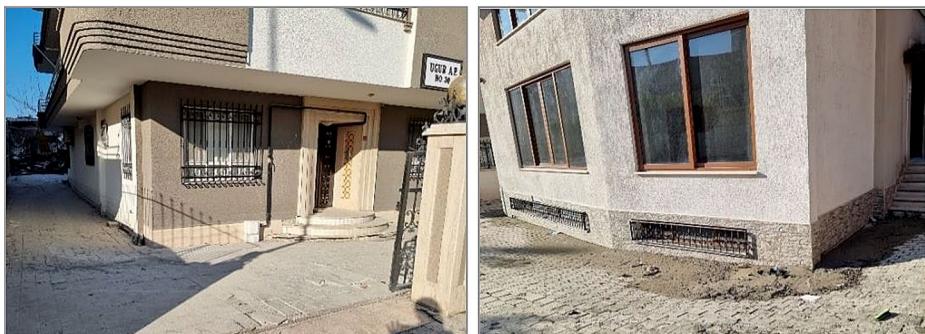
Soil liquefaction is defined as a significant loss of strength and stiffness due to the development of excess pore water pressures resulting in zero effective stress in the soil during a seismic event (Cetin and İlgaç 2023). The soil liquefaction phenomena were predominantly observed in the İskenderun district of Hatay, affecting both existing structures and open areas. Some examples of observed liquefaction-induced sand ejecta surrounding the buildings in İskenderun's coastal part are presented in Fig. 4. The field investigations here have shown that the liquefied sand reached out of the surface, especially from the corners and edges of buildings. The structures have made a uniform settlement between 30 and 50 cm but have maintained their functions.

Fig. 4 Uniform settlement of a building (left) and sand ejecta around a structure (right) in Iskenderun coastal region of Hatay

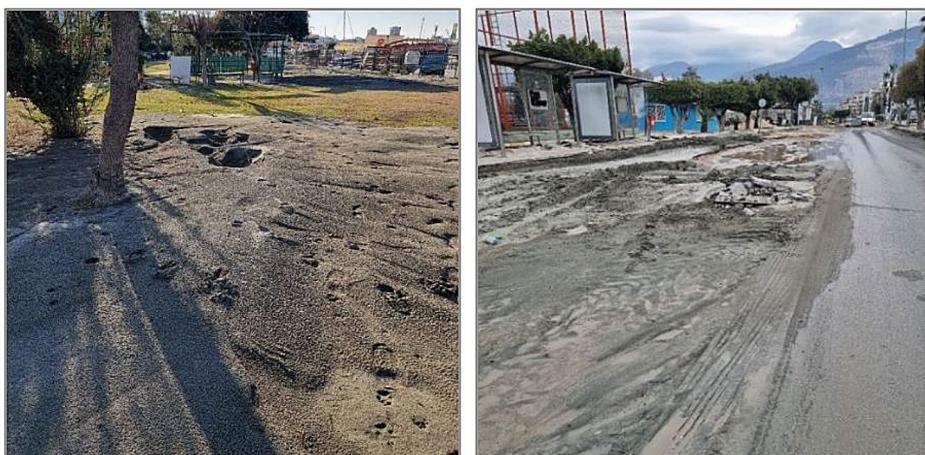
Fig. 5 Sand cones and crater geometries along the coastline (left) and some of the damages on road structures (right) in Iskenderun district of Hatay

Moreover, towards the coastline, commonly, liquefaction and sand cones phenomena in open areas were observed. An example of the sand cones and ejecta can be seen in Fig. 5. Considering the number and volume of the cones, it has been determined that the liquefaction has spread over a wide area here. As a result of that widespread liquefaction occurred in this region; a large amount of water reached out of the ground surface with the liquefied sand. This also caused floods on the coastline, especially along Atatürk Boulevard. Excessive deformations in road structures due to settlements and sand ejecta also became a striking point of the observations (see Fig. 5).

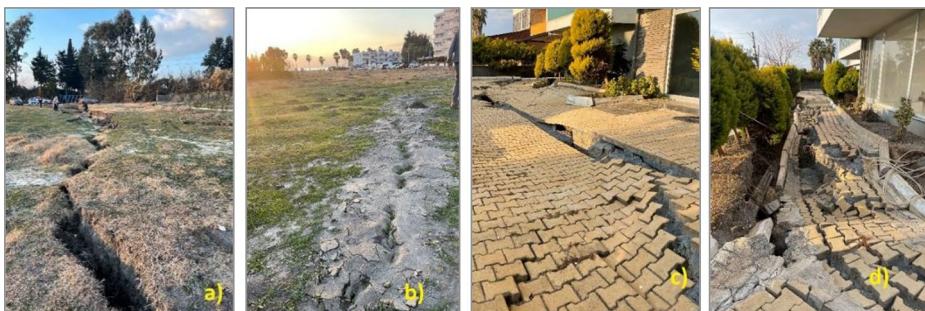
Soil liquefaction phenomena were also observed in Antakya (Demirköprü), Arsuz, Kirikhan and Dörtyol districts of Hatay. Lateral spreading, observed on the coastal part of Dörtyol district, is given in Fig. 6a. Sand ejecta were observed in the free-field here (Fig. 6b) as a result of lateral spreading caused by liquefaction. As a result of this spread, a failure surface of approximately 900 m length was formed. It was determined that the buildings in the western part of Dörtyol

Fig. 6 Liquefaction-induced failures observed in Dörtyol district of Hatay

district were exposed to about 80 cm vertical settlements in addition to the lateral deformations. Some apparent examples of these deformations can be seen in Fig. 6c, d.

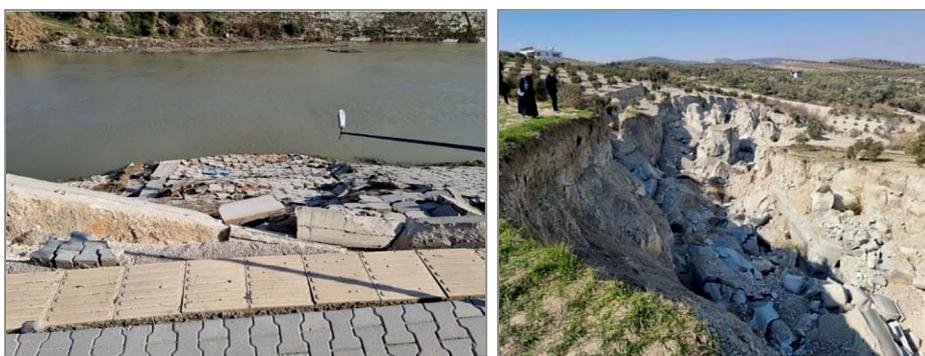
Fig. 7 Landslide damage observed in Antakya (left) and in Altınözü (right) districts of Hatay

Apart from liquefaction, geotechnical damages were also detected in Antakya city center. The first of these was the small-scale slides in the Asi River, which passes through the middle of the city center. Another damage is the large-scale landslide that occurred in Altınözü, approximately 200 m long and 400 m wide. It has been observed that weak sedimentary rocks dominate at the base of the landslide area. The mentioned damages are shown in Fig. 7.

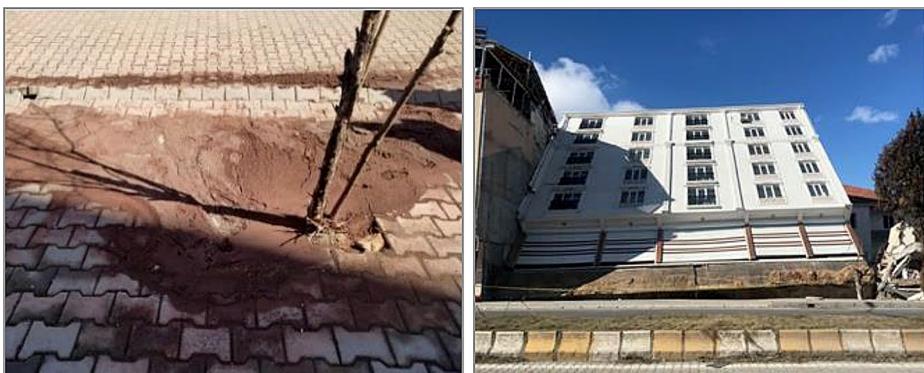
Lastly, during the Kahramanmaraş earthquakes, widespread soil problems were observed in the Gölbaşı area. Many buildings have faced issues such as excessive settlement, tilting and toppling over, etc. These problems are thought to arise from the poor earthquake per-

Fig. 8 Sand ejecta (left) and an overturned building (right) in Gölbaşı district of Adiyaman

formance of young alluvial soils with a high groundwater level. Additionally, the presence of sand ejecta in the free-field was also determined, as presented in Fig. 8. A building, near the close vicinity to this sand ejecta, was toppled over along the short side of the foundation. This indicates that liquefaction phenomena have caused many soil problems in Gölbaşı. The low depth of the foundation and the high length-to-width ratio of the building were also determined to facilitate the toppling. Consequently, it has been deduced that similar to past earthquakes, the necessity of considering the soil characteristics in the infrastructure design and construction has emerged again after the recent Kahramanmaraş earthquakes to ensure the safety of the infrastructures to be built in earthquake zones.

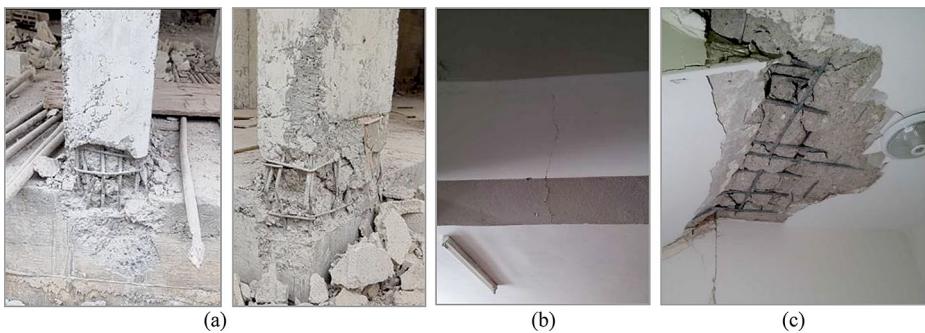
Fig. 9 Examples of plastic hinges at the bottom of columns (a), flexure cracks in beams (b), and damage in stair landings (c)

ings throughout the region. That caused the formation of plastic hinges at the upper and lower ends of the columns.

The general building stock has been observed to consist of frame systems with low aspect ratios. While this reduces the seismic force on the structure, it also causes structures to behave flexibly and have larger periods. In fact, in the field surveys conducted throughout the region, column joints at the ground floor foundation or basement walls have caused hinges even in new buildings. Due to the large displacements, it has been observed that concrete was crushed, and reinforcement was buckled or ruptured in the areas where hinges occurred. In buildings with rigid ground floors, hinges have been observed at the endpoints of the ground-floor columns (Fig. 9a). Flexure and shear cracks caused by seismic forces have also been observed in beams (Fig. 9b). Damage has been observed in beams due to torsion and stair landings due to the torsion effect (Fig. 9c).

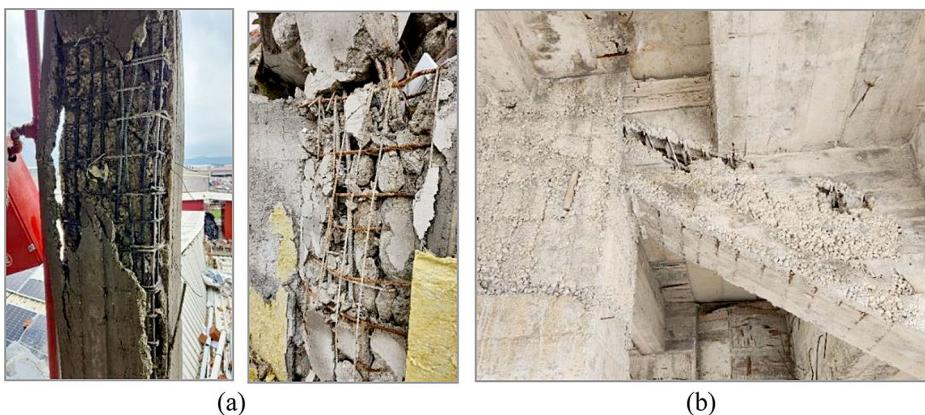
Most buildings constructed before 2000 were built using man-made concrete mixed and manufactured by human labor. Therefore, they have common mistakes such as wrong concrete mix (wrong water, cement, and aggregate ratio), low cement ratio, the existence of organic and inorganic materials in the mix, very small or massive aggregate, wrong placement of concrete (heavy segregation), etc. some examples of poor concrete quality and segregation are depicted in Fig. 10.

Fig. 10 Examples of poor concrete quality (a) and wrong placement of concrete (segregation) (b)

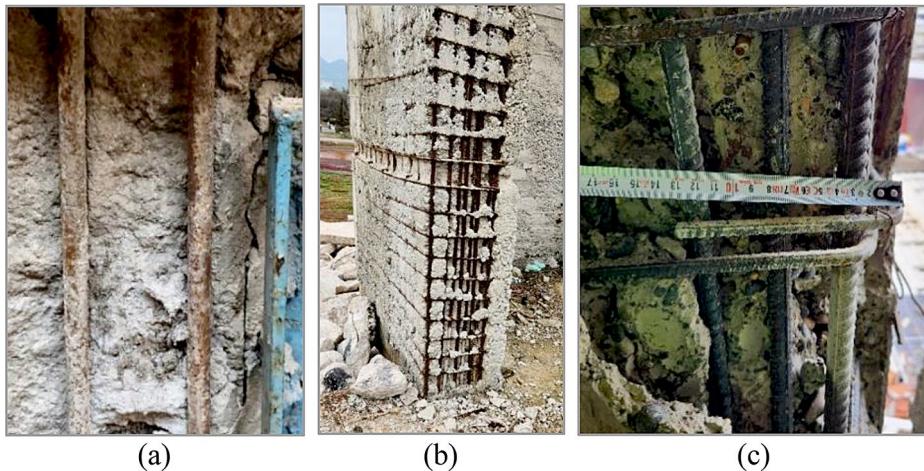
Additionally, it has been observed that plain reinforcing steel was generally used in buildings constructed before 2000. The reinforcement steel also had significant corrosion due to insufficient concrete cover (Fig. 11a). Concrete segregation has also been detected in these buildings (Fig. 11b). In many buildings, stirrups were bent wrongly at 90-degree instead of 135-degree, as prescribed in the TBEC 2018 (Fig. 11c). In many buildings in the region, it was observed that the protruding reinforcement bars of columns and walls from the foundation did not comply with the overlapping length requirement specified in the regulations. In these areas, due to the lack of proper spacing between reinforcement bars and the bending of reinforcing bars at 90-degree angles, plastic hinges have formed at the bottom of the columns, causing concrete cracking and reinforcement deformation.

Fig. 11 Unriveted smooth reinforcement and heavy corrosion (a), insufficient concrete cover and heavy segregation (b), and wrongly bent stirrups (90-degree bent) (c)

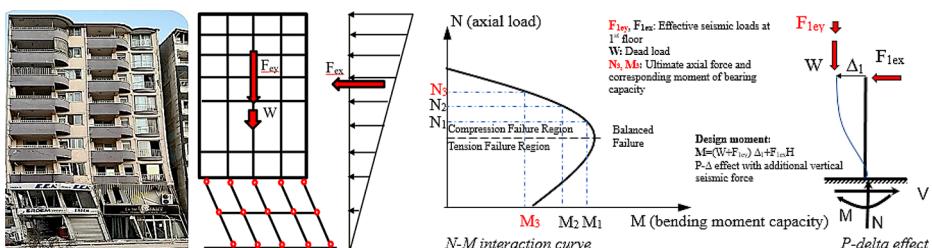
Fig. 12 Collapse mechanism due to soft story effect: P-delta effects with additional vertical inertial forces

It should also be noted that the vertical accelerations generated by the 2023 Kahramanmaraş earthquakes were as effective as the horizontal acceleration components. Therefore, especially the buildings designed with ribbed floor slabs were subjected to significant seismic forces. In this case, ribbed slab construction leads to additional axial loads on vertical structural members as they cannot show sufficient resistance against high vertical accelerations like conventional two-way beam-supported slabs. While the moments of bearing capacity at the ground floor columns decreased drastically with the increase of the axial load, the second-moment effects emerged because of the earthquake's excessive displacement demand on these floors, and the design moment on these load-bearing elements increased significantly (Fig. 12). As shown in Fig. 13, the stability of individual column members on the ground floor was influenced adversely by the increased number of plastic hinges triggering the collapse mechanism of soft story action due to the demand of undesired large story drift depending on the additional vertical inertia forces.

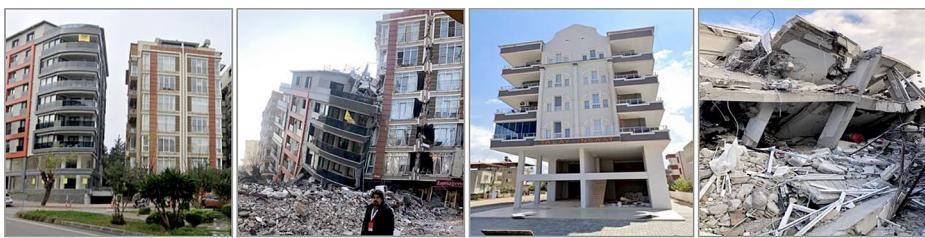
(a) Building 1, before (left) and after (right) earthquakes (b) Building 2, before (left) and after (right) earthquakes

The heavily damaged and collapsed reinforced concrete buildings, which were generally constructed after 2000 years in the densely populated settlements such as Nurdağı, İslahiye, Pazarcık, Türkoğlu, Kırıkkale, and Antakya, are examined closely in the post-earthquake region. Notably, they have similar architectural features and were arranged with the same type of load-bearing system, especially for the floor members. As can be seen from Figs. 12 and 13, the first two floors of such multi-story buildings have been designed for commercial workplace purposes, and the floors above them are used as residential areas with large and heavy overhangs. It has been observed in the field that these types of apartment buildings with similar engineering and architectural design errors failed against seismic forces.

Fig. 13 Examples of typical buildings in the earthquake-hit region and heavy structural damages due to engineering and architectural design errors

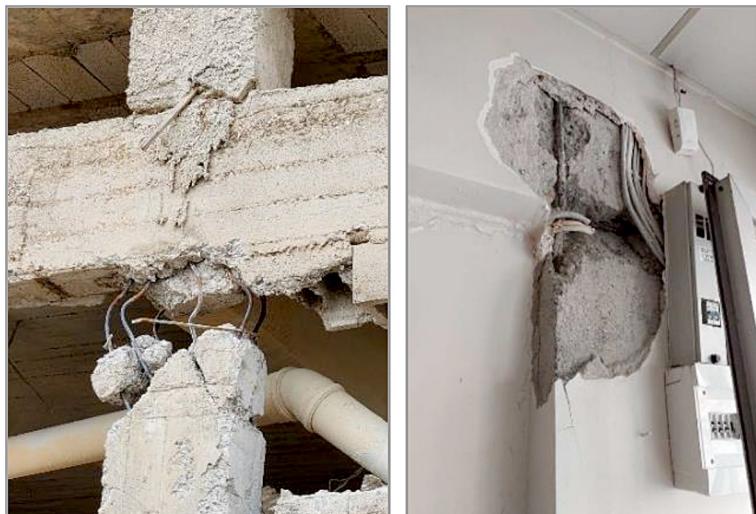
Additionally, the 1998 Turkish Earthquake Code is the first in Türkiye to address the concept of ductility for designing structures that will not collapse in earthquakes, as well as the design of column-beam joint regions and strong column-weak beam design. As a result of field surveys conducted under this regulation, it has been observed that in buildings constructed before 1998, columns have weaker cross-sections compared to beams. Most residential buildings in the region have not been designed to comply with the strong column-weak beam principle. Therefore, those buildings were severely damaged or collapsed during the Kahramanmaraş earthquakes. Lastly, the insufficient resistance of columns to beams has led to the formation of shear cracks and hinges at the top and bottom ends of the columns (Fig. 14).

Fig. 14 Examples of a strong beam weak column design and damage on columns

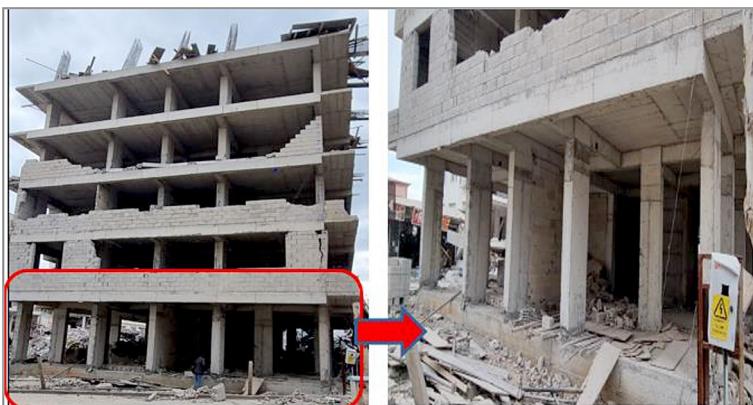
Fig. 15 Examples of large and heavy overhangs on RC buildings in the earthquake-hit region

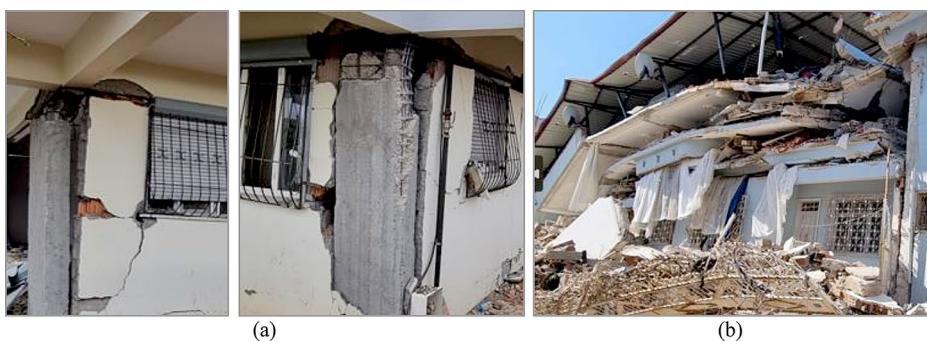
Fig. 16 Examples of column damage due to large overhangs (a) and a building collapse due to additional floors (b)

specifically located on main streets had extensive overhangs extending to 1.5 m. Moreover, the columns carrying those overhangs were not connected with the beams, and that caused the formation of an insufficient tied framing system. Therefore, the columns could not work together or provide proper load transfer (Fig. 15). Moreover, in earthquake-resistant building design, placing shear walls that can withstand a significant portion of the earthquake forces is important. In the region, even if shear walls were included in the buildings, it was observed that they were not symmetrically placed in structures. The resulting irregularity in torsion and the additional moment effects caused by the heavy overhangs resulted in the formation of plastic hinges at the end regions of all columns in the outer axis (Fig. 16a).

Additionally, one of the most essential structural problems observed in the areas affected by earthquakes is that existing buildings have been completed by the addition of new floors on the structures over the years without having any engineering services. During the construction of these additional floors, the load-bearing system of the existing floor, vertical element continuity in the new floors, cold joints between floors, construction techniques, and material differences were not considered. For example, the building in Fig. 16b was initially built as a single-story masonry ground floor. Over the years, a three-story RC structure was

added, and finally, it was completed with a steel frame roof floor. While the original ground floor remained standing, the additional stories built on top collapsed during the earthquakes.

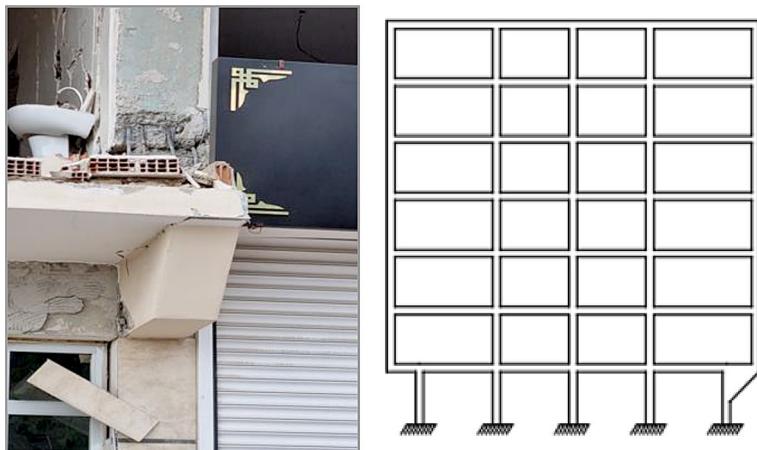
Fig. 17 An example of a column connecting on the end of cantilever beams (the right drawing from TBEC 2018)

Lastly, many seismic codes never allow the placement of columns on the top or end of cantilever beams or on the gussets formed on the lower columns of any building floor. However, during the field surveys, plastic hinge occurrences have been observed in some buildings due to reinforcement bending and concrete pouring at the bottom of columns as a result of that practice (Fig. 17).

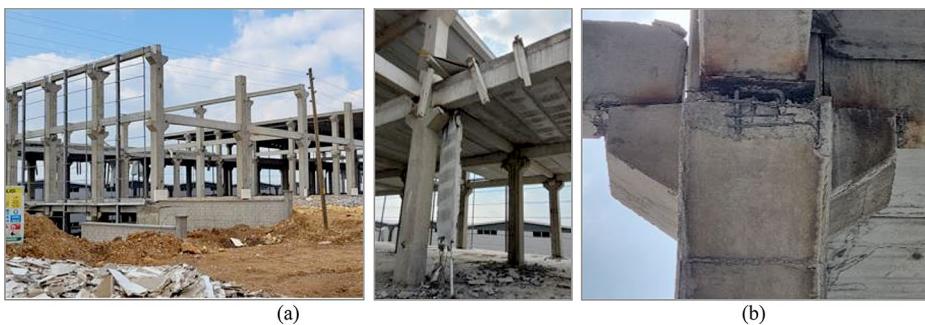
After the 2023 Kahramanmaraş earthquakes, a field investigation was conducted on the precast structures in and around Kahramanmaraş province, and the damage patterns were observed on those structures. The most common type of damage was the falling of the horizontal beams resting on the column corbels by disconnecting their joints. Similarly, damage to the ends of roof purlins that were not adequately connected to the beams and falling of them to the ground was common (Fig. 18). The damage was generally caused by the inability of the structural elements to respond to the seismic displacement and rotation demands in joint regions, the weakness of the members in the joints, and pin connections that are not filled with cement mortar. Due to the lack of connection details, the precast floor elements sitting on the beams also separated from

Fig. 18 Examples of insufficient fastening of roof purlins to beams (a), and damage in joint regions (b)

the connection points, disrupting the integrity of the building and could not show the diaphragm behavior supposed to be provided at floor levels (Fig. 18).

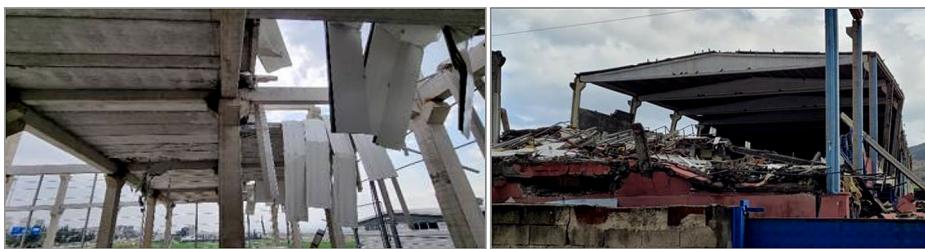
Fig. 19 Floor damage due to poor connection detailing (left) and a precast concrete structure with weak columns and heavy roof beams (right)

The architectural and structural system plans, which were arranged incorrectly, revealed the effects of torsion and caused the beams to be separated from the columns. For example, a 5-meter-high mezzanine floor was built in a part of a reinforced concrete precast building with a floor height of 10 m (see Fig. 19). In these two regions, the damage occurred due to the simultaneous rigid and flexible behavior that differs depending on the column lengths and the mezzanine diaphragm. Moreover, severe damage and collapses were widely observed in prefabricated structures with weak columns and heavy roof beams that could not provide horizontal stability (Fig. 19).

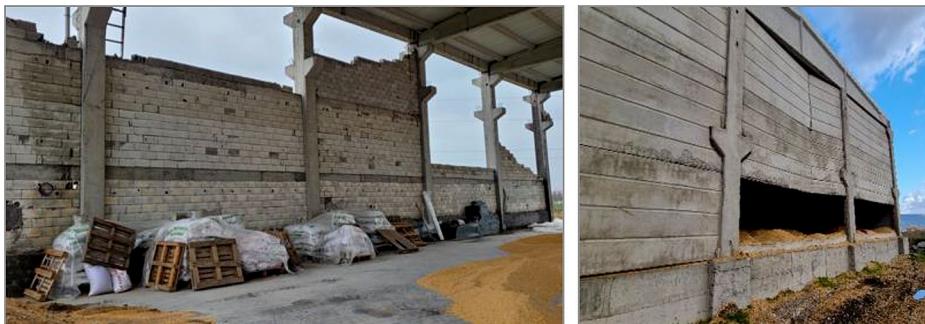
Additionally, infill wall damage in prefabricated buildings was also widespread. Low-strength, hollow briquettes, commonly called “bims” have been widely used in the structures located in the region. Due to low horizontal reinforced concrete beams providing stability in large-span walls and exceeding the maximum unsupported wall length, the out-of-plane movement occurred in the walls during the Kahramanmaraş earthquakes (Fig. 20). Moreover, the panels coming out of the slots supported on the columns or out-of-plane movement were one of the common and typical damages seen in the precast wall panels (Fig. 20). Failure to perform the necessary precision quality to the joints during the production and assembly stages, filling the pins with low-strength cement mortar or not filling them at all, and insufficient or no use of nuts, washers, and welds caused significant damage on precast wall panels. Lastly, bending cracks at the lower end of the columns, separation of the shell

Fig. 20 Examples of large-span walls exceeding the maximum unsupported wall length on the walls (left) and out-of-plane tipping damage on the precast wall panels (right)

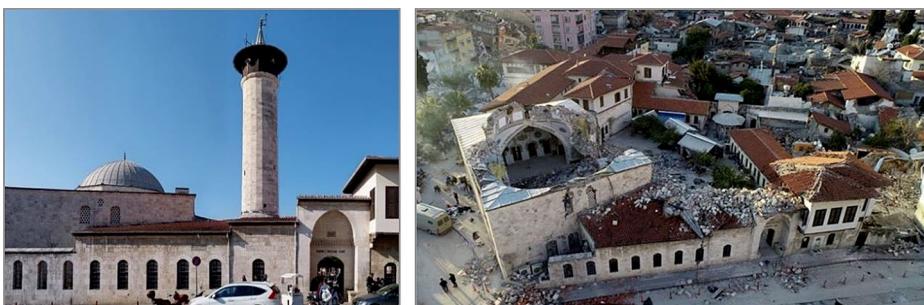
More than half of the buildings collapsed in the historical city center of Hatay. Among them, Habib-i Neccar Mosque, Sarumiye Mosque, Historical Saints Peter and Paul Church, Greek Orthodox Church, and Iskenderun Italian Latin Catholic Church are essential struc-

Fig. 21 Habibi Necar Mosque, Antakya, Hatay, before (left) and after (right) the Kahramanmaraş earthquakes

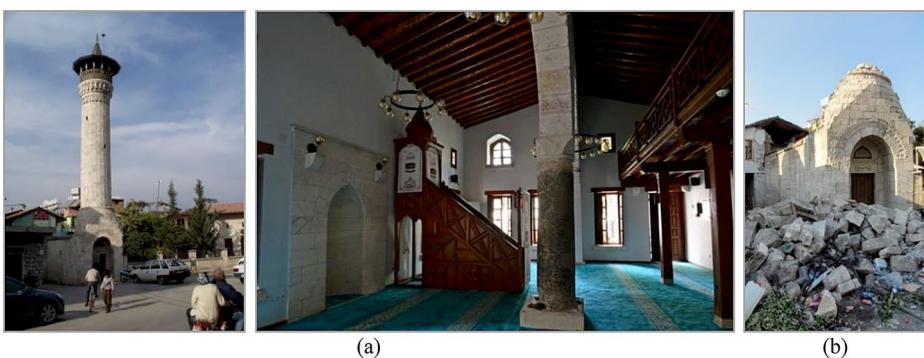
Fig. 22 Sarimiye Mosque, Antakya, Hatay, before (a) and after (b) the Kahramanmaraş earthquakes

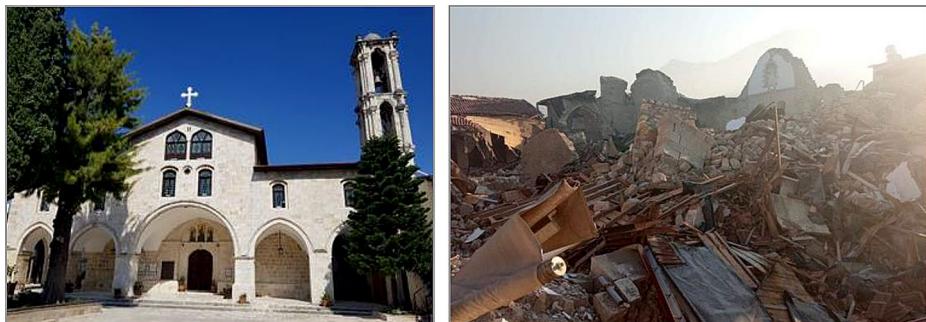
Fig. 23 The Historical Church of Saints Peter and Paul, Antakya, Hatay, before (left) and after (right) the Kahramanmaraş earthquakes

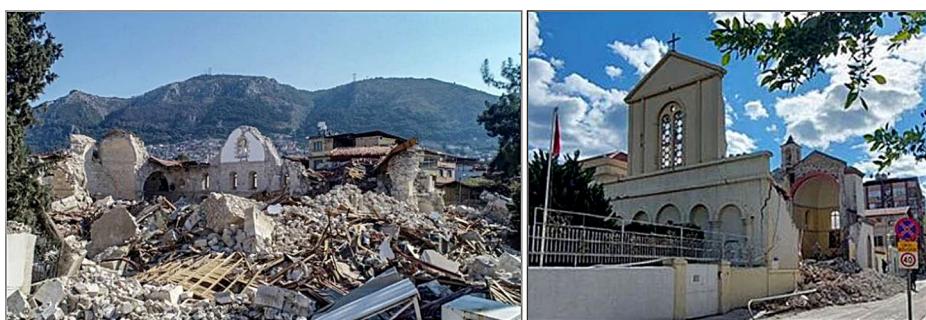
Fig. 24 Antakya Greek Orthodox Church (left) and Iskenderun Italian Latin Catholic Church (right) after the Kahramanmaraş earthquakes

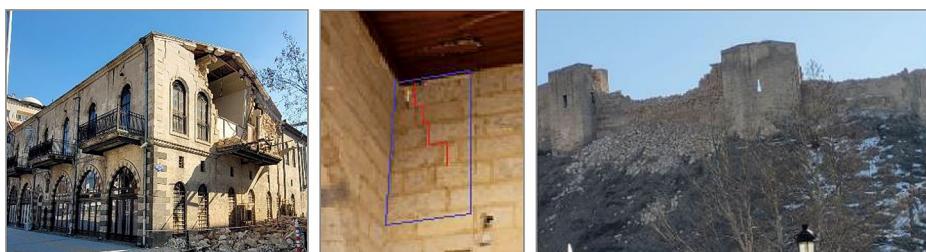
Fig. 25 Examples of damage to the structural main walls

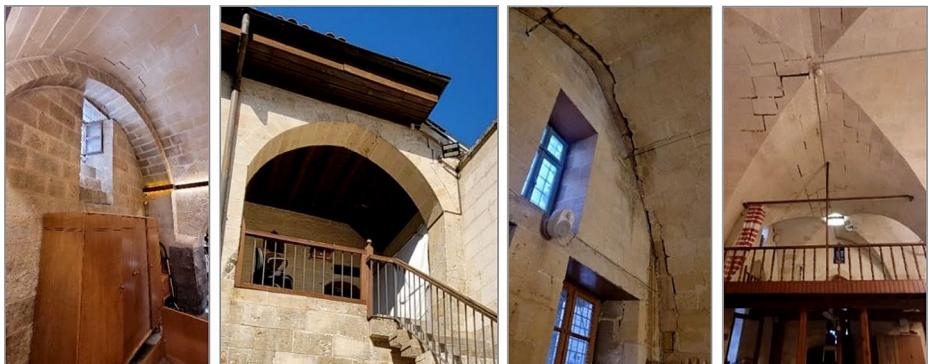
the structures with a box-like structural behavior, prevents external façades from falling over during earthquakes, and increases earthquake performance. It has been observed in the region that horizontal diaphragms prevented the out-of-plane falling mechanism of the facade walls. Moreover, the use of steel tensioners in the masonry construction technique contributed to preventing wall collapses. As a result, since most of the architectural heritage masonry buildings are still in use in the region and Türkiye, it should be noted that they are susceptible to seismic effects due to their both high specific mass and low tensile strength.

Fig. 26 Examples of tensile cracks at joints in arches, vaults, and domes, out-of-plane movements

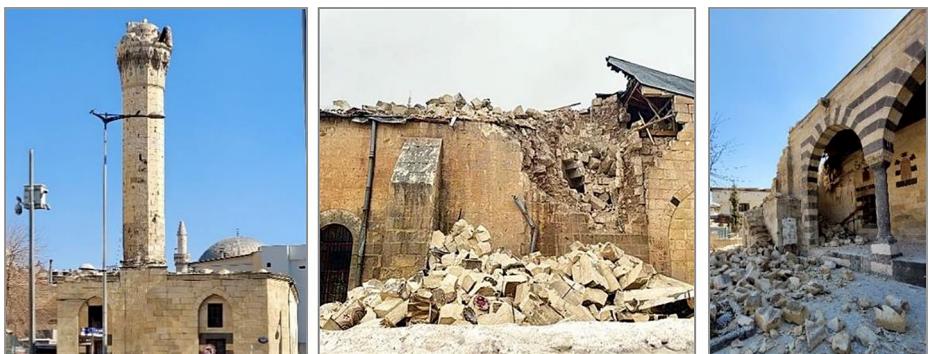
Moreover, the investigated historical buildings in Gaziantep, built mainly between the 17th century and the end of the 19th century, performed better seismic response due to being far from the fault line. Restored historical building examples showing good performance in the historical center of Gaziantep province were examined. Since these structures are relatively far from the fault line, the structures exited with accelerations smaller than the design earthquake level of TBEC 2018. In the historical buildings inspected in Gaziantep province, slip cracks in the main walls, openings in the joints, and local separations in the outer layers of the walls were observed (see Fig. 25). There was damage to the joints of arches and vaults, and out-of-plane movements were detected at the wall-vault joints (Fig. 26). Opening at the joints, vertical cracks, and overturning on the pedestals were observed in the mosque's minarets (Fig. 27).

Fig. 27 Examples of damage to minarets
