### FLOOD THREAT ADVISORY

**To: Brgy. Chairperson  
Brgy. Santa Elena  
City of Marikina  
Metropolitan Manila**

**Date: October 9, 2024**

## BARANGAY SANTA ELENA

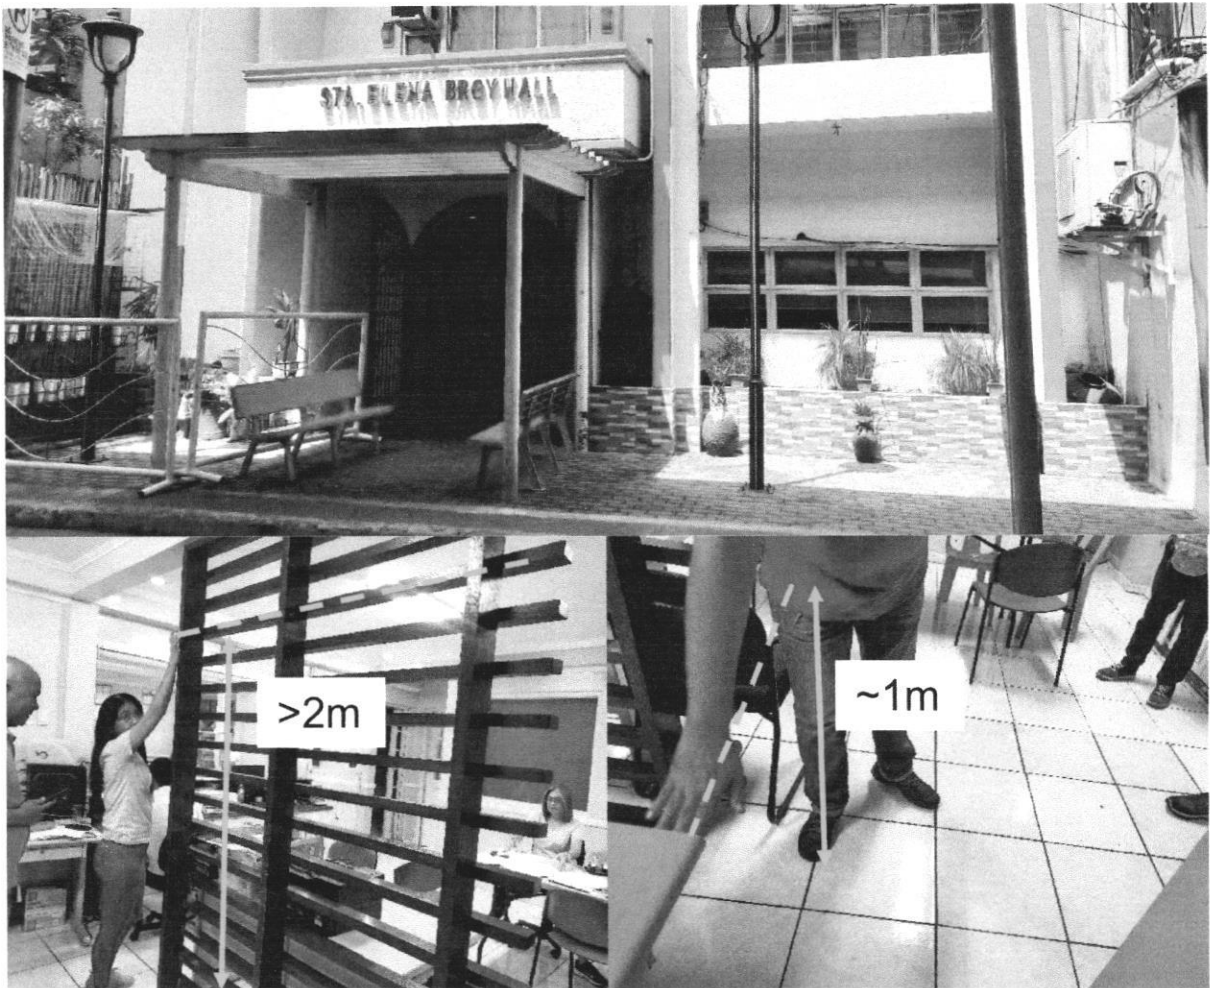
| Purok / Sitio<br>/ Area of<br>Concern | GPS<br>Coordinates<br>(Luzon 1911) | Flood<br>Susceptibility<br>Rating | Geohazards Assessment |
|---|---|---|---|
| Barangay<br>Hall and<br>vicinity | 14° 38' 04.3" N,<br>121° 05' 45.1" E | Very High | The barangay hall was inundated with greater than 2m flood height during Ondoy, while ~1m was reported during Ulysses. Floodwaters during said tropical cyclones subsides overnight. |

The barangay hall was inundated with greater than 2m flood height during Ondoy (*bottom left*), while ~1m was reported during Ulysses (*bottom right*). Floodwaters during said tropical cyclones subside overnight (GPS Coordinates: 14° 38' 04.3" N, 121° 05' 45.1" E).

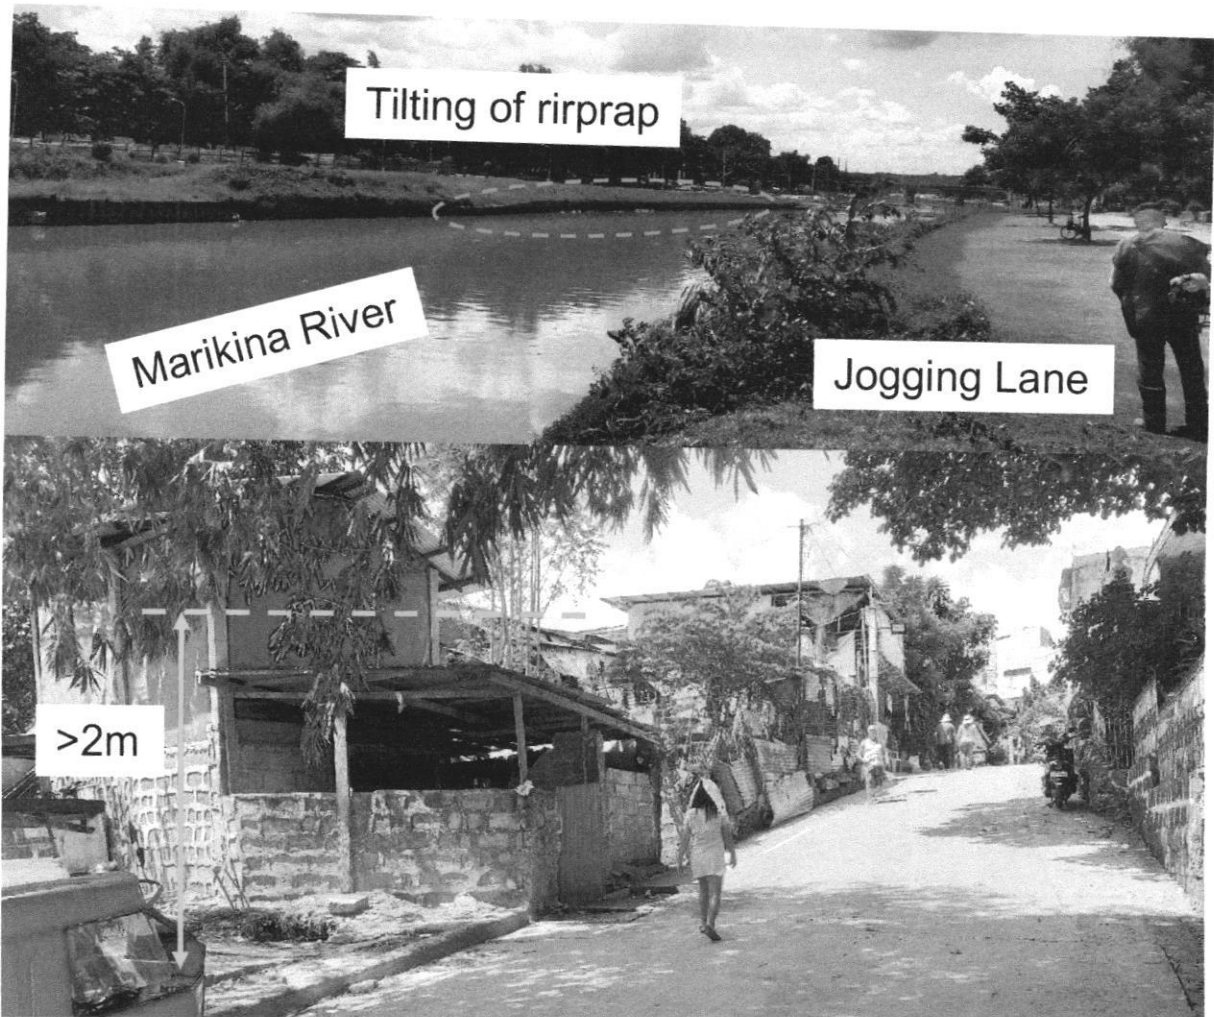
| Purok / Sitio<br>/ Area of<br>Concern | GPS<br>Coordinates<br>(Luzon 1911) | Flood<br>Susceptibility<br>Rating | Geohazards Assessment |
|---|---|---|---|
| Lambak /<br>Riverside | 14° 37' 56.2" N,<br>121° 05' 34.8" E | Very High | Area is adjacent to the Marikina River. During Ondoy, the first floor was completely submerged midway along the sloping road, while the 2 <sup>nd</sup> floor of buildings closest to the river were also inundated. In recent years floodwaters rarely reached the jogging lane along the river and the river water level recedes fast. No observed dike or flood mitigation along river, but there is ongoing piling in some sections. Moreover, evidence of riverbank erosion manifested as tilted riprap along the Jesus Dela Peña side of the Marikina River. |

Area is adjacent to the Marikina River. During Ondoy, the first floor was completely submerged midway along the sloping road, while the 2<sup>nd</sup> floor of buildings closest to the river were also inundated. In recent years floodwaters rarely reached the jogging lane along the river and the river water level recedes fast. No observed dike or flood mitigation along river, but there is ongoing piling in some sections. Moreover, evidence of riverbank erosion manifested as tilted riprap along the Jesus Dela Peña side of the Marikina River (GPS Coordinates: 14° 37' 56.2" N, 121° 05' 34.8" E).

- ✓ Construction of appropriate and well-studied engineering measures (e.g., dike, flood wall, etc.) should be implemented to minimize the rate of erosion along rivers/creeks. Ensure that the structure follows engineering standards and has structural integrity. Also, damages in the structural mitigation measures should be reported to concerned agency/office responsible for the installation. The LGU is also encouraged to maintain such measures or reinforce identified damages, with the strong support of the barangay officials and active engagement of the communities and the private sector.
