Republic of the Philippines  
Department of Environment and Natural Resources  
**MINES AND GEOSCIENCES BUREAU**

**LANDSLIDE AND FLOOD THREAT ADVISORIES**

To: **Brgy. Chairperson  
Brgy. Barangka  
City of Marikina  
Metropolitan Manila**

**Date: Oct 9, 2024**

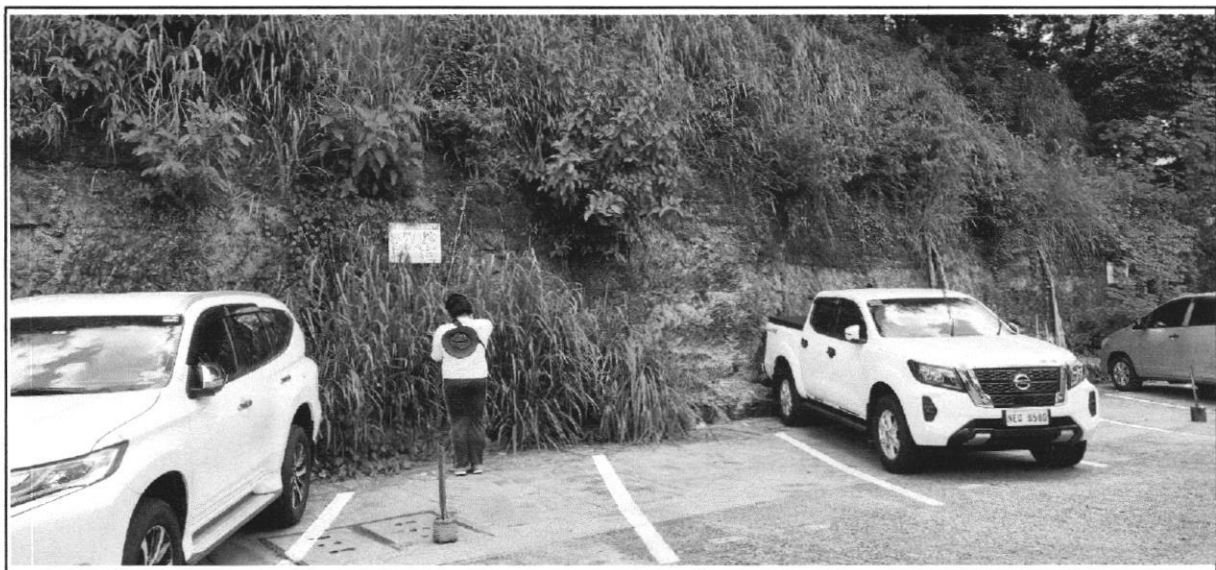
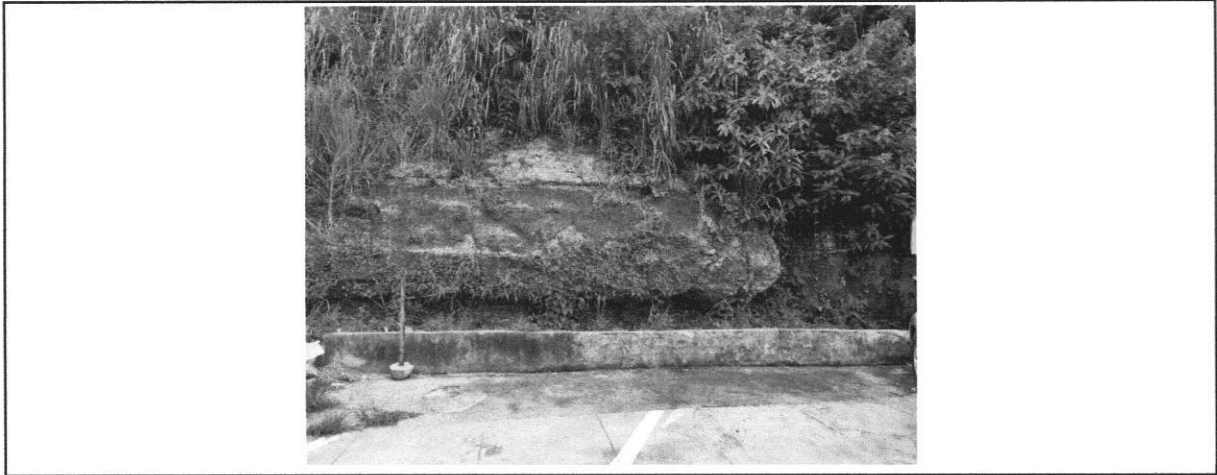
Such situation was observed in a parking lot in Dela Costa Homes. Although no major landslide (rock fall) incident had been reported, the CDRRMO noted instances of pebble to cobble sized rocks chipping off the exposed slope. The said slope is an exposure of bedded adobe with visible jointing. Some fractures are noted to be widening (30 cm) with a visible talus fan. The area is currently being used as a parking lot for residents. It is recommended to put a warning signage to warn car owners that the area is prone to rock fall. (GPS coordinates: N 14°38'13.3", E 121°04' 50.4")

- ✓ **Observe presence of mass movement** (e.g. landslides, tension cracks) within the identified critical area/steep slopes and report to the local authorities and/or the MGB.

- ✓ **Observe for saturated ground and/or displaced roads surfaces** and report to the MGB/local authorities.
- ✓ **Implementation and maintenance of appropriate slope stabilization** (or slope protection/engineering intervention) measures along identified critical areas and roadcuts are highly recommended.

- ✓ Barangay Disaster Risk Reduction Management Team must **implement monitoring and pre-emptive evacuation** during monsoon and typhoon season where extreme heavy rainfall occurs.

- ✓ **Activate** Barangay Disaster Risk Reduction Management Team in cooperation with the City Disaster Risk Reduction Management Team during monsoon and typhoon season.

- ✓ The CDRRMO together with the BDRRMO should conduct information and education awareness on this particular type of geohazard, particularly on landslide hazard to the landslide-prone communities.
