**FLOOD THREAT ADVISORY**

To: **Brgy. Chairperson  
Brgy. Concepcion Dos  
City of Marikina  
Metropolitan Manila**

**Date: October 9, 2024**

## BARANGAY CONCEPCION DOS

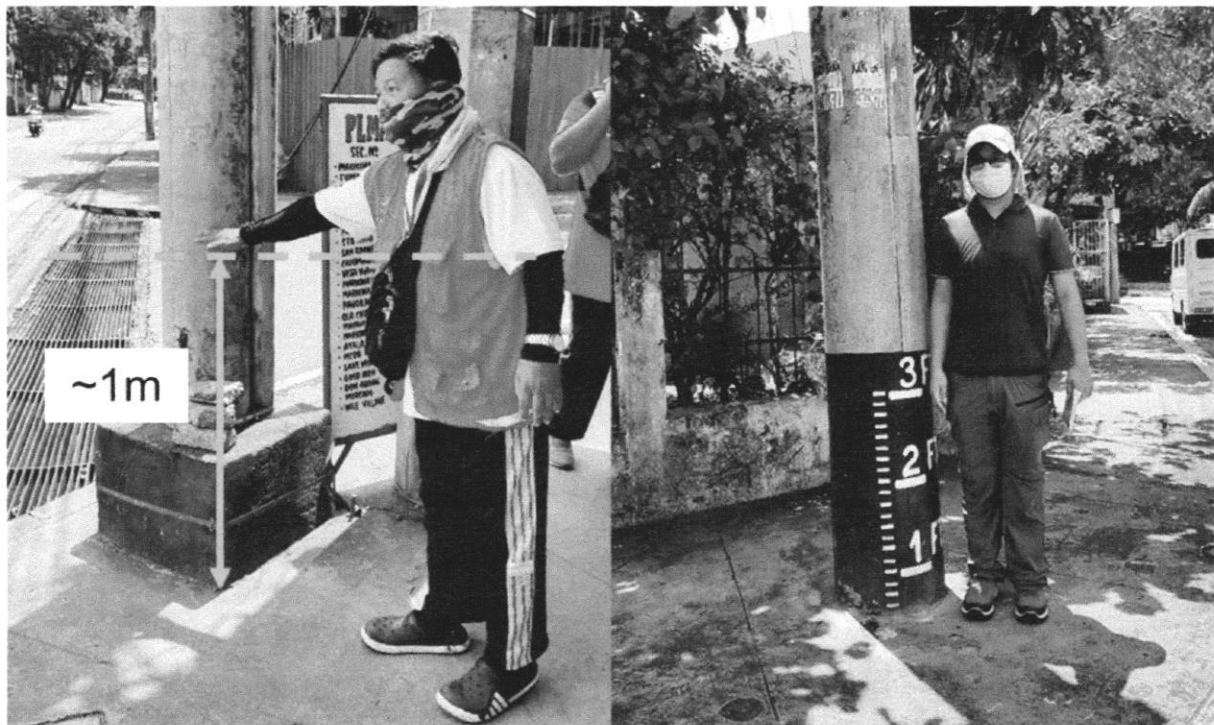
Similar to the previous observation point, Rainbow St. also receives surface runoff from the "highlands" (elevated portion of barangay and neighboring barangays). During Ondoy, roughly 1m-high floodwaters were noted along the street. More recently (Ulysses), the flood height did not exceed that of the gutter (GPS Coordinates: 14° 39' 31.6" N, 121° 06' 56.1" E).

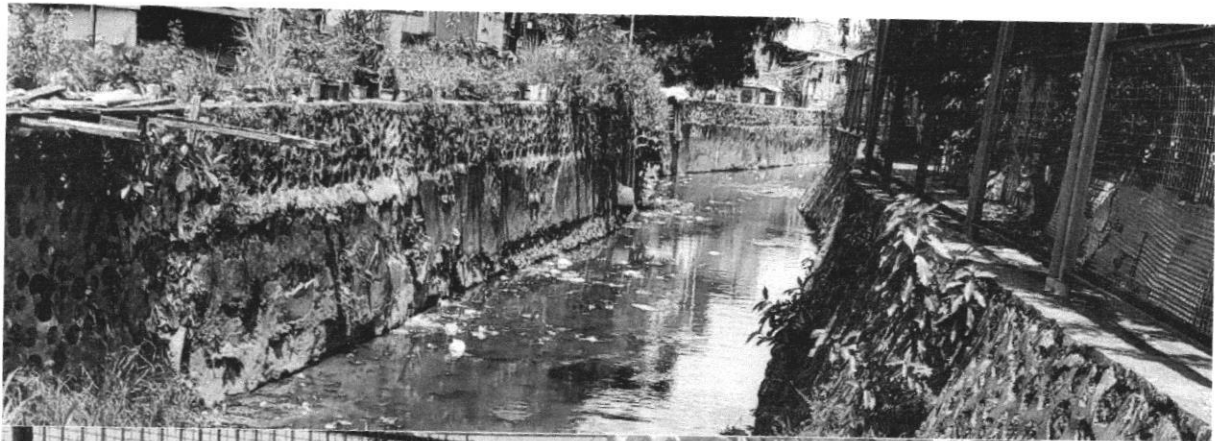
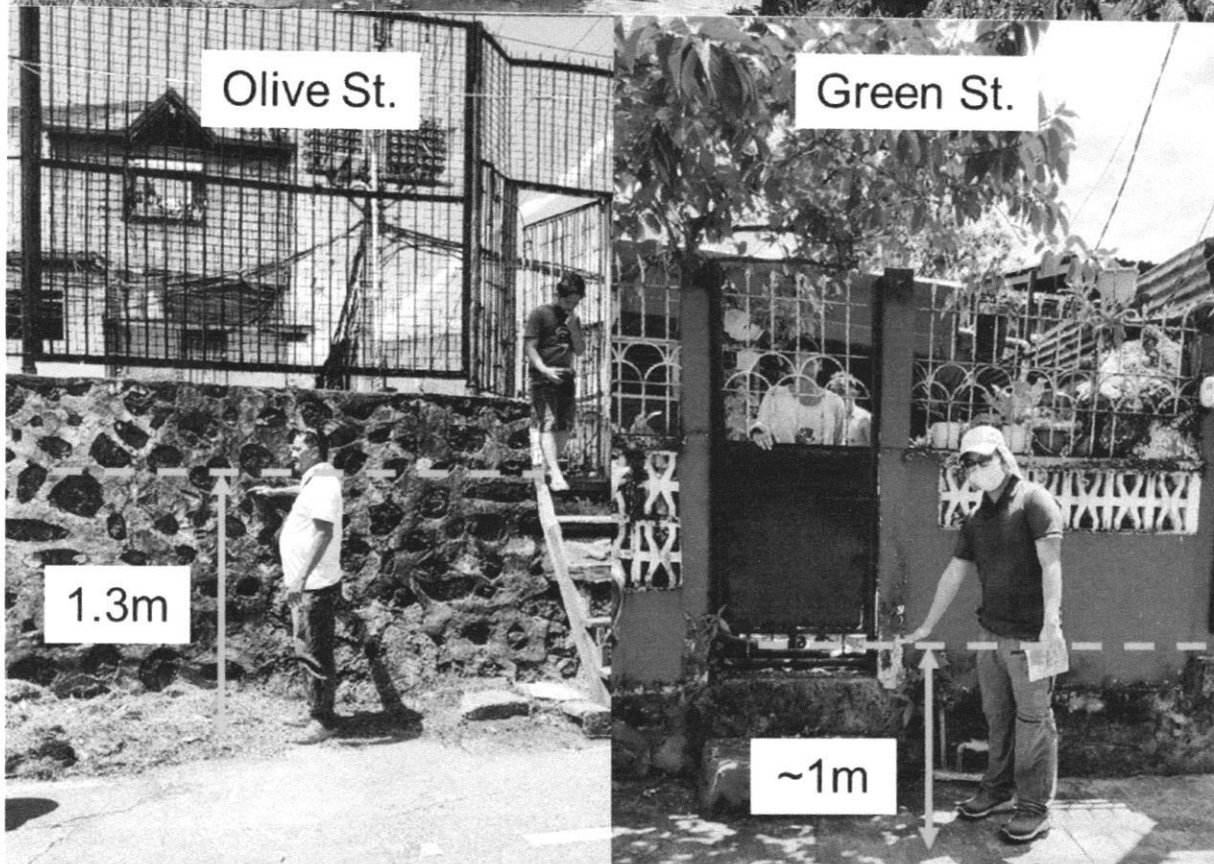
Various observations points within the periphery of Balante Creek are characterized by flood heights ranging from 1 to 1.5m, primarily caused by overwhelmed canals unable to drain to the creek, rarely due to overtopping of dike along the creek (GPS Coordinates: 14° 38' 16.6 and 23.8" N, 121° 07' 06" and 12.0 and 53.1" E).

- ✓ It is highly recommended to implement appropriate easements in construction of settlements or other infrastructure along rivers/creeks as specified in the Presidential Decree No. 1067 known as Water Code of the Philippines.
- ✓ Improvement and proper maintenance of existing drainage system in the barangay are recommended to prevent inundation of residential areas, critical facilities, and other assets. Avoid improper waste disposal, particularly along drainage canals as it may cause clogging and obstruction of water flow. Ensure regular clearing of natural and artificial drainage pathways, or prior to an impending tropical cyclone or other rain-bearing weather systems.
- ✓ Construction of appropriate and well-studied engineering measures (e.g., dike, flood wall, etc.) should be implemented to minimize the rate of erosion along rivers/creeks.

Ensure that the structure follows engineering standards and has structural integrity. Also, damages in the structural mitigation measures should be reported to concerned agency/office responsible for the installation. The LGU is also encouraged to maintain such measures or reinforce identified damages, with the strong support of the barangay officials and active engagement of the communities and the private sector.
