Republic of the Philippines  
Department of Environment and Natural Resources  
**MINES AND GEOSCIENCES BUREAU**

**LANDSLIDE AND FLOOD THREAT ADVISORIES**

To: **Brgy. Chairperson  
Brgy. Calumpang  
City of Marikina  
Metropolitan Manila**

**Date: Oct 9, 2024**

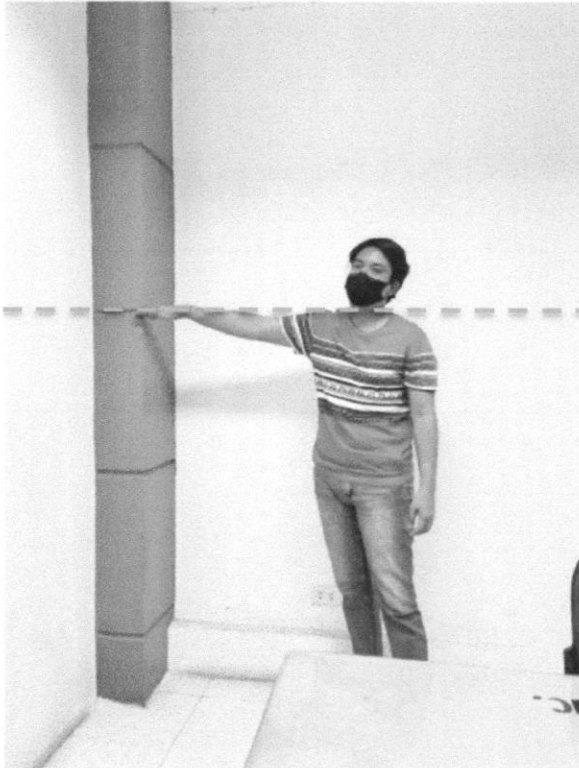
| Purok / Sitio / Area of Concern | GPS Coordinates (Coordinate System: Luzon 1911) | Flood Susceptibility Rating | Geohazards Assessment |
|---|---|---|---|
| <b>Old Barangay Hall</b> | 14°37' 32.4" N<br>121°05' 3.1" E | <b>High</b> | Calumpang Barangay Hall is situated along the riverbanks. It was inundated with 4 m floodwaters during both typhoons Ondoy and Ulysses. Floodwaters receded quickly. Dredging and piping are being done along the stretch of river near the barangay hall to help mitigate the flooding. |

Flood height on the second floor of the Calumpang Barangay Hall during typhoon Ondoy (left). Flood Height during typhoon Ulysses near in the residential area near LRT station (right)

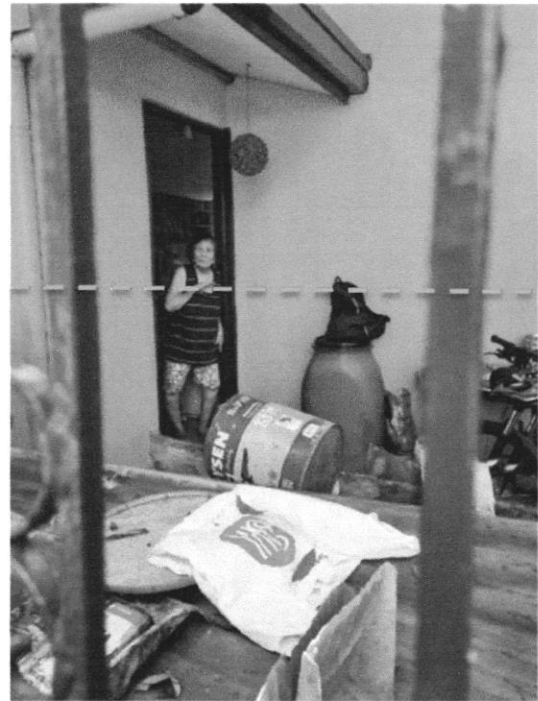
| Purok / Sitio / Area of Concern | GPS Coordinates (Coordinate System: Luzon 1911) | Flood Susceptibility Rating | Geohazards Assessment |
|---|---|---|---|
| <b>Tambangan-Tambuli</b> | 14°37' 34.7" N<br>121°05' 1.2" E | <b>High</b> | Areas near the LRT Station was submerged in 1.75 m floodwaters during Typhoon Ulysses. Floodwaters in this area took around 12 hours to subside |
