# **CORNER RESTORATION SURVEY**

SECTION CORNER COMMON TO SECTIONS 18,19,13 & 24 T5N, R3W & RW4, W.M.

AUGUST 15, 2016

COLUMBIA COUNTY SURVEYOR'S OFFICE

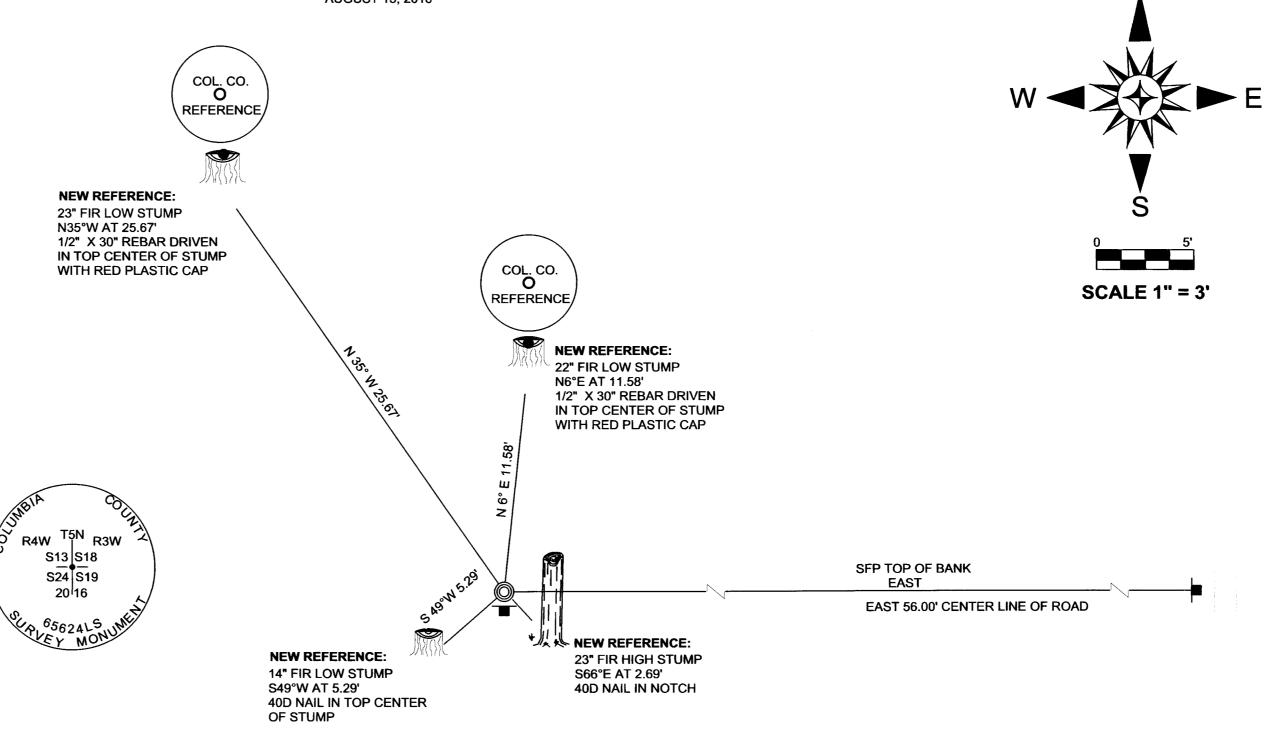
FOUND THE ORIGINAL FIR BEARING TREE FOR THE SECTION CORNER. THIS BEARING TREE IS DOWN AND DEAD. CRUISER MARKS SHOWN ON THE TRUNK OF THE TREE. THESE MARKS WERE WELL OVERGROWN INDICATING THAT THEY WERE PLACED THERE MANY YEARS AGO. THE ORIGINAL FACE ON THIS TREE IS DECAYED AND BURNED. NO SCRIBE MARKS SHOW. ROLAND MASTEN'S CRUISER MARK ARE PRESENT ON A STUMP, EAST OF CORNER APPROX. 10 TO 15' WE ARE CONVINCED BEYOND A DOUBT THAT THIS IS THE WITNESS TREE FOR THIS SECTION CORNER. FROM THE BEARING AND DISTANCE AS RECORDED IN THE ORIGINAL FIELD NOTES WE DROVE AN IRON PIPE AT THE POSITION OF SECTION CORNER.REFERENCED THIS CORNER AS FOLLOWS:

NOTED ON SURVEY FOUND 1 1/4" IRON PIPE

NOTED ON SURVEY FOUND 1 1/2" IRON PIPE SET BY LONGVIEW FIBRE CO. 1952

THE PURPOSE OF THIS CORNER RESTORATION WAS TO ADD ADDITIONAL REFERENCES FOR THE LOCATION OF THE SECTION CORNER COMMON TO SECTION 18, 19, 13, AND 24, TOWNSHIP 5 NORTH RANGE 3 AND 4 WEST. THE REHAB OF CORNER WAS PERFORMED TO PERPETUATE THE LOCATION OF ORIGINAL GOVERNMENT LAND CORNER SET DURING GLO CONTRACT #50. WE ALSO ESTABLISHED GPS COORDINATES AS PART OF AN ON GOING GIS MAPPING PROJECT FOR COLUMBIA COUNTY. WE SET A 1 1/4" GALVANIZED IRON PIPE OVER EXISTING FOUND 1" STAINLESS STEEL PIPE. A 3 1/4" ALUMINUM CAP STAMPED AS SHOWN ABOVE FIRMLY ATTACHED TO TOP OF NEW PIPE.
