JOURNEY RISK MANAGEMENT (JRM) STUDY

Gorakhpur LPG BP TO BANKATA INDANE GRAMI

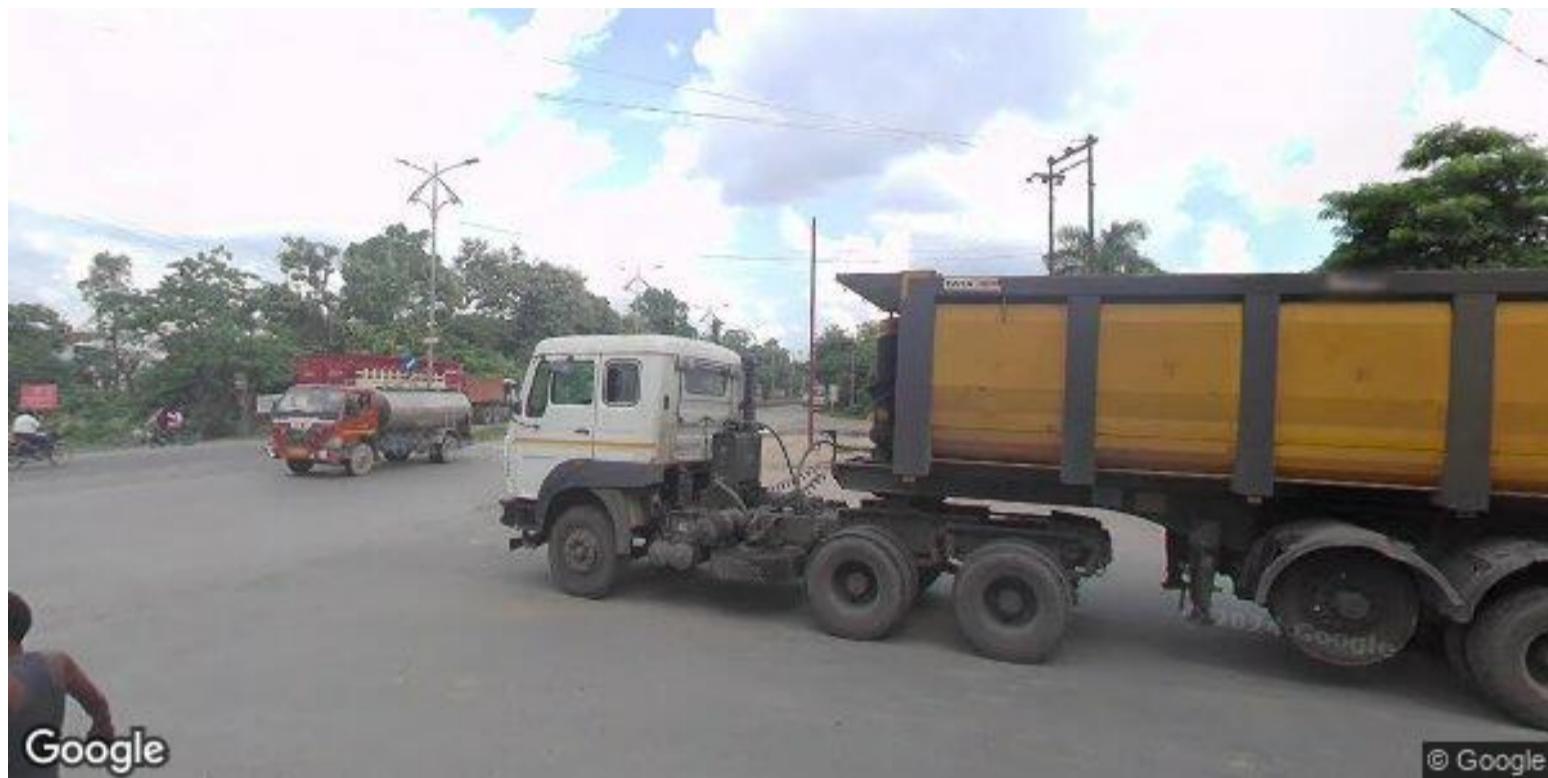
Risk Type: Blind Spot

Risk Level: Blind Spot

Speed Limit: 10 KM/Hr

Distance from Start: 2.17 km

Coordinates: 26.75126, 83.22476

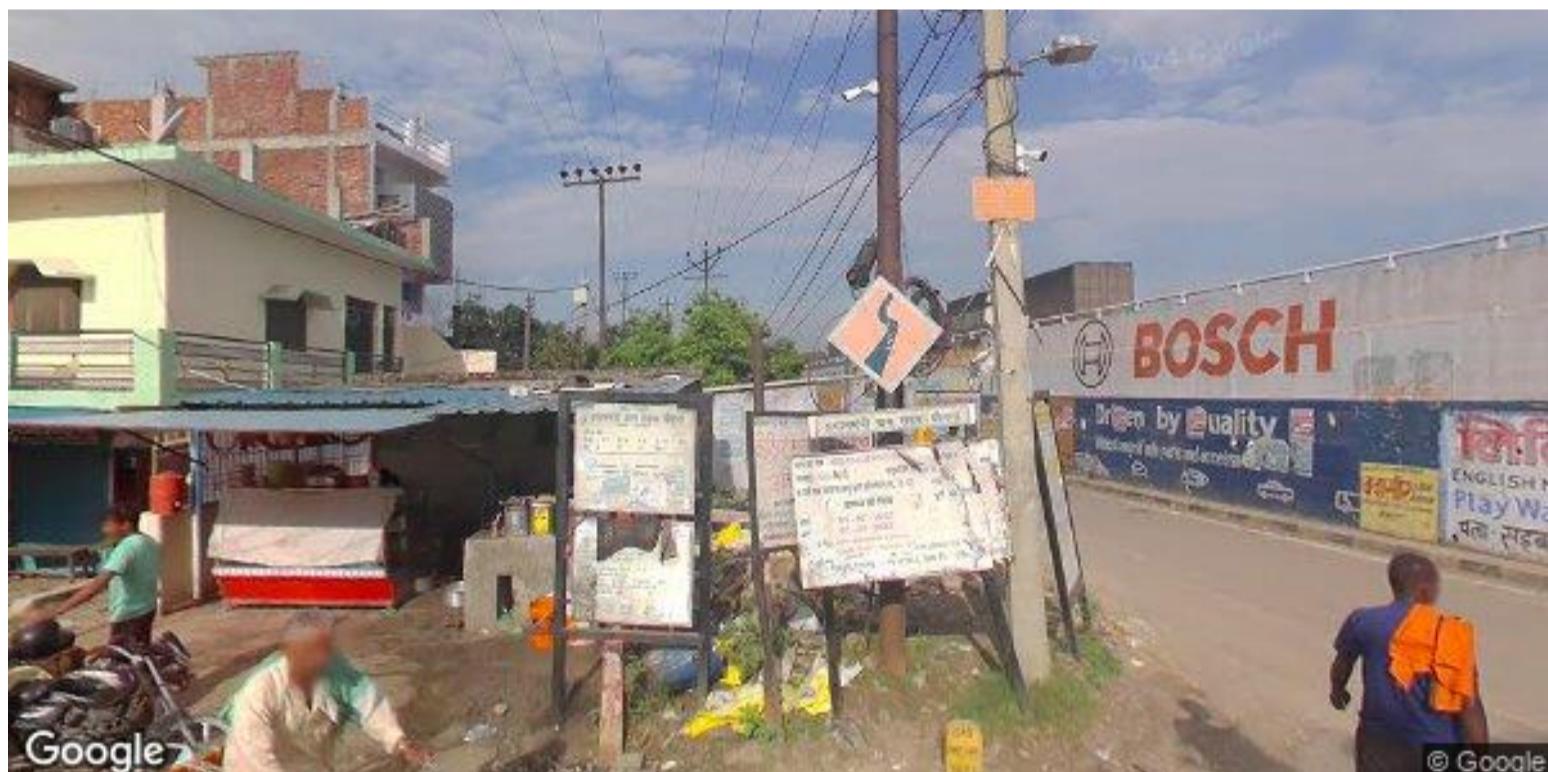
Risk Type: Blind Spot

Risk Level: Blind Spot

Speed Limit: 10 KM/Hr

Distance from Start: 4.23 km

Coordinates: 26.75353, 83.20457

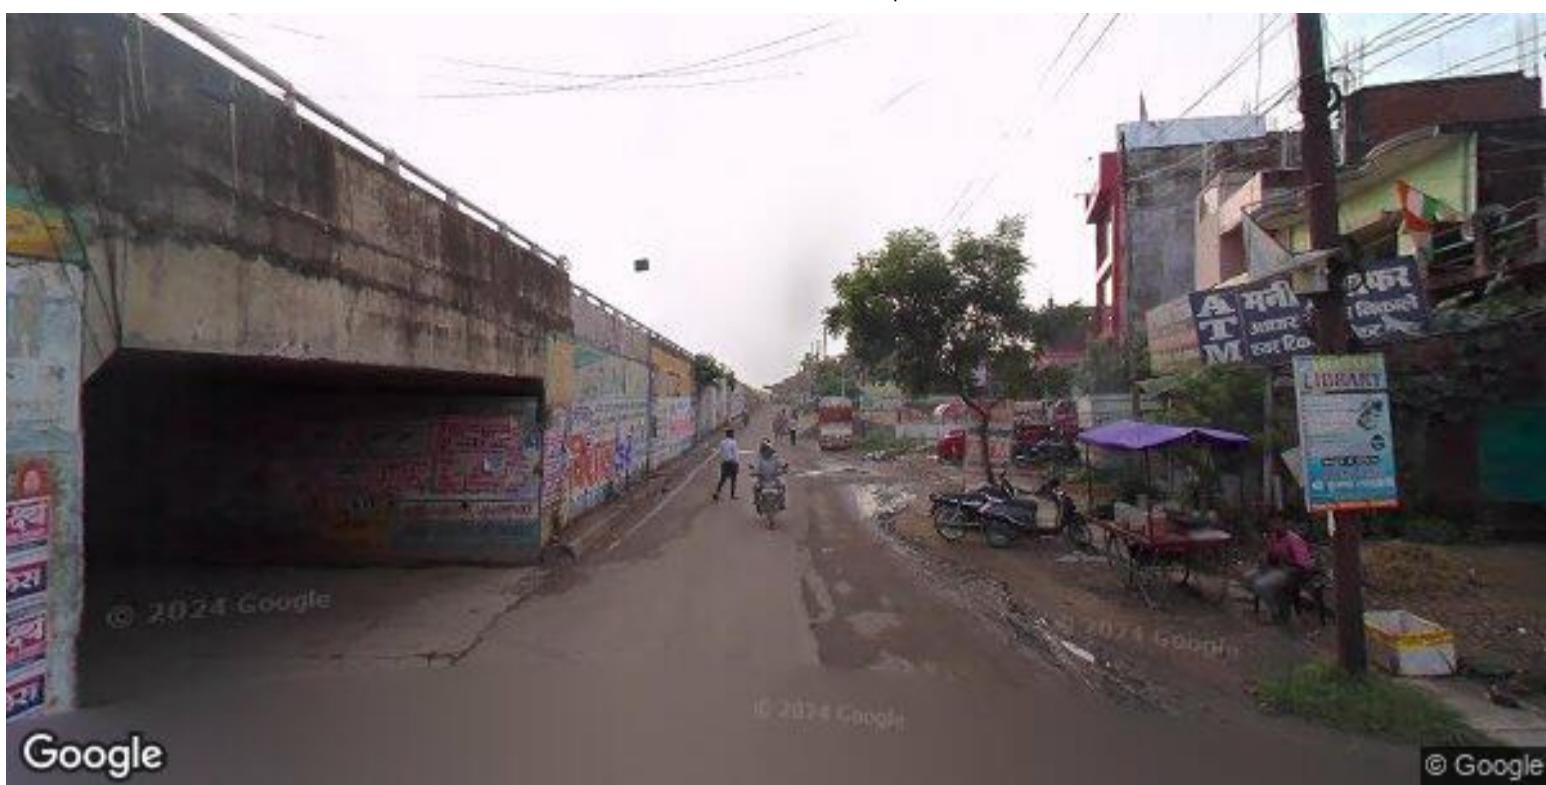
Risk Type: Turn**Risk Level: High****Speed Limit: 15 KM/Hr****Distance from Start: 4.30 km****Coordinates: 26.75381, 83.20466**

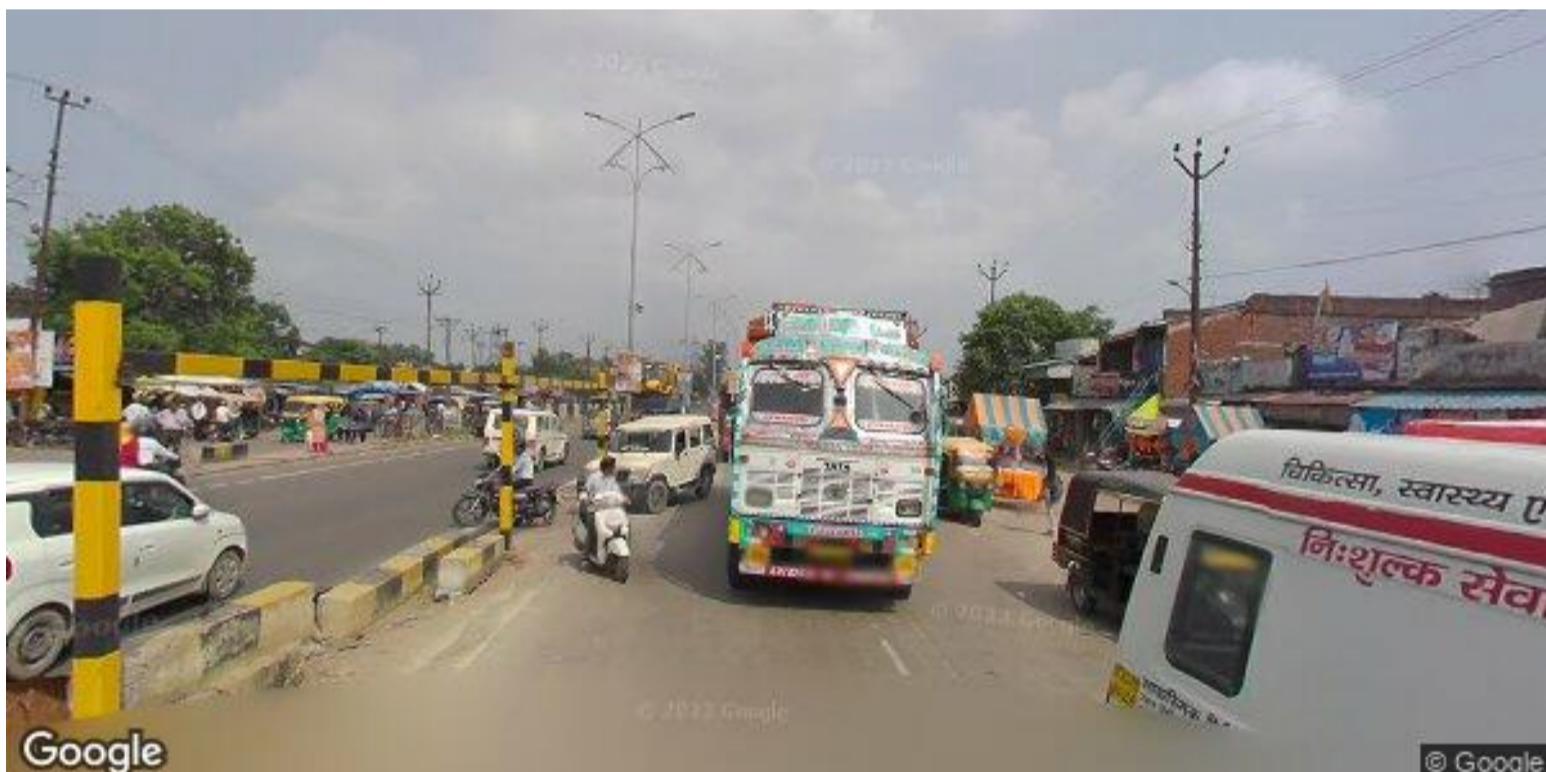
Risk Type: Turn**Risk Level: High****Speed Limit: 15 KM/Hr****Distance from Start: 5.17 km****Coordinates: 26.75377, 83.21355**

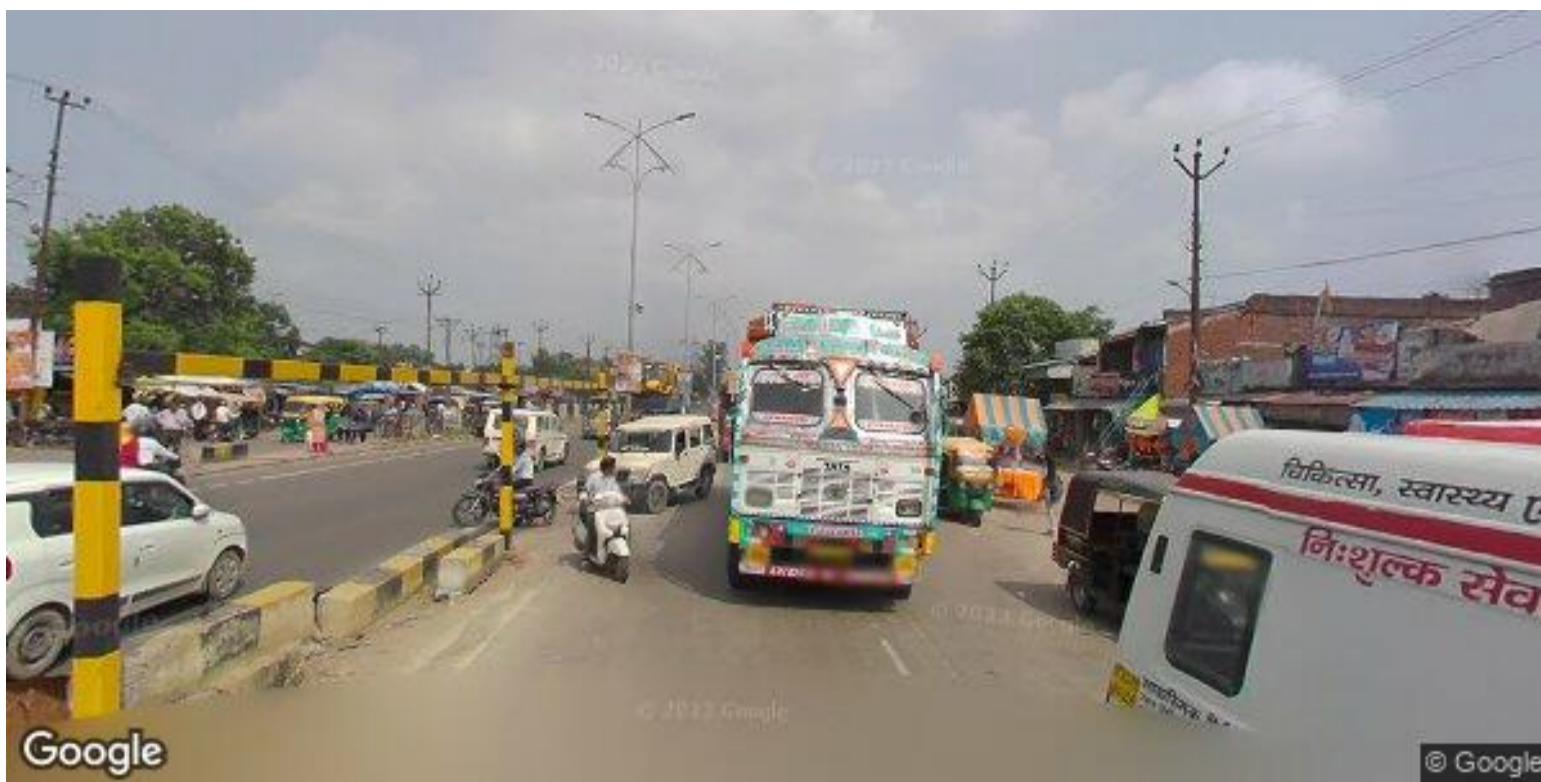
Risk Type: Blind Spot**Risk Level:** Blind Spot**Speed Limit:** 10 KM/Hr**Distance from Start:** 5.17 km**Coordinates:** 26.75377, 83.21355

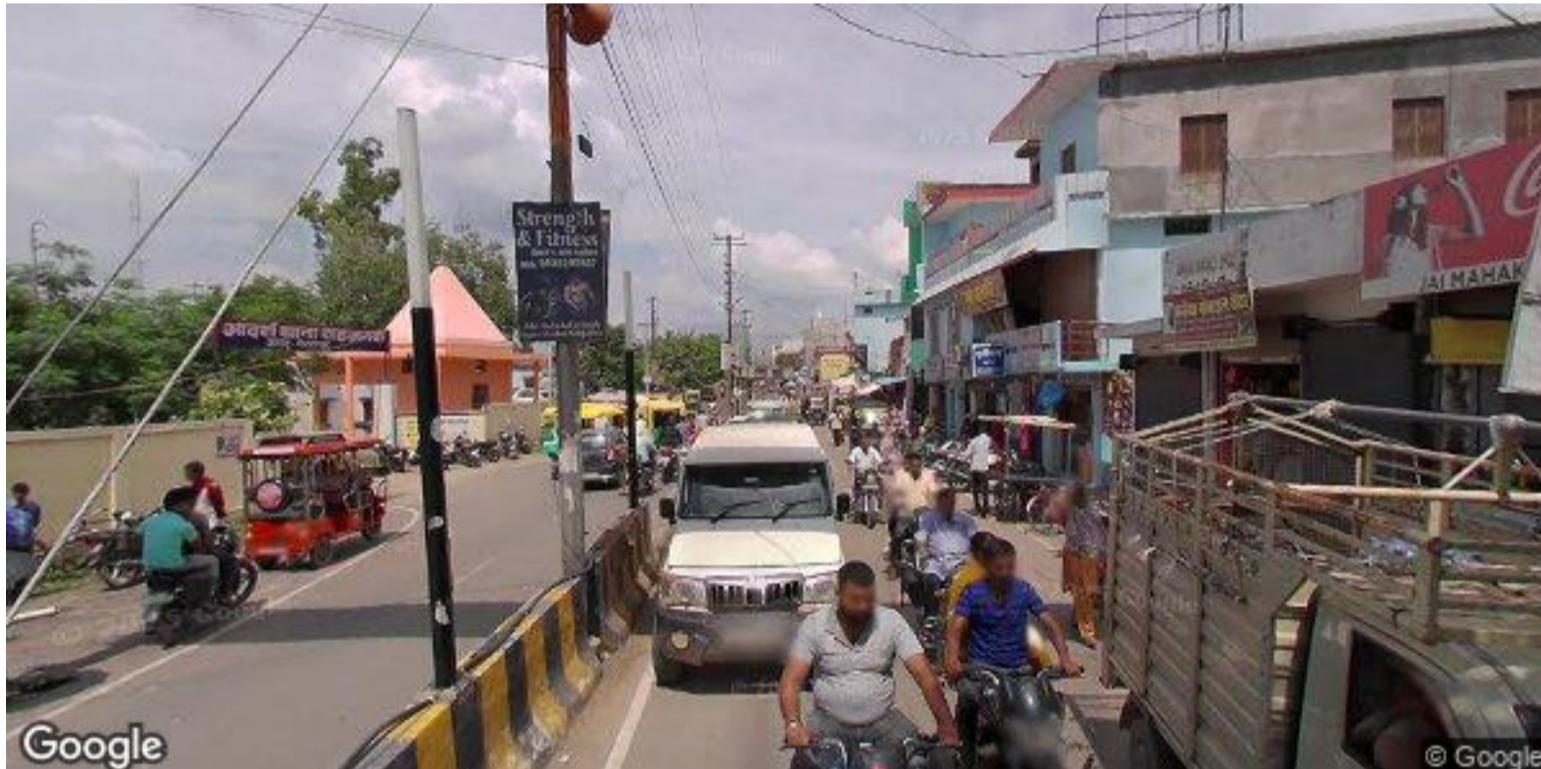
Risk Type: Blind Spot**Risk Level:** Blind Spot**Speed Limit:** 10 KM/Hr**Distance from Start:** 5.21 km**Coordinates:** 26.75407, 83.21347

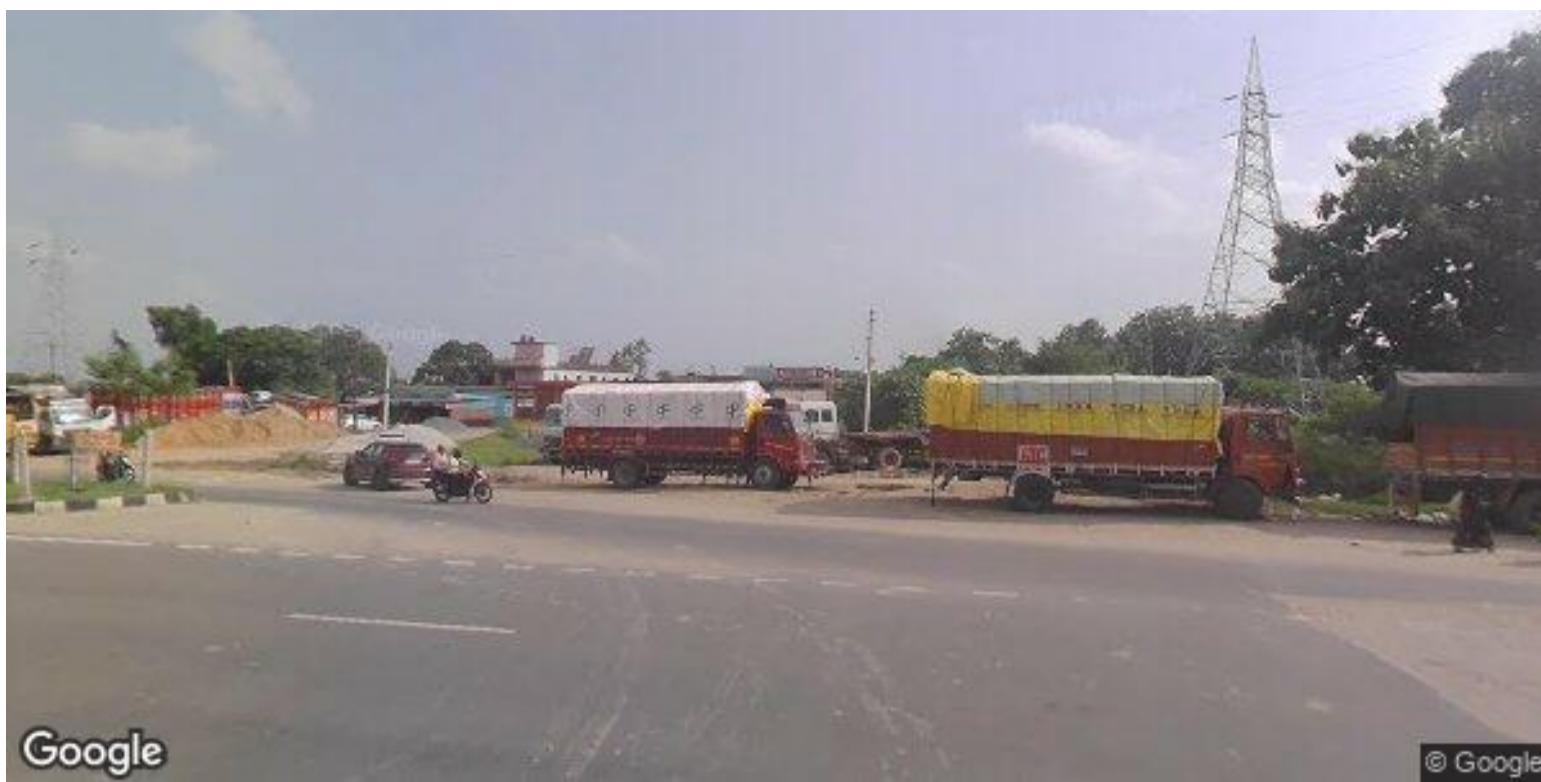
Risk Type: Blind Spot**Risk Level:** Blind Spot**Speed Limit:** 10 KM/Hr**Distance from Start:** 8.85 km**Coordinates:** 26.74712, 83.24909

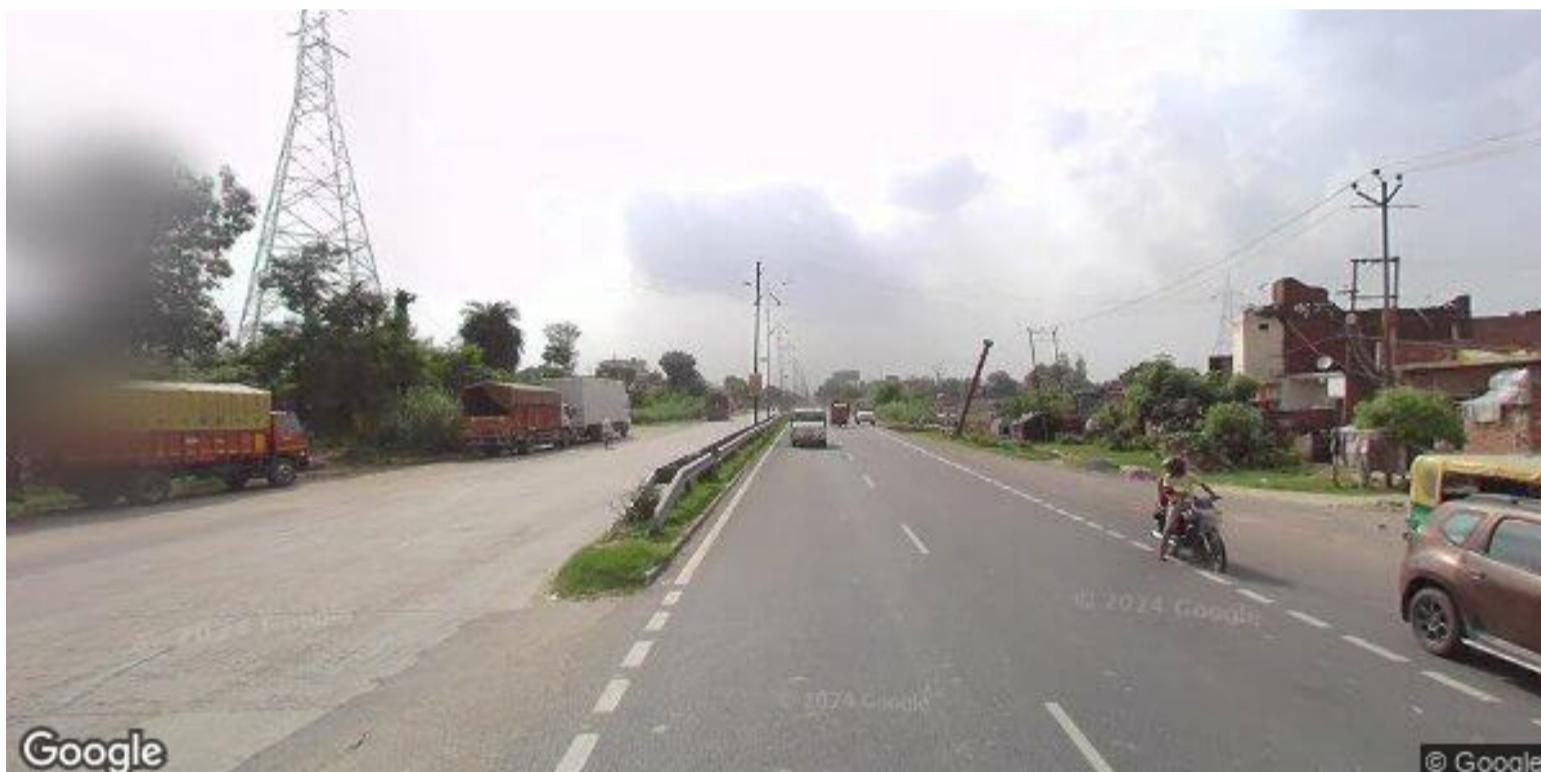
Risk Type: U-Turn**Risk Level:** High**Speed Limit:** 10 KM/Hr**Distance from Start:** 8.85 km**Coordinates:** 26.7471208, 83.2490873

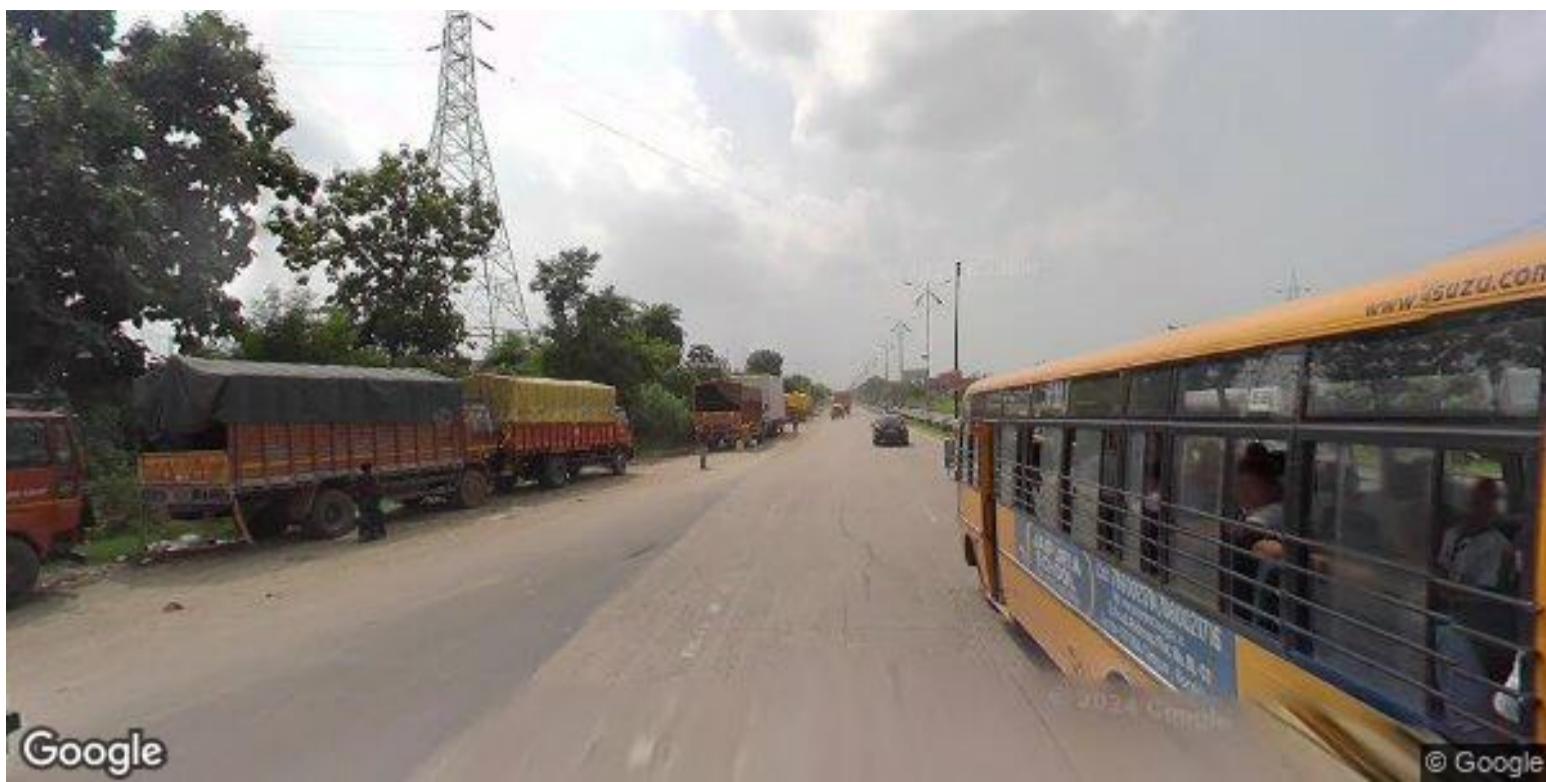
Risk Type: Turn

Risk Level: High

Speed Limit: 15 KM/Hr

Distance from Start: 8.86 km

Coordinates: 26.74703, 83.24907

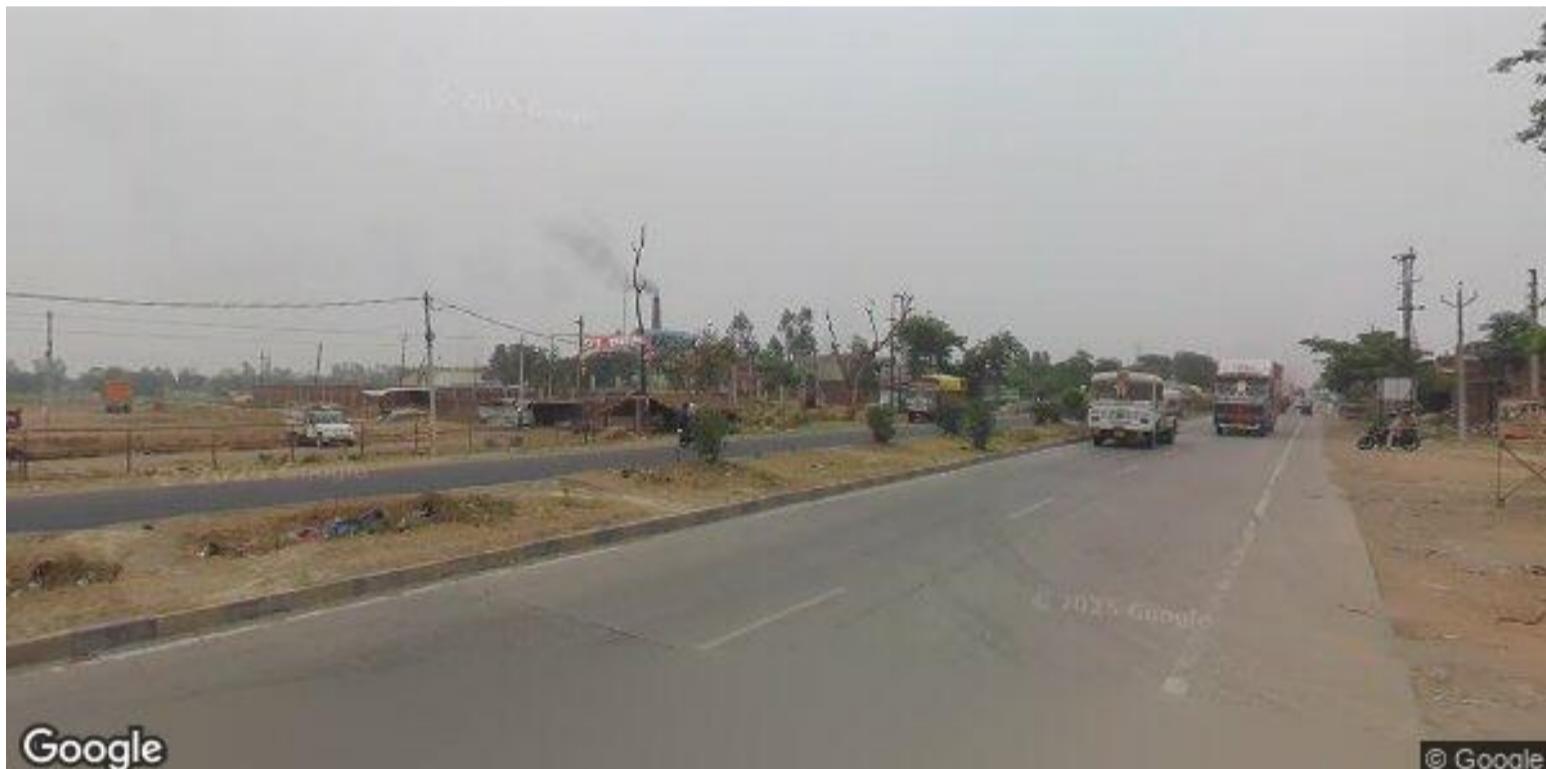
Risk Type: Turn

Risk Level: High

Speed Limit: 15 KM/Hr

Distance from Start: 23.88 km

Coordinates: 26.75869, 83.10123

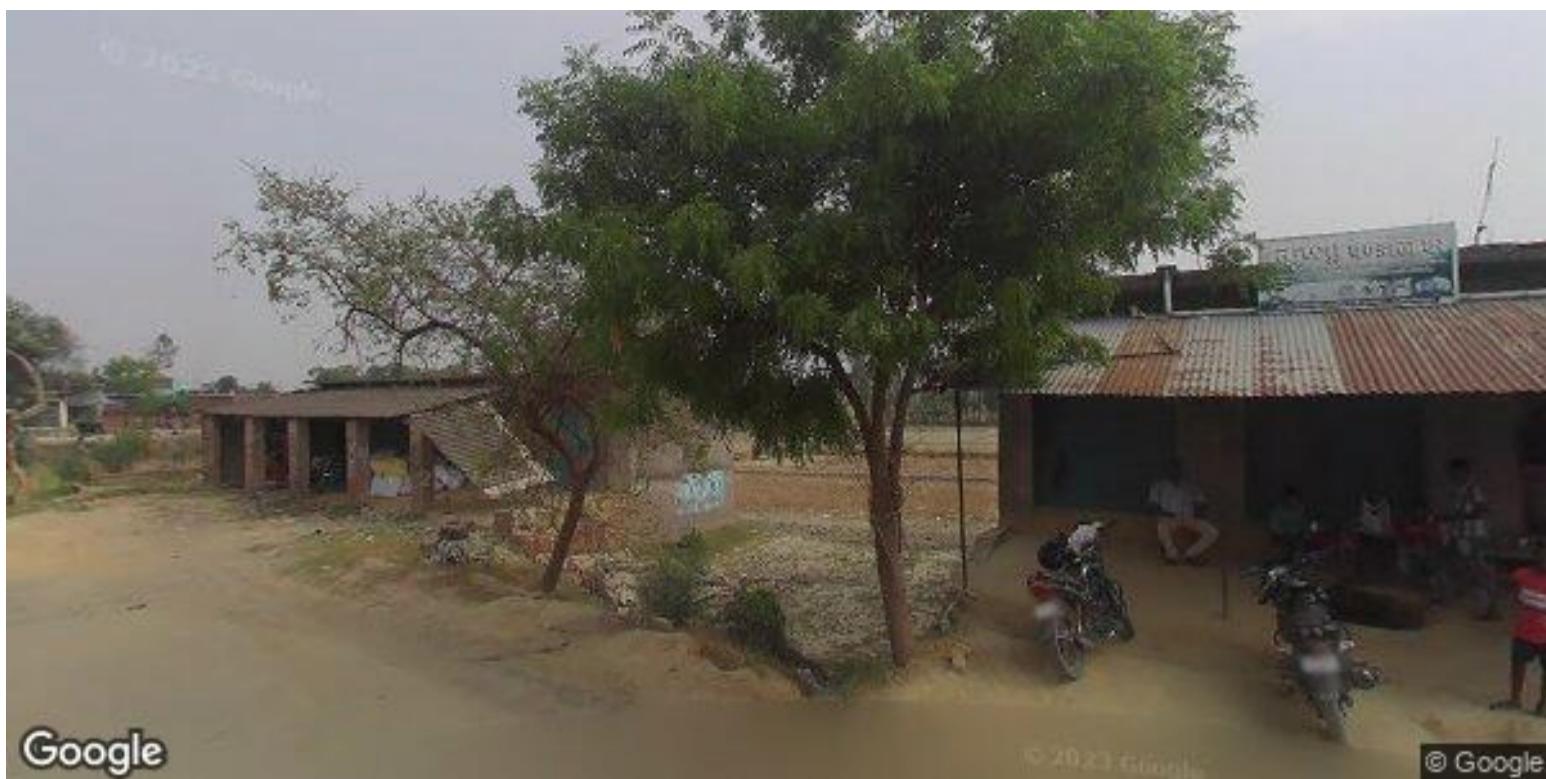
Risk Type: Turn**Risk Level:** Medium**Speed Limit:** 30 KM/Hr**Distance from Start:** 24.55 km**Coordinates:** 26.75467, 83.09984

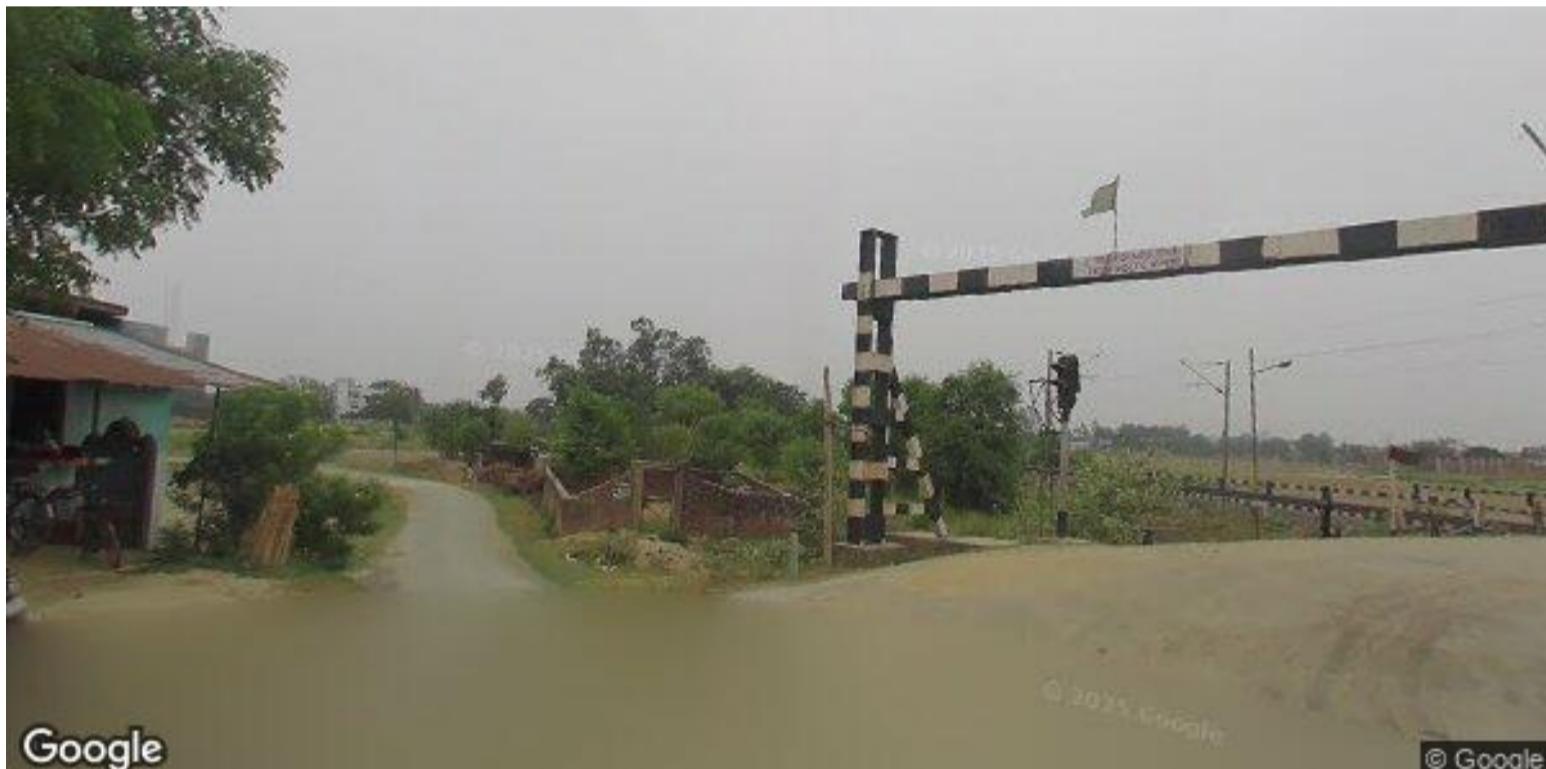
Risk Type: Turn**Risk Level:** Medium**Speed Limit:** 30 KM/Hr**Distance from Start:** 24.56 km**Coordinates:** 26.75463, 83.09986

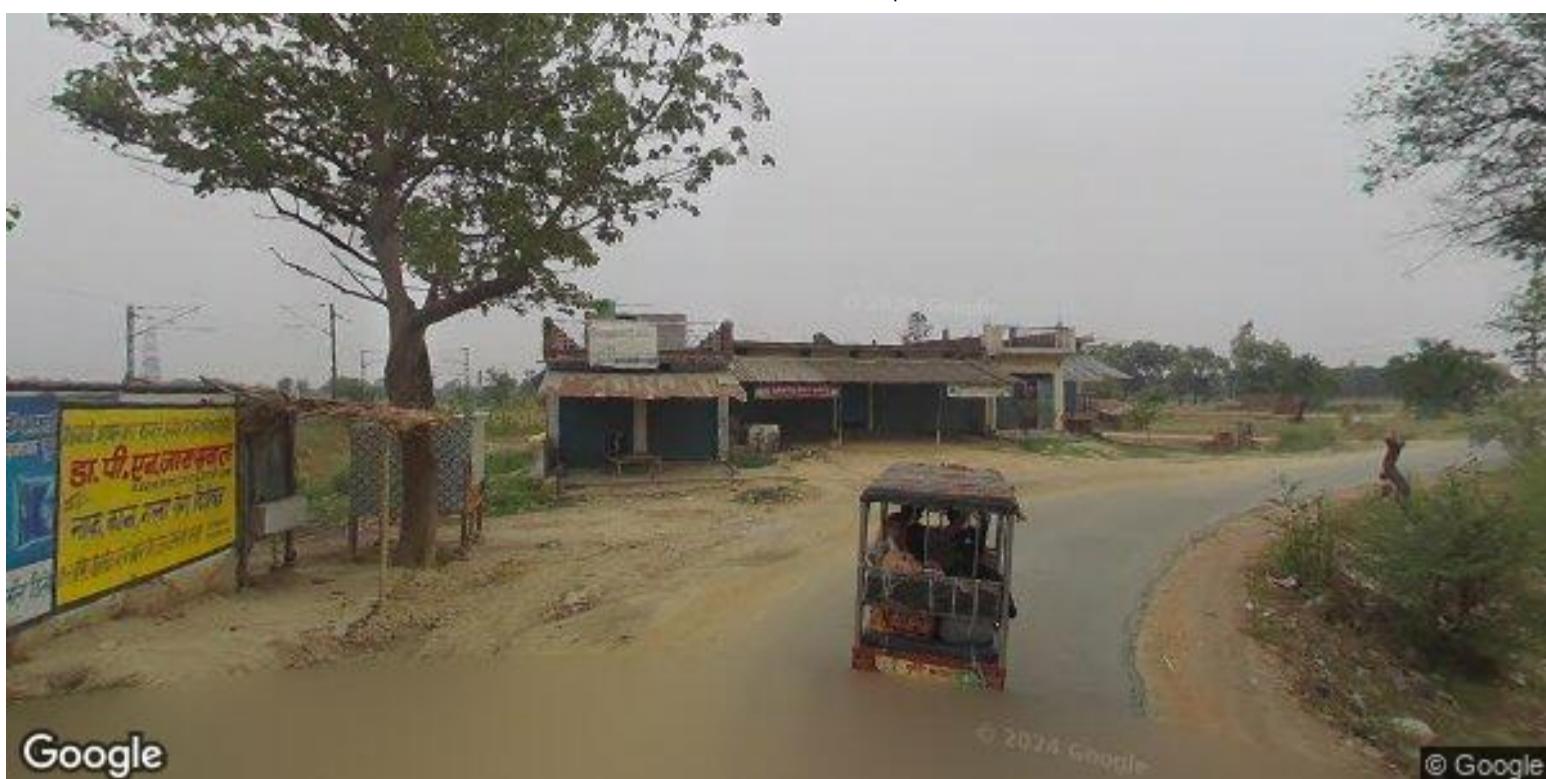
Risk Type: Turn**Risk Level:** Medium**Speed Limit:** 30 KM/Hr**Distance from Start:** 24.62 km**Coordinates:** 26.75430, 83.10045

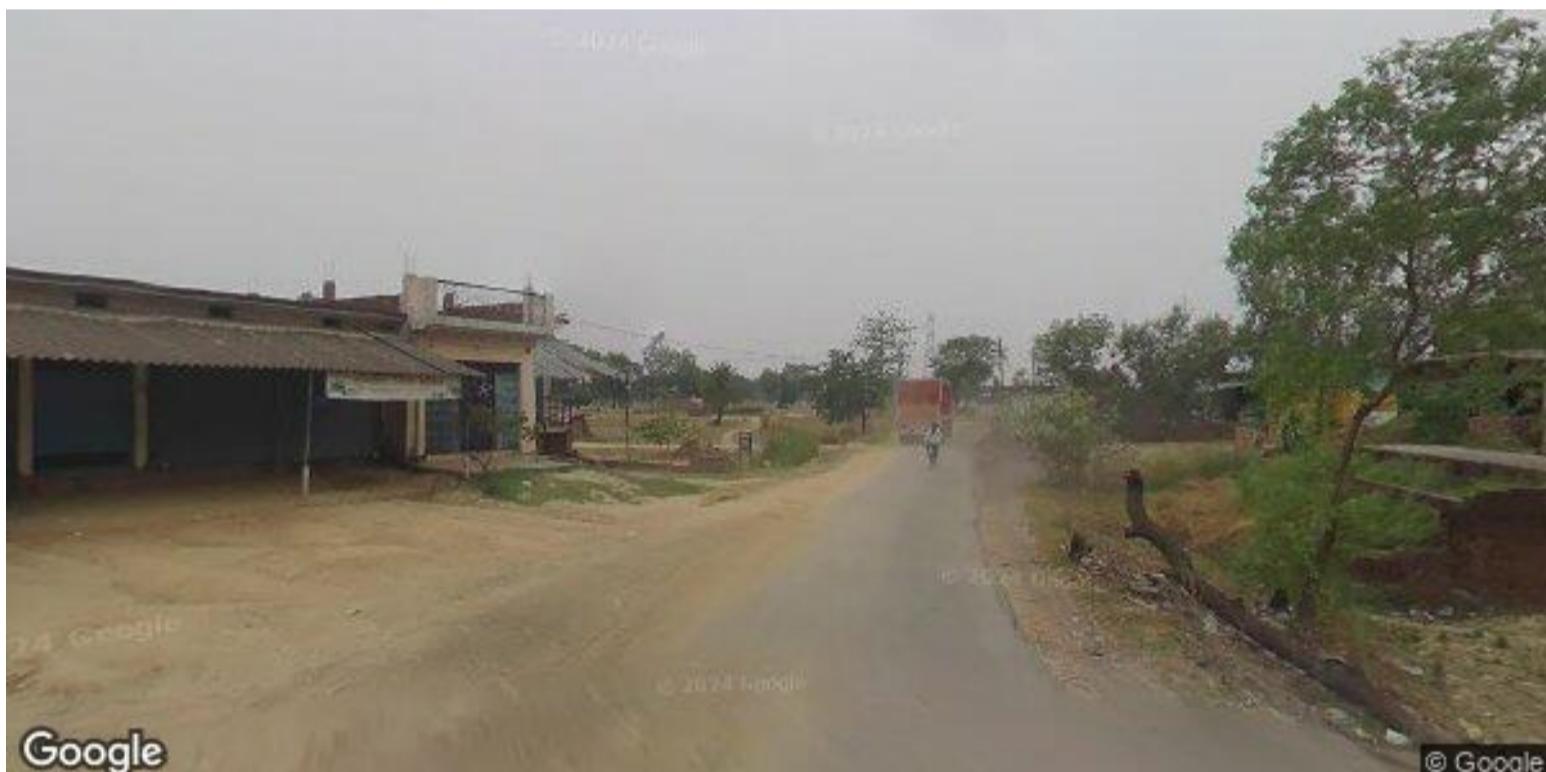
Risk Type: Turn**Risk Level:** Medium**Speed Limit:** 30 KM/Hr**Distance from Start:** 24.64 km**Coordinates:** 26.75423, 83.10048

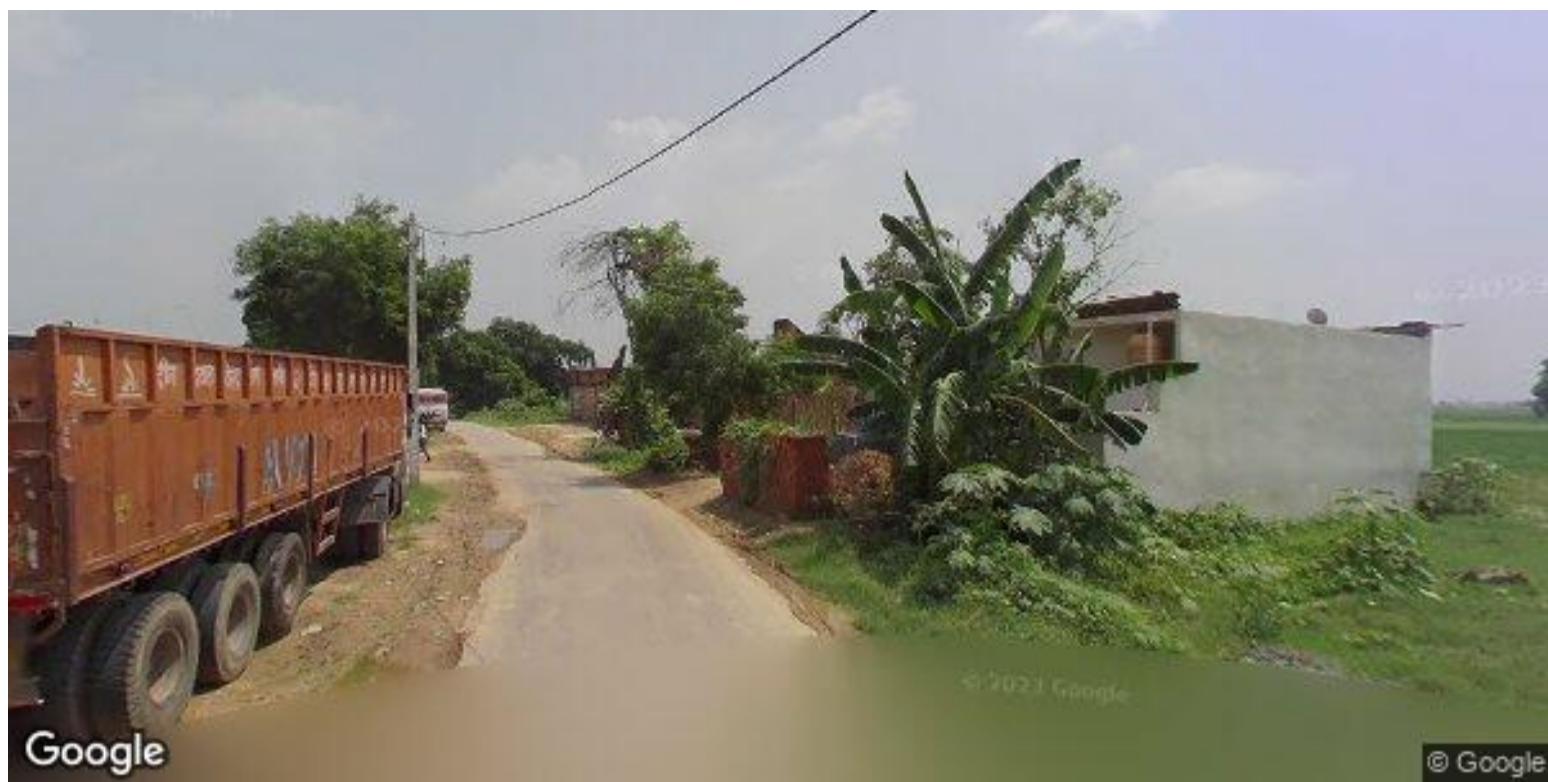
Risk Type: Turn**Risk Level:** Medium**Speed Limit:** 30 KM/Hr**Distance from Start:** 27.31 km**Coordinates:** 26.73653, 83.08968

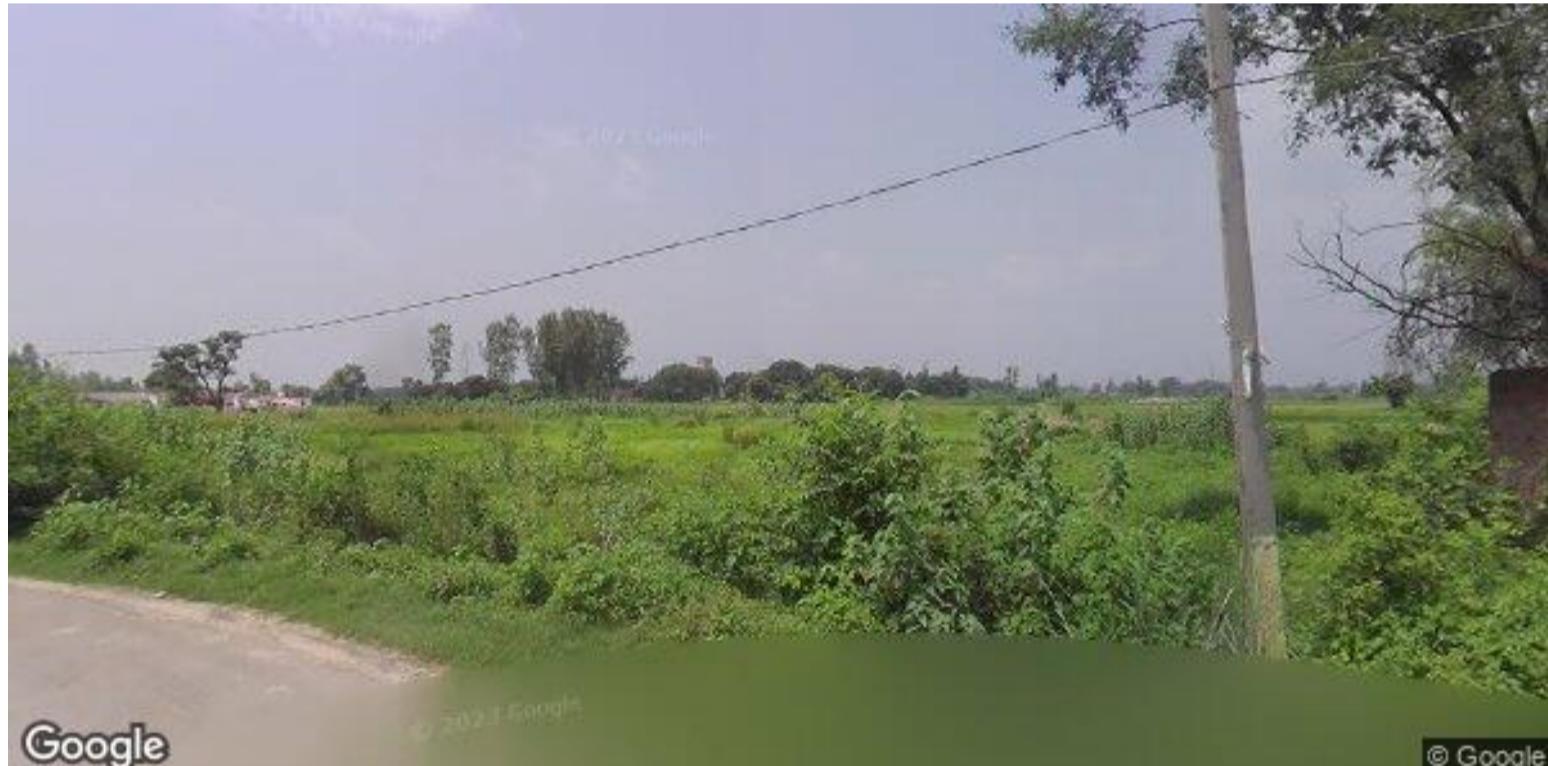
Risk Type: Turn**Risk Level:** High**Speed Limit:** 15 KM/Hr**Distance from Start:** 28.27 km**Coordinates:** 26.73367, 83.08098

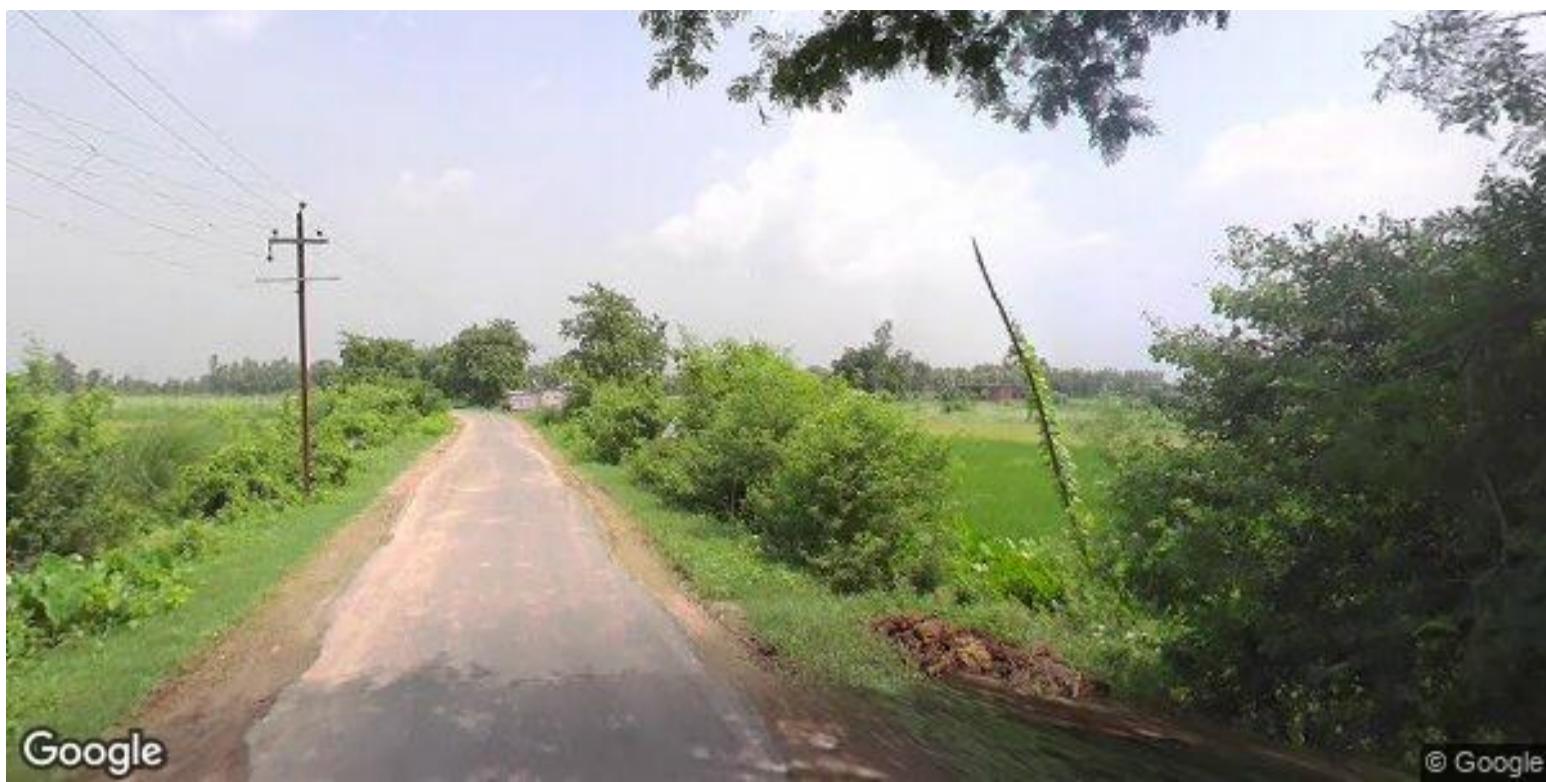
Risk Type: Turn**Risk Level:** Medium**Speed Limit:** 30 KM/Hr**Distance from Start:** 29.02 km**Coordinates:** 26.72805, 83.07659

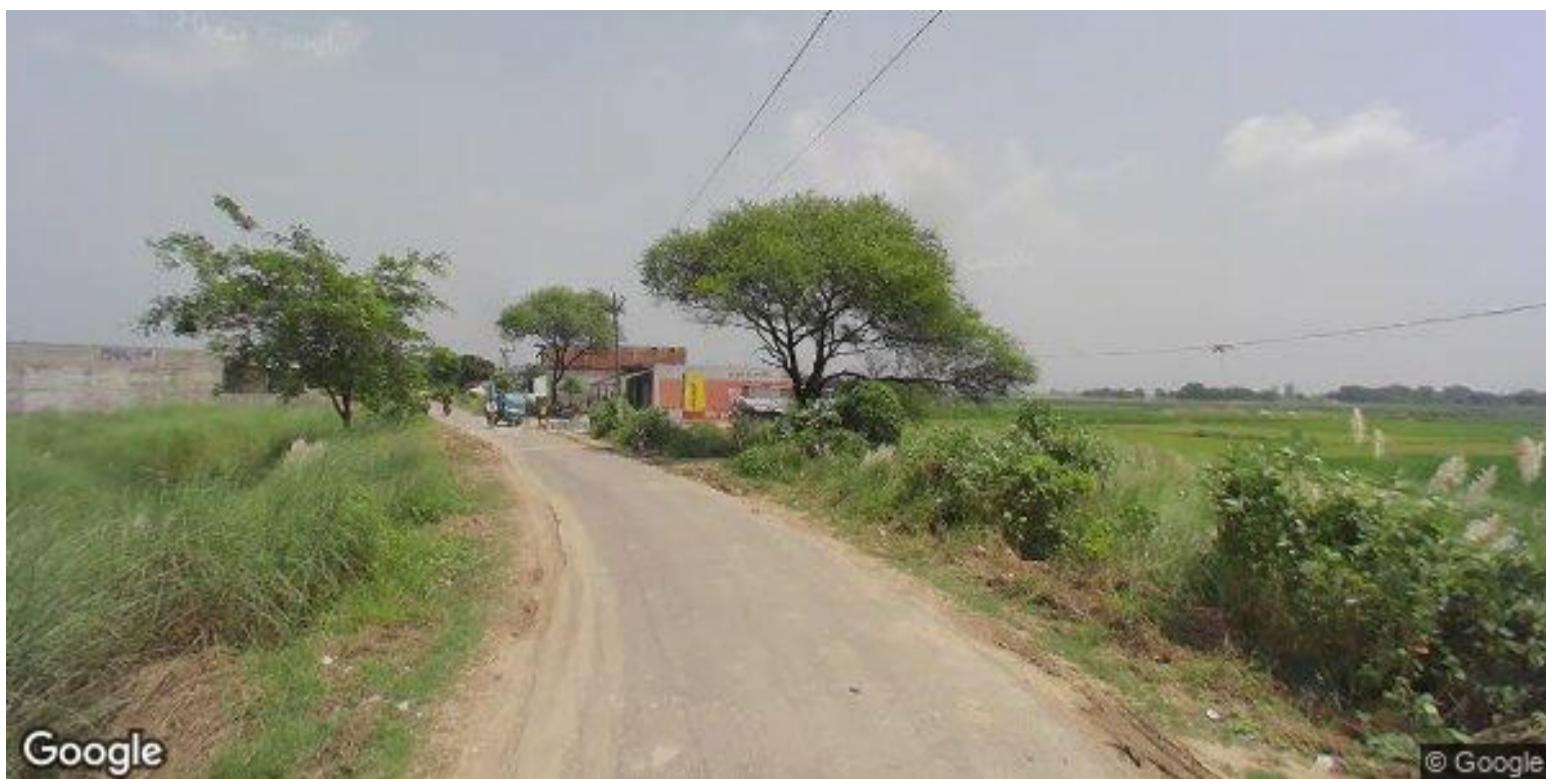
Risk Type: Turn

Risk Level: Medium

Speed Limit: 30 KM/Hr

Distance from Start: 29.38 km

Coordinates: 26.72521, 83.07483
