JOURNEY RISK MANAGEMENT (JRM) STUDY

Gorakhpur LPG BP TO BANKATA INDANE GRAMI

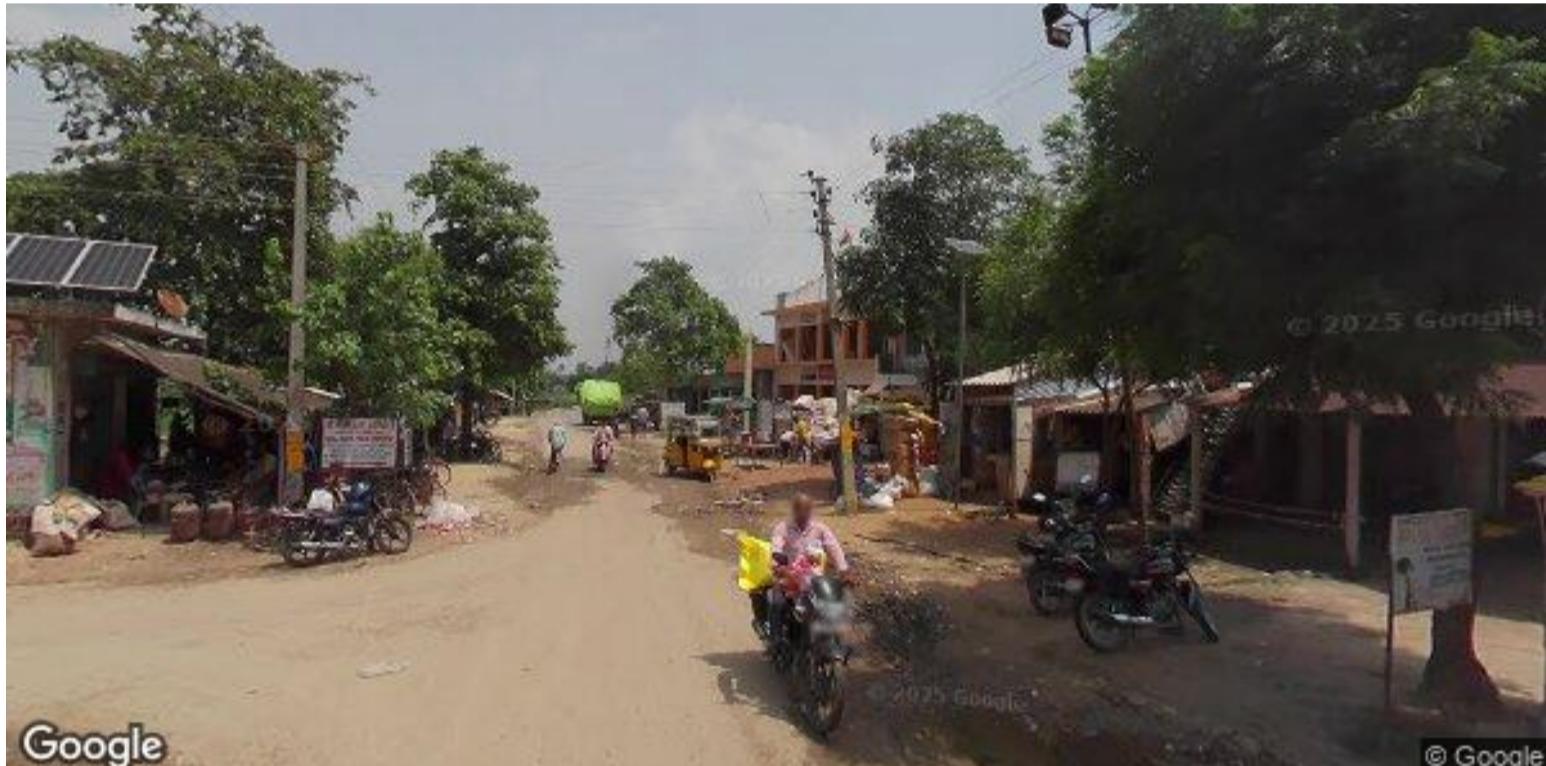
Risk Type: Turn

Risk Level: High

Speed Limit: 15 KM/Hr

Distance from Start: 29.57 km

Coordinates: 26.72420, 83.07351

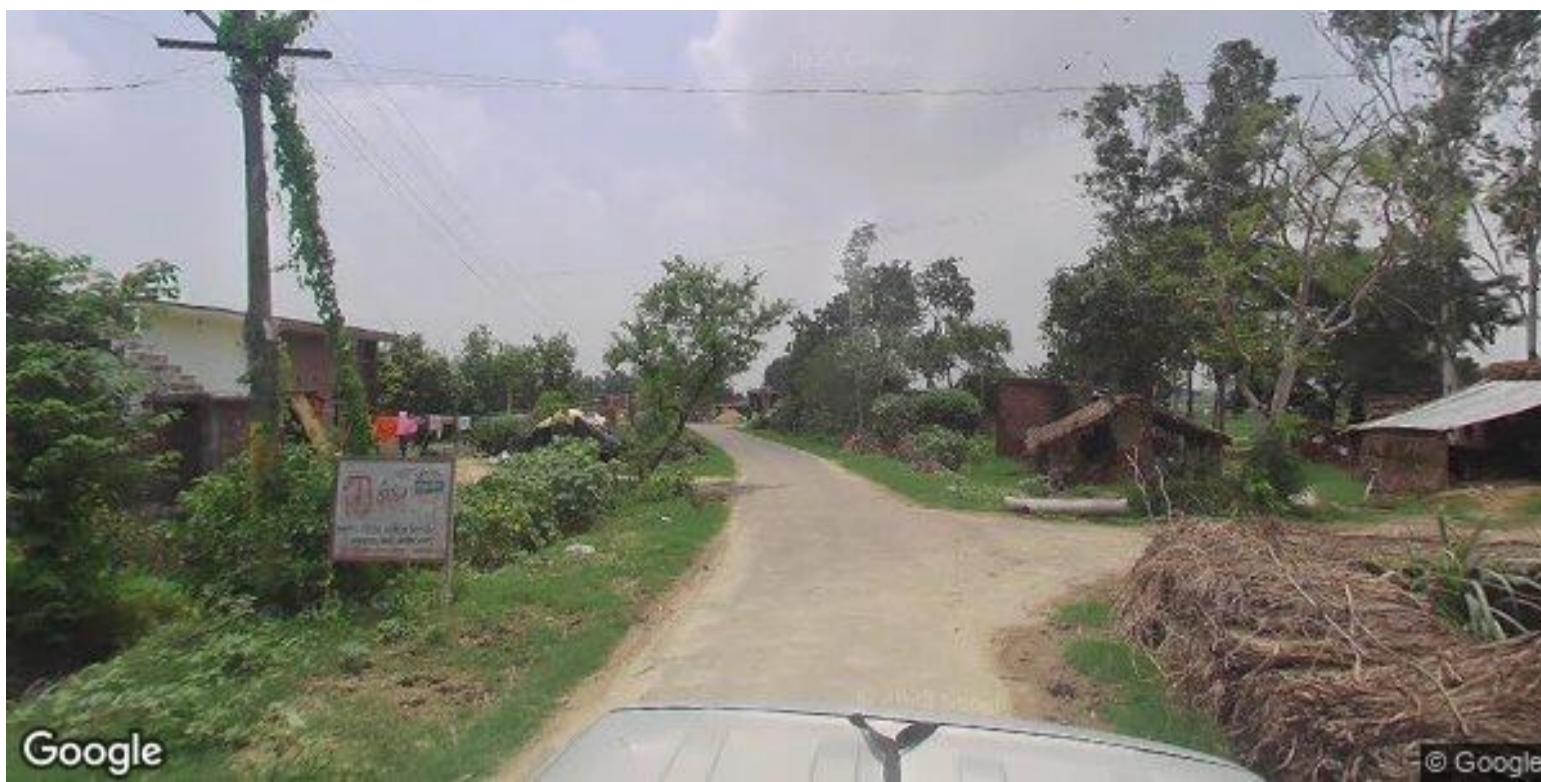
Risk Type: Turn

Risk Level: High

Speed Limit: 15 KM/Hr

Distance from Start: 29.96 km

Coordinates: 26.72606, 83.07077
