JOURNEY RISK MANAGEMENT (JRM) STUDY

Gorakhpur LPG BP to KALPANA INDANE SERVICE

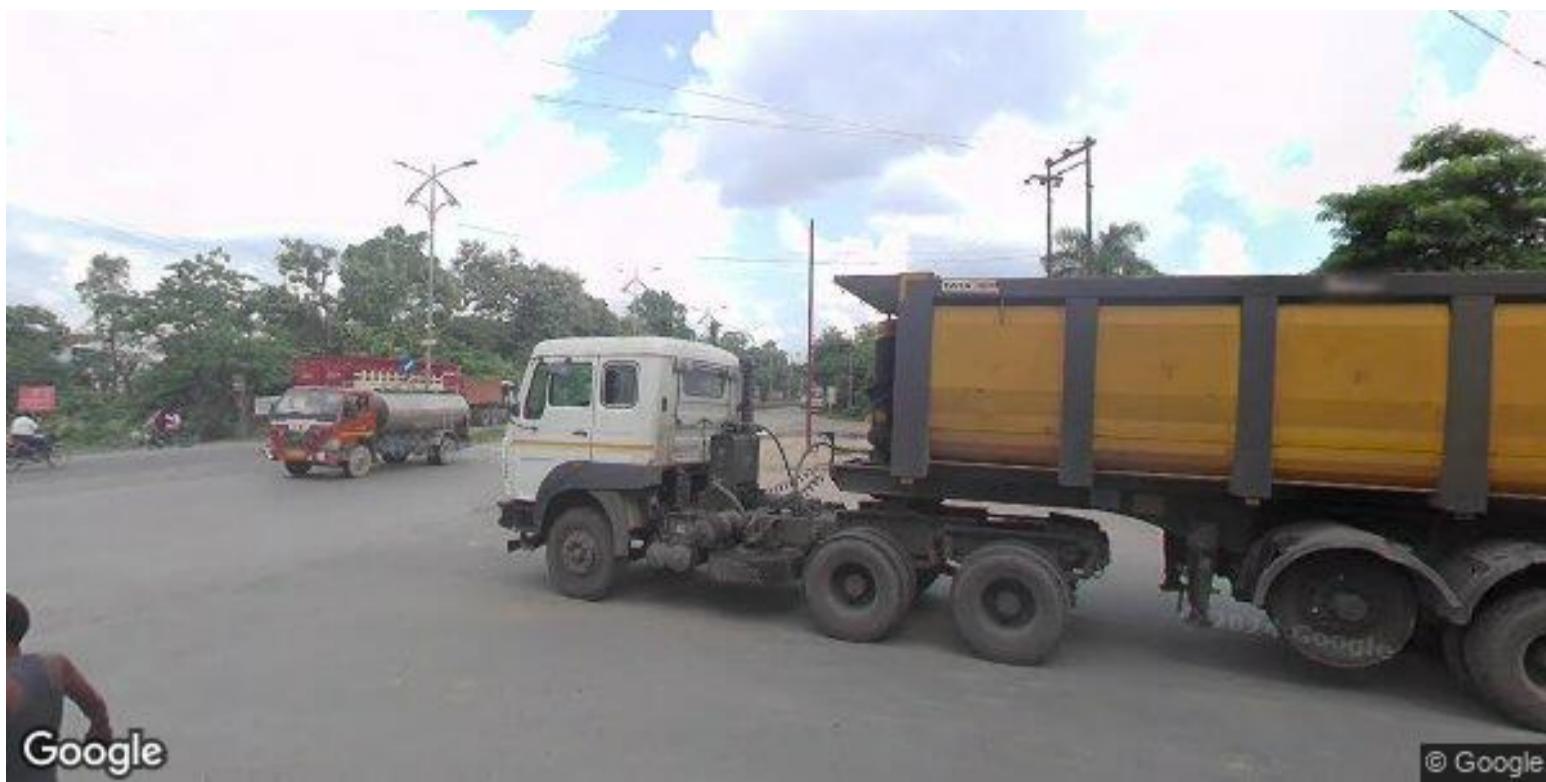
Risk Type: Blind Spot

Risk Level: Blind Spot

Speed Limit: 10 KM/Hr

Distance from Start: 2.17 km

Coordinates: 26.75126, 83.22476

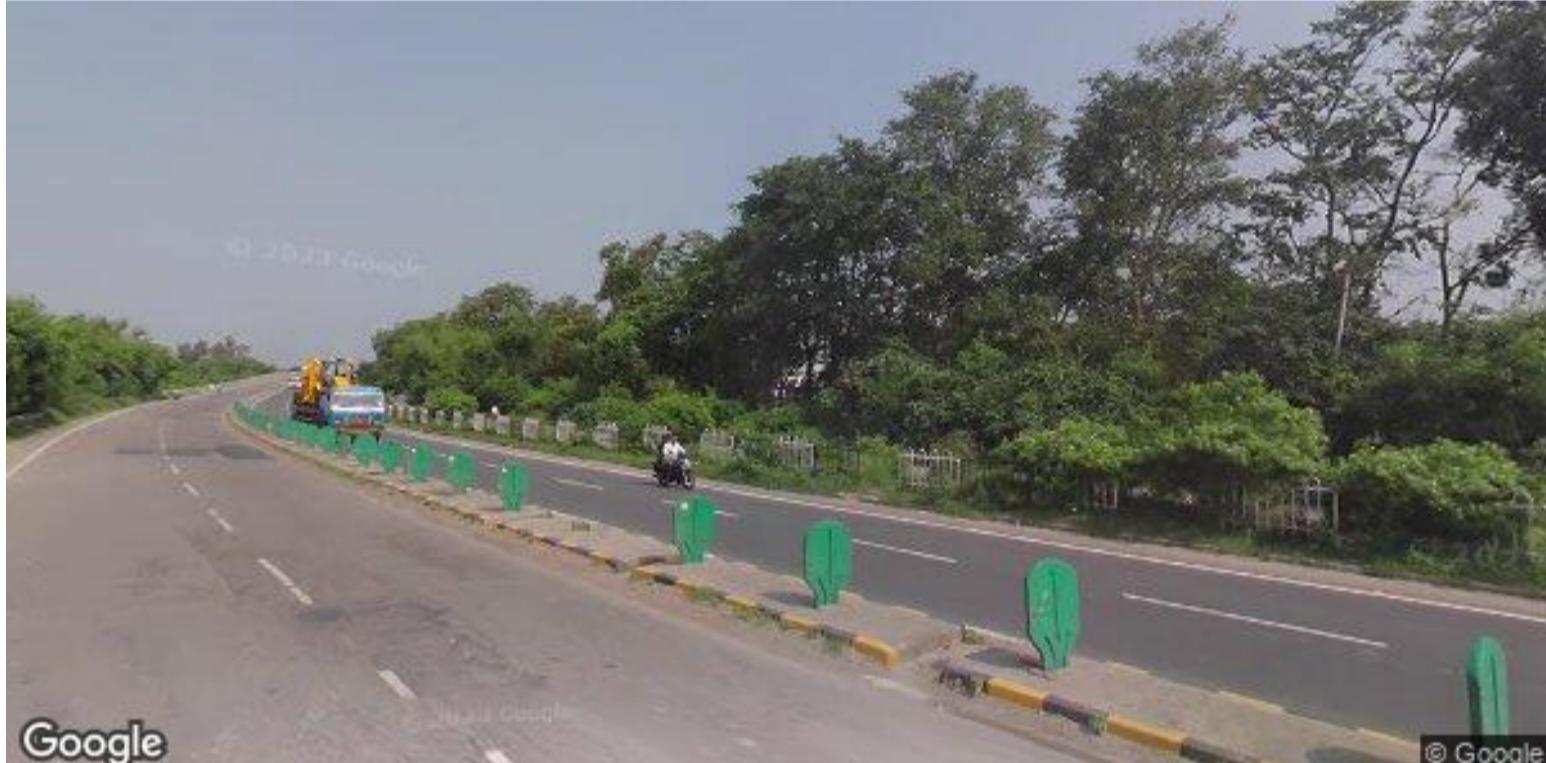
Risk Type: Turn

Risk Level: High

Speed Limit: 15 KM/Hr

Distance from Start: 7.73 km

Coordinates: 26.75469, 83.16936

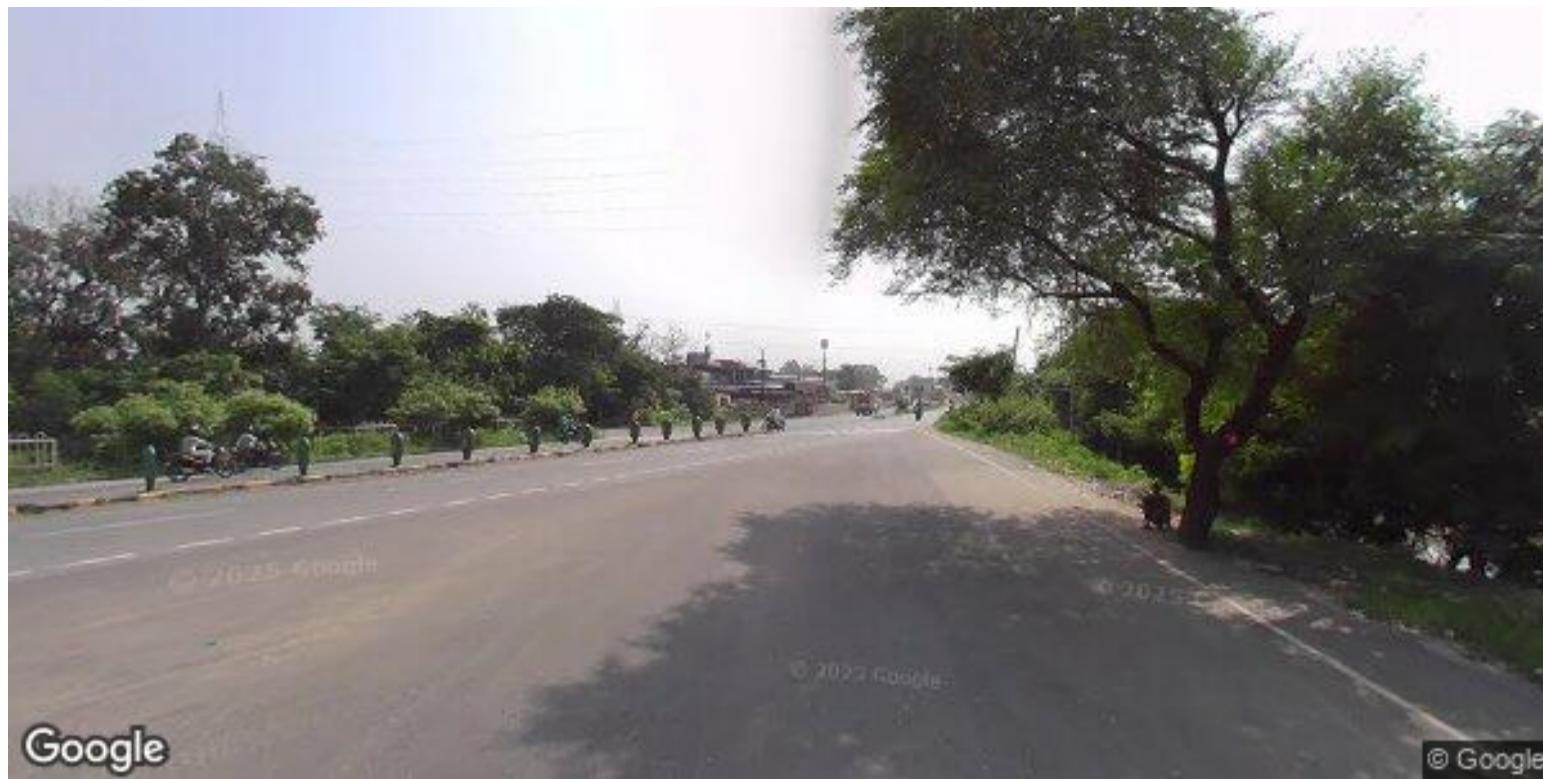
Risk Type: Turn

Risk Level: Medium

Speed Limit: 30 KM/Hr

Distance from Start: 7.77 km

Coordinates: 26.75464, 83.16931

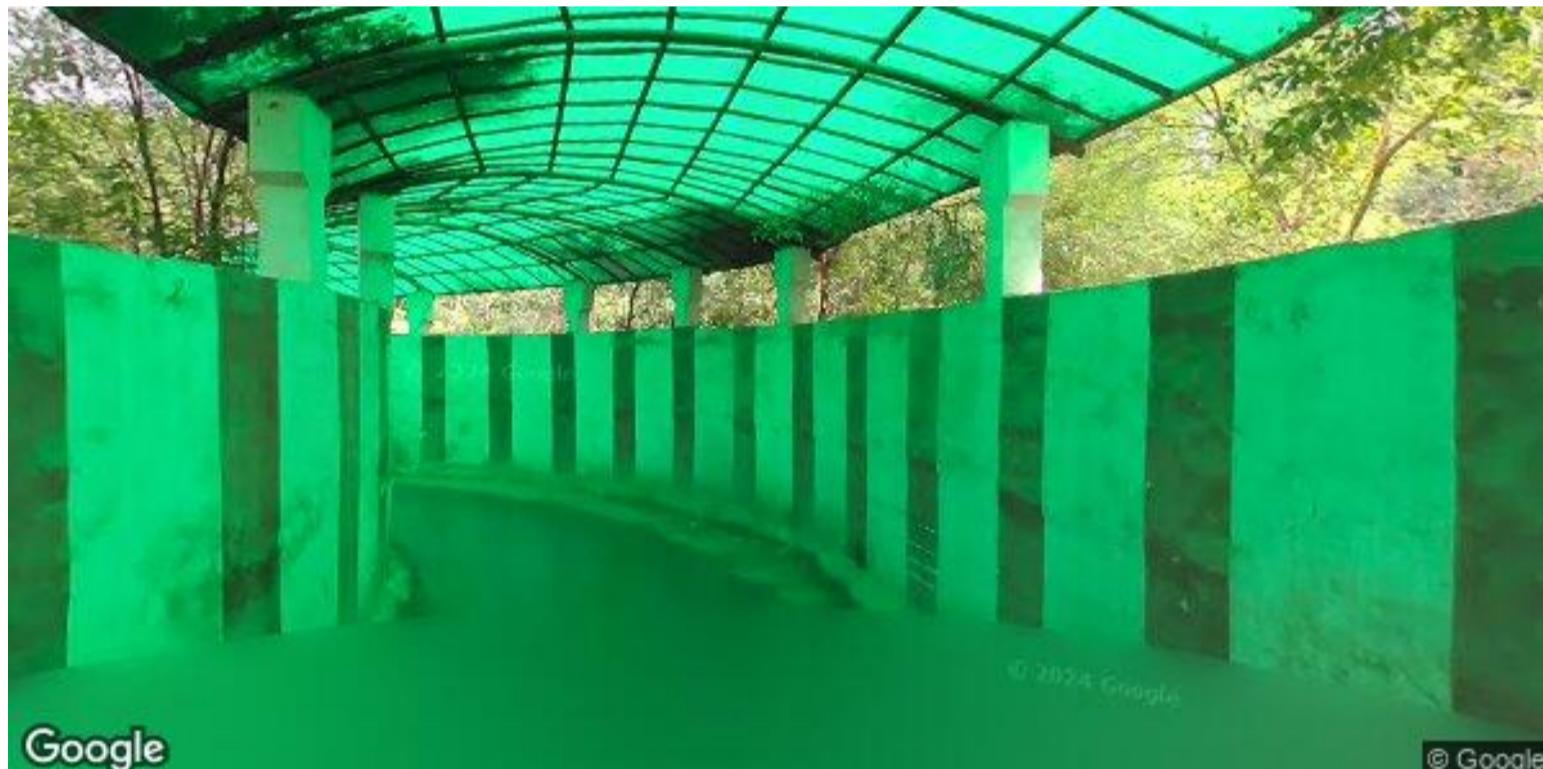
Risk Type: Turn

Risk Level: Medium

Speed Limit: 30 KM/Hr

Distance from Start: 9.28 km

Coordinates: 26.75563, 83.15436

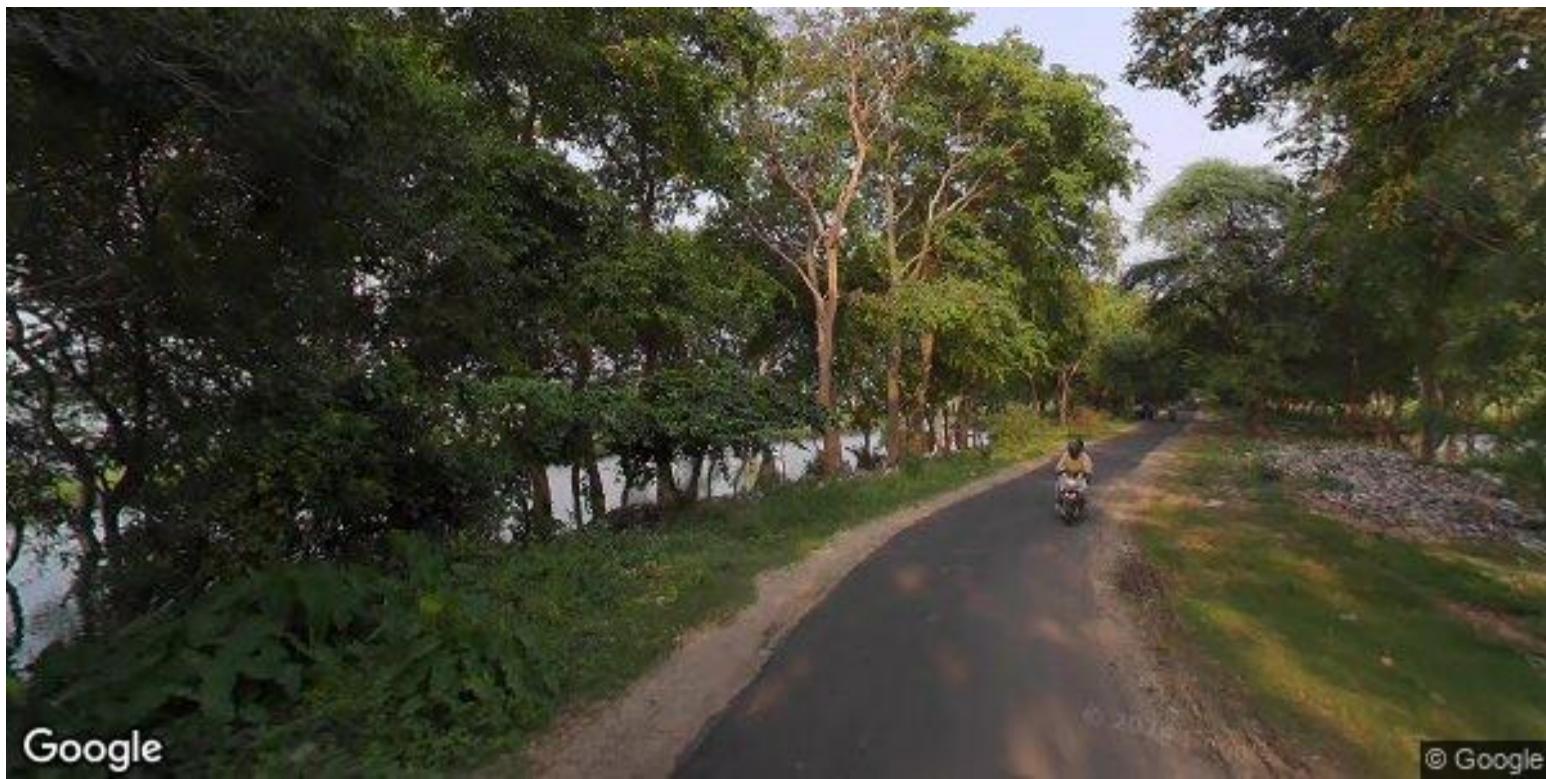
Risk Type: Turn

Risk Level: Medium

Speed Limit: 30 KM/Hr

Distance from Start: 10.90 km

Coordinates: 26.75386, 83.13806

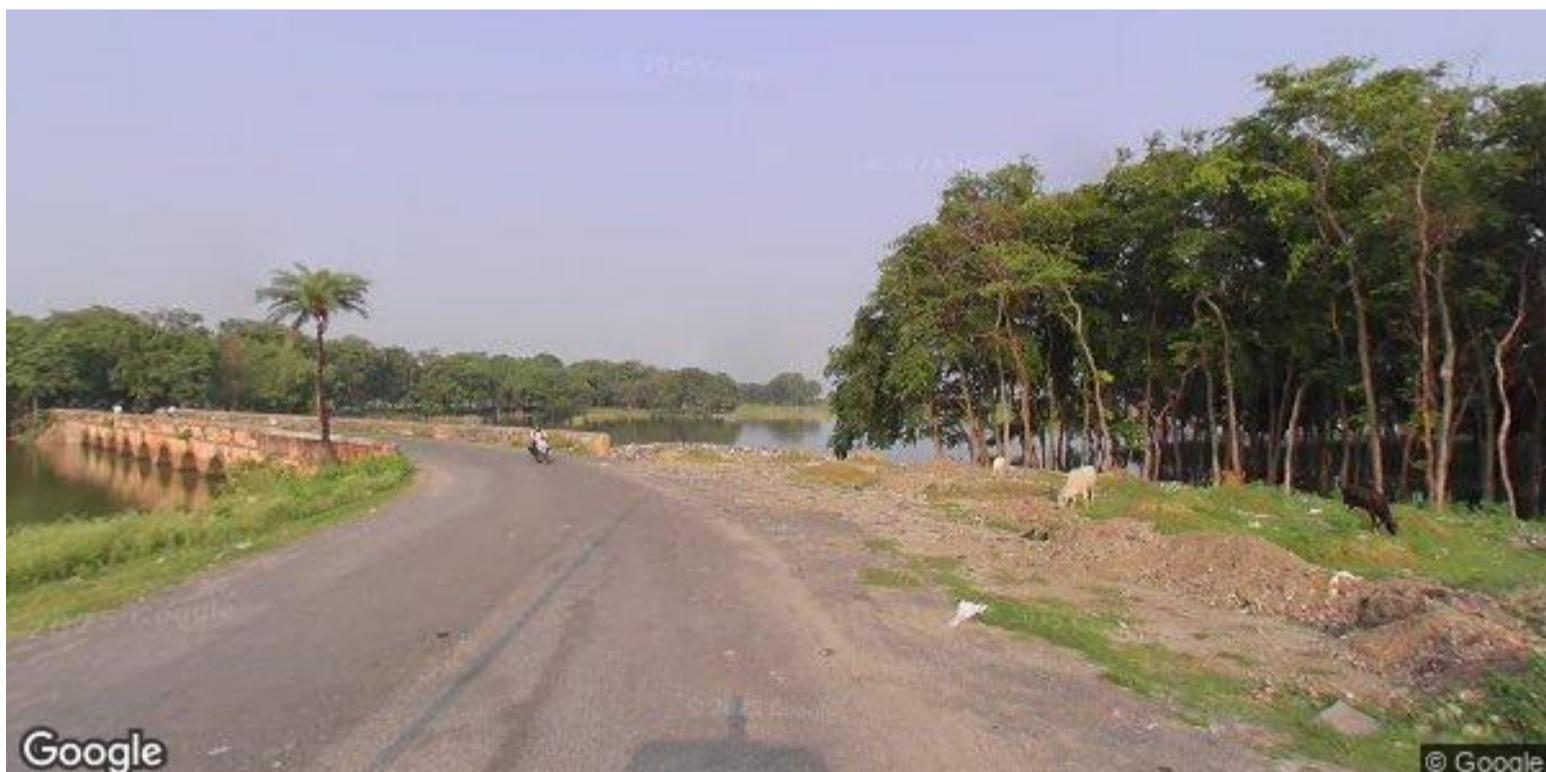
Risk Type: Turn

Risk Level: Medium

Speed Limit: 30 KM/Hr

Distance from Start: 11.15 km

Coordinates: 26.75277, 83.13646

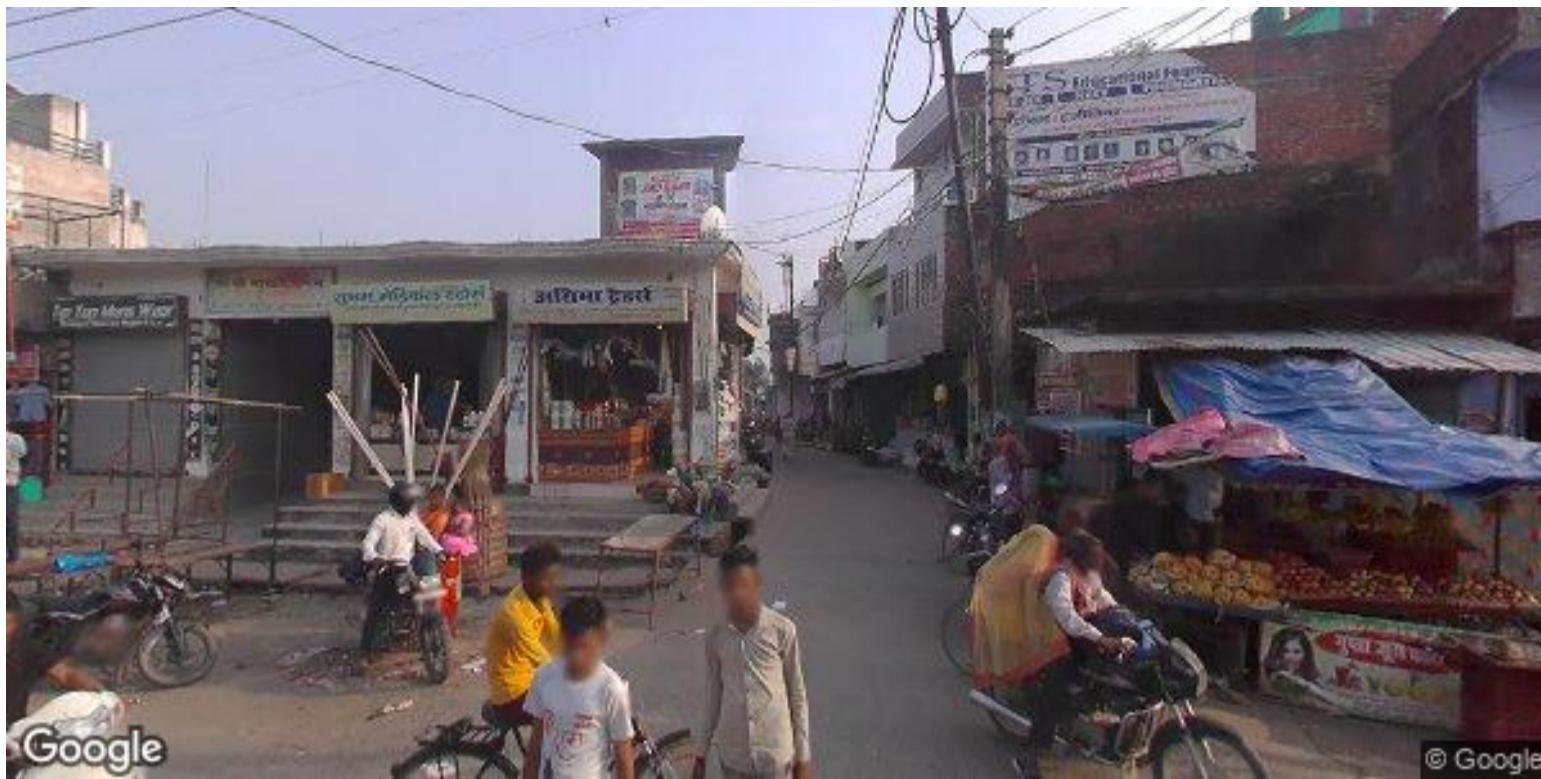
Risk Type: Blind Spot

Risk Level: Blind Spot

Speed Limit: 10 KM/Hr

Distance from Start: 11.78 km

Coordinates: 26.75347, 83.12984
