JOURNEY RISK MANAGEMENT (JRM) STUDY

Gorakhpur LPG BP TO ATUL INDANE SERVICE

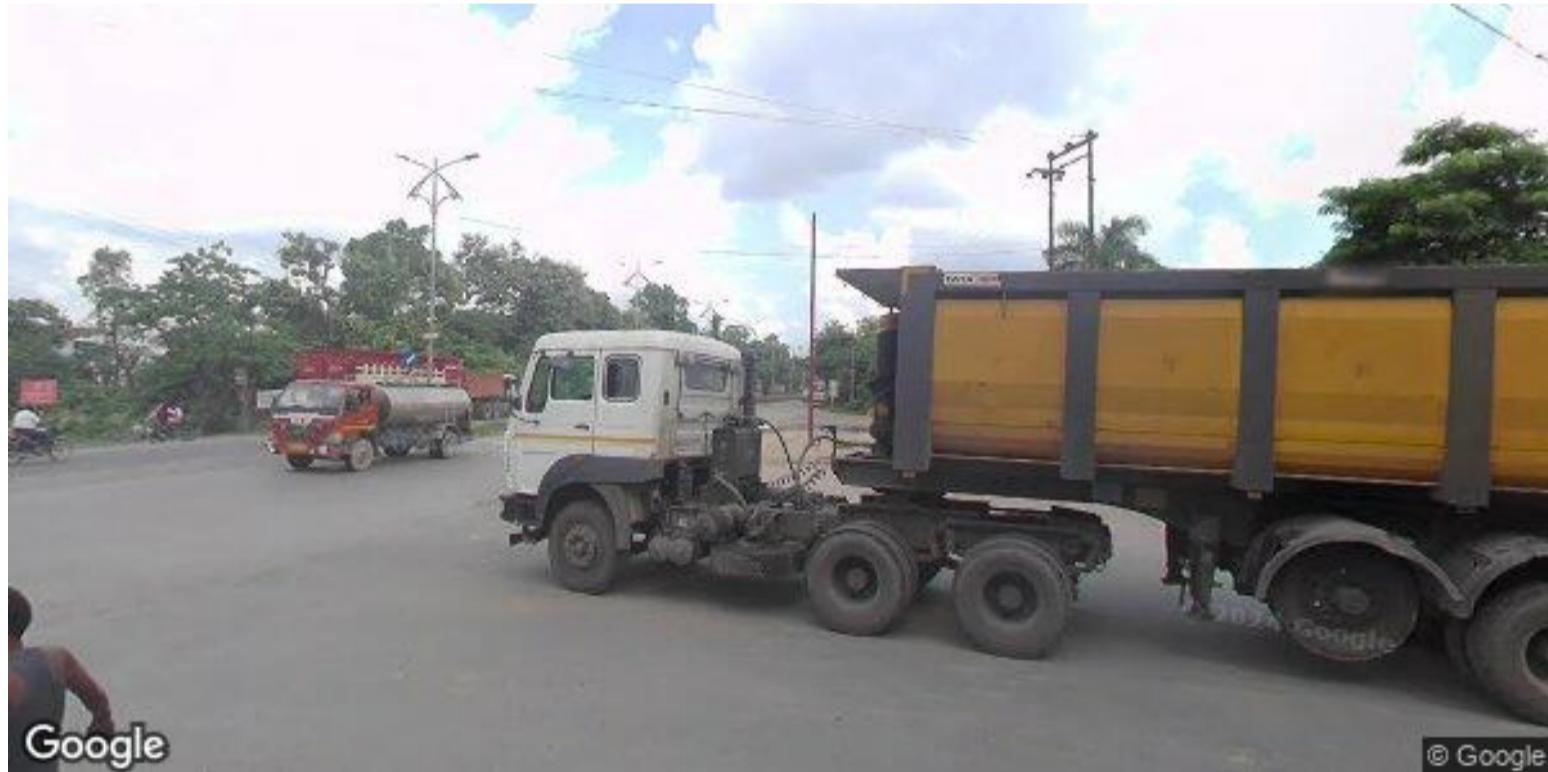
Coordinates: 26.75126, 83.22476

Risk Type: Blind Spot

Risk Level: Blind Spot

Speed Limit: 10 KM/Hr

Distance from Start: 2.17 km

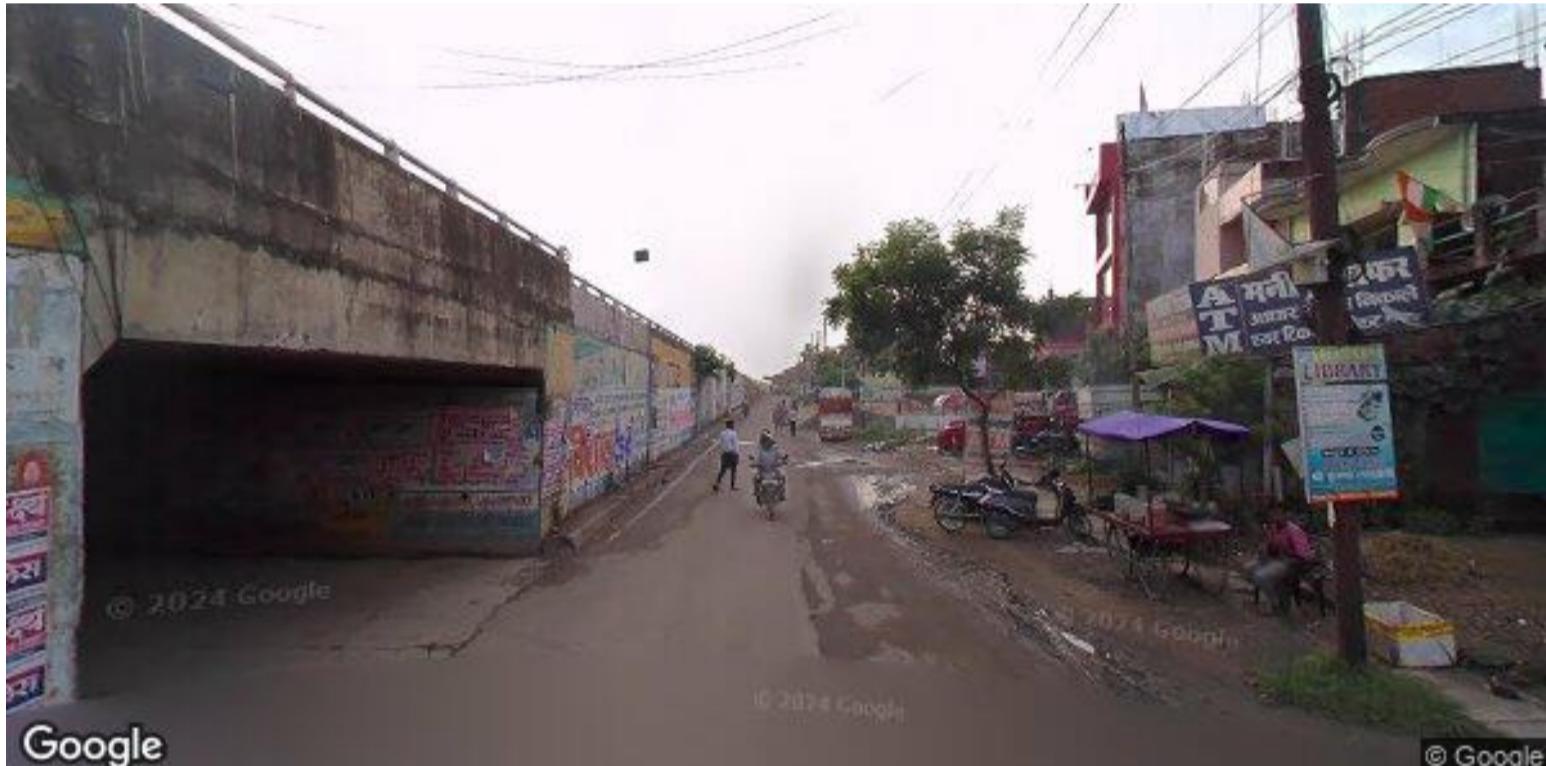
Coordinates: 26.75381, 83.20466

Risk Type: Turn

Risk Level: High

Speed Limit: 15 KM/Hr

Distance from Start: 4.30 km

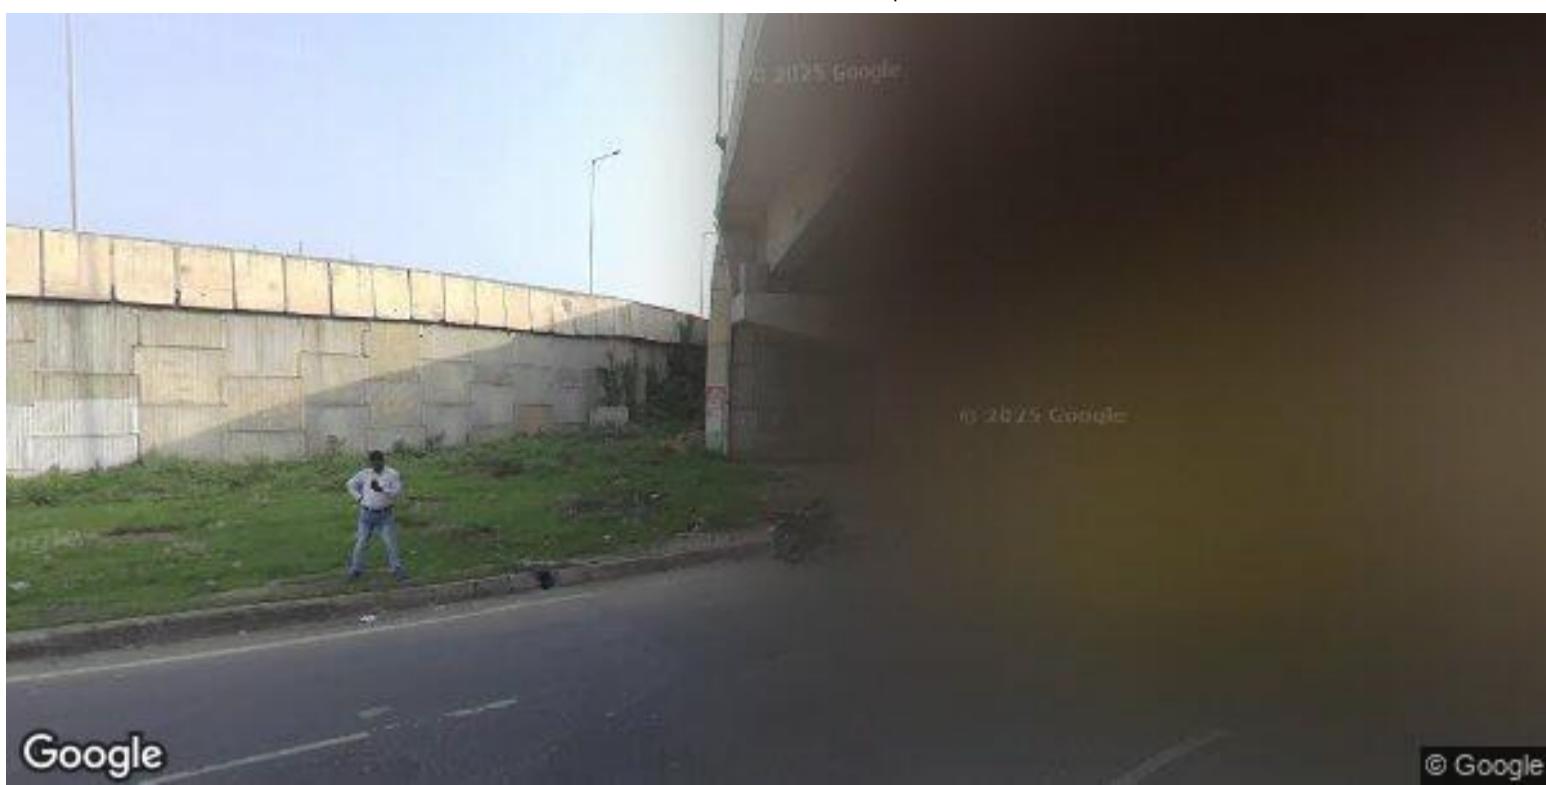
Risk Type: Roundabout**Risk Level:** High**Speed Limit:** 15 KM/Hr**Distance from Start:** 8.99 km**Coordinates:** 26.74681, 83.25111

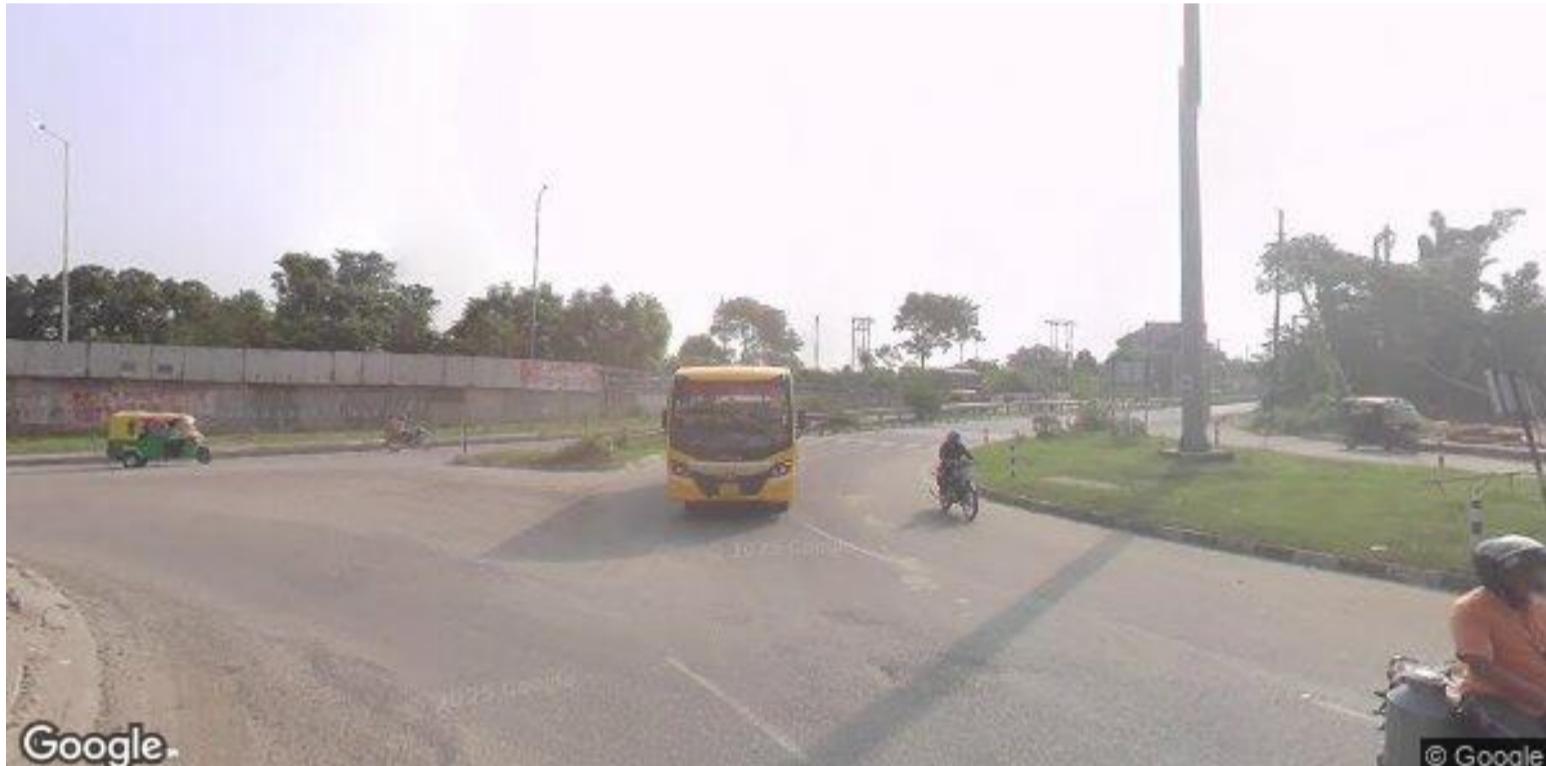
Risk Type: Turn**Risk Level:** Medium**Speed Limit:** 30 KM/Hr**Distance from Start:** 9.07 km**Coordinates:** 26.74644, 83.25150

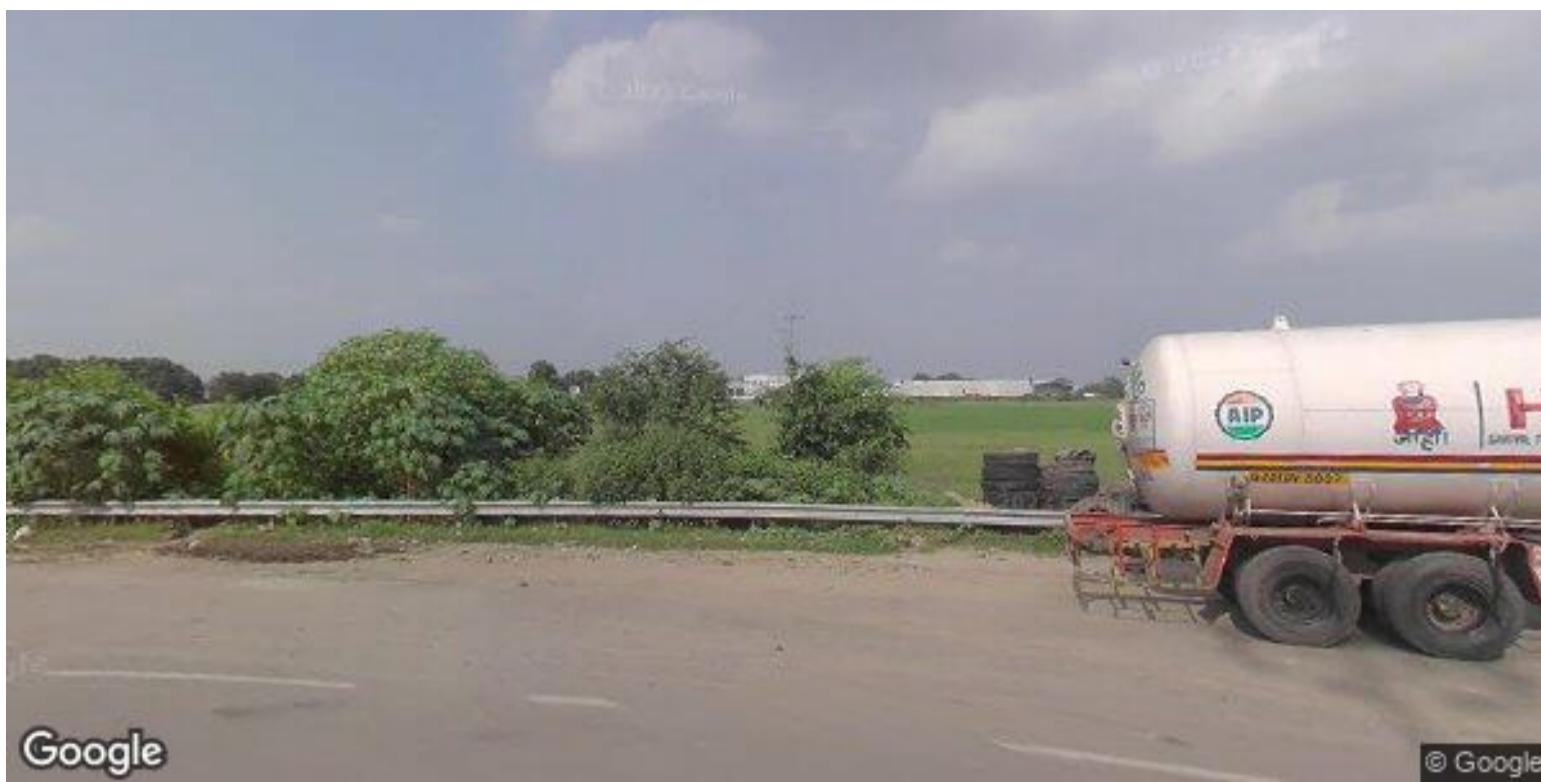
Risk Type: Turn**Risk Level:** Medium**Speed Limit:** 30 KM/Hr**Distance from Start:** 9.49 km**Coordinates:** 26.74310, 83.25343

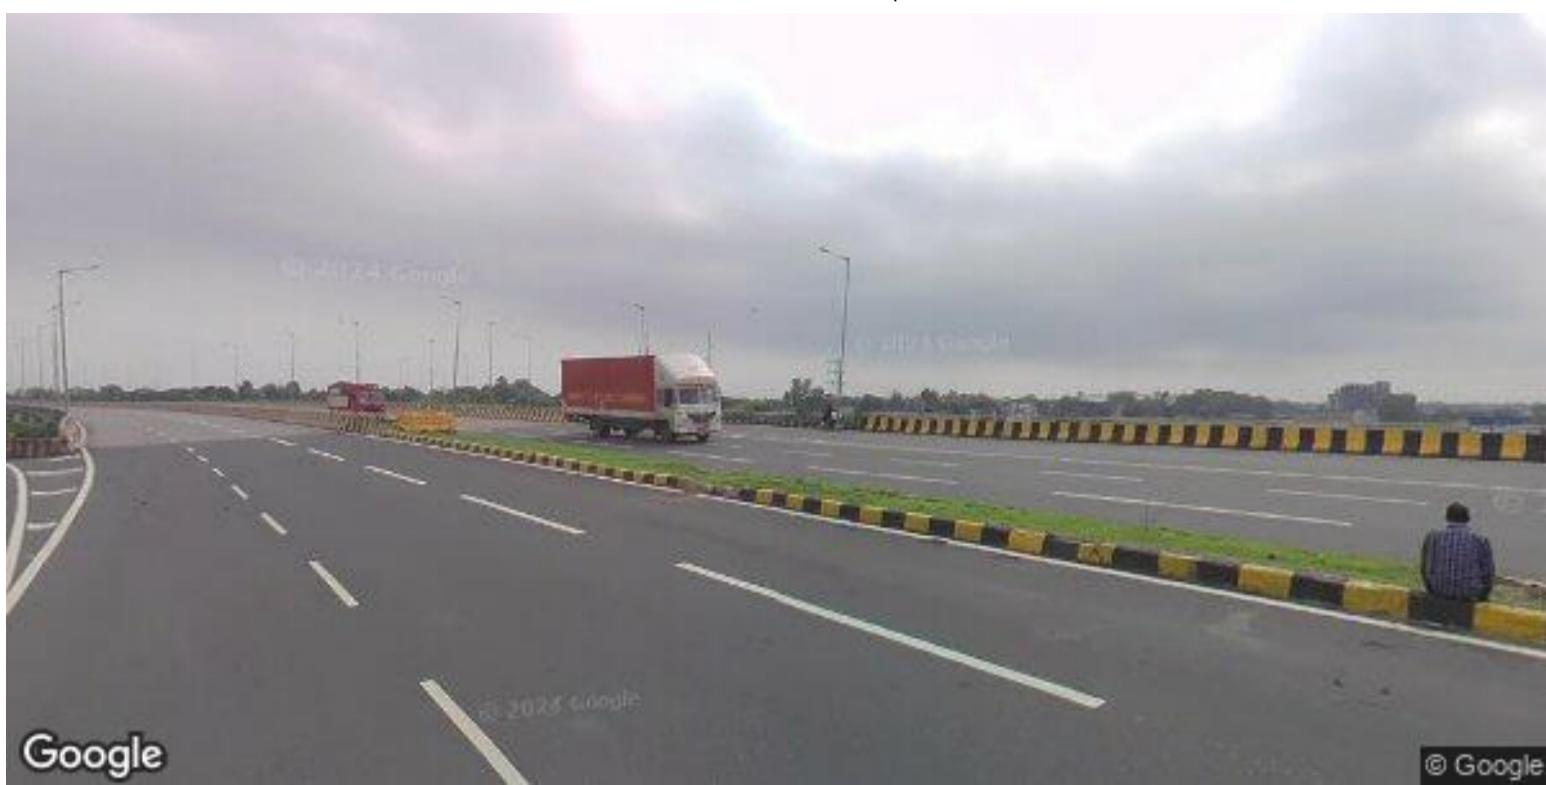
Coordinates: 26.69632, 83.47492

Risk Type: Turn

Risk Level: High

Speed Limit: 15 KM/Hr

Distance from Start: 33.16 km

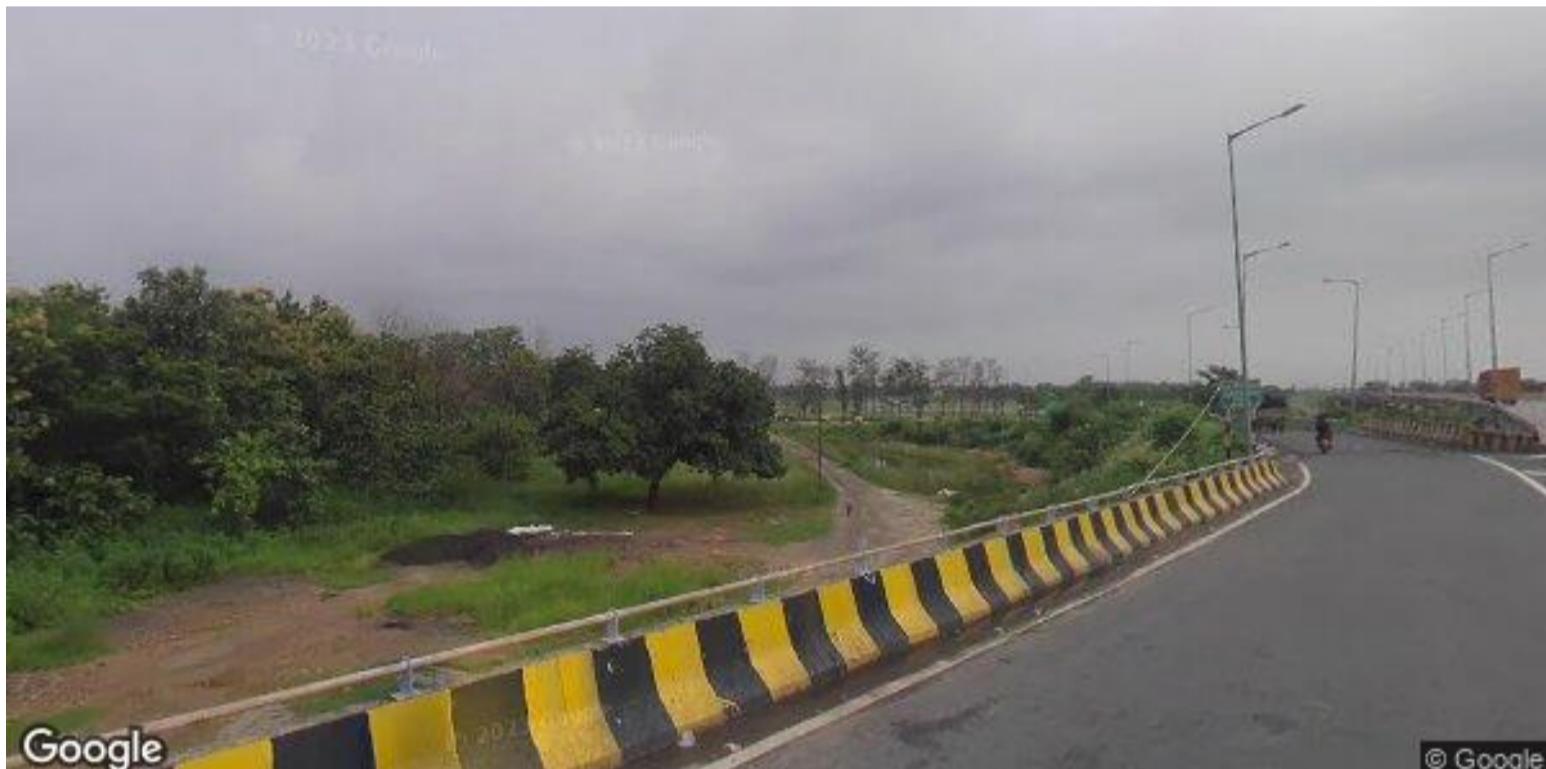
Coordinates: 26.69640, 83.47492

Risk Type: Turn

Risk Level: High

Speed Limit: 15 KM/Hr

Distance from Start: 33.17 km

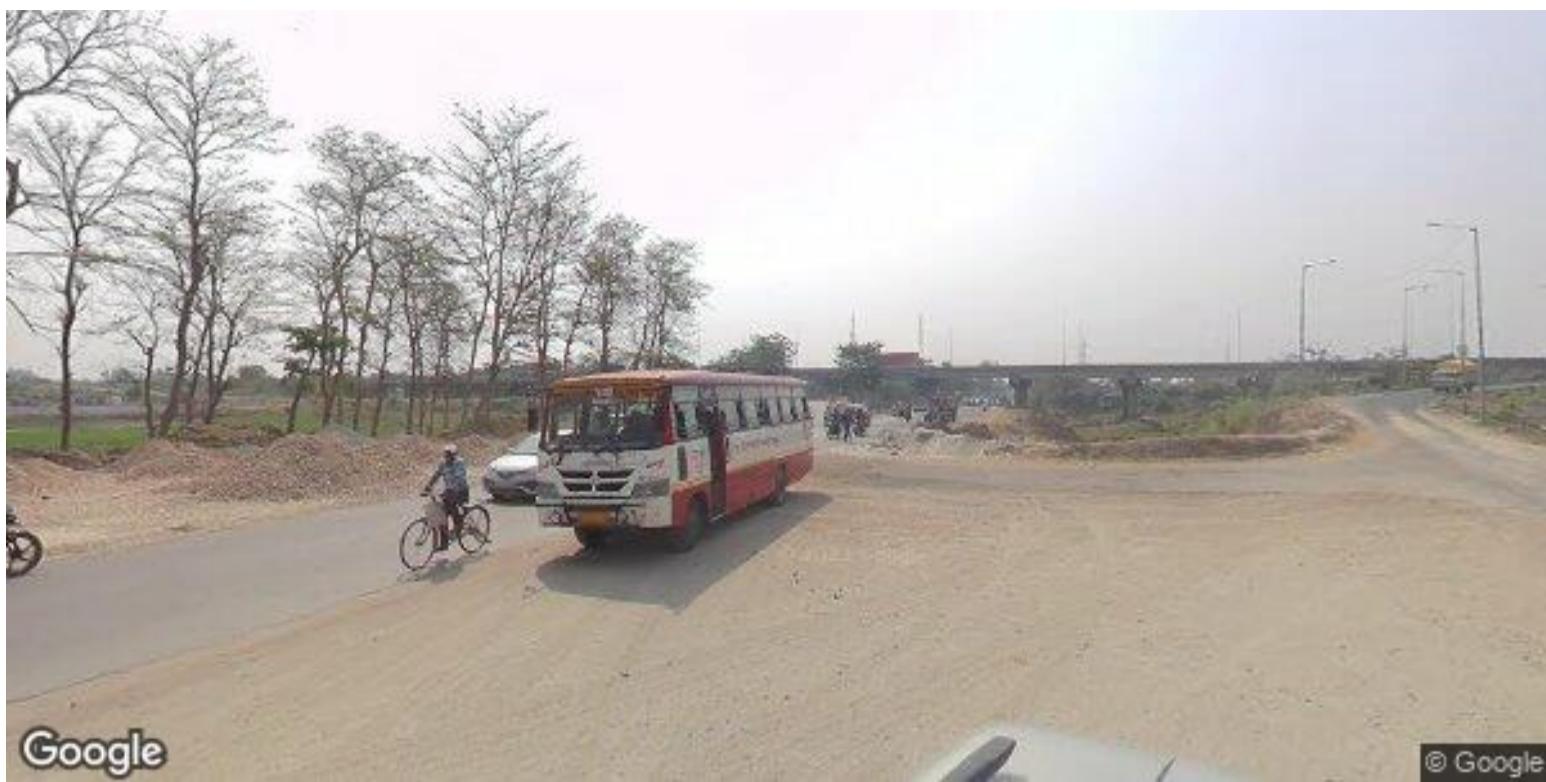
Risk Type: Turn**Risk Level:** Medium**Speed Limit:** 30 KM/Hr**Distance from Start:** 33.41 km**Coordinates:** 26.69835, 83.47489

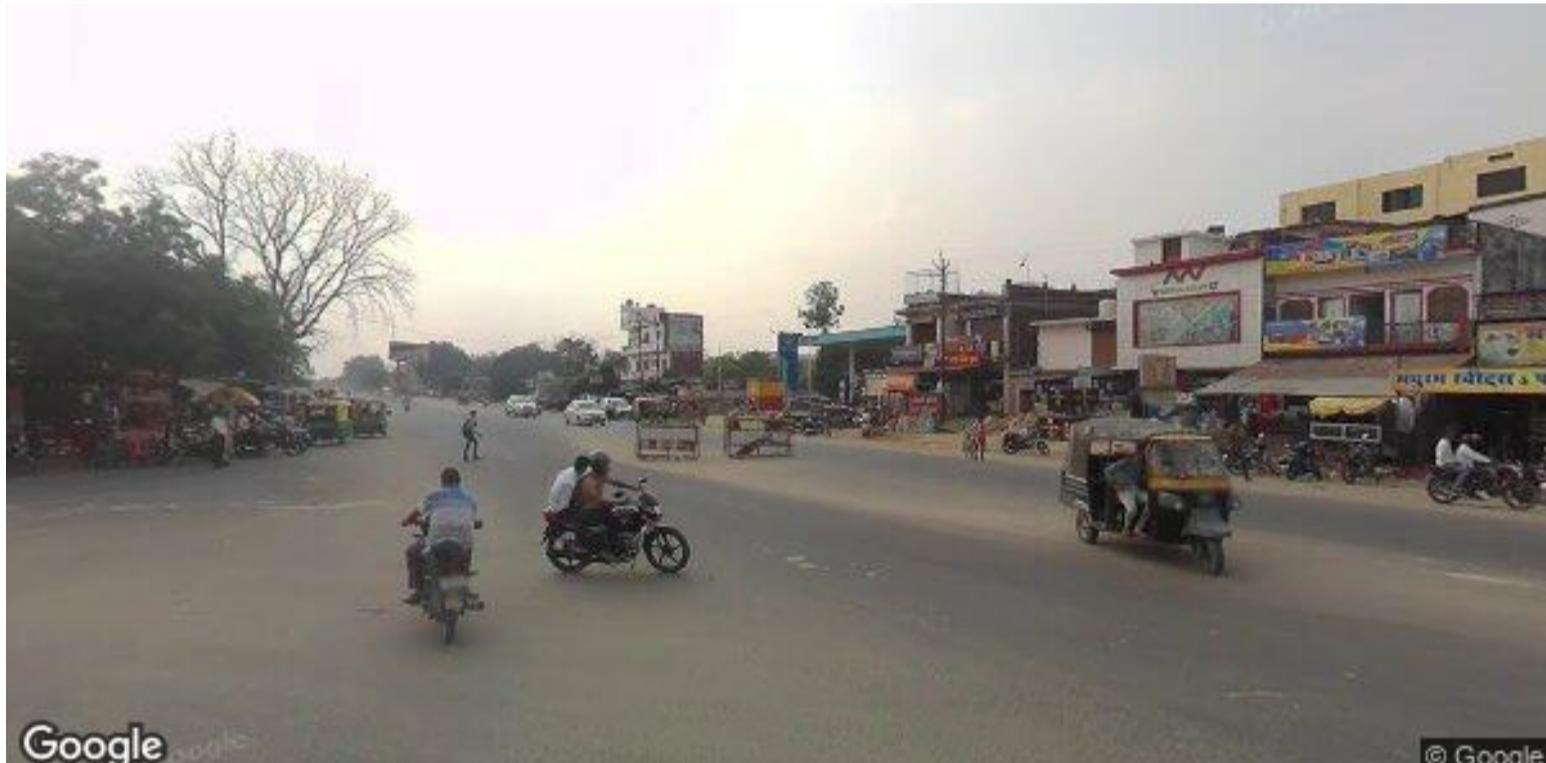
Risk Type: Turn**Risk Level:** High**Speed Limit:** 15 KM/Hr**Distance from Start:** 36.47 km**Coordinates:** 26.71257, 83.44780

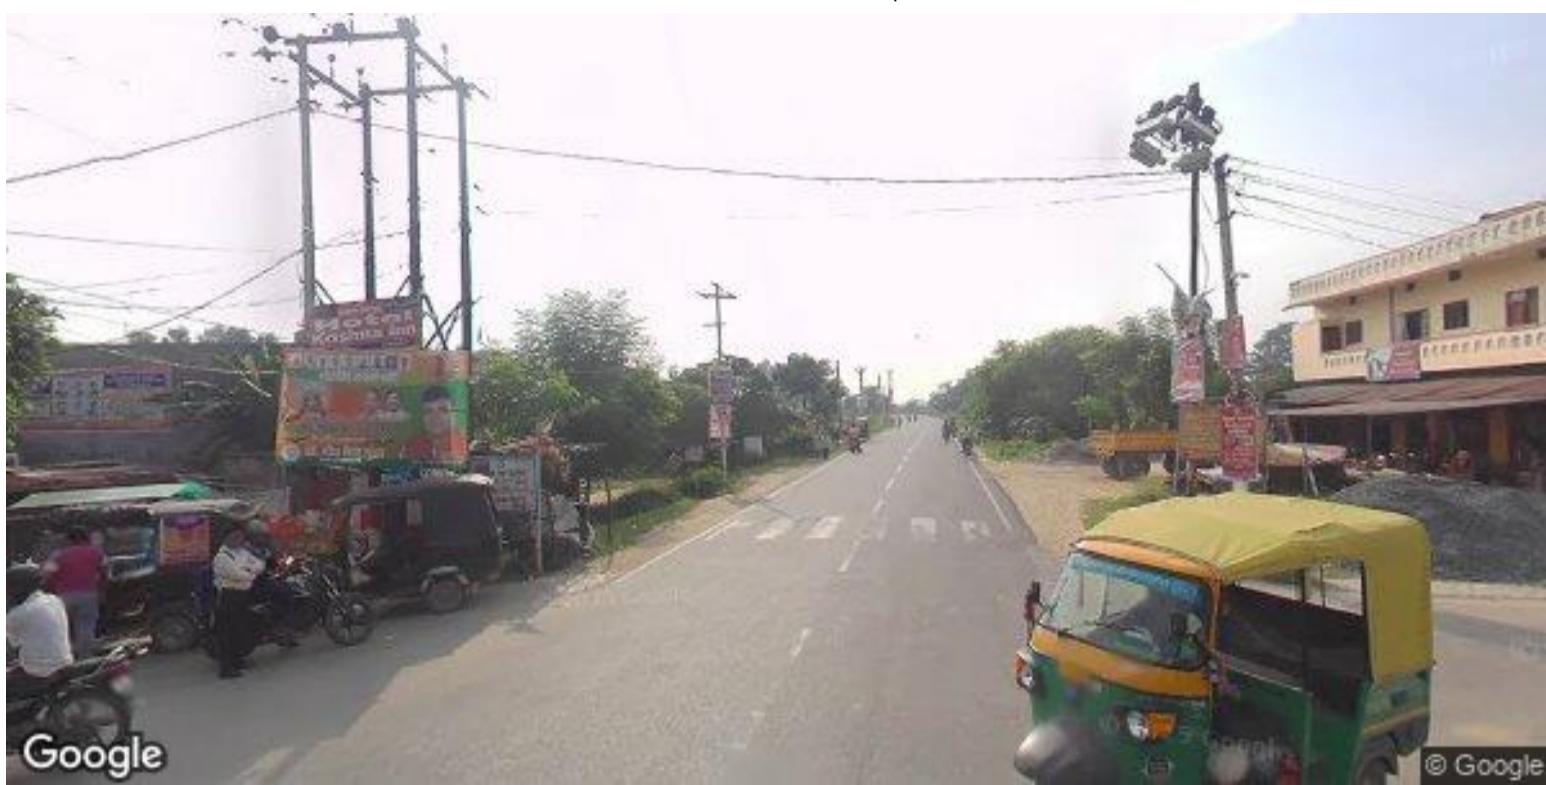
Risk Type: Blind Spot**Risk Level:** Blind Spot**Speed Limit:** 10 KM/Hr**Distance from Start:** 39.92 km**Coordinates:** 26.70186, 83.41900

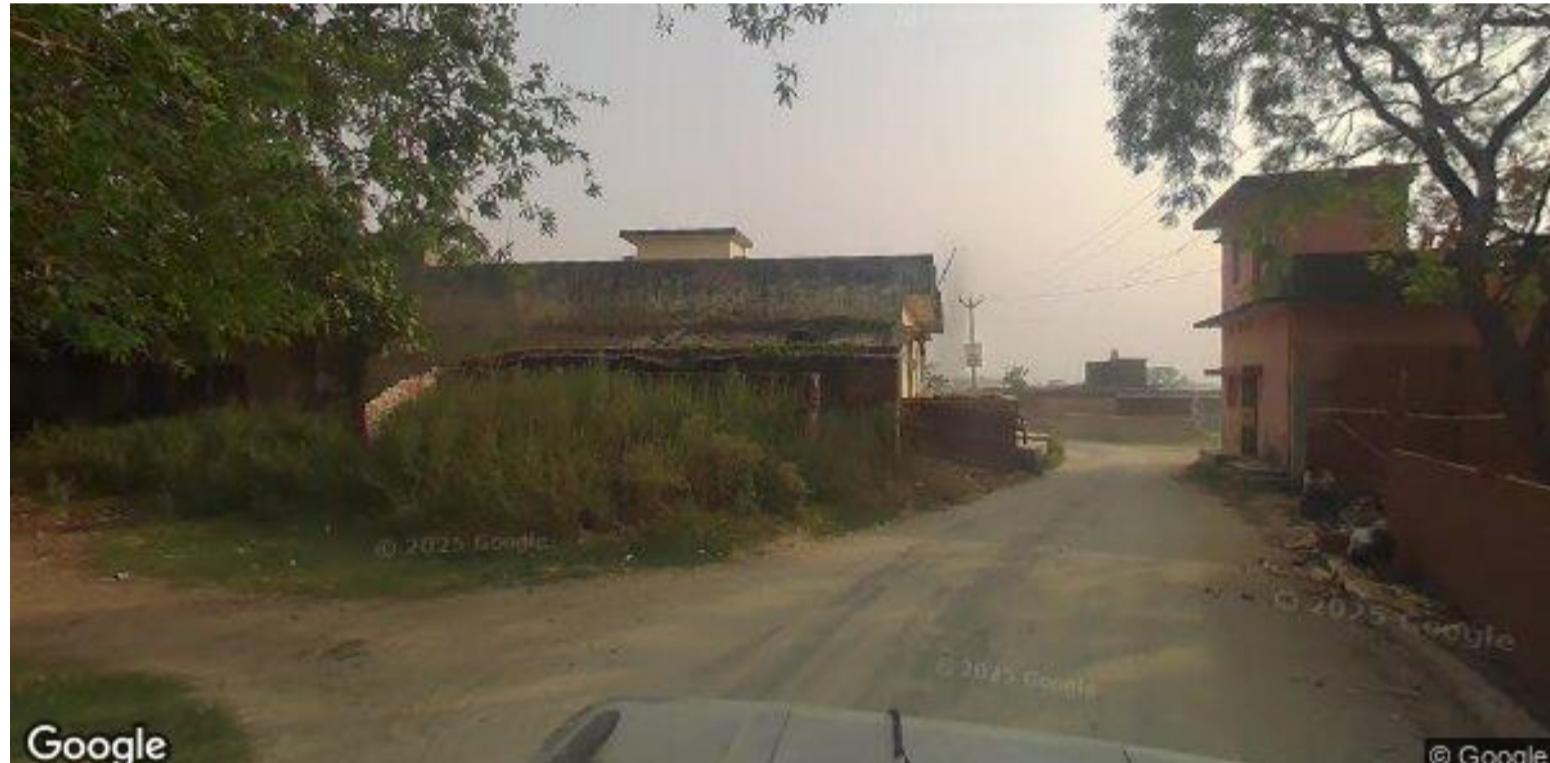
Risk Type: Turn**Risk Level:** Medium**Speed Limit:** 30 KM/Hr**Distance from Start:** 41.08 km**Coordinates:** 26.69264, 83.41444

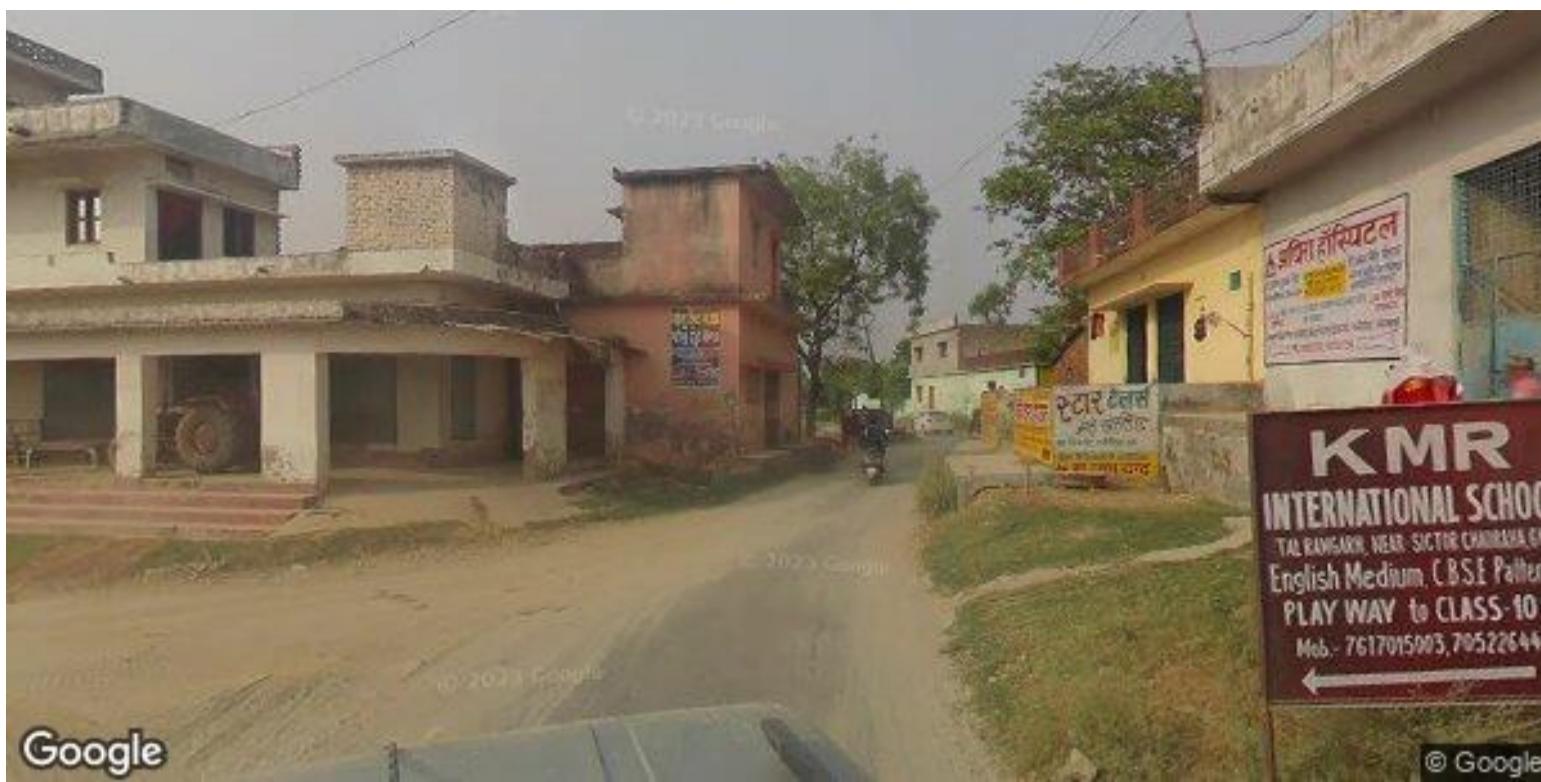
Risk Type: Turn**Risk Level:** High**Speed Limit:** 15 KM/Hr**Distance from Start:** 41.13 km**Coordinates:** 26.69245, 83.41410

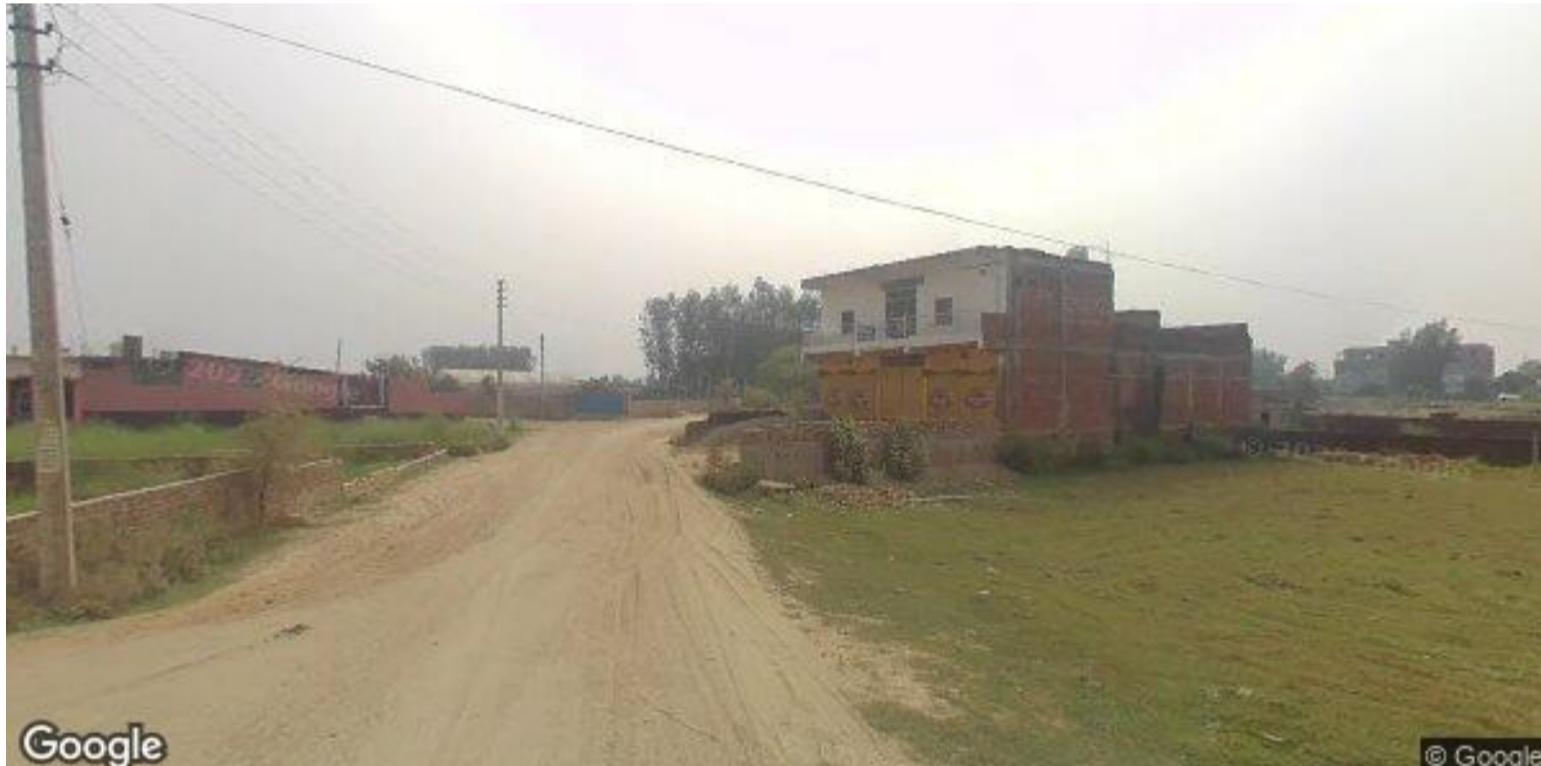
Risk Type: Turn**Risk Level:** High**Speed Limit:** 15 KM/Hr**Distance from Start:** 41.87 km**Coordinates:** 26.69552, 83.40808
