IndianOil

JOURNEY RISK MANAGEMENT (JRM) STUDY

Gorakhpur LPG BP TO KUNDAULI INDANE GRAM

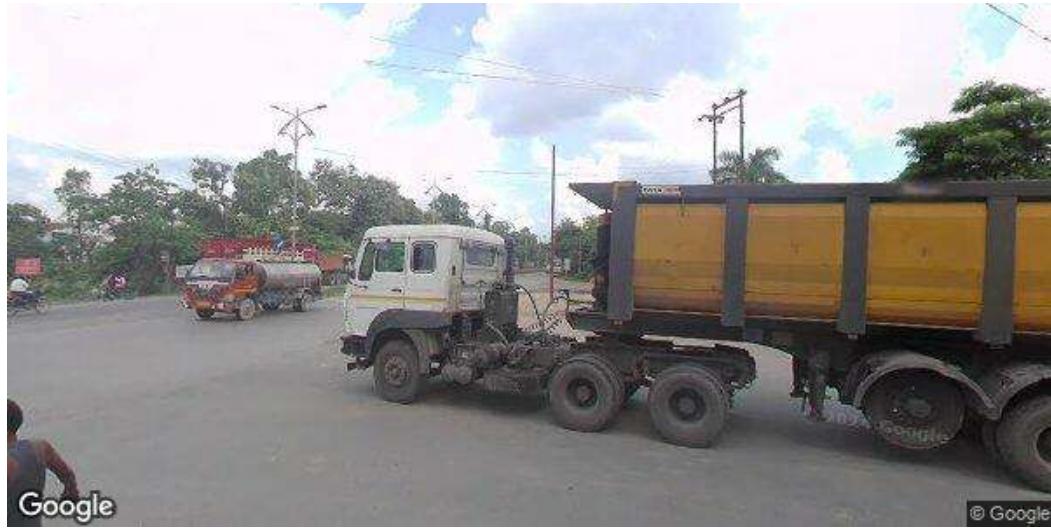
Risk Type: Blind Spot

Risk Level: Blind Spot

Speed Limit: 10 KM/Hr

Distance from Start: 2.16 km

Coordinates: 26.75126, 83.22476

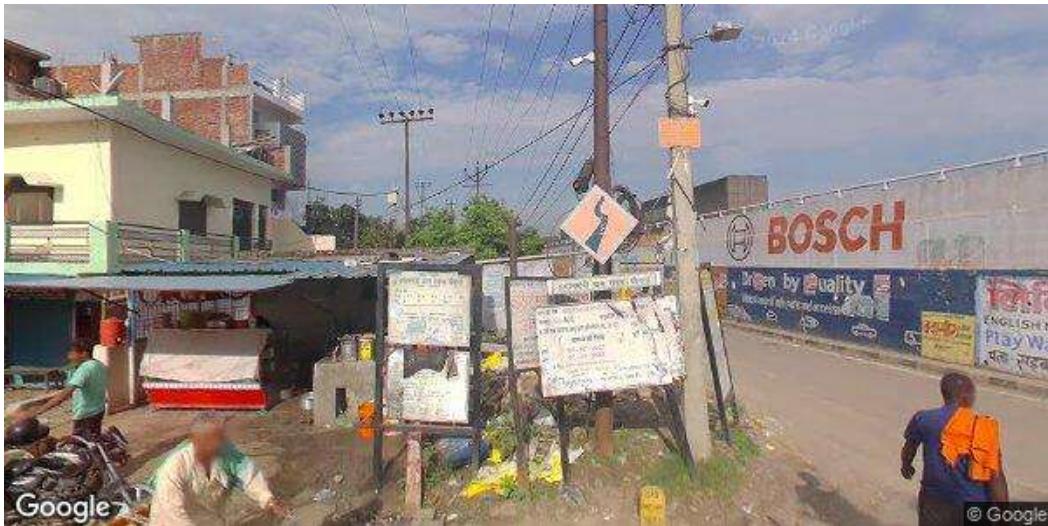
Risk Type: Blind Spot

Risk Level: Blind Spot

Speed Limit: 10 KM/Hr

Distance from Start: 4.22 km

Coordinates: 26.75353, 83.20457

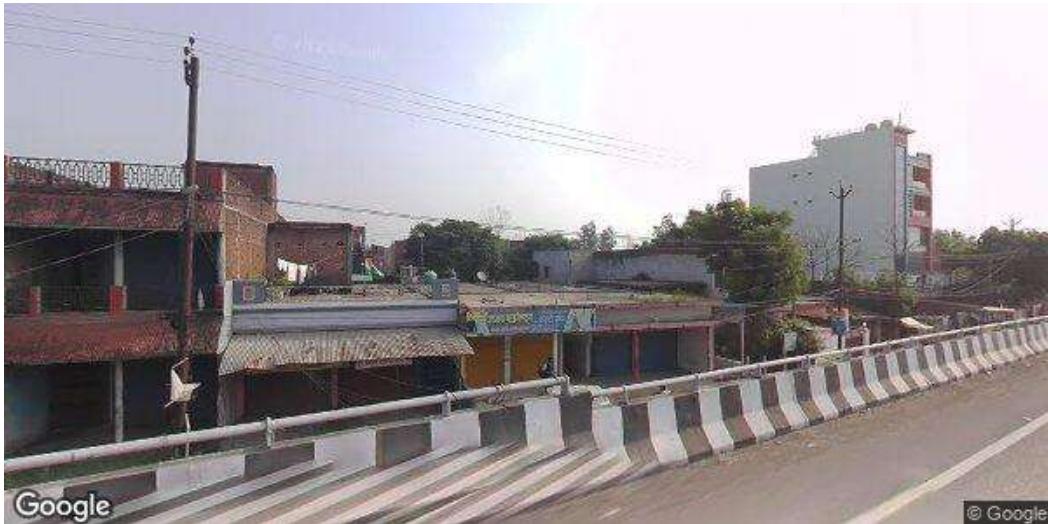
Risk Type: Turn

Risk Level: High

Speed Limit: 15 KM/Hr

Distance from Start: 4.27 km

Coordinates: 26.75377, 83.20465

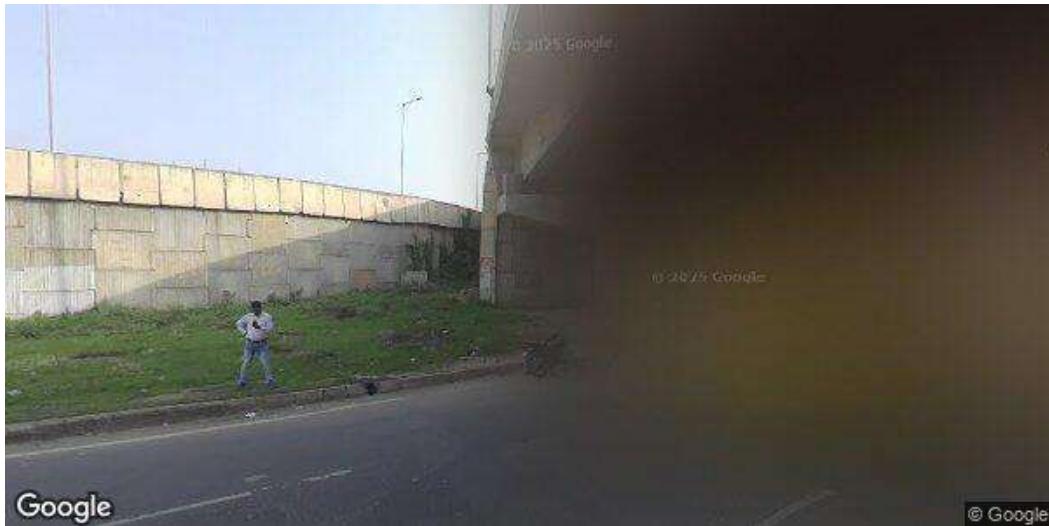
Risk Type: Roundabout
Risk Level: High
Speed Limit: 15 KM/Hr
Distance from Start: 8.13 km
Coordinates: 26.74681, 83.25111

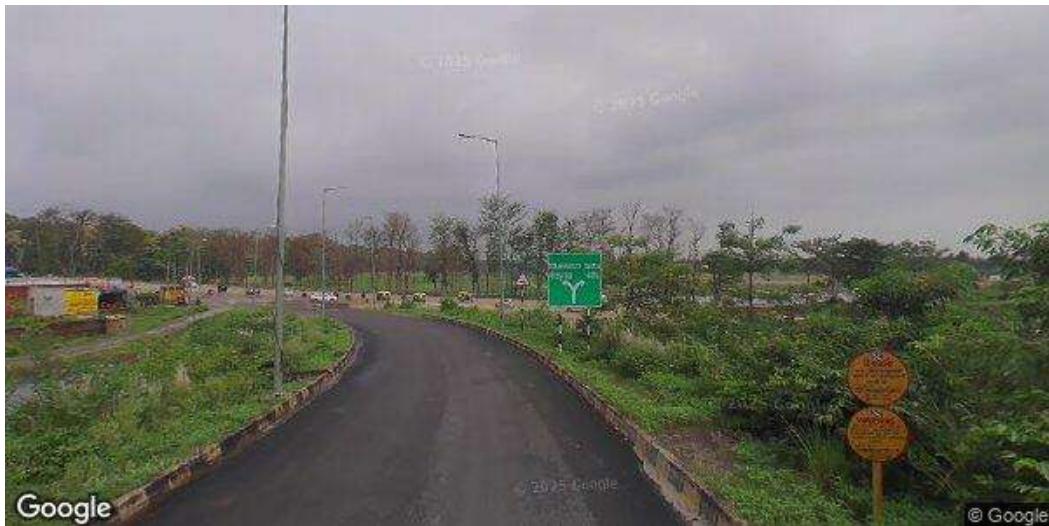
Risk Type: Turn
Risk Level: Medium
Speed Limit: 30 KM/Hr
Distance from Start: 33.25 km
Coordinates: 26.69741, 83.47552

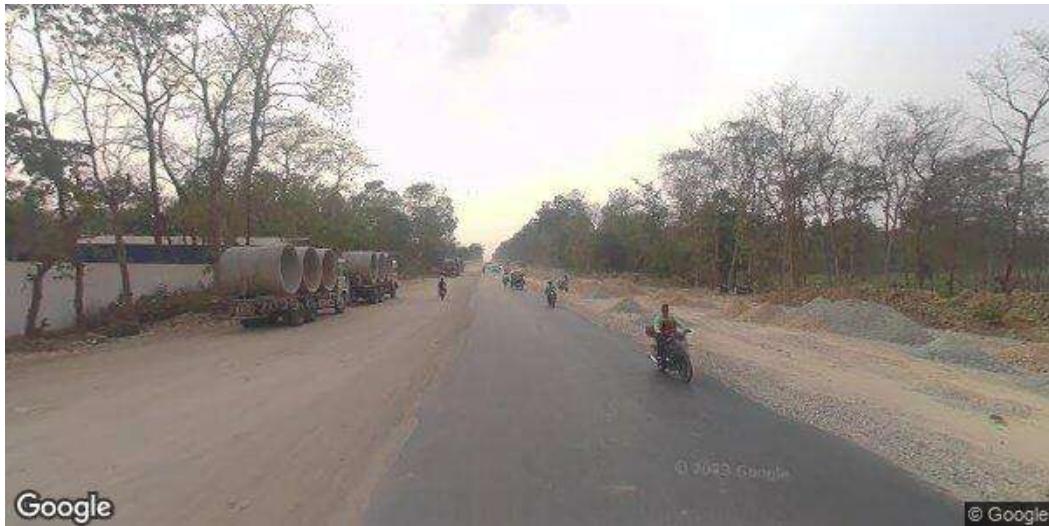
Risk Type: Blind Spot**Risk Level:** Blind Spot**Speed Limit:** 10 KM/Hr**Distance from Start:** 33.41 km**Coordinates:** 26.69844, 83.47473

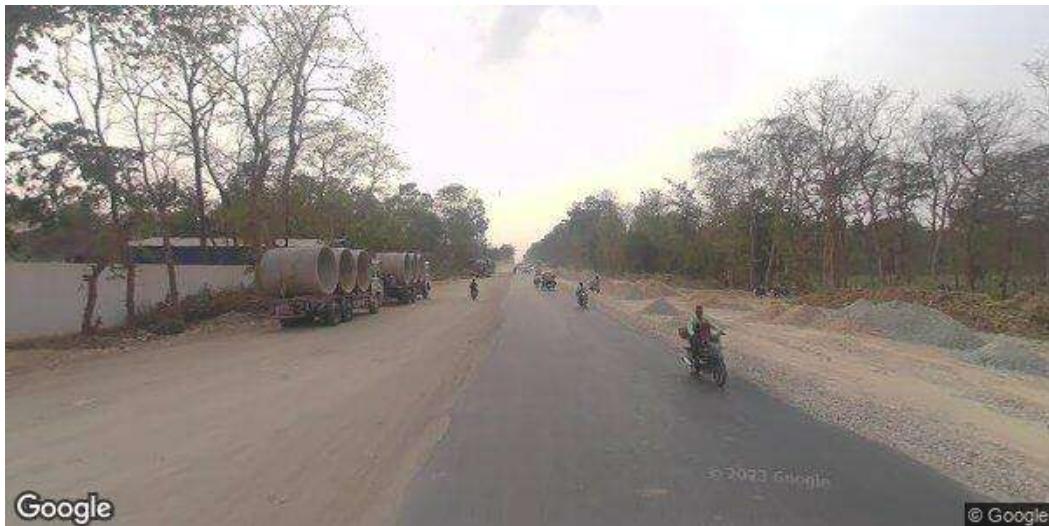
Risk Type: U-Turn**Risk Level:** High**Speed Limit:** 10 KM/Hr**Distance from Start:** 33.41 km**Coordinates:** 26.698439, 83.4747268

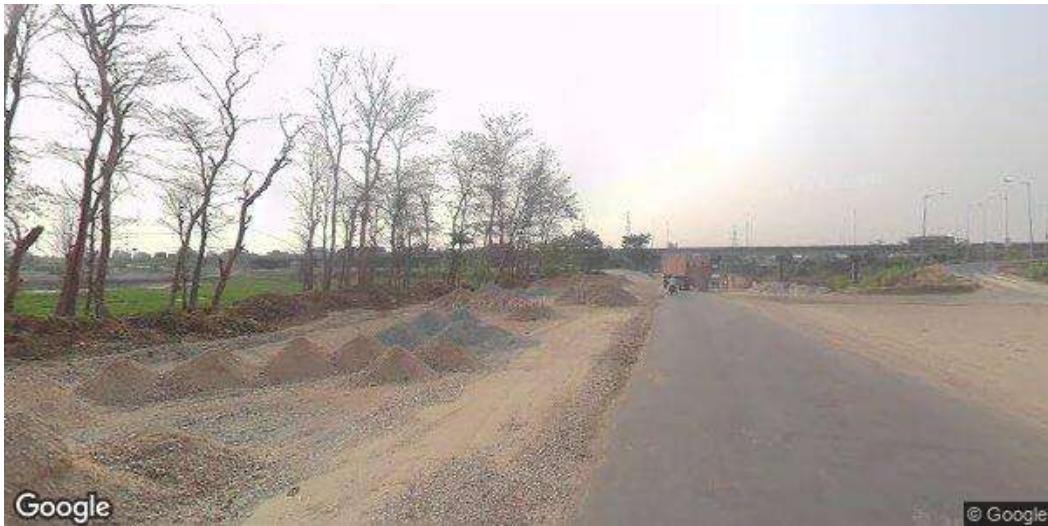
Risk Type: Turn

Risk Level: High

Speed Limit: 15 KM/Hr

Distance from Start: 33.43 km

Coordinates: 26.69857, 83.47481

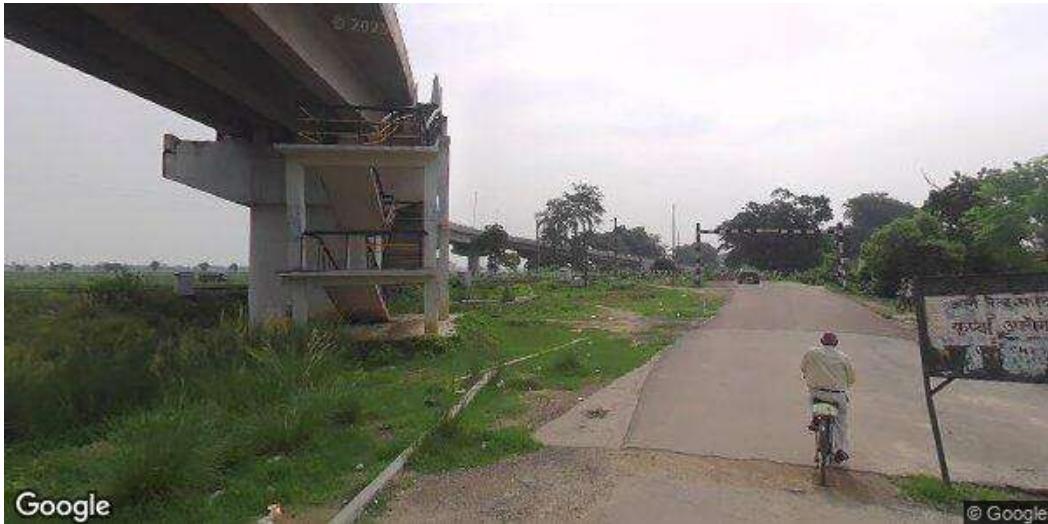
Risk Type: Turn

Risk Level: Medium

Speed Limit: 30 KM/Hr

Distance from Start: 47.40 km

Coordinates: 26.63752, 83.59723

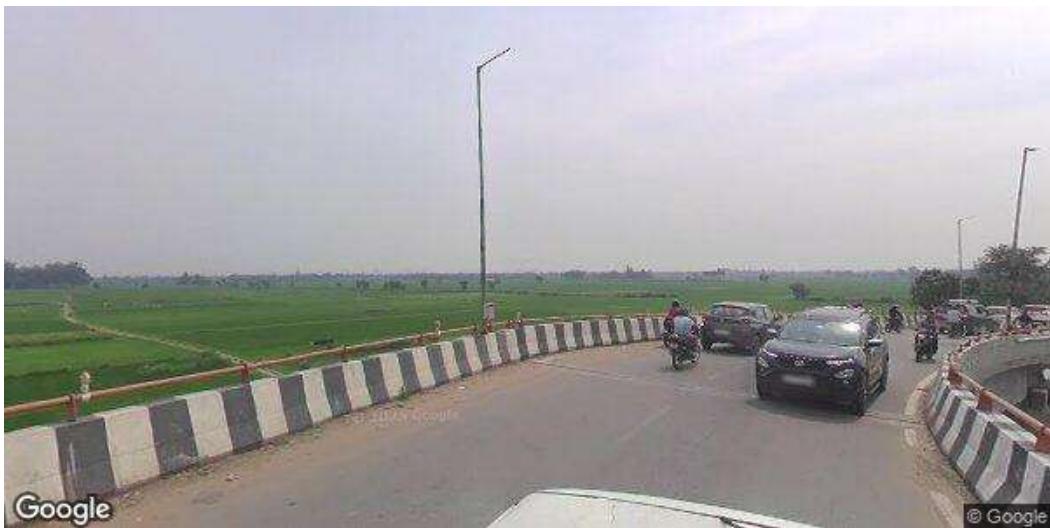
Risk Type: Turn

Risk Level: Medium

Speed Limit: 30 KM/Hr

Distance from Start: 47.46 km

Coordinates: 26.63761, 83.59795

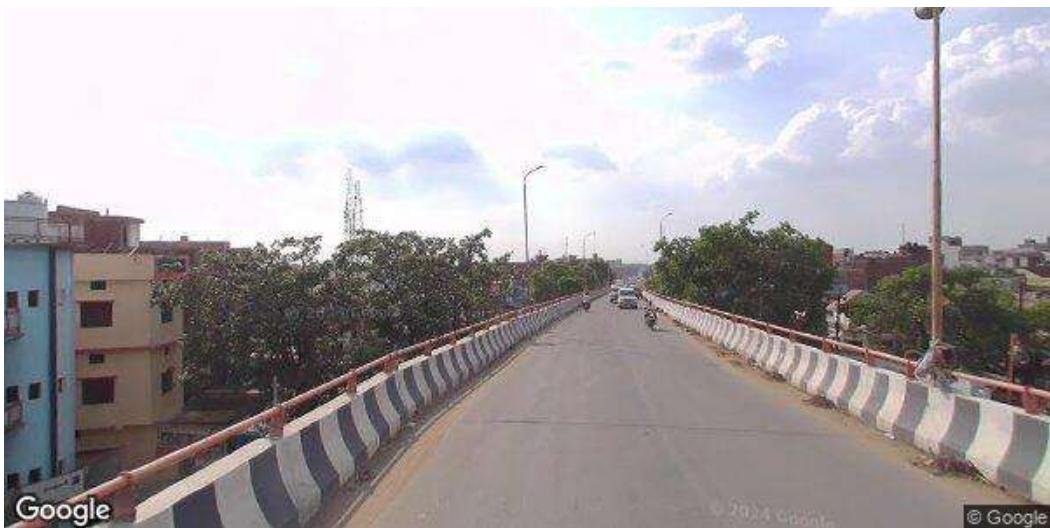
Risk Type: Turn

Risk Level: Medium

Speed Limit: 30 KM/Hr

Distance from Start: 100.12 km

Coordinates: 26.29409, 83.92225

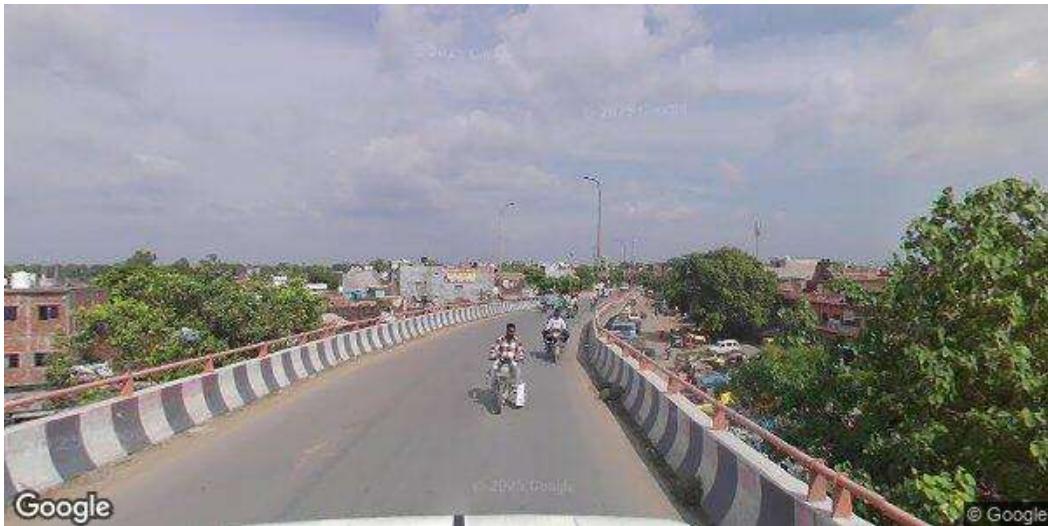
Risk Type: Turn

Risk Level: Medium

Speed Limit: 30 KM/Hr

Distance from Start: 100.37 km

Coordinates: 26.29365, 83.92376

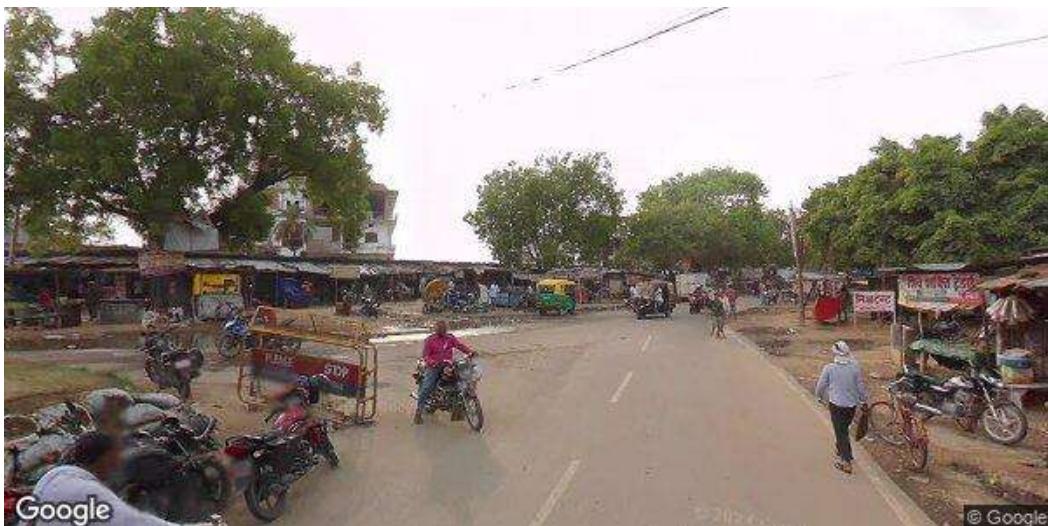
Risk Type: Blind Spot

Risk Level: Blind Spot

Speed Limit: 10 KM/Hr

Distance from Start: 103.38 km

Coordinates: 26.27606, 83.94517

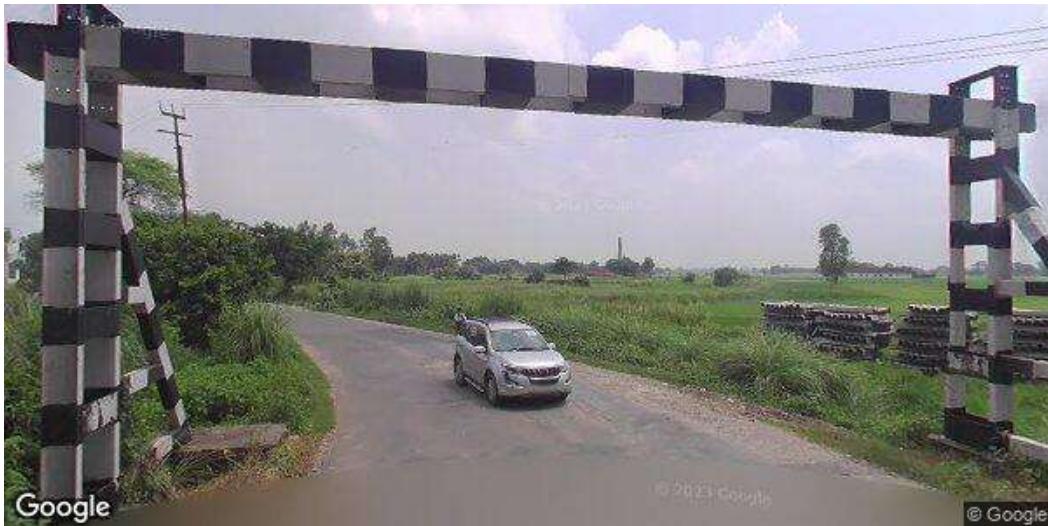
Risk Type: Turn

Risk Level: Medium

Speed Limit: 30 KM/Hr

Distance from Start: 107.73 km

Coordinates: 26.24561, 83.91559

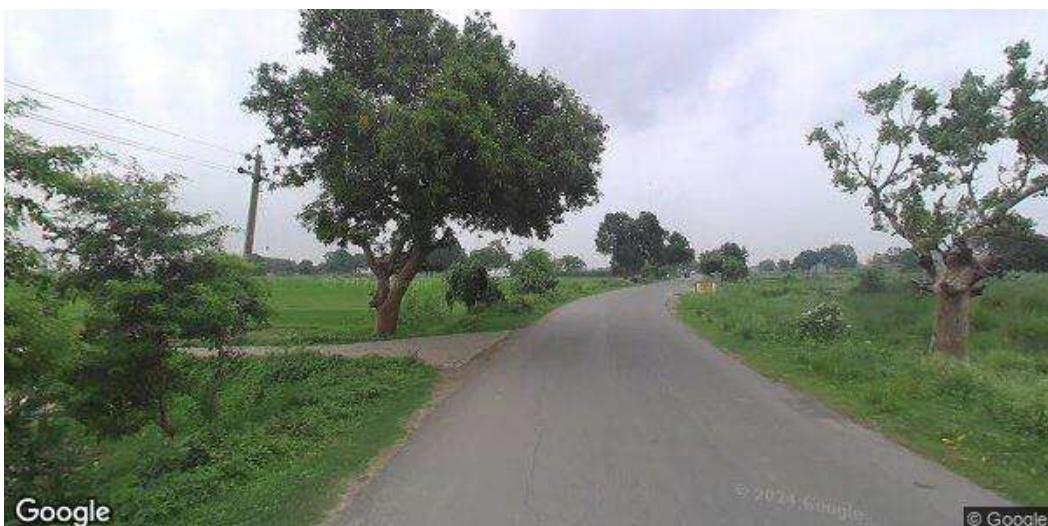
Risk Type: Turn

Risk Level: Medium

Speed Limit: 30 KM/Hr

Distance from Start: 111.15 km

Coordinates: 26.21768, 83.90127

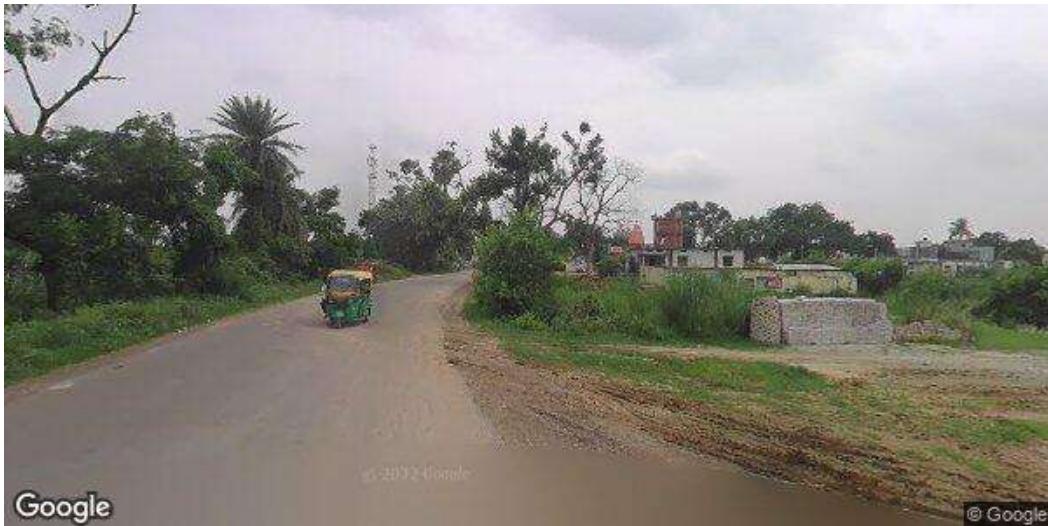
Risk Type: Turn

Risk Level: Medium

Speed Limit: 30 KM/Hr

Distance from Start: 112.04 km

Coordinates: 26.21160, 83.90290

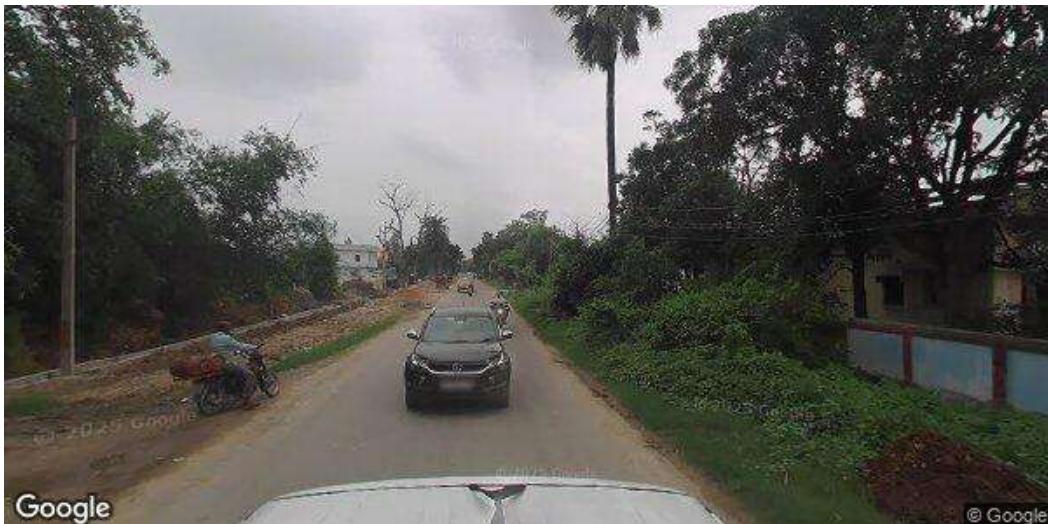
Risk Type: Blind Spot

Risk Level: Blind Spot

Speed Limit: 10 KM/Hr

Distance from Start: 112.36 km

Coordinates: 26.20895, 83.90250
