## JOURNEY RISK MANAGEMENT (JRM) STUDY

### Gorakhpur LPG BP to ASHISH INDANE GAS SERVICE

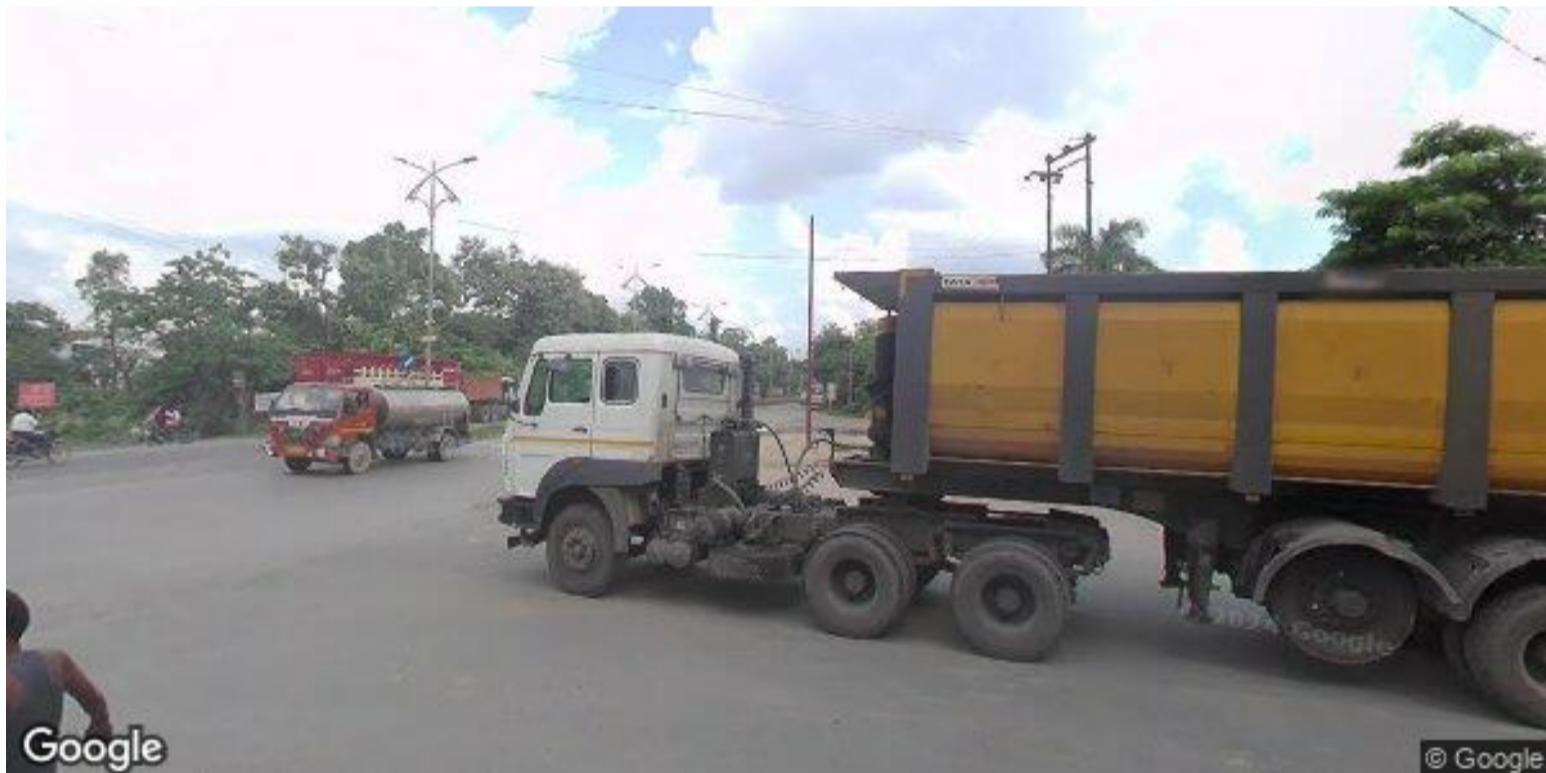
**Coordinates:** 26.75126, 83.22476

**Risk Type:** Blind Spot

**Risk Level:** Blind Spot

**Speed Limit:** 10 KM/Hr

**Distance from Start:** 2.17 km

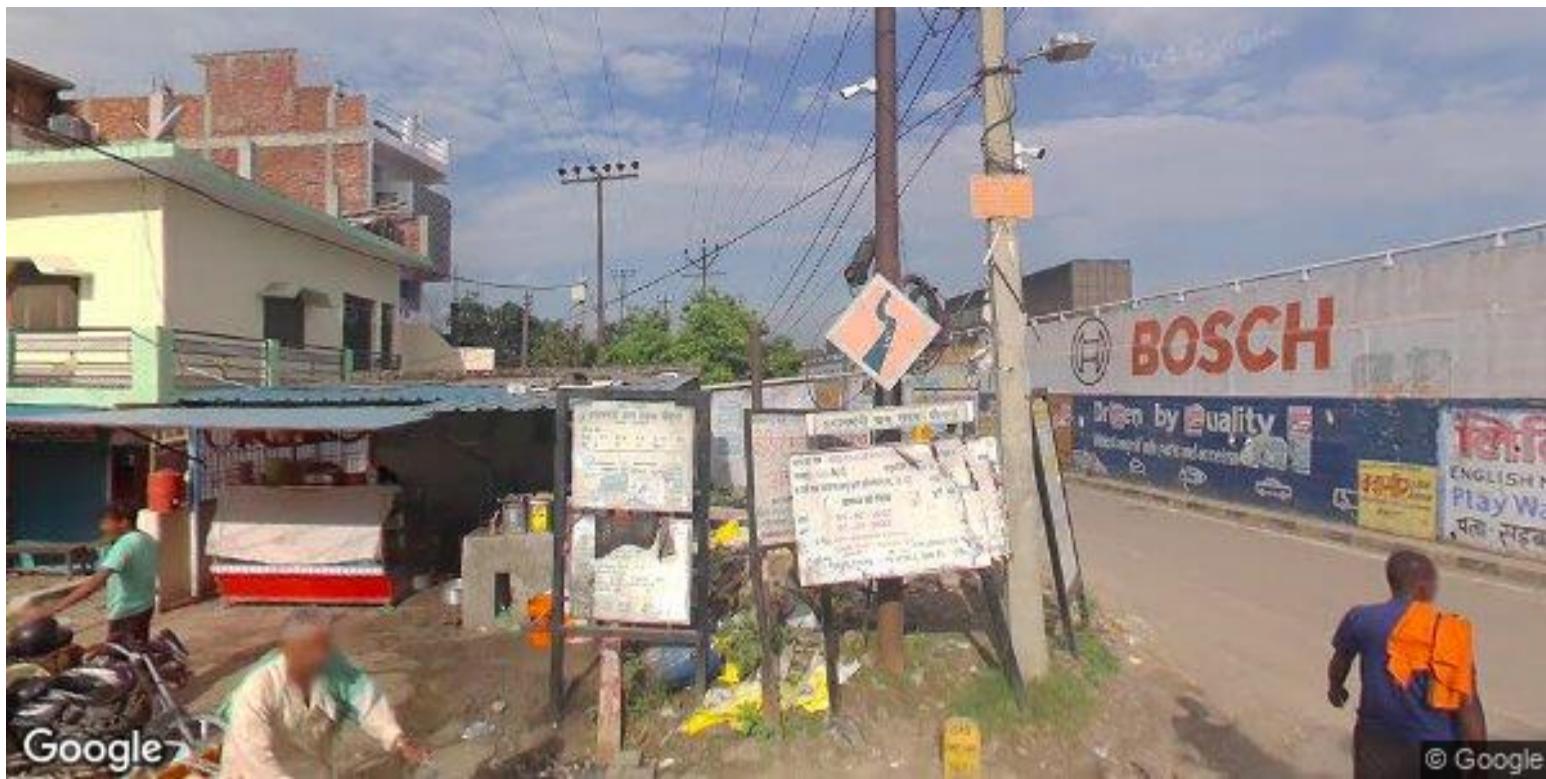
**Coordinates:** 26.75353, 83.20457

**Risk Type:** Blind Spot

**Risk Level:** Blind Spot

**Speed Limit:** 10 KM/Hr

**Distance from Start:** 4.23 km

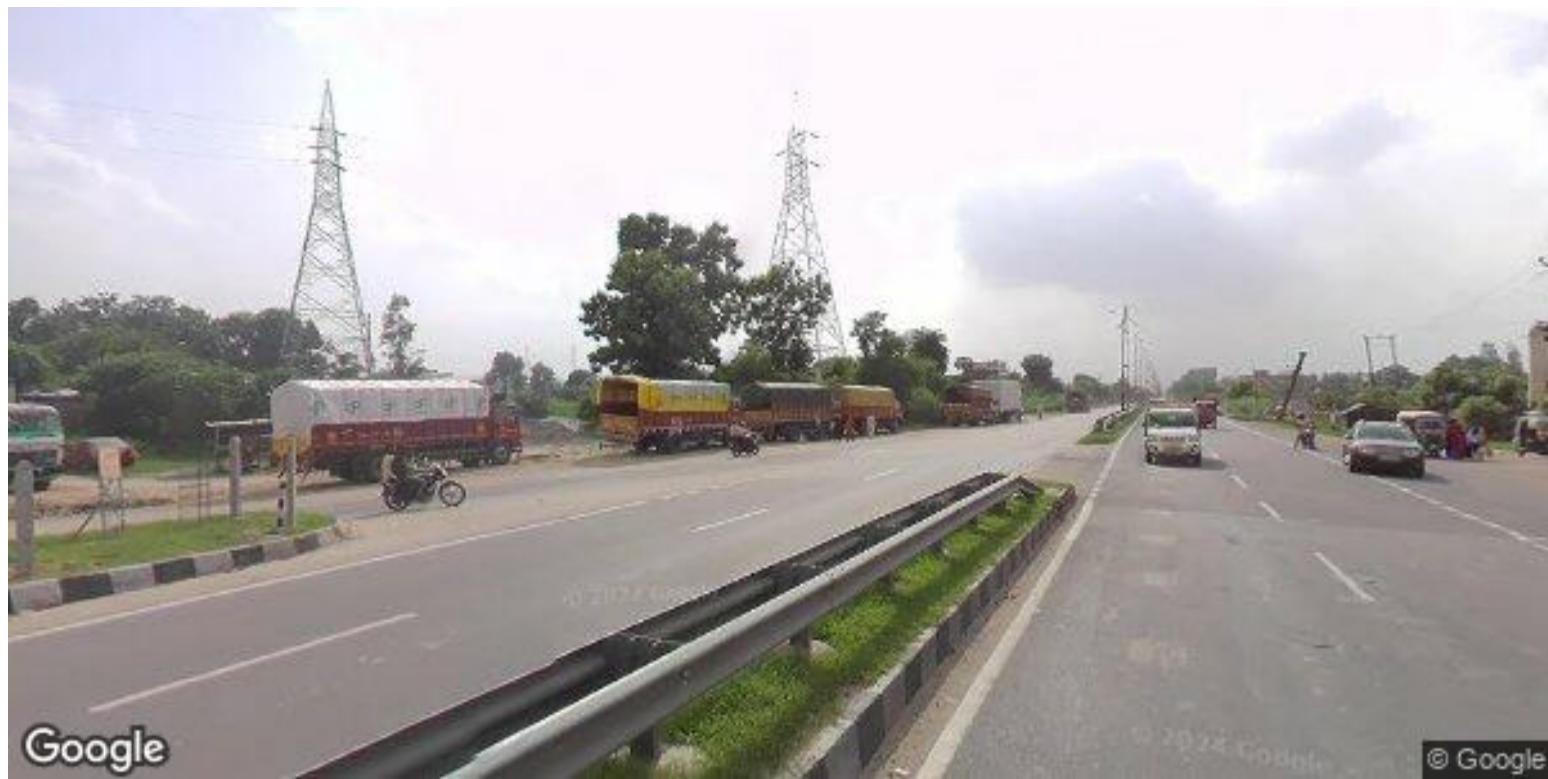
**Coordinates:** 26.74708, 83.24935

**Risk Type:** Turn

**Risk Level:** High

**Speed Limit:** 15 KM/Hr

**Distance from Start:** 8.81 km

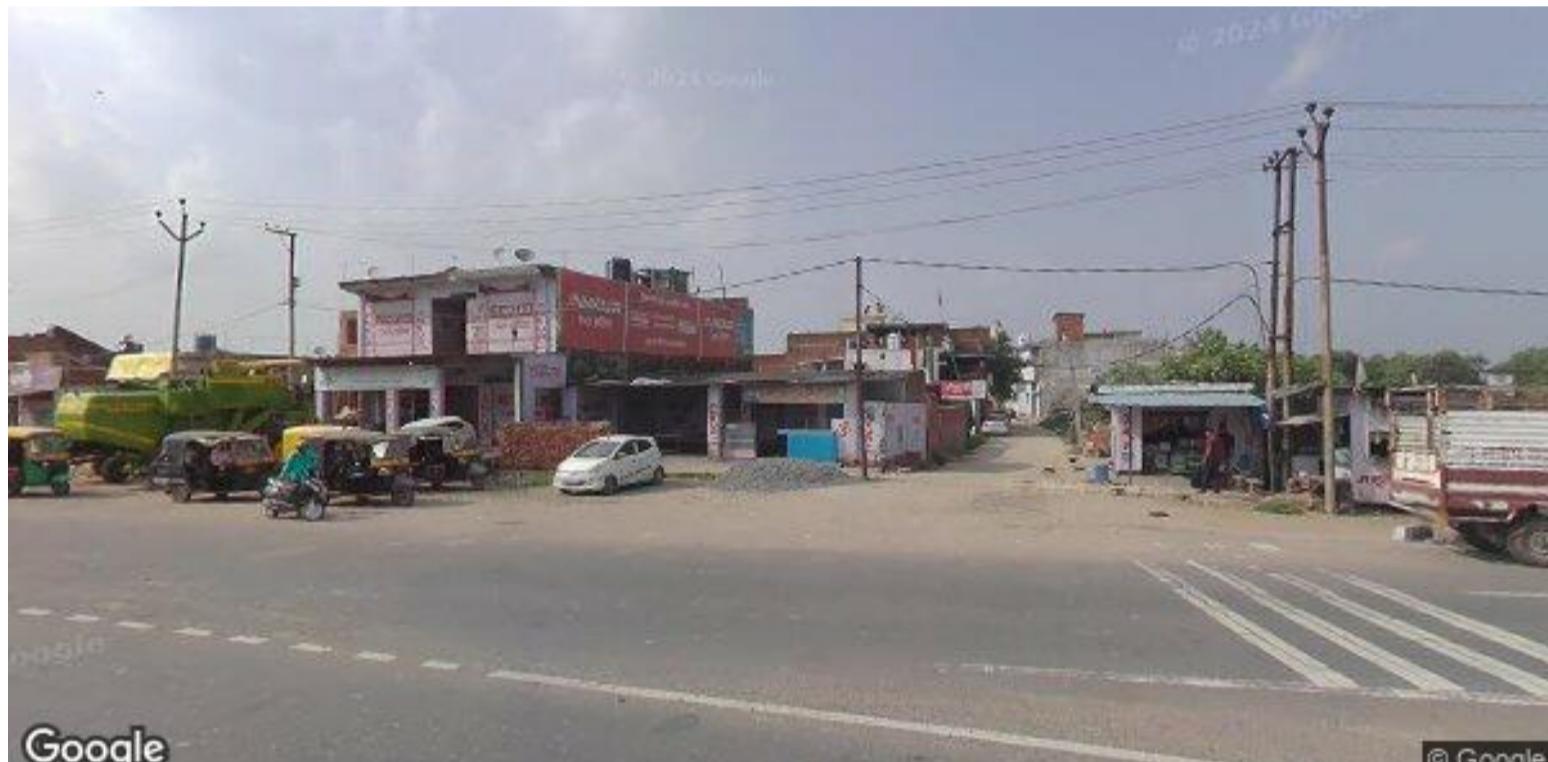
**Coordinates:** 26.74712, 83.24938

**Risk Type:** Turn

**Risk Level:** Medium

**Speed Limit:** 30 KM/Hr

**Distance from Start:** 8.82 km

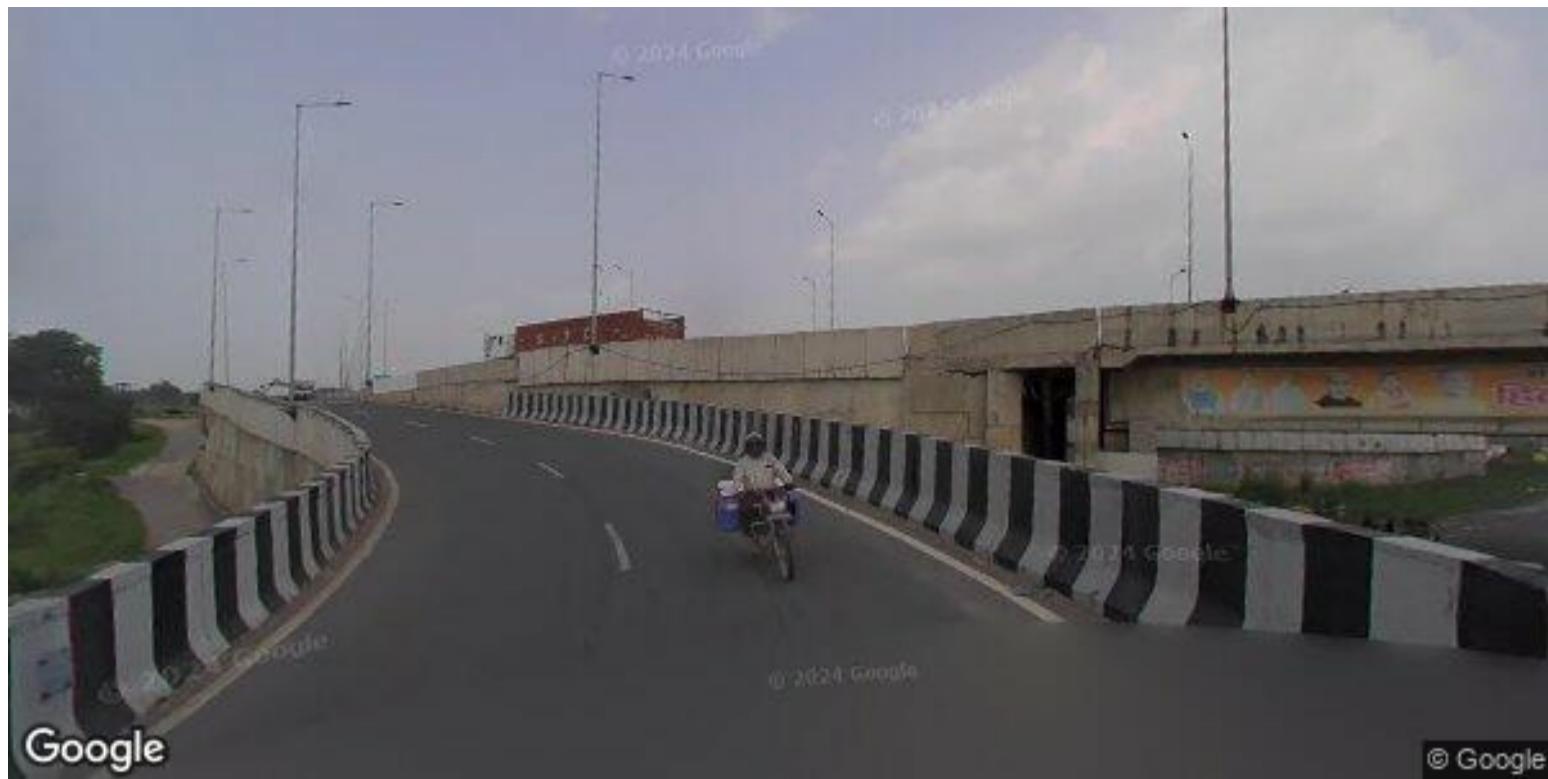
**Coordinates:** 26.74703, 83.25096

**Risk Type:** Turn

**Risk Level:** Medium

**Speed Limit:** 30 KM/Hr

**Distance from Start:** 8.98 km

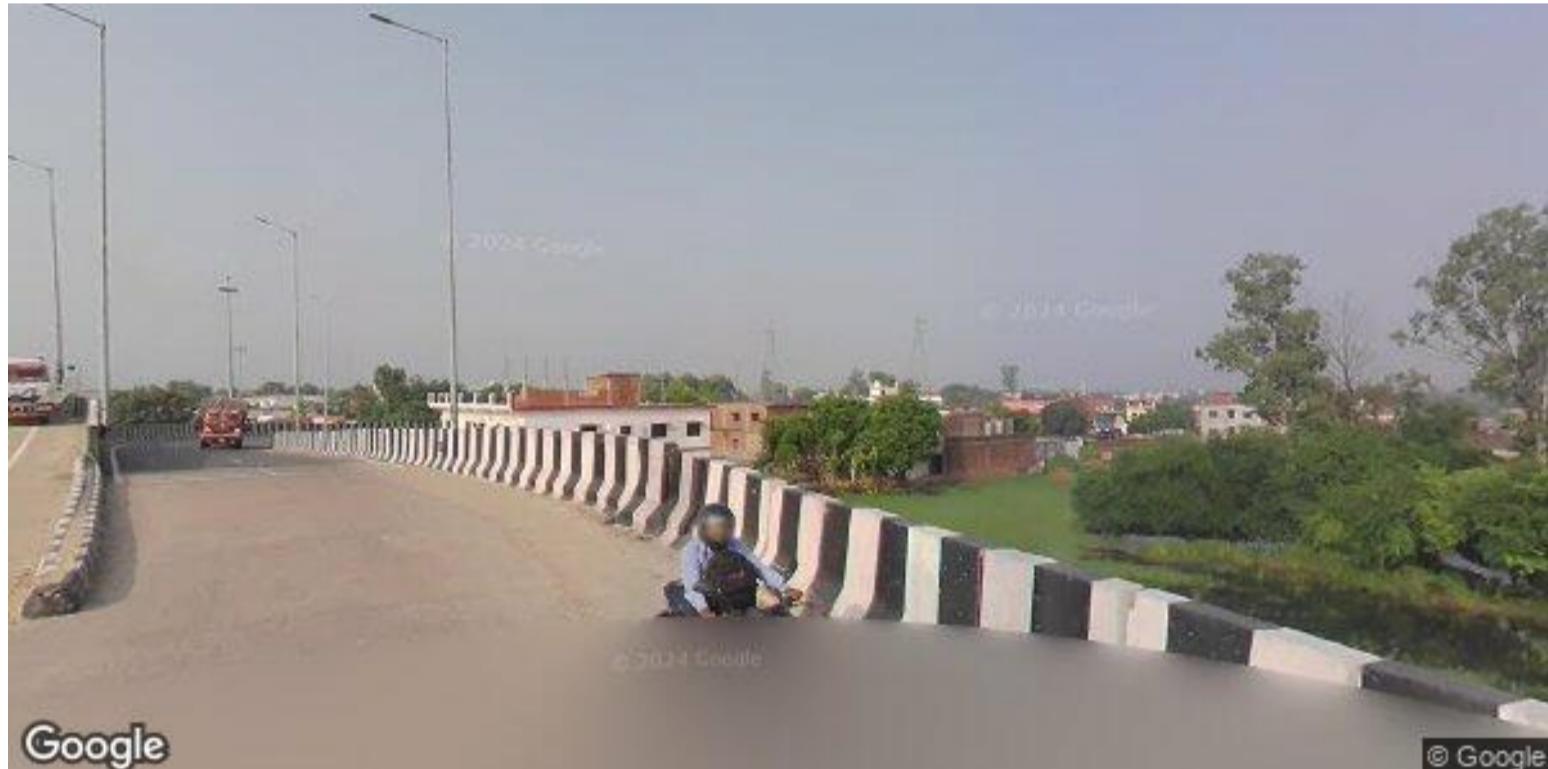
**Coordinates:** 26.74767, 83.25139

**Risk Type:** Turn

**Risk Level:** Medium

**Speed Limit:** 30 KM/Hr

**Distance from Start:** 9.06 km

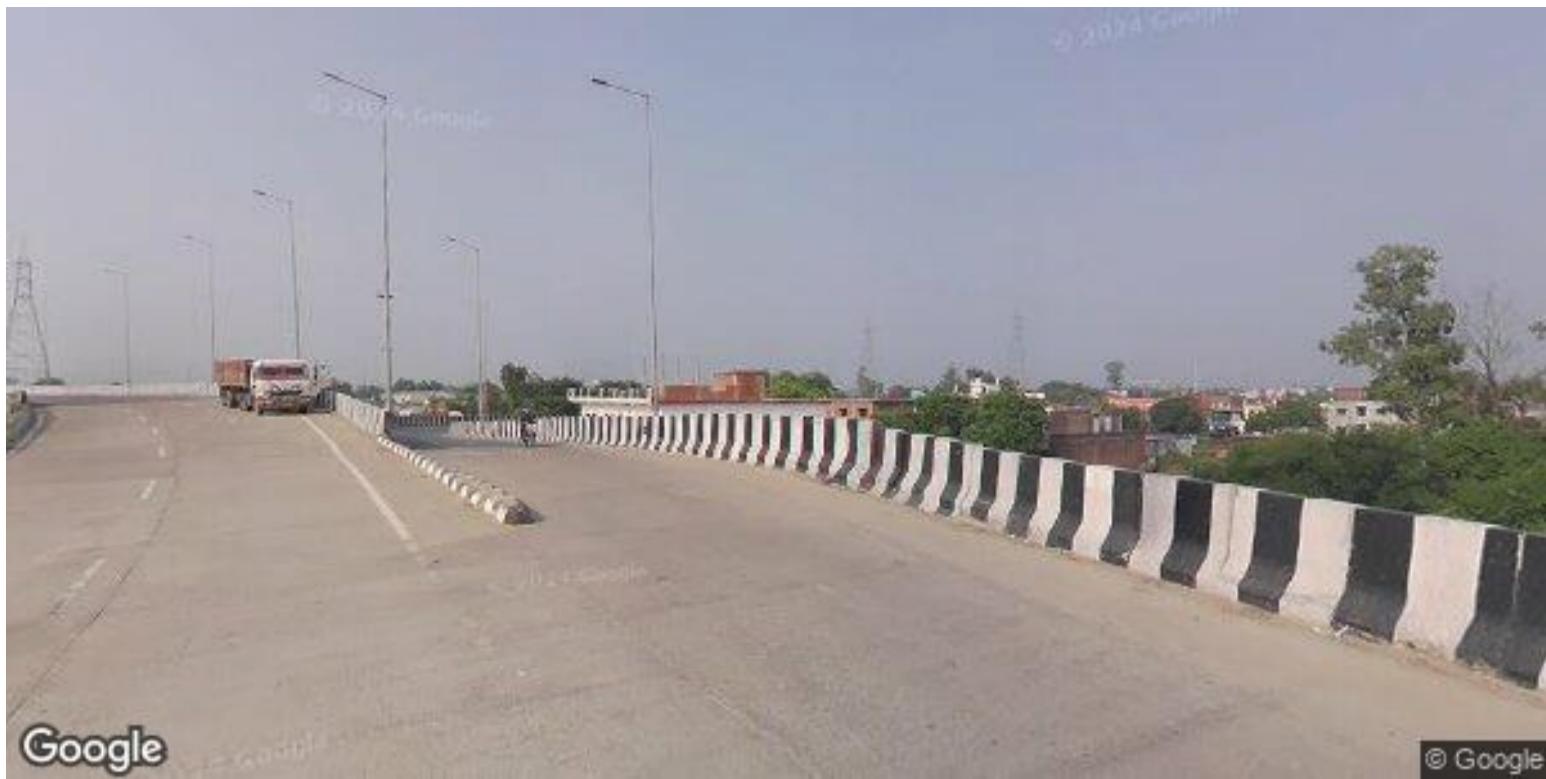
**Coordinates:** 26.74769, 83.25146

**Risk Type:** Turn

**Risk Level:** High

**Speed Limit:** 15 KM/Hr

**Distance from Start:** 9.07 km

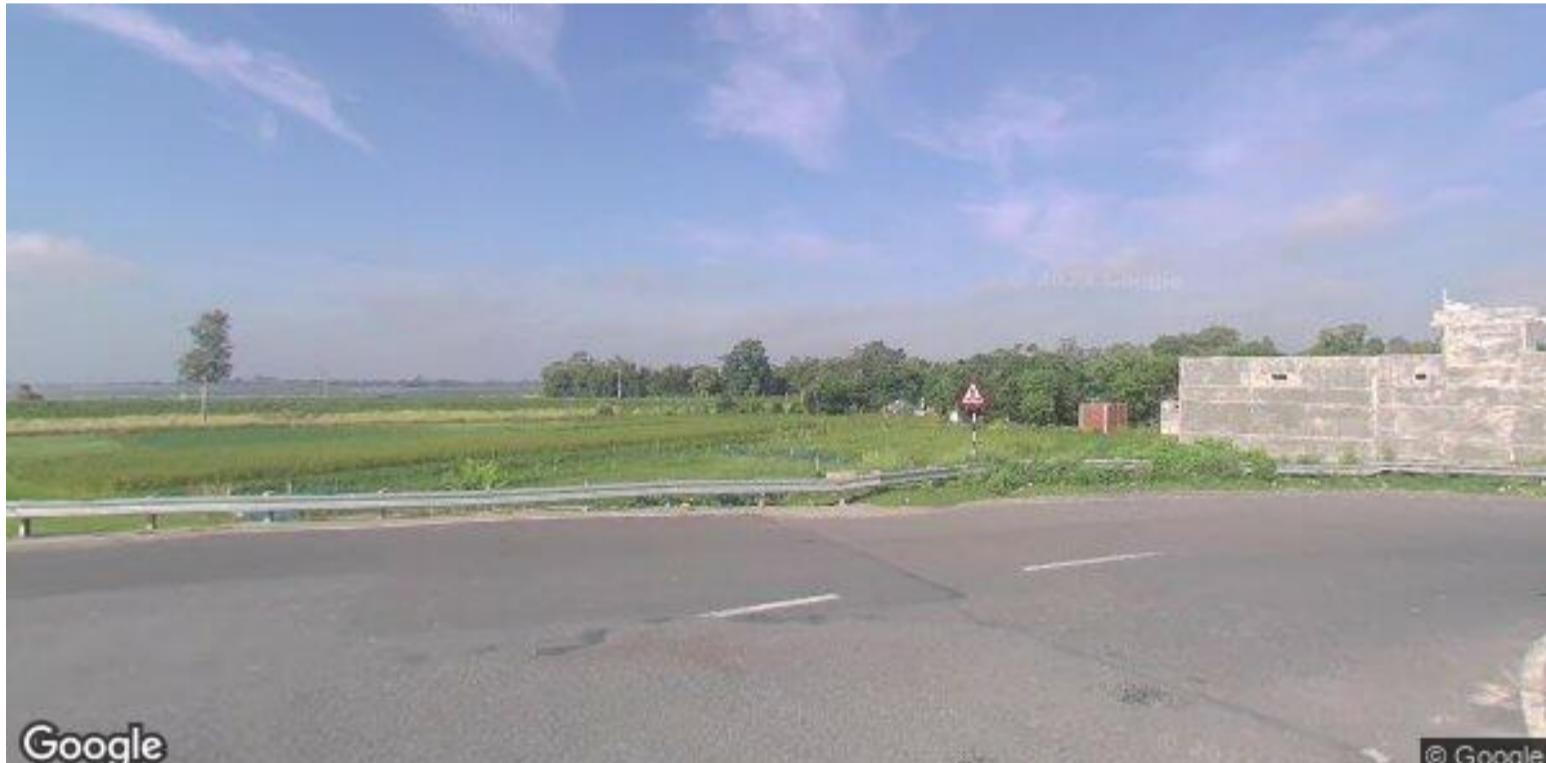
**Coordinates:** 26.86209, 83.31517

**Risk Type:** Roundabout

**Risk Level:** High

**Speed Limit:** 15 KM/Hr

**Distance from Start:** 24.87 km

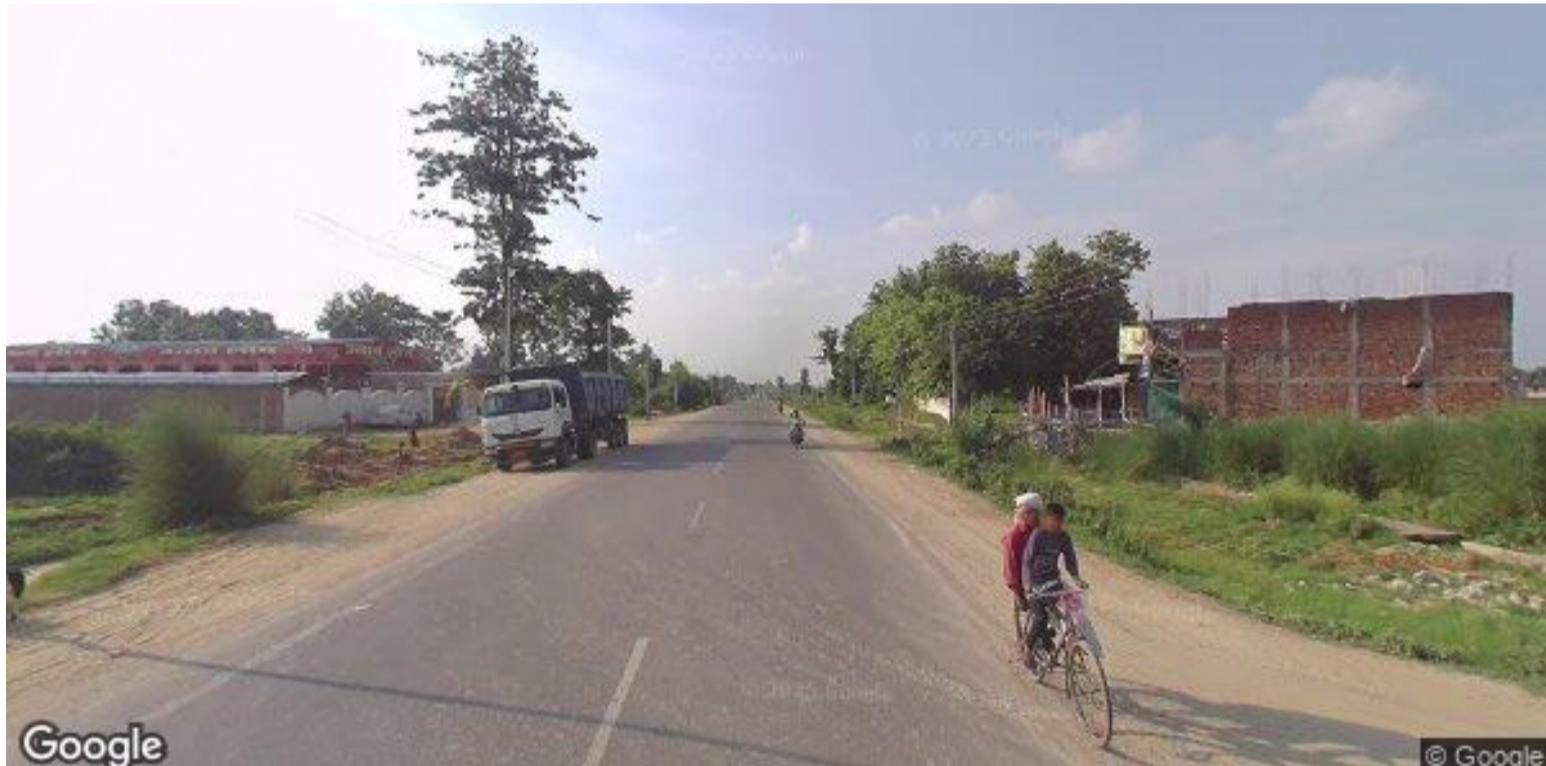
**Coordinates:** 26.94870, 83.29539

**Risk Type:** Blind Spot

**Risk Level:** Blind Spot

**Speed Limit:** 10 KM/Hr

**Distance from Start:** 35.07 km
