JOURNEY RISK MANAGEMENT (JRM) STUDY

Gorakhpur LPG BP TO ADITYA INDANE GAS SE

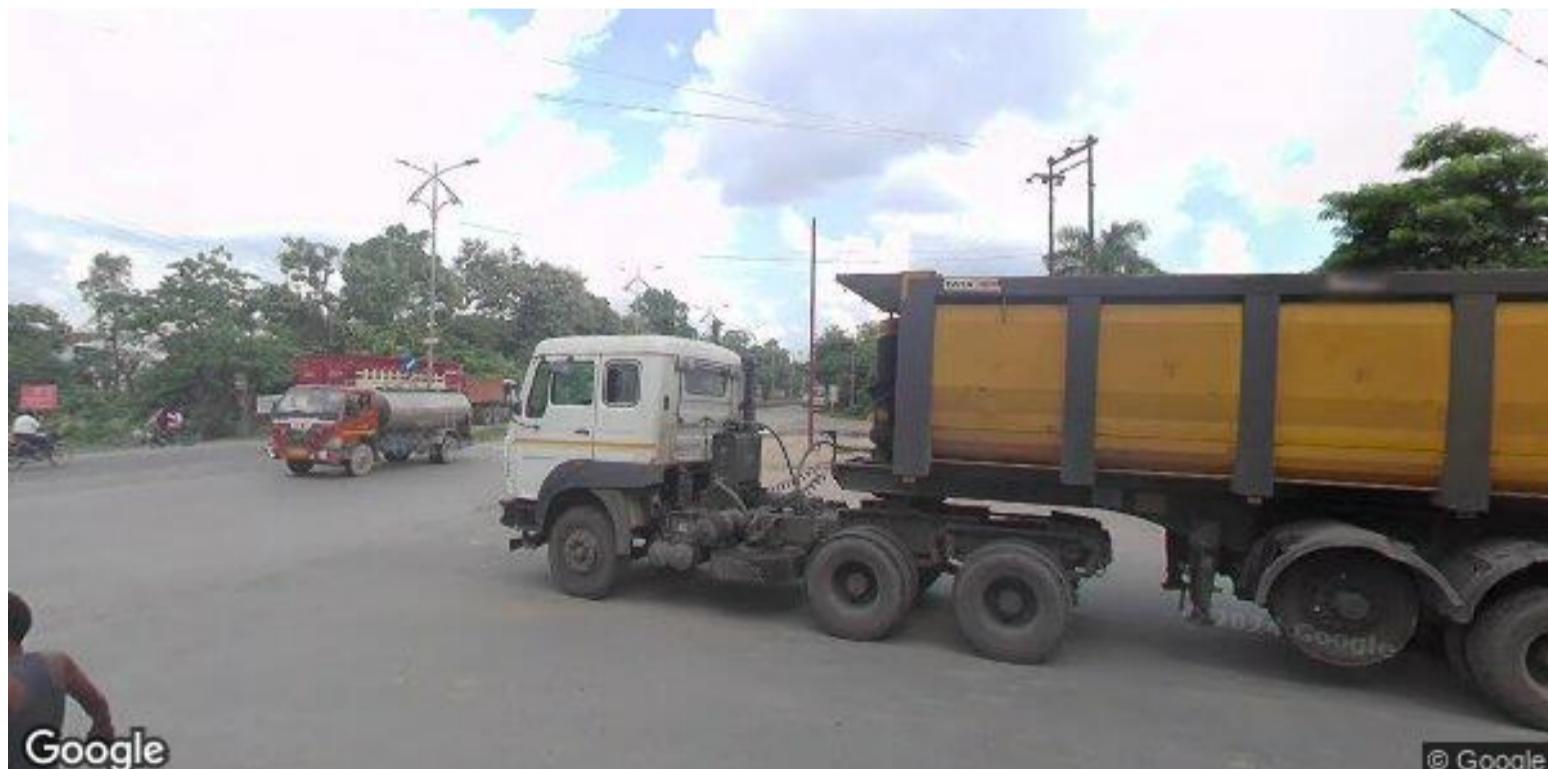
Coordinates: 26.75126, 83.22476

Risk Type: Blind Spot

Risk Level: Blind Spot

Speed Limit: 10 KM/Hr

Distance from Start: 2.17 km

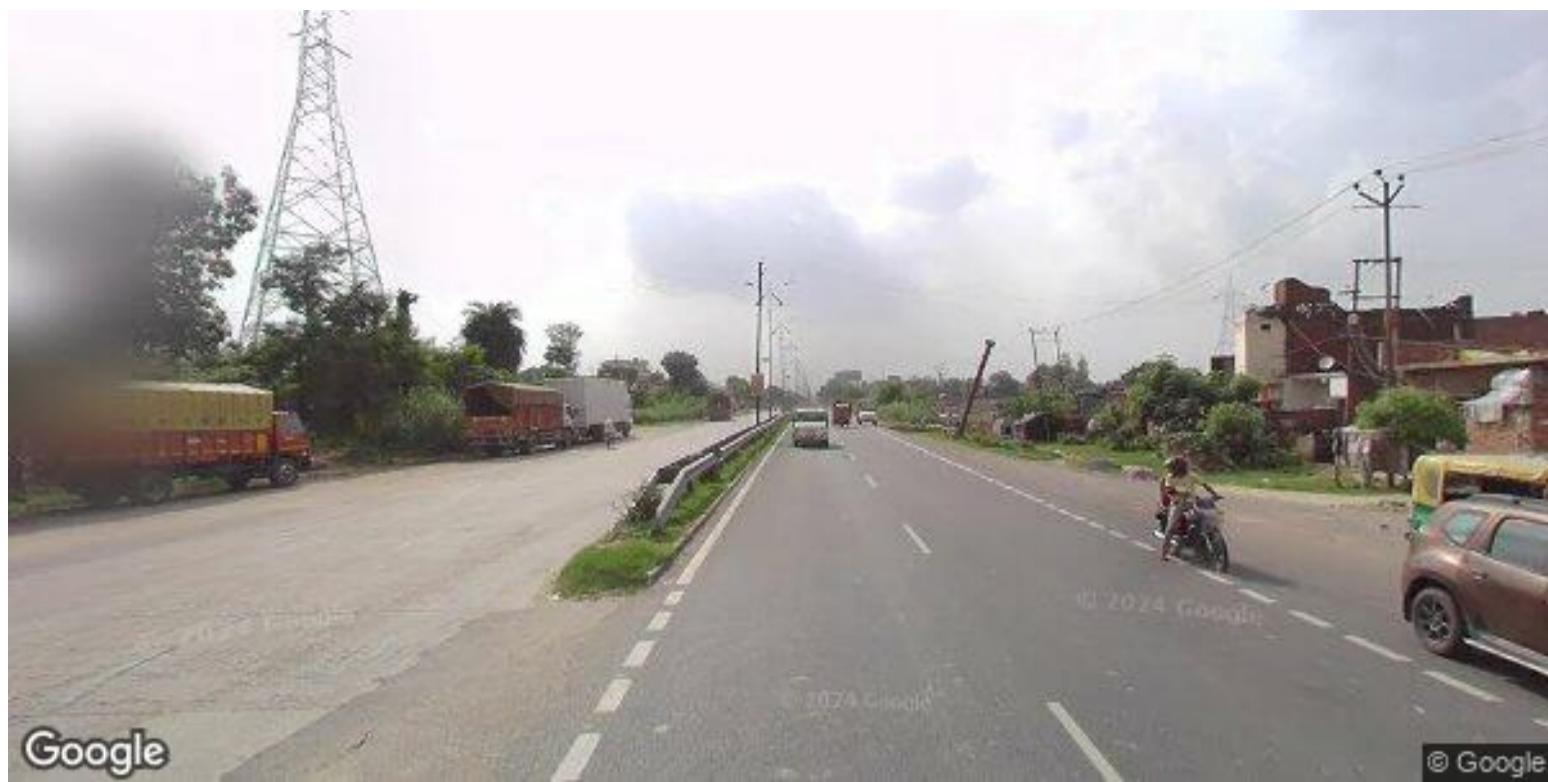
Risk Type: U-Turn**Risk Level: High****Speed Limit: 10 KM/Hr****Distance from Start: 8.76 km****Coordinates: 26.7471208, 83.2490873**

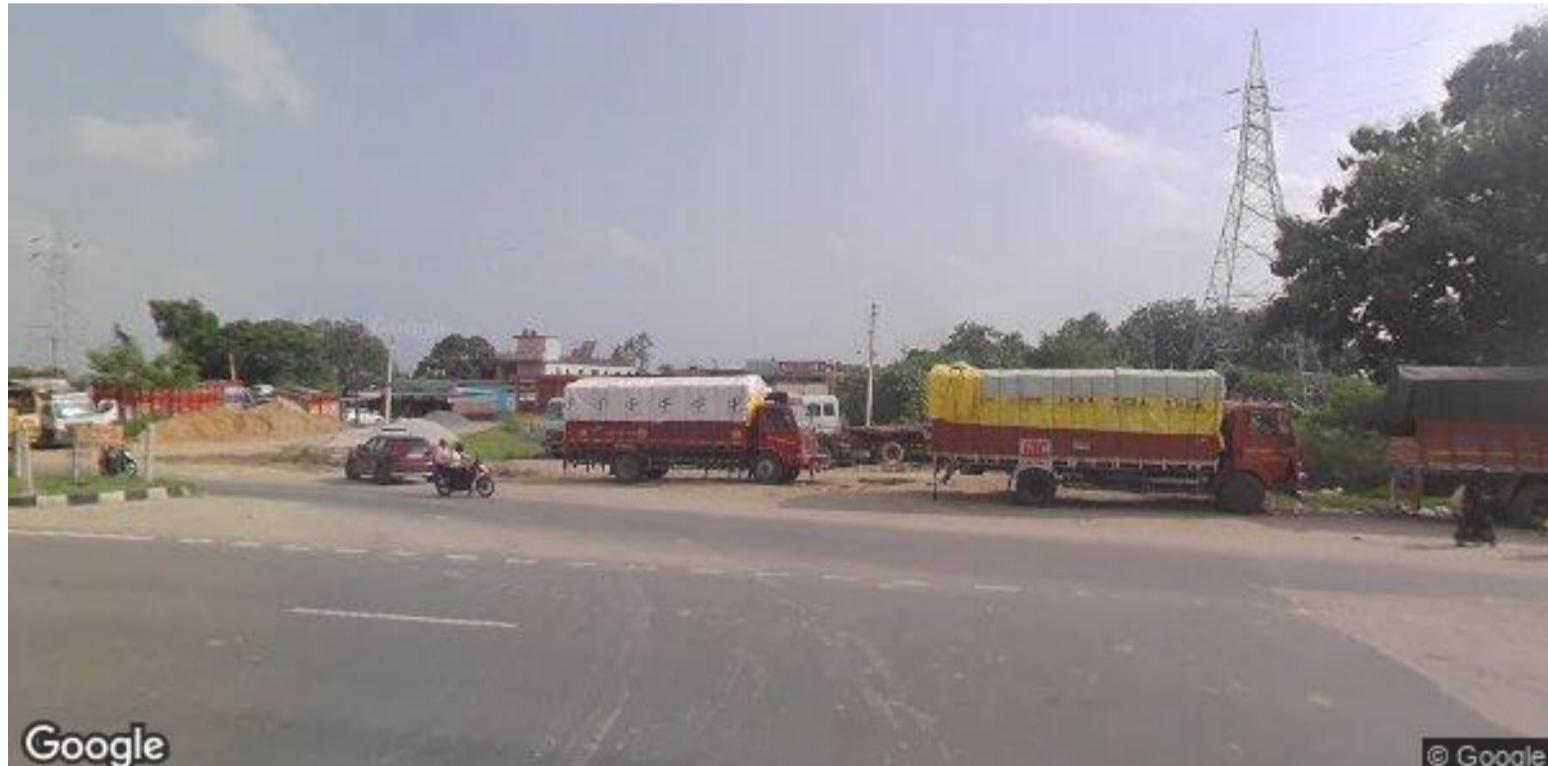
Risk Type: Blind Spot**Risk Level: Blind Spot****Speed Limit: 10 KM/Hr****Distance from Start: 8.76 km****Coordinates: 26.74712, 83.24909**

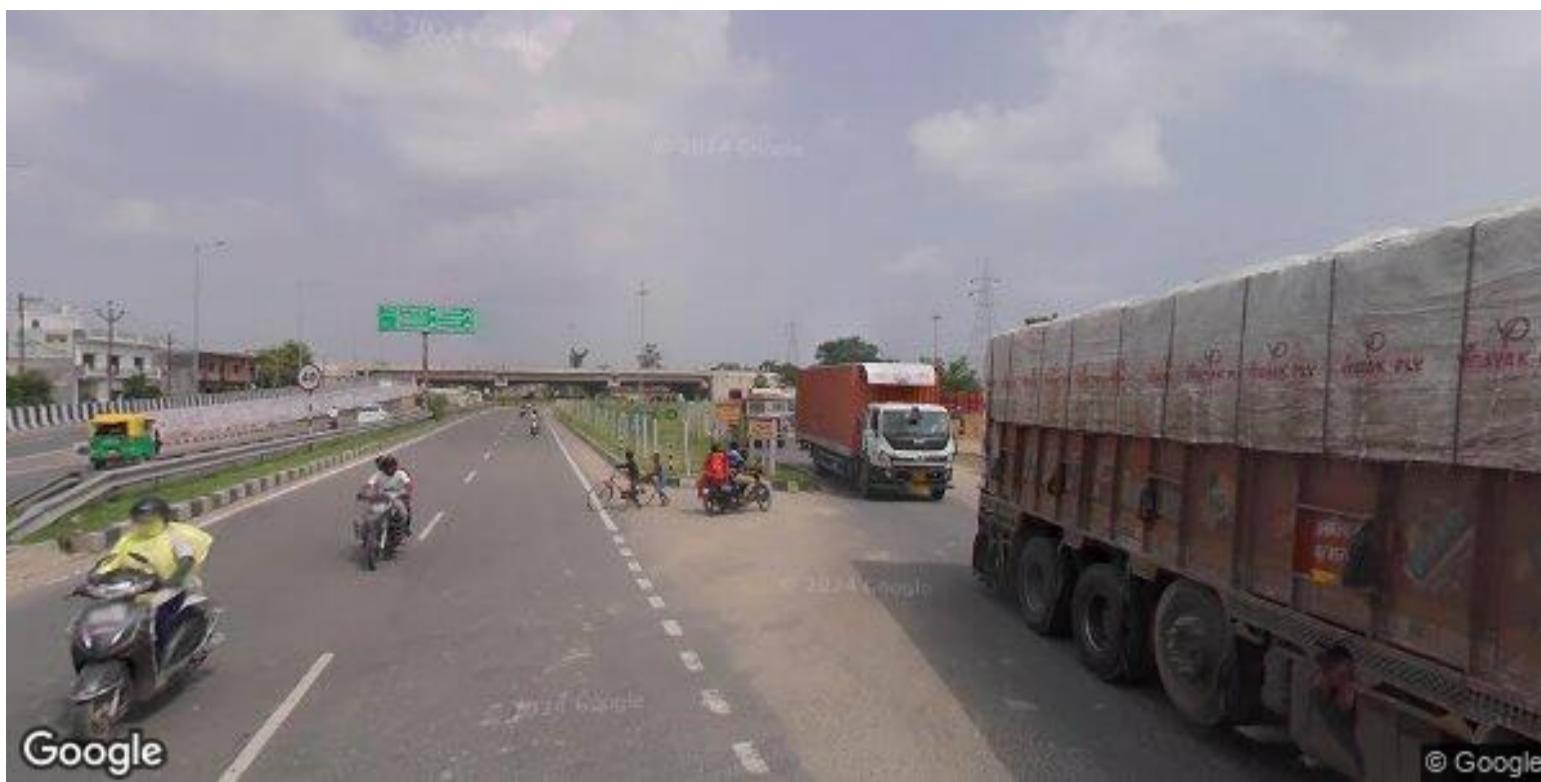
Coordinates: 26.74703, 83.24907

Risk Type: Turn

Risk Level: High

Speed Limit: 15 KM/Hr

Distance from Start: 8.80 km

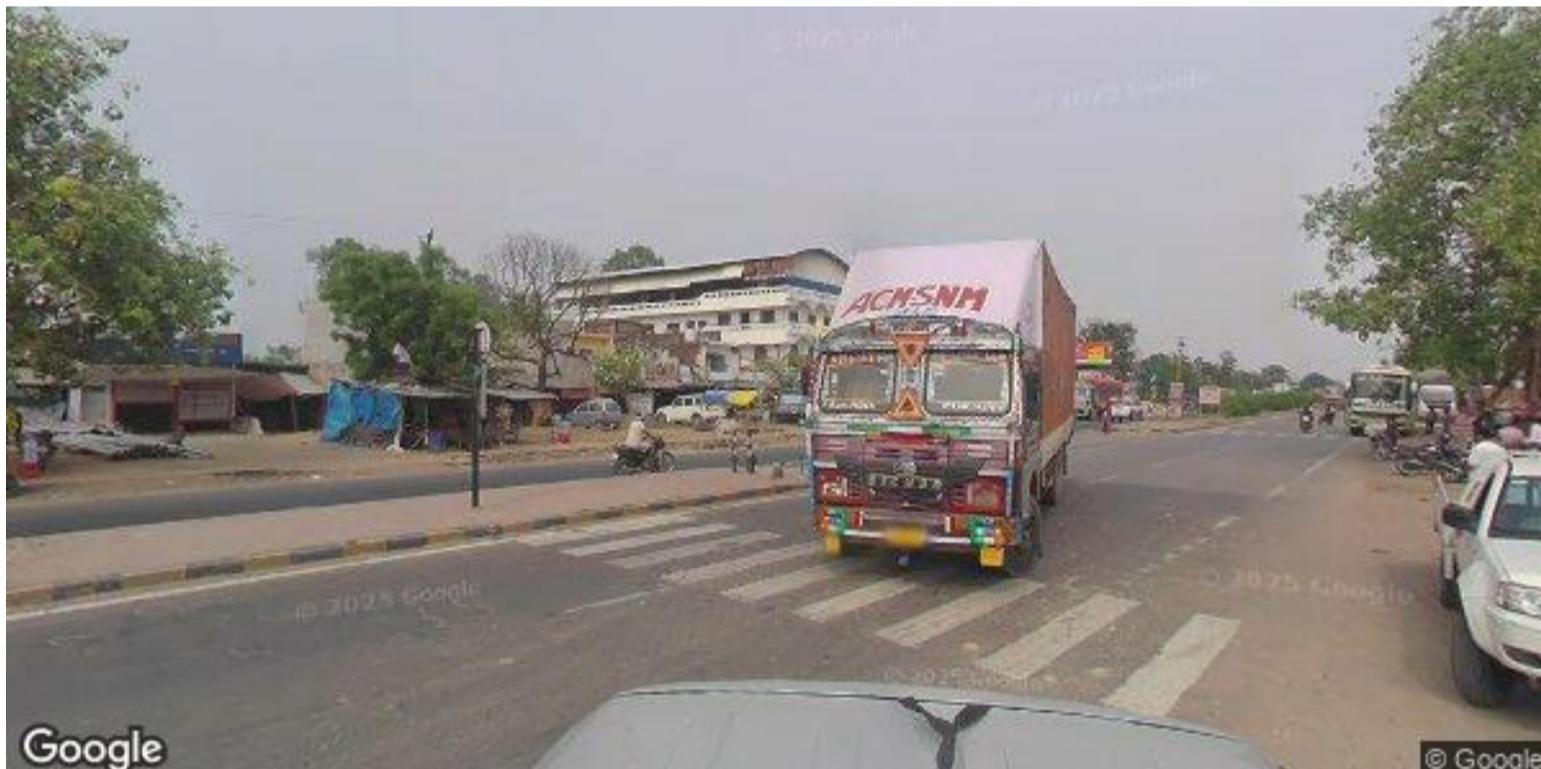
Coordinates: 26.76249, 83.08902

Risk Type: Turn

Risk Level: Medium

Speed Limit: 30 KM/Hr

Distance from Start: 25.31 km

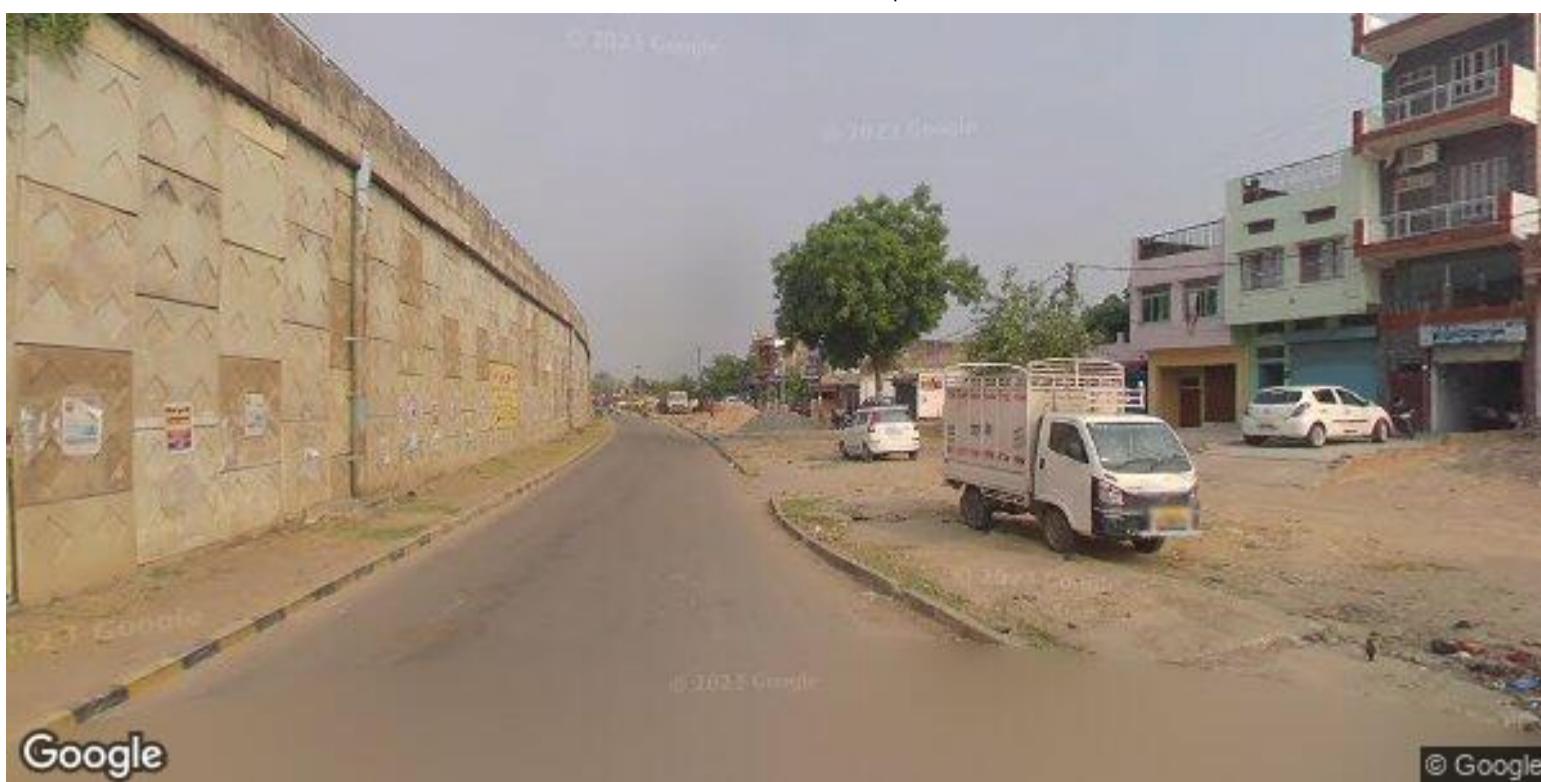
Coordinates: 26.76571, 83.08355

Risk Type: Turn

Risk Level: Medium

Speed Limit: 30 KM/Hr

Distance from Start: 25.97 km

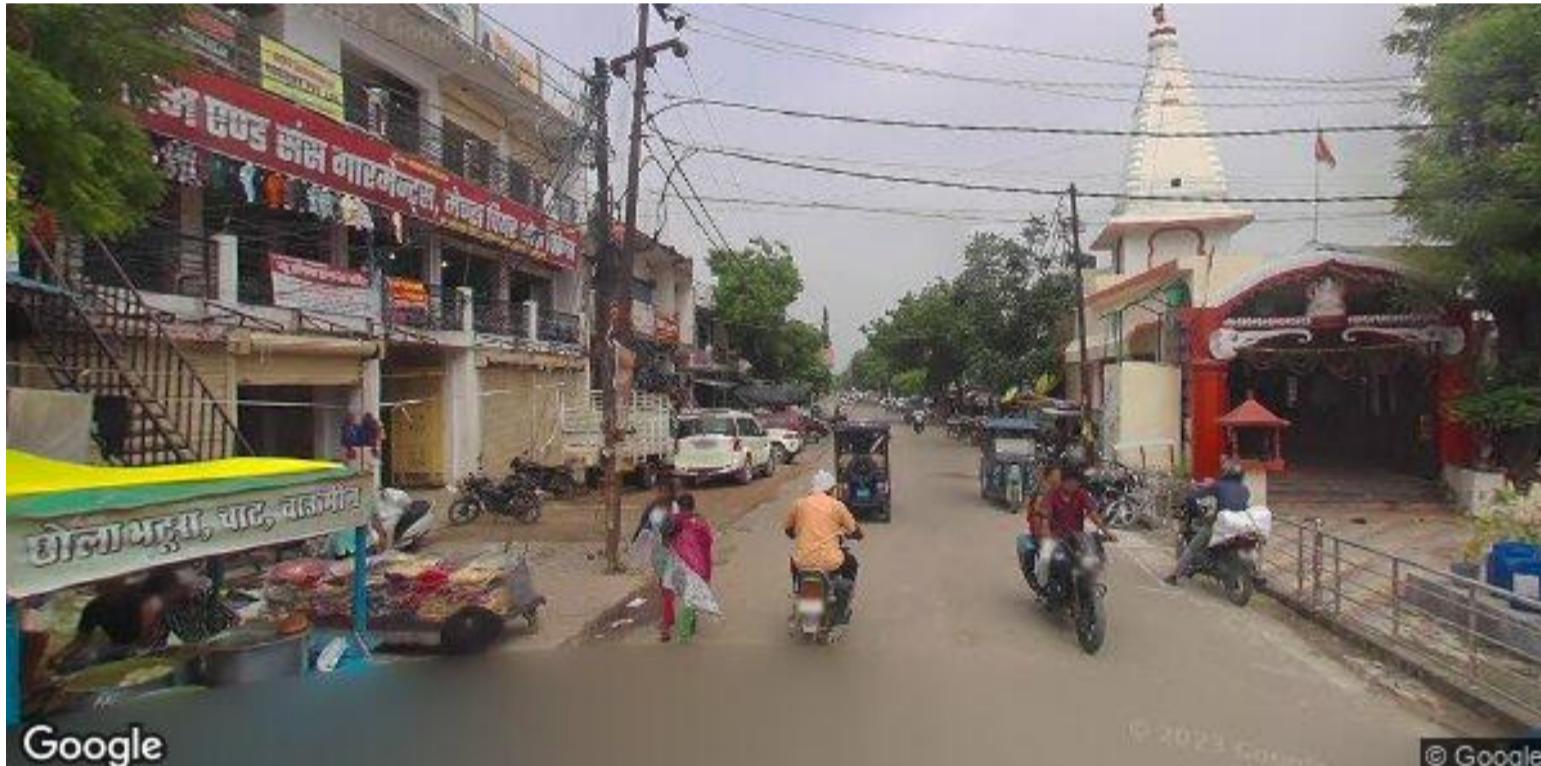
Coordinates: 26.76902, 83.07734

Risk Type: Turn

Risk Level: Medium

Speed Limit: 30 KM/Hr

Distance from Start: 26.68 km

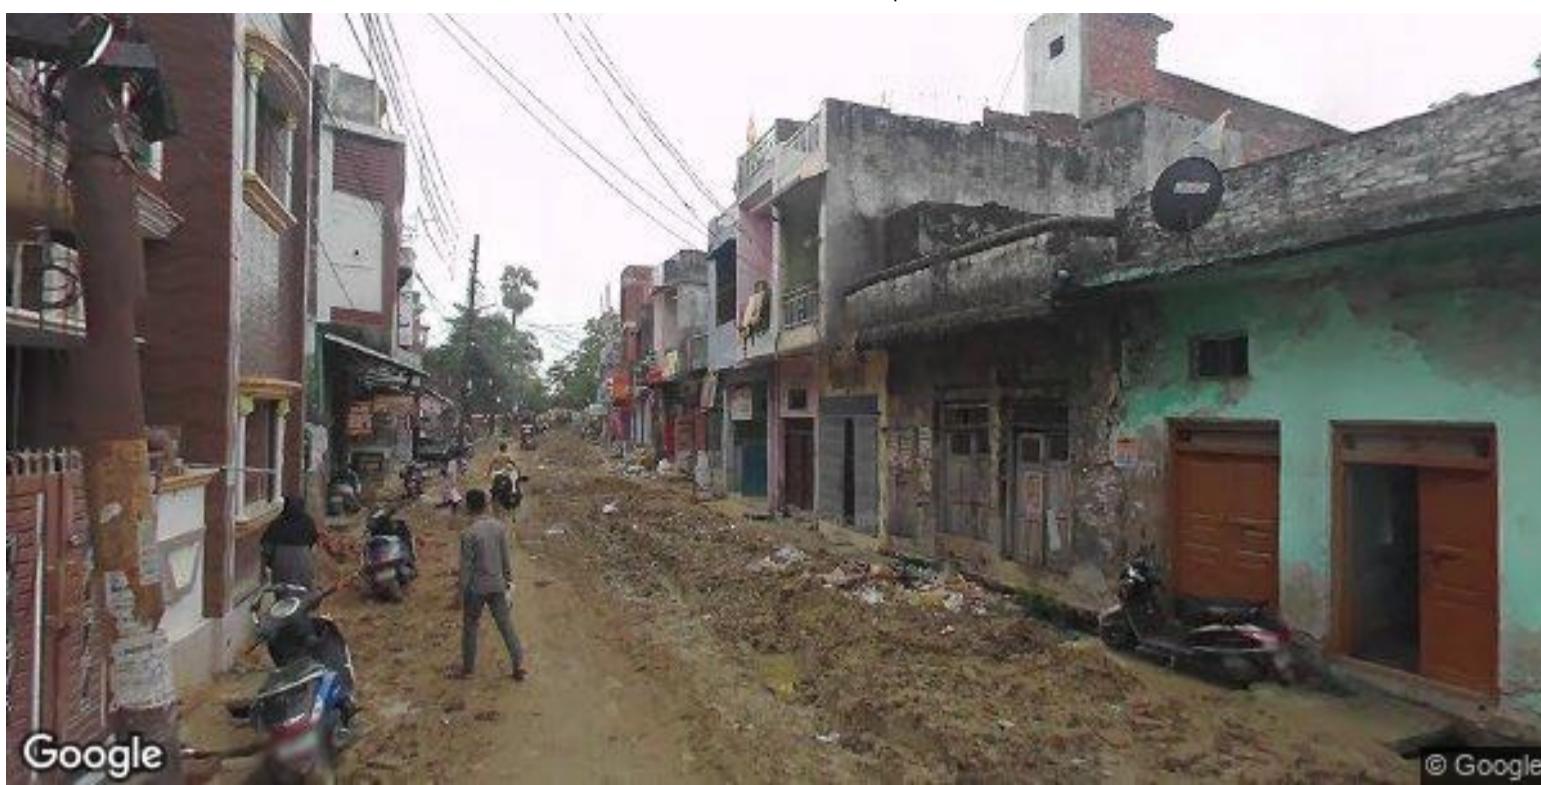
Risk Type: Turn**Risk Level:** Medium**Speed Limit:** 30 KM/Hr**Distance from Start:** 27.11 km**Coordinates:** 26.77176, 83.07436

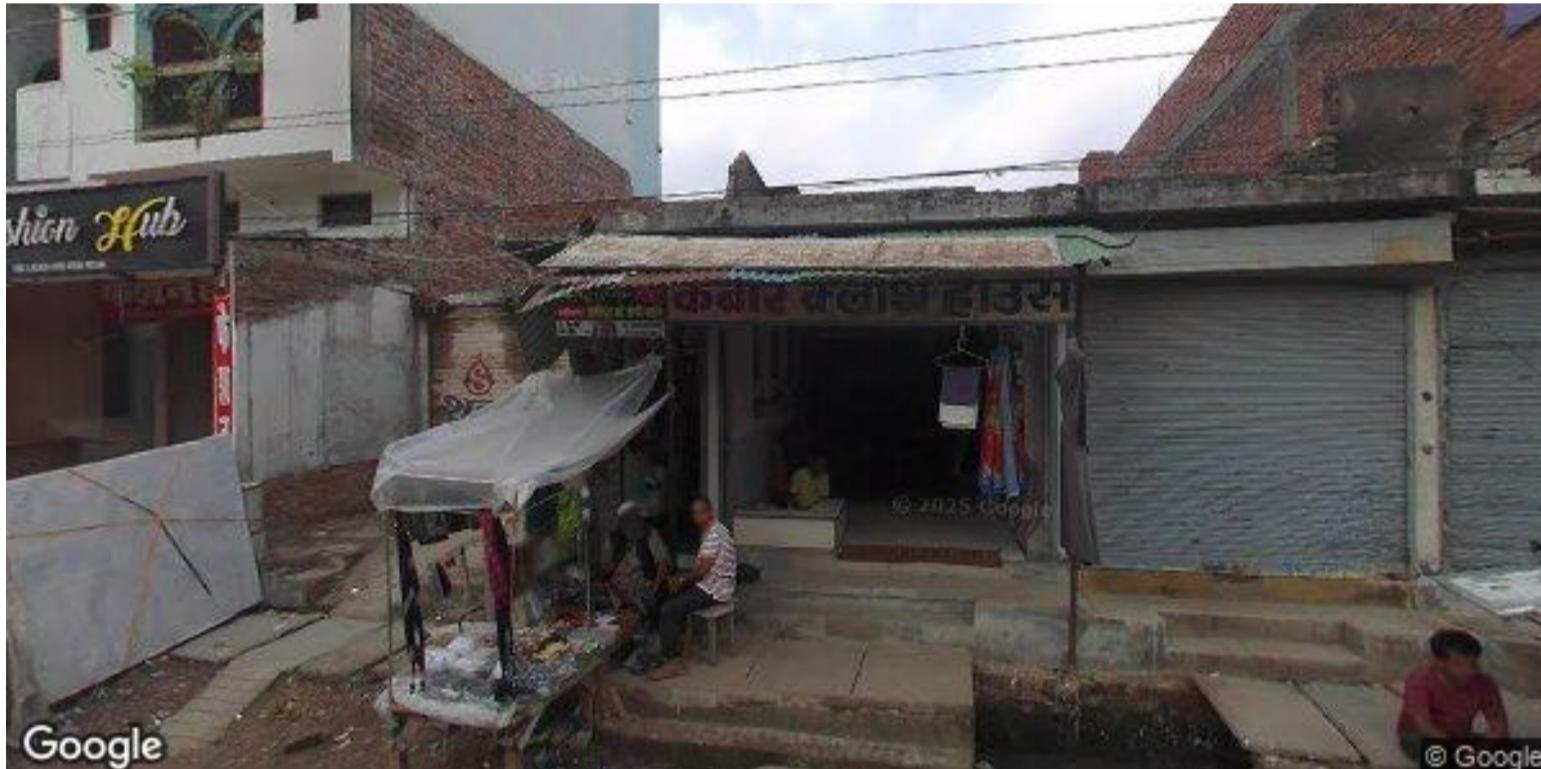
Risk Type: Turn**Risk Level:** High**Speed Limit:** 15 KM/Hr**Distance from Start:** 27.56 km**Coordinates:** 26.77296, 83.06947

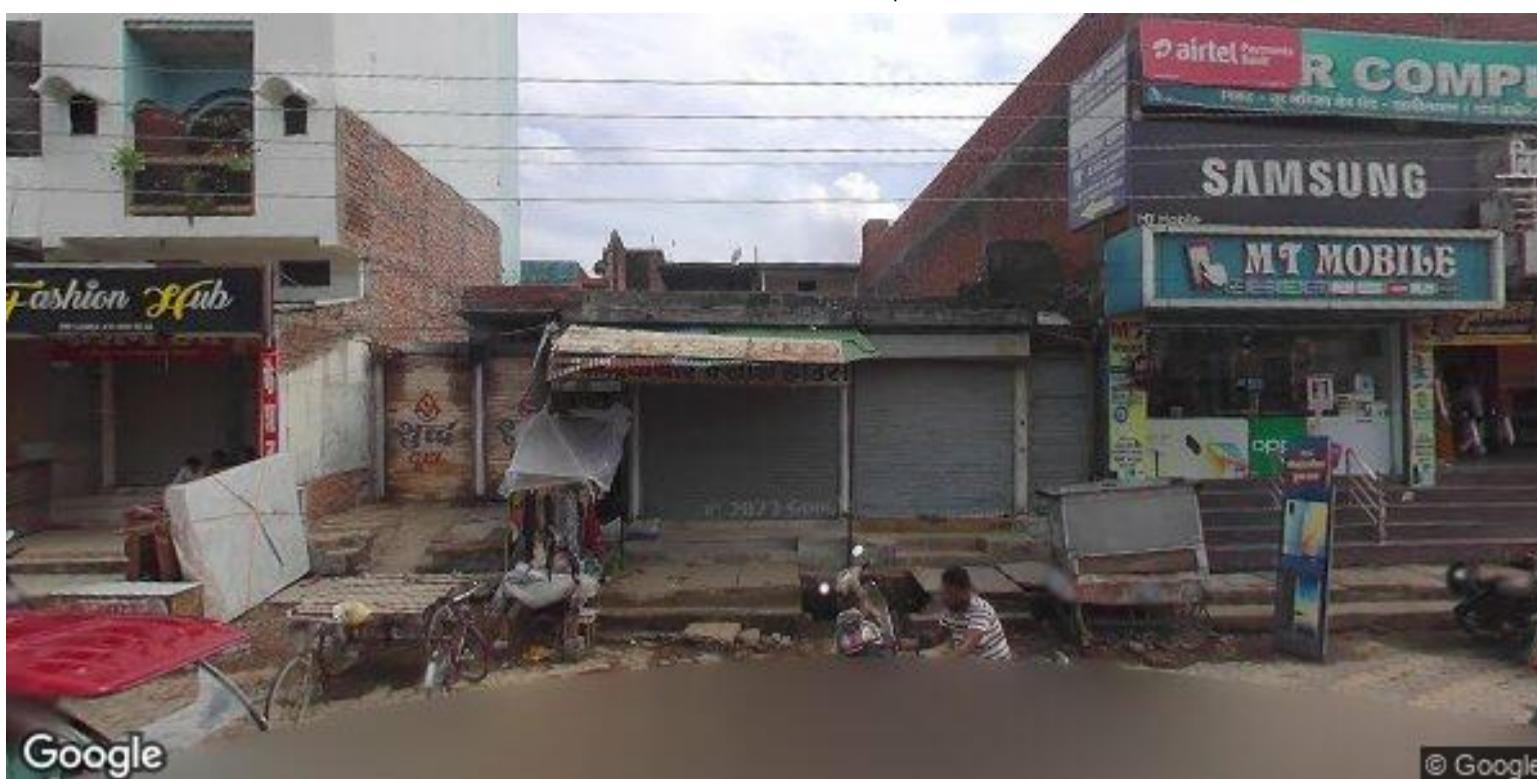
Risk Type: Turn**Risk Level: High****Speed Limit: 15 KM/Hr****Distance from Start: 27.64 km****Coordinates: 26.77304, 83.06947**

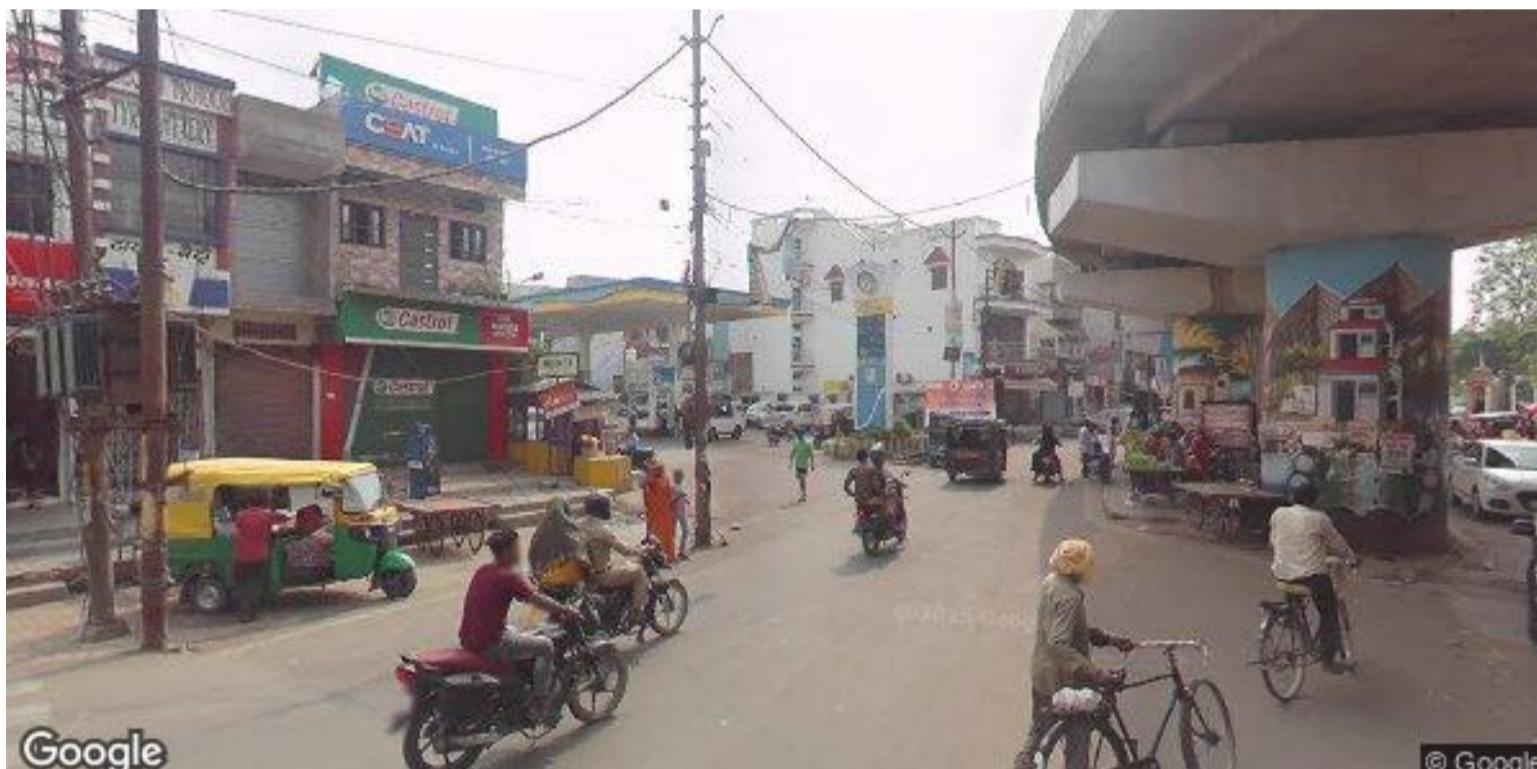
Risk Type: Turn**Risk Level: Medium****Speed Limit: 30 KM/Hr****Distance from Start: 27.98 km****Coordinates: 26.77383, 83.06611**

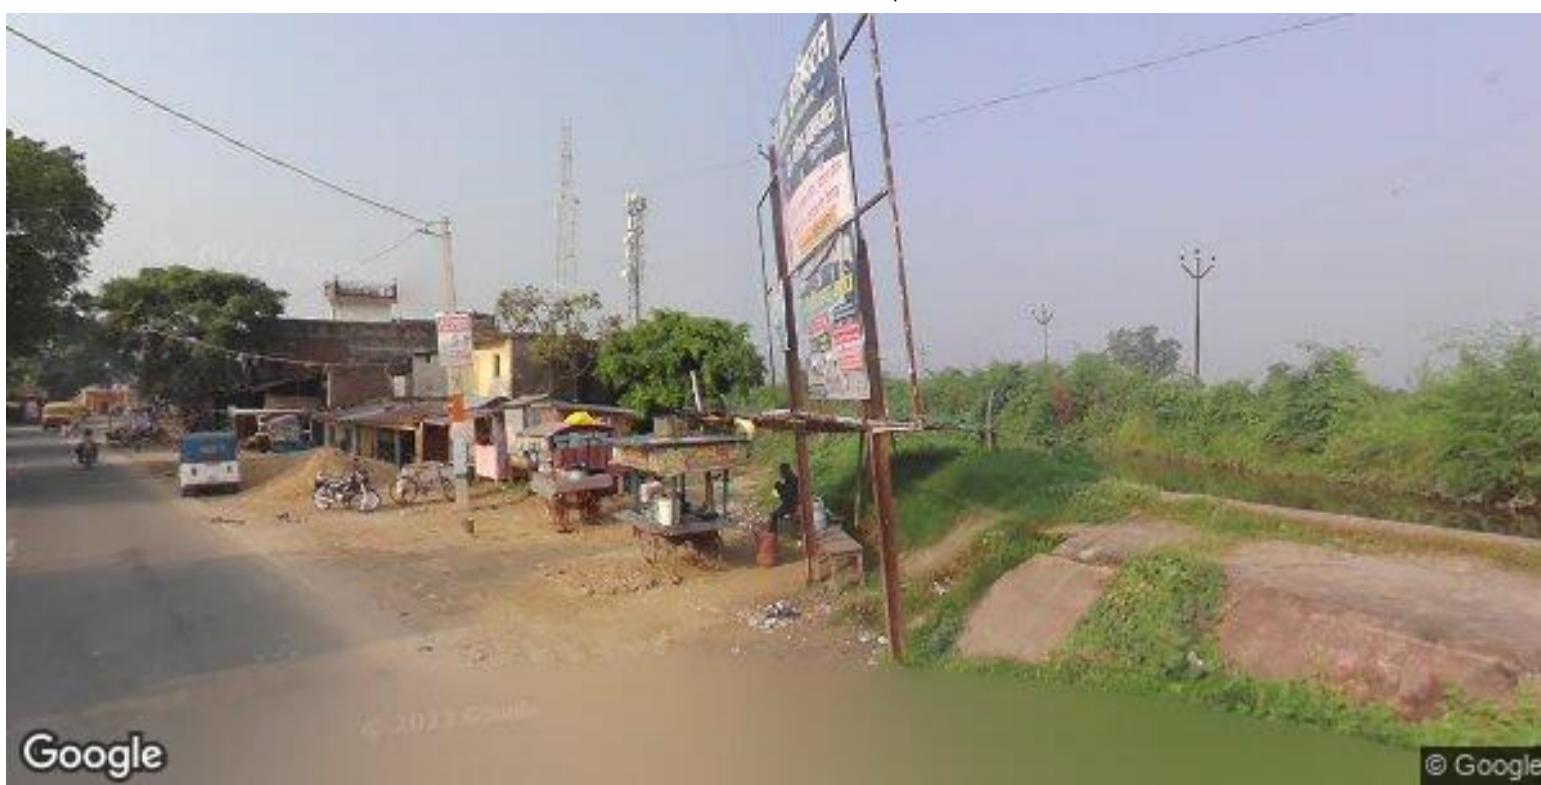
Risk Type: Blind Spot**Risk Level:** Blind Spot**Speed Limit:** 10 KM/Hr**Distance from Start:** 47.34 km**Coordinates:** 26.60939, 83.02446
