## JOURNEY RISK MANAGEMENT (JRM) STUDY

### Gorakhpur LPG BP TO BEV MUSTAKHAM INDANE

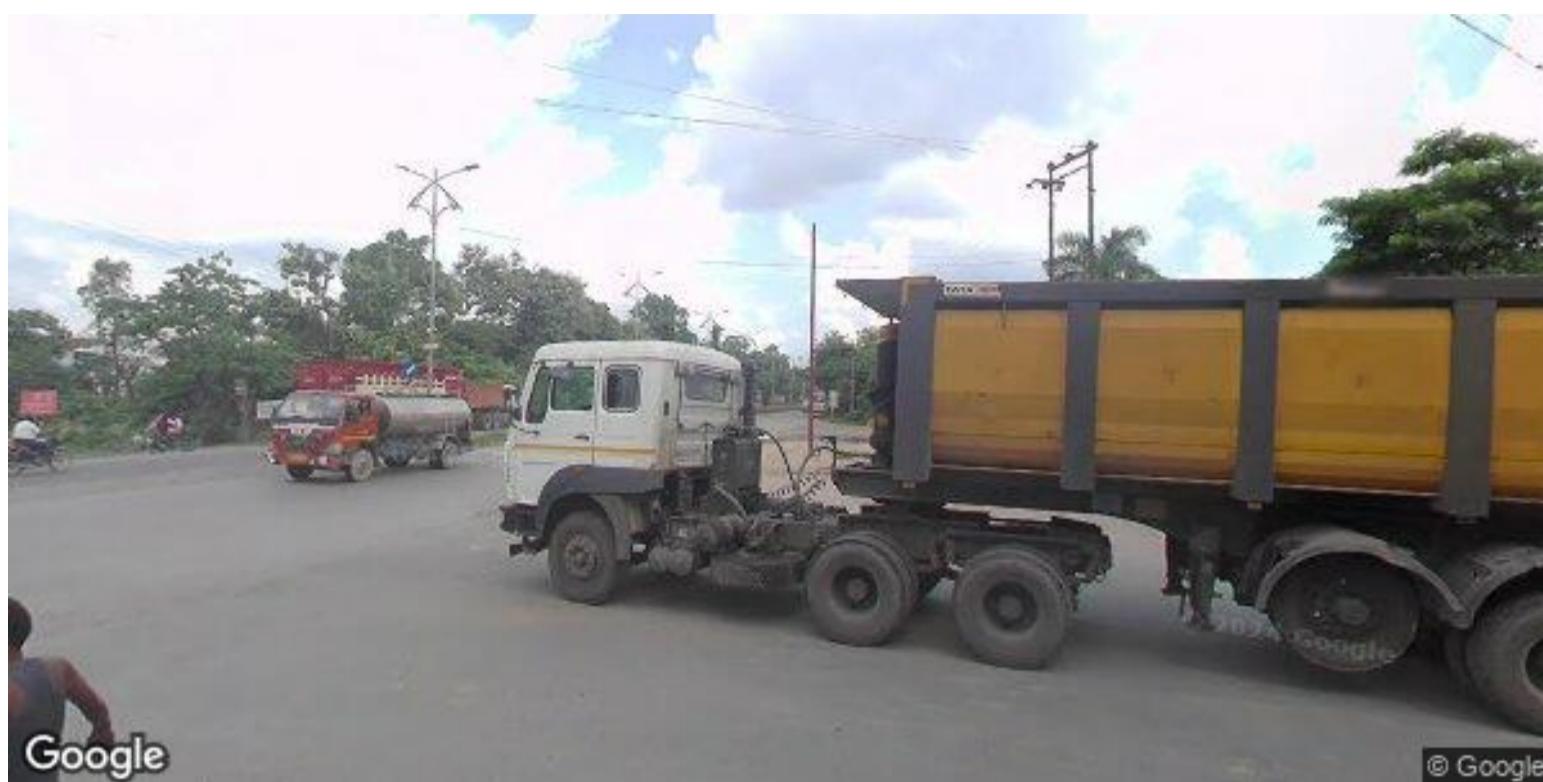
**Coordinates:** 26.75126, 83.22476

| | Risk Type | Risk Level | Coordinates | Speed Limit | Distance from Start |
|---|---|---|---|---|---|
| 6 | Blind Spot | Blind Spot | 26.75126, 83.22476 | 10 KM/Hr | 2.15 km |

**Risk Type:** Blind Spot

**Risk Level:** Blind Spot

**Speed Limit:** 10 KM/Hr

**Distance from Start:** 2.15 km

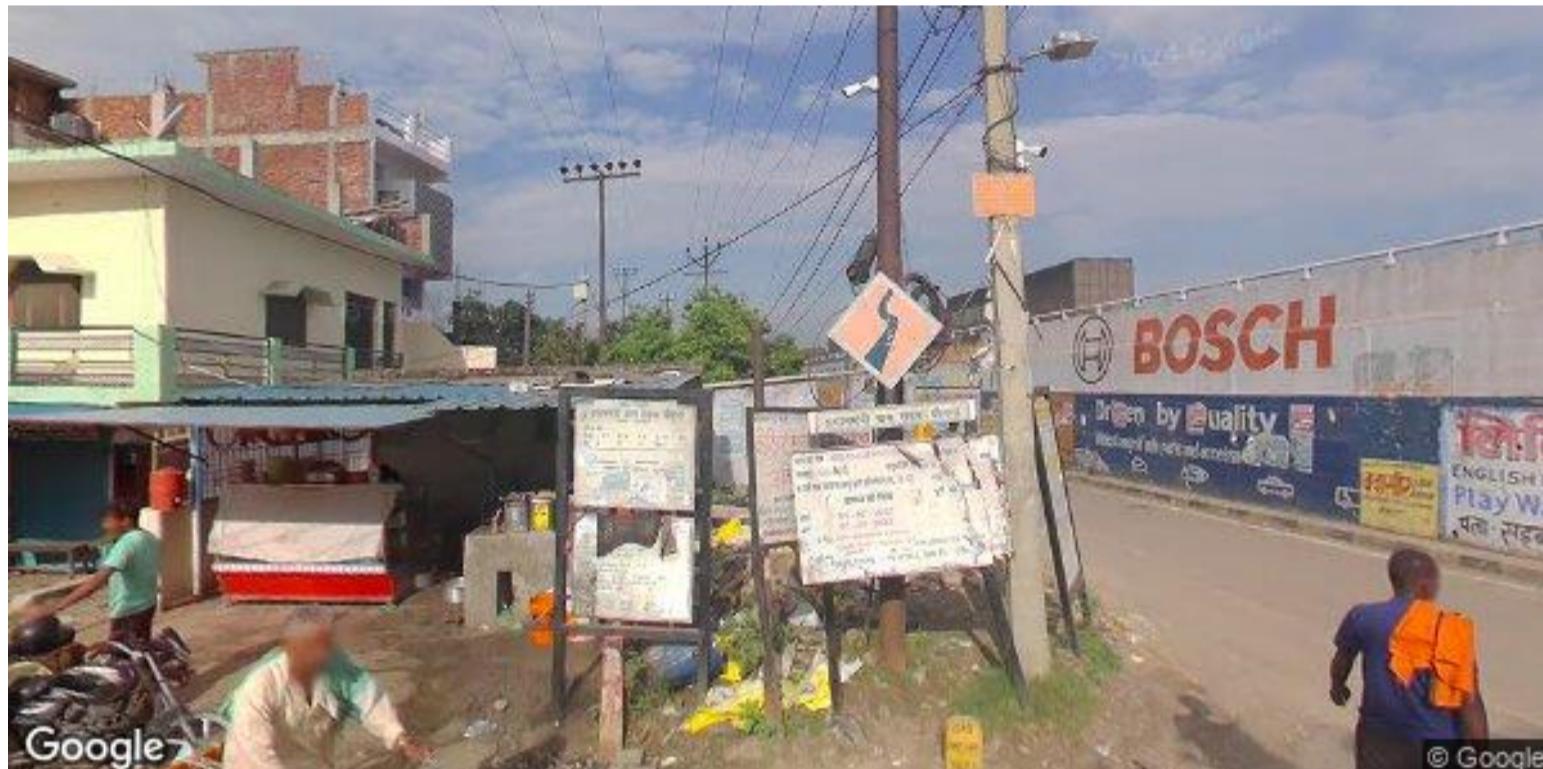
**Coordinates:** 26.75353, 83.20457

| | Risk Type | Risk Level | Coordinates | Speed Limit | Distance from Start |
|---|---|---|---|---|---|
| 7 | Blind Spot | Blind Spot | 26.75353, 83.20457 | 10 KM/Hr | 4.21 km |

**Risk Type:** Blind Spot

**Risk Level:** Blind Spot

**Speed Limit:** 10 KM/Hr

**Distance from Start:** 4.21 km

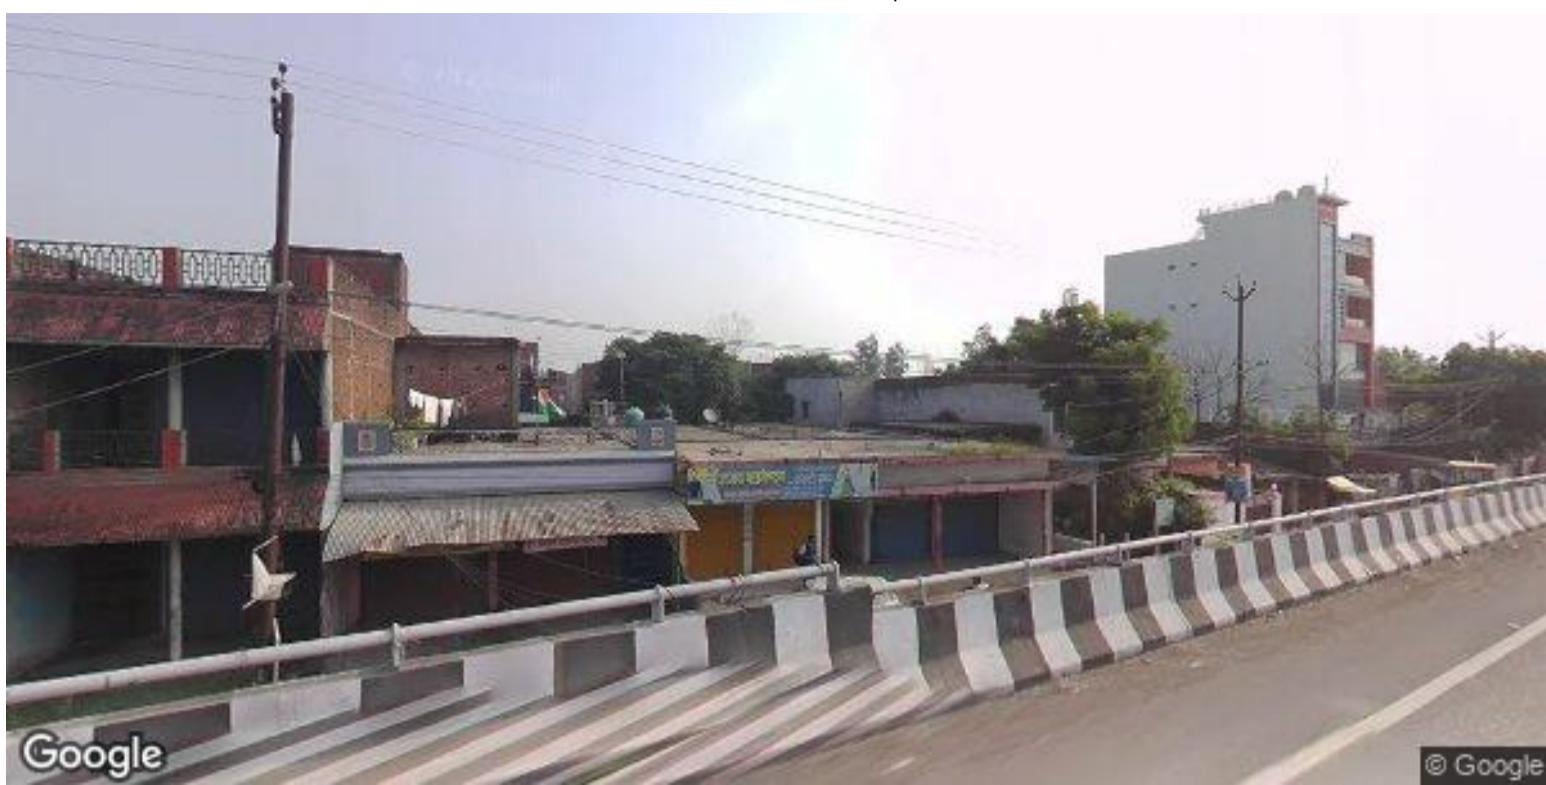
| | Risk Type | Risk Level | Coordinates | Speed Limit | Distance from Start |
|---|---|---|---|---|---|
| 8 | Turn | High | 26.75377, 83.20465 | 15 KM/Hr | 4.26 km |

**Risk Type: Turn****Risk Level: High****Speed Limit: 15 KM/Hr****Distance from Start: 4.26 km****Coordinates: 26.75377, 83.20465**

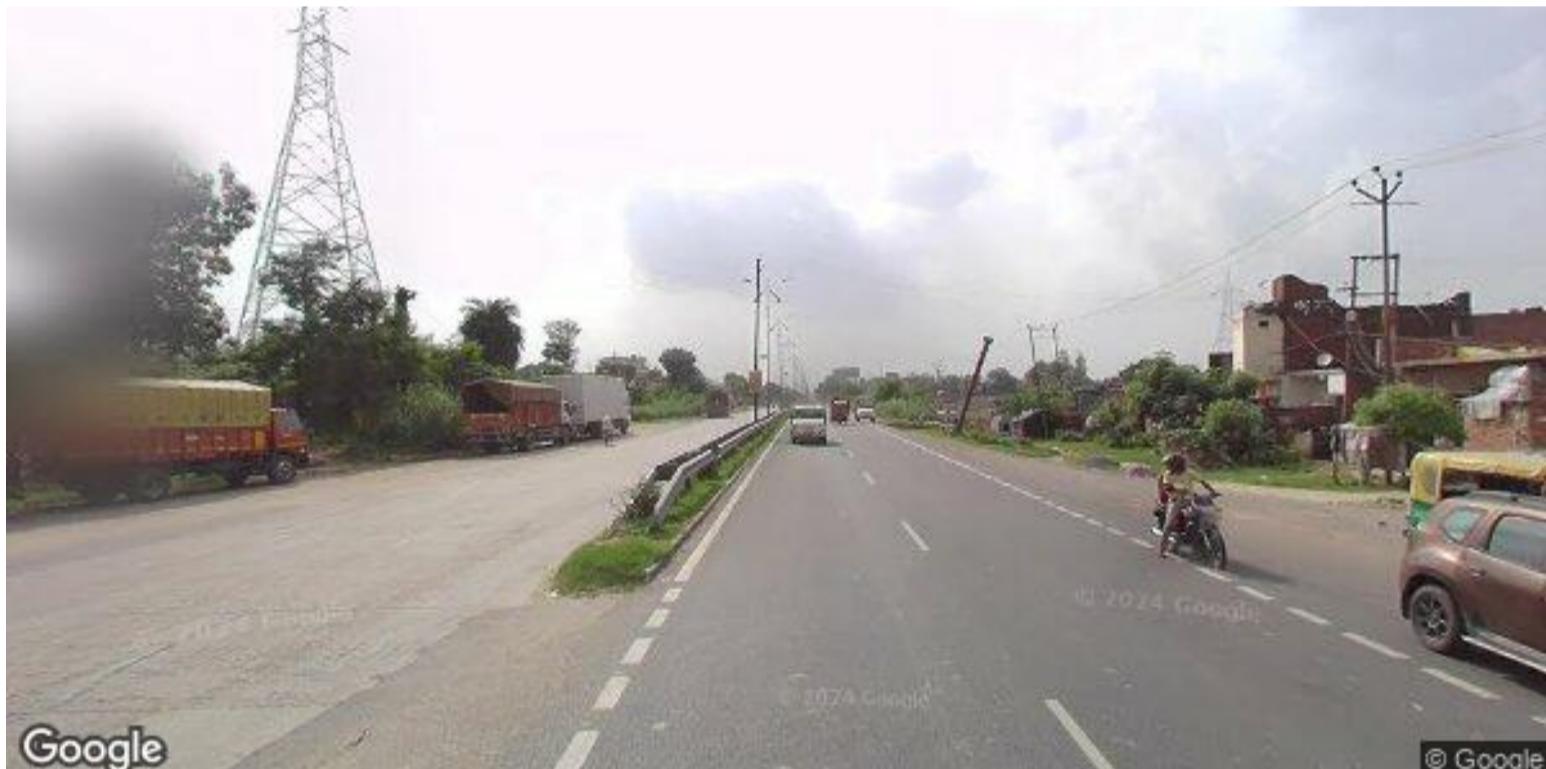
| | Risk Type | Risk Level | Coordinates | Speed Limit | Distance from Start |
|---|---|---|---|---|---|
| 0 | U-Turn | High | 26.7471208, 83.2490873 | 10 KM/Hr | 8.74 km |

**Risk Type: U-Turn****Risk Level: High****Speed Limit: 10 KM/Hr****Distance from Start: 8.74 km****Coordinates: 26.7471208, 83.2490873**

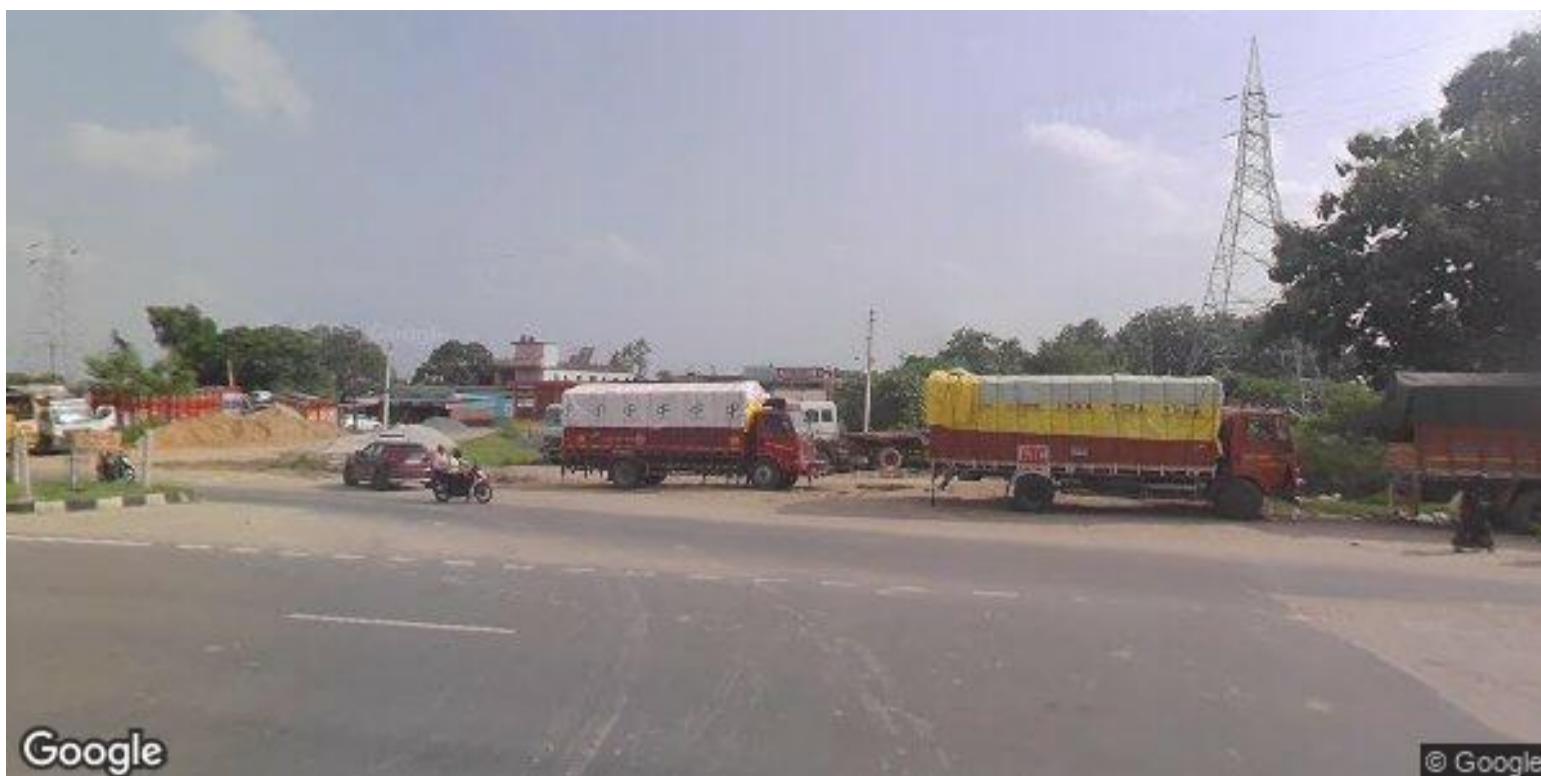
| | Risk Type | Risk Level | Coordinates | Speed Limit | Distance from Start |
|---|---|---|---|---|---|
| 9 | Blind Spot | Blind Spot | 26.74712, 83.24909 | 10 KM/Hr | 8.74 km |

**Risk Type:** Blind Spot**Risk Level:** Blind Spot**Speed Limit:** 10 KM/Hr**Distance from Start:** 8.74 km**Coordinates:** 26.74712, 83.24909

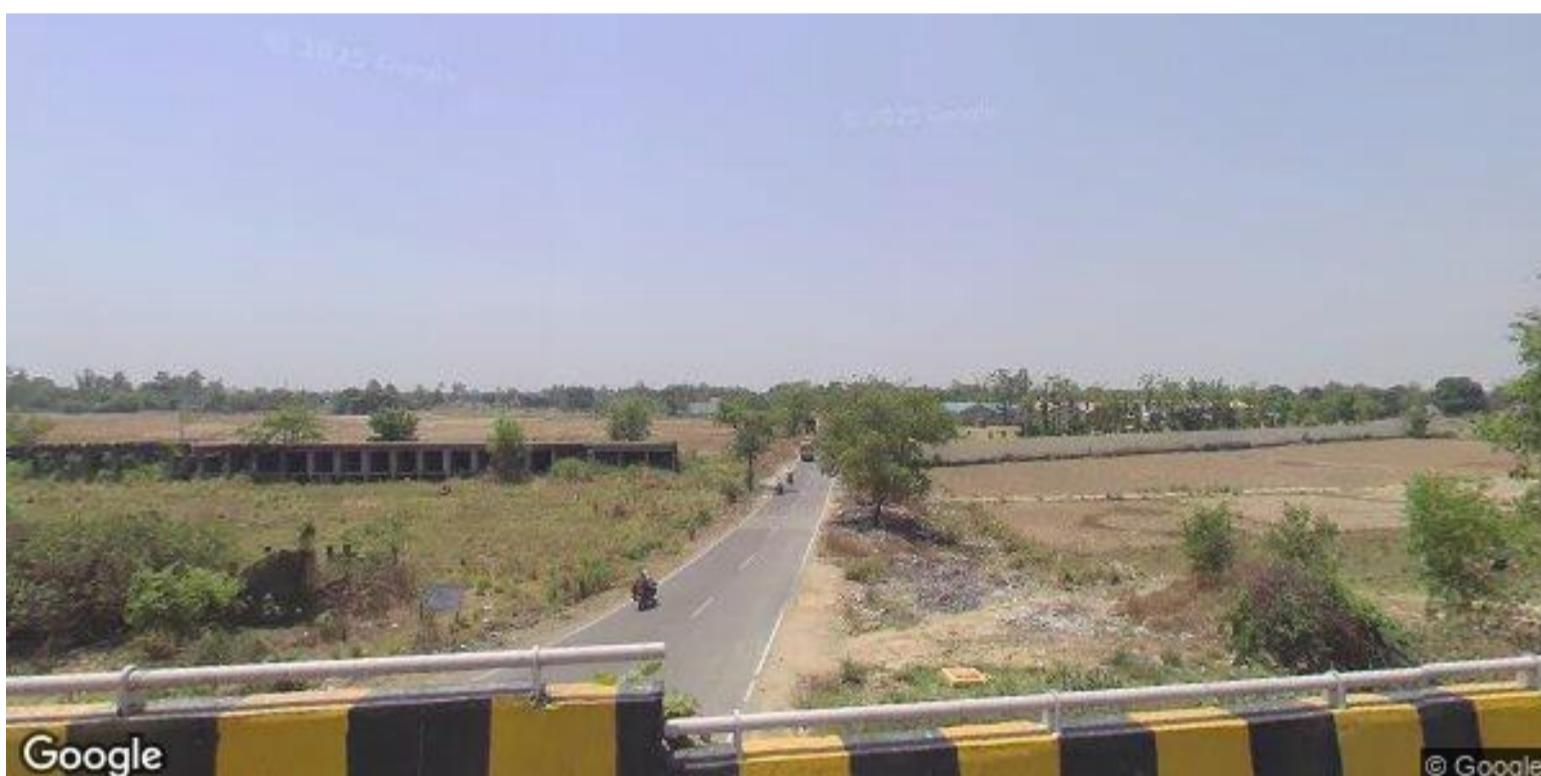
| | Risk Type | Risk Level | Coordinates | Speed Limit | Distance from Start |
|---|---|---|---|---|---|
| 10 | Blind Spot | Blind Spot | 26.82853, 82.75360 | 10 KM/Hr | 60.42 km |

**Risk Type:** Blind Spot**Risk Level:** Blind Spot**Speed Limit:** 10 KM/Hr**Distance from Start:** 60.42 km**Coordinates:** 26.82853, 82.75360

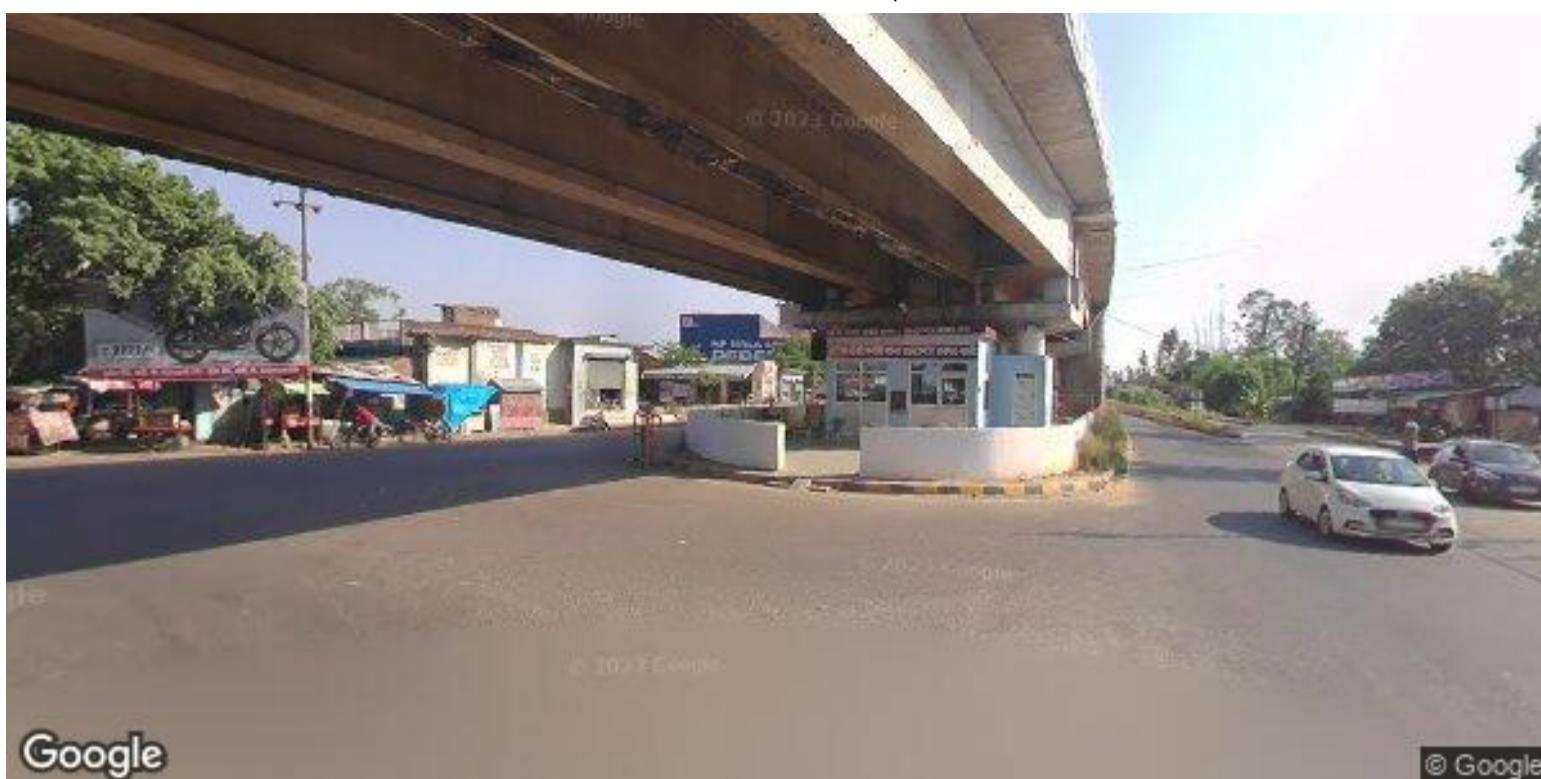
| | Risk Type | Risk Level | Coordinates | Speed Limit | Distance from Start |
|---|---|---|---|---|---|
| 11 | Turn | Medium | 26.83823, 82.74869 | 30 KM/Hr | 61.63 km |

**Risk Type:** Turn**Risk Level:** Medium**Speed Limit:** 30 KM/Hr**Distance from Start:** 61.63 km**Coordinates:** 26.83823, 82.74869

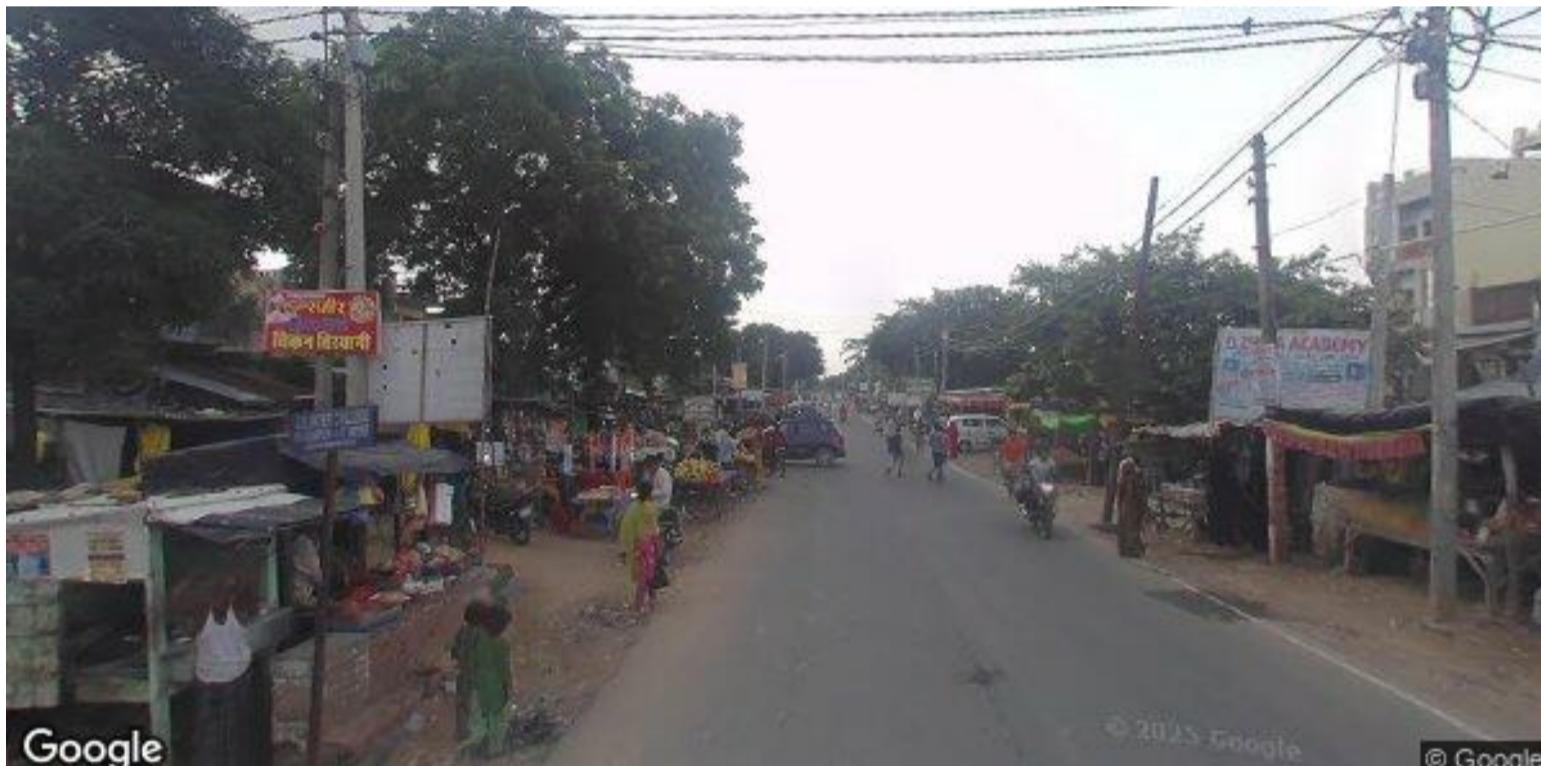
| | Risk Type | Risk Level | Coordinates | Speed Limit | Distance from Start |
|---|---|---|---|---|---|
| 12 | Turn | High | 27.19794, 82.52228 | 15 KM/Hr | 113.37 km |

**Risk Type:** Turn**Risk Level:** High**Speed Limit:** 15 KM/Hr**Distance from Start:** 113.37 km**Coordinates:** 27.19794, 82.52228

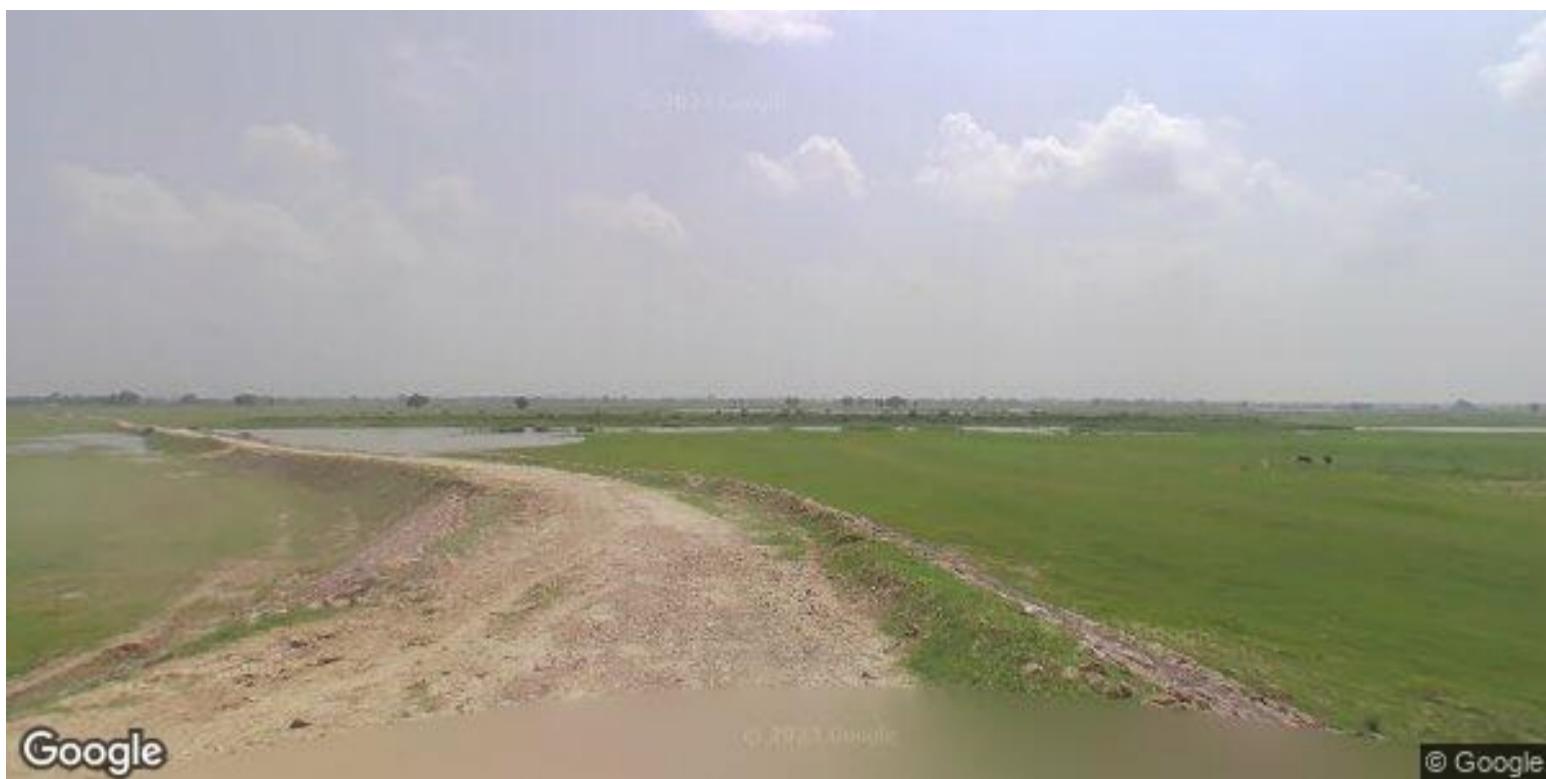
**Coordinates:** 27.21771, 82.52246

| | Risk Type | Risk Level | Coordinates | Speed Limit | Distance from Start |
|---|---|---|---|---|---|
| 19 | Turn | Medium | 27.21771, 82.52246 | 30 KM/Hr | 116.21 km |

**Risk Type:** Turn

**Risk Level:** Medium

**Speed Limit:** 30 KM/Hr

**Distance from Start:** 116.21 km

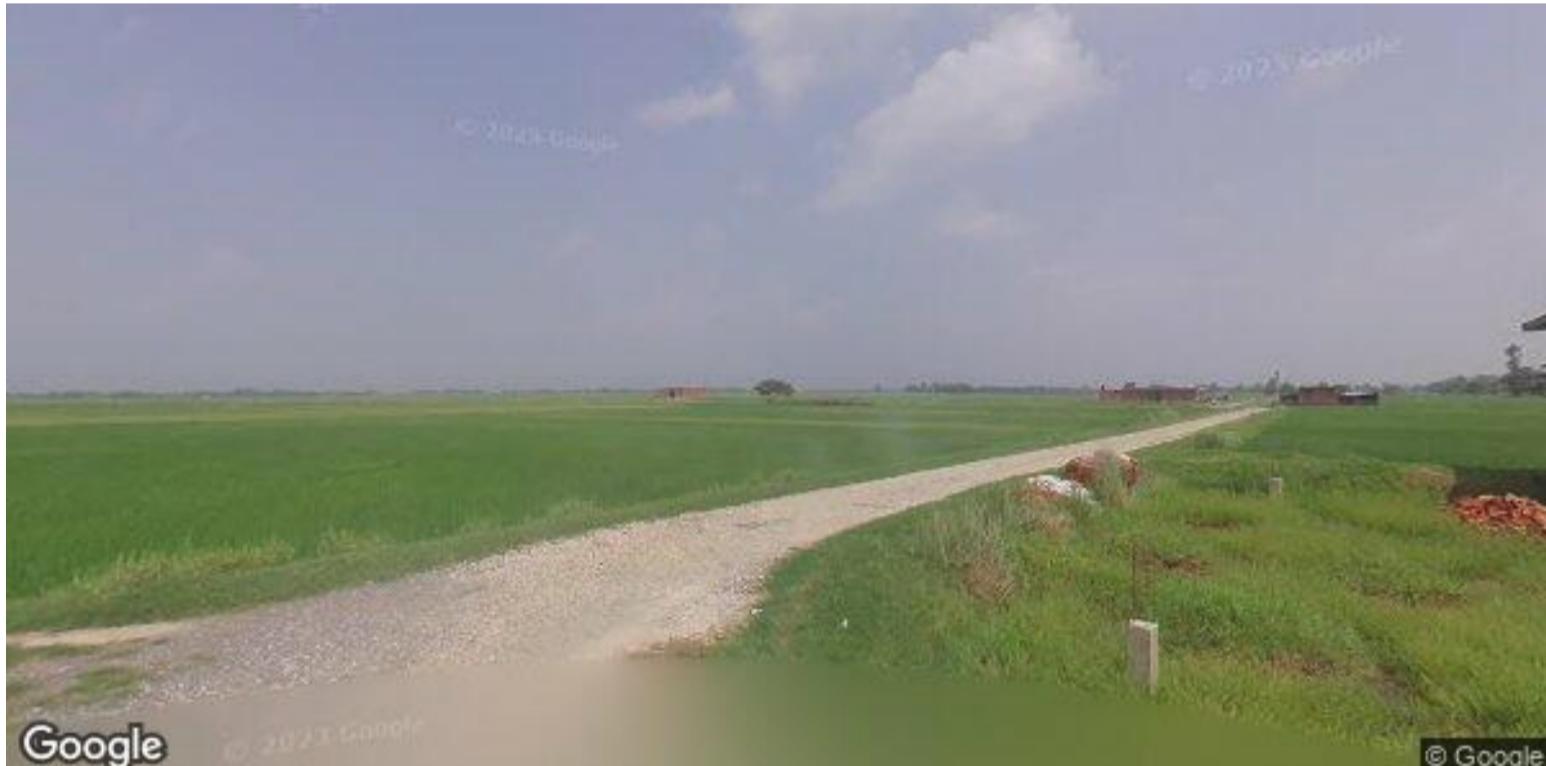
**Coordinates:** 27.22867, 82.52709

| | Risk Type | Risk Level | Coordinates | Speed Limit | Distance from Start |
|---|---|---|---|---|---|
| 22 | Turn | High | 27.22867, 82.52709 | 15 KM/Hr | 117.58 km |

**Risk Type:** Turn

**Risk Level:** High

**Speed Limit:** 15 KM/Hr

**Distance from Start:** 117.58 km
