JOURNEY RISK MANAGEMENT (JRM) STUDY

Gorakhpur LPG BP TO SONMATI INDANE GRAMI

Route Analysis Report: GIDA Industrial Area Phase 1, Sahjanwa to Tighra Khairwa

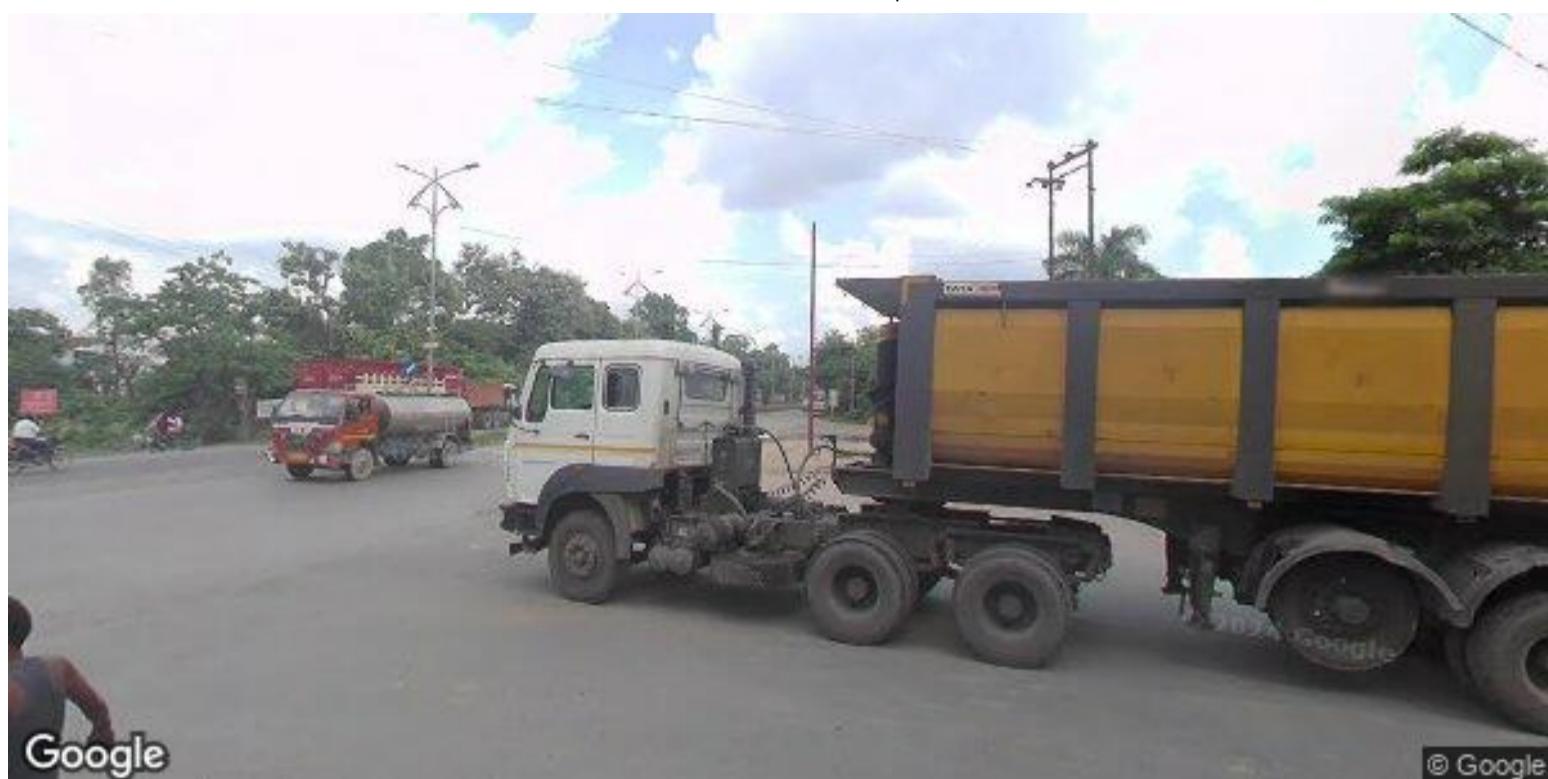
Coordinates: 26.75126, 83.22476

Risk Type: Blind Spot

Risk Level: Blind Spot

Speed Limit: 10 KM/Hr

Distance from Start: 2.17 km

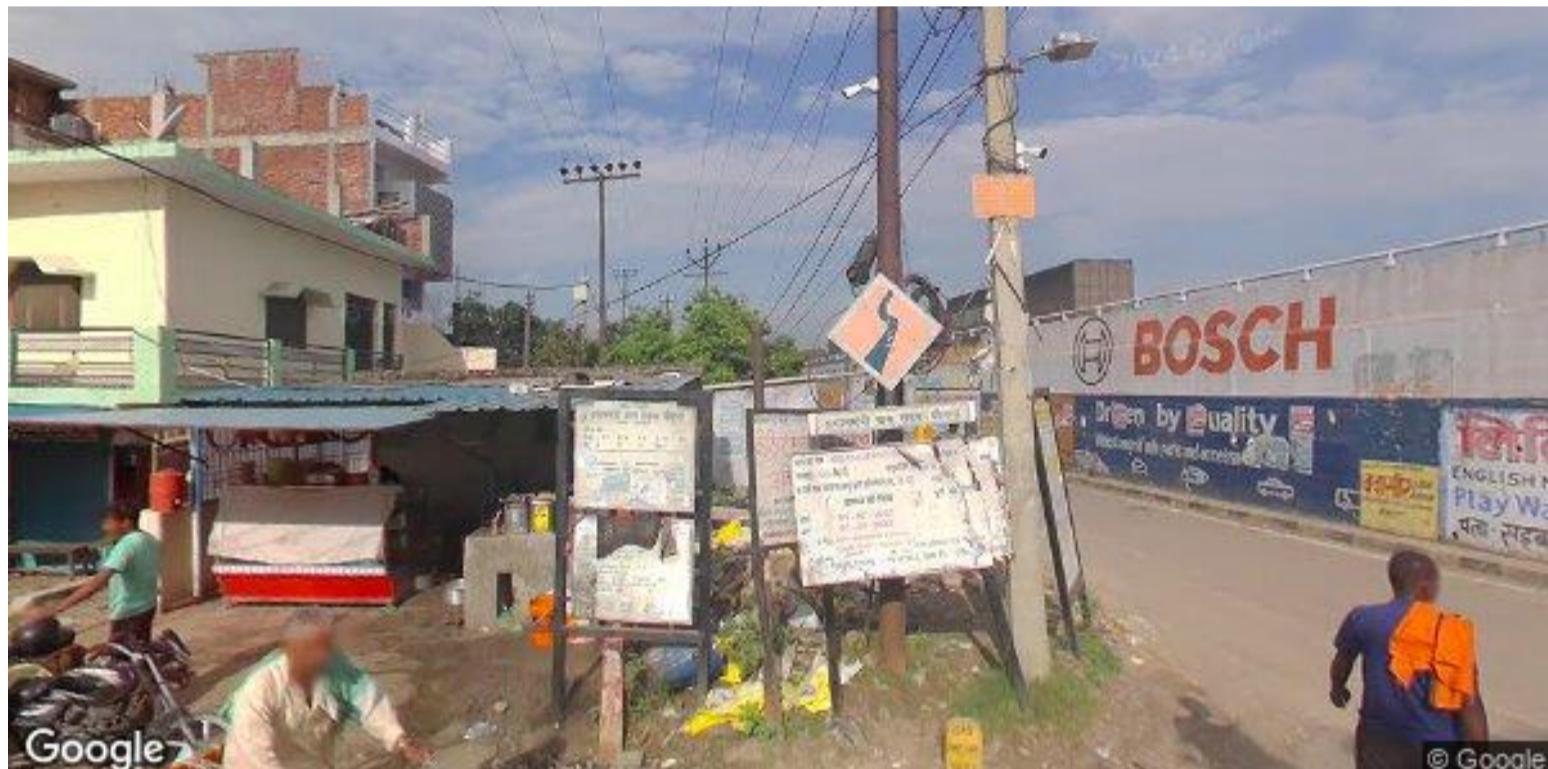
Coordinates: 26.75353, 83.20457

Risk Type: Blind Spot

Risk Level: Blind Spot

Speed Limit: 10 KM/Hr

Distance from Start: 4.23 km

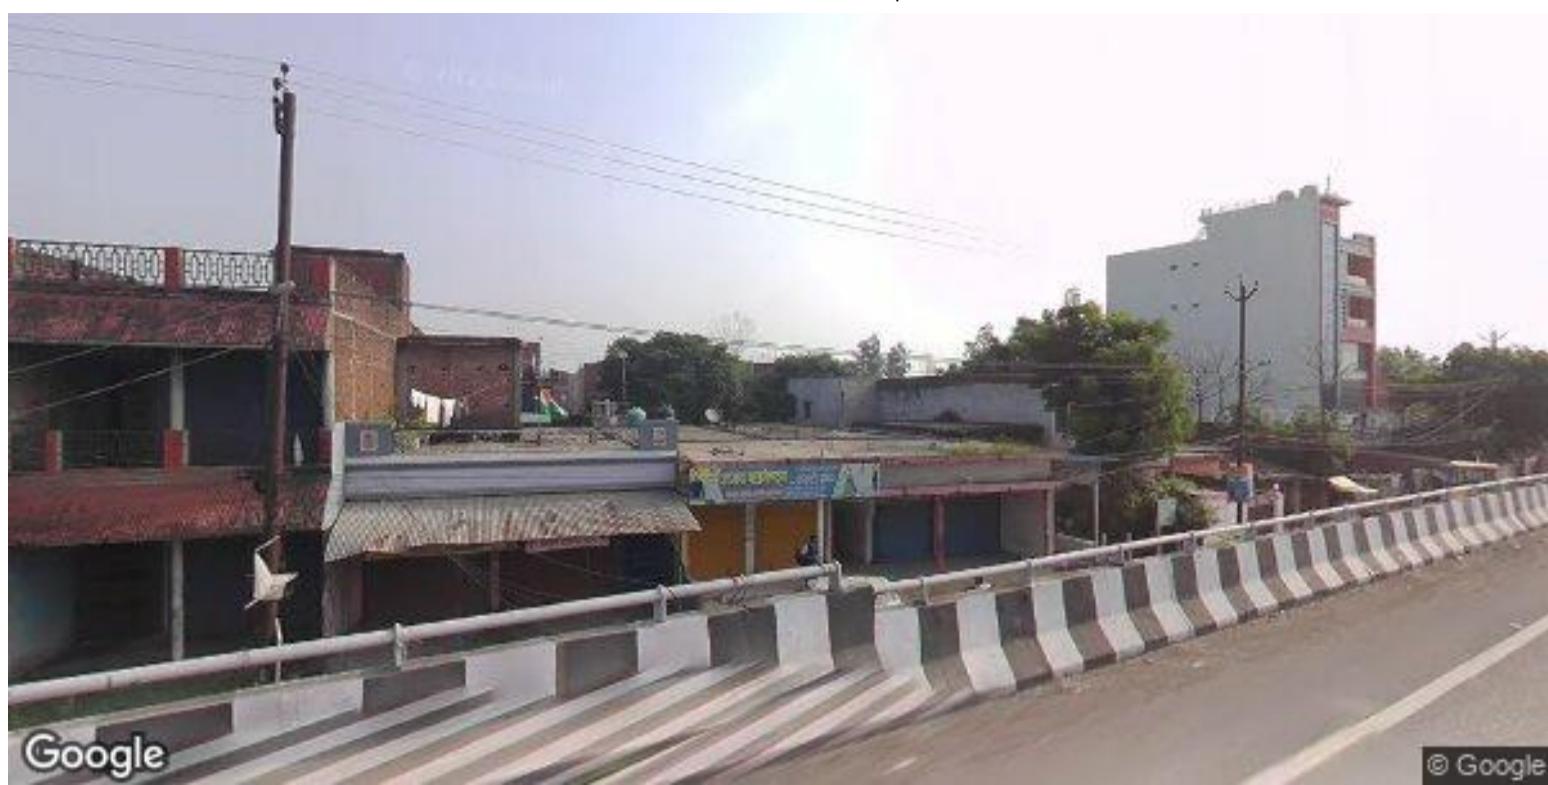
Coordinates: 26.75377, 83.20465

Risk Type: Turn

Risk Level: High

Speed Limit: 15 KM/Hr

Distance from Start: 4.28 km

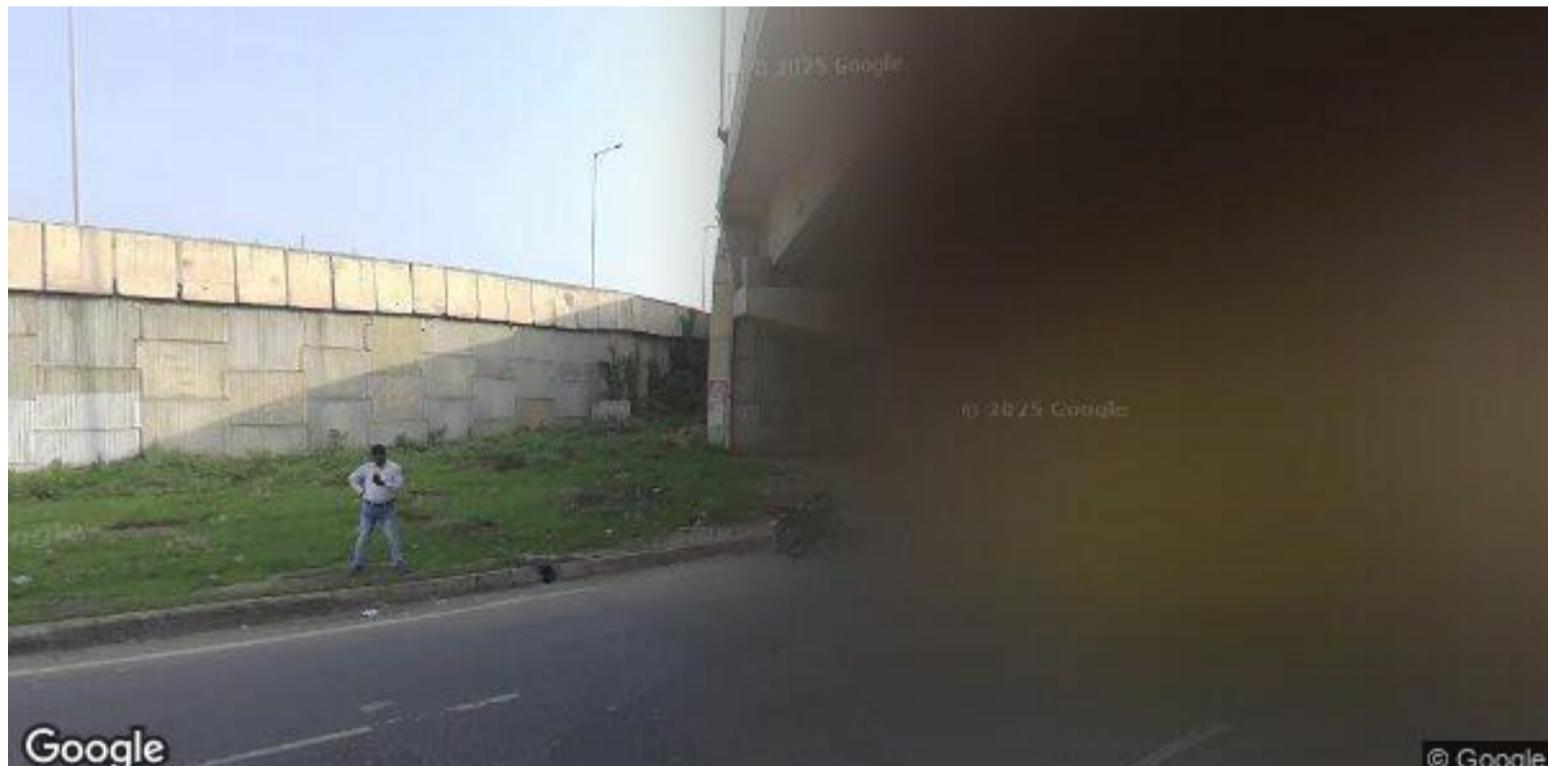
Coordinates: 26.74681, 83.25111

Risk Type: Roundabout

Risk Level: High

Speed Limit: 15 KM/Hr

Distance from Start: 8.90 km

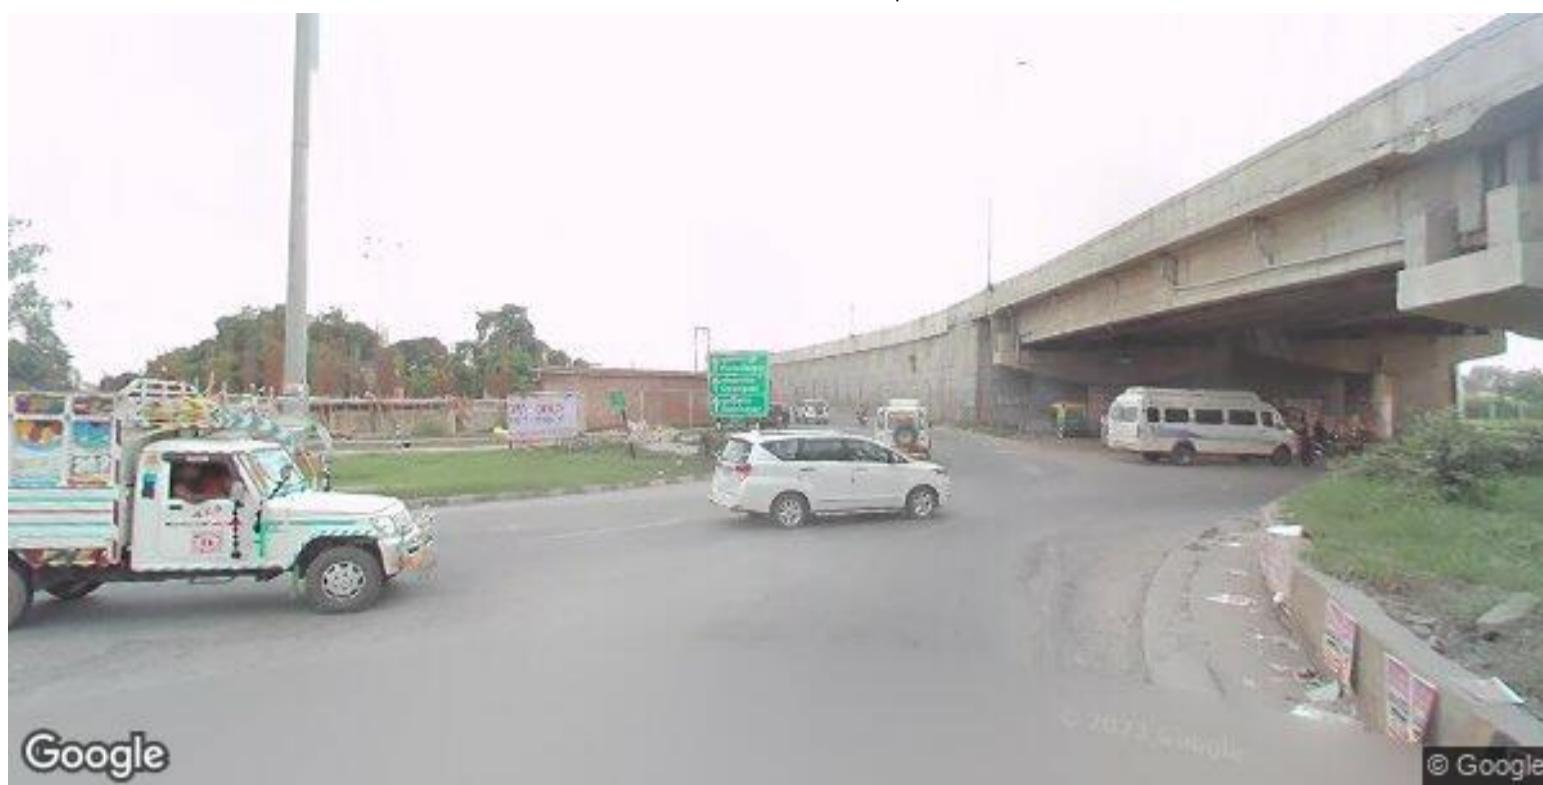
Coordinates: 26.74658, 83.25155

Risk Type: Turn

Risk Level: Medium

Speed Limit: 30 KM/Hr

Distance from Start: 9.04 km

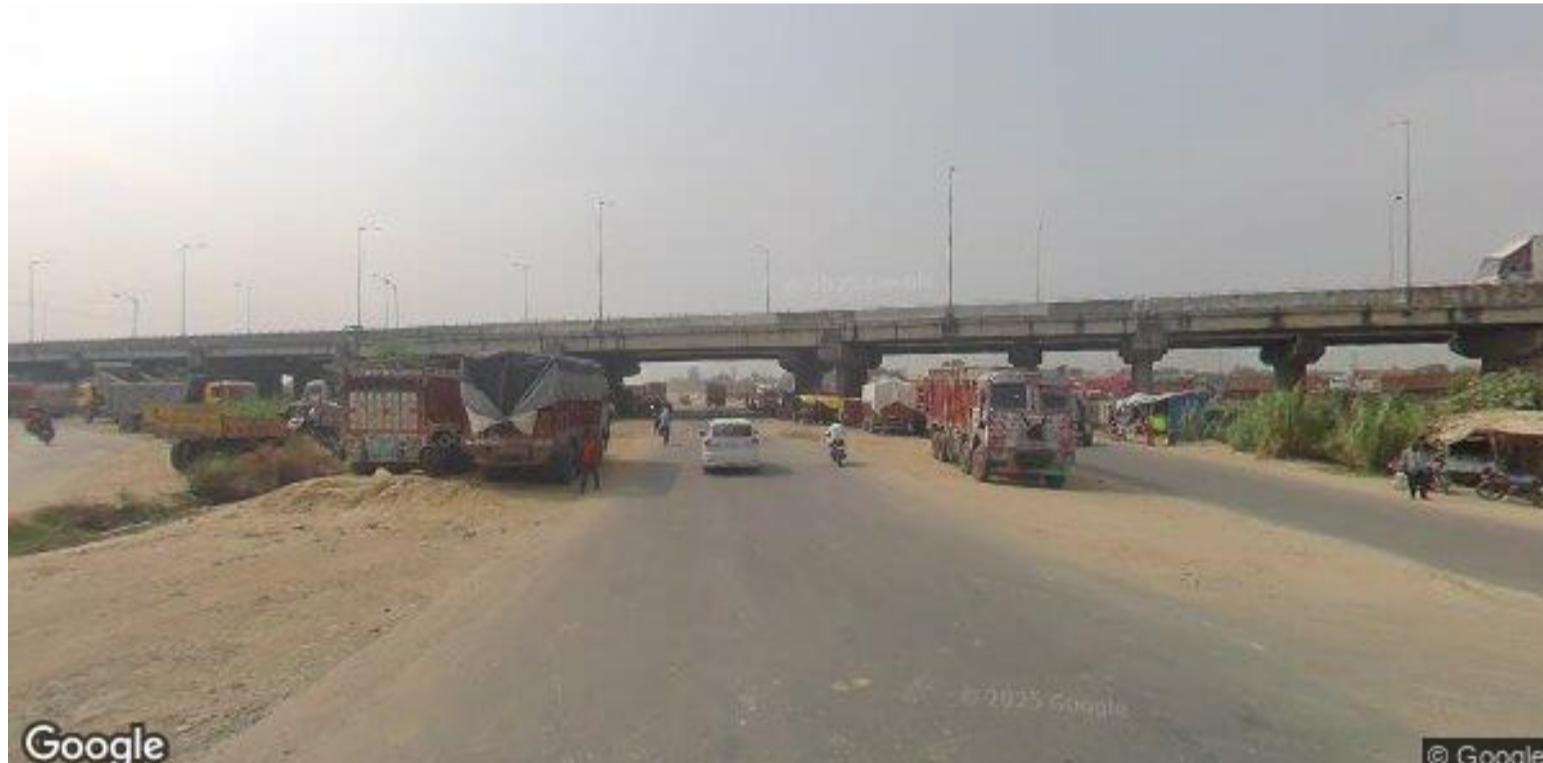
Coordinates: 26.70798, 83.33175

Risk Type: Turn

Risk Level: High

Speed Limit: 15 KM/Hr

Distance from Start: 18.62 km

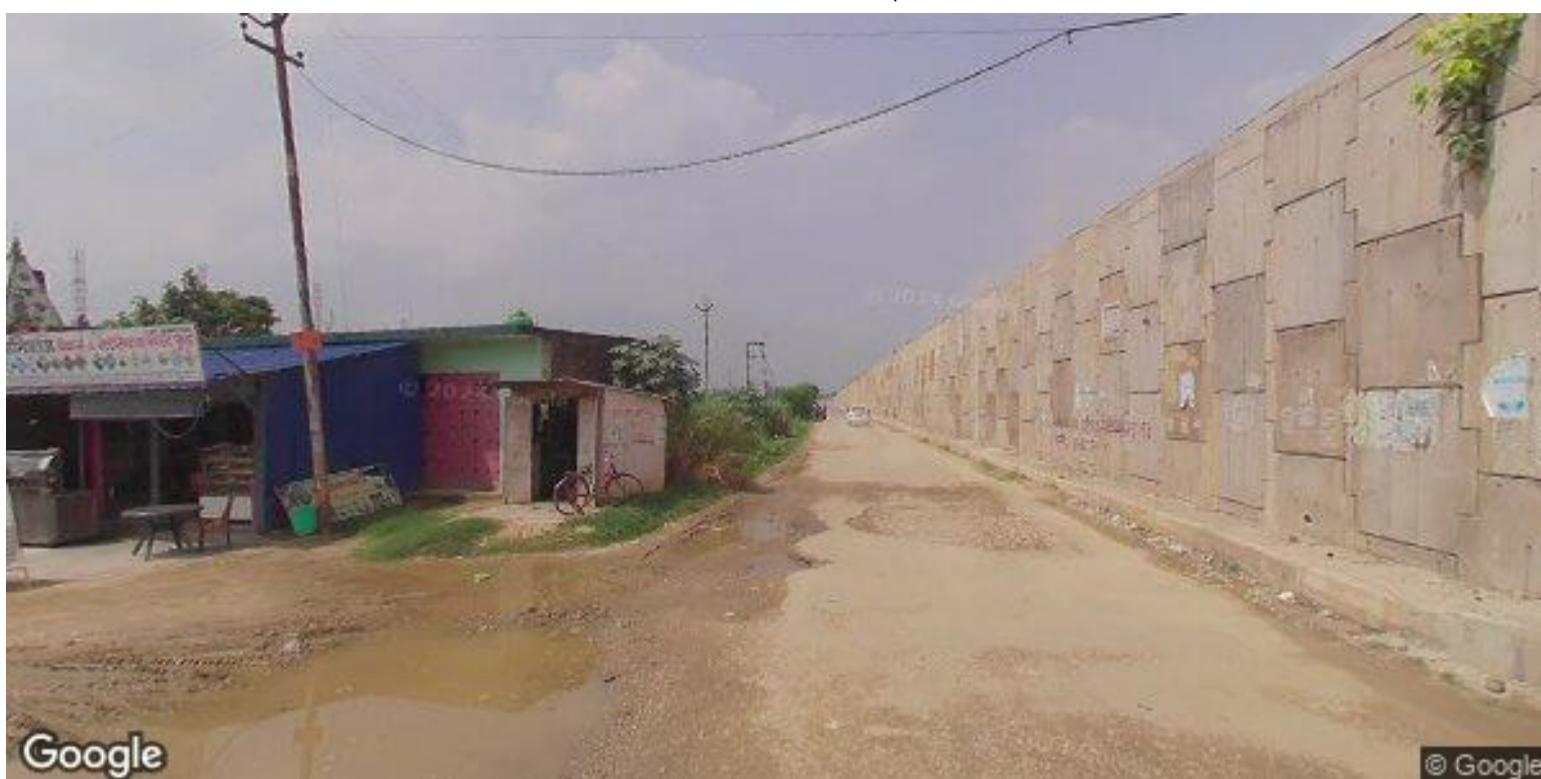
Risk Type: Turn**Risk Level: High****Speed Limit: 15 KM/Hr****Distance from Start: 43.93 km****Coordinates: 26.51679, 83.42326**

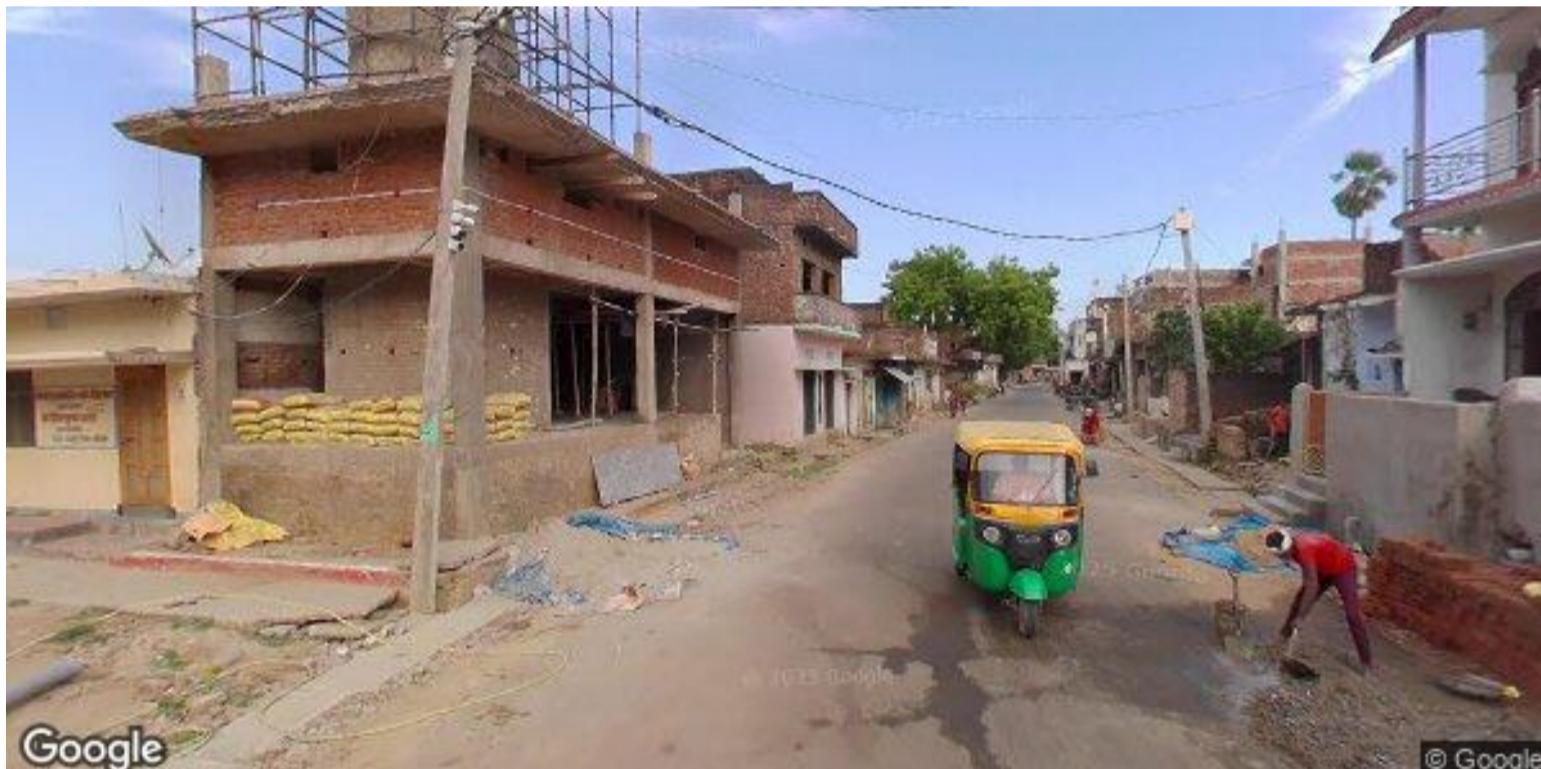
Risk Type: Turn**Risk Level: Medium****Speed Limit: 30 KM/Hr****Distance from Start: 49.83 km****Coordinates: 26.49533, 83.47376**

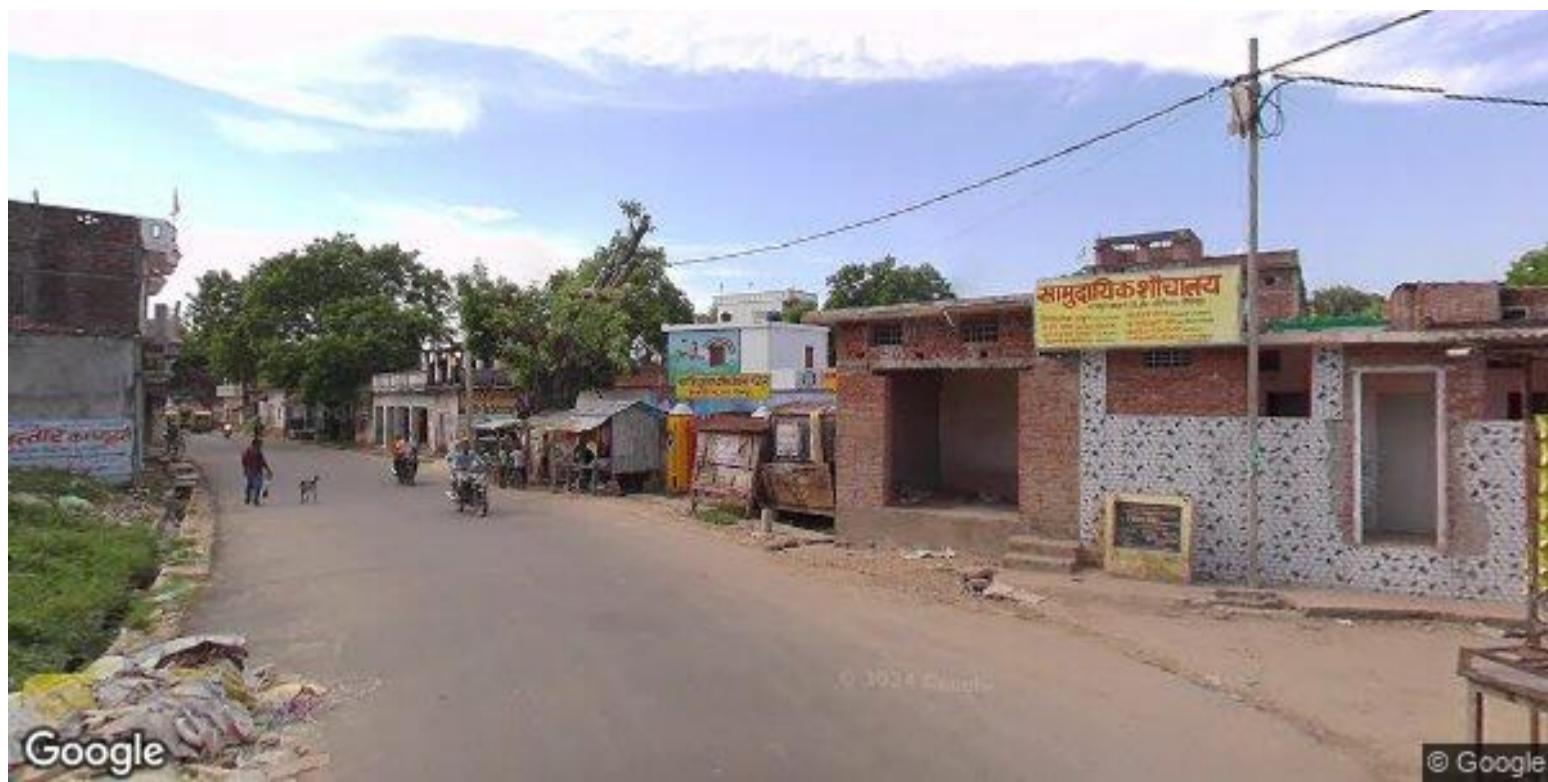
Risk Type: Turn**Risk Level:** Medium**Speed Limit:** 30 KM/Hr**Distance from Start:** 49.98 km**Coordinates:** 26.49451, 83.47509

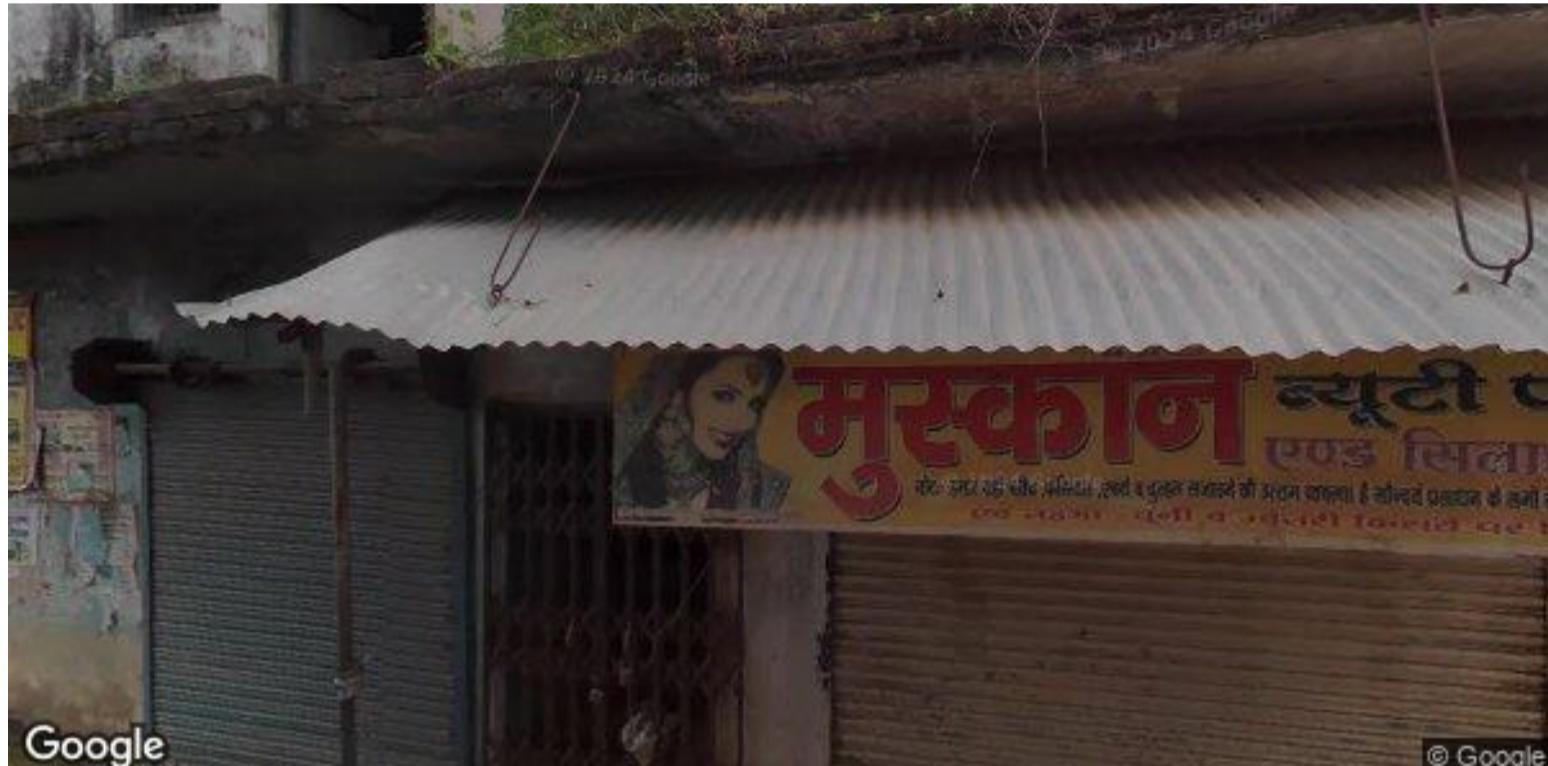
Risk Type: Turn**Risk Level:** High**Speed Limit:** 15 KM/Hr**Distance from Start:** 50.06 km**Coordinates:** 26.49401, 83.47522

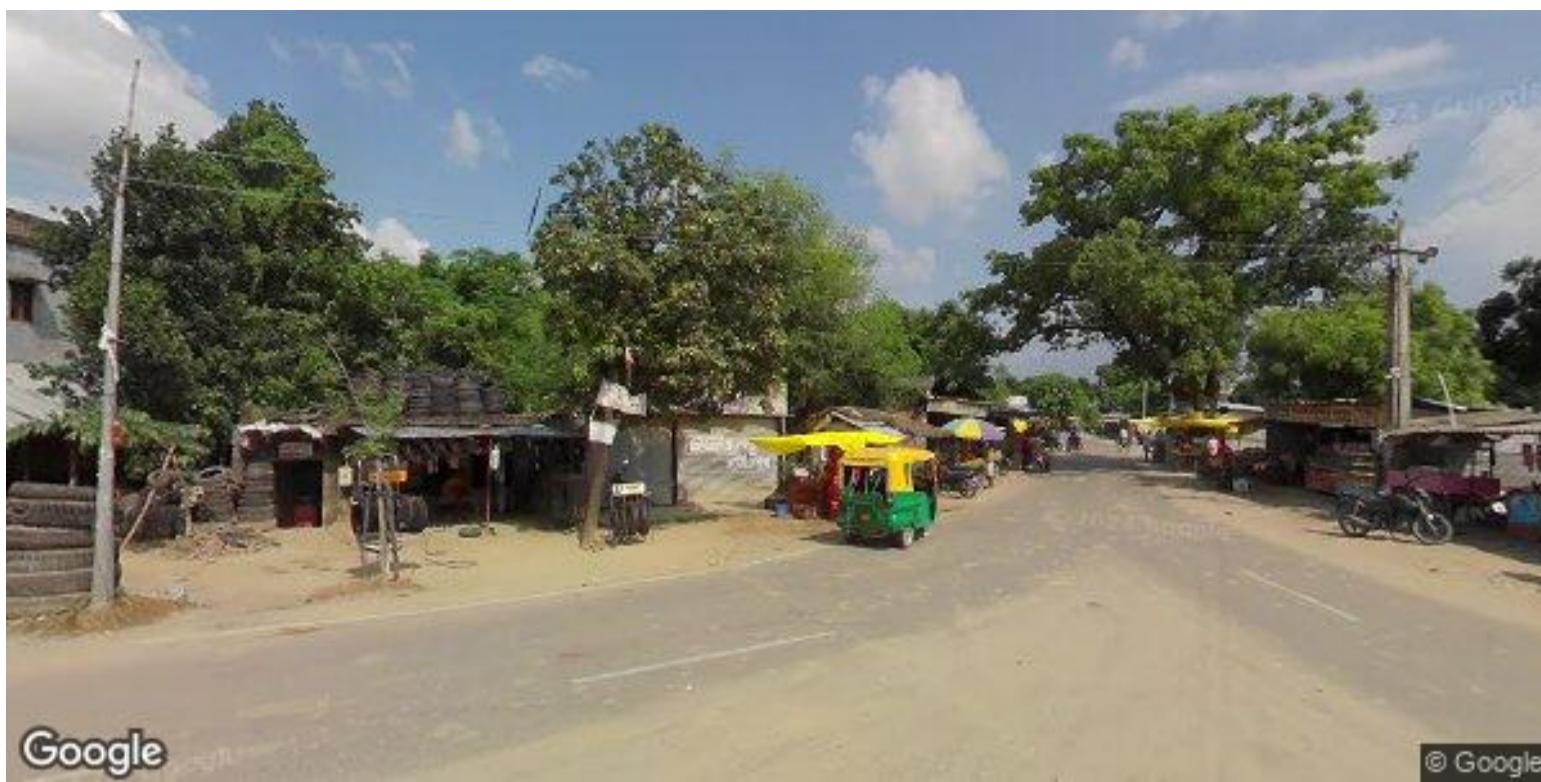
Risk Type: Turn**Risk Level:** Medium**Speed Limit:** 30 KM/Hr**Distance from Start:** 51.24 km**Coordinates:** 26.48447, 83.48064

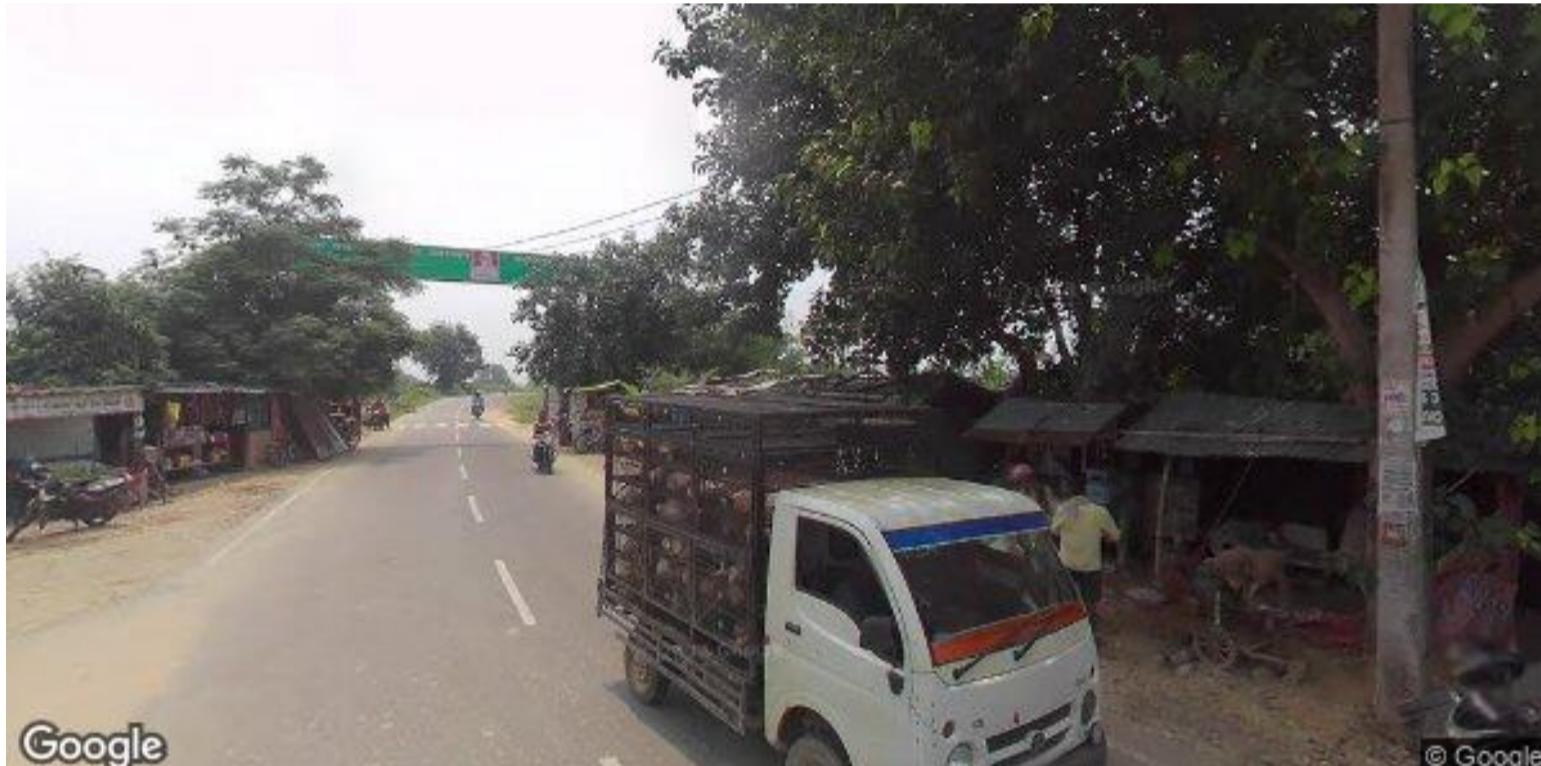
Risk Type: Turn**Risk Level:** High**Speed Limit:** 15 KM/Hr**Distance from Start:** 52.55 km**Coordinates:** 26.48301, 83.49206

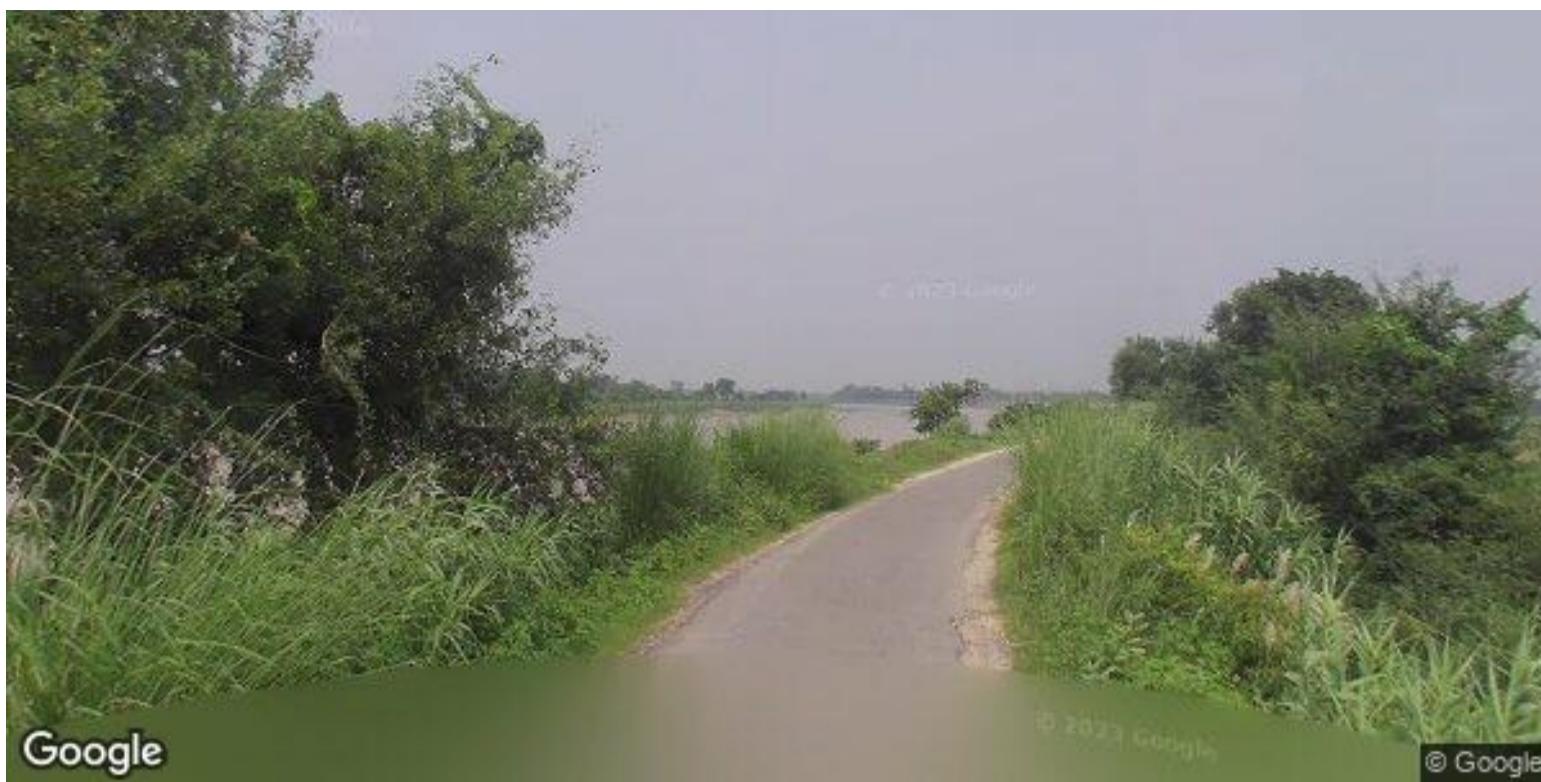
Risk Type: Turn**Risk Level:** Medium**Speed Limit:** 30 KM/Hr**Distance from Start:** 52.82 km**Coordinates:** 26.48536, 83.49168

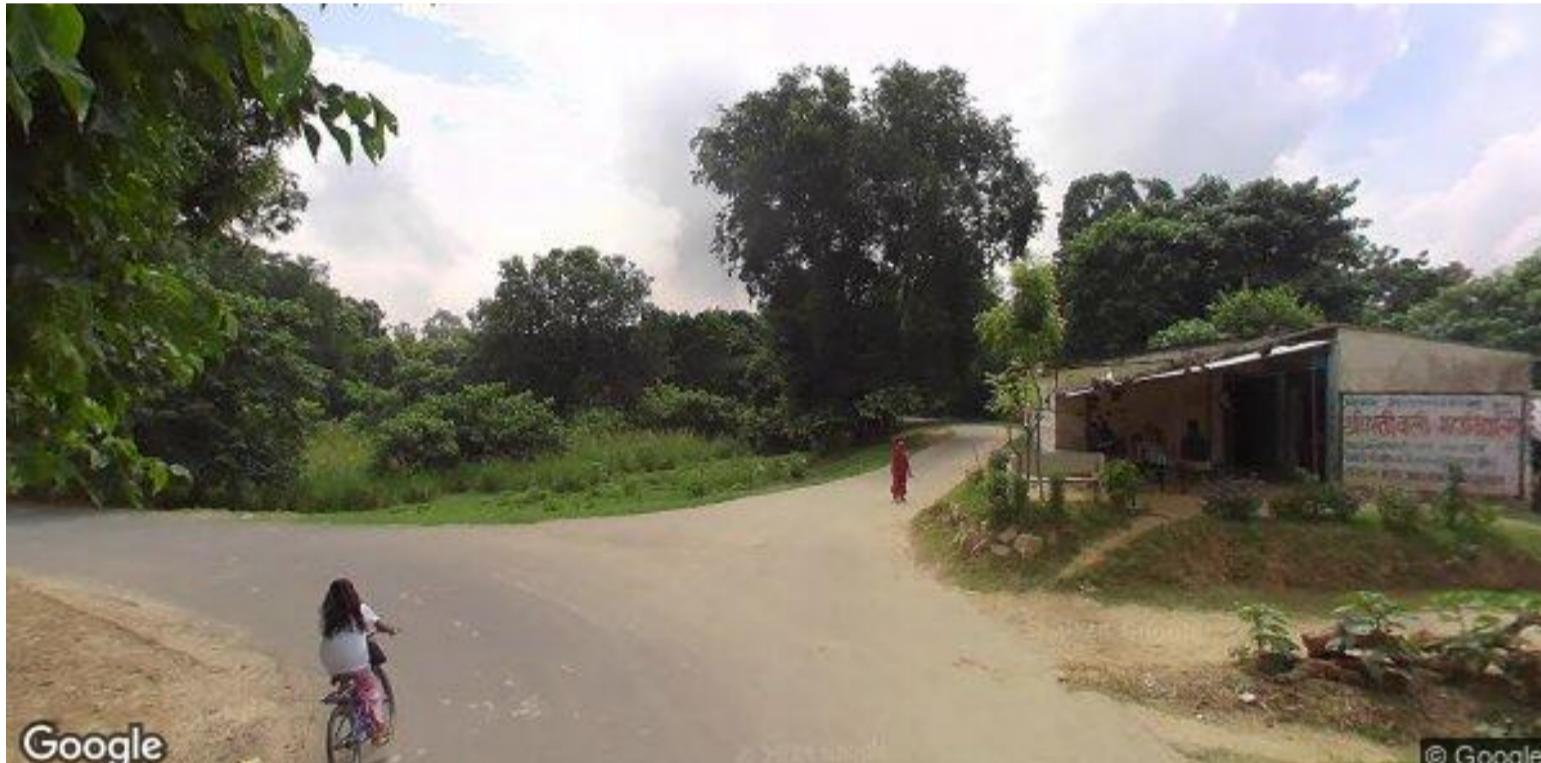
Risk Type: Turn**Risk Level:** Medium**Speed Limit:** 30 KM/Hr**Distance from Start:** 54.49 km**Coordinates:** 26.49663, 83.49948
