JOURNEY RISK MANAGEMENT (JRM) STUDY

Gorakhpur LPG BP TO SNEH INDANE GAS SERV

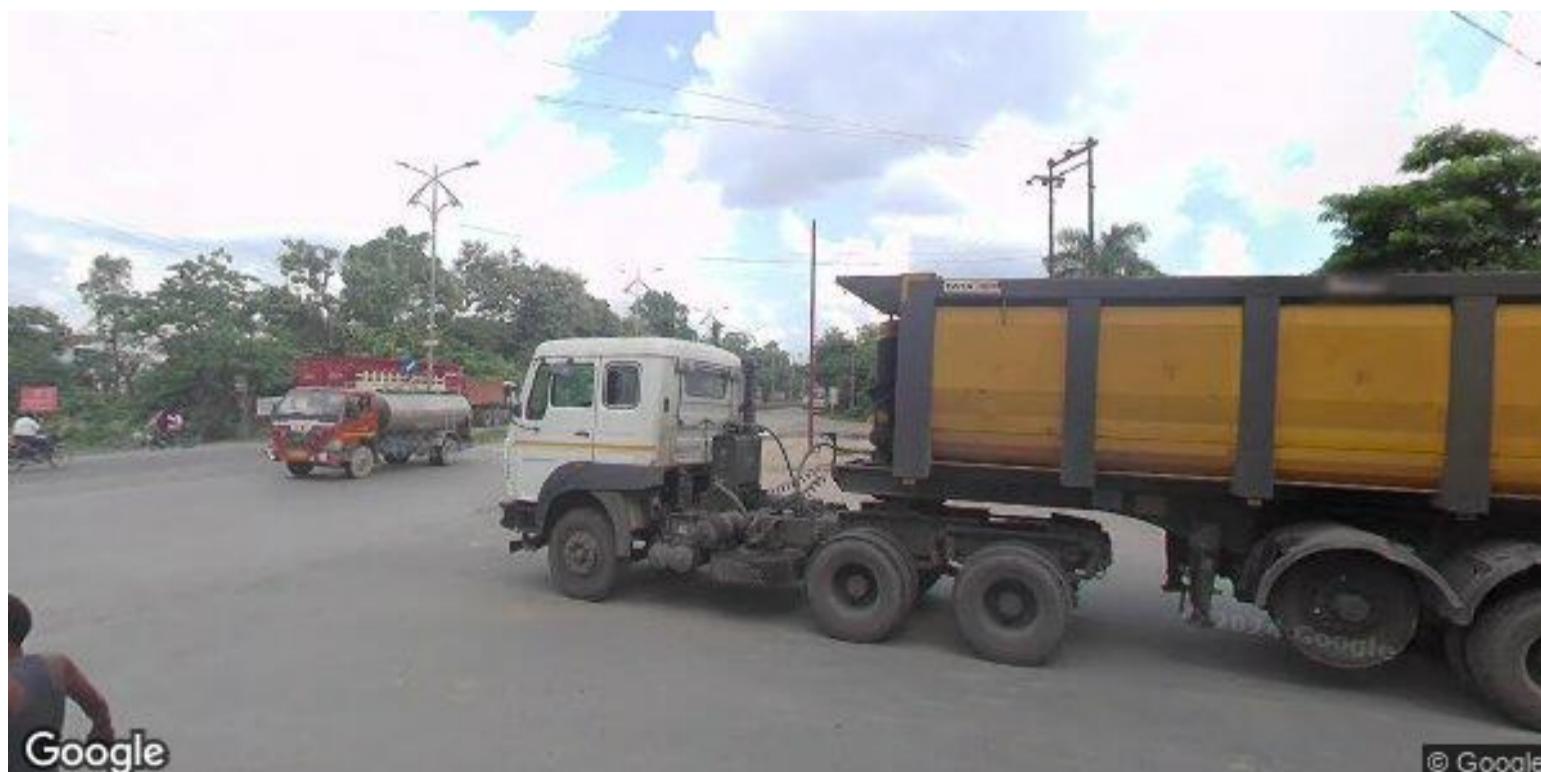
Distance from Start: 2.16 km
Coordinates: 26.75126, 83.22476

Risk Type: Blind Spot

Risk Level: Blind Spot

Speed Limit: 10 KM/Hr

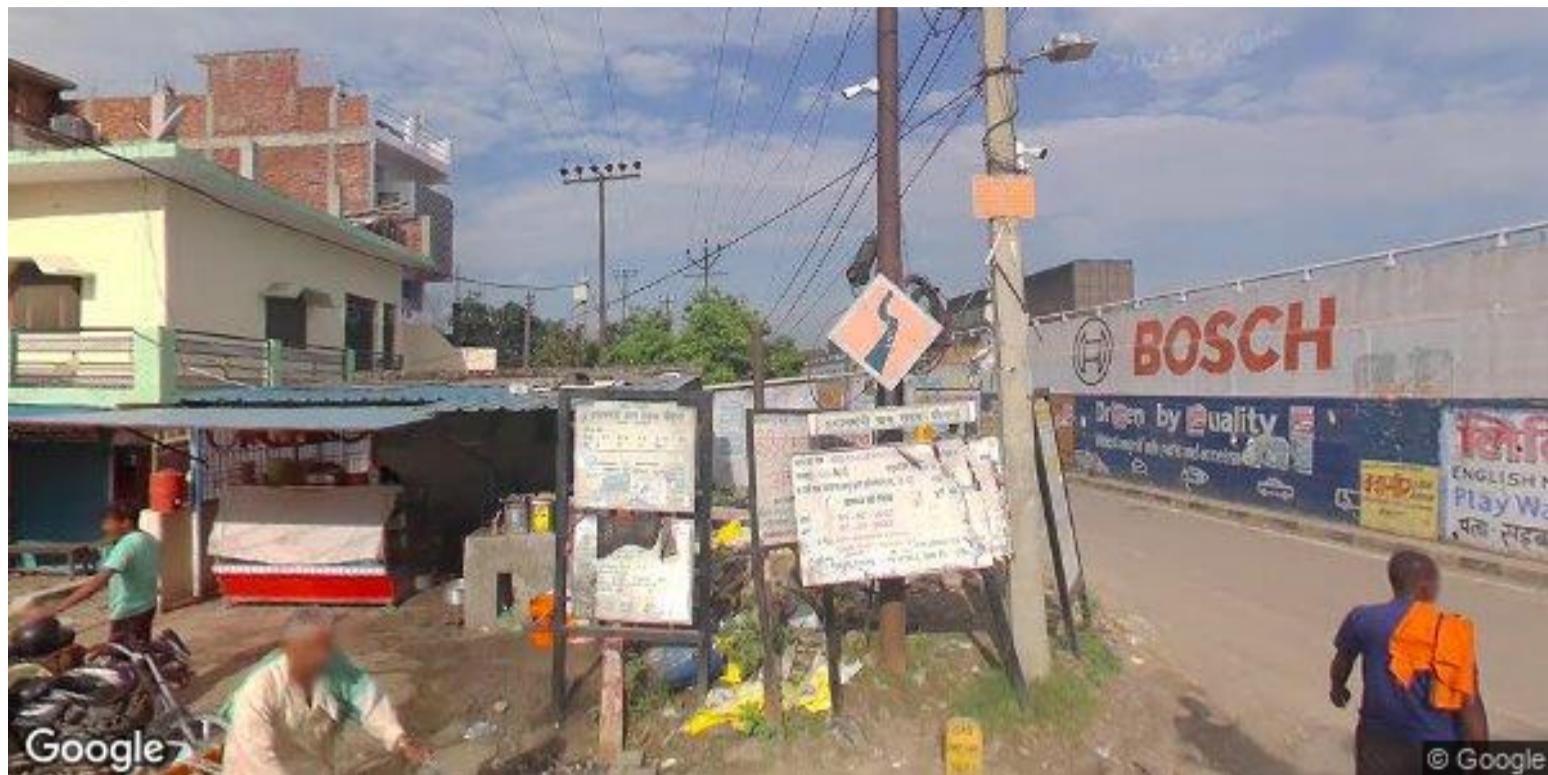
Distance from Start: 4.22 km

Risk Type: Blind Spot

Risk Level: Blind Spot

Speed Limit: 10 KM/Hr

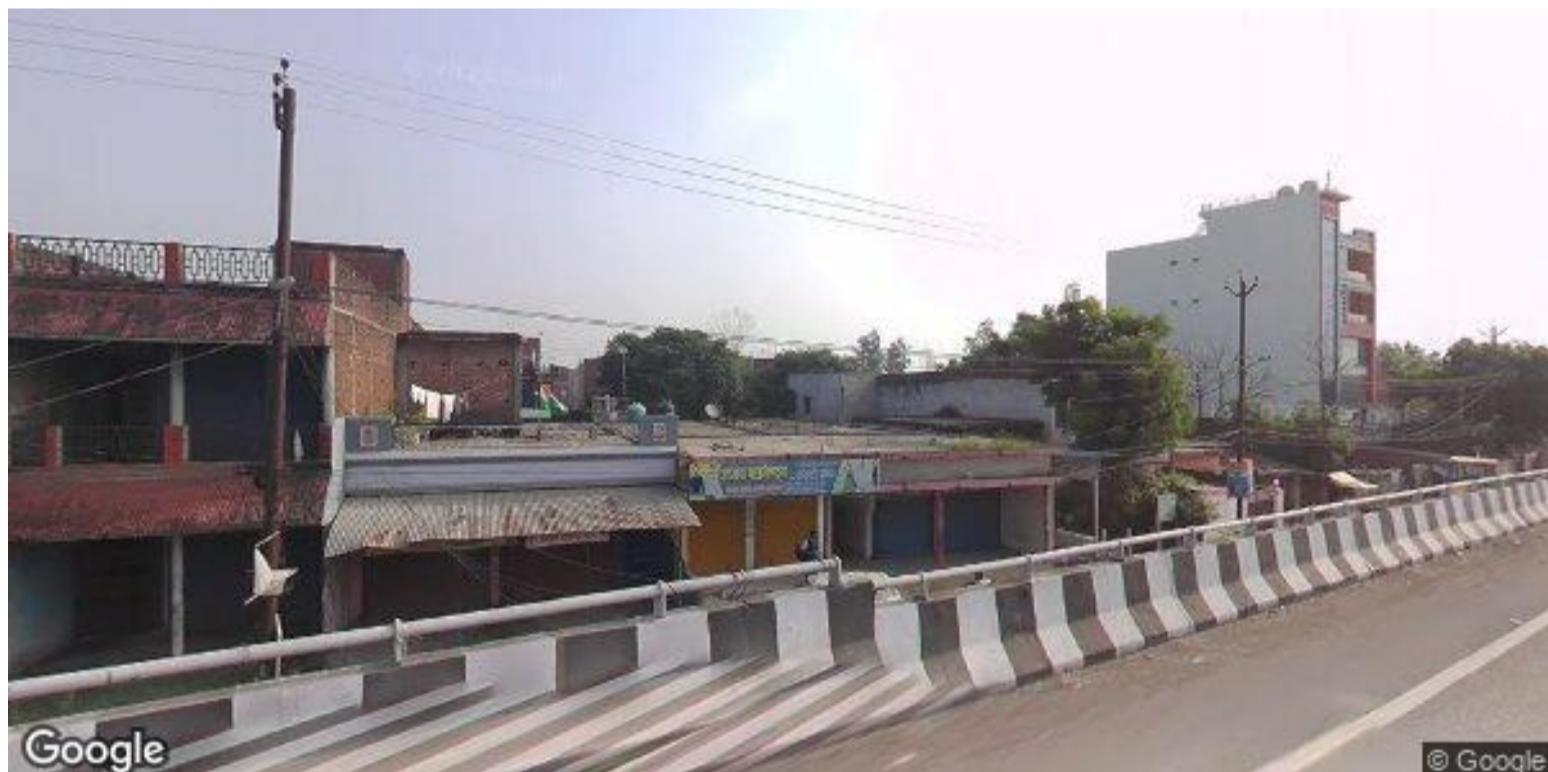
Distance from Start: 4.27 km

Risk Type: Turn

Risk Level: High

Speed Limit: 15 KM/Hr

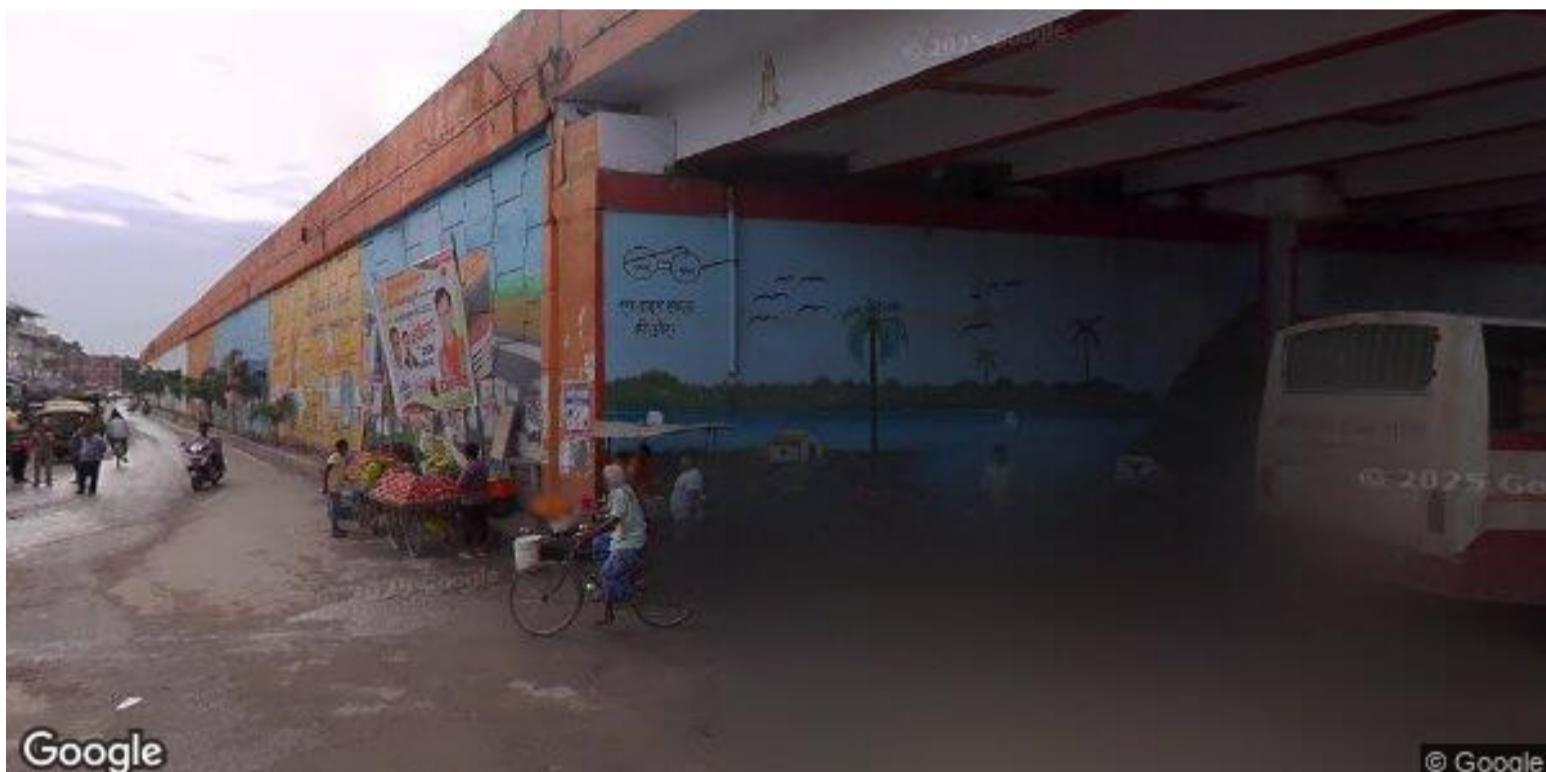
Risk Type: Turn**Risk Level:** High**Speed Limit:** 15 KM/Hr**Distance from Start:** 108.71 km**Coordinates:** 26.68889, 84.17995

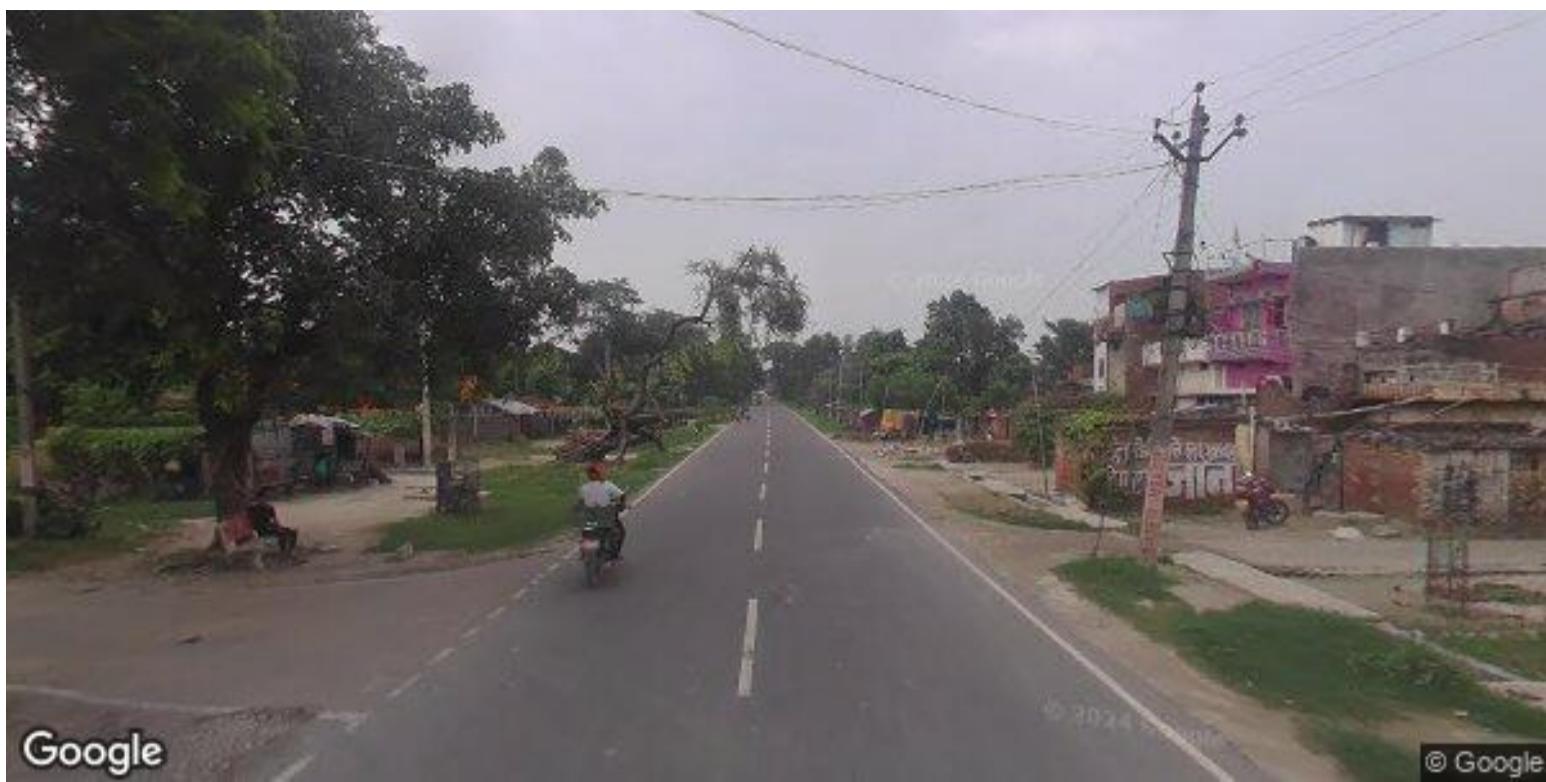
Distance from Start: 115.62 km

Risk Type: Turn

Risk Level: High

Speed Limit: 15 KM/Hr
