JOURNEY RISK MANAGEMENT (JRM) STUDY

Gorakhpur LPG BP TO SURYANATH INDANE GAS

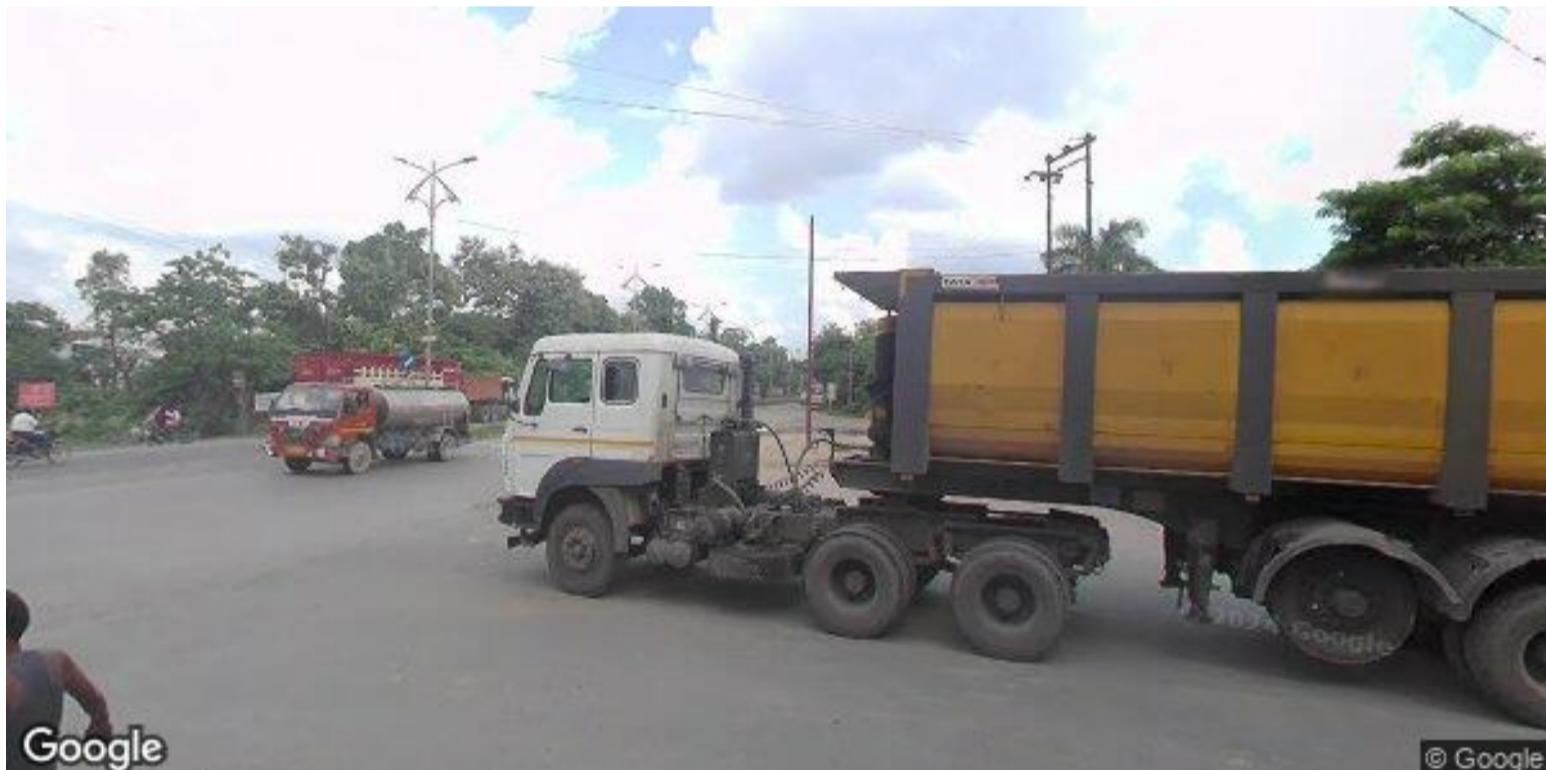
Distance from Start: 2.17 km

Risk Type: Blind Spot

Risk Level: Blind Spot

Speed Limit: 10 KM/Hr

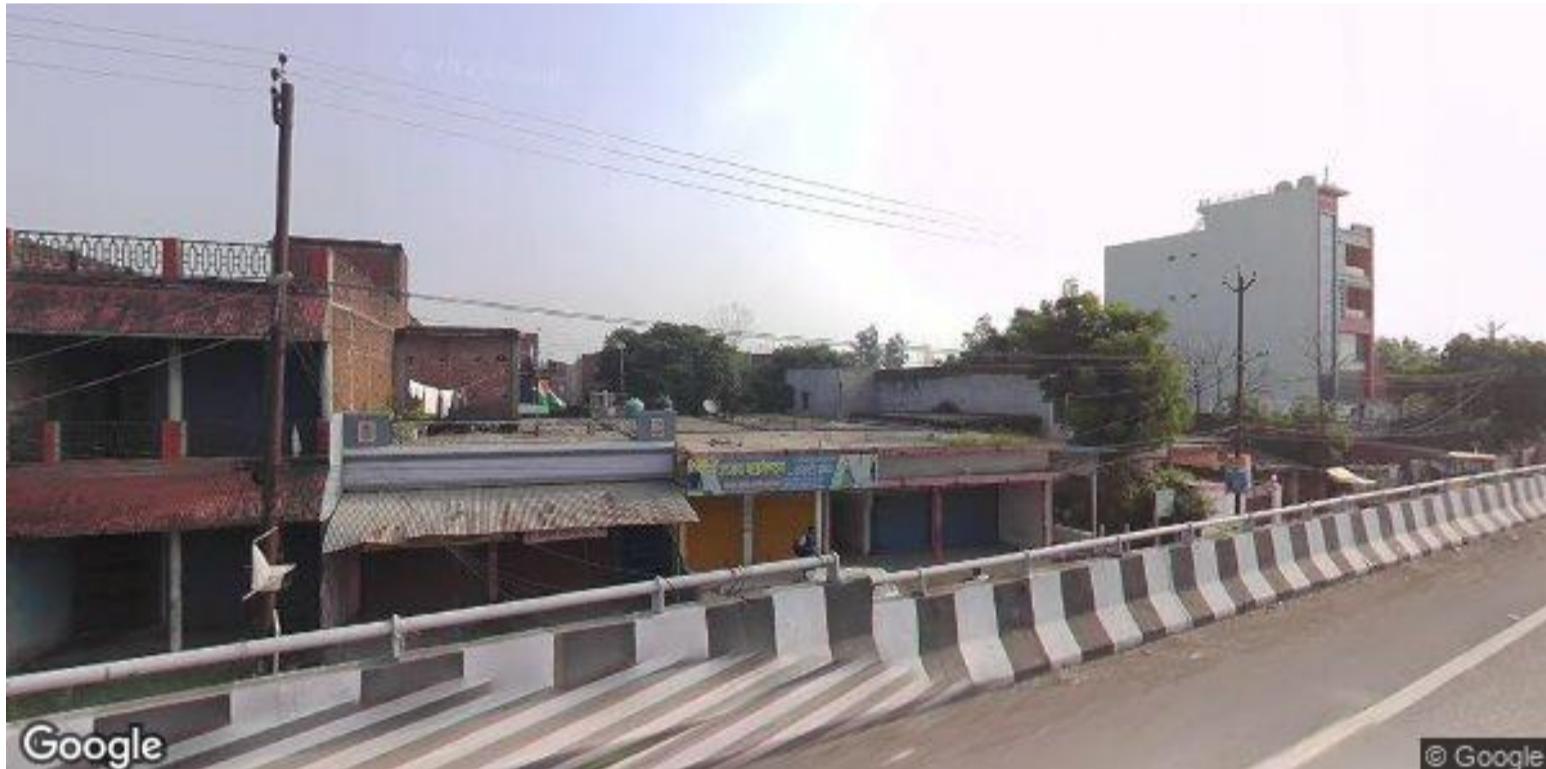
Distance from Start: 4.28 km

Risk Type: Turn

Risk Level: High

Speed Limit: 15 KM/Hr

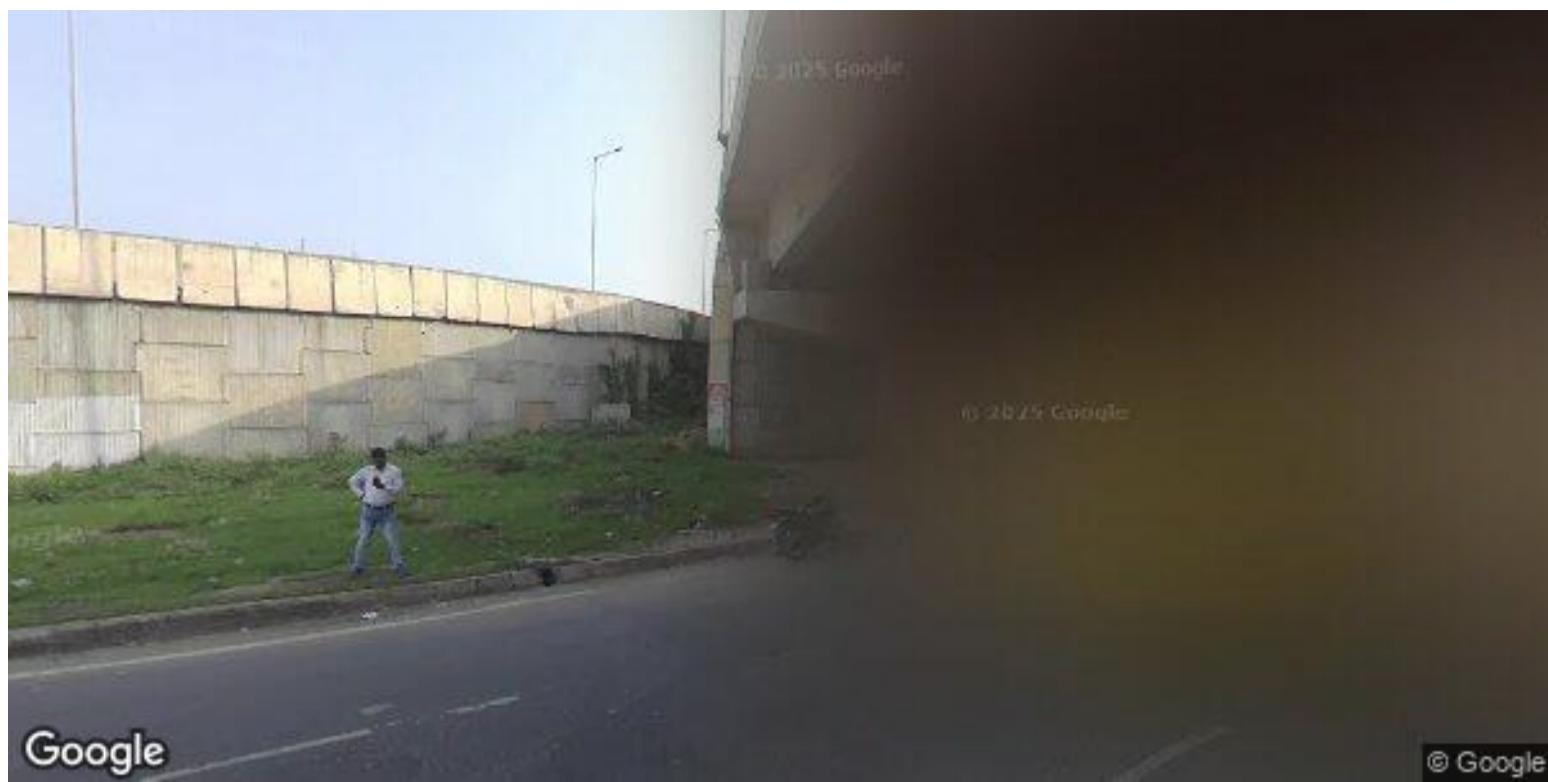
Risk Type: Roundabout**Risk Level:** High**Speed Limit:** 15 KM/Hr**Distance from Start:** 8.75 km**Coordinates:** 26.74681, 83.25111

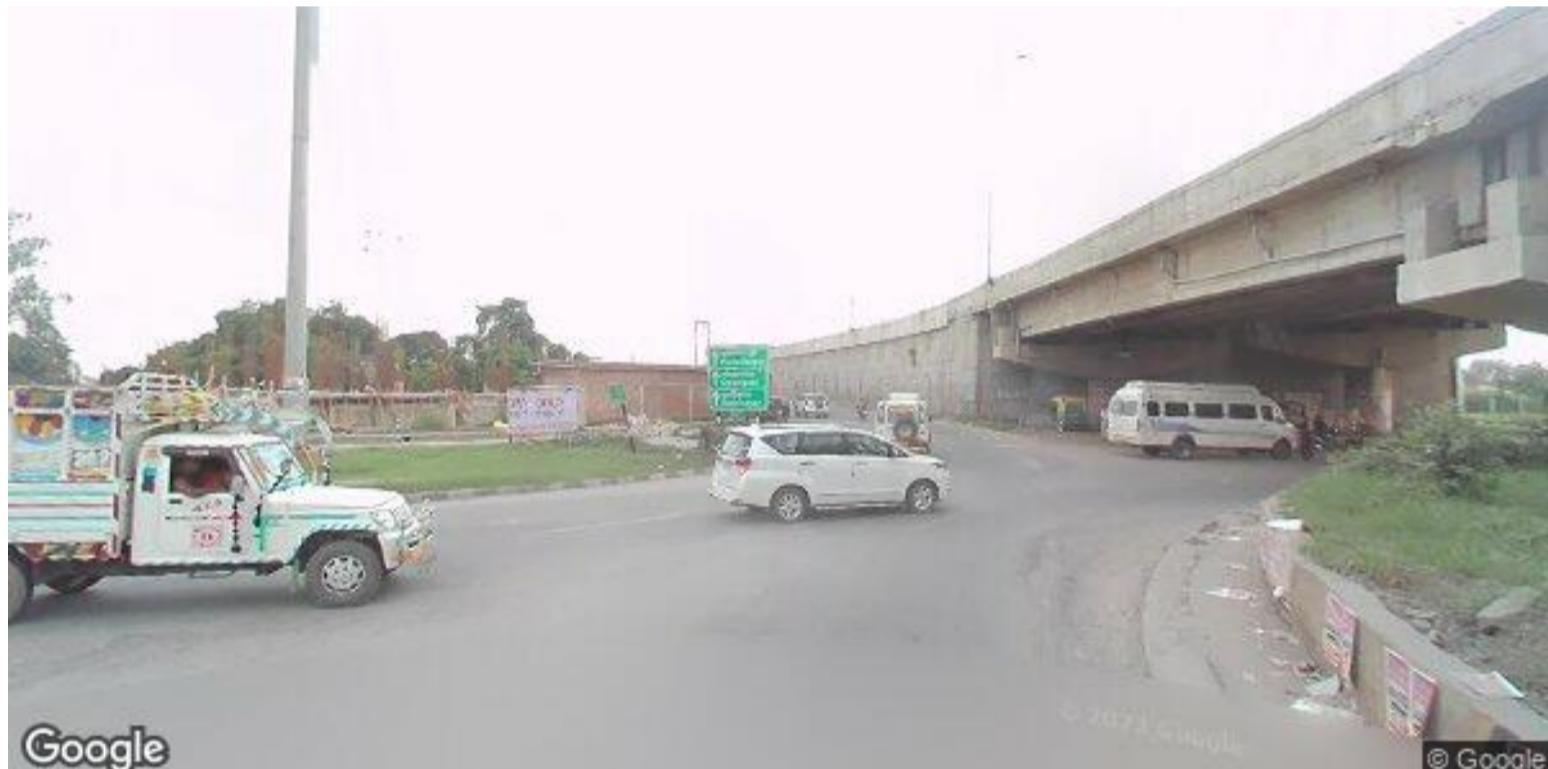
Risk Type: Turn**Risk Level:** Medium**Speed Limit:** 30 KM/Hr**Distance from Start:** 9.04 km**Coordinates:** 26.74658, 83.25155

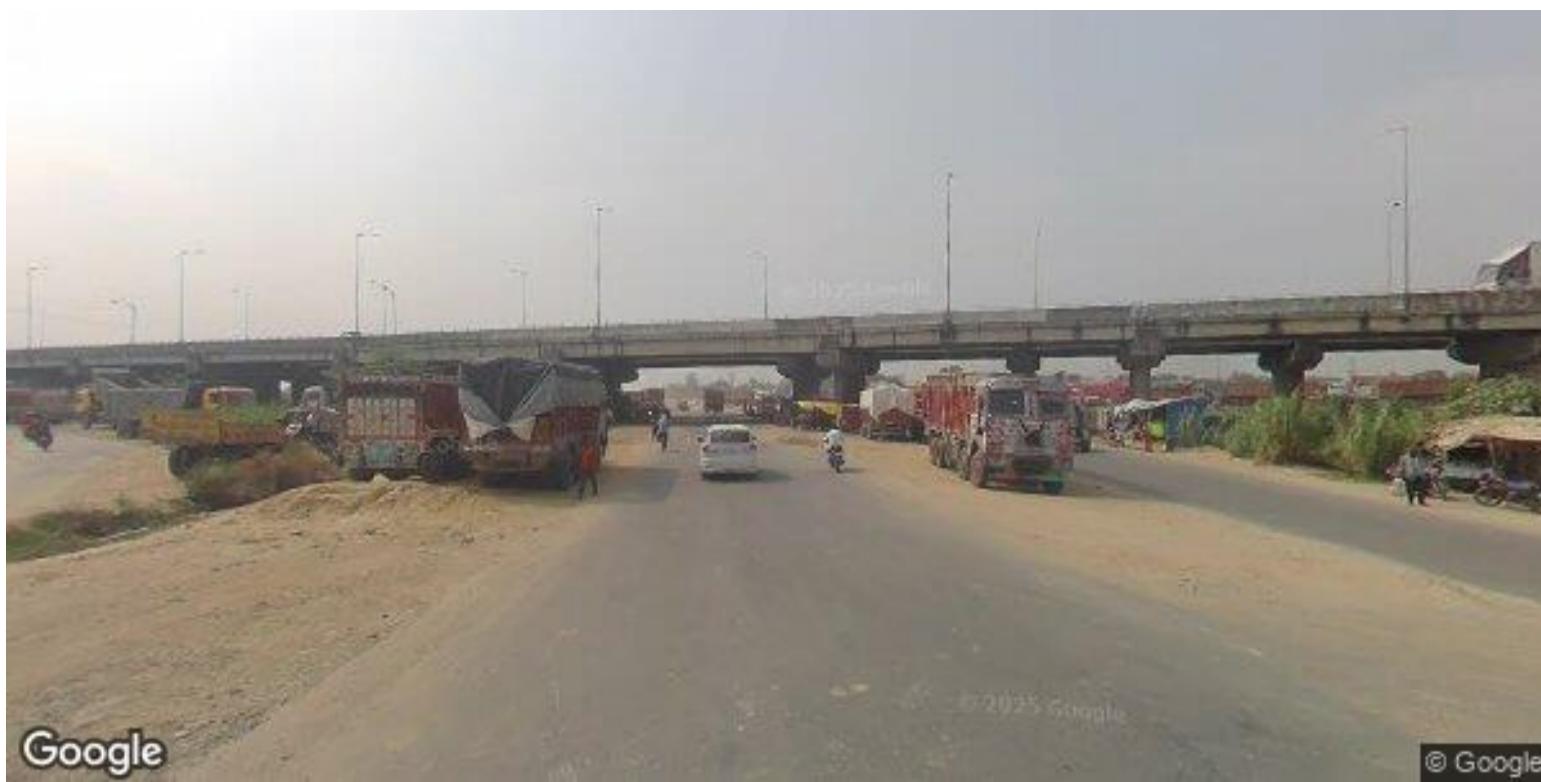
Distance from Start: 18.62 km

Risk Type: Turn

Risk Level: High

Speed Limit: 15 KM/Hr

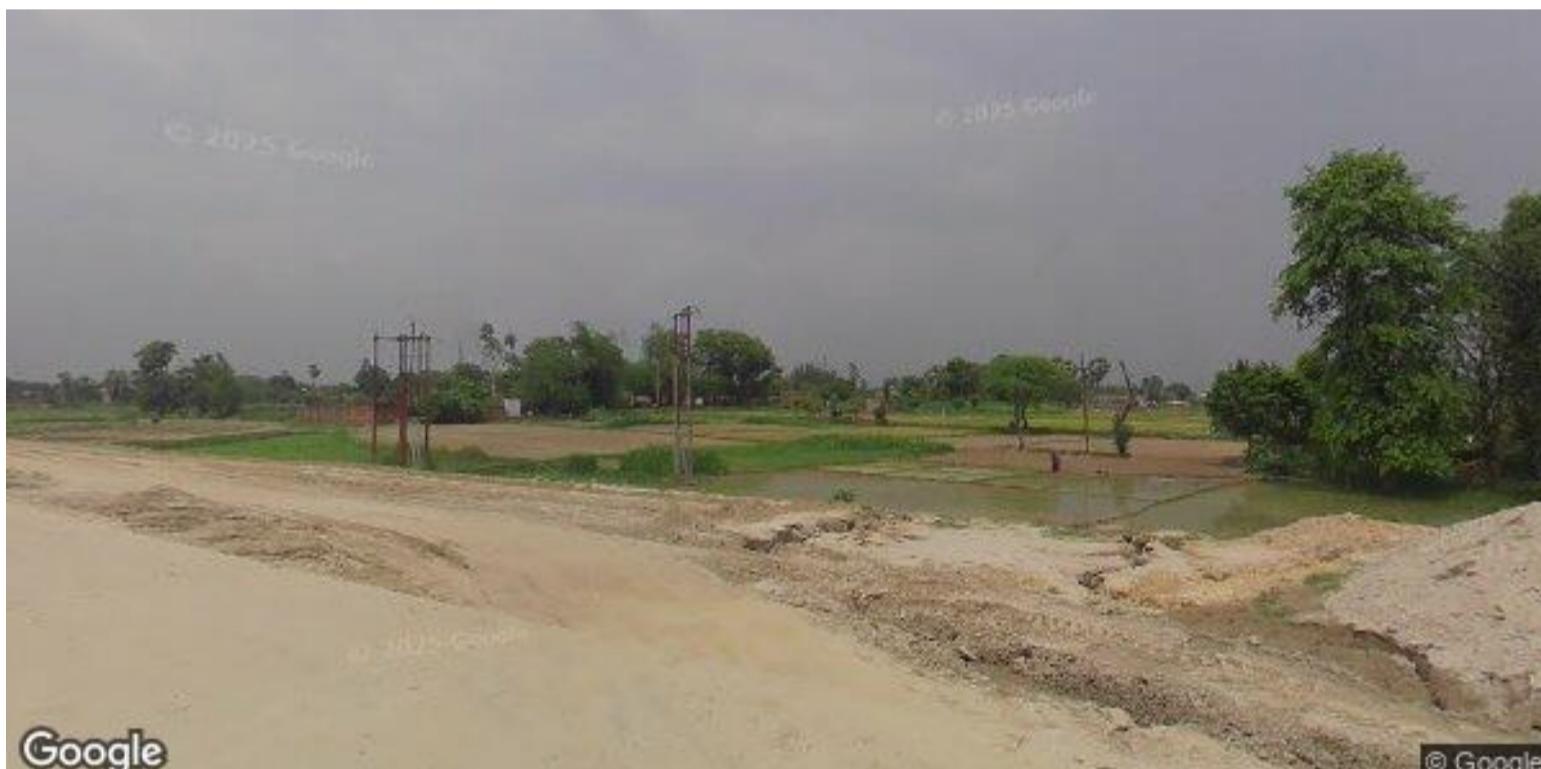
Distance from Start: 76.50 km

Risk Type: Turn

Risk Level: High

Speed Limit: 15 KM/Hr

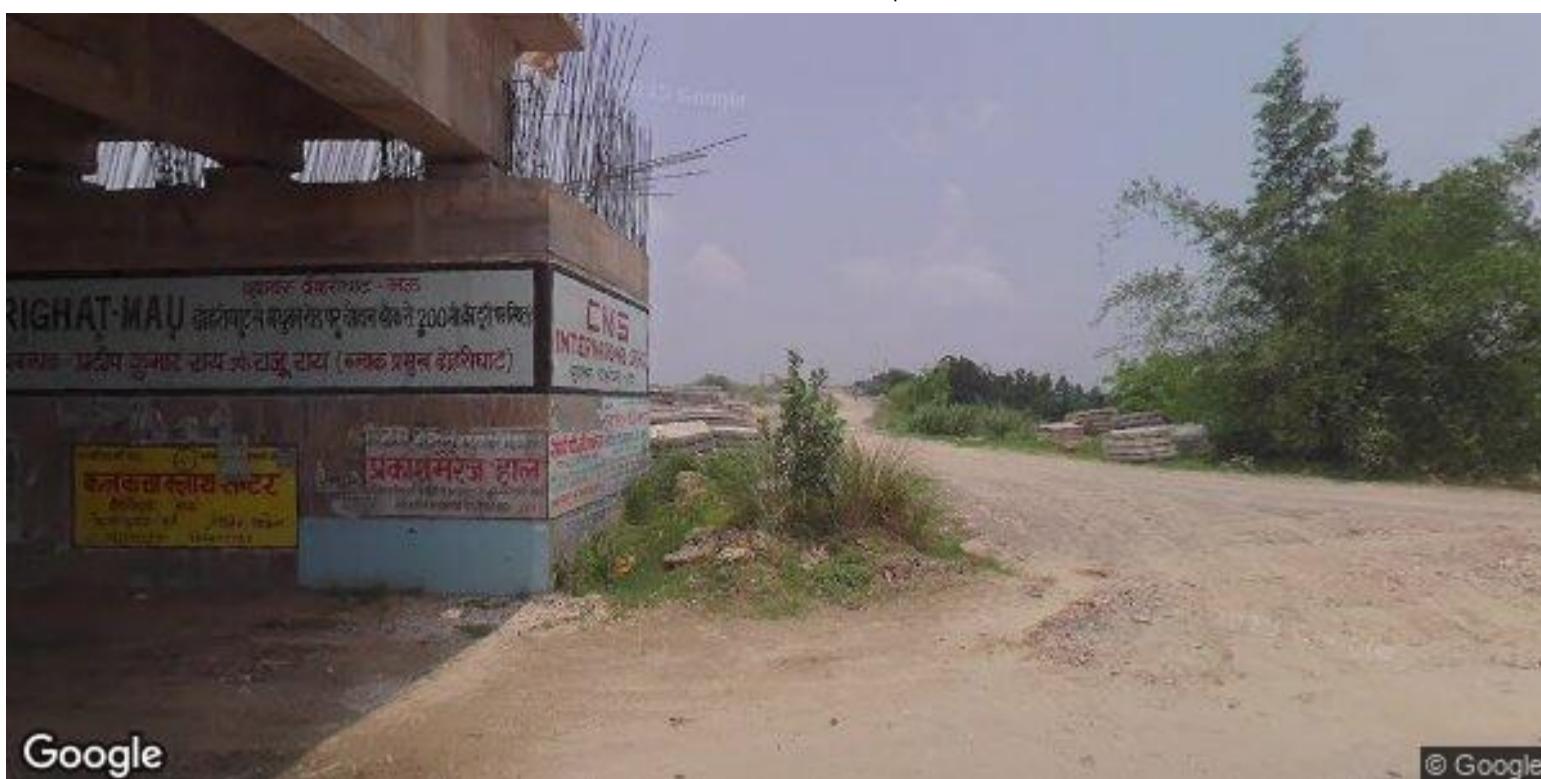
Risk Type: Blind Spot**Risk Level:** Blind Spot**Speed Limit:** 10 KM/Hr**Distance from Start:** 77.04 km**Coordinates:** 26.25173, 83.47714

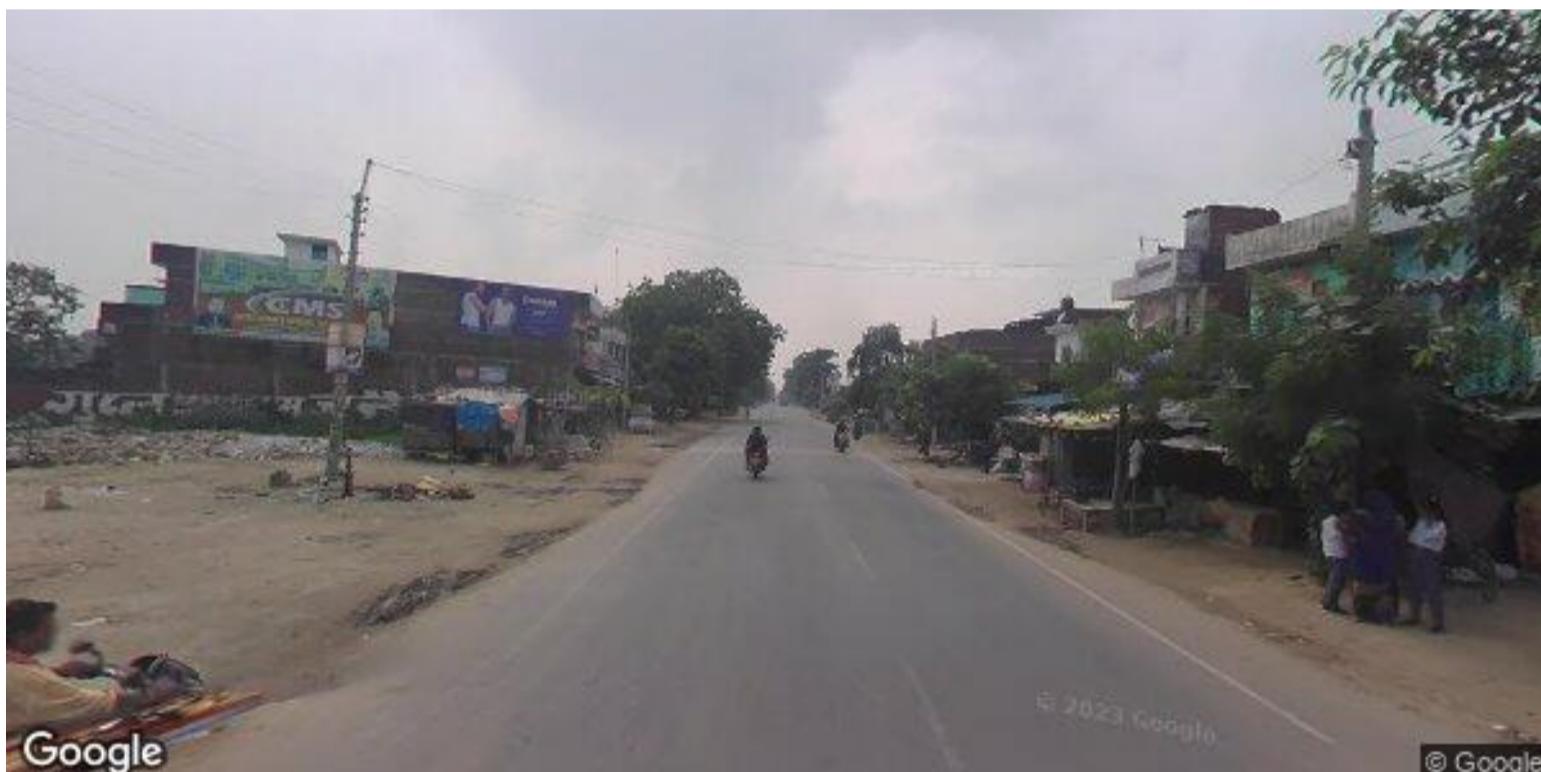
Risk Type: Turn**Risk Level:** High**Speed Limit:** 15 KM/Hr**Distance from Start:** 83.70 km**Coordinates:** 26.23164, 83.41244
