JOURNEY RISK MANAGEMENT (JRM) STUDY

Gorakhpur LPG BP TO SHREYA INDANE SERVIC

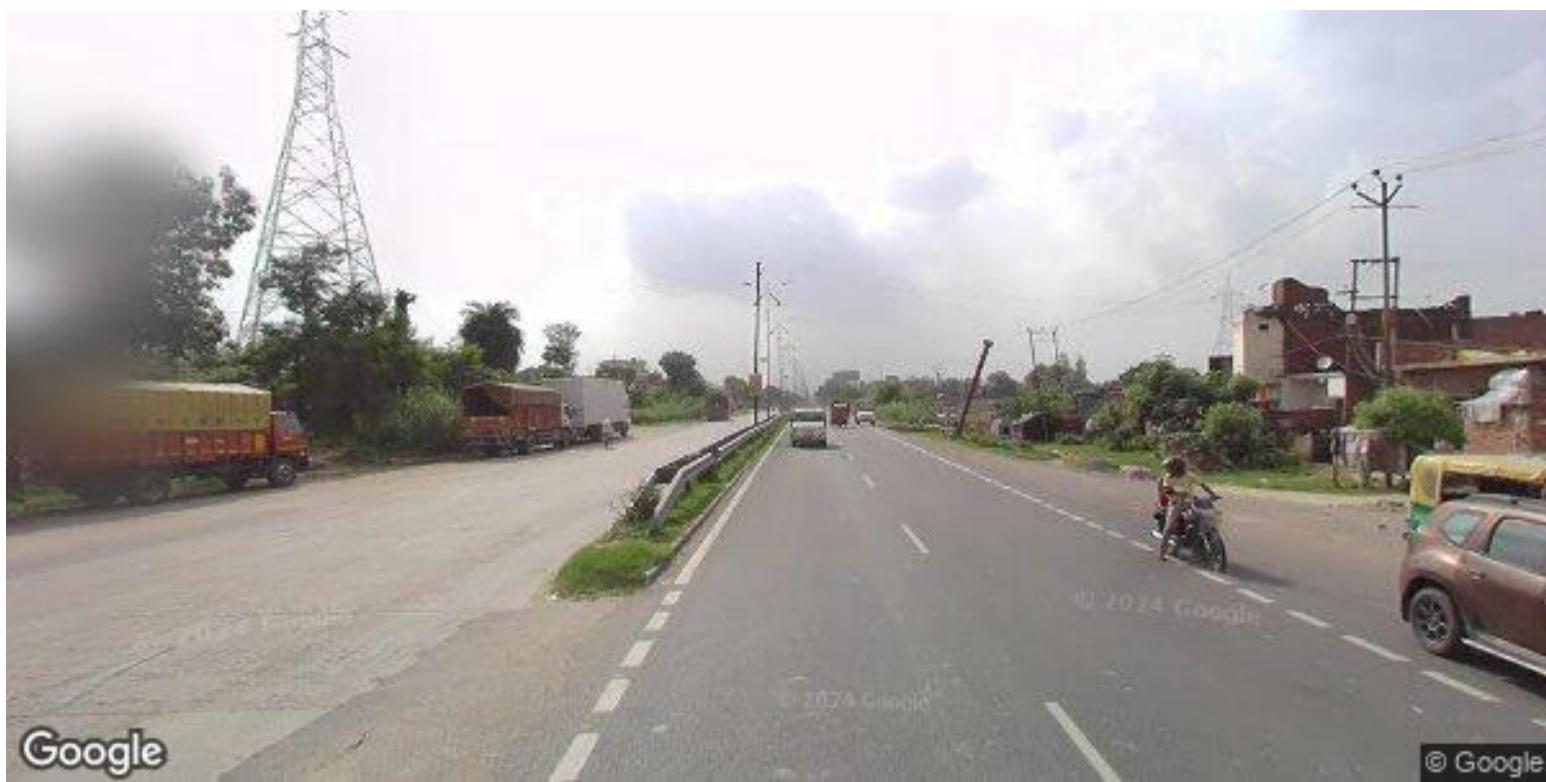
Risk Type: U-Turn**Risk Level: High****Speed Limit: 10 KM/Hr****Distance from Start: 8.85 km****Coordinates: 26.7471208, 83.2490873**

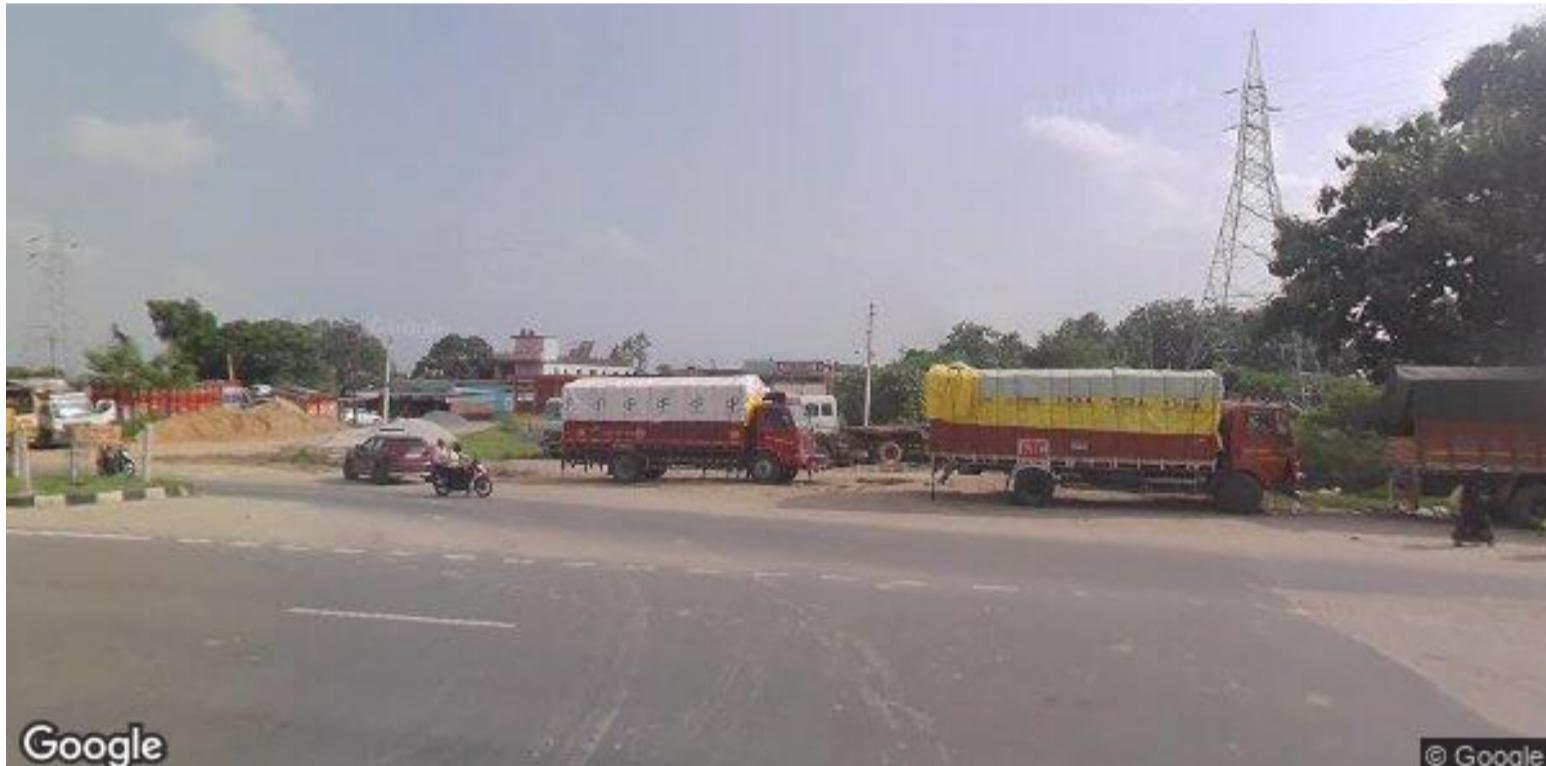
Risk Type: Blind Spot**Risk Level: Blind Spot****Speed Limit: 10 KM/Hr****Distance from Start: 8.85 km****Coordinates: 26.74712, 83.24909**

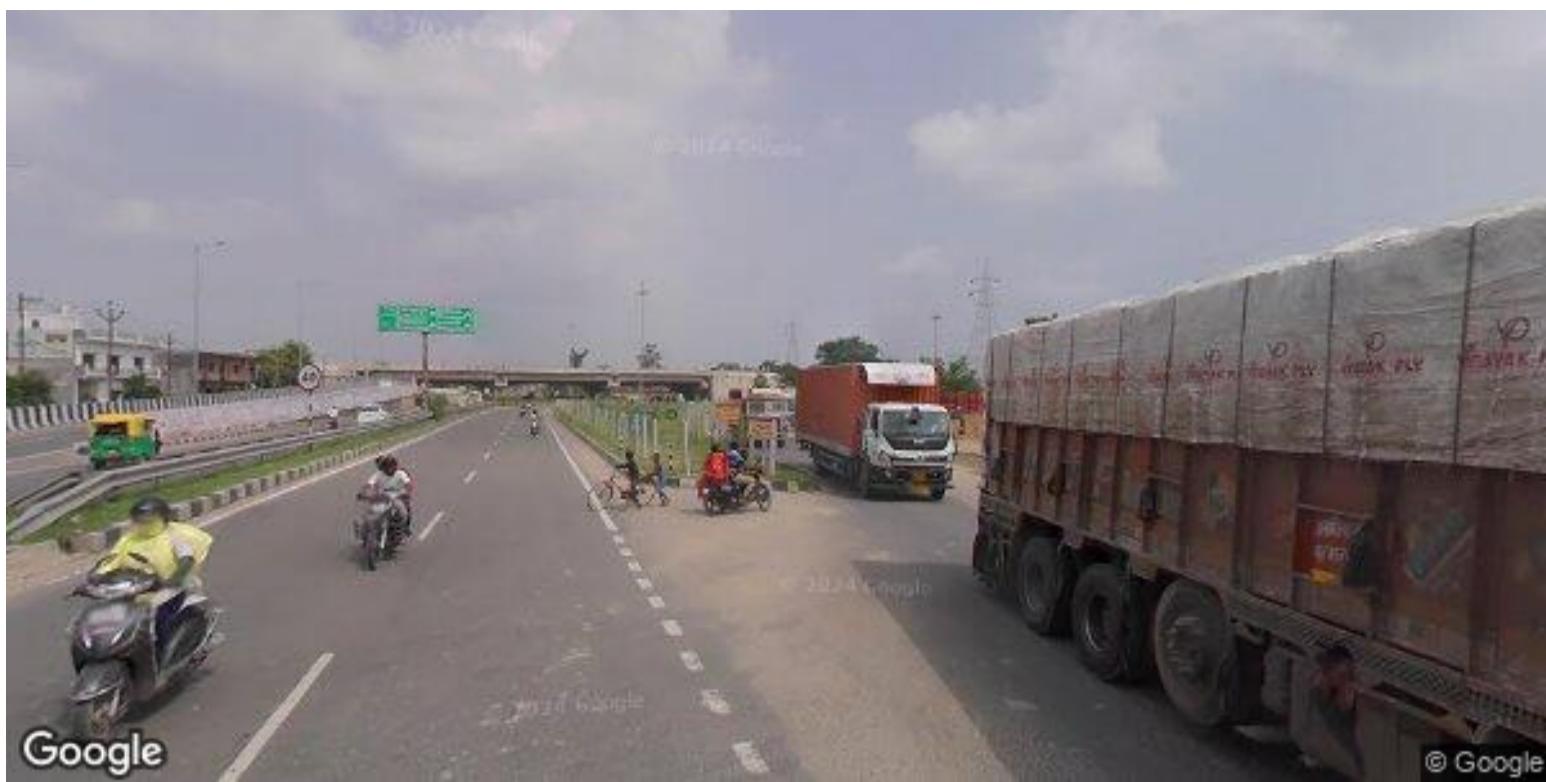
Risk Type: Turn

Risk Level: High

Speed Limit: 15 KM/Hr

Distance from Start: 8.86 km

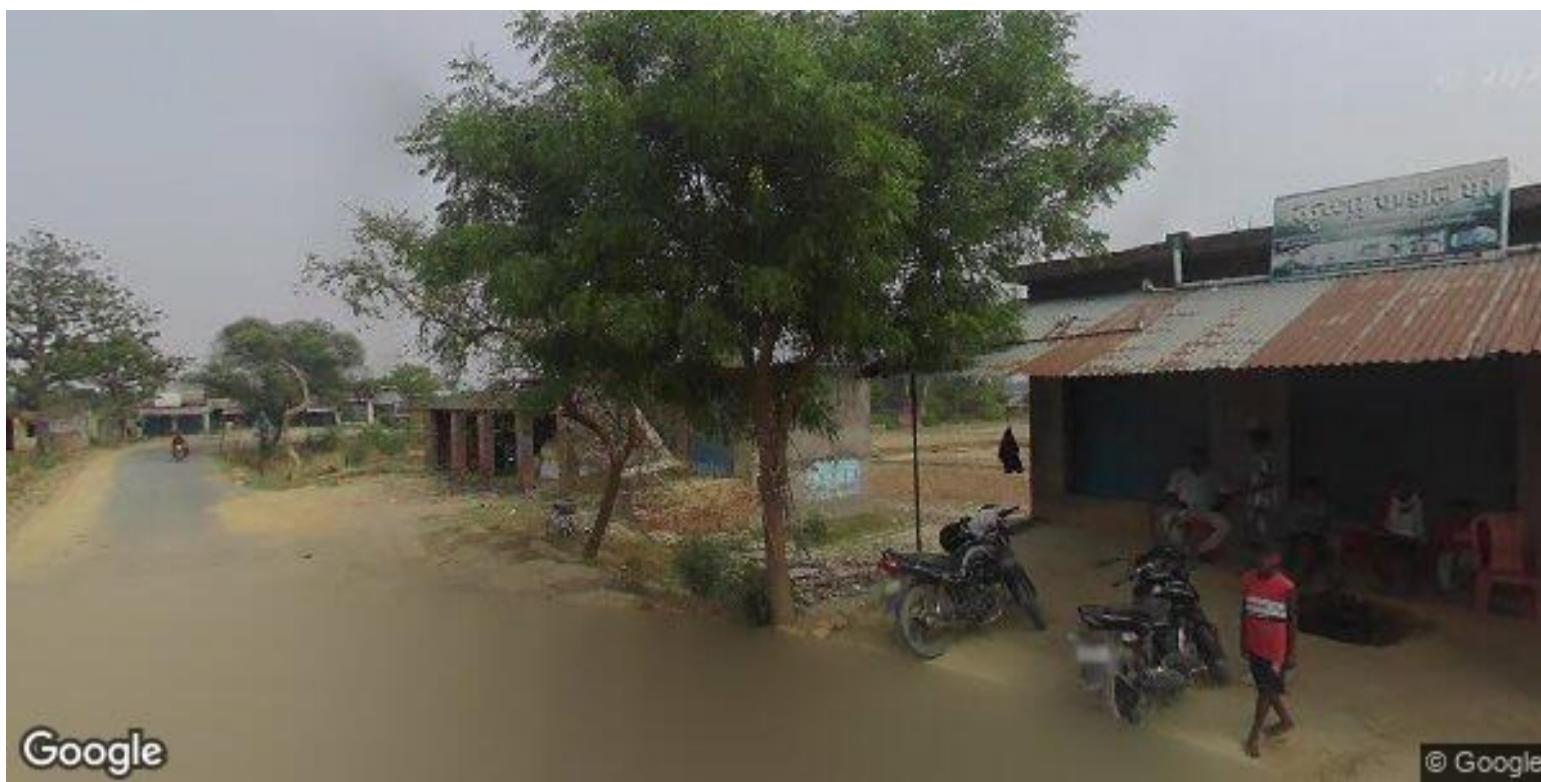
Risk Type: Turn**Risk Level:** Medium**Speed Limit:** 30 KM/Hr**Distance from Start:** 24.55 km**Coordinates:** 26.75468, 83.09984

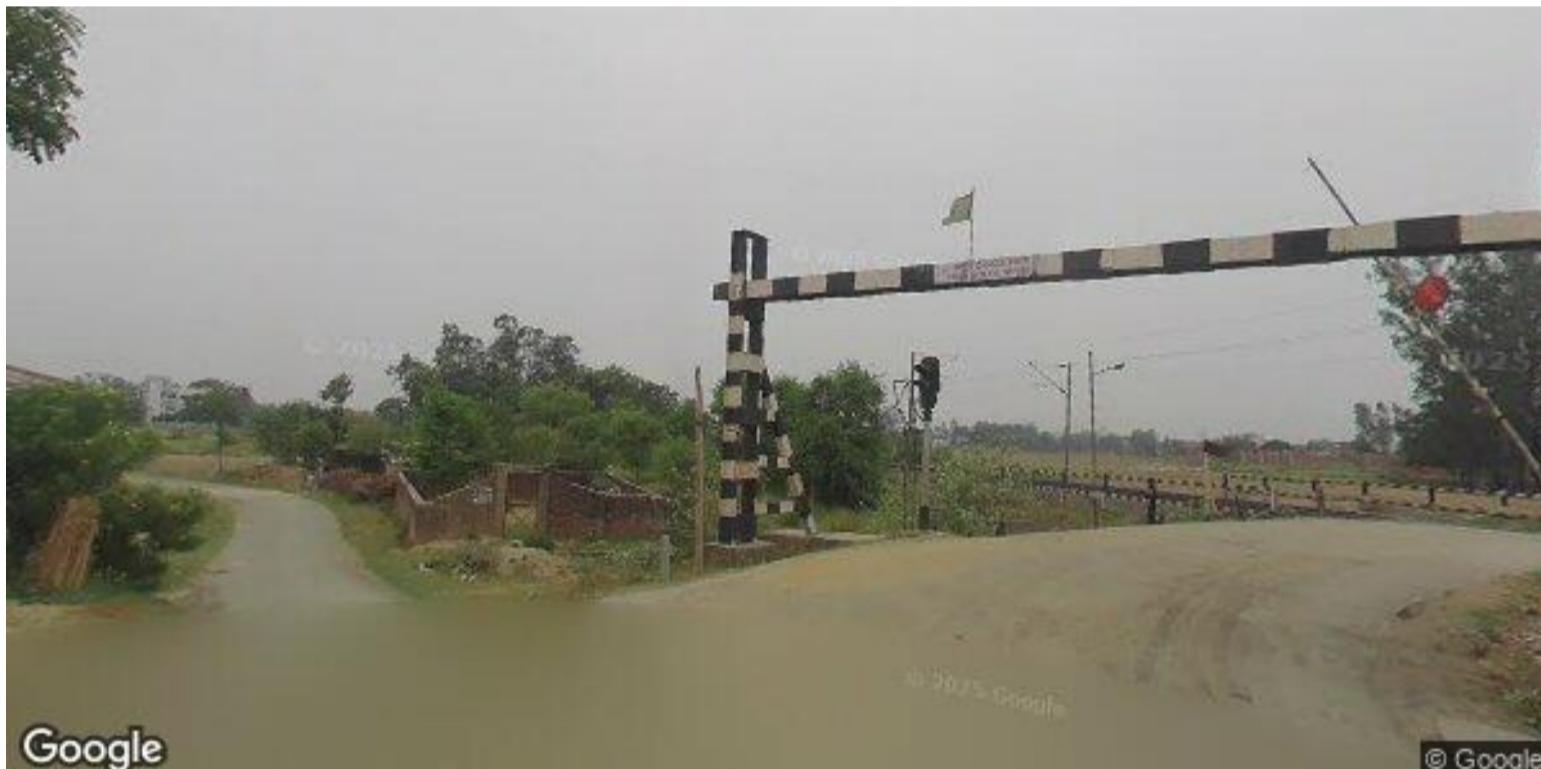
Risk Type: Turn**Risk Level:** Medium**Speed Limit:** 30 KM/Hr**Distance from Start:** 24.56 km**Coordinates:** 26.75462, 83.09988

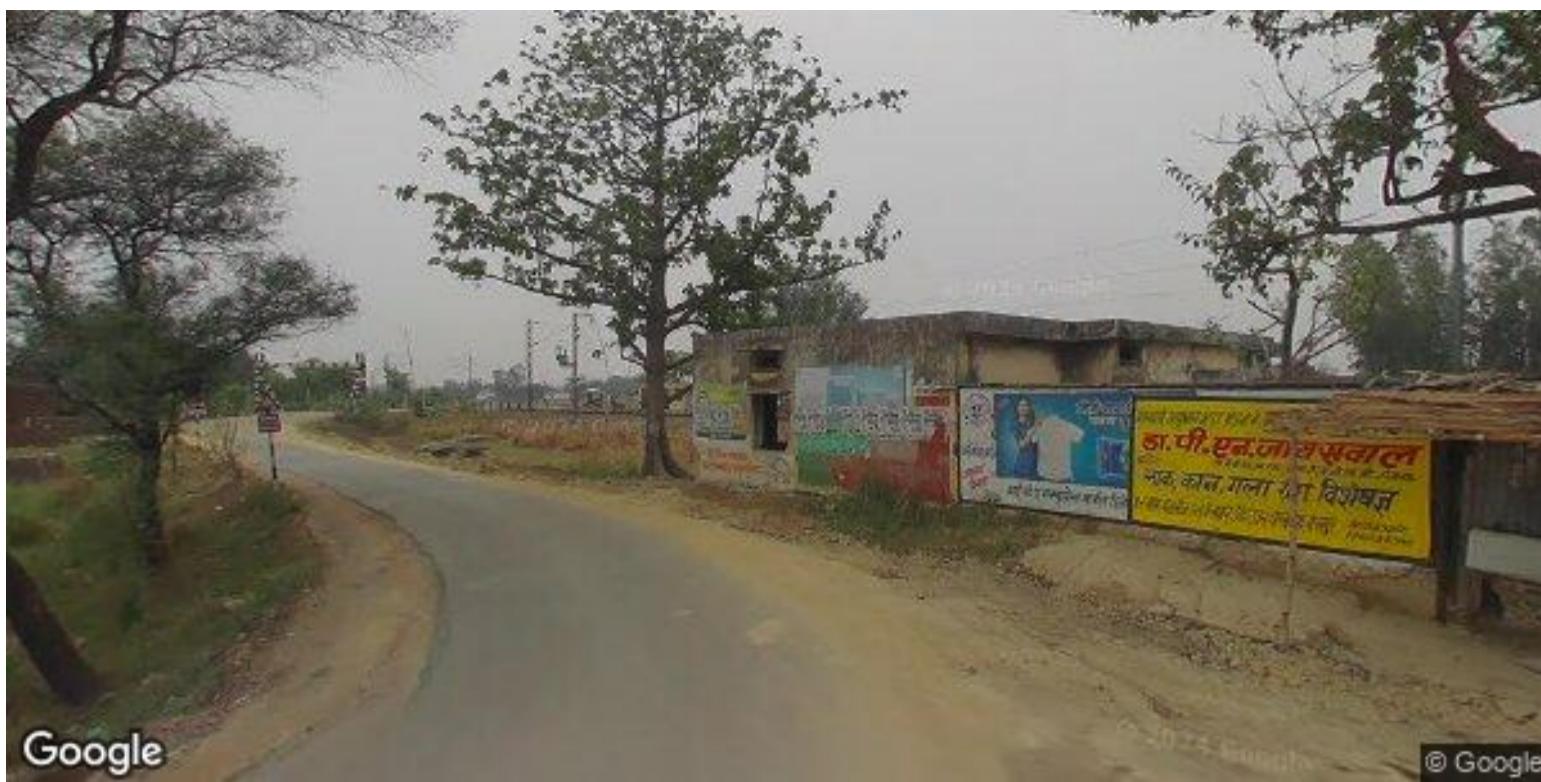
Risk Type: Turn**Risk Level:** Medium**Speed Limit:** 30 KM/Hr**Distance from Start:** 24.63 km**Coordinates:** 26.75427, 83.10047

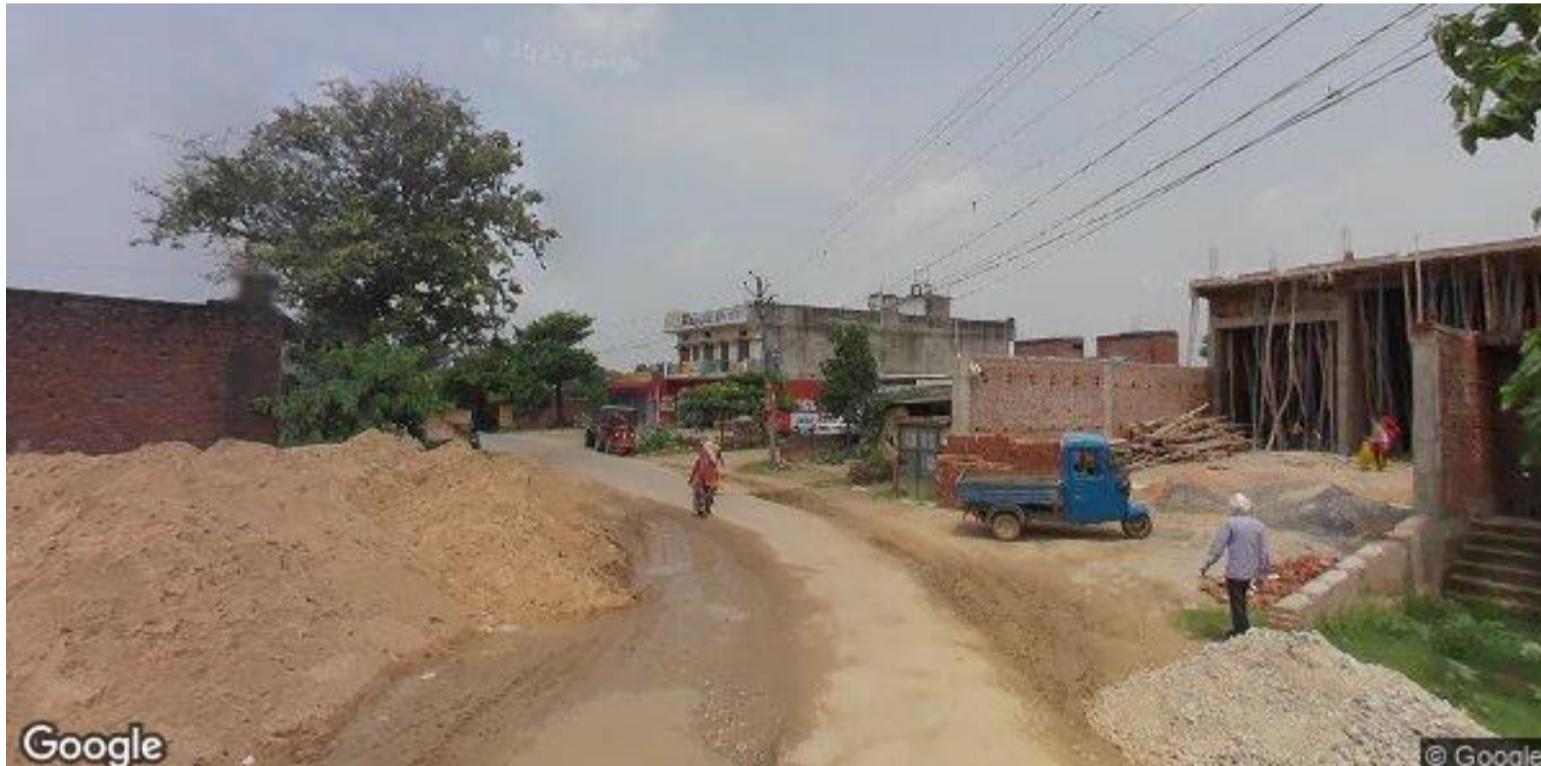
Risk Type: Turn**Risk Level:** Medium**Speed Limit:** 30 KM/Hr**Distance from Start:** 25.49 km**Coordinates:** 26.74747, 83.10305

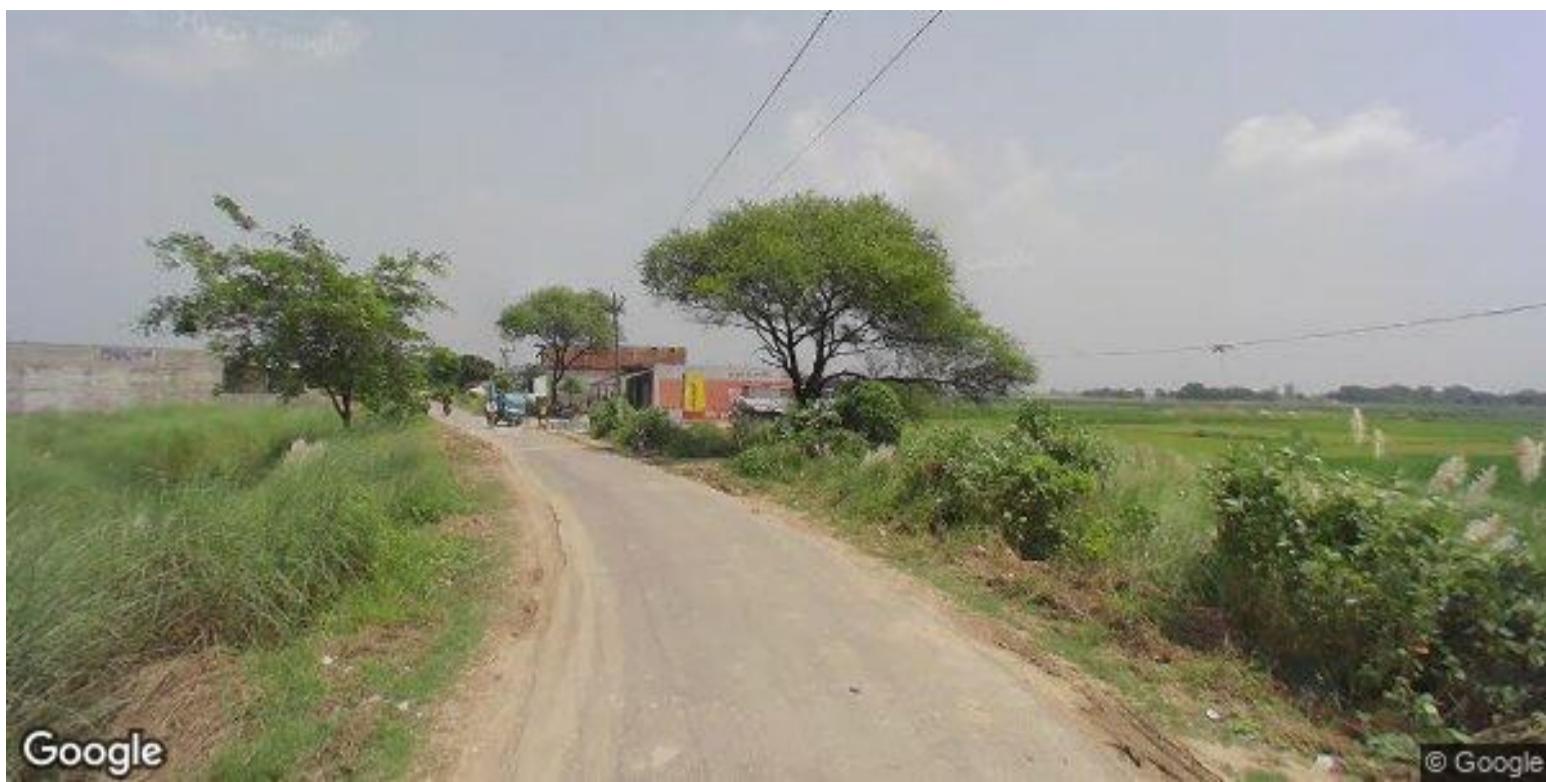
Risk Type: Turn

Risk Level: Medium

Speed Limit: 30 KM/Hr

Distance from Start: 29.40 km

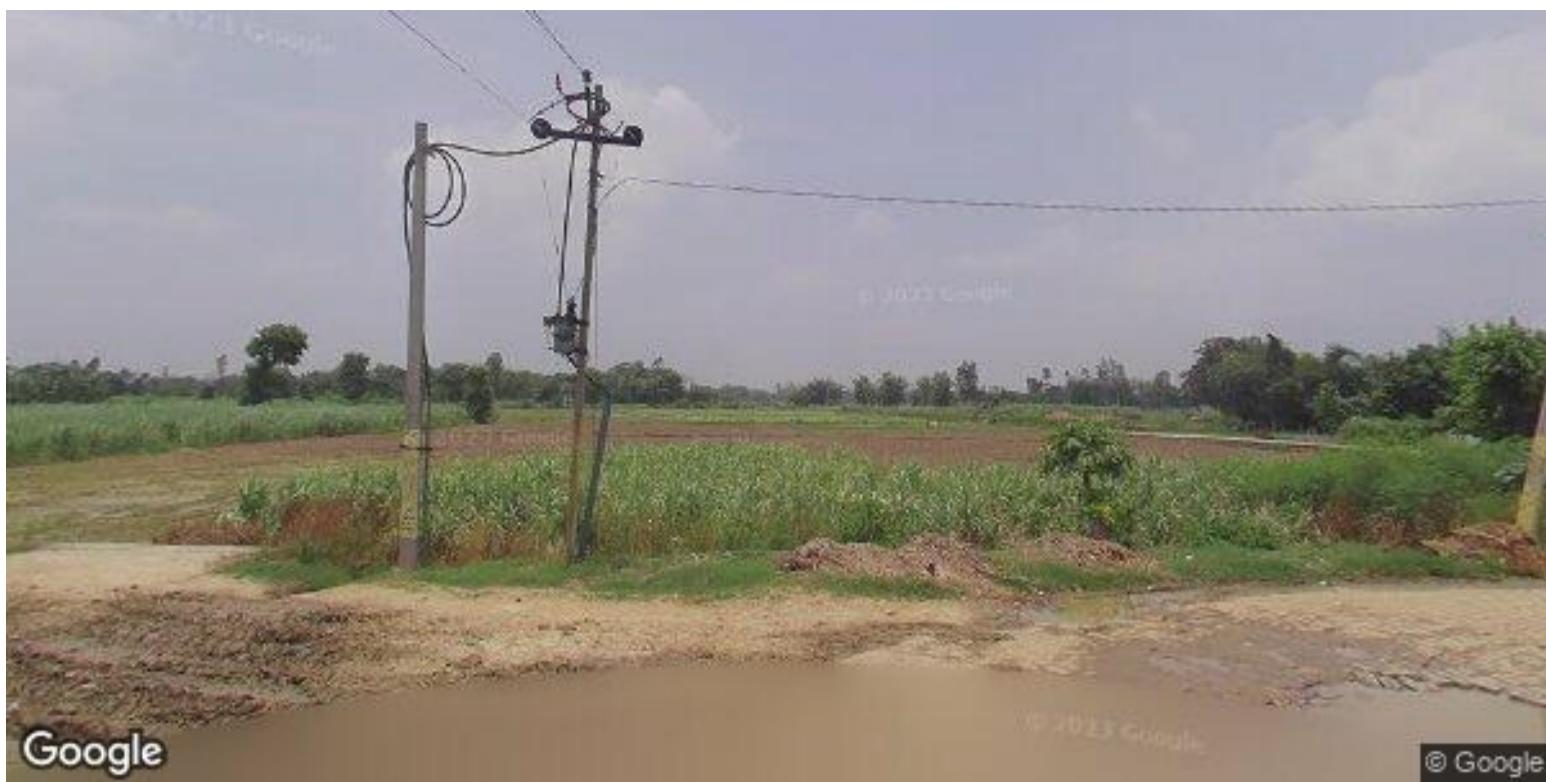
Risk Type: Turn**Risk Level:** Medium**Speed Limit:** 30 KM/Hr**Distance from Start:** 30.50 km**Coordinates:** 26.72907, 83.06724

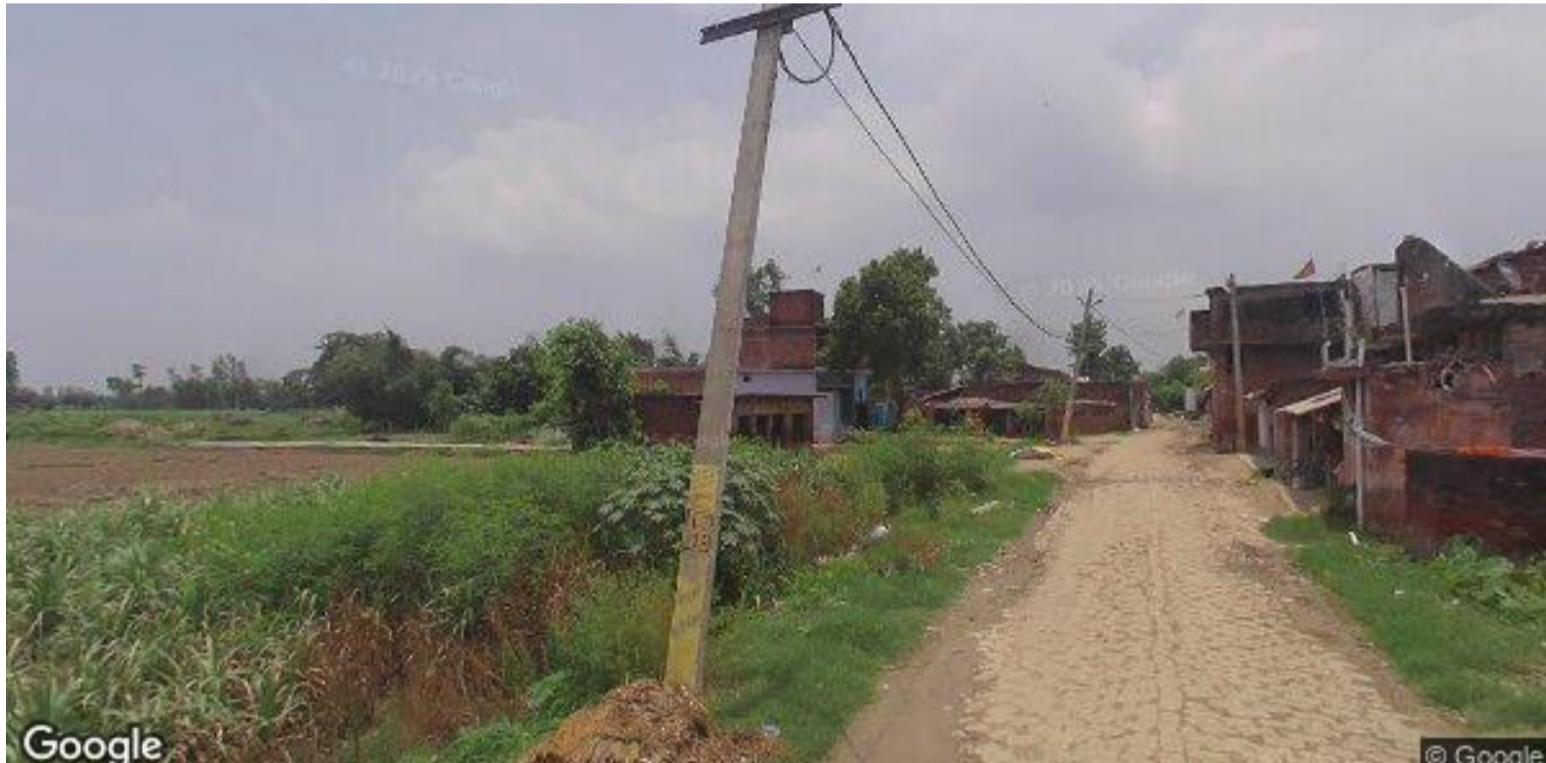
Risk Type: Turn**Risk Level:** Medium**Speed Limit:** 30 KM/Hr**Distance from Start:** 30.51 km**Coordinates:** 26.72918, 83.06720

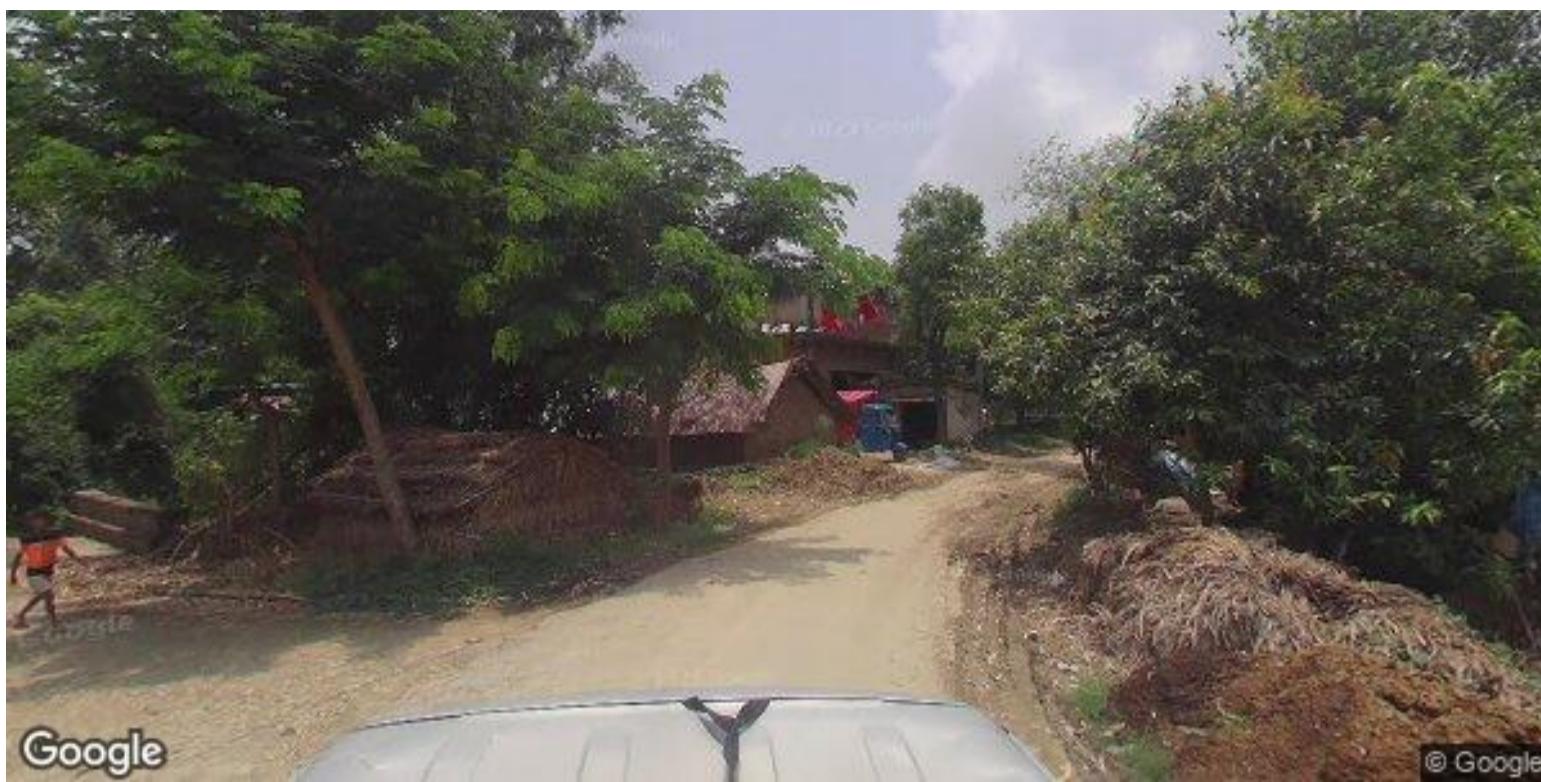
Risk Type: Turn

Risk Level: Medium

Speed Limit: 30 KM/Hr

Distance from Start: 30.72 km

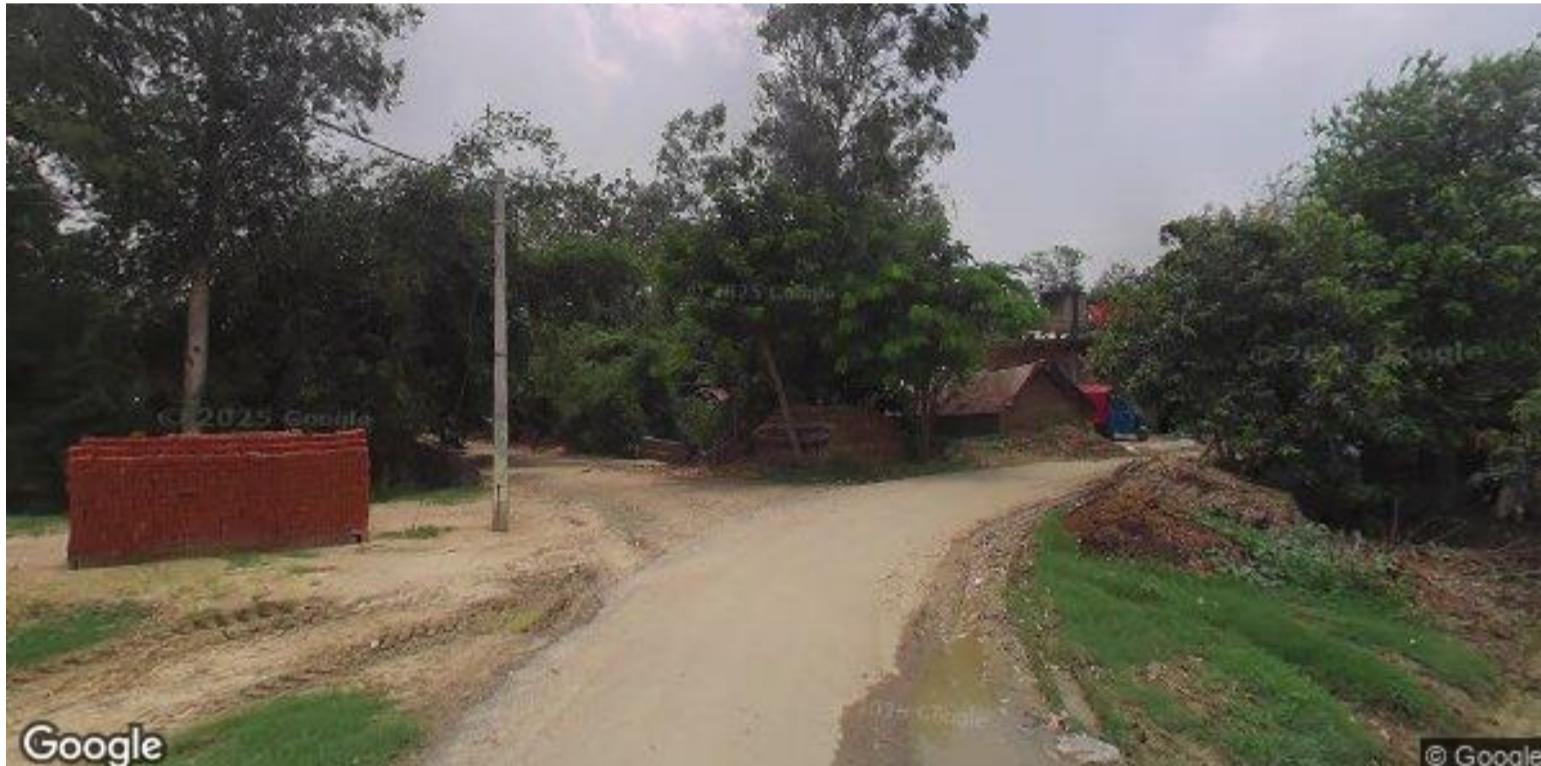
Risk Type: Turn

Risk Level: Medium

Speed Limit: 30 KM/Hr

Distance from Start: 30.73 km

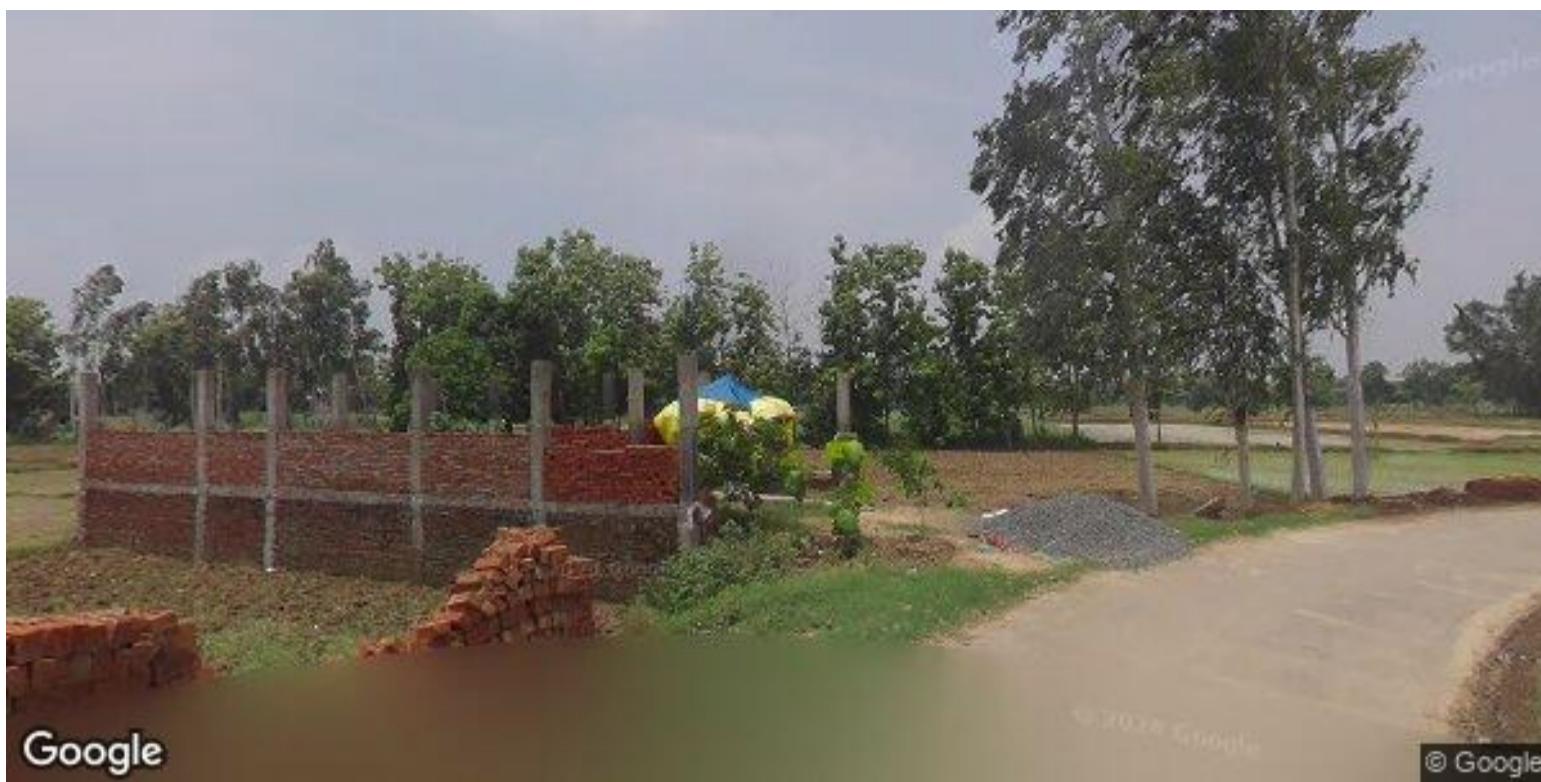
Risk Type: Turn**Risk Level:** Medium**Speed Limit:** 30 KM/Hr**Distance from Start:** 30.88 km**Coordinates:** 26.73190, 83.06656

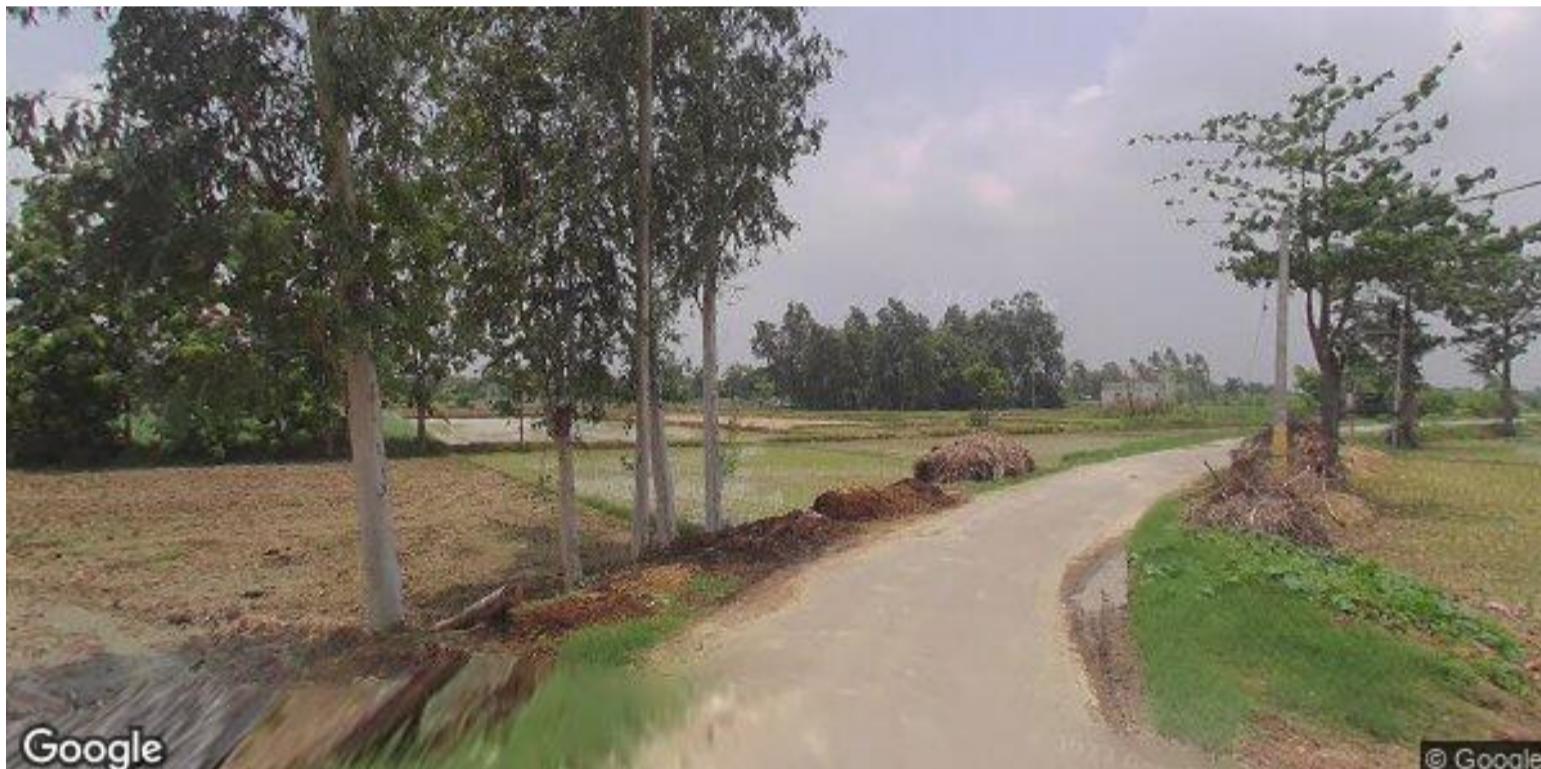
Risk Type: Turn**Risk Level:** Medium**Speed Limit:** 30 KM/Hr**Distance from Start:** 30.91 km**Coordinates:** 26.73198, 83.06649

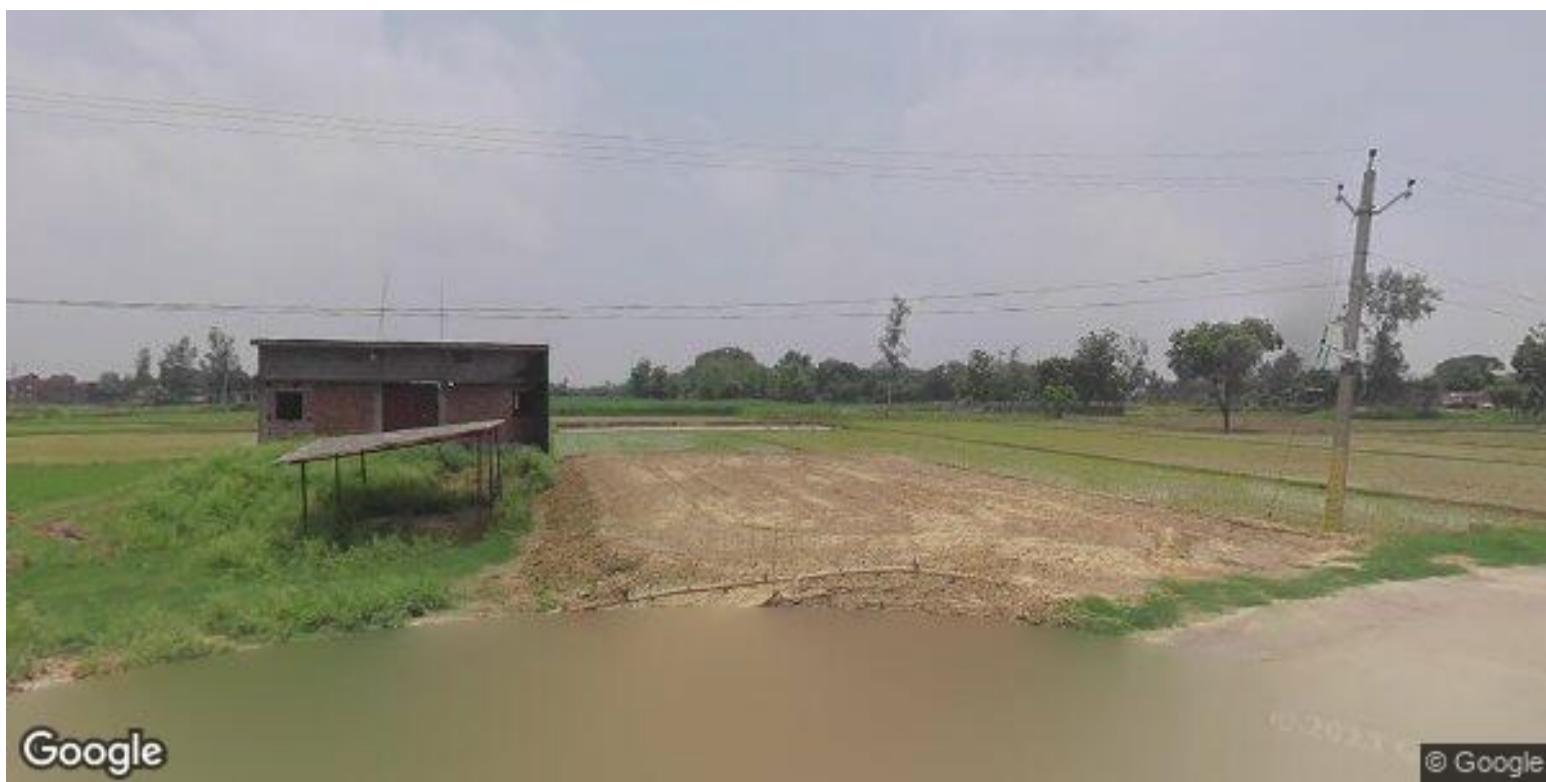
Risk Type: Turn**Risk Level: High****Speed Limit: 15 KM/Hr****Distance from Start: 31.07 km****Coordinates: 26.73339, 83.06682**

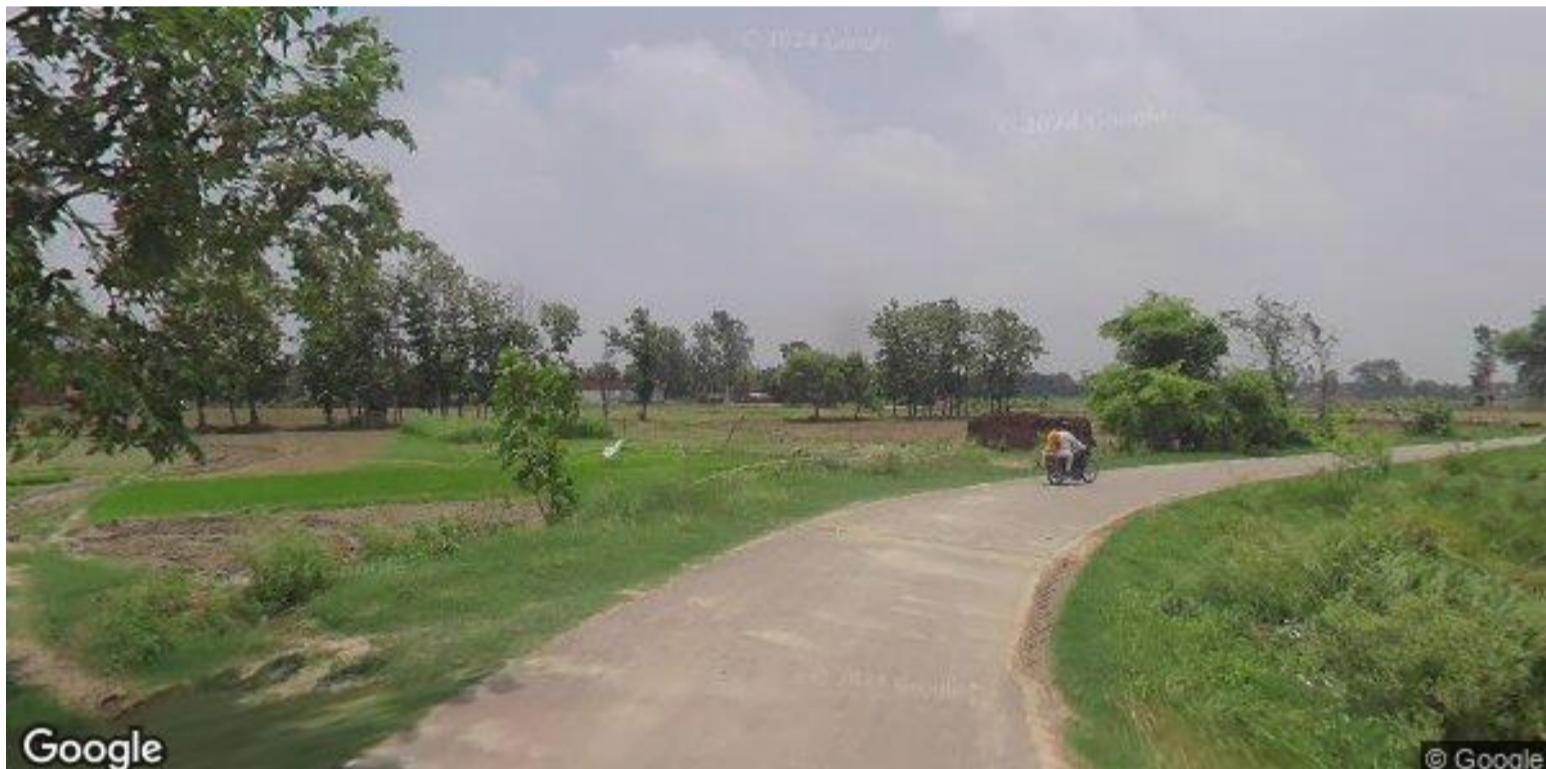
Risk Type: Turn**Risk Level: Medium****Speed Limit: 30 KM/Hr****Distance from Start: 31.37 km****Coordinates: 26.73461, 83.06416**
