JOURNEY RISK MANAGEMENT (JRM) STUDY

Gorakhpur LPG BP TO MANIRAM INDANE SERVI

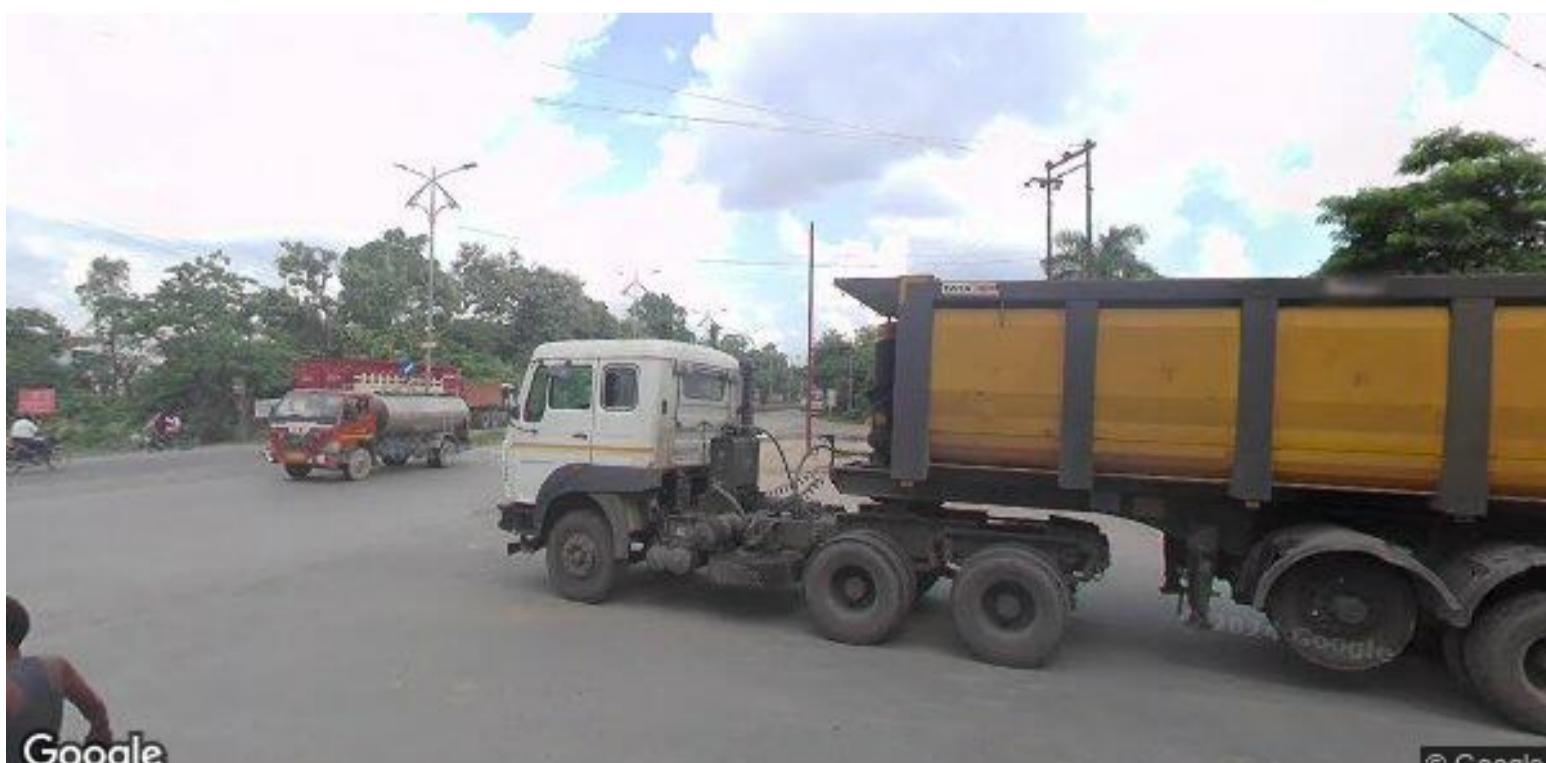
Coordinates: 26.75126, 83.22476

Risk Type: Blind Spot

Risk Level: Blind Spot

Distance from Start: 2.17 km

Speed Limit: 10 KM/Hr

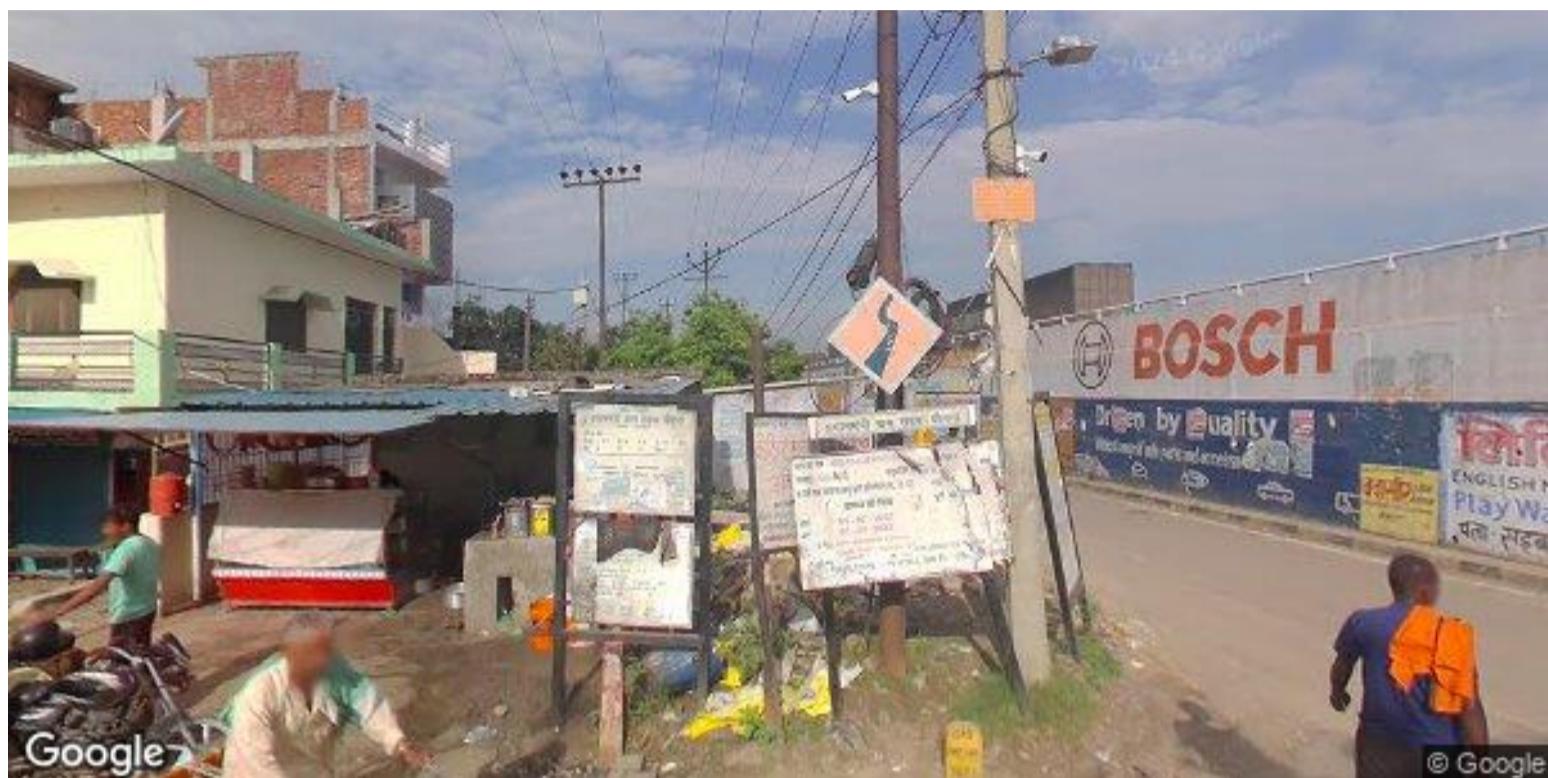
Coordinates: 26.75353, 83.20457

Risk Type: Blind Spot

Risk Level: Blind Spot

Distance from Start: 4.23 km

Speed Limit: 10 KM/Hr

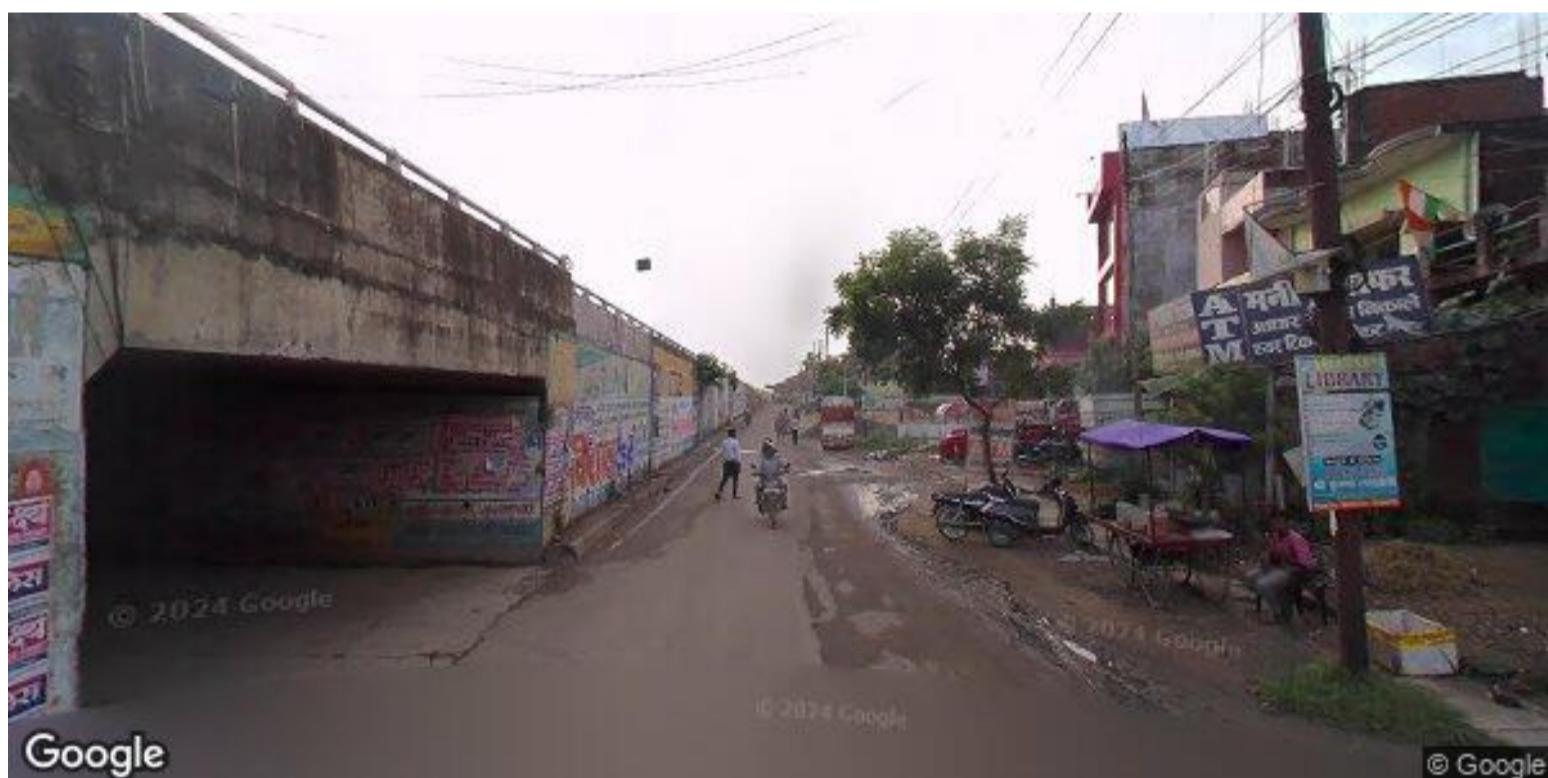
Coordinates: 26.75381, 83.20466

Risk Type: Turn

Risk Level: High

Distance from Start: 4.30 km

Speed Limit: 15 KM/Hr

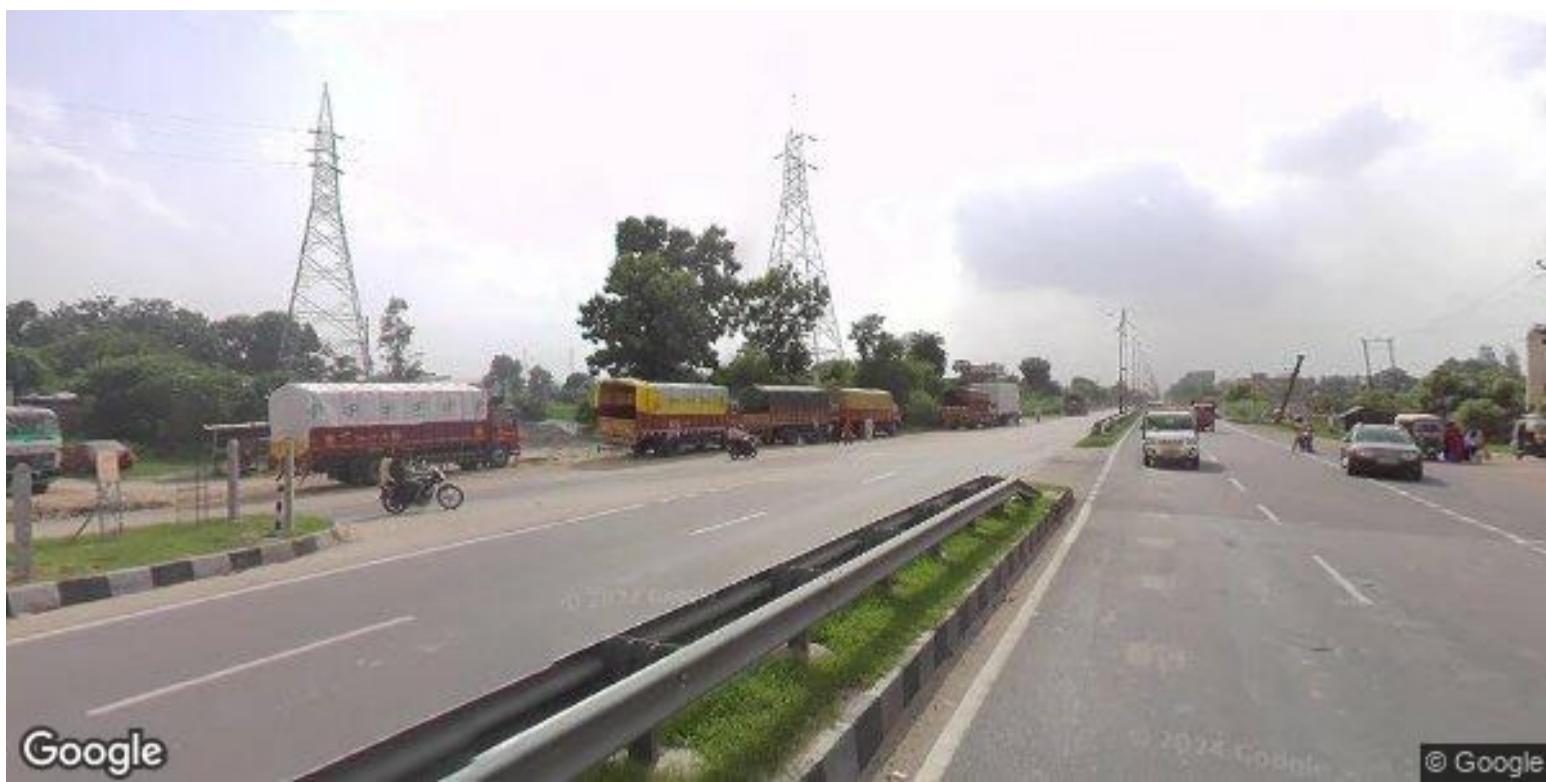
Coordinates: 26.74708, 83.24935

Risk Type: Turn

Risk Level: High

Distance from Start: 8.77 km

Speed Limit: 15 KM/Hr

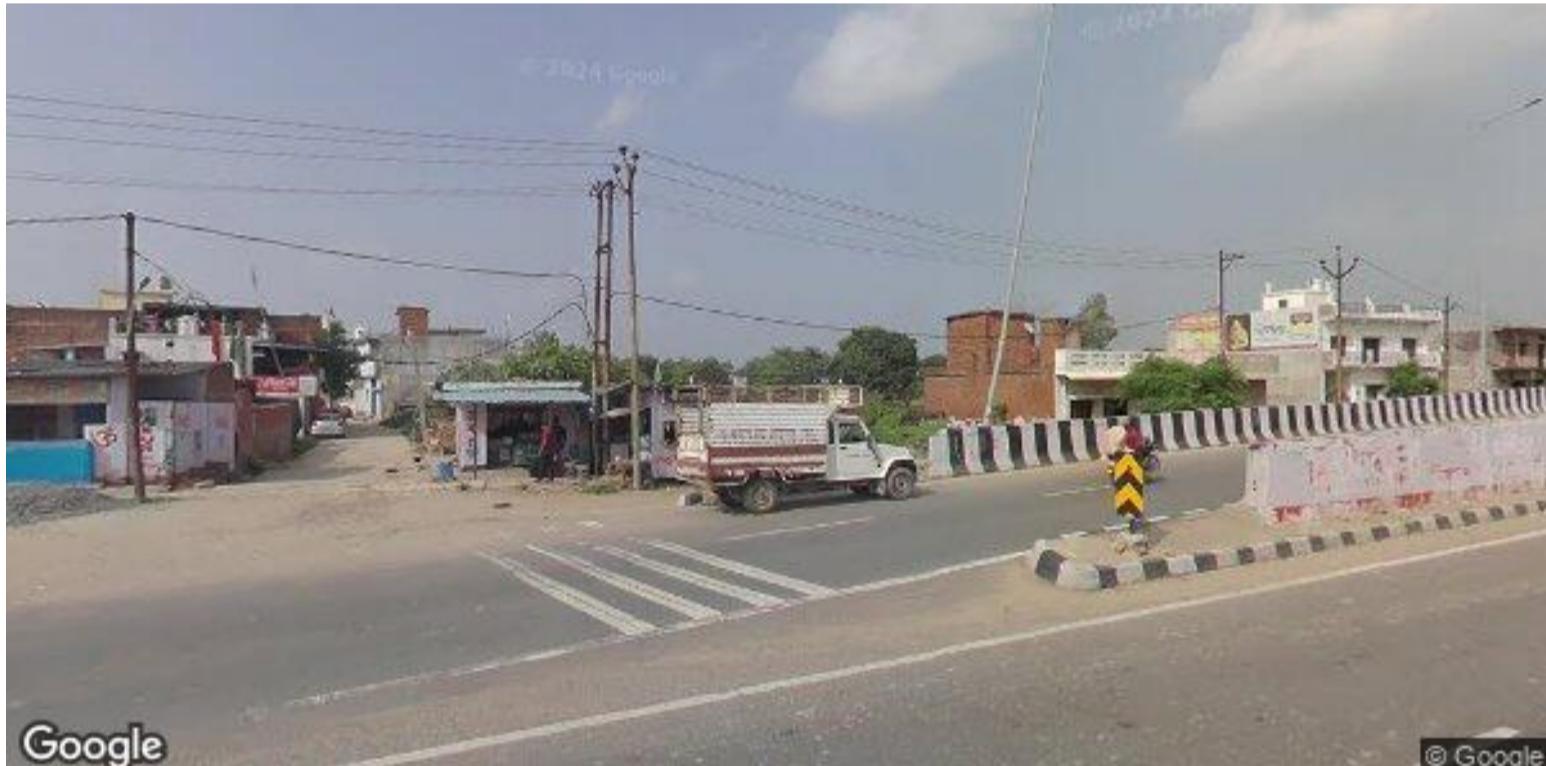
Coordinates: 26.74714, 83.24943

Risk Type: Turn

Risk Level: Medium

Distance from Start: 8.82 km

Speed Limit: 30 KM/Hr

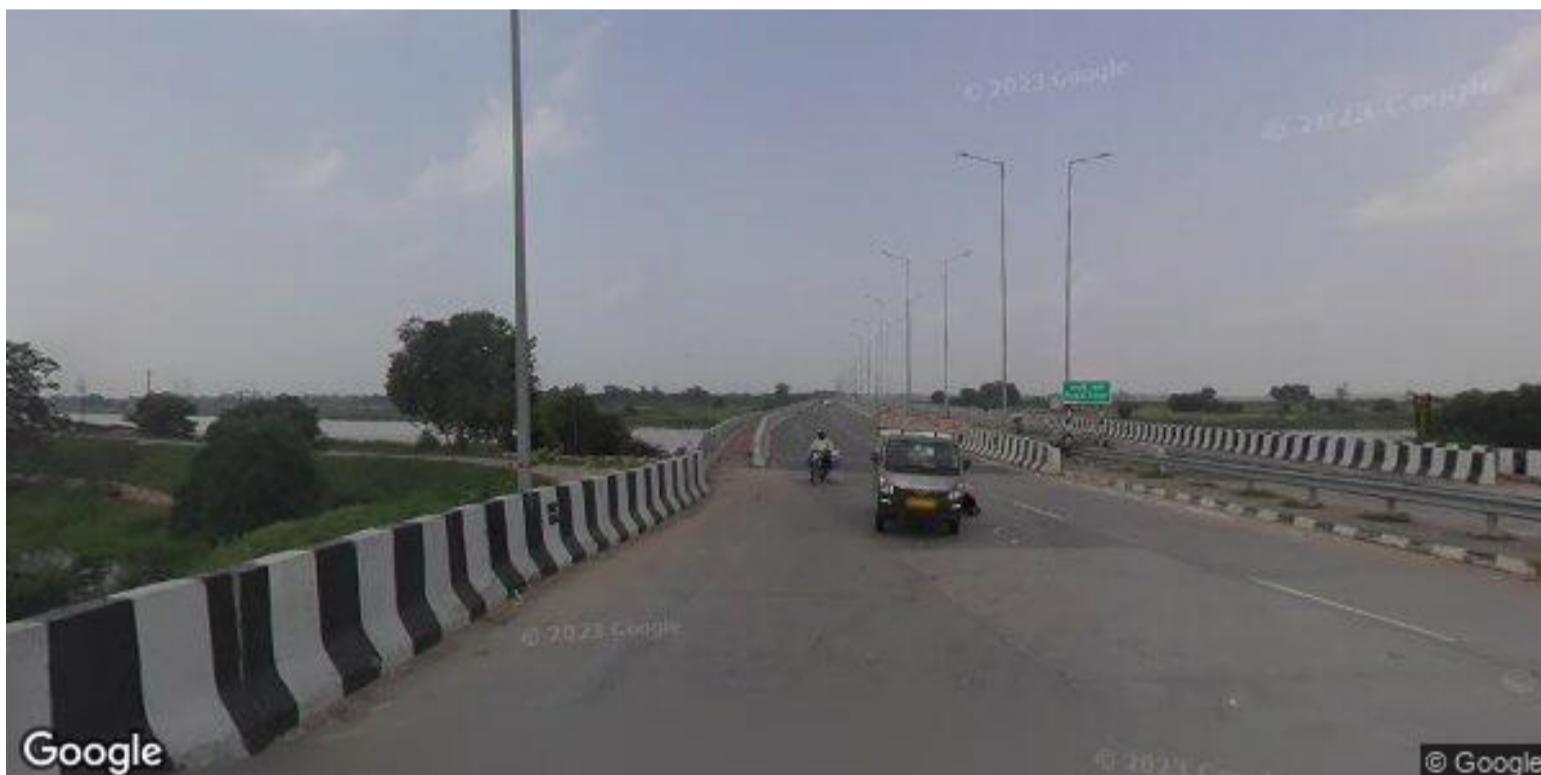
Risk Type: Turn**Risk Level:** Medium**Speed Limit:** 30 KM/Hr**Distance from Start:** 9.05 km**Coordinates:** 26.74765, 83.25136

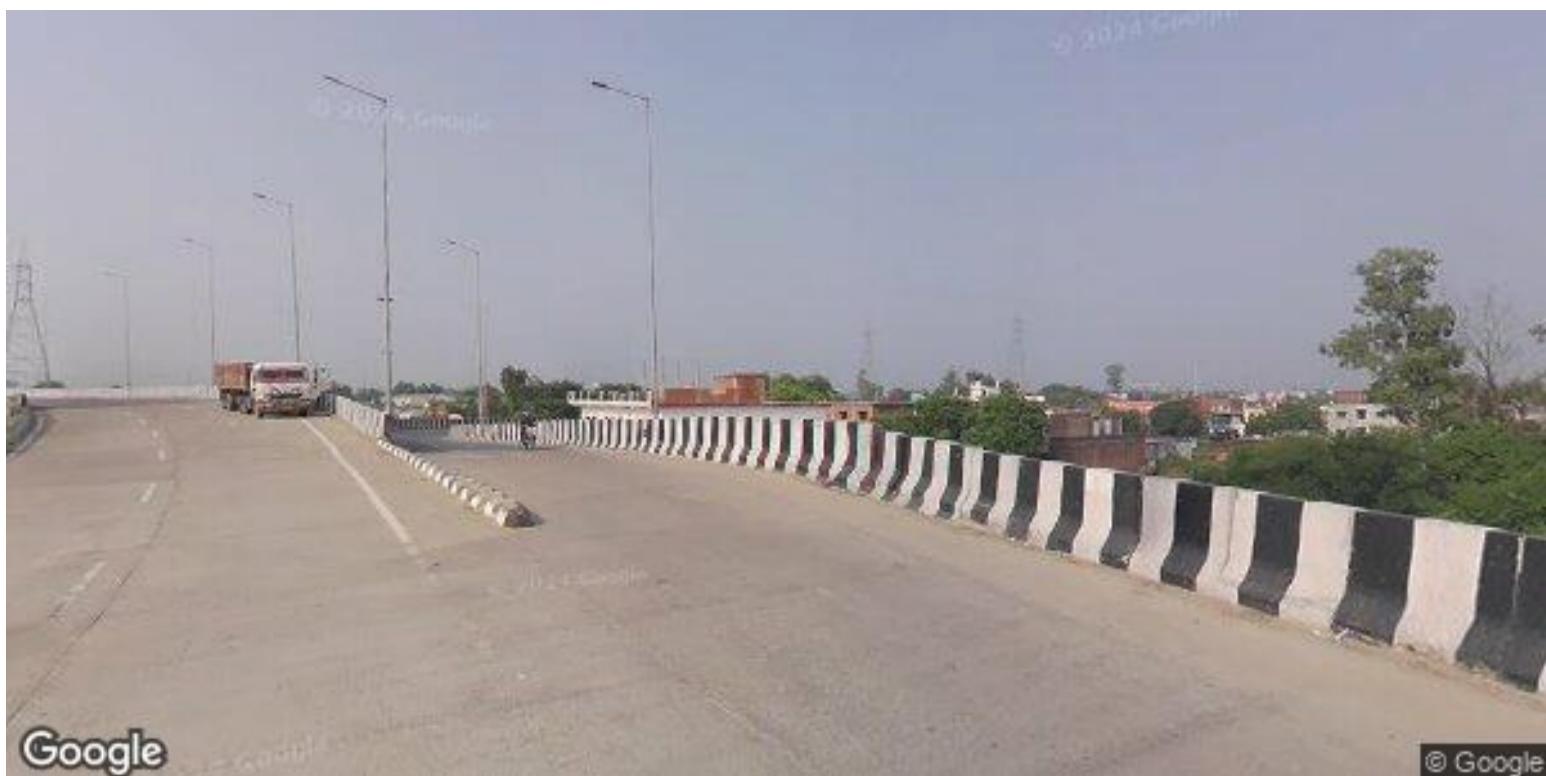
Risk Type: Turn**Risk Level: High****Speed Limit: 15 KM/Hr****Distance from Start: 9.07 km****Coordinates: 26.74769, 83.25146**

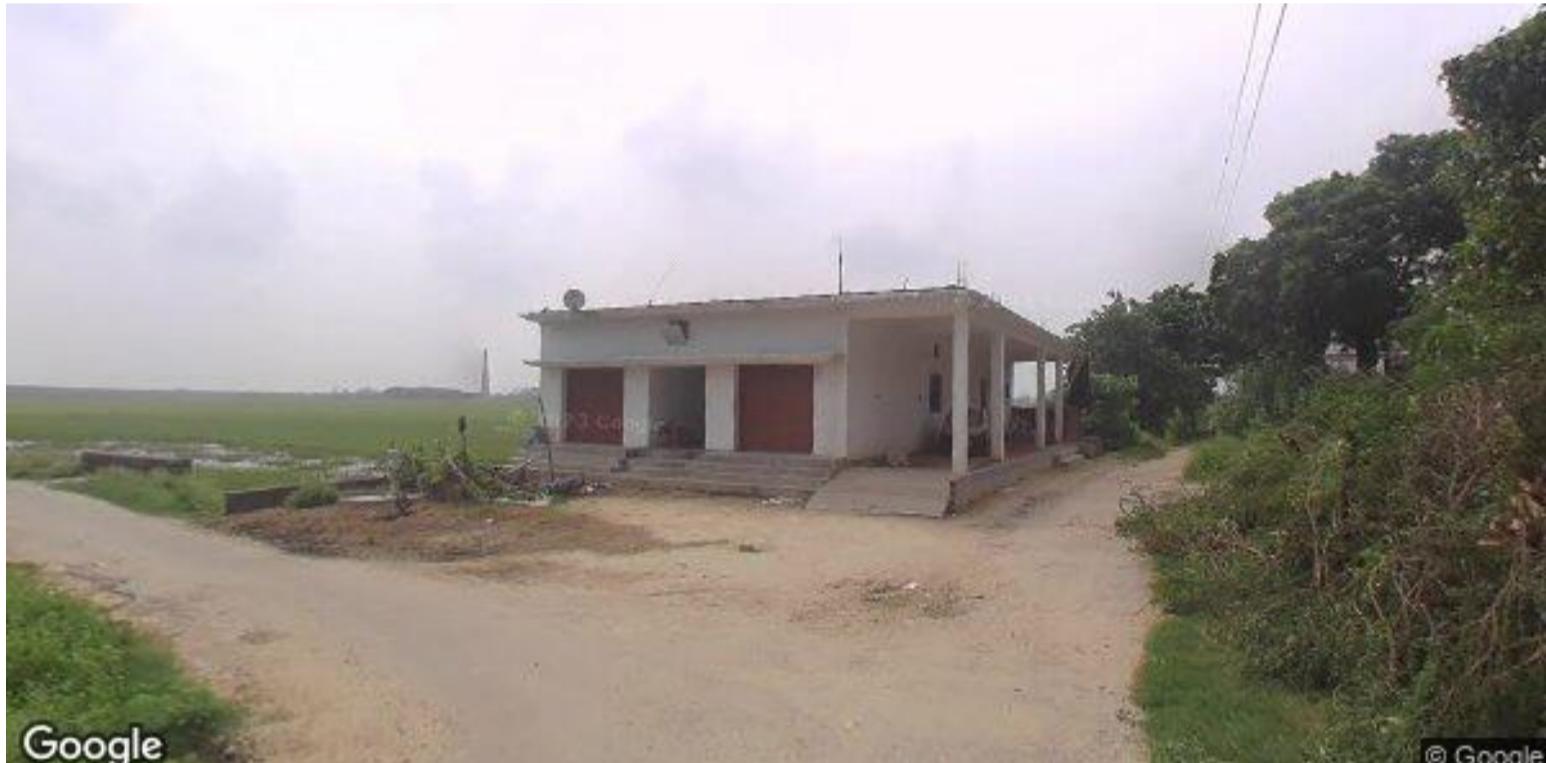
Risk Type: Turn**Risk Level: High****Speed Limit: 15 KM/Hr****Distance from Start: 21.86 km****Coordinates: 26.83859, 83.29387**

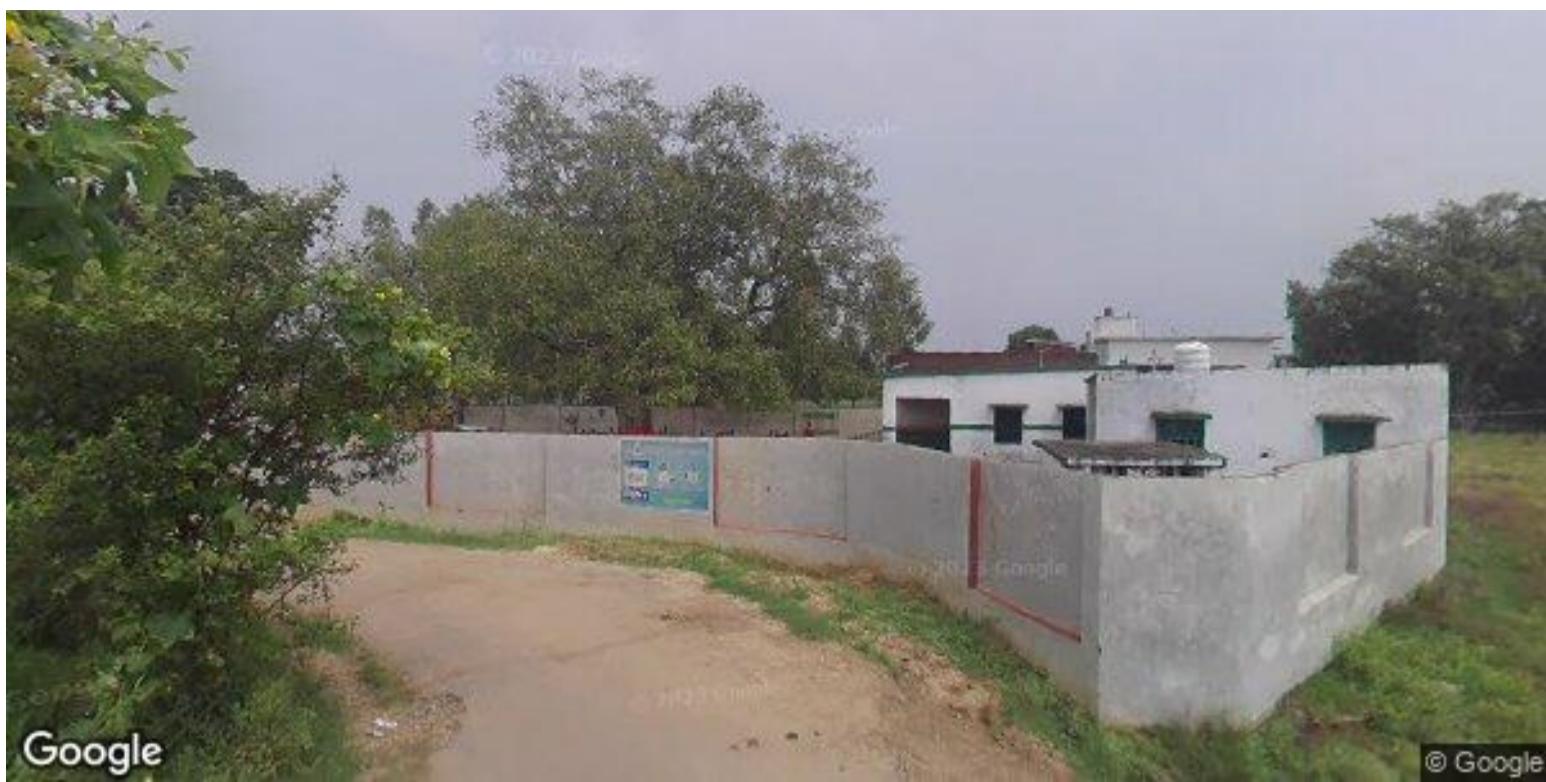
Coordinates: 26.83950, 83.29403

Risk Type: Turn

Risk Level: Medium

Distance from Start: 21.97 km

Speed Limit: 30 KM/Hr

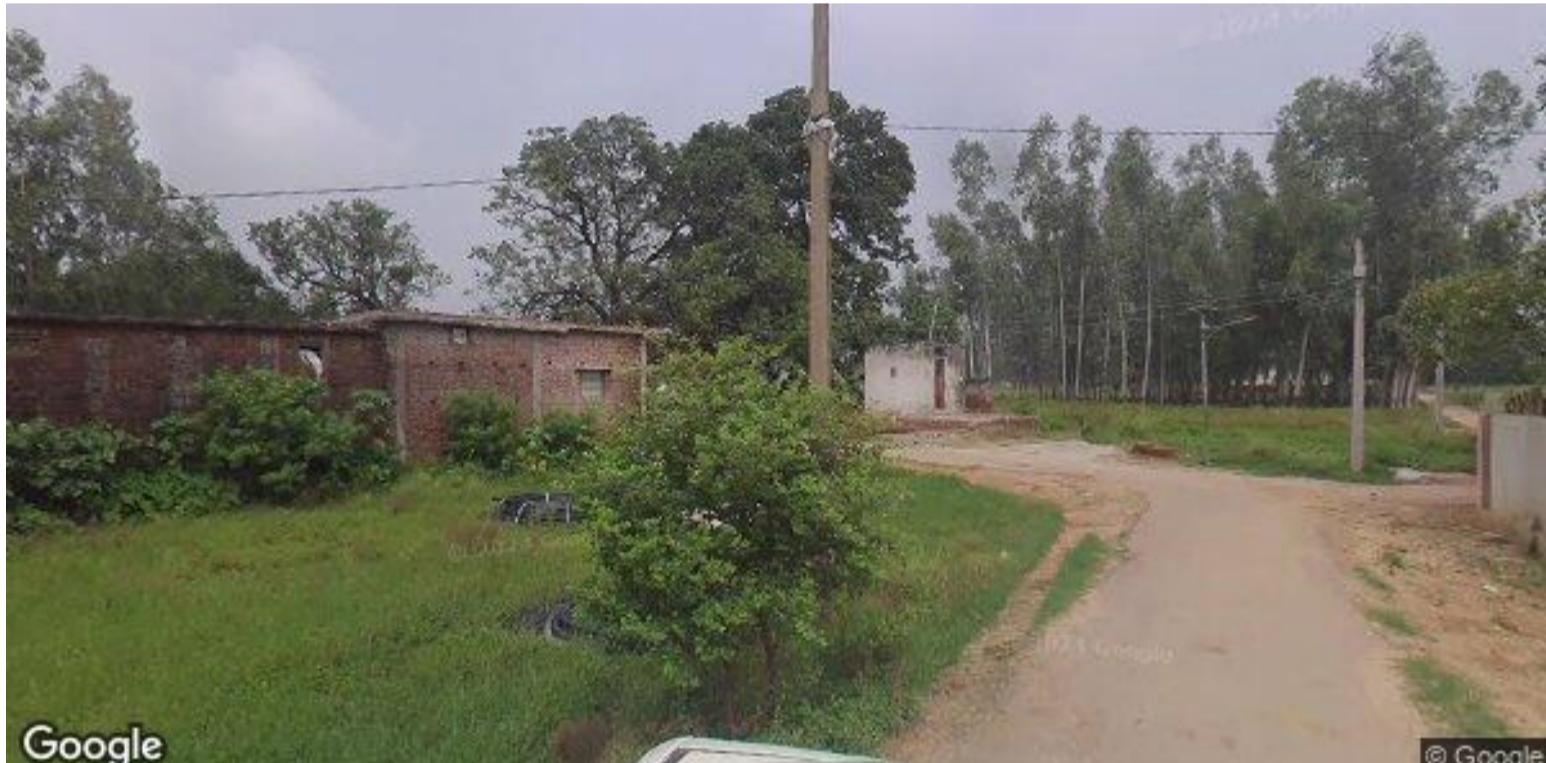
Coordinates: 26.83976, 83.29392

Risk Type: Turn

Risk Level: Medium

Distance from Start: 22.00 km

Speed Limit: 30 KM/Hr

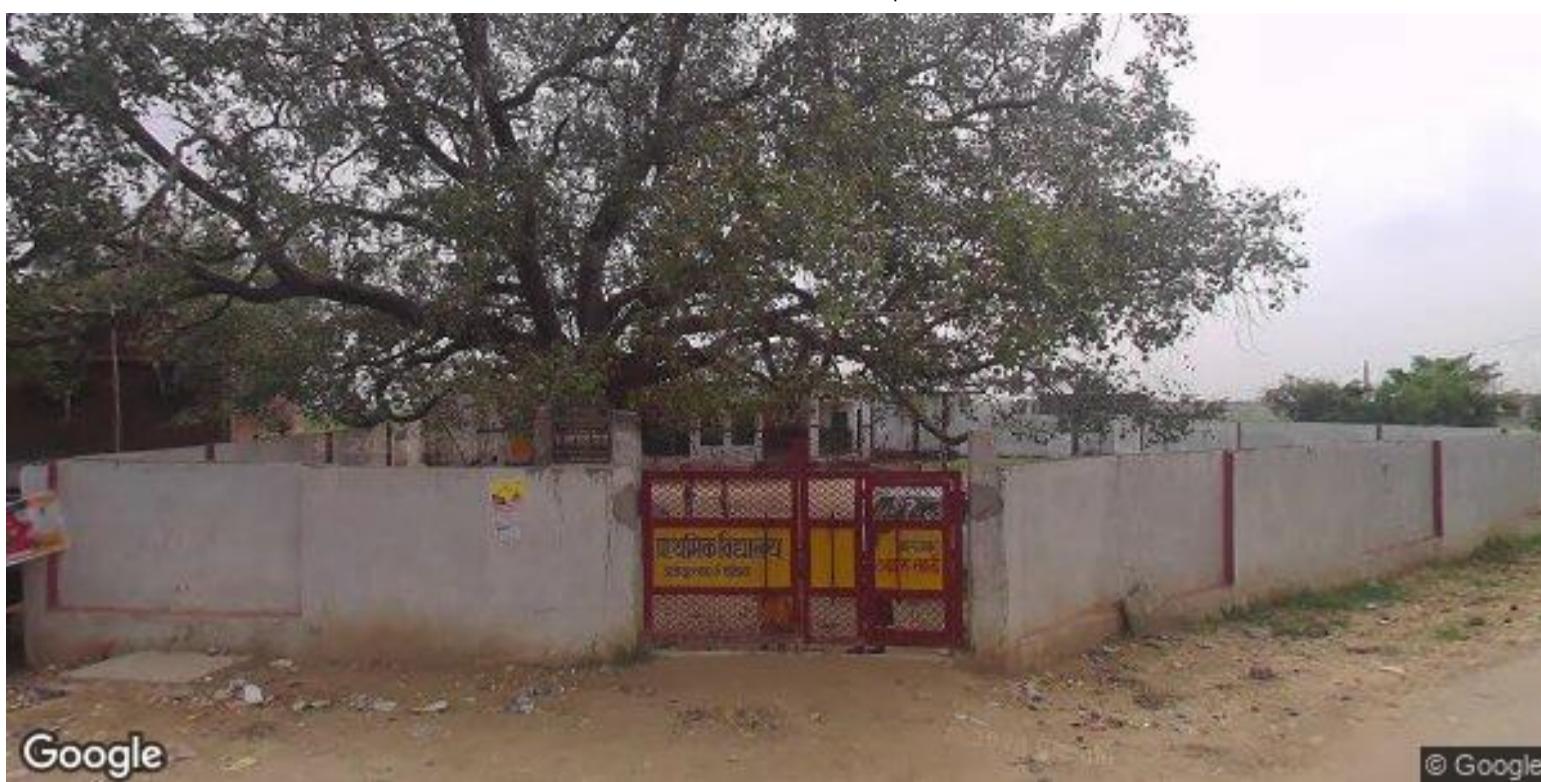
Risk Type: Turn**Risk Level:** High**Speed Limit:** 15 KM/Hr**Distance from Start:** 22.02 km**Coordinates:** 26.83989, 83.29395

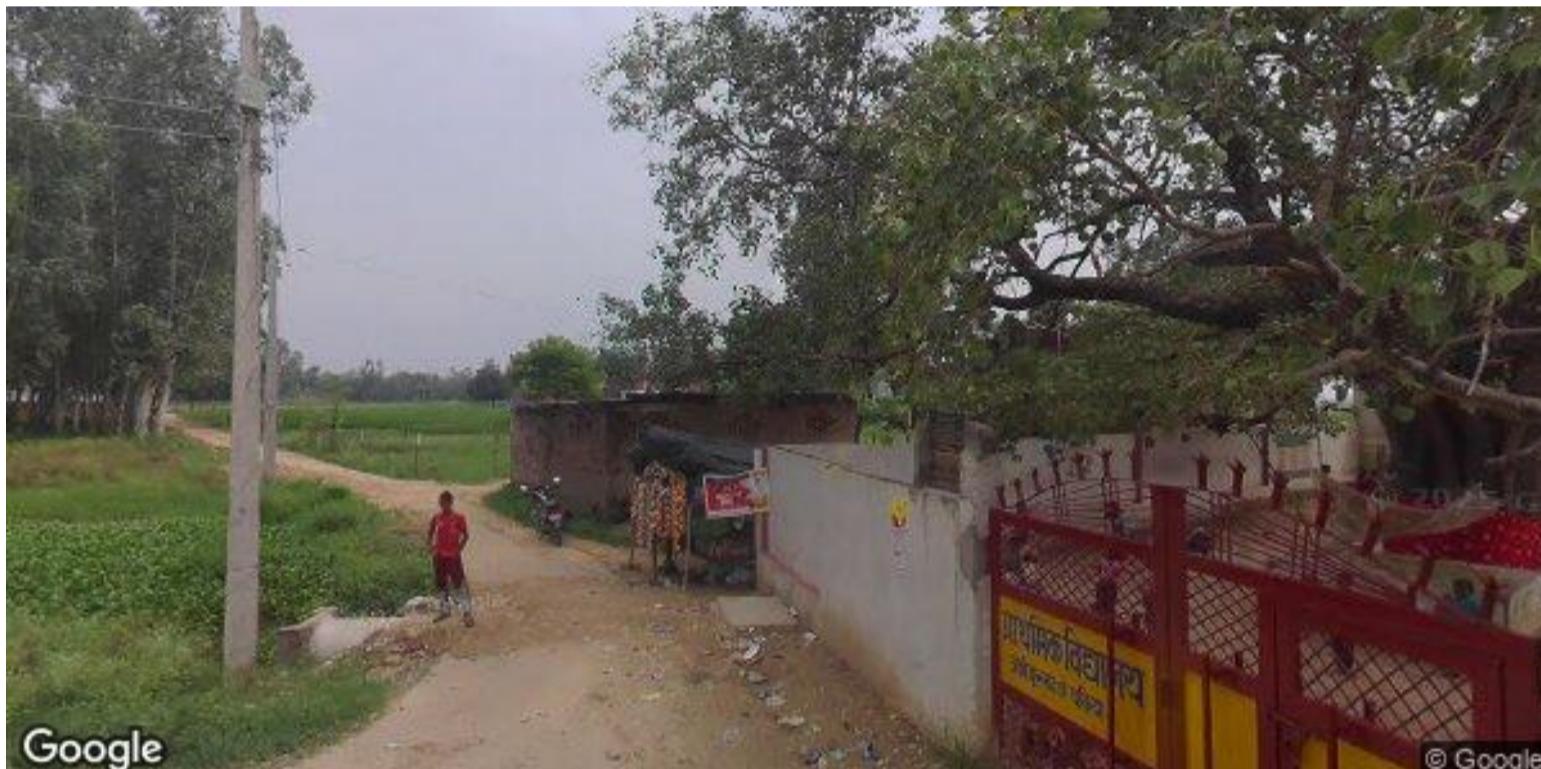
Risk Type: Turn**Risk Level:** Medium**Speed Limit:** 30 KM/Hr**Distance from Start:** 22.03 km**Coordinates:** 26.83991, 83.29401

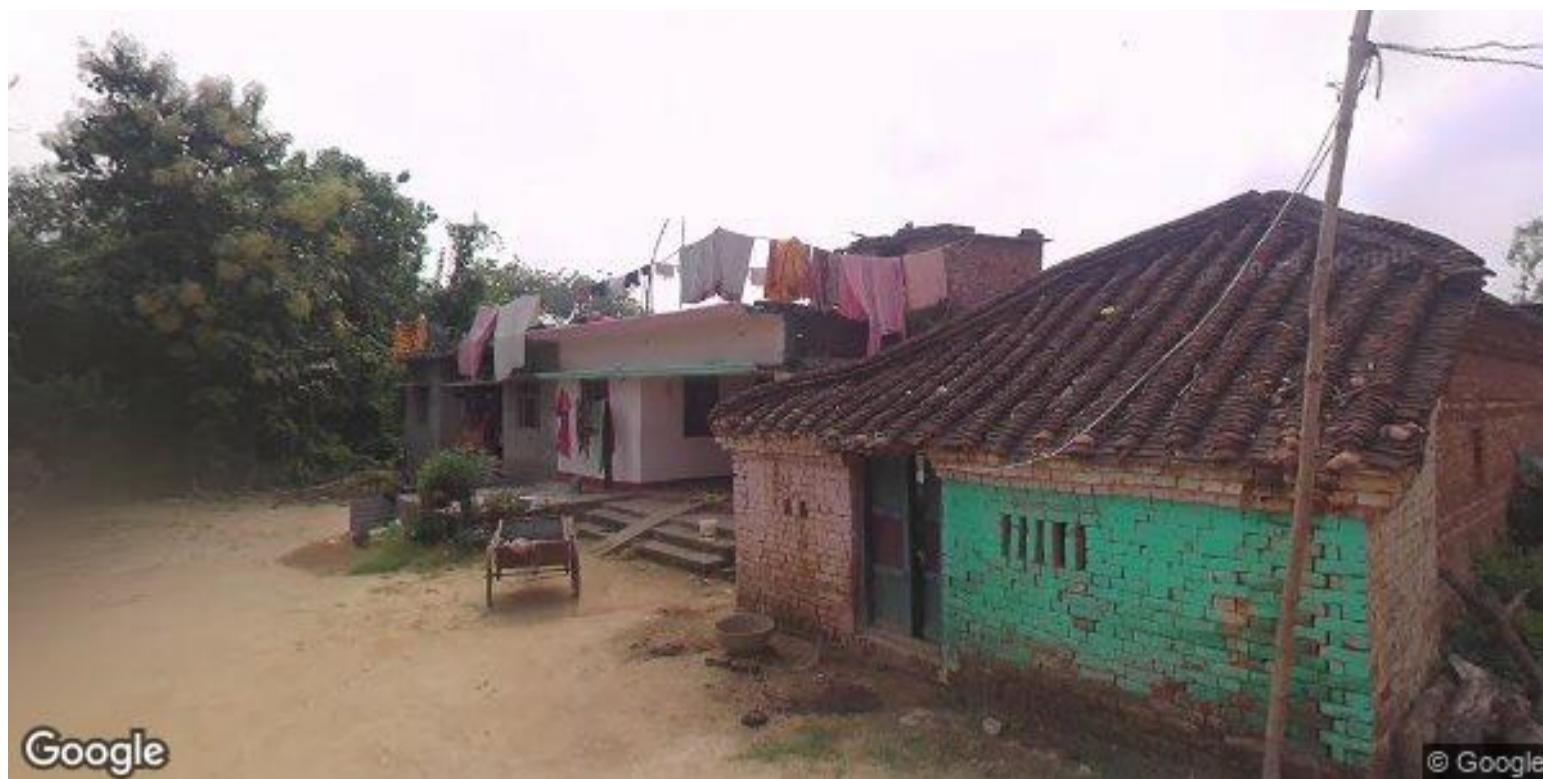
Coordinates: 26.84344, 83.29812

Risk Type: Turn

Risk Level: High

Distance from Start: 22.68 km

Speed Limit: 15 KM/Hr
