JOURNEY RISK MANAGEMENT (JRM) STUDY

Gorakhpur LPG BP TO VASUPRADA INDANE SER

Route Safety Analysis Report

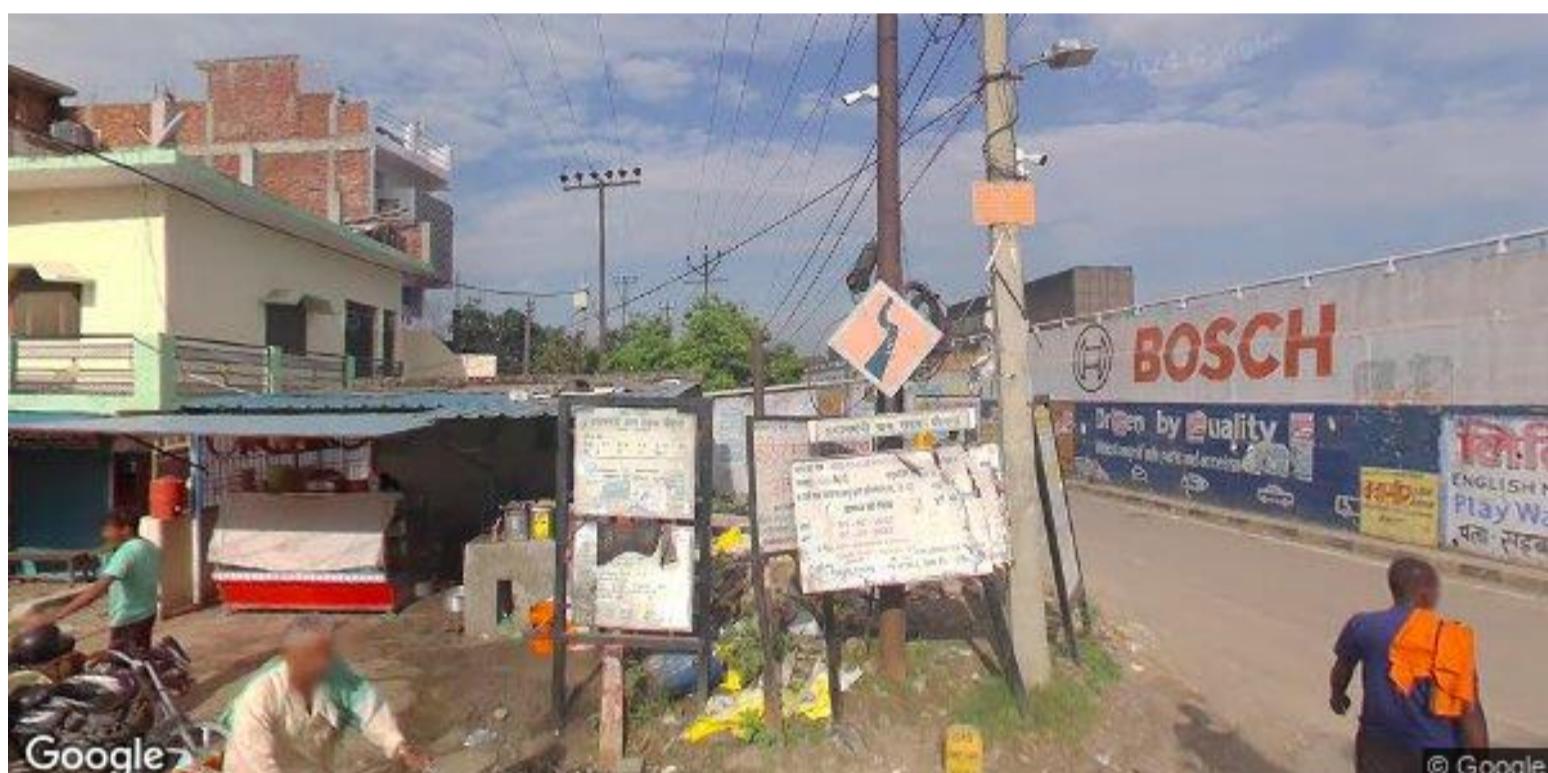
Risk Type: Blind Spot**Risk Level:** Blind Spot**Speed Limit:** 10 KM/Hr**Distance from Start:** 4.23 km**Coordinates:** 26.75353, 83.20457

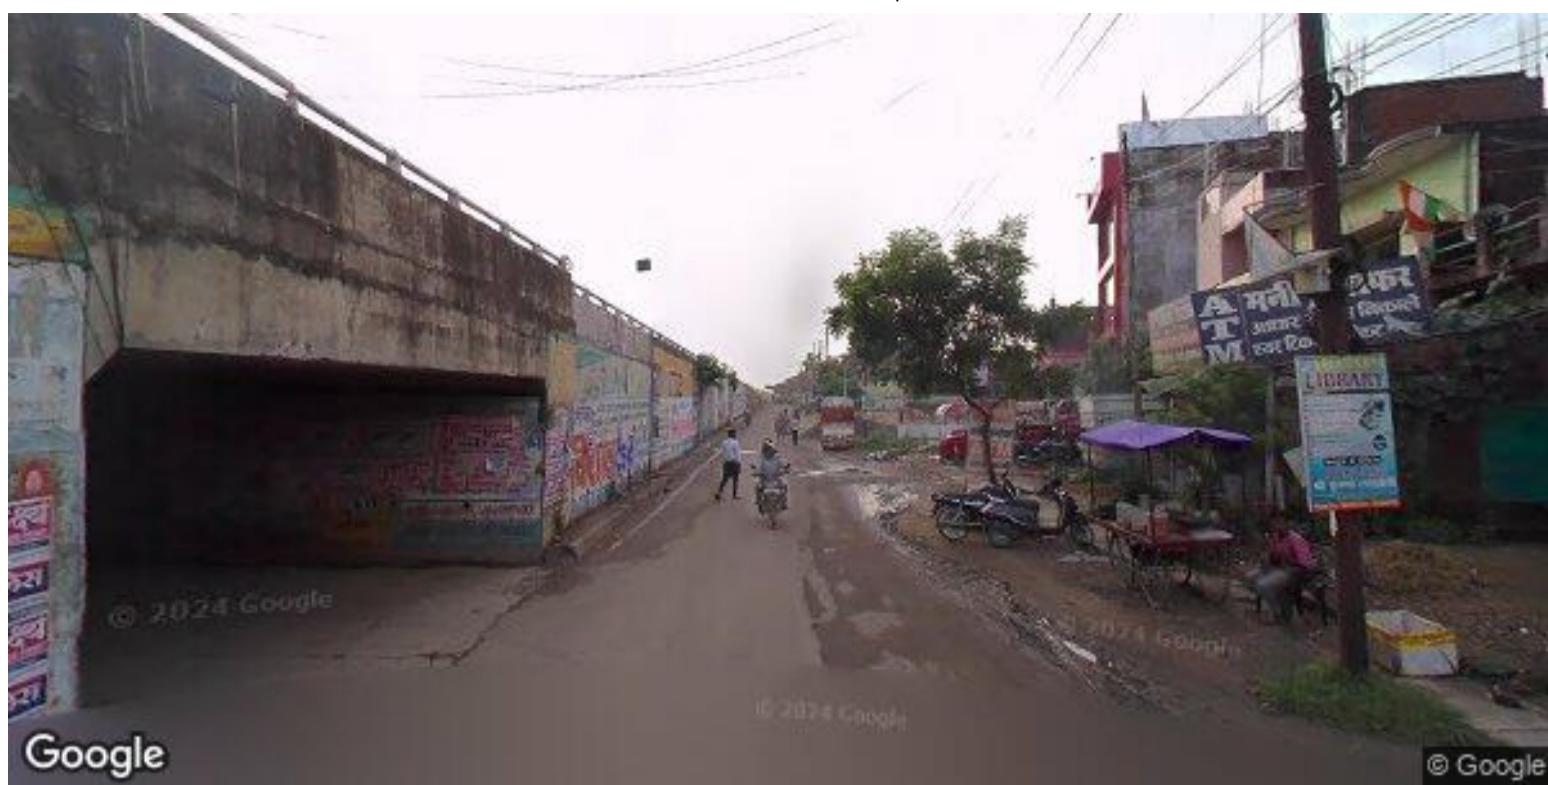
Risk Type: Turn**Risk Level: High****Speed Limit: 15 KM/Hr****Distance from Start: 4.30 km****Coordinates: 26.75381, 83.20466**

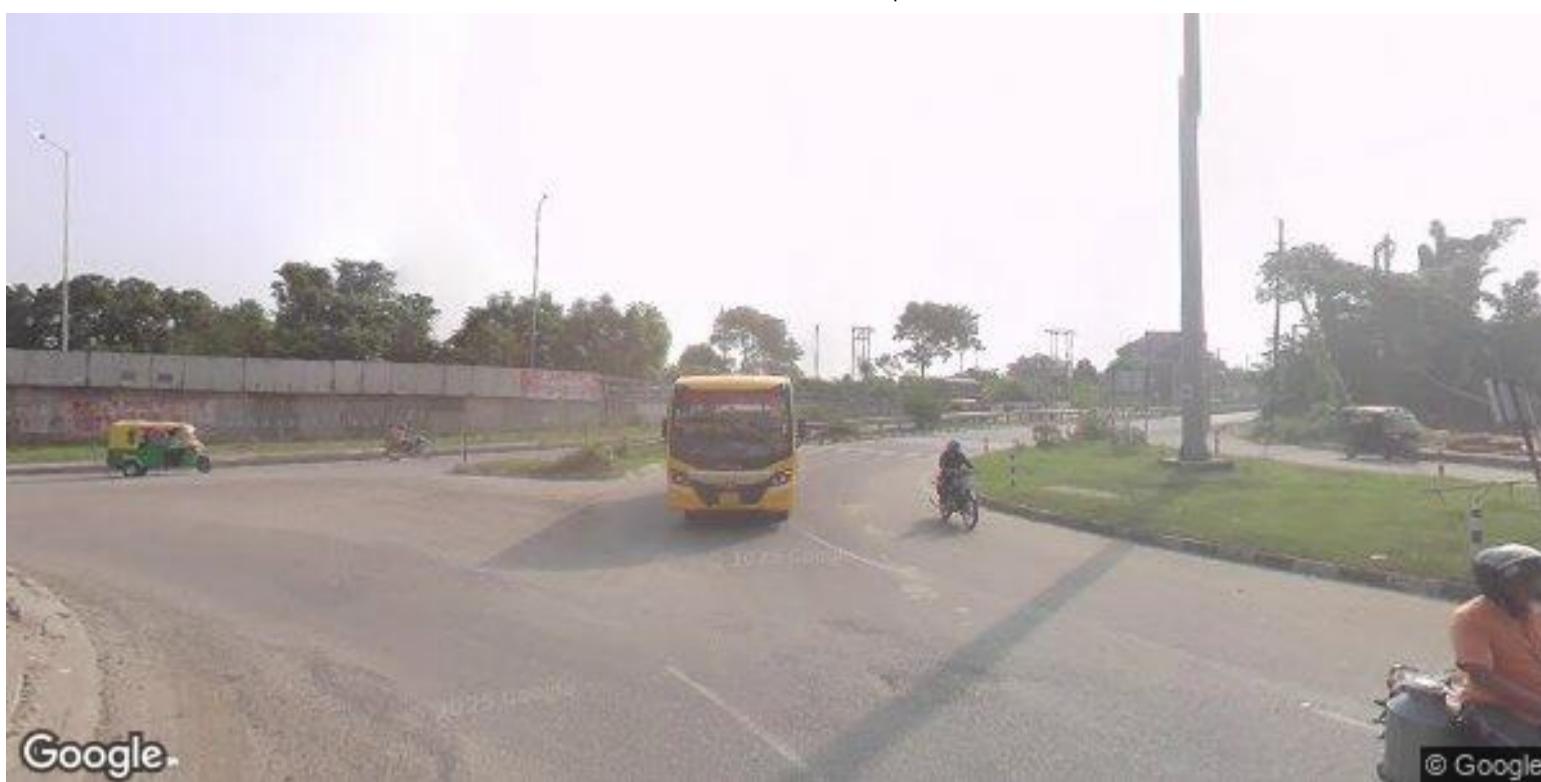
Risk Type: Turn

Risk Level: Medium

Speed Limit: 30 KM/Hr

Distance from Start: 9.07 km

Coordinates: 26.74644, 83.25150

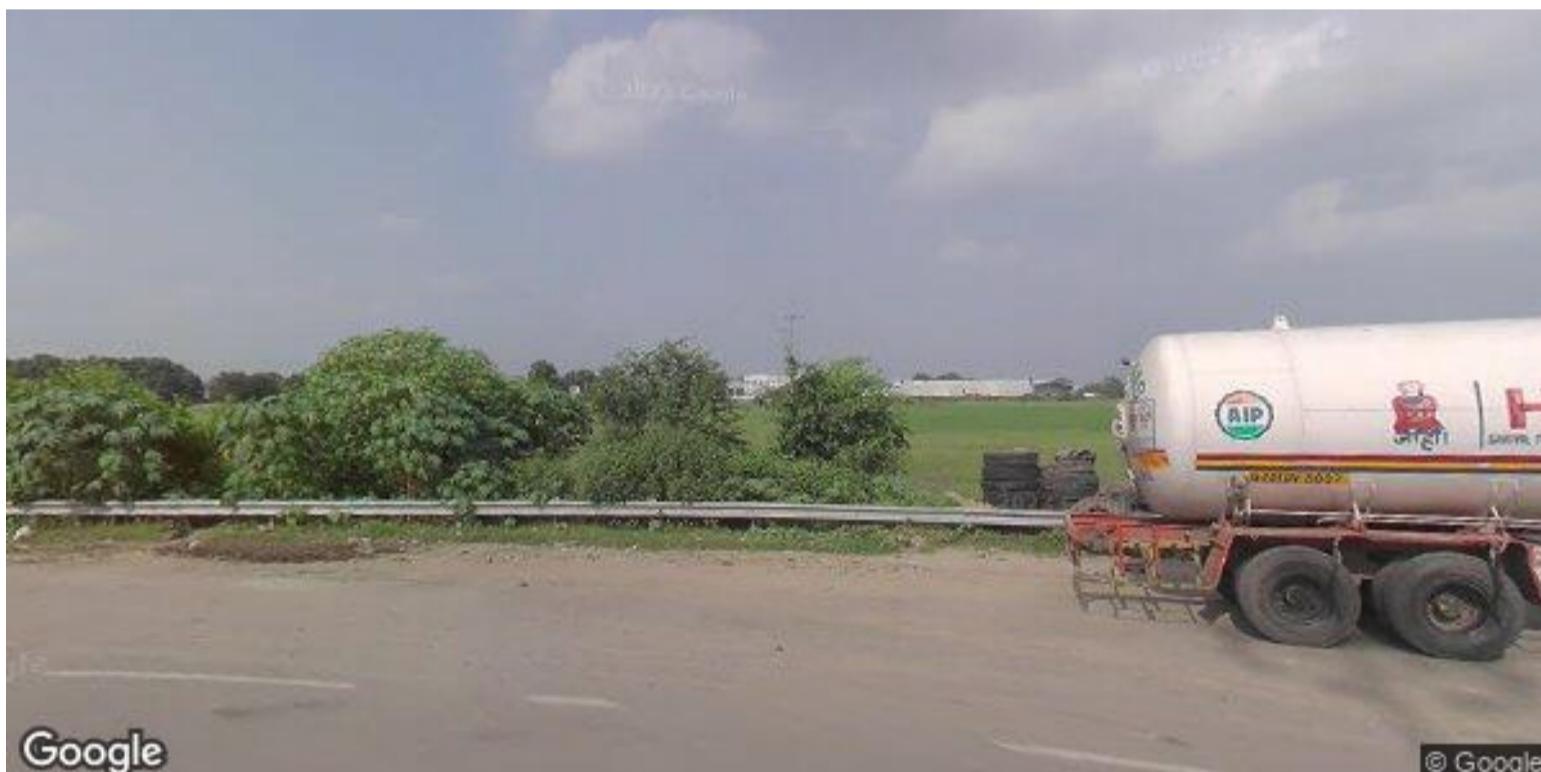
Risk Type: Turn

Risk Level: Medium

Speed Limit: 30 KM/Hr

Distance from Start: 9.49 km

Coordinates: 26.74310, 83.25343

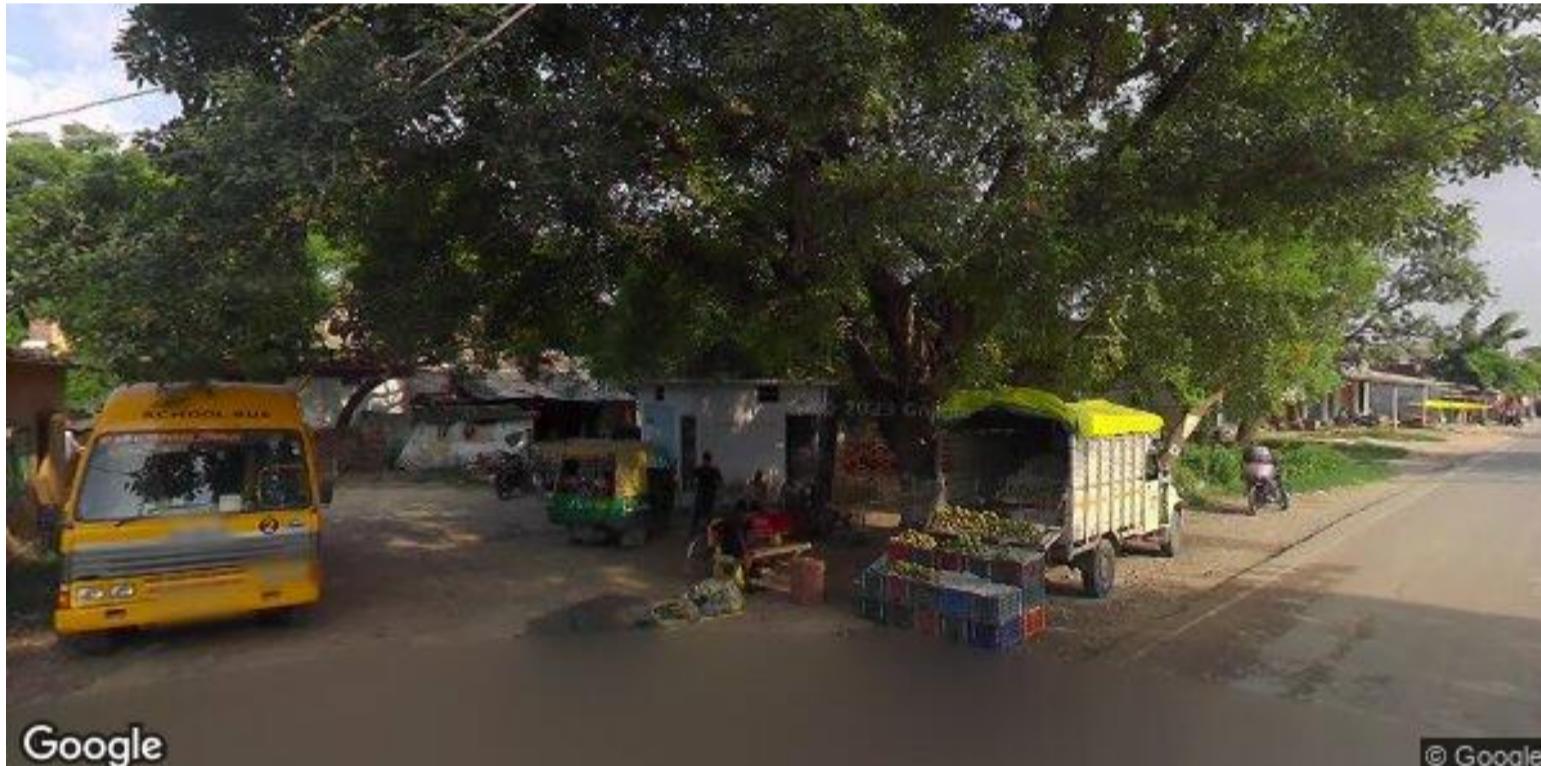
Risk Type: Blind Spot

Risk Level: Blind Spot

Speed Limit: 10 KM/Hr

Distance from Start: 27.70 km

Coordinates: 26.61852, 83.24070

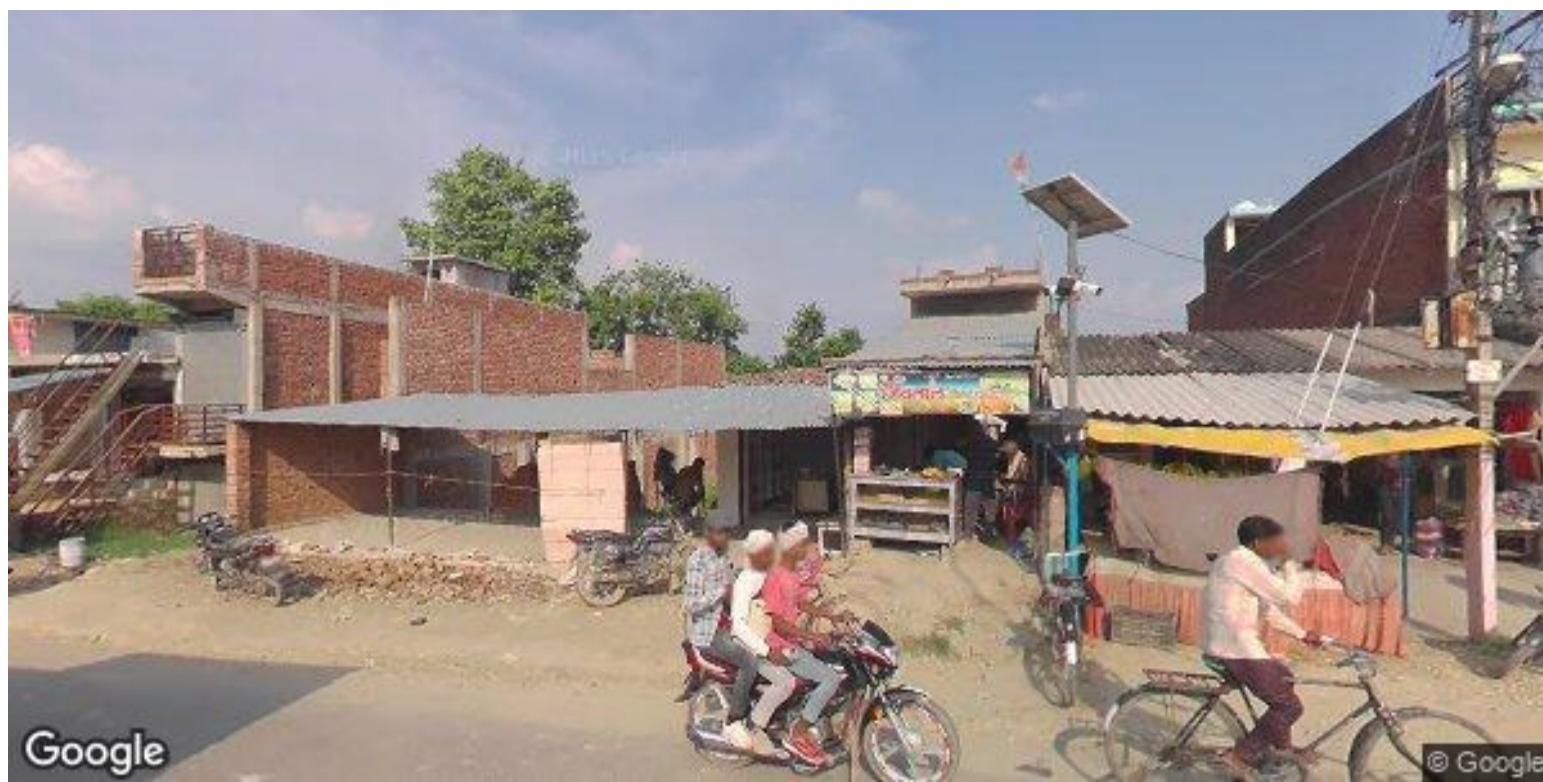
Risk Type: Blind Spot

Risk Level: Blind Spot

Speed Limit: 10 KM/Hr

Distance from Start: 31.46 km

Coordinates: 26.58601, 83.23080
