JOURNEY RISK MANAGEMENT (JRM) STUDY

Gorakhpur LPG BP TO RAMPRASAD INDANE GAS

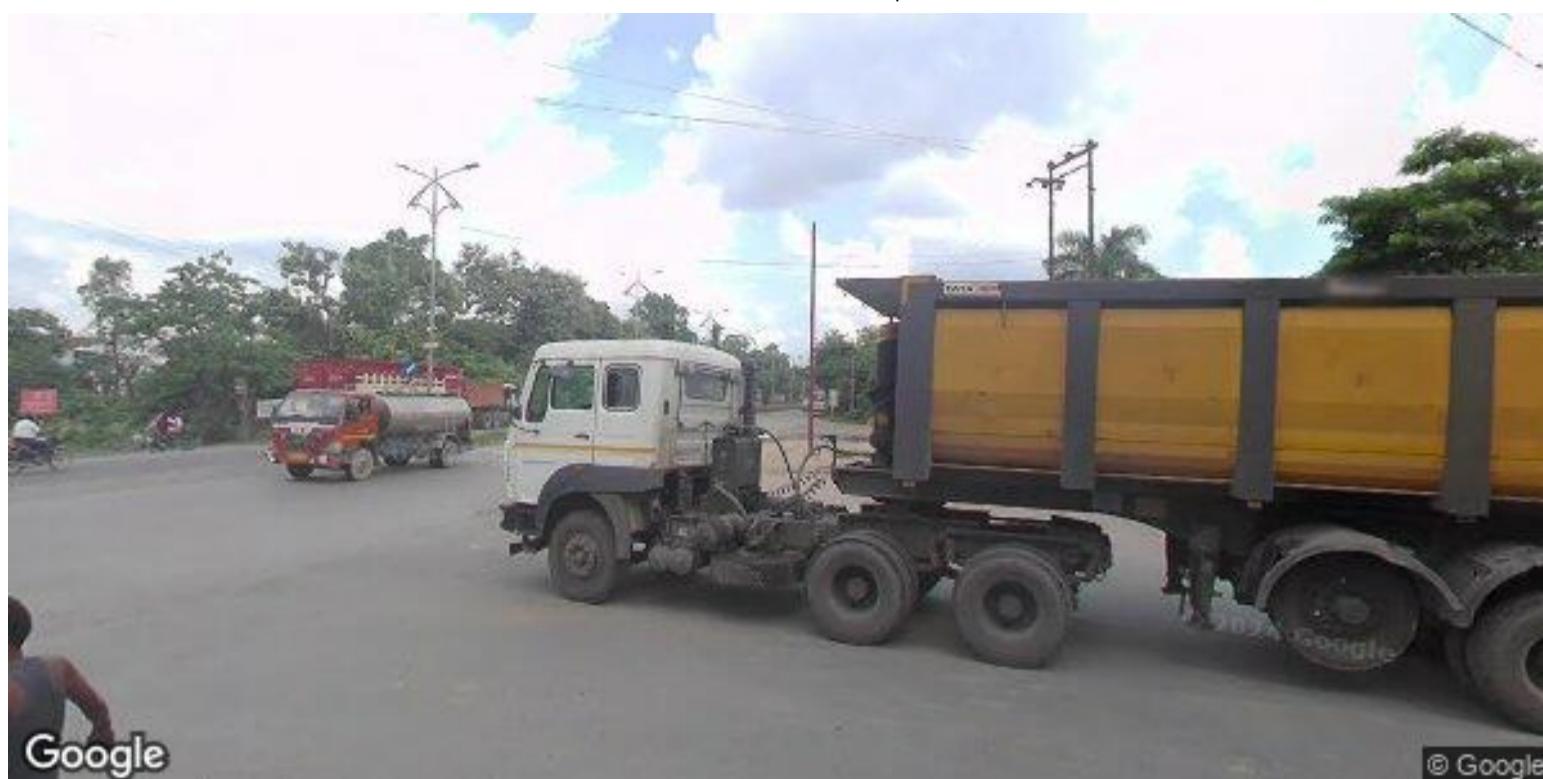
Coordinates: 26.75126, 83.22476

Risk Type: Blind Spot

Risk Level: Blind Spot

Speed Limit: 10 KM/Hr

Distance from Start: 2.17 km

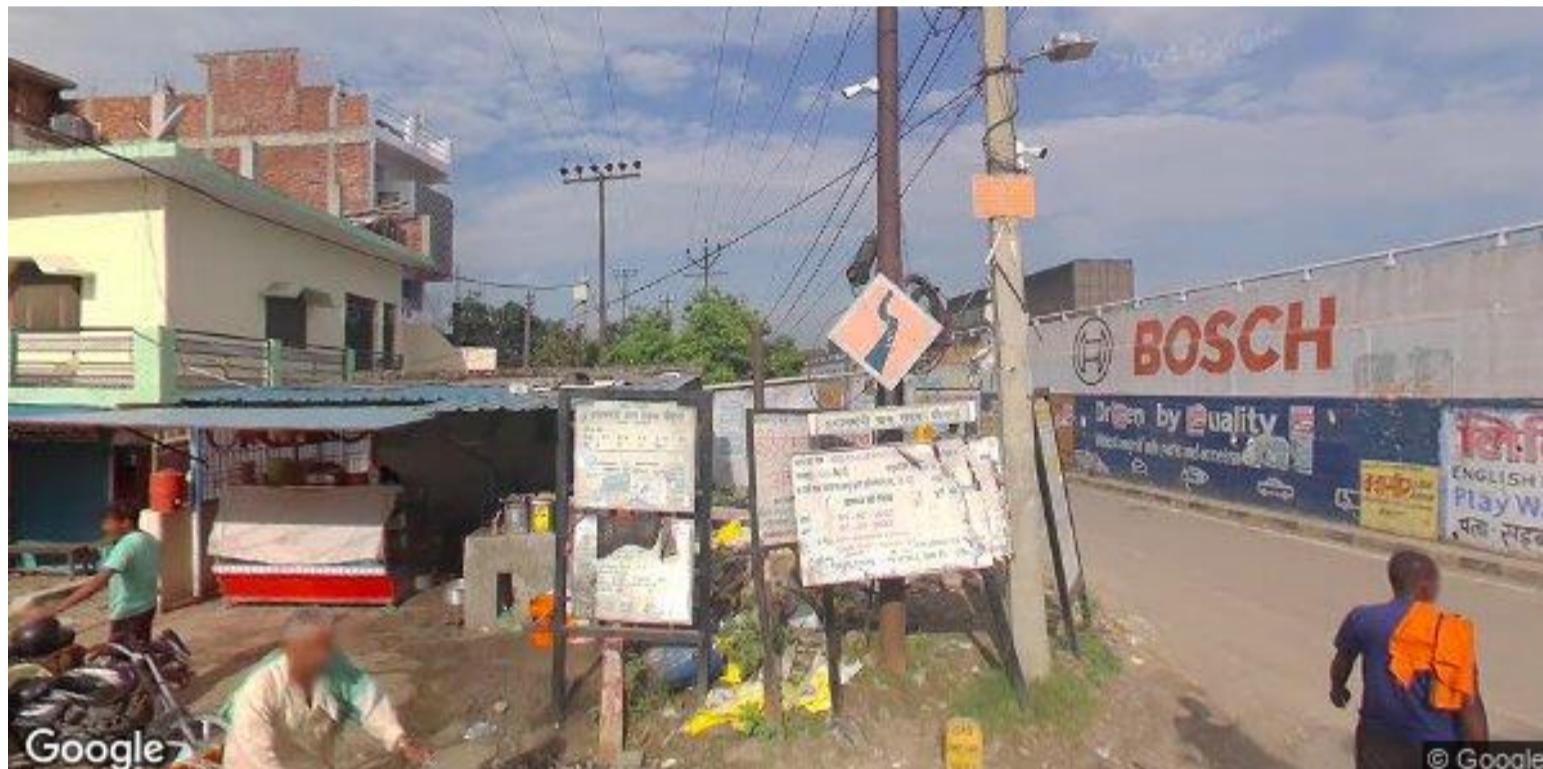
Coordinates: 26.75353, 83.20457

Risk Type: Blind Spot

Risk Level: Blind Spot

Speed Limit: 10 KM/Hr

Distance from Start: 4.23 km

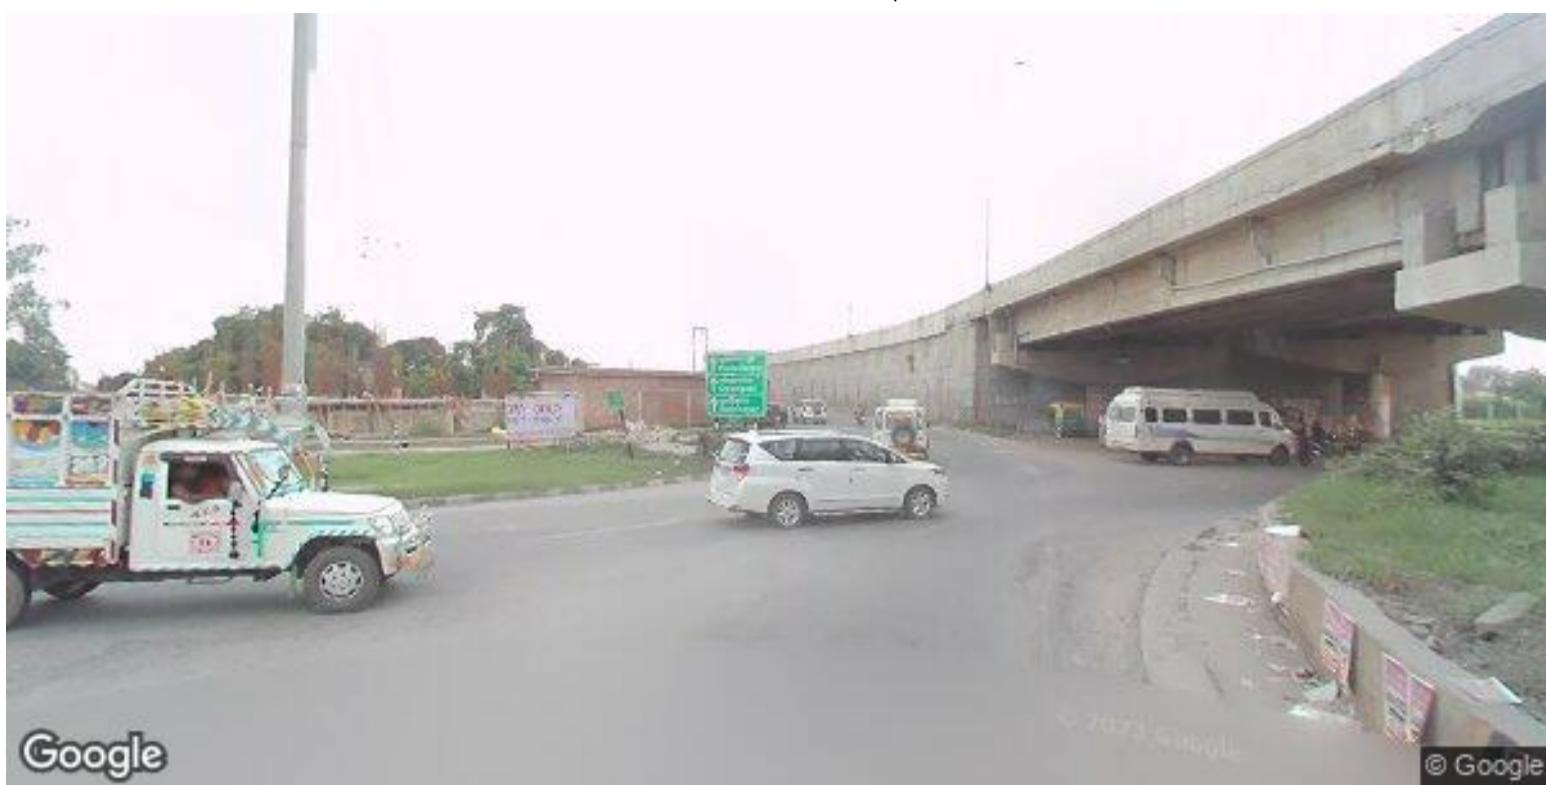
Coordinates: 26.74658, 83.25155

Risk Type: Turn

Risk Level: Medium

Speed Limit: 30 KM/Hr

Distance from Start: 9.05 km

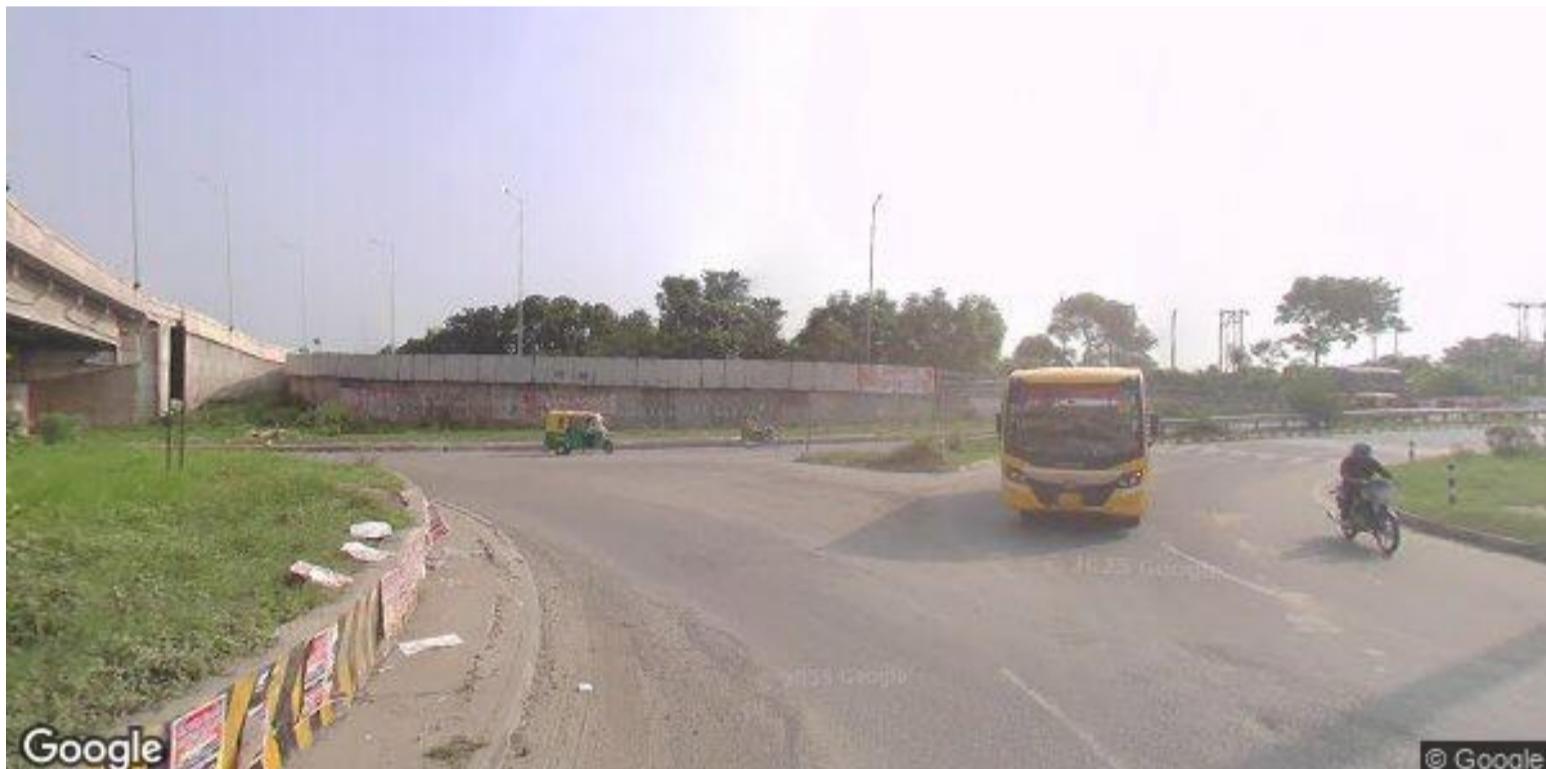
Coordinates: 26.74646, 83.25151

Risk Type: Turn

Risk Level: Medium

Speed Limit: 30 KM/Hr

Distance from Start: 9.07 km

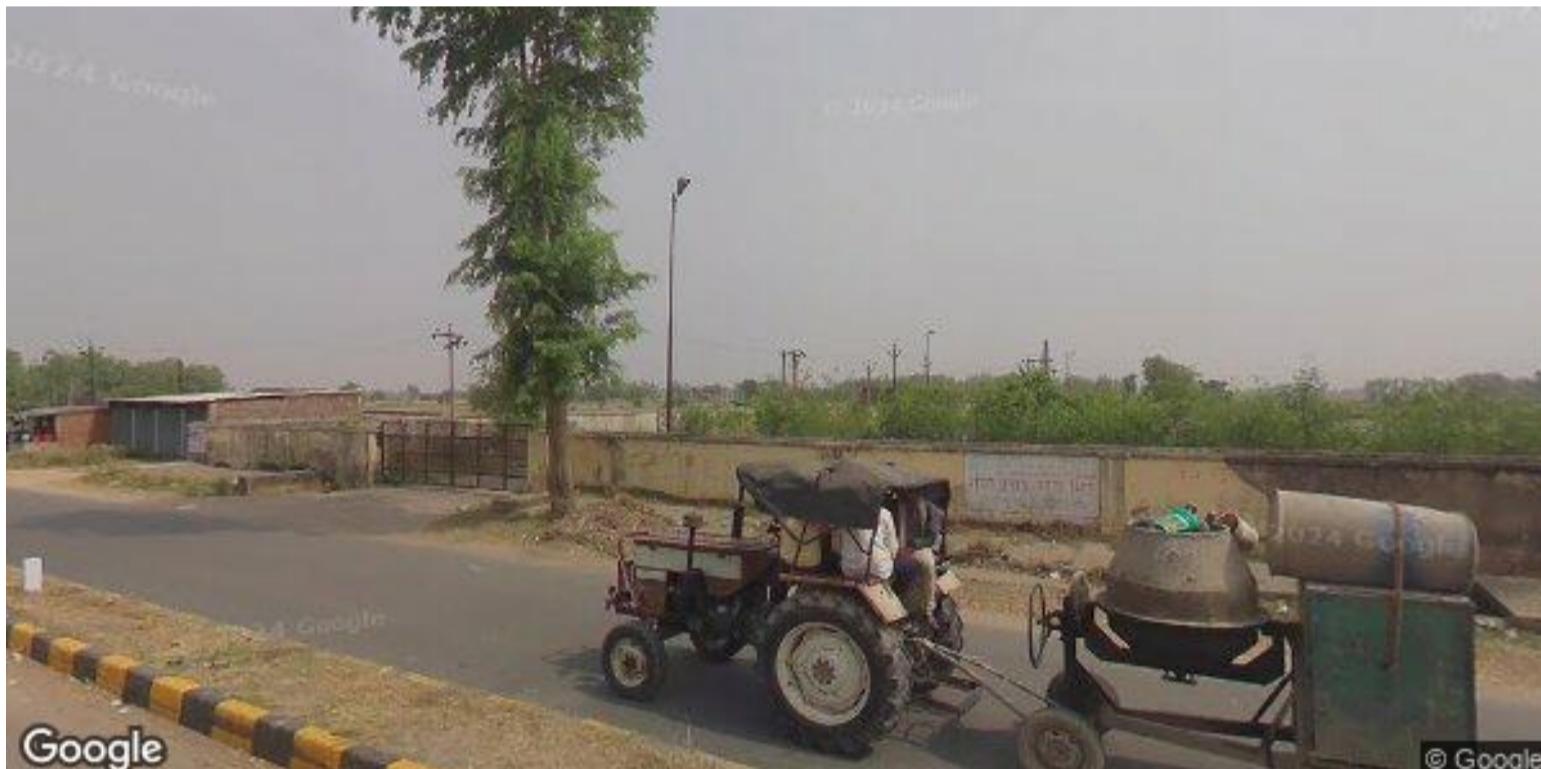
Risk Type: Turn**Risk Level:** Medium**Speed Limit:** 30 KM/Hr**Distance from Start:** 41.17 km**Coordinates:** 26.74526, 83.53161

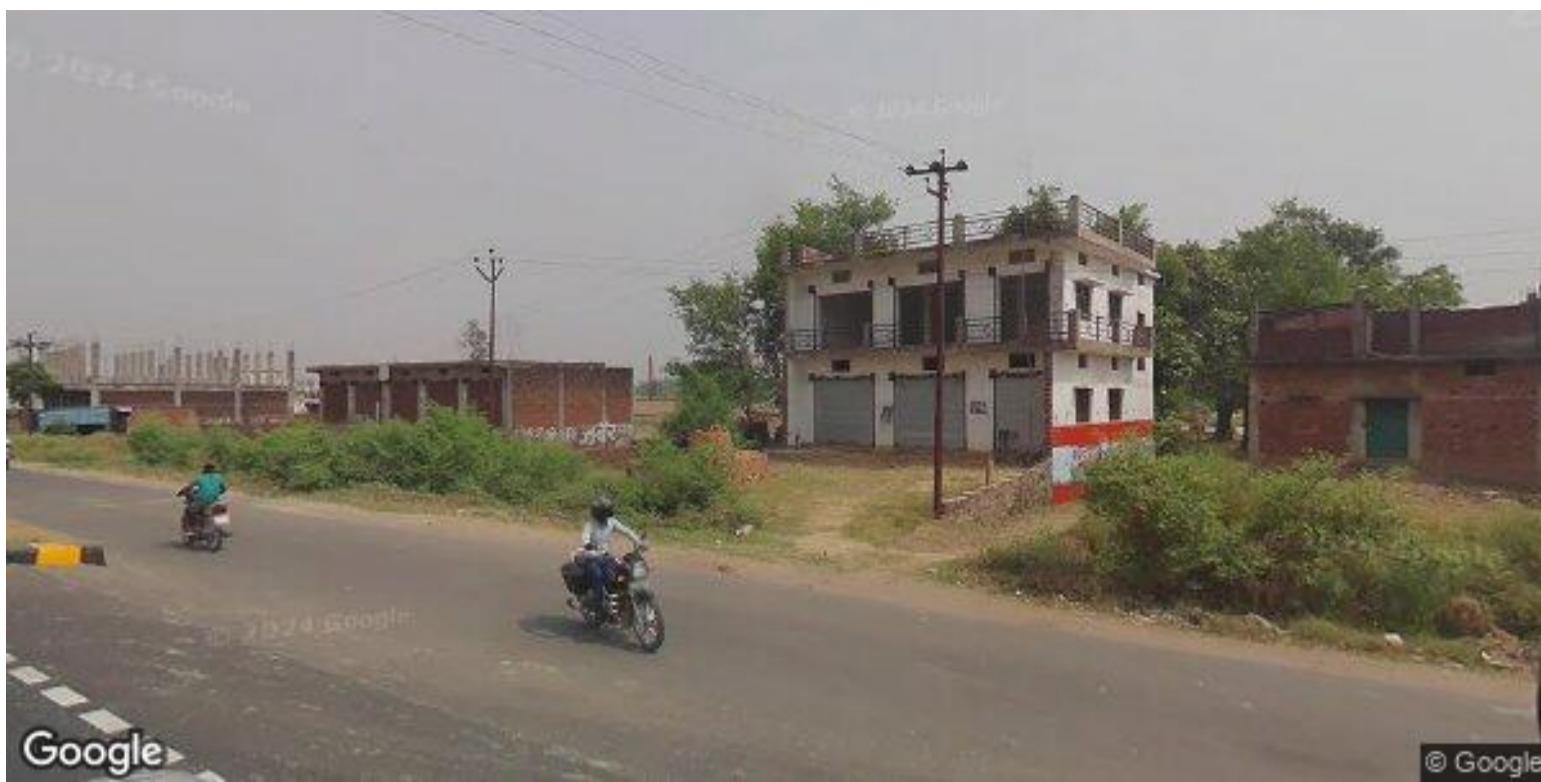
Coordinates: 26.74501, 83.53448

Risk Type: Turn

Risk Level: High

Speed Limit: 15 KM/Hr

Distance from Start: 41.39 km

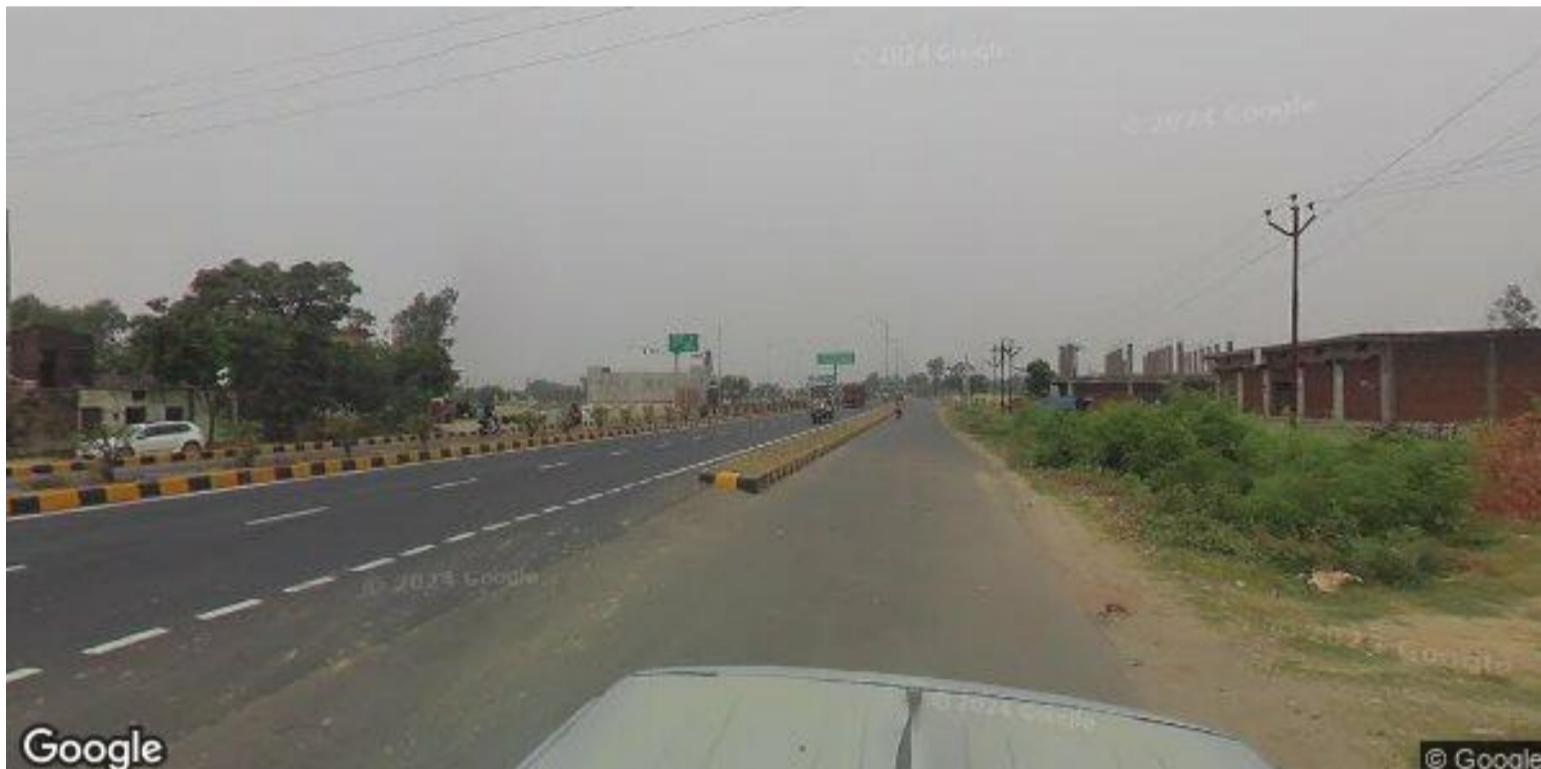
Coordinates: 26.74508, 83.53450

Risk Type: Turn

Risk Level: High

Speed Limit: 15 KM/Hr

Distance from Start: 41.47 km

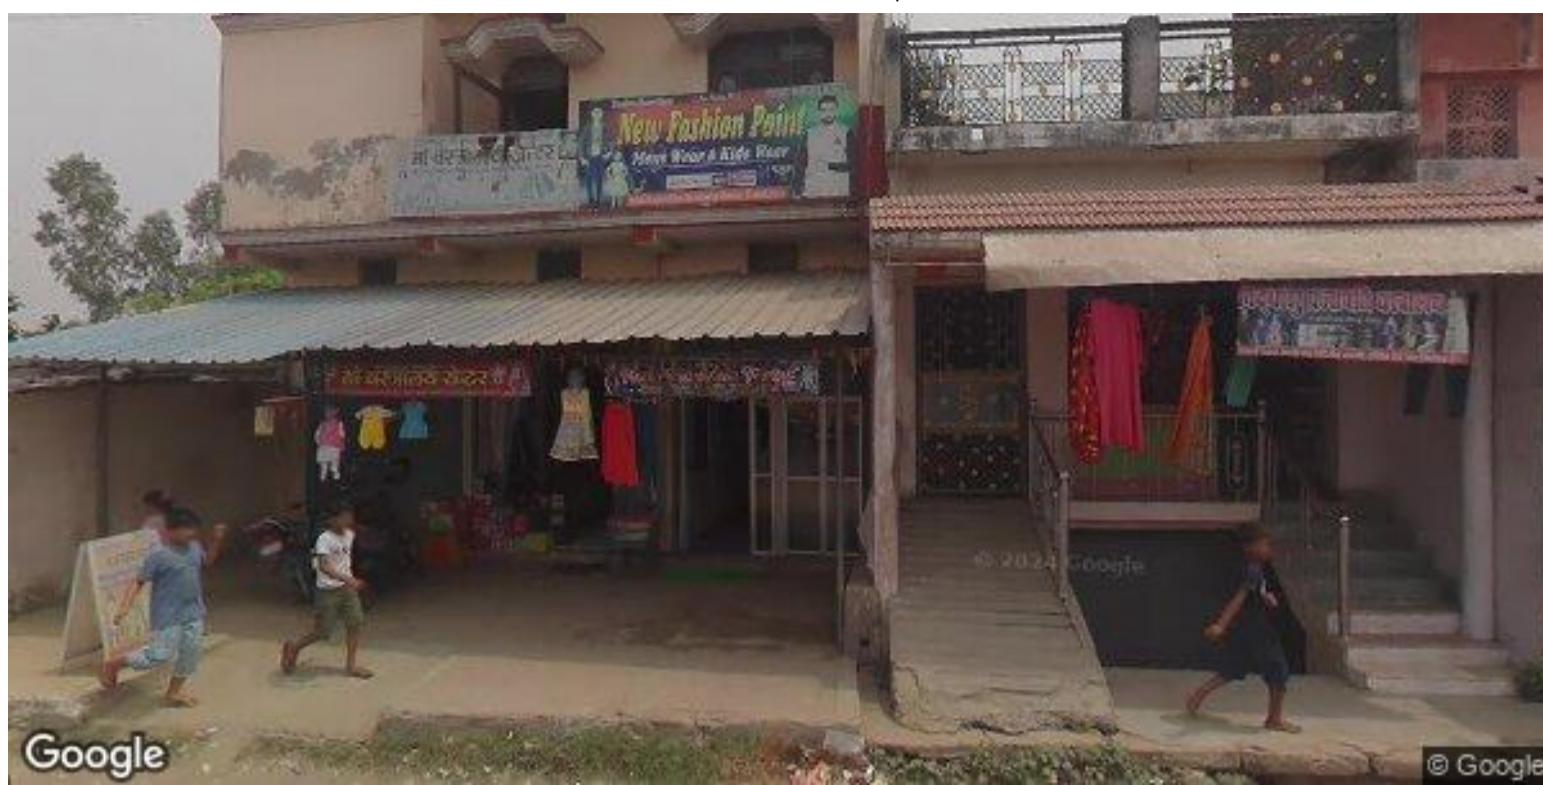
Coordinates: 26.73953, 83.58576

Risk Type: Turn

Risk Level: High

Speed Limit: 15 KM/Hr

Distance from Start: 46.59 km

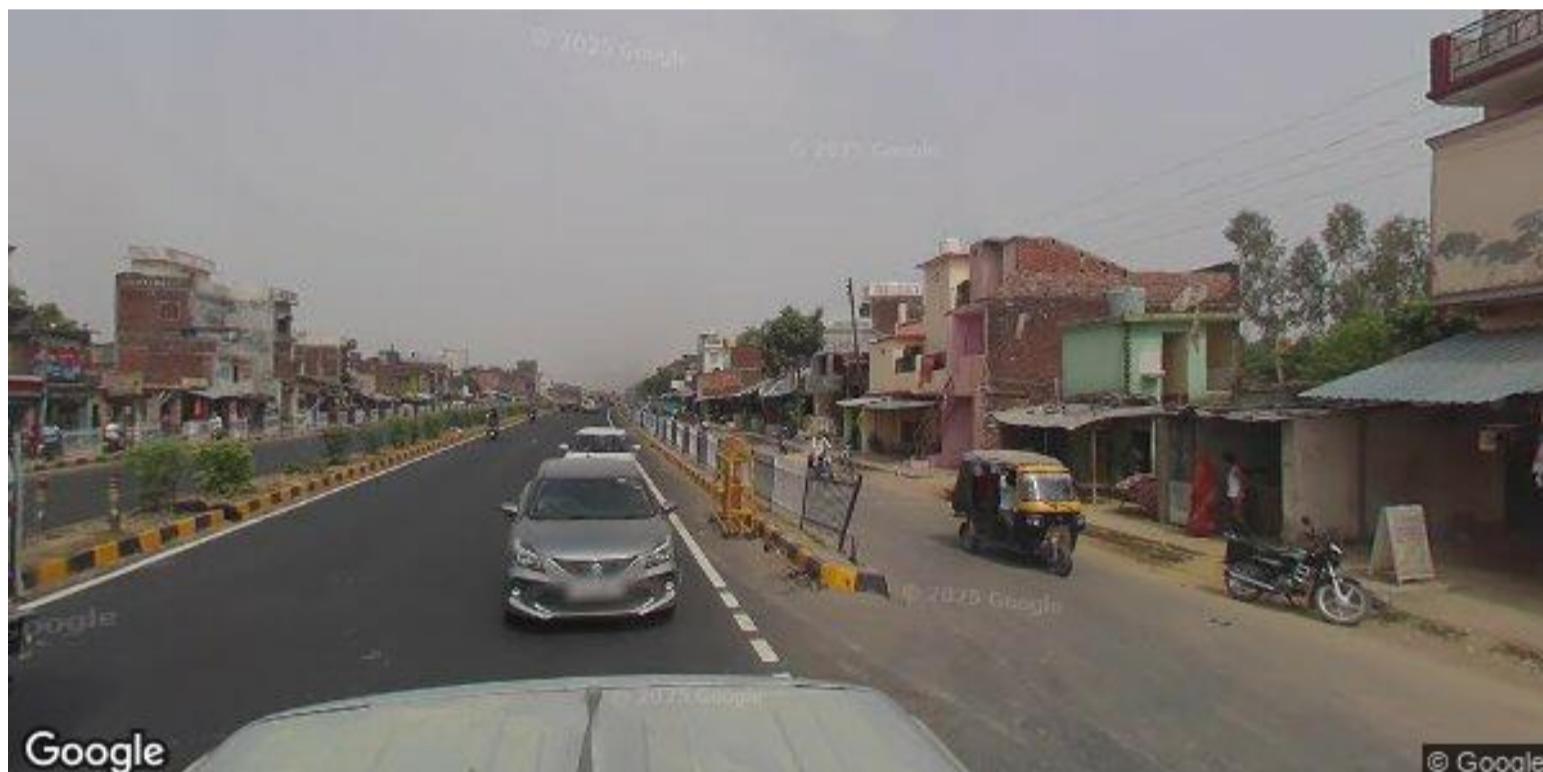
Coordinates: 26.73944, 83.58576

Risk Type: Turn

Risk Level: High

Speed Limit: 15 KM/Hr

Distance from Start: 46.61 km

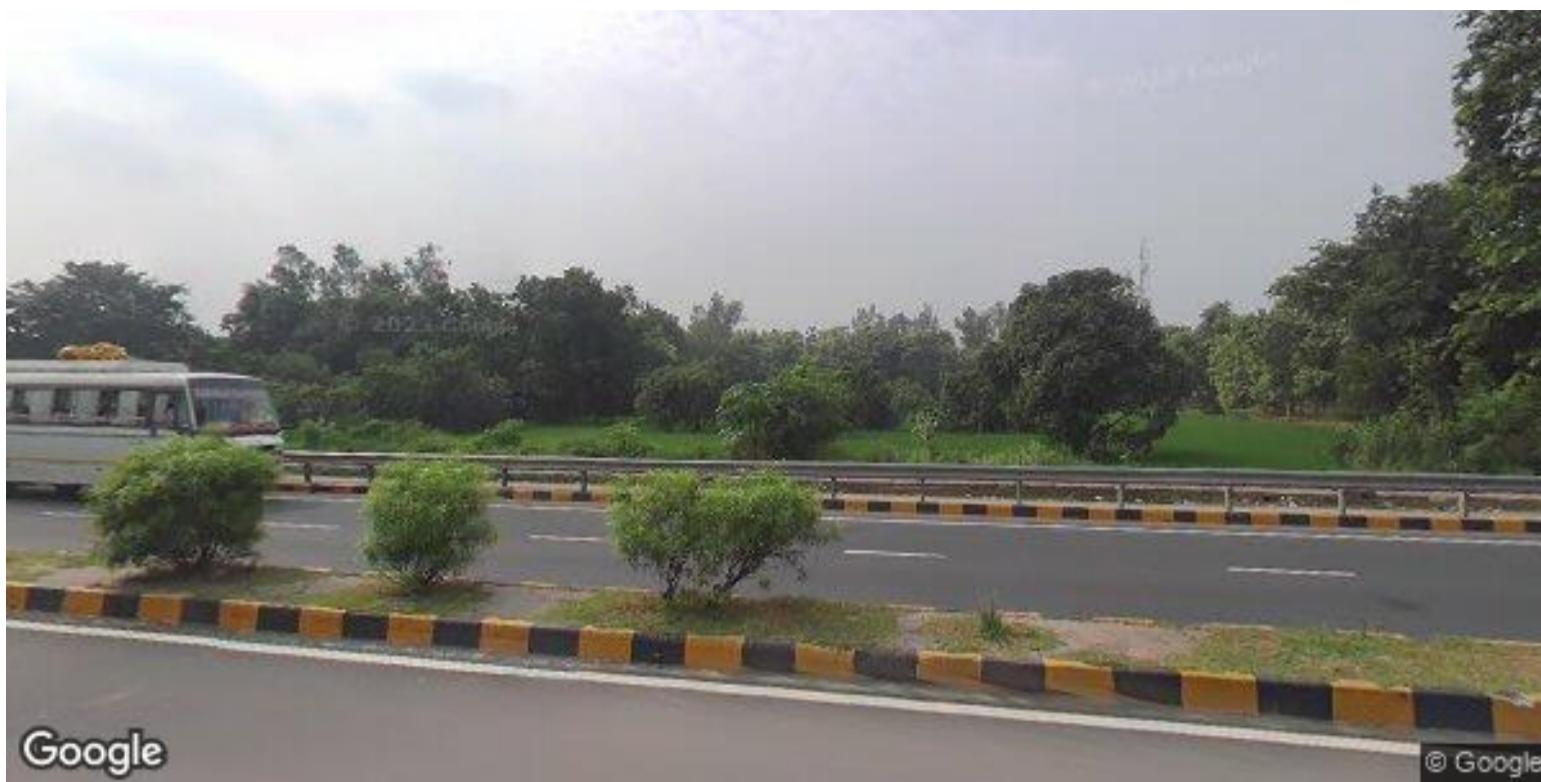
Risk Type: Blind Spot**Risk Level:** Blind Spot**Speed Limit:** 10 KM/Hr**Distance from Start:** 57.35 km**Coordinates:** 26.73580, 83.69460

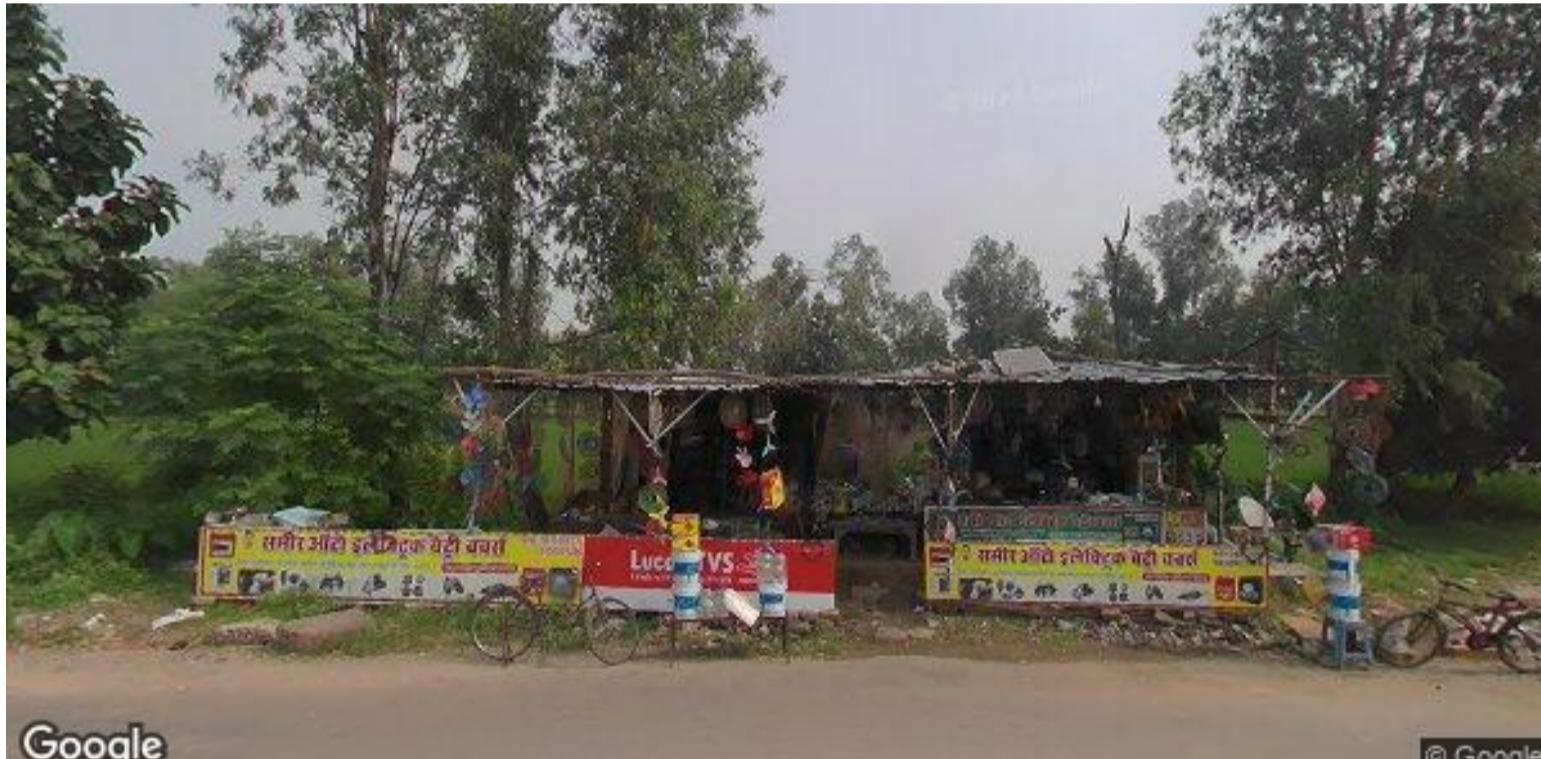
Risk Type: Turn**Risk Level:** High**Speed Limit:** 15 KM/Hr**Distance from Start:** 57.45 km**Coordinates:** 26.73588, 83.69460

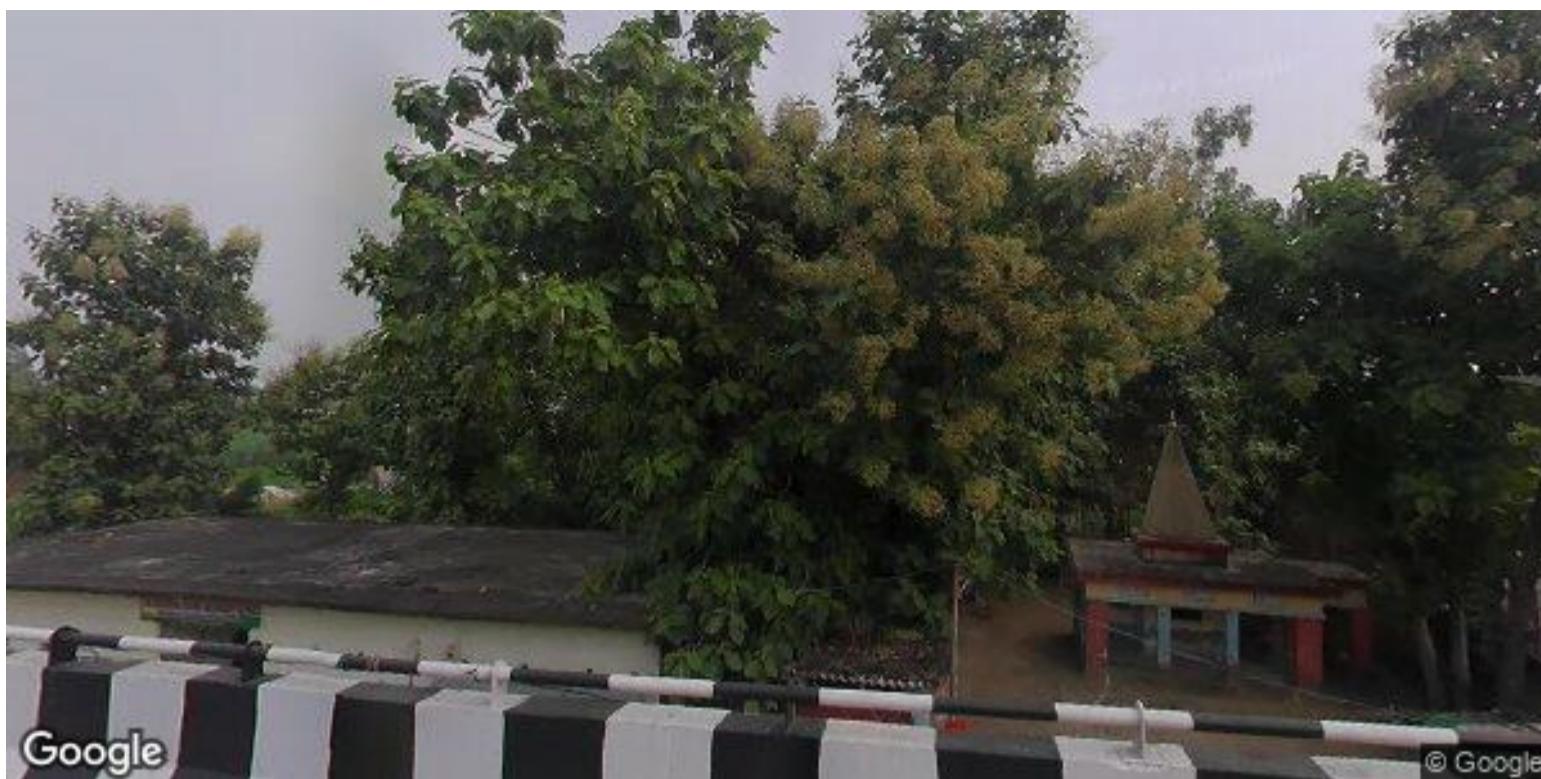
Coordinates: 26.73590, 83.69894

Risk Type: Blind Spot

Risk Level: Blind Spot

Speed Limit: 10 KM/Hr

Distance from Start: 57.84 km

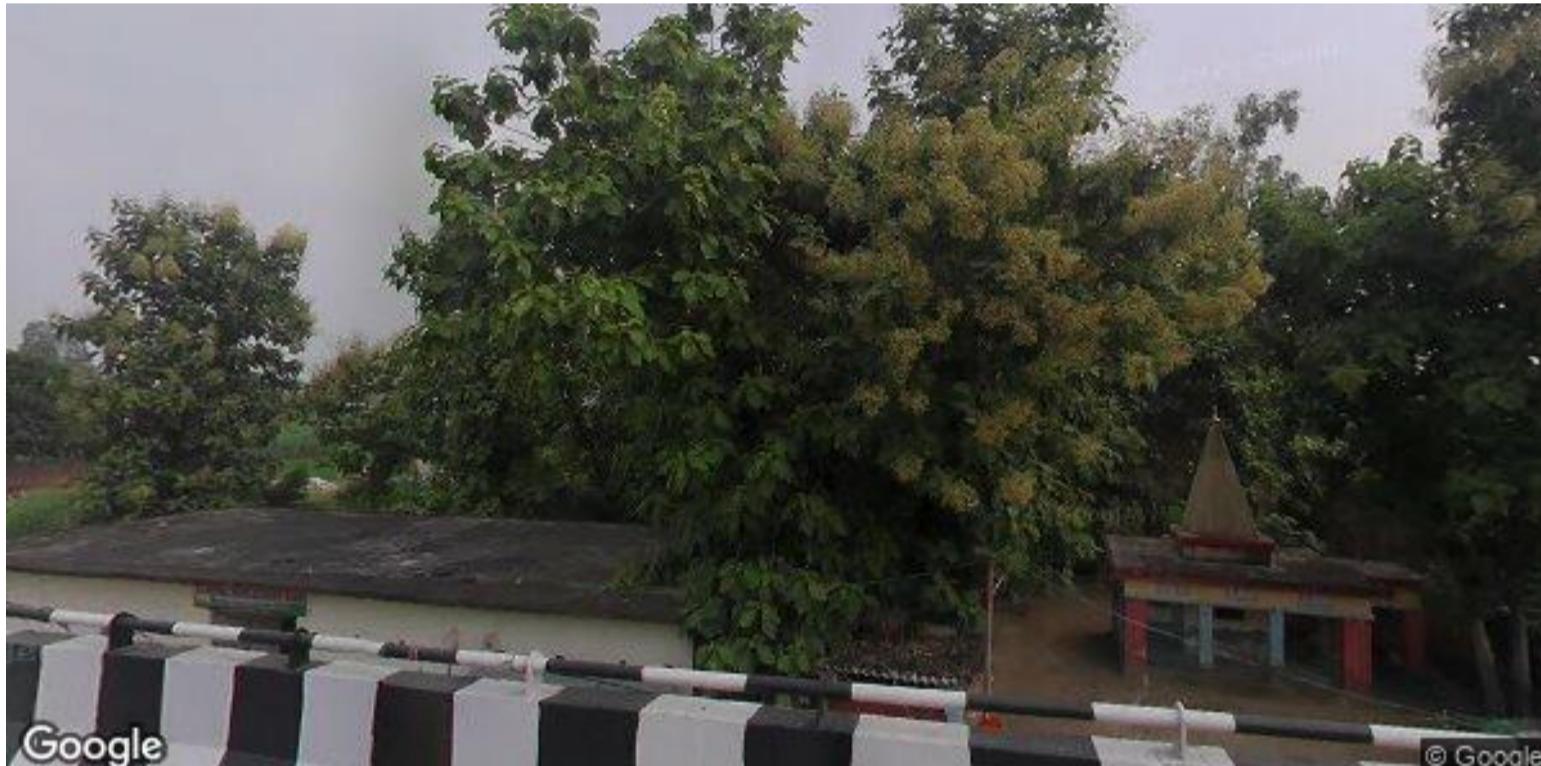
Coordinates: 26.7358961, 83.6989372

Risk Type: U-Turn

Risk Level: High

Speed Limit: 10 KM/Hr

Distance from Start: 57.84 km

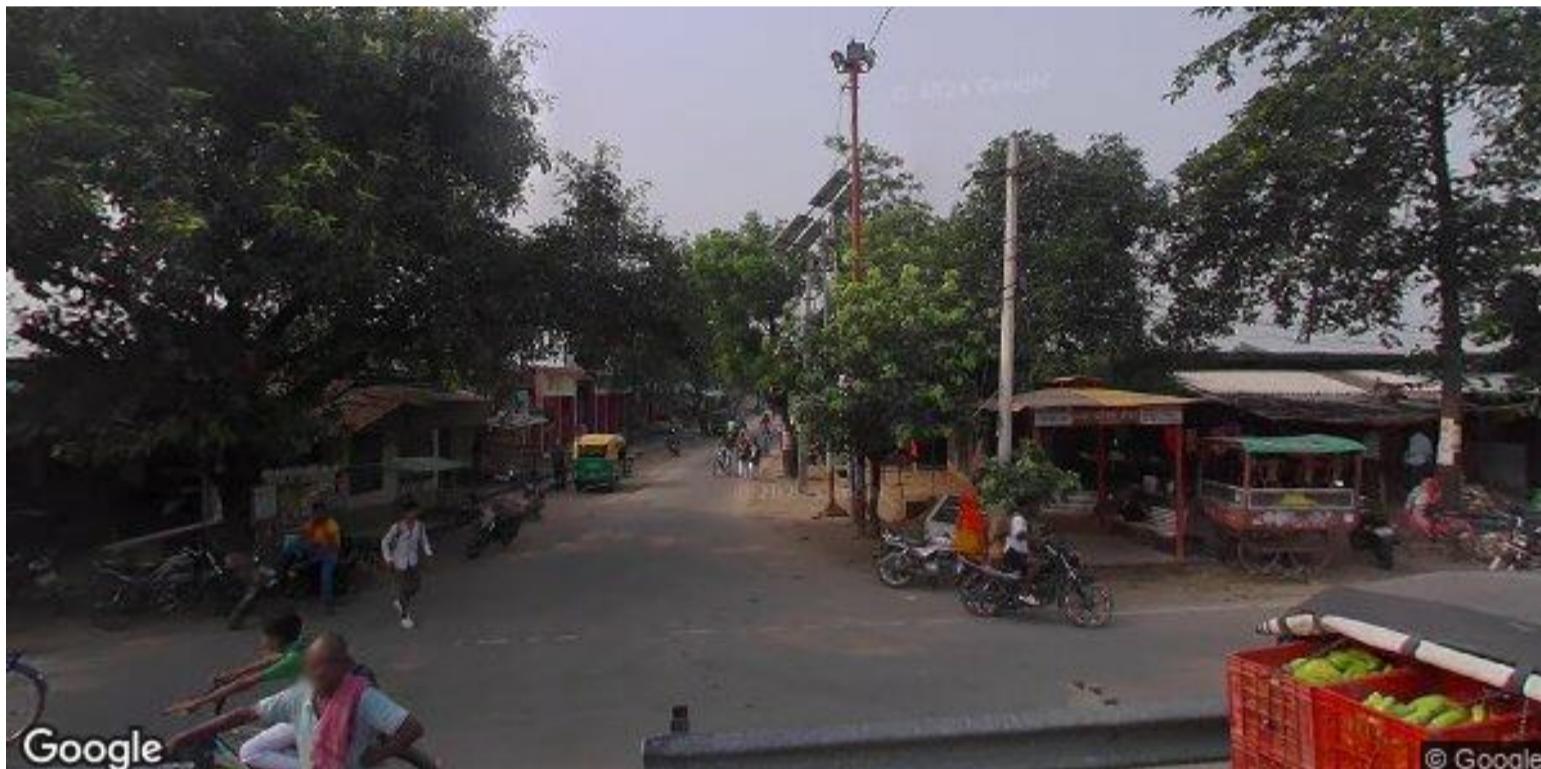
Risk Type: Turn**Risk Level: High****Speed Limit: 15 KM/Hr****Distance from Start: 58.77 km****Coordinates: 26.73565, 83.68774**
