## JOURNEY RISK MANAGEMENT (JRM) STUDY

### Gorakhpur LPG BP TO KATSAHRA INDANE SERV

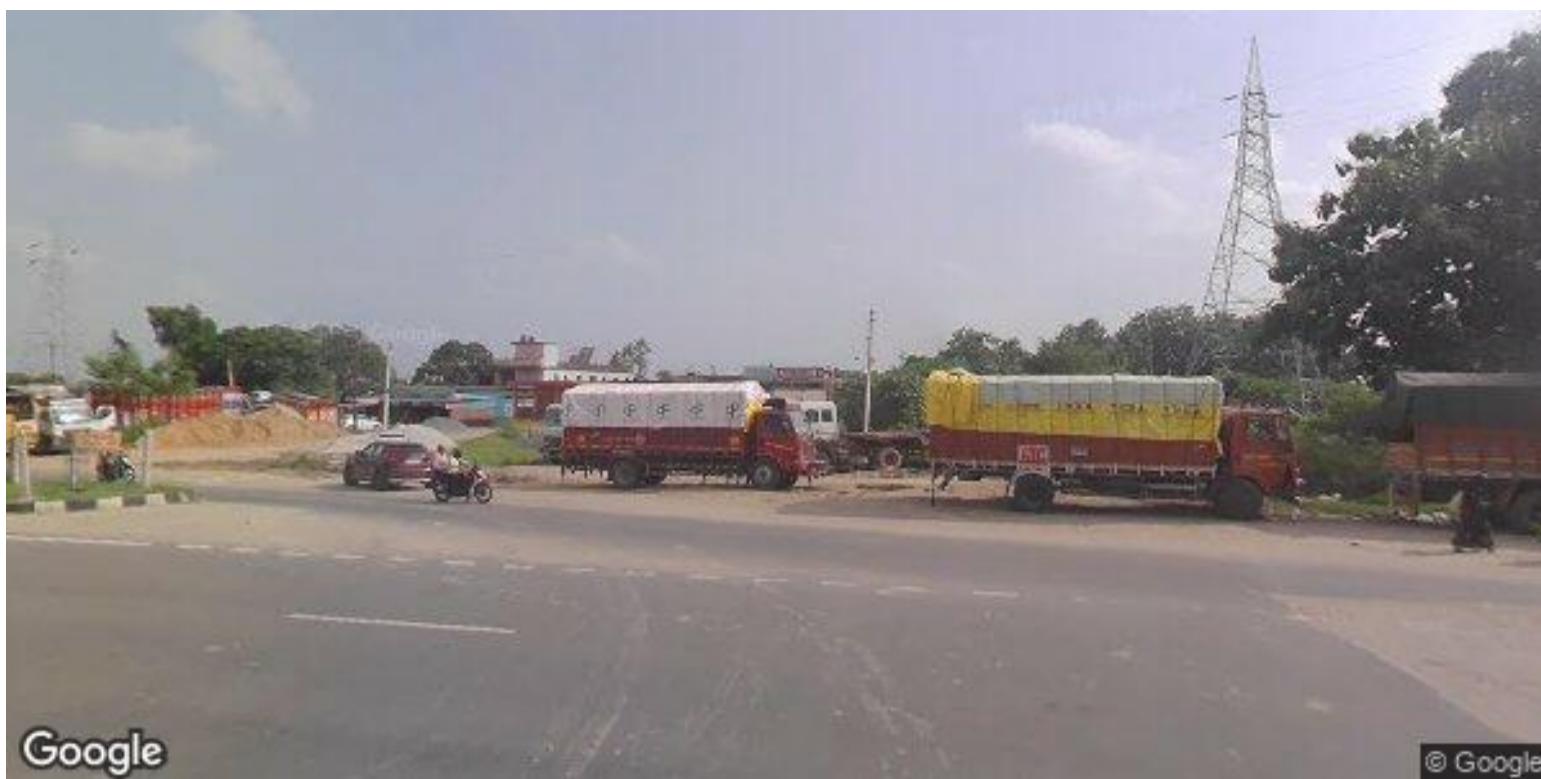
**Distance from Start:** 8.76 km

**Risk Type:** Blind Spot

**Risk Level:** Blind Spot

**Speed Limit:** 10 KM/Hr

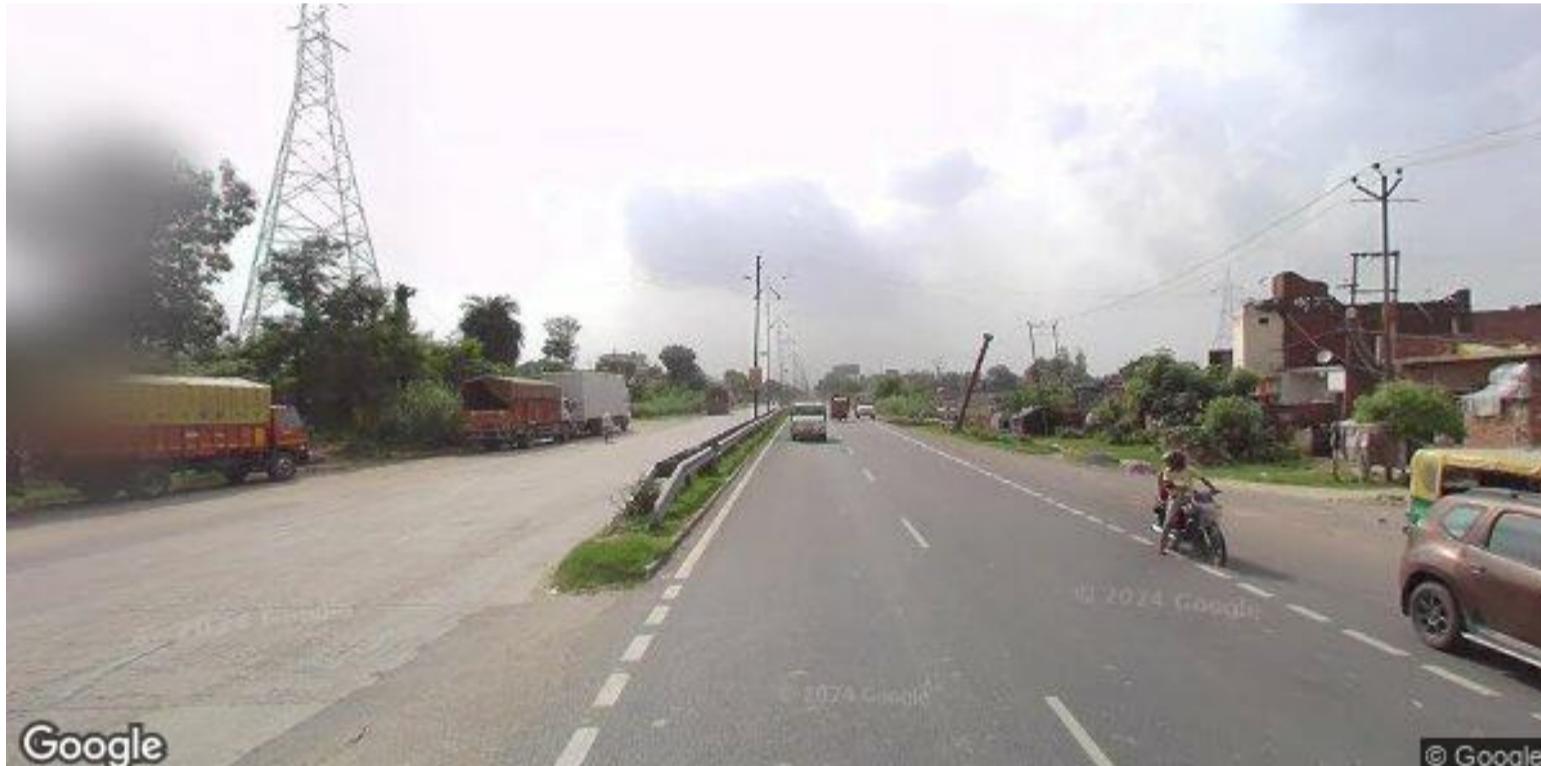
**Distance from Start:** 8.76 km

**Risk Type:** U-Turn

**Risk Level:** High

**Speed Limit:** 10 KM/Hr

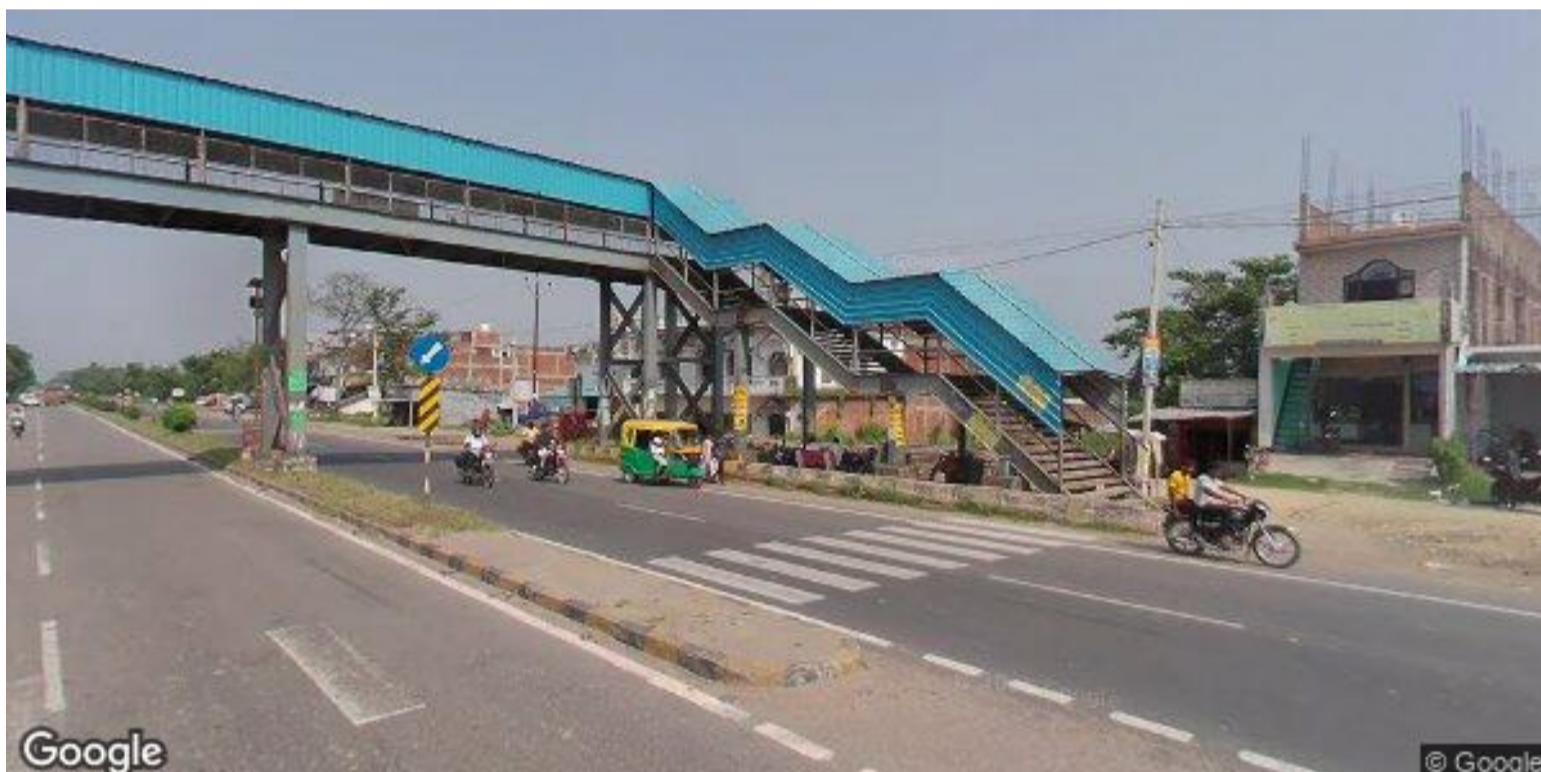
**Distance from Start:** 15.33 km

**Risk Type:** Turn

**Risk Level:** High

**Speed Limit:** 15 KM/Hr
