JOURNEY RISK MANAGEMENT (JRM) STUDY

Gorakhpur LPG BP TO JAI SHIV INDANE SERV

Route Summary:
Total Distance: 30.01 km
Estimated Duration: 0.7 hours
Adjusted Duration (Heavy Vehicle): 0.8 hours
Start: (26.735959, 83.229398)
End: (26.83183, 83.34951)

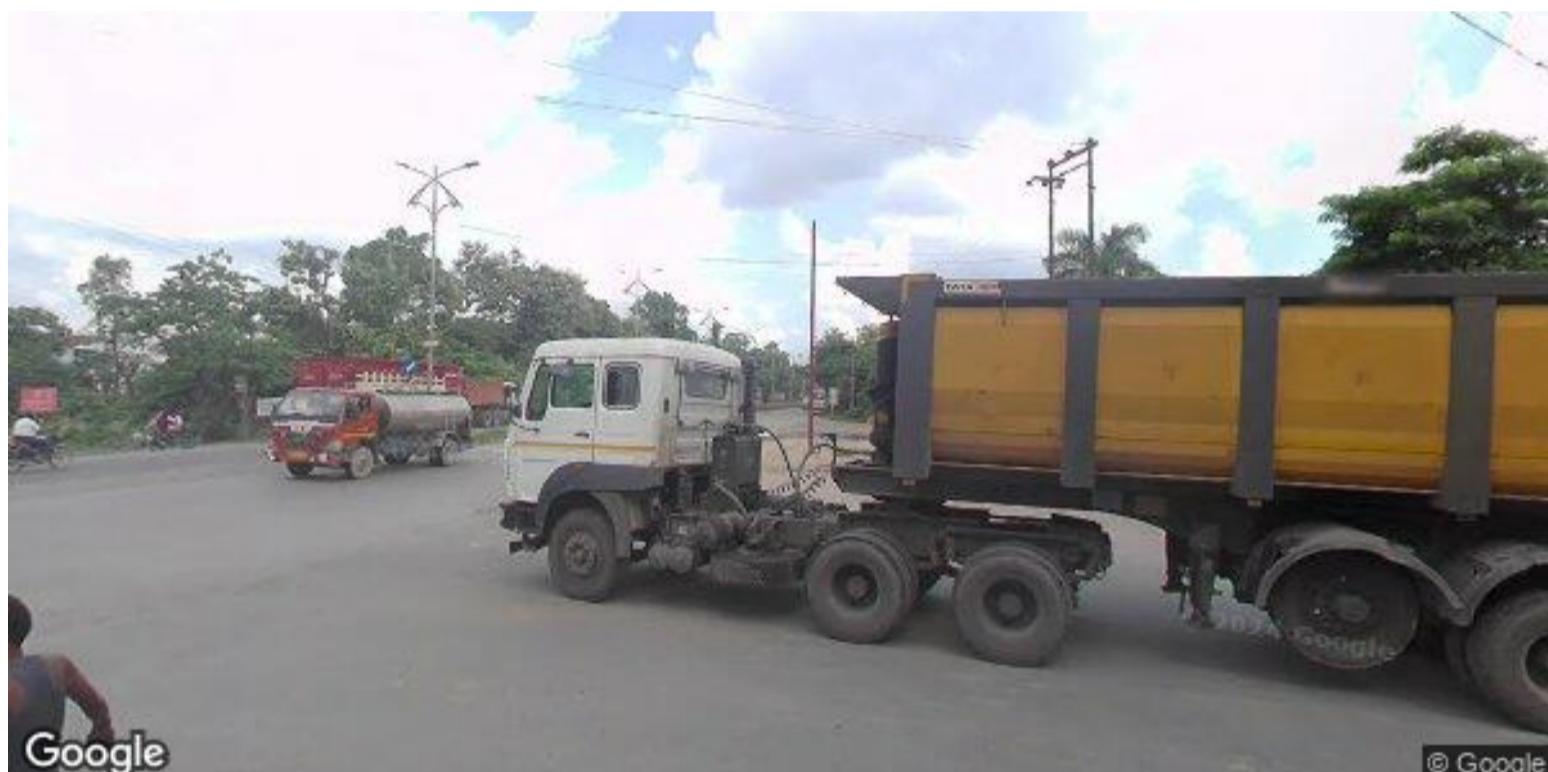
Risk Type: Blind Spot

Risk Level: Blind Spot

Speed Limit: 10 KM/Hr

Distance from Start: 2.17 km

Coordinates: 26.75126, 83.22476

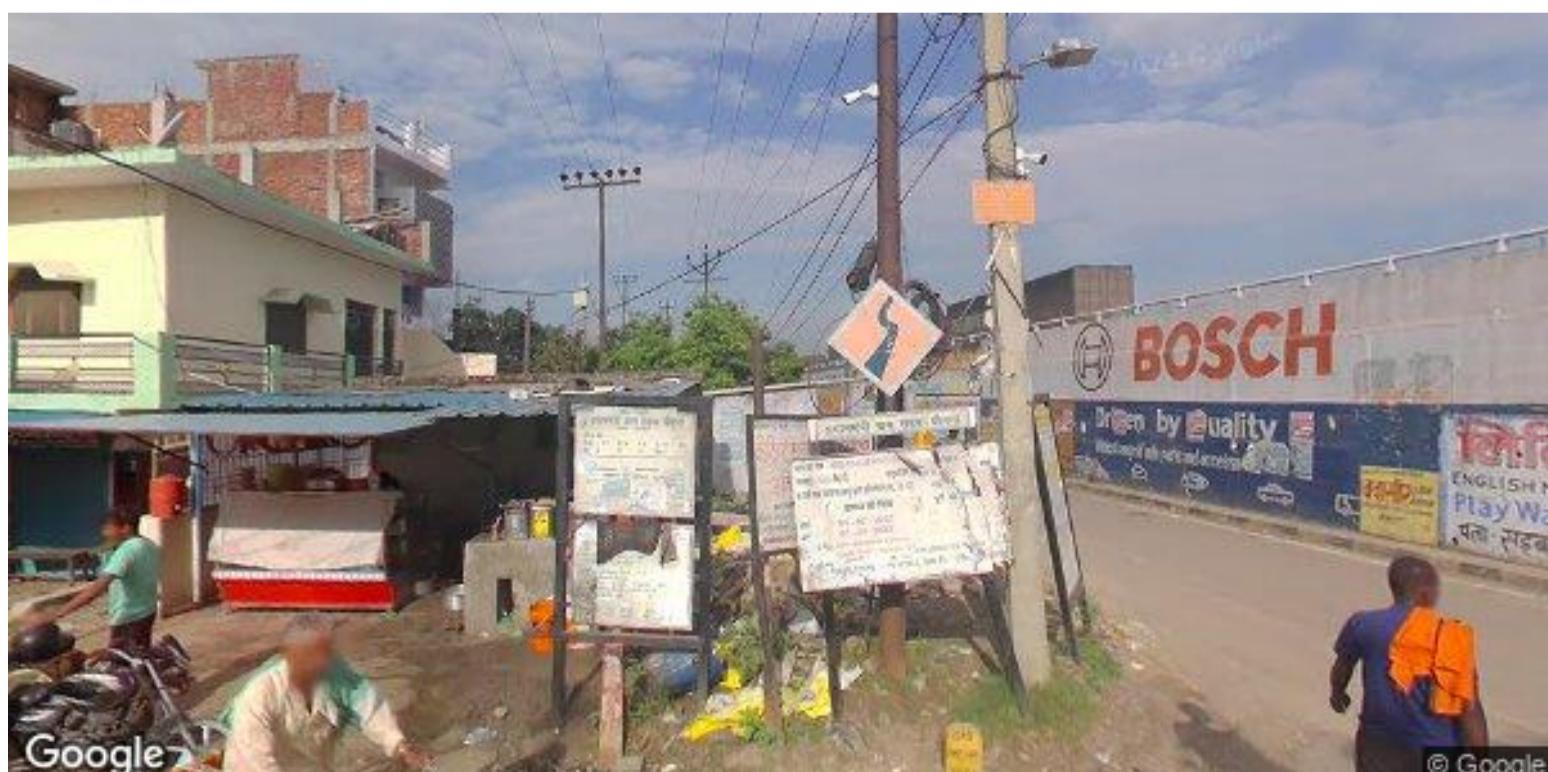
Risk Type: Blind Spot

Risk Level: Blind Spot

Speed Limit: 10 KM/Hr

Distance from Start: 4.23 km

Coordinates: 26.75353, 83.20457

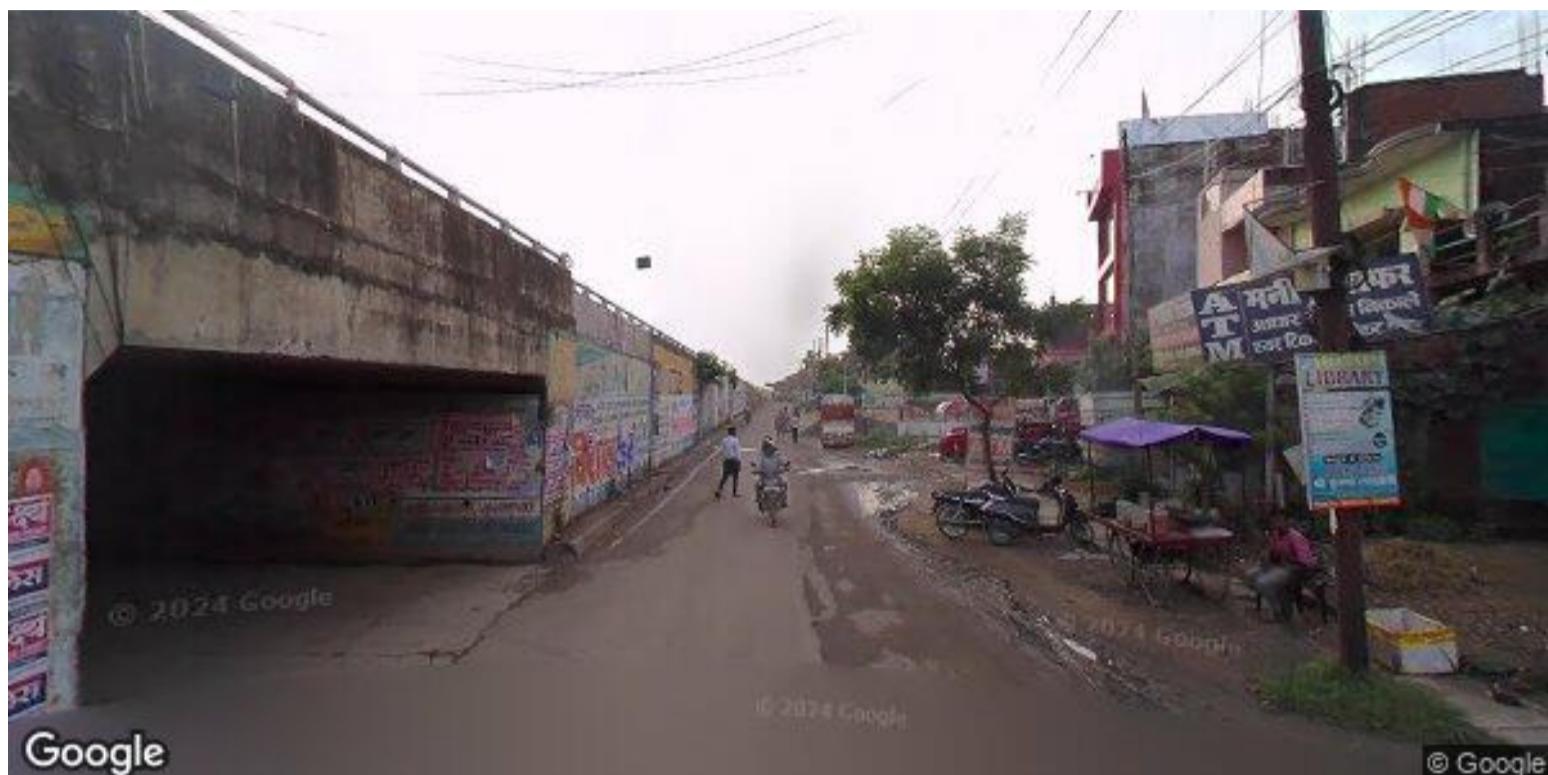
Risk Type: Turn

Risk Level: High

Speed Limit: 15 KM/Hr

Distance from Start: 4.30 km

Coordinates: 26.75381, 83.20466

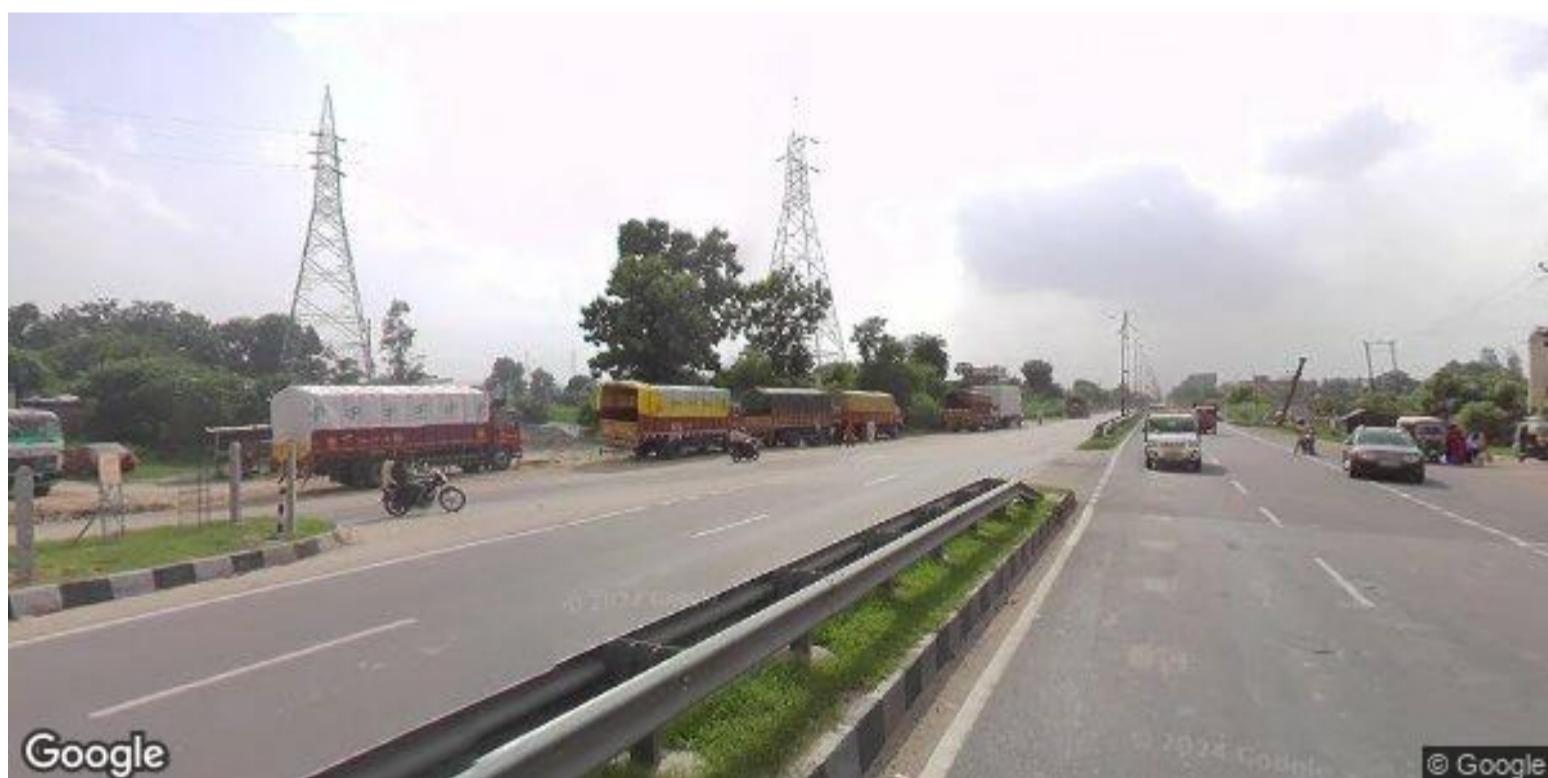
Risk Type: Turn

Risk Level: High

Speed Limit: 15 KM/Hr

Distance from Start: 8.81 km

Coordinates: 26.74708, 83.24935

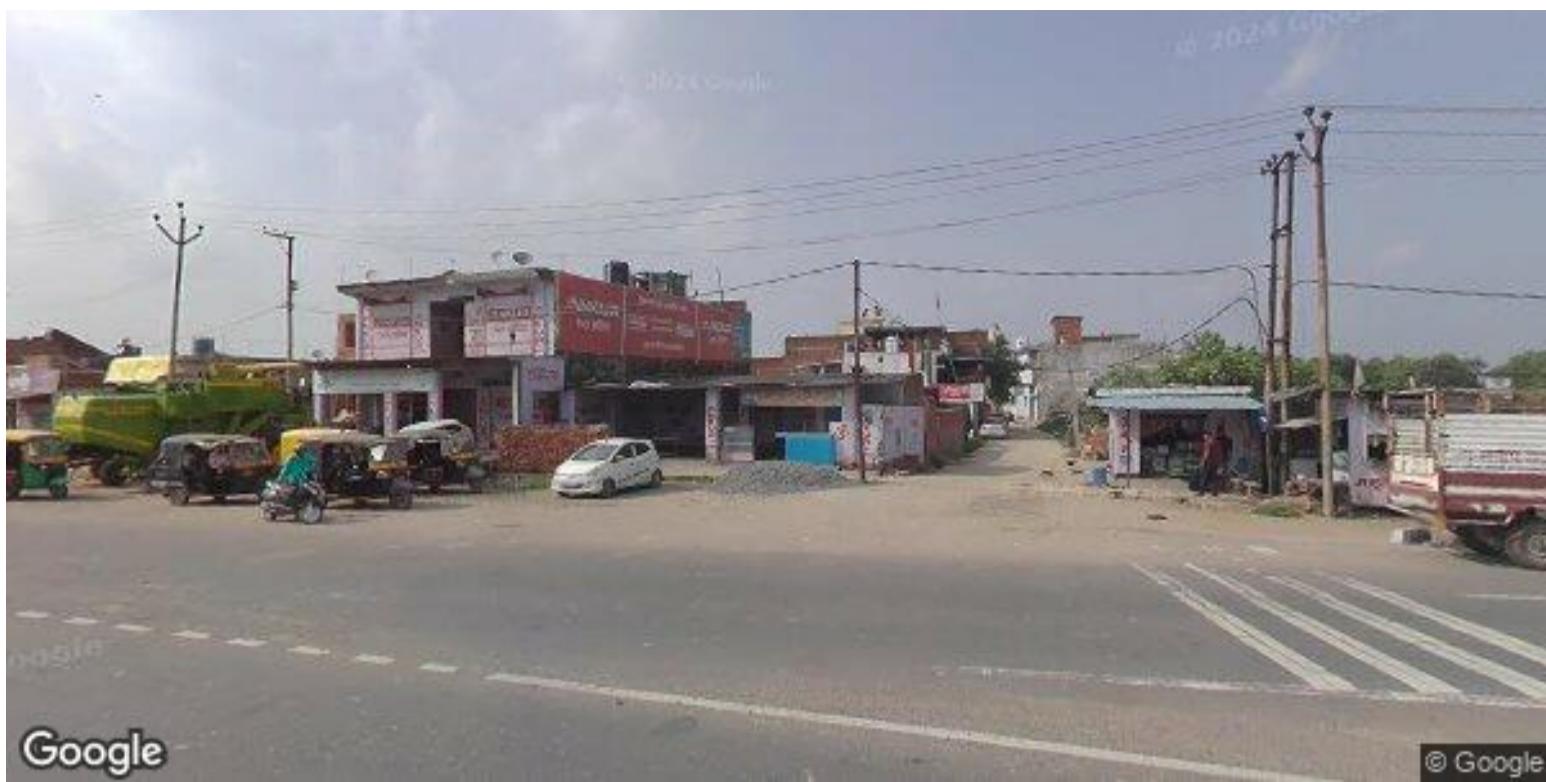
Risk Type: Turn**Risk Level:** Medium**Speed Limit:** 30 KM/Hr**Distance from Start:** 8.82 km**Coordinates:** 26.74712, 83.24938

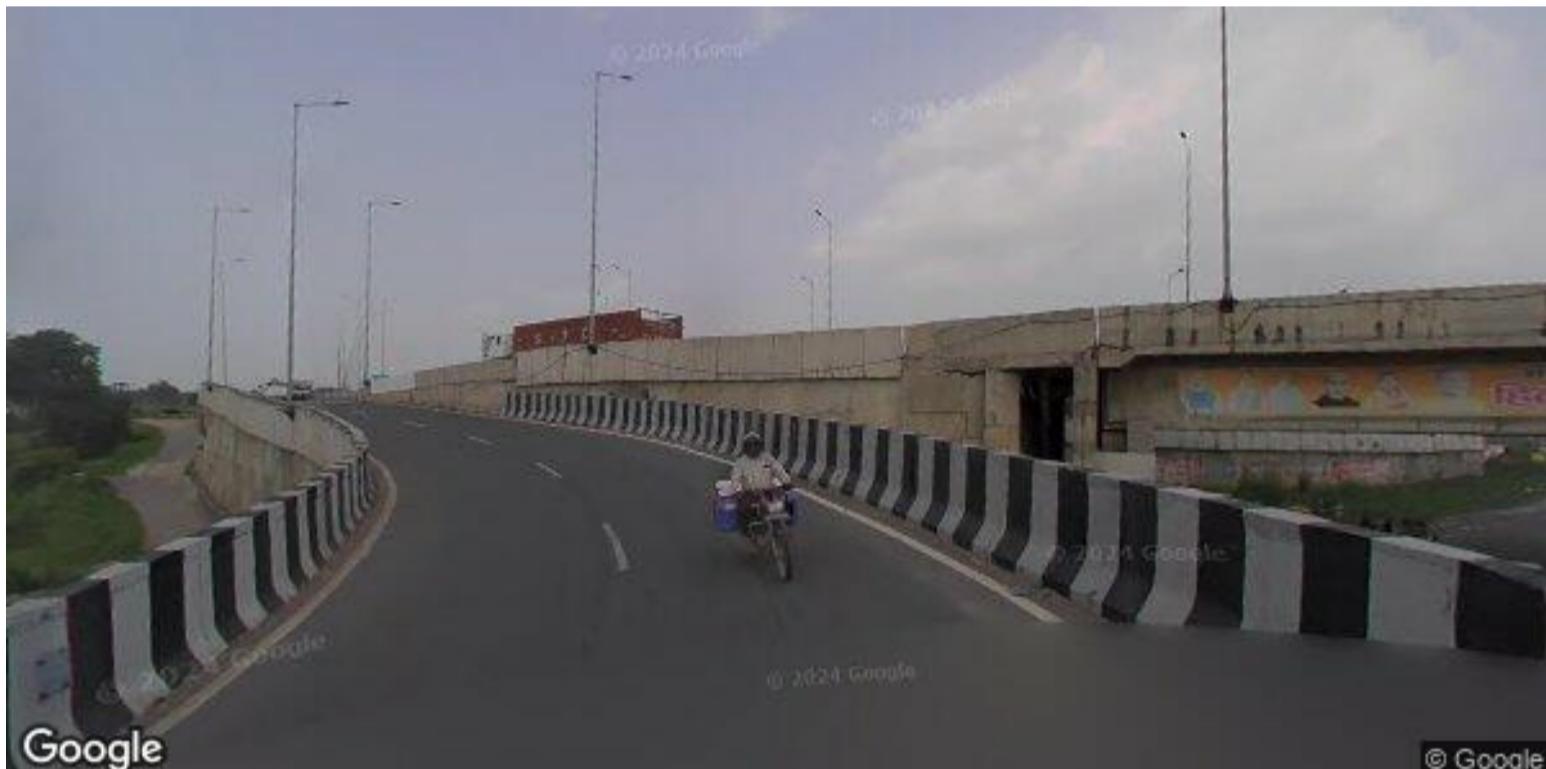
Risk Type: Turn**Risk Level:** Medium**Speed Limit:** 30 KM/Hr**Distance from Start:** 8.98 km**Coordinates:** 26.74703, 83.25096

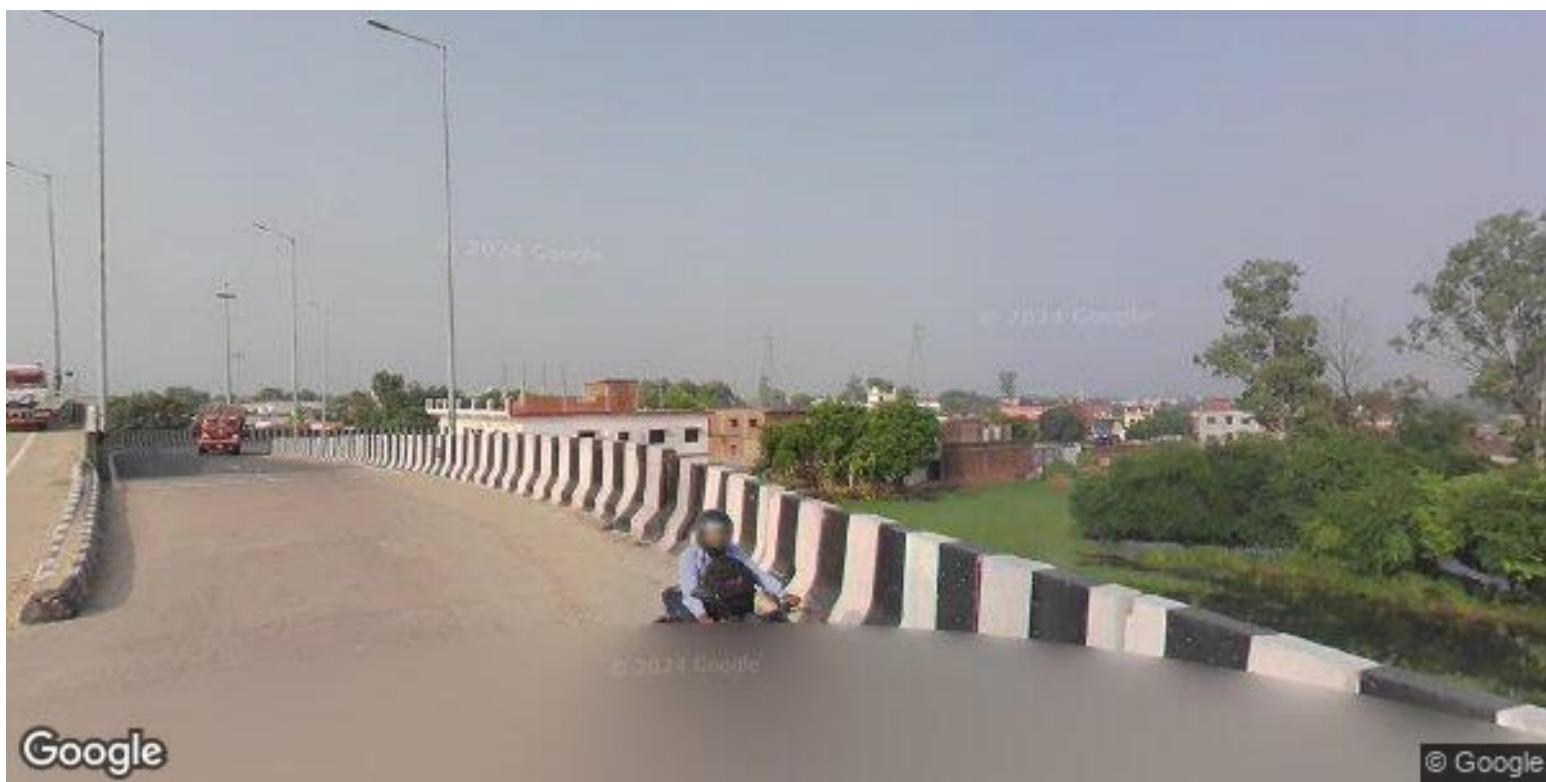
Risk Type: Turn**Risk Level:** Medium**Speed Limit:** 30 KM/Hr**Distance from Start:** 9.06 km**Coordinates:** 26.74767, 83.25139

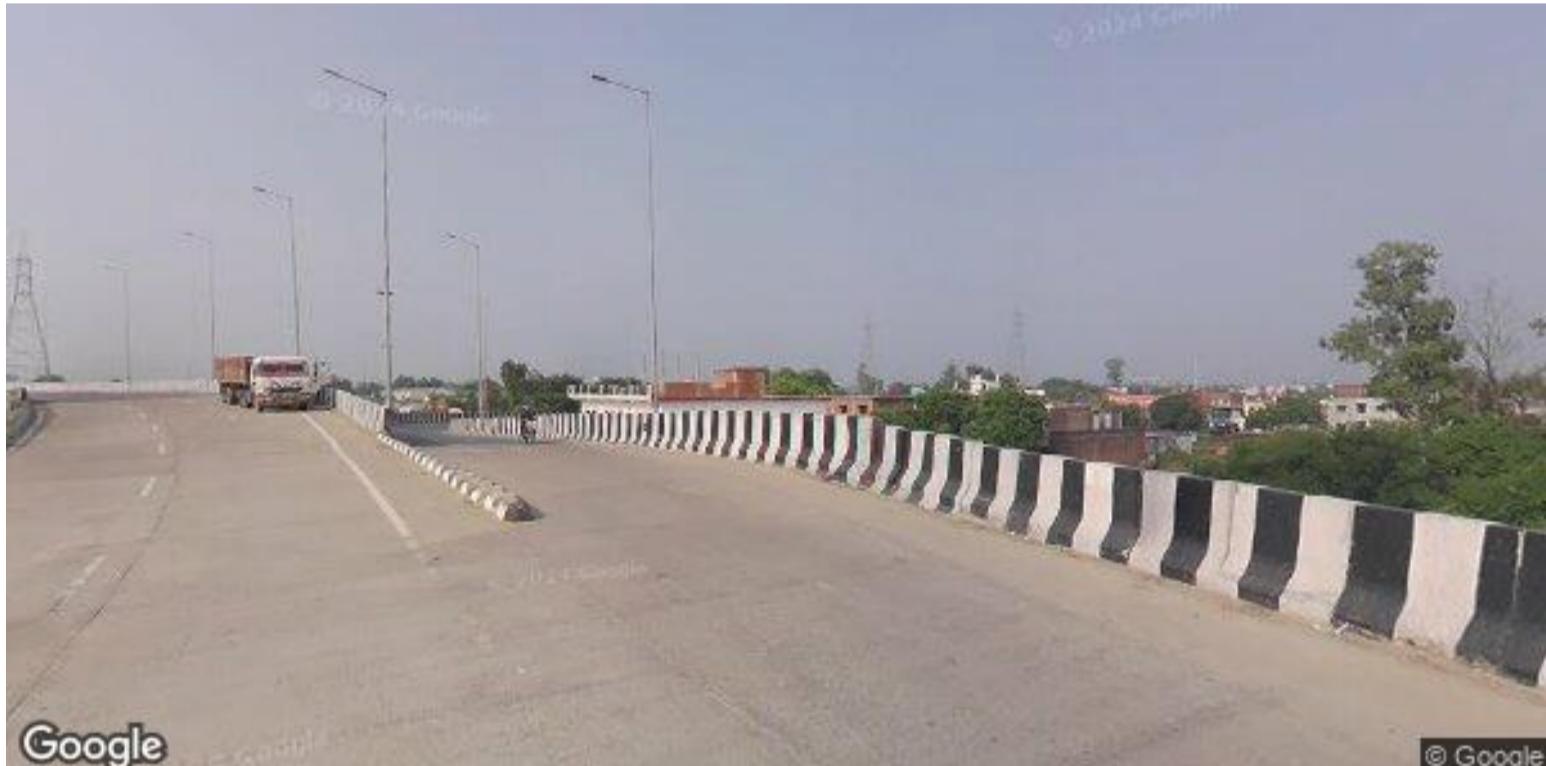
Risk Type: Turn**Risk Level:** High**Speed Limit:** 15 KM/Hr**Distance from Start:** 9.07 km**Coordinates:** 26.74769, 83.25146

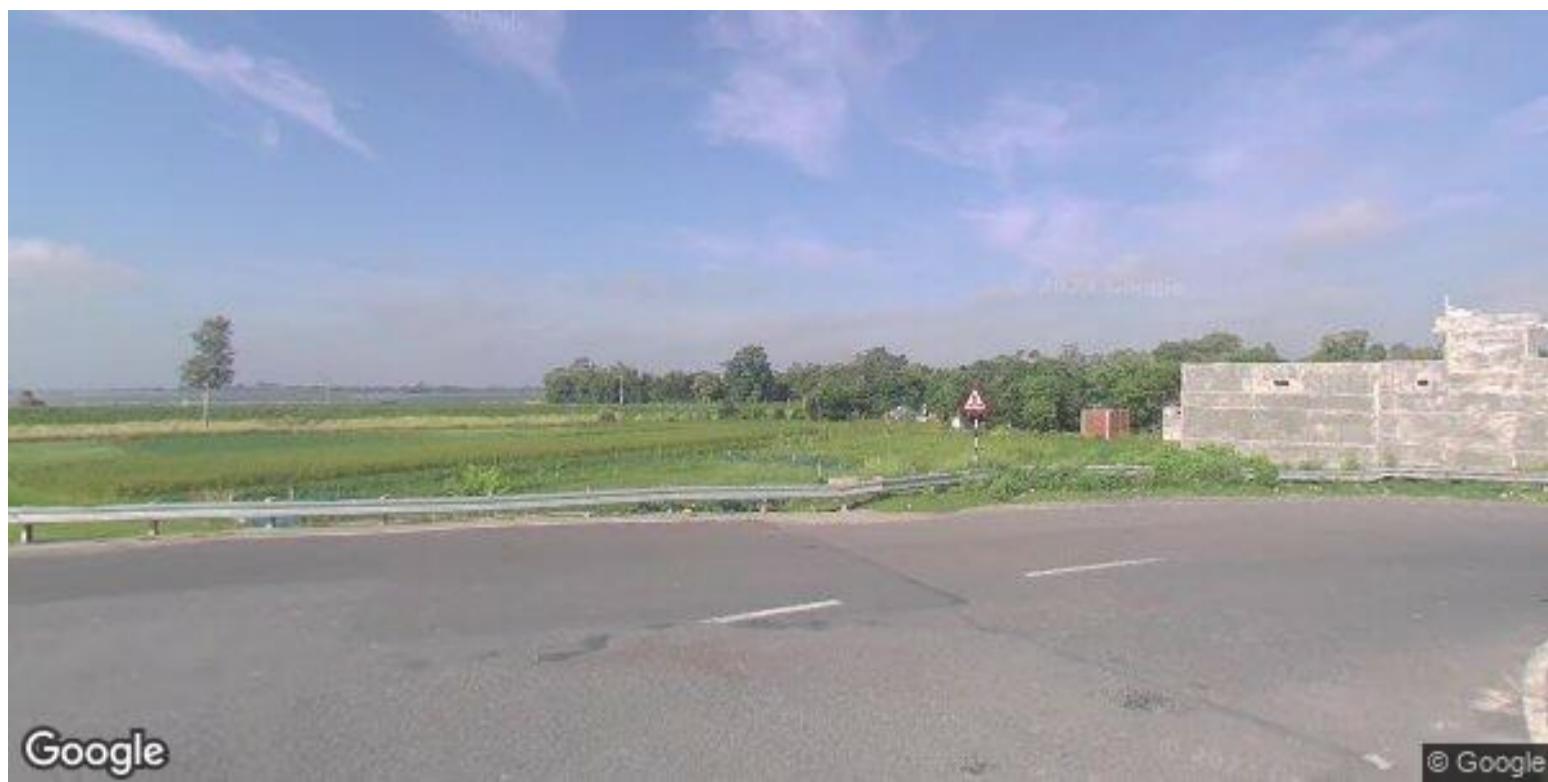
Risk Type: Roundabout

Risk Level: High

Speed Limit: 15 KM/Hr

Distance from Start: 24.88 km

Coordinates: 26.86209, 83.31517
