JOURNEY RISK MANAGEMENT (JRM) STUDY

Gorakhpur LPG BP TO ABHA INDANE SERVICE

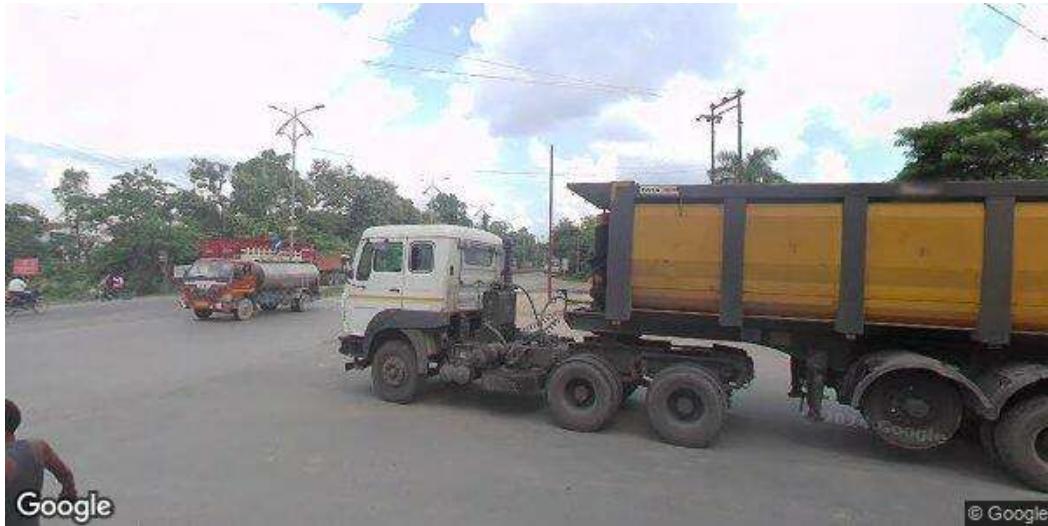
Coordinates: 26.75126, 83.22476

Risk Type: Blind Spot

Risk Level: Blind Spot

Speed Limit: 10 KM/Hr

Distance from Start: 2.16 km

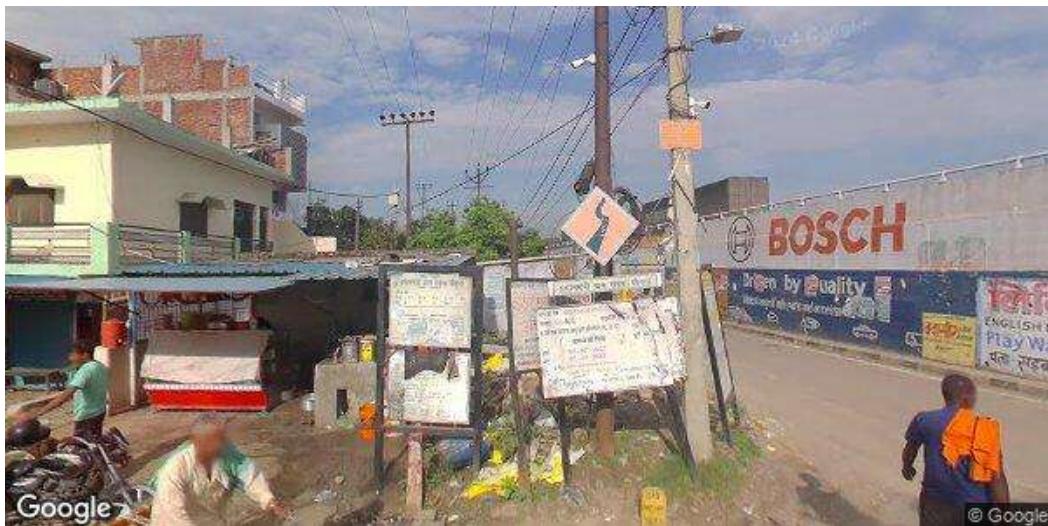
Coordinates: 26.75353, 83.20457

Risk Type: Blind Spot

Risk Level: Blind Spot

Speed Limit: 10 KM/Hr

Distance from Start: 4.22 km

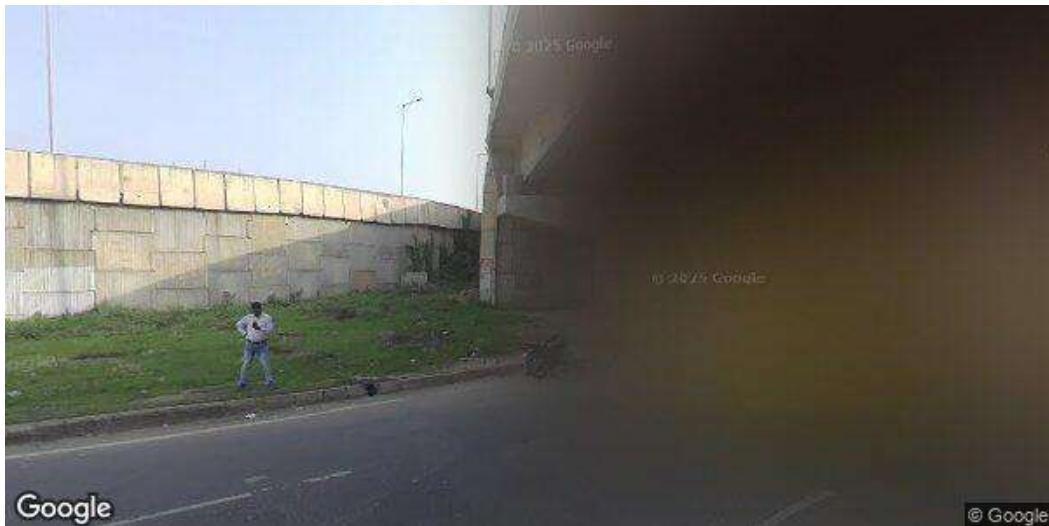
Risk Type: Roundabout**Risk Level:** High**Speed Limit:** 15 KM/Hr**Distance from Start:** 8.13 km**Coordinates:** 26.74681, 83.25111

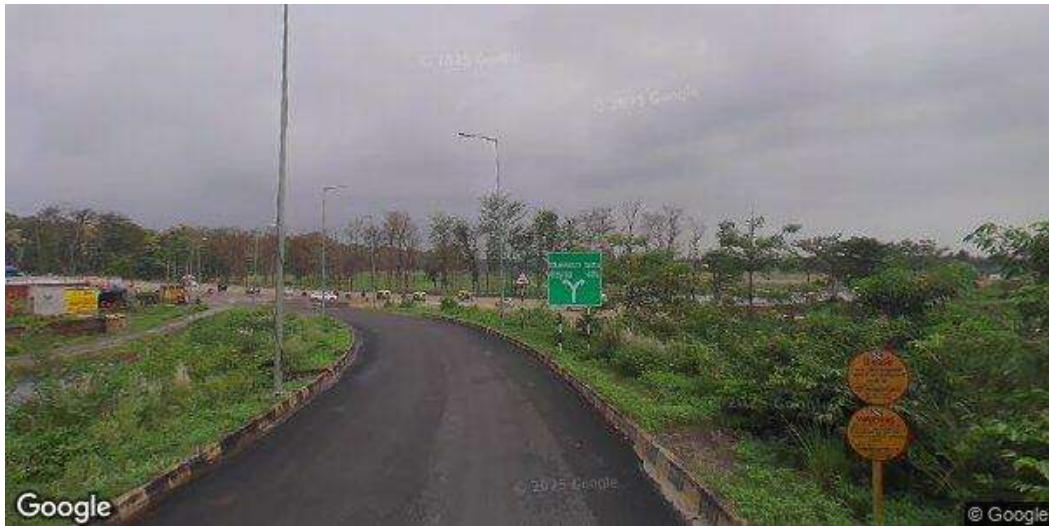
Coordinates: 26.69741, 83.47552

Risk Type: Turn

Risk Level: Medium

Speed Limit: 30 KM/Hr

Distance from Start: 33.24 km

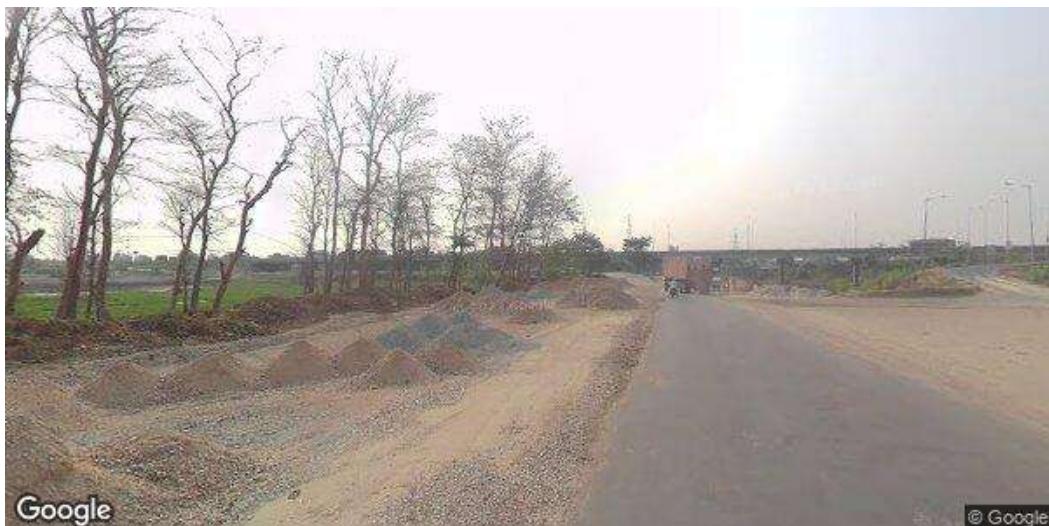
Coordinates: 26.69857, 83.47481

Risk Type: Blind Spot

Risk Level: Blind Spot

Speed Limit: 10 KM/Hr

Distance from Start: 33.41 km

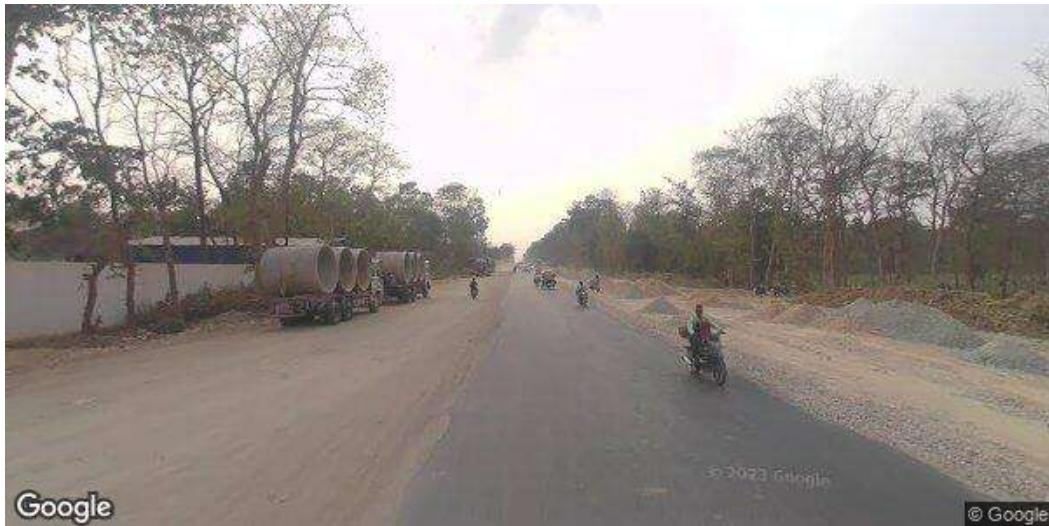
Risk Type: U-Turn**Risk Level:** High**Speed Limit:** 10 KM/Hr**Distance from Start:** 33.41 km**Coordinates:** 26.698439, 83.4747268

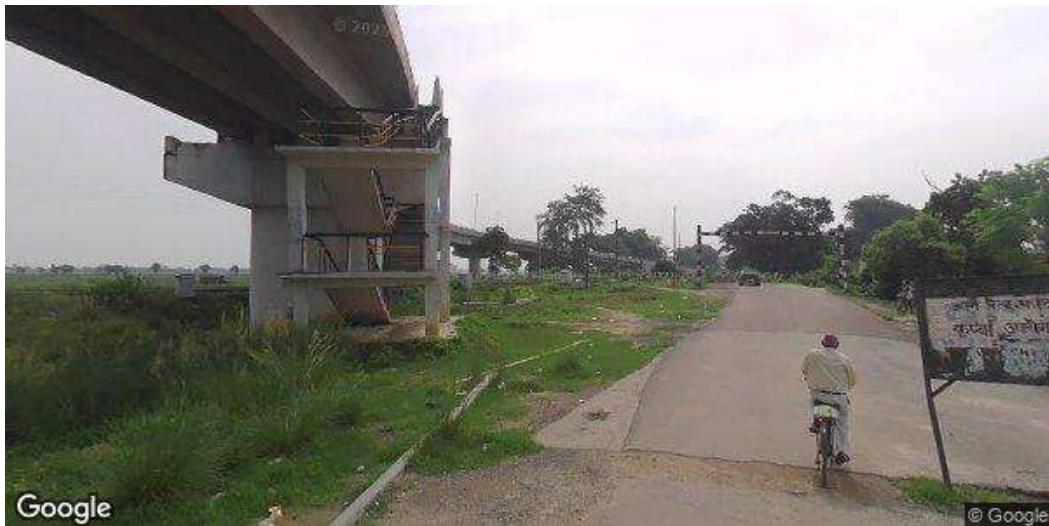
Risk Type: Turn**Risk Level:** Medium**Speed Limit:** 30 KM/Hr**Distance from Start:** 47.38 km**Coordinates:** 26.63752, 83.59723

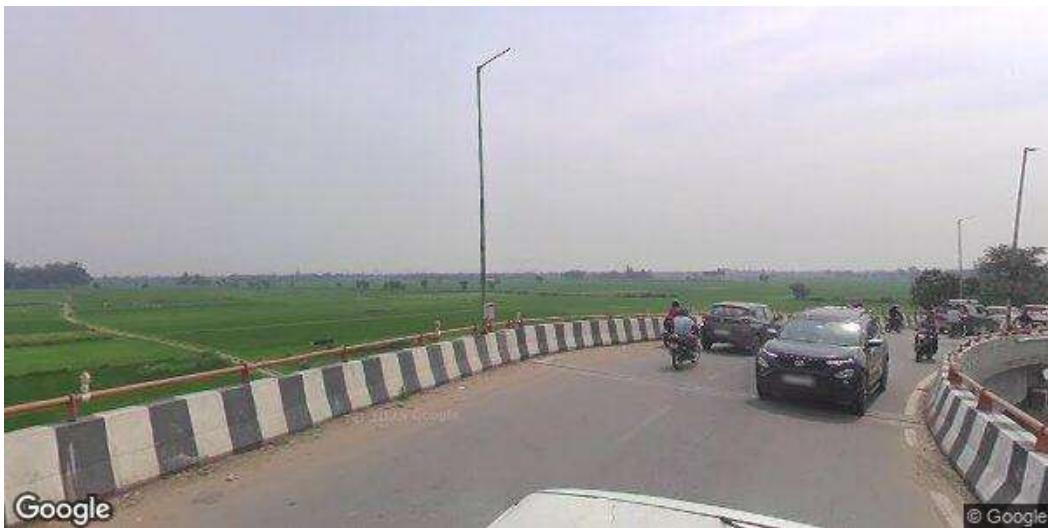
Coordinates: 26.63761, 83.59795

Risk Type: Turn

Risk Level: Medium

Speed Limit: 30 KM/Hr

Distance from Start: 47.44 km

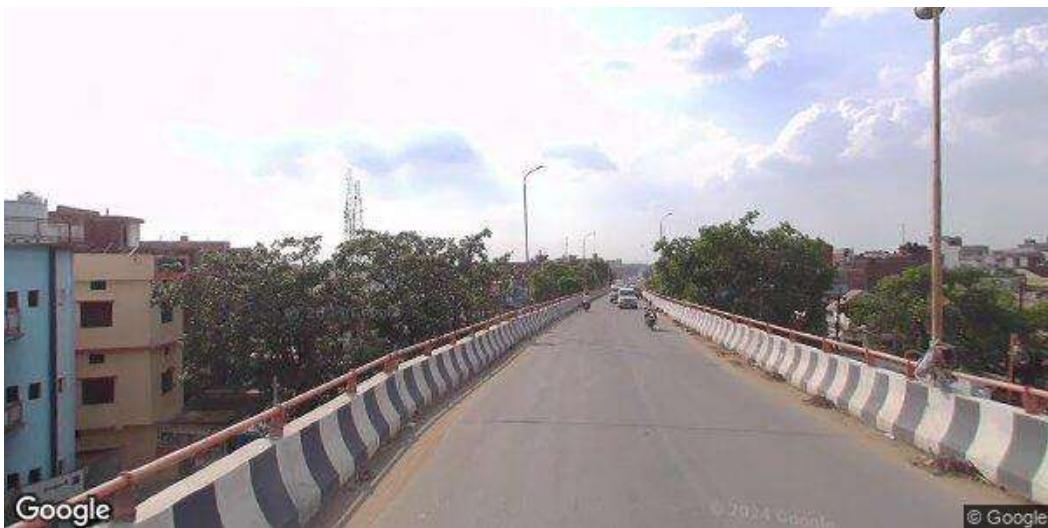
Coordinates: 26.29409, 83.92225

Risk Type: Turn

Risk Level: Medium

Speed Limit: 30 KM/Hr

Distance from Start: 100.10 km

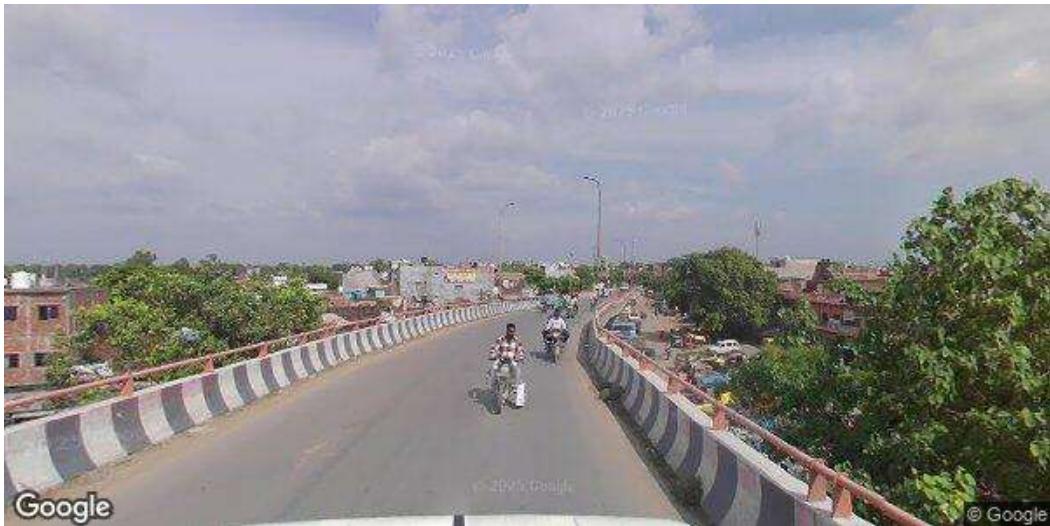
Coordinates: 26.29365, 83.92376

Risk Type: Turn

Risk Level: Medium

Speed Limit: 30 KM/Hr

Distance from Start: 100.35 km

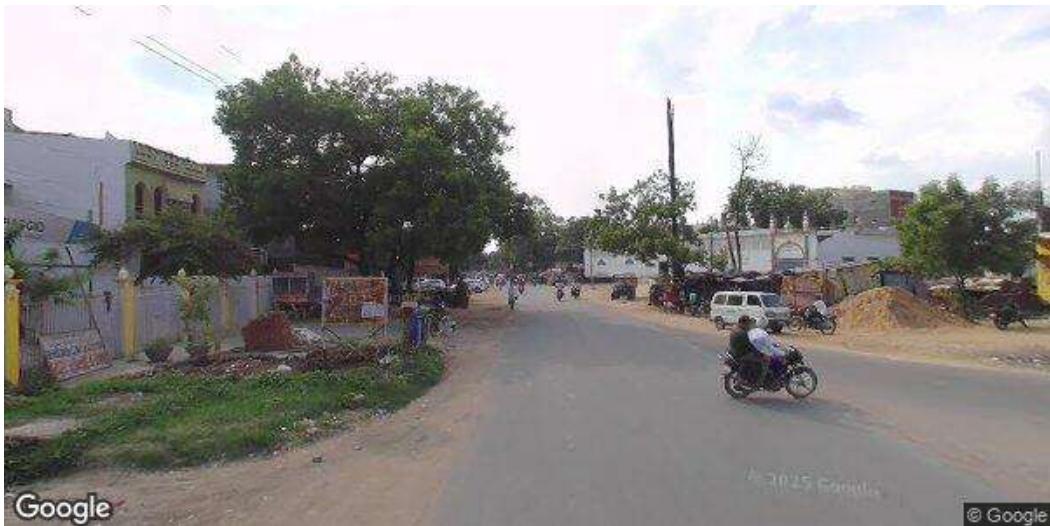
Coordinates: 26.28964, 83.92949

Risk Type: Turn

Risk Level: High

Speed Limit: 15 KM/Hr

Distance from Start: 101.14 km

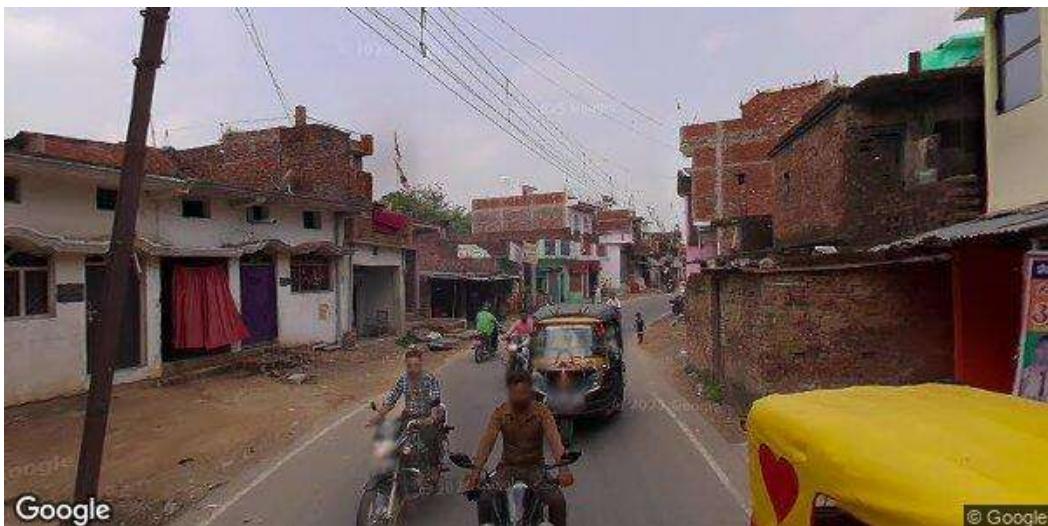
Coordinates: 26.29598, 83.96354

Risk Type: Turn

Risk Level: Medium

Speed Limit: 30 KM/Hr

Distance from Start: 104.97 km

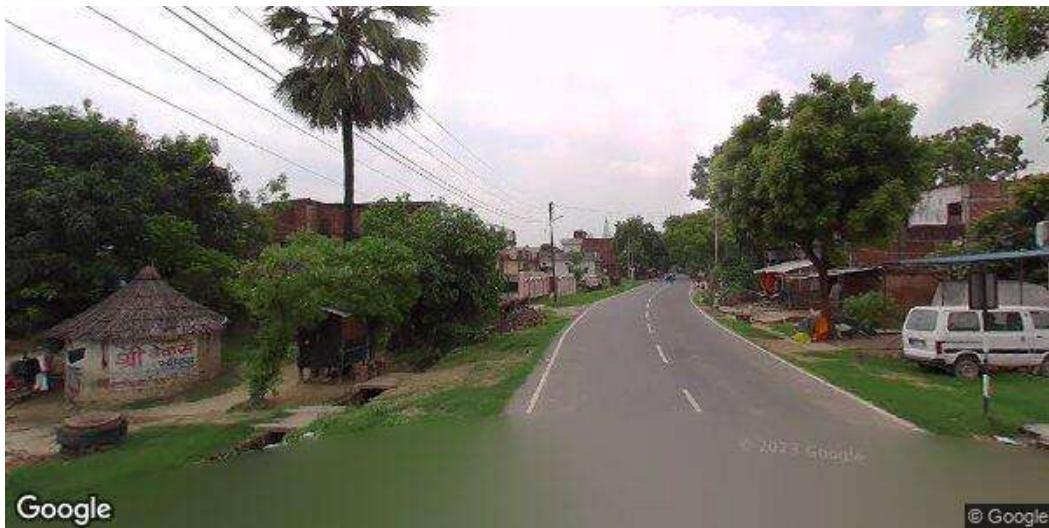
Risk Type: Turn**Risk Level:** Medium**Speed Limit:** 30 KM/Hr**Distance from Start:** 106.12 km**Coordinates:** 26.29648, 83.97616
