JOURNEY RISK MANAGEMENT (JRM) STUDY

Gorakhpur LPG BP TO VINDU INDANE SERVICE

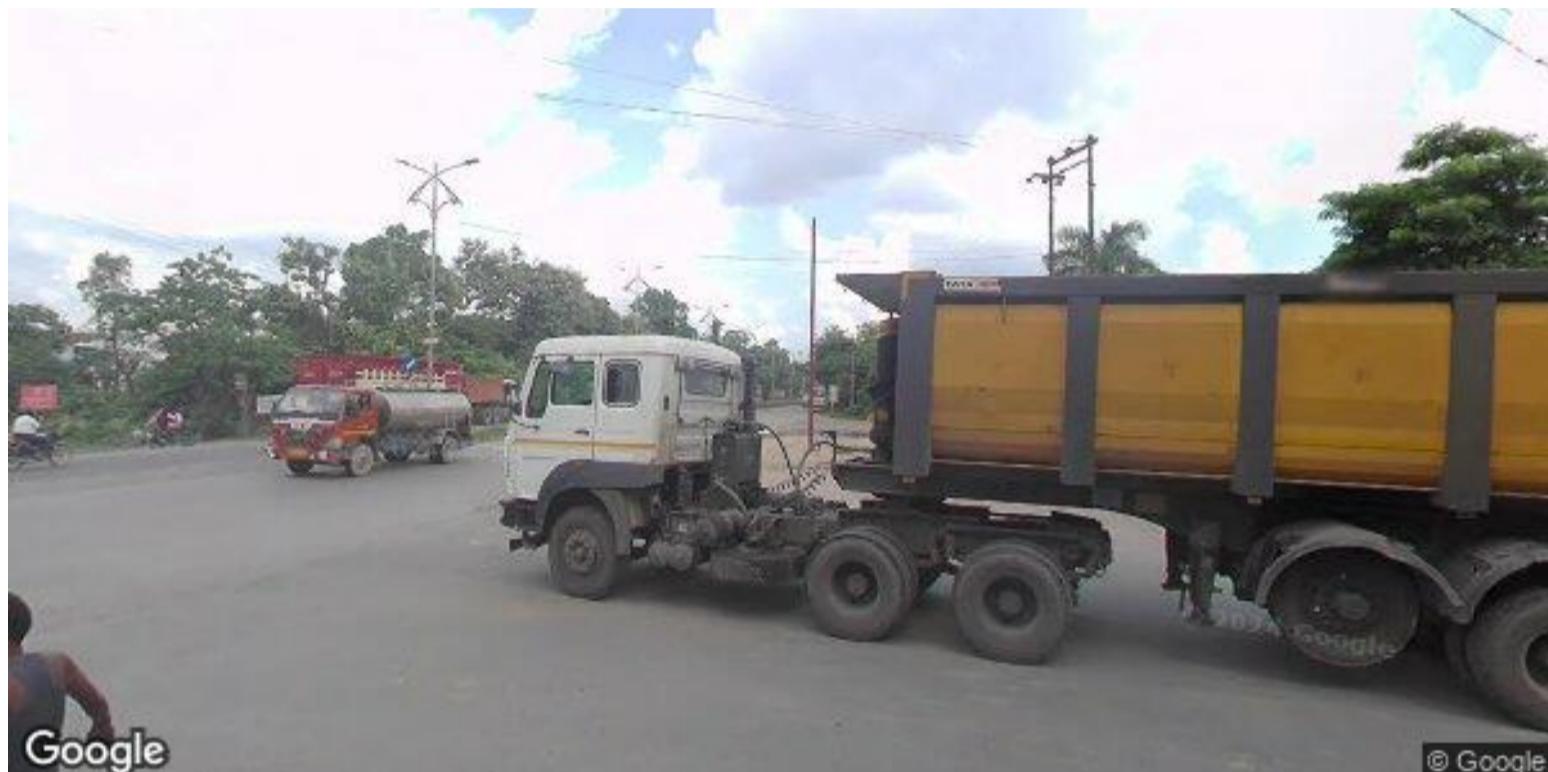
Distance from Start: 2.17 km

Risk Type: Blind Spot

Risk Level: Blind Spot

Speed Limit: 10 KM/Hr

Coordinates: 26.75126, 83.22476

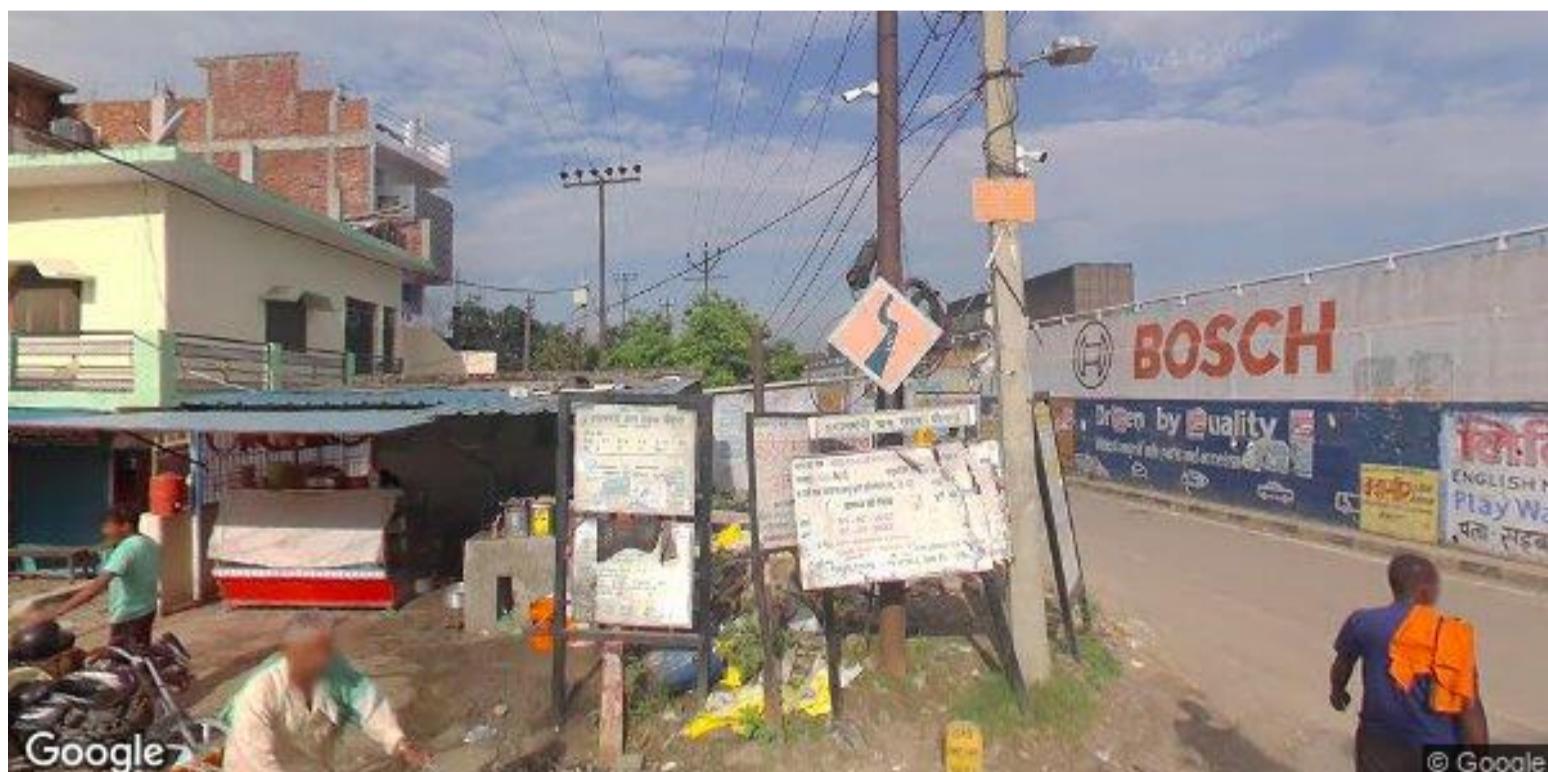
Distance from Start: 4.23 km

Risk Type: Blind Spot

Risk Level: Blind Spot

Speed Limit: 10 KM/Hr

Coordinates: 26.75353, 83.20457

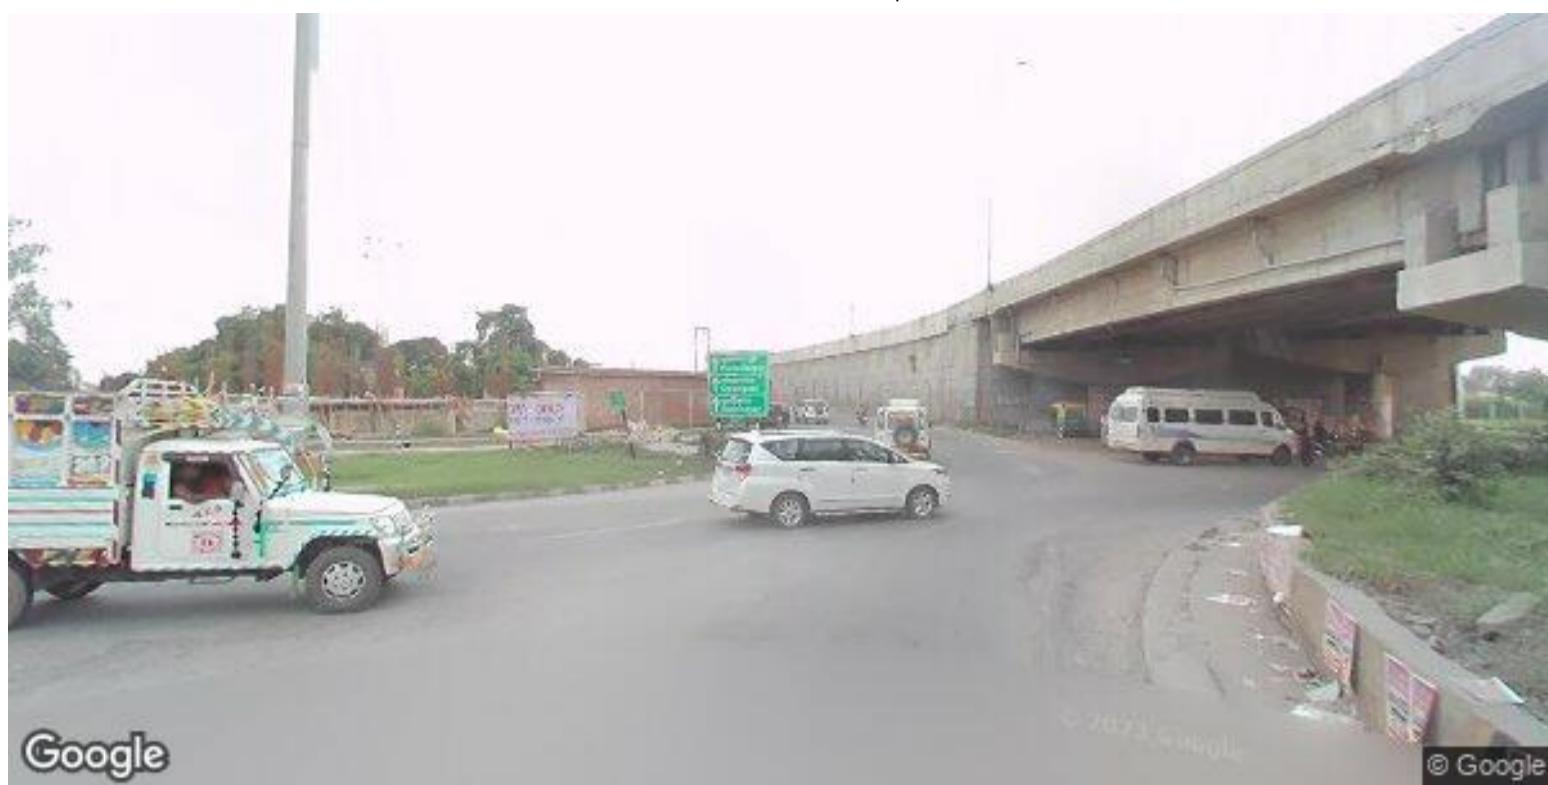
Distance from Start: 9.04 km

Risk Type: Turn

Risk Level: Medium

Speed Limit: 30 KM/Hr

Coordinates: 26.74658, 83.25155

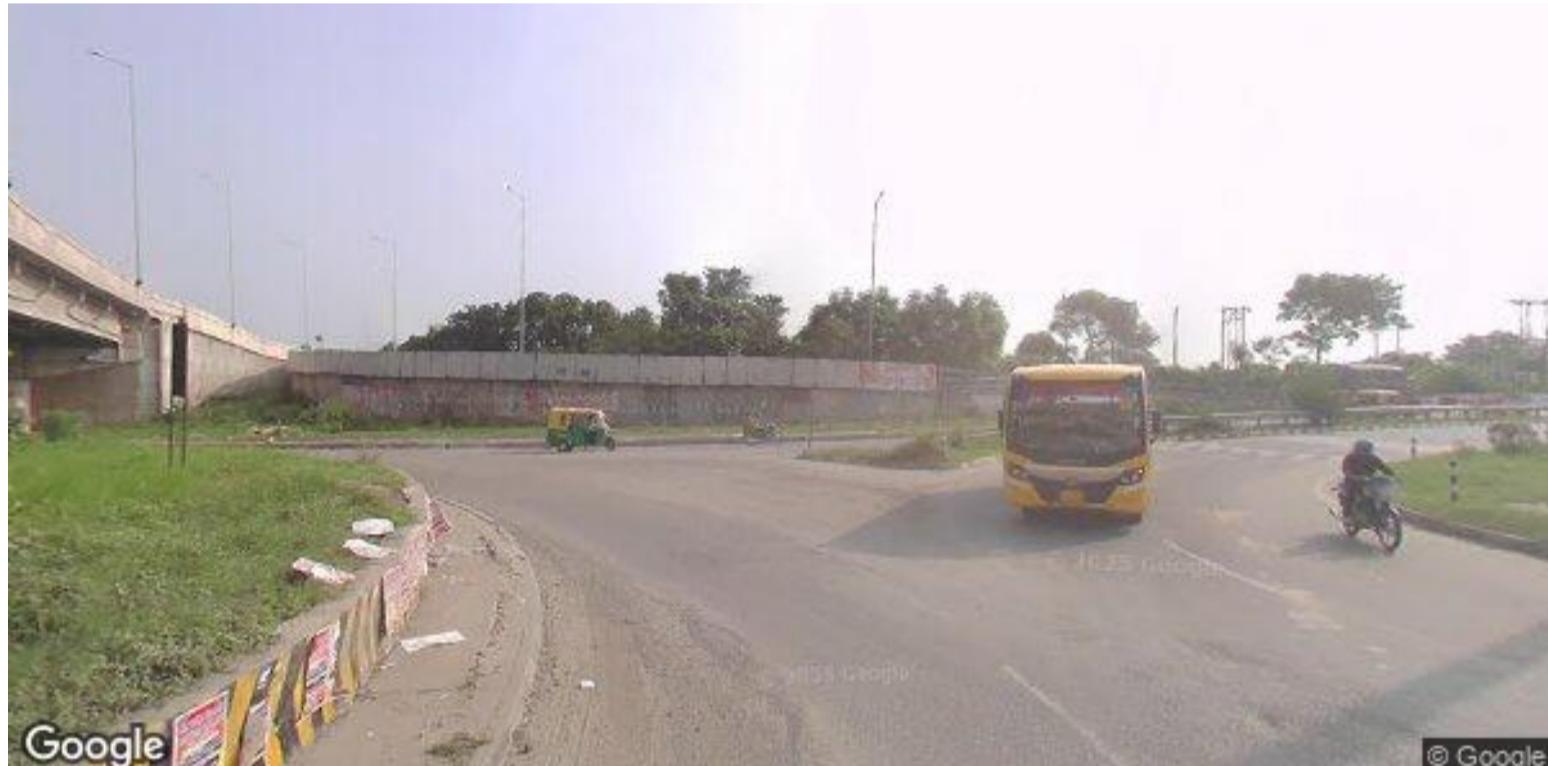
Distance from Start: 9.06 km

Risk Type: Turn

Risk Level: Medium

Speed Limit: 30 KM/Hr

Coordinates: 26.74646, 83.25151

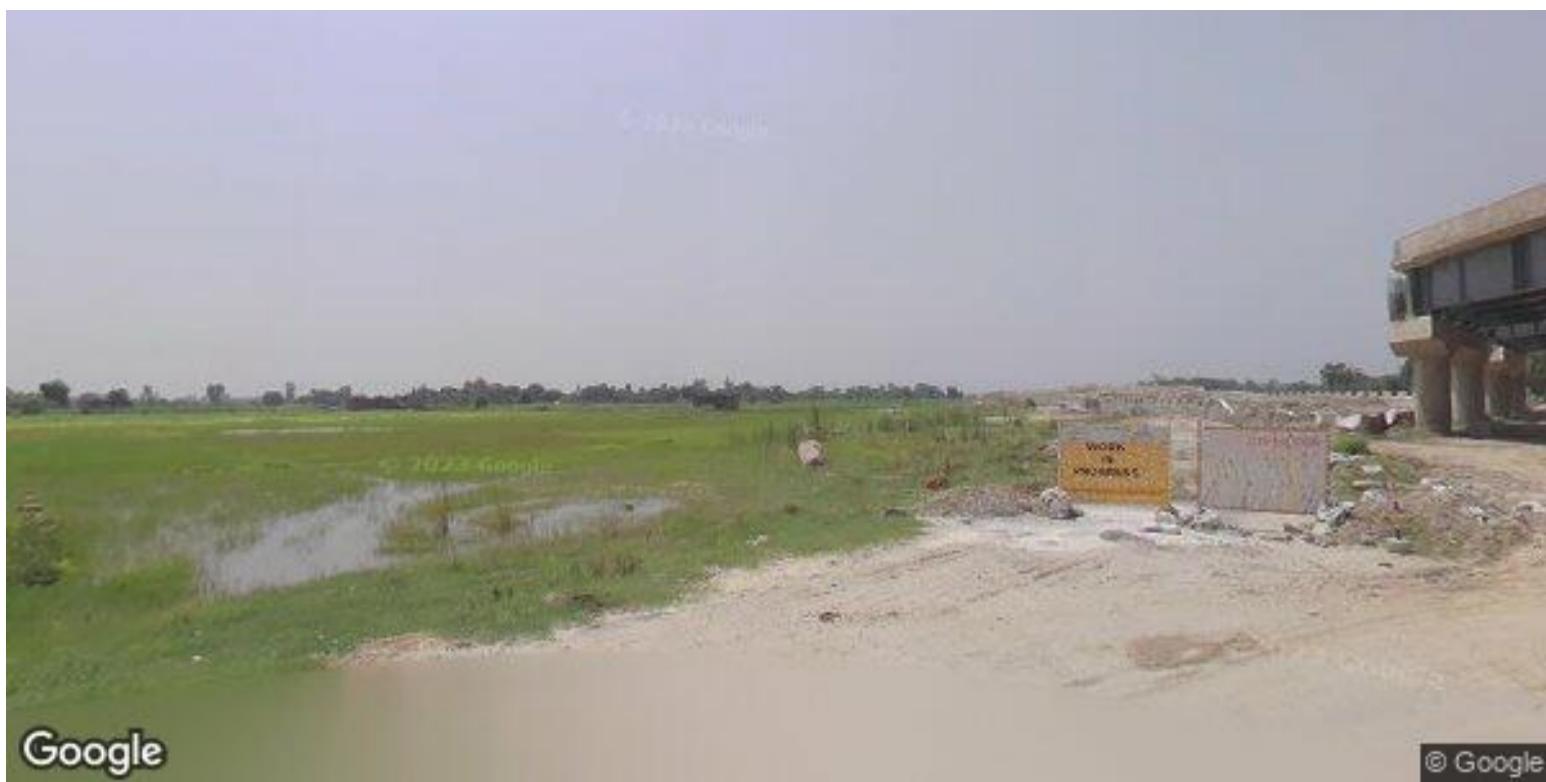
Distance from Start: 51.54 km

Risk Type: Turn

Risk Level: Medium

Speed Limit: 30 KM/Hr

Coordinates: 26.44260, 83.14691

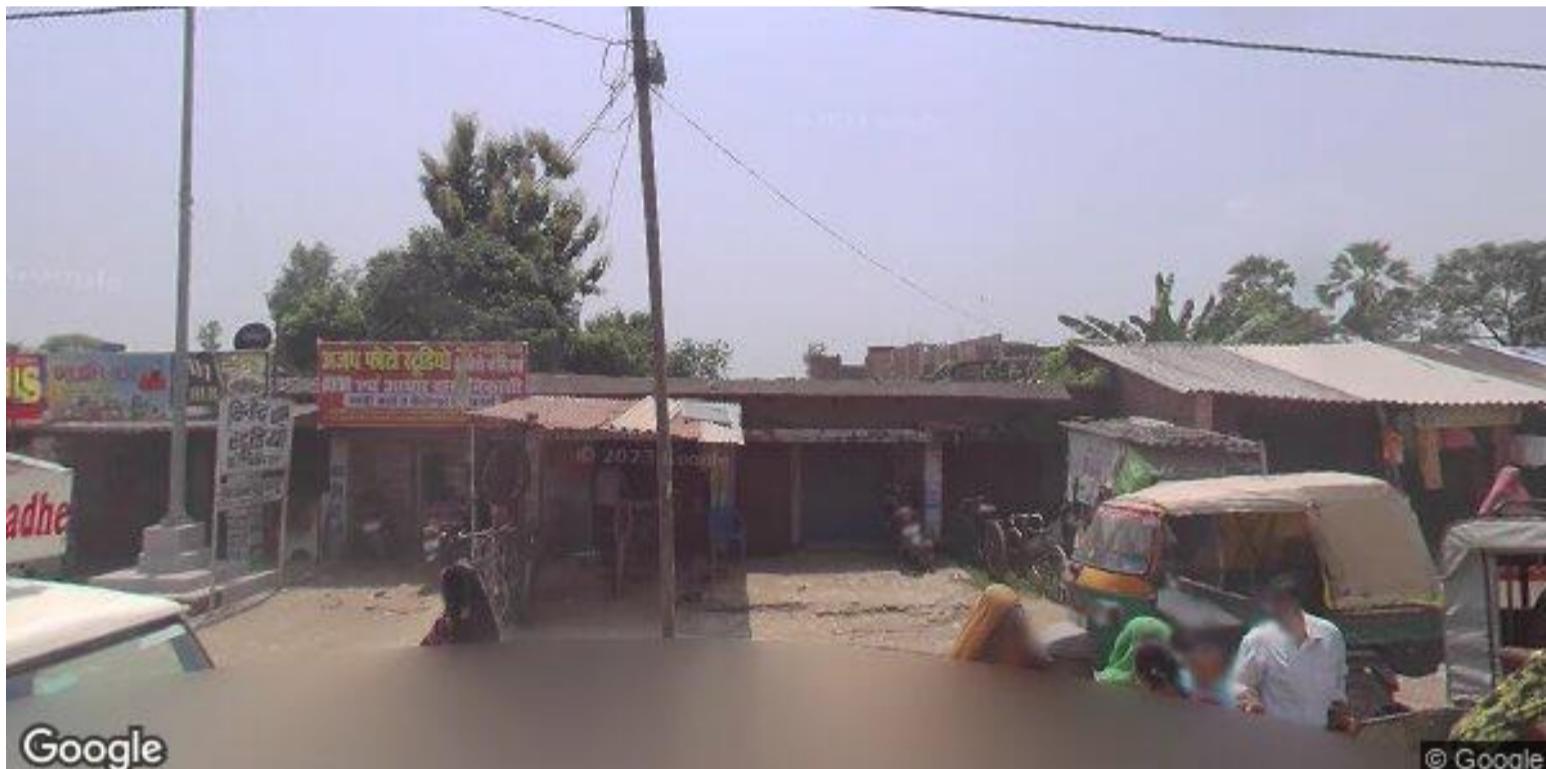
Distance from Start: 55.05 km

Risk Type: Turn

Risk Level: High

Speed Limit: 15 KM/Hr

Coordinates: 26.45770, 83.11679

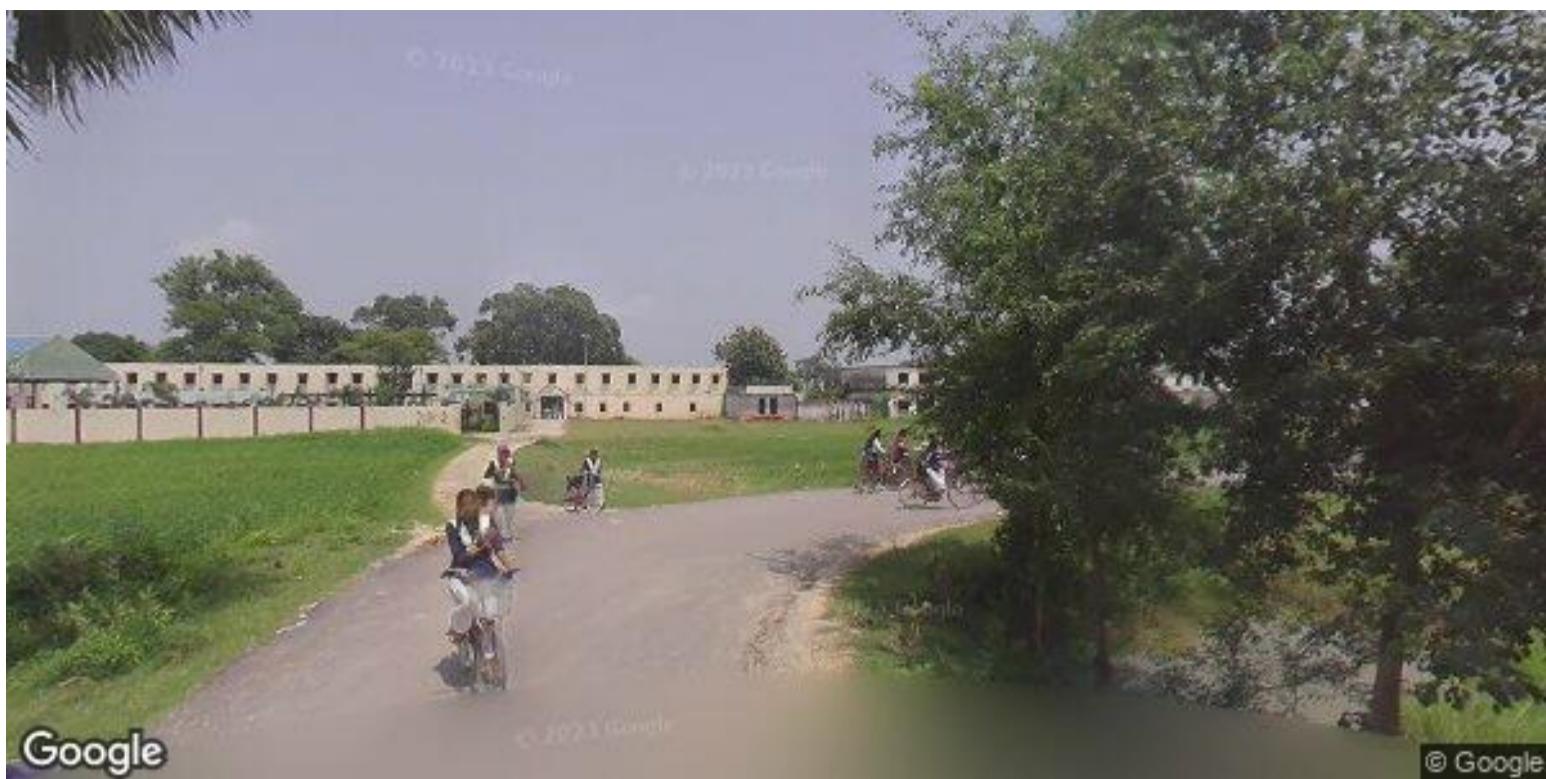
Distance from Start: 56.21 km

Risk Type: Turn

Risk Level: High

Speed Limit: 15 KM/Hr

Coordinates: 26.46684, 83.12259

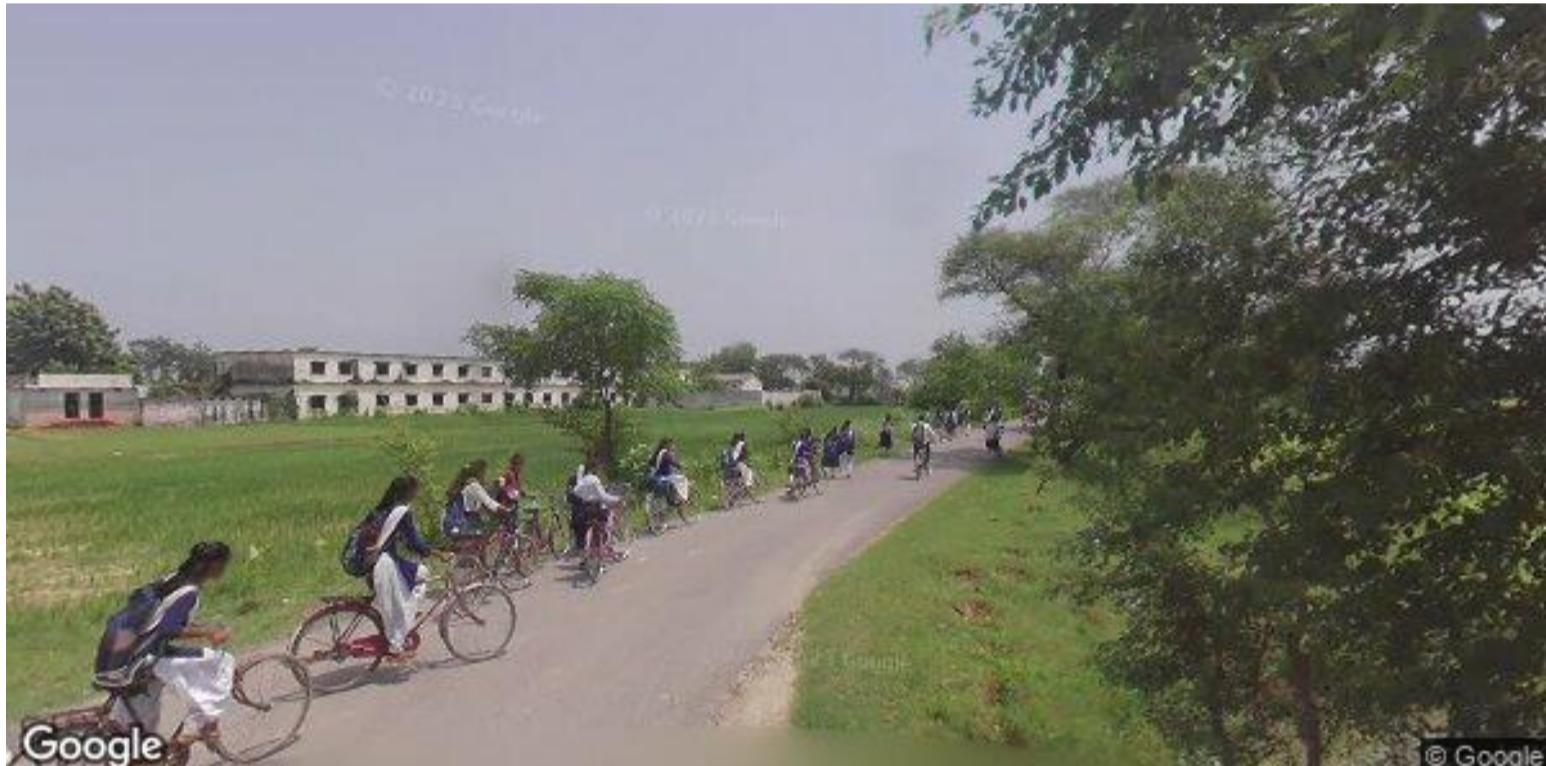
Distance from Start: 56.25 km

Risk Type: Turn

Risk Level: Medium

Speed Limit: 30 KM/Hr

Coordinates: 26.46685, 83.12269
