JOURNEY RISK MANAGEMENT (JRM) STUDY

Gorakhpur LPG BP TO BATRAULI INDANE GRAM

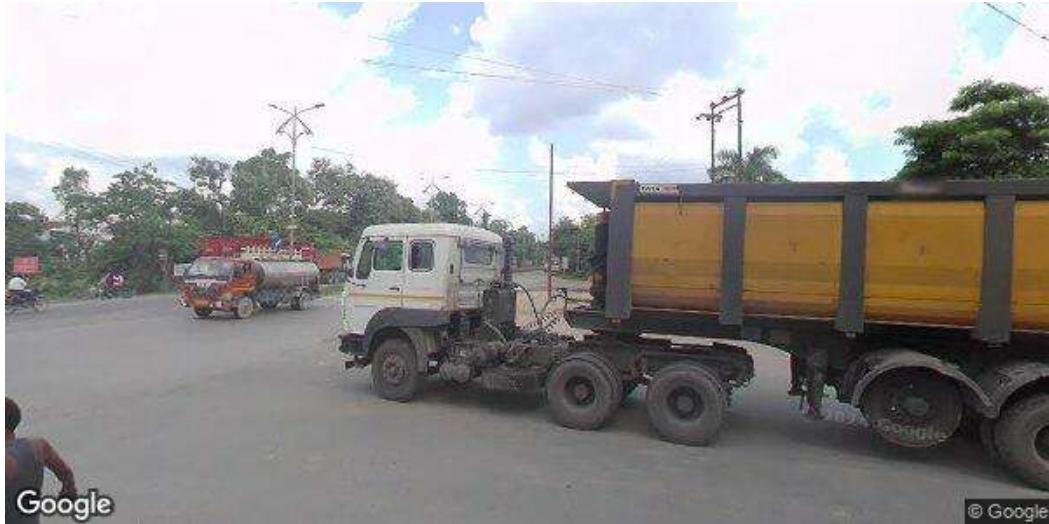
Risk Type: Blind Spot
Risk Level: Blind Spot
Speed Limit: 10 KM/Hr
Distance from Start: 2.17 km
Coordinates: 26.75126, 83.22476

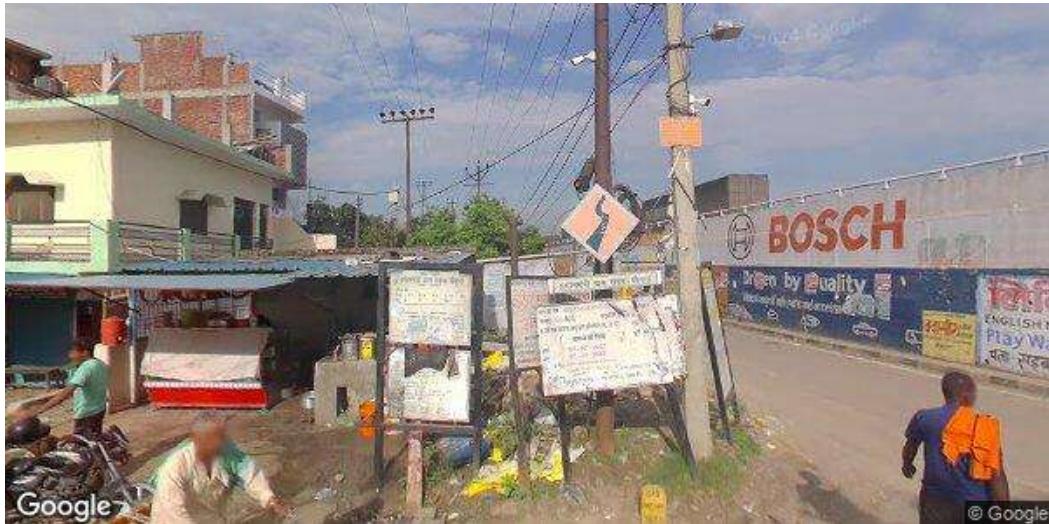
Risk Type: Blind Spot
Risk Level: Blind Spot
Speed Limit: 10 KM/Hr
Distance from Start: 4.23 km
Coordinates: 26.75353, 83.20457

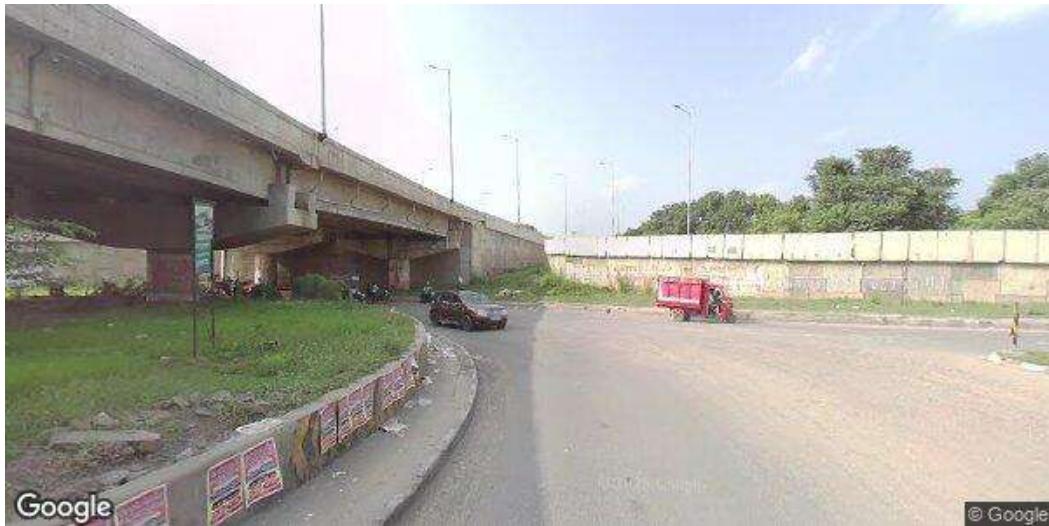
Risk Type: Turn**Risk Level:** Medium**Speed Limit:** 30 KM/Hr**Distance from Start:** 9.04 km**Coordinates:** 26.74656, 83.25154

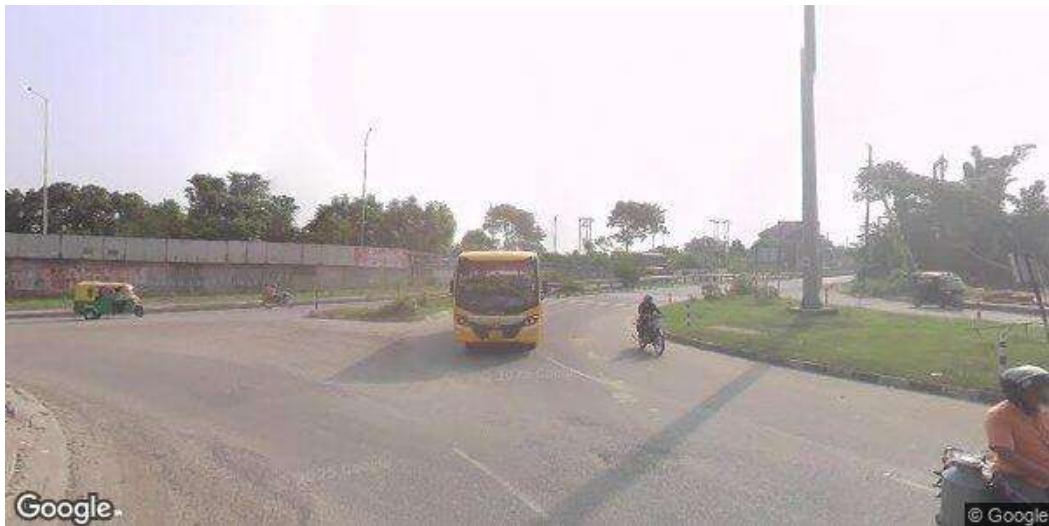
Risk Type: Turn**Risk Level:** Medium**Speed Limit:** 30 KM/Hr**Distance from Start:** 9.07 km**Coordinates:** 26.74644, 83.25150

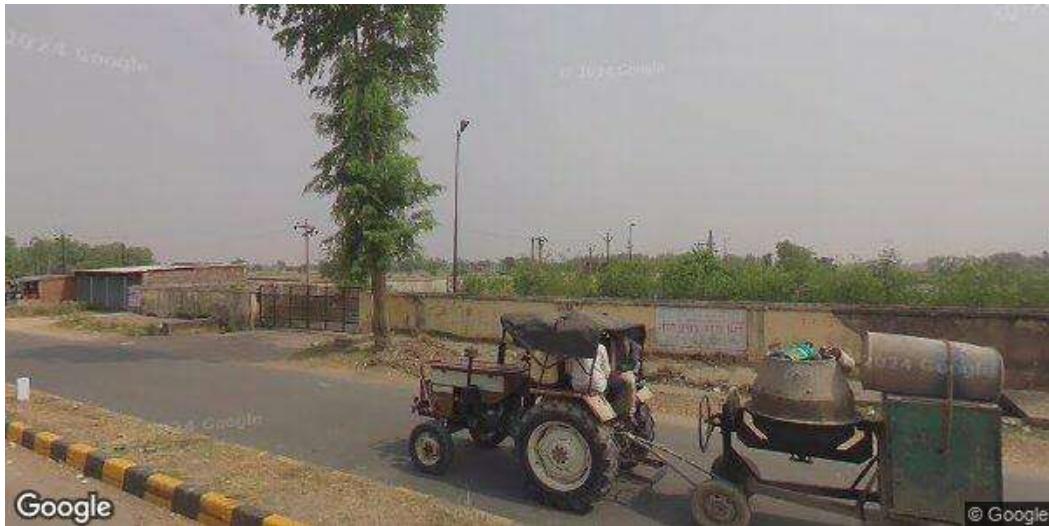
Risk Type: Turn

Risk Level: Medium

Speed Limit: 30 KM/Hr

Distance from Start: 41.17 km

Coordinates: 26.74526, 83.53161

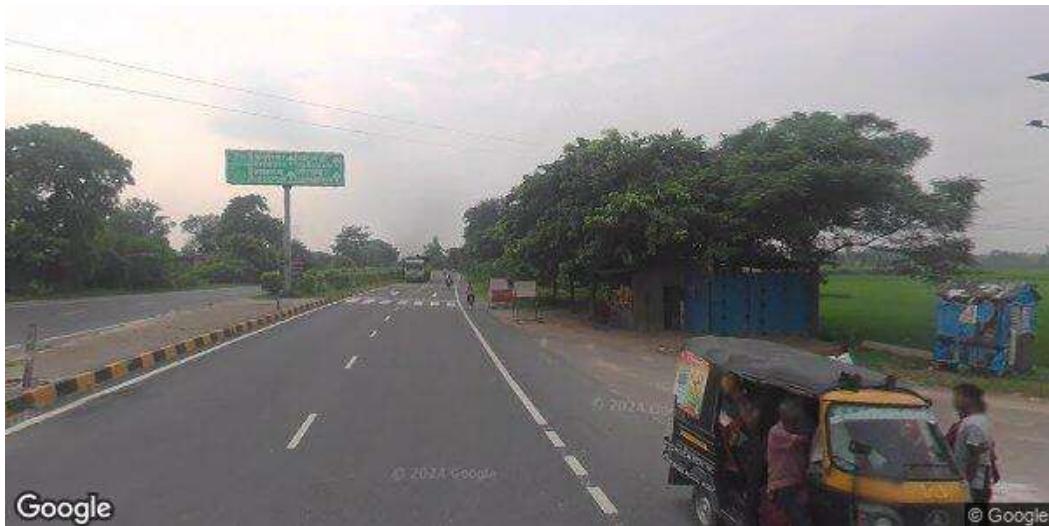
Risk Type: Turn

Risk Level: High

Speed Limit: 15 KM/Hr

Distance from Start: 68.81 km

Coordinates: 26.73410, 83.80421

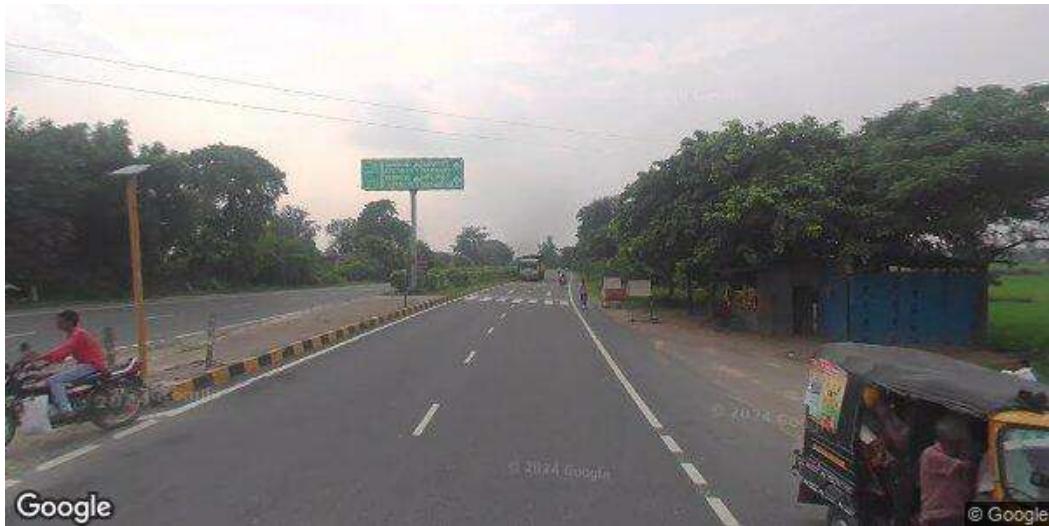
Risk Type: U-Turn

Risk Level: High

Speed Limit: 10 KM/Hr

Distance from Start: 68.81 km

Coordinates: 26.7340985, 83.8042062

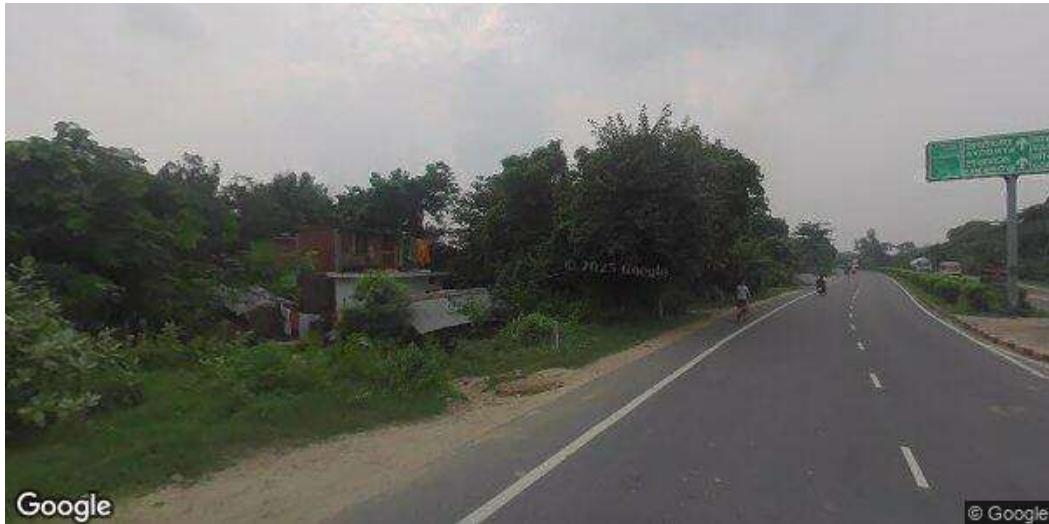
Risk Type: Blind Spot

Risk Level: Blind Spot

Speed Limit: 10 KM/Hr

Distance from Start: 68.85 km

Coordinates: 26.73396, 83.80420

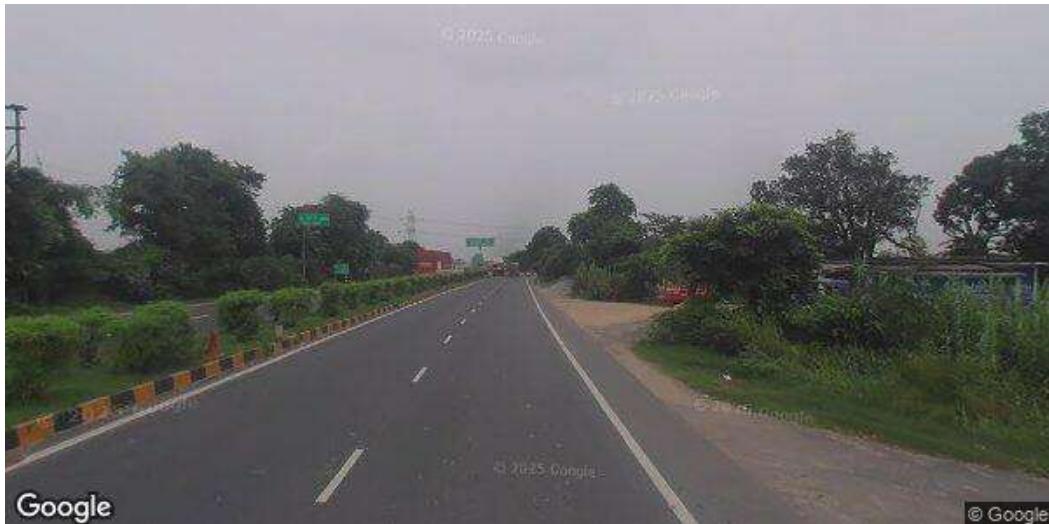
Risk Type: Turn**Risk Level: High****Speed Limit: 15 KM/Hr****Distance from Start: 68.95 km****Coordinates: 26.73411, 83.80277**
