IndianOil

JOURNEY RISK MANAGEMENT (JRM) STUDY

Gorakhpur LPG BP to ADARSH INDANE GRAMIN VITRAK

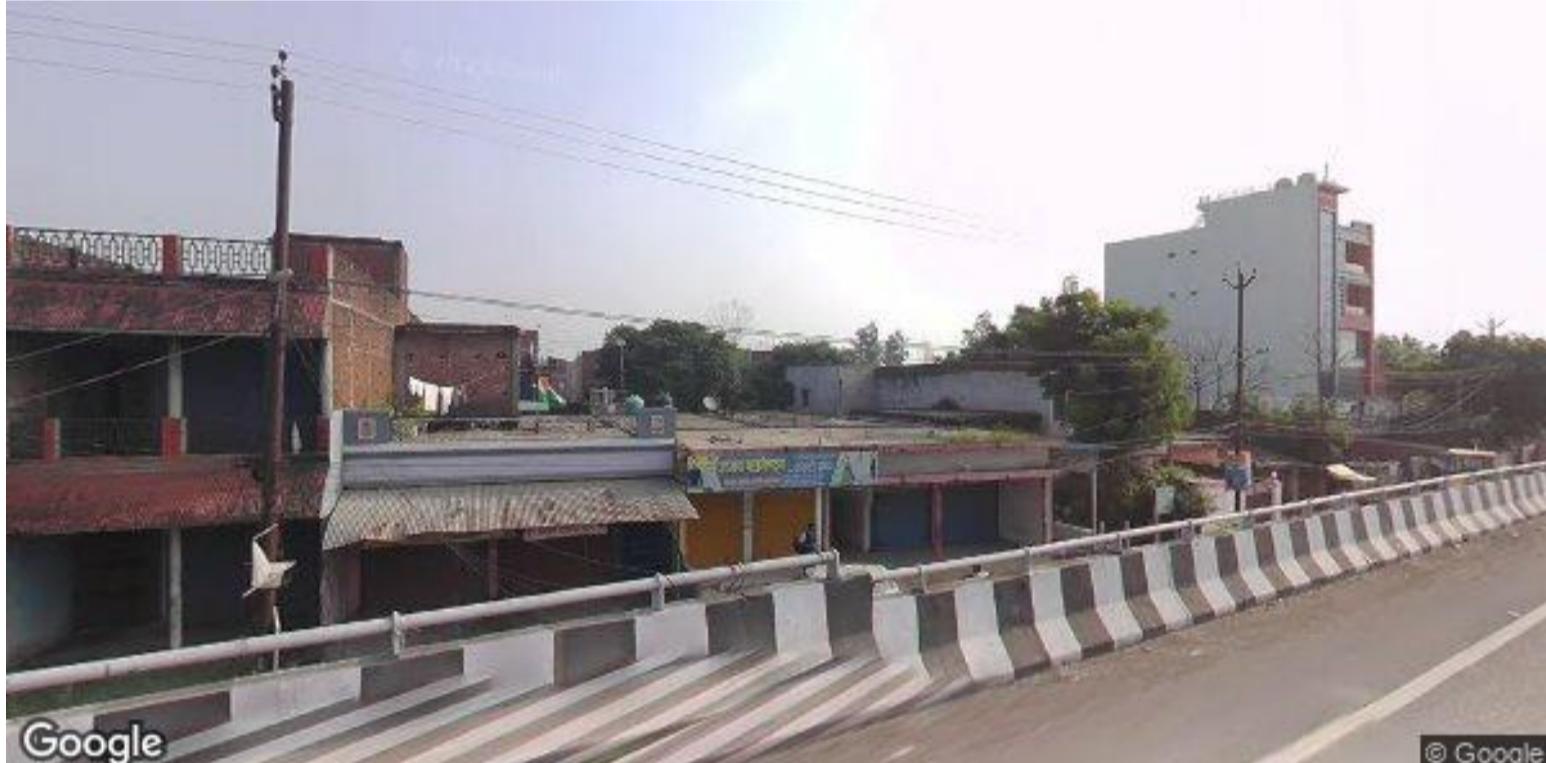
Coordinates: 26.75377, 83.20465

Risk Type: Turn

Risk Level: High

Speed Limit: 15 KM/Hr

Distance from Start: 4.27 km

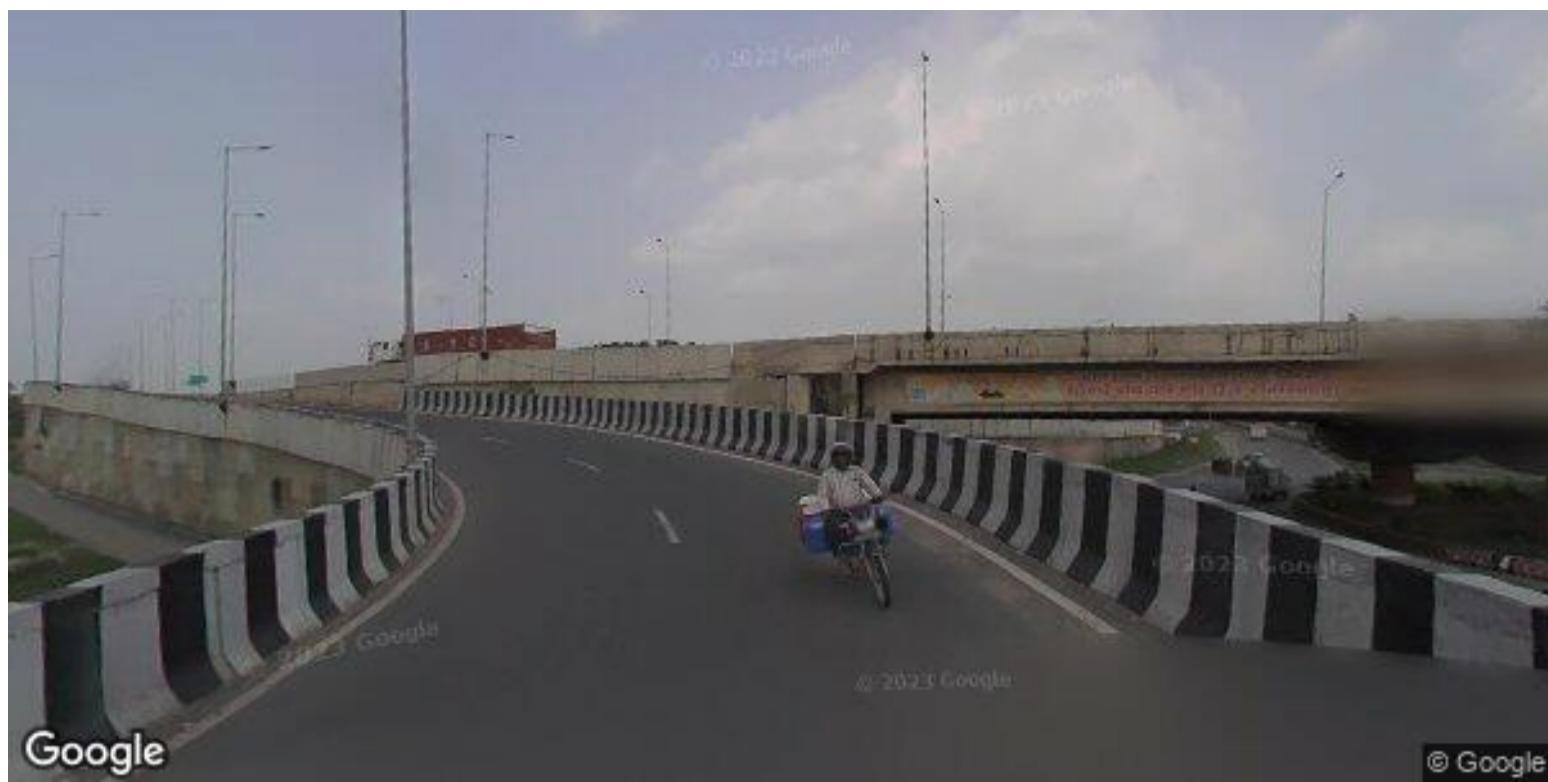
Coordinates: 26.74700, 83.25085

Risk Type: Turn

Risk Level: Medium

Speed Limit: 30 KM/Hr

Distance from Start: 8.90 km

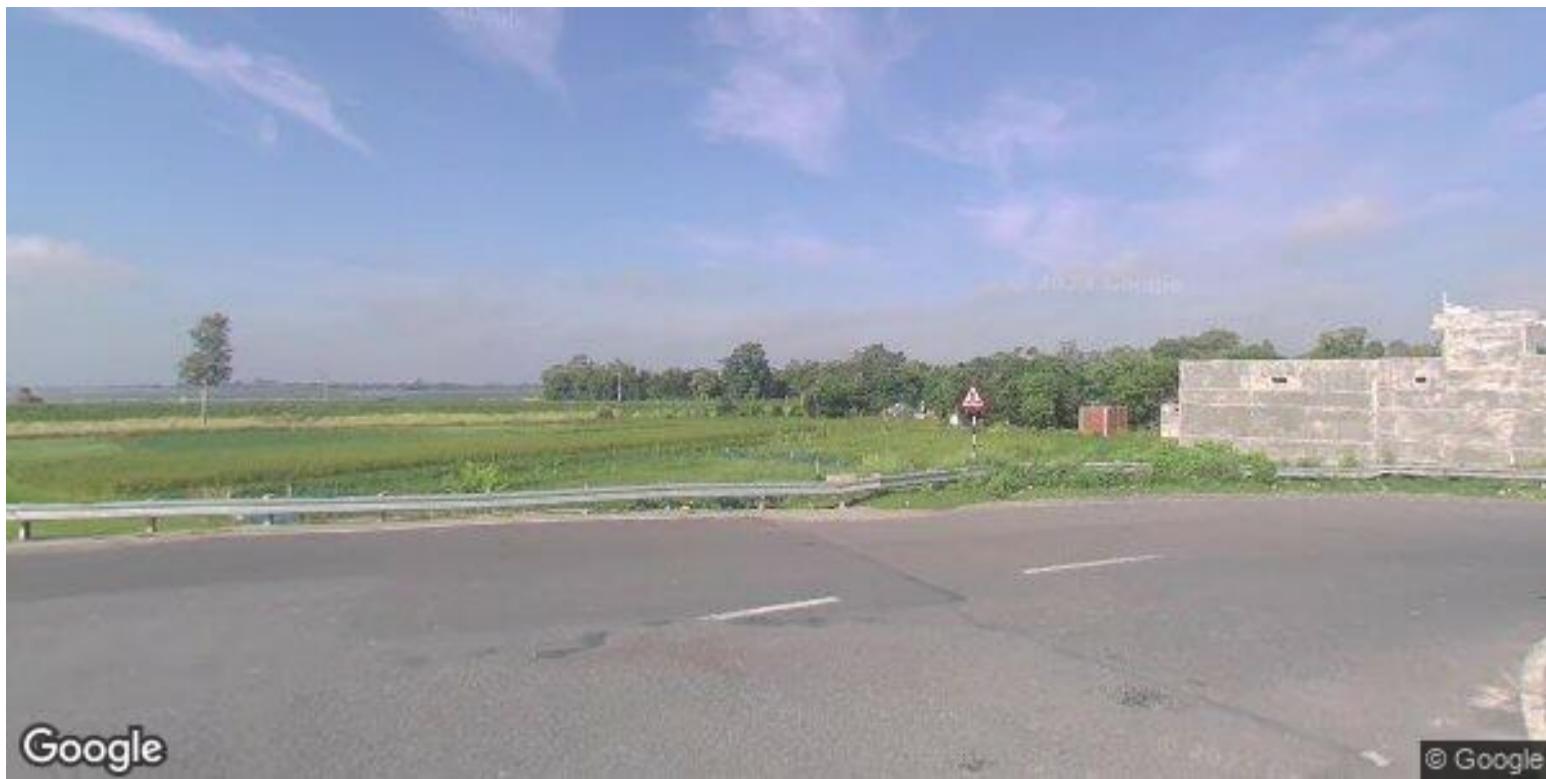
Coordinates: 26.86209, 83.31517

Risk Type: Roundabout

Risk Level: High

Speed Limit: 15 KM/Hr

Distance from Start: 24.85 km

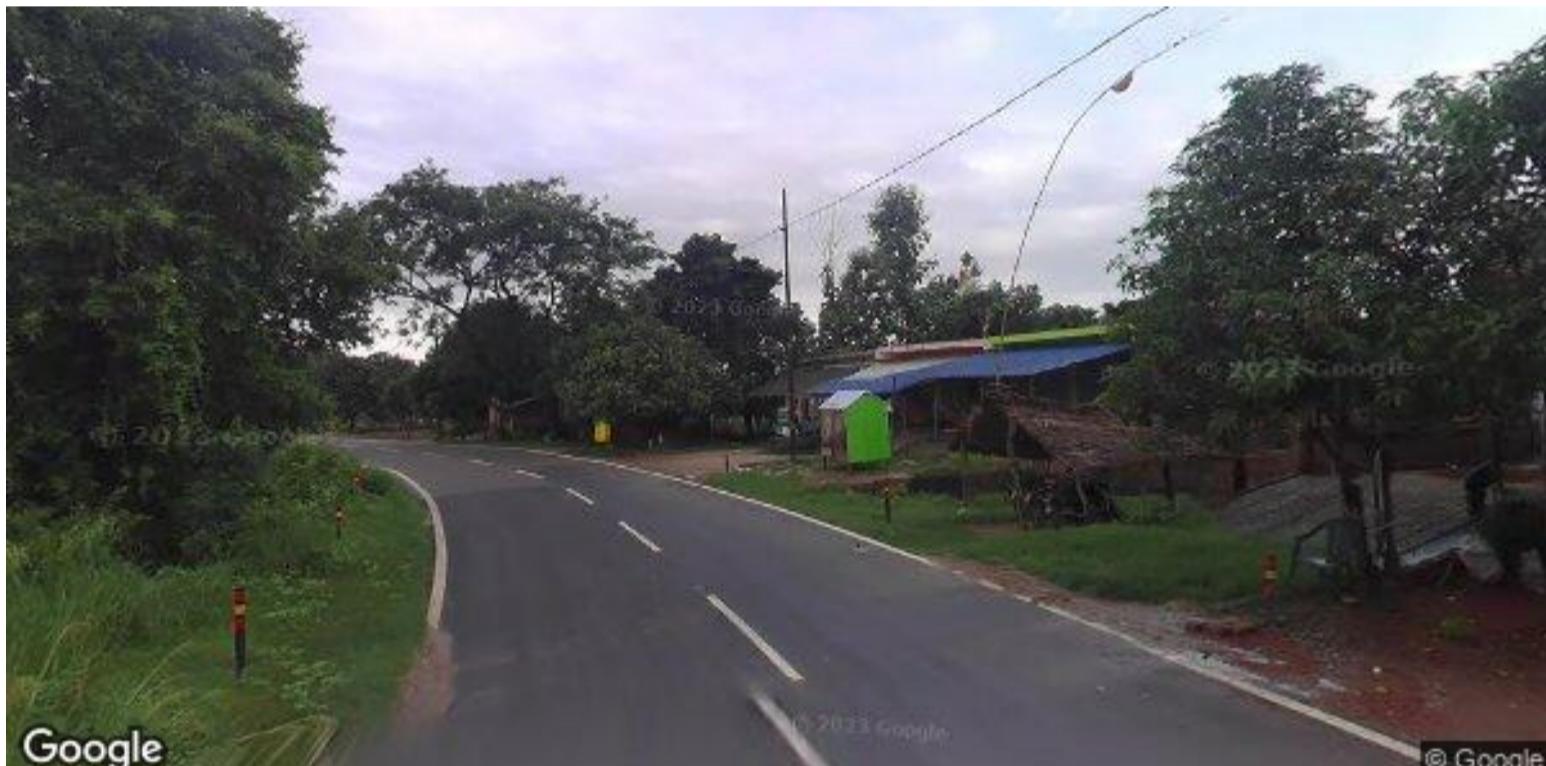
Coordinates: 27.17074, 83.26442

Risk Type: Turn

Risk Level: Medium

Speed Limit: 30 KM/Hr

Distance from Start: 60.69 km

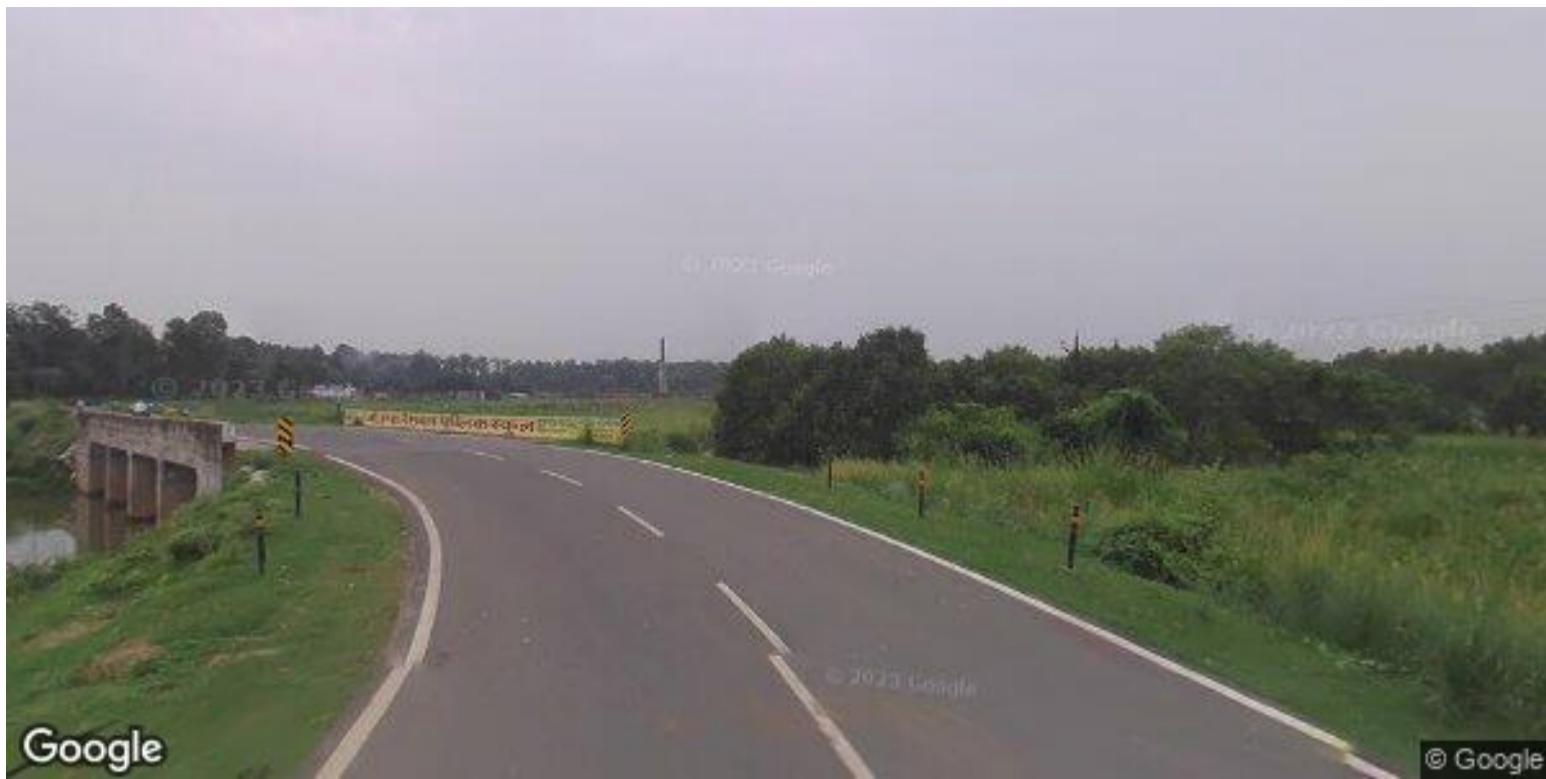
Coordinates: 27.18920, 83.25991

Risk Type: Turn

Risk Level: Medium

Speed Limit: 30 KM/Hr

Distance from Start: 62.96 km

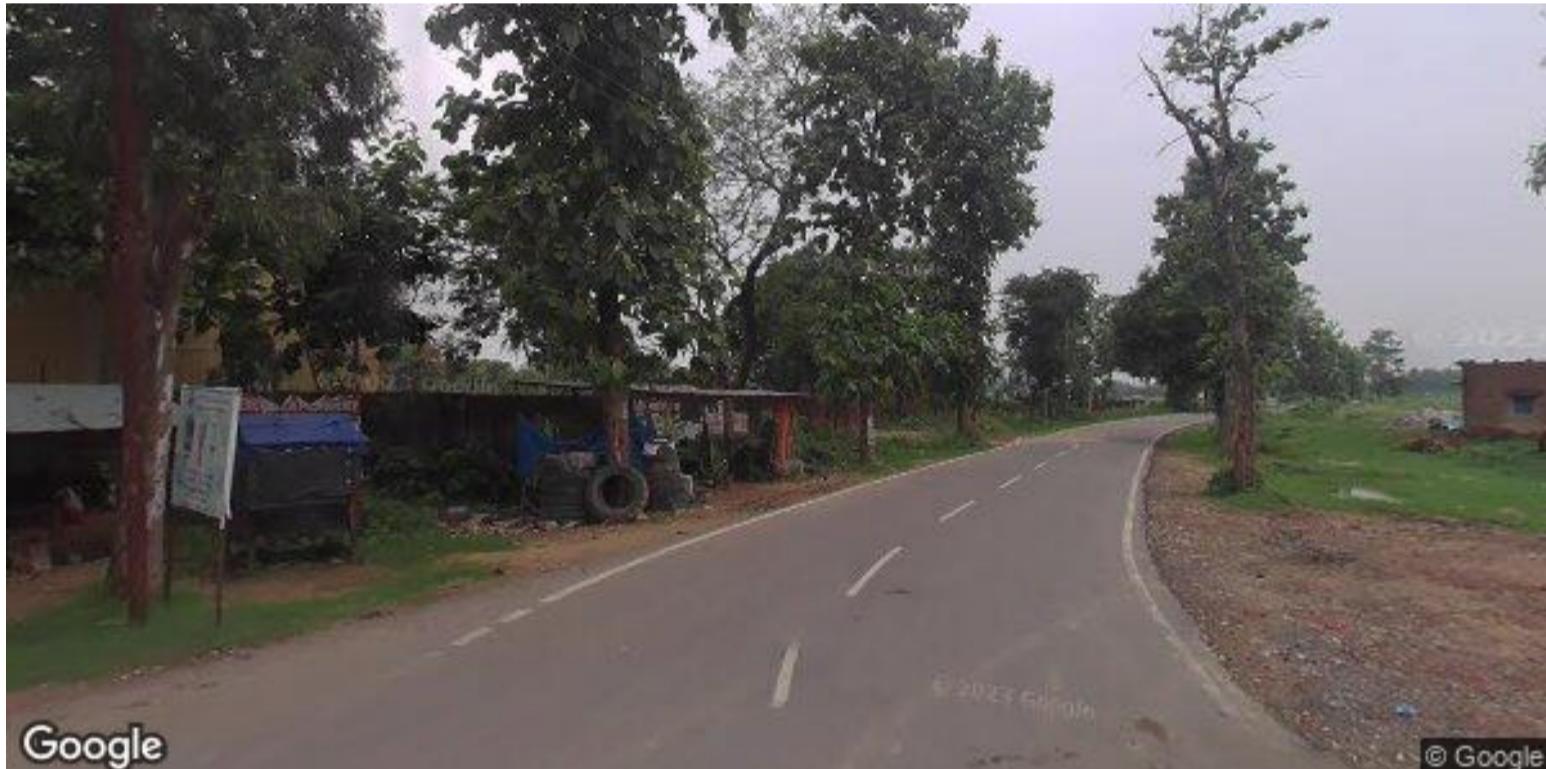
Coordinates: 27.19319, 83.25903

Risk Type: Turn

Risk Level: High

Speed Limit: 15 KM/Hr

Distance from Start: 63.41 km

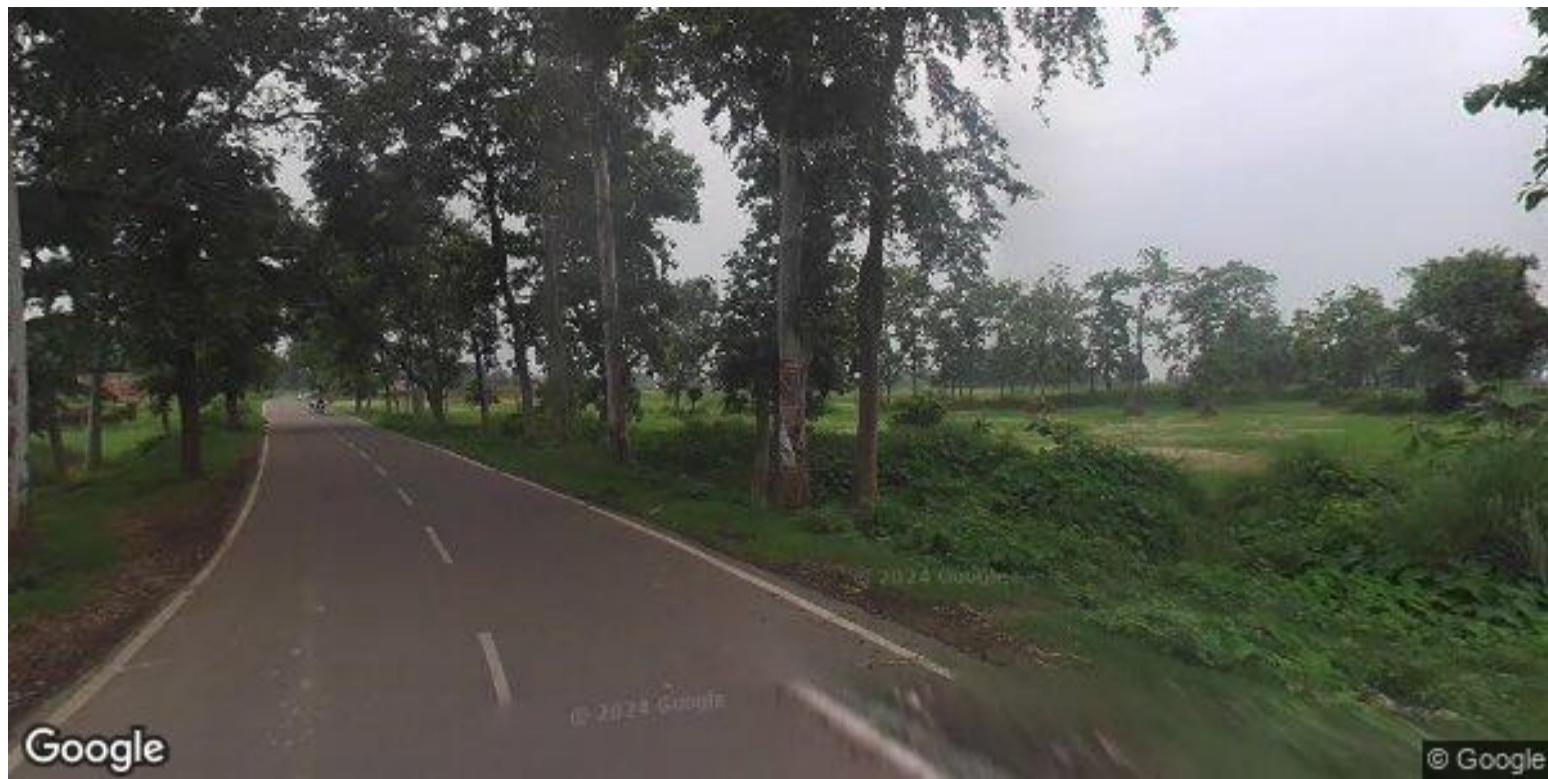
Coordinates: 27.19329, 83.25886

Risk Type: Turn

Risk Level: Medium

Speed Limit: 30 KM/Hr

Distance from Start: 63.46 km

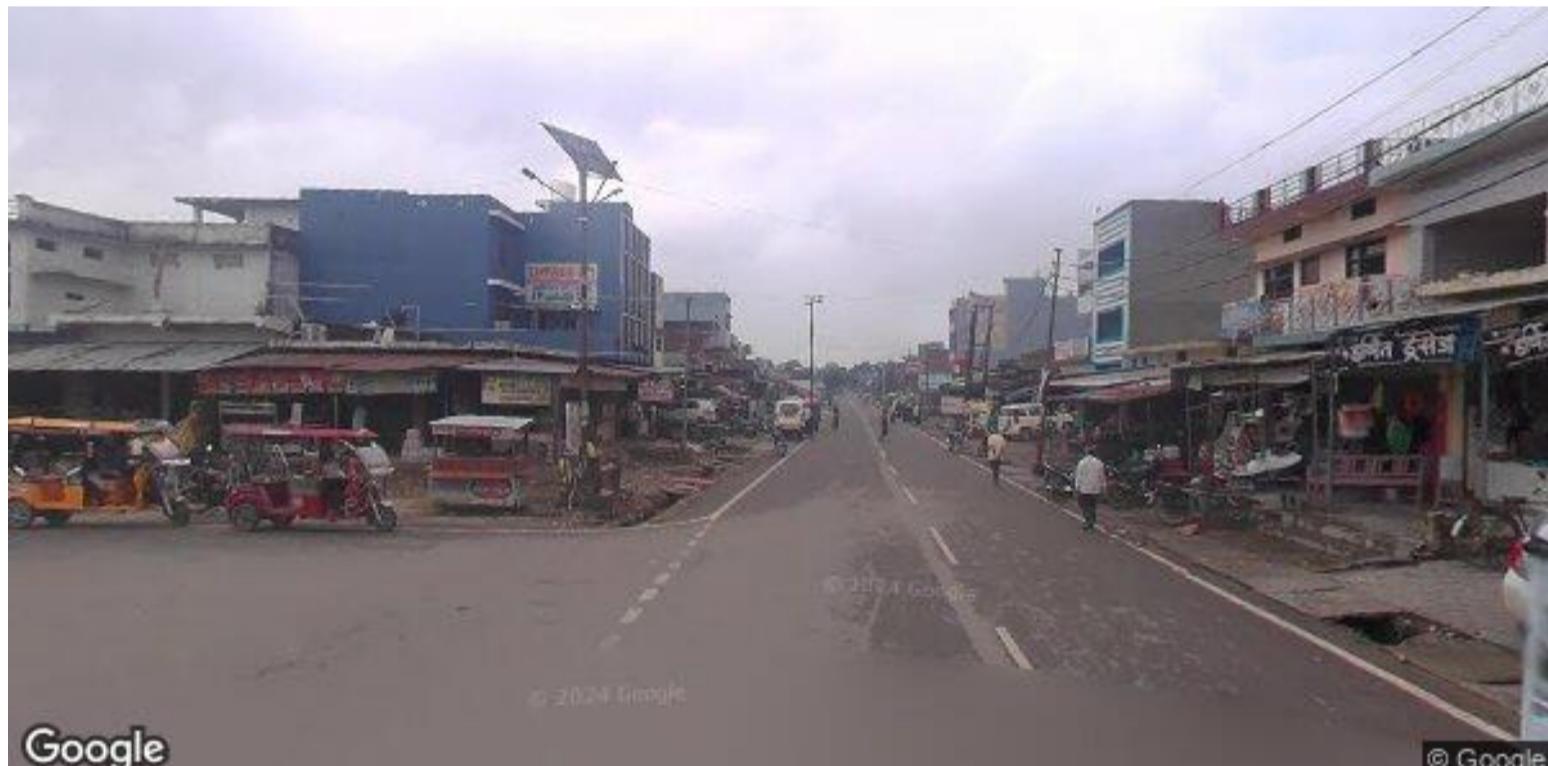
Coordinates: 27.19788, 83.19904

Risk Type: Turn

Risk Level: High

Speed Limit: 15 KM/Hr

Distance from Start: 69.37 km

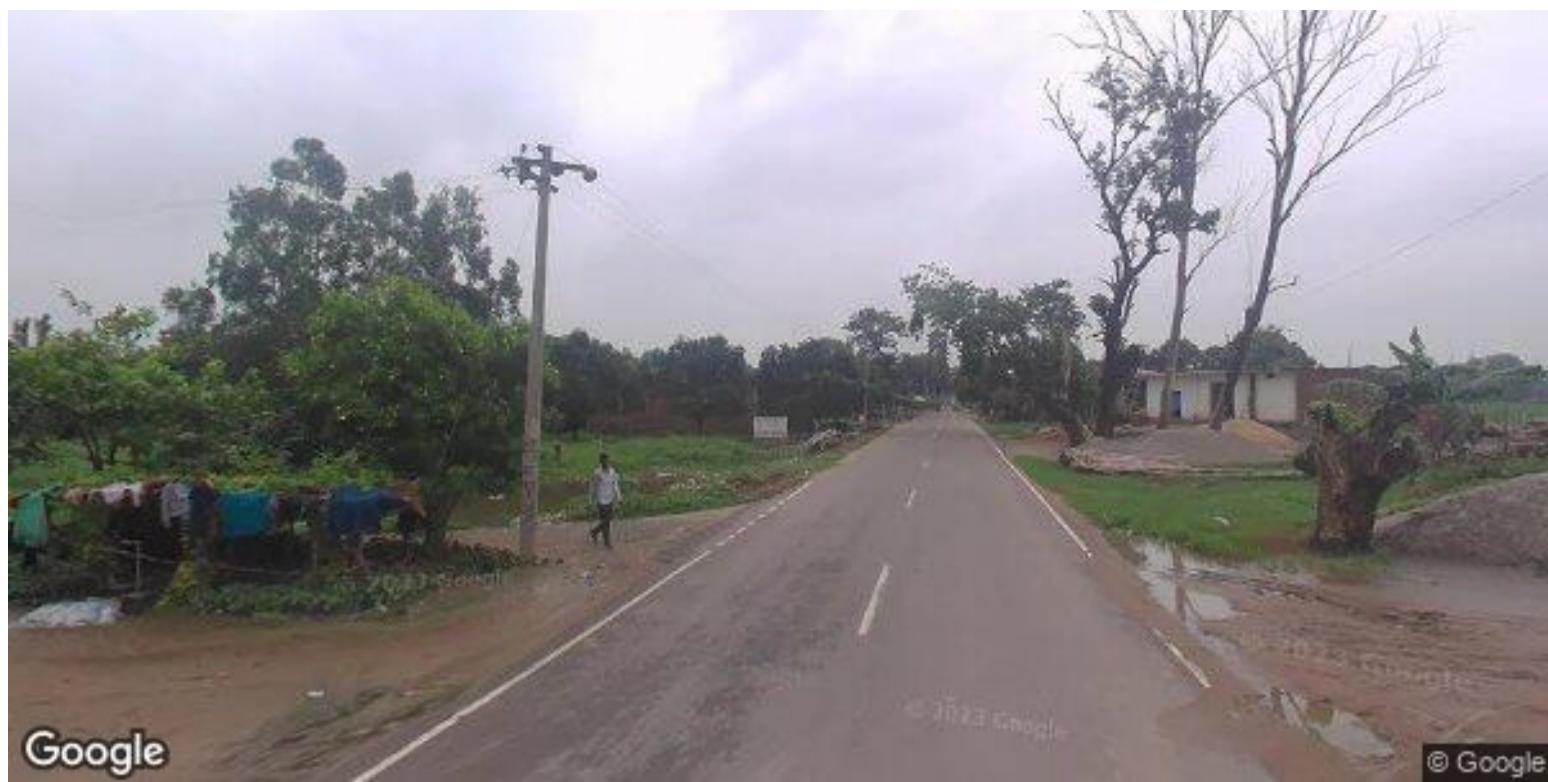
Coordinates: 27.21140, 83.21310

Risk Type: Blind Spot

Risk Level: Blind Spot

Speed Limit: 10 KM/Hr

Distance from Start: 71.63 km

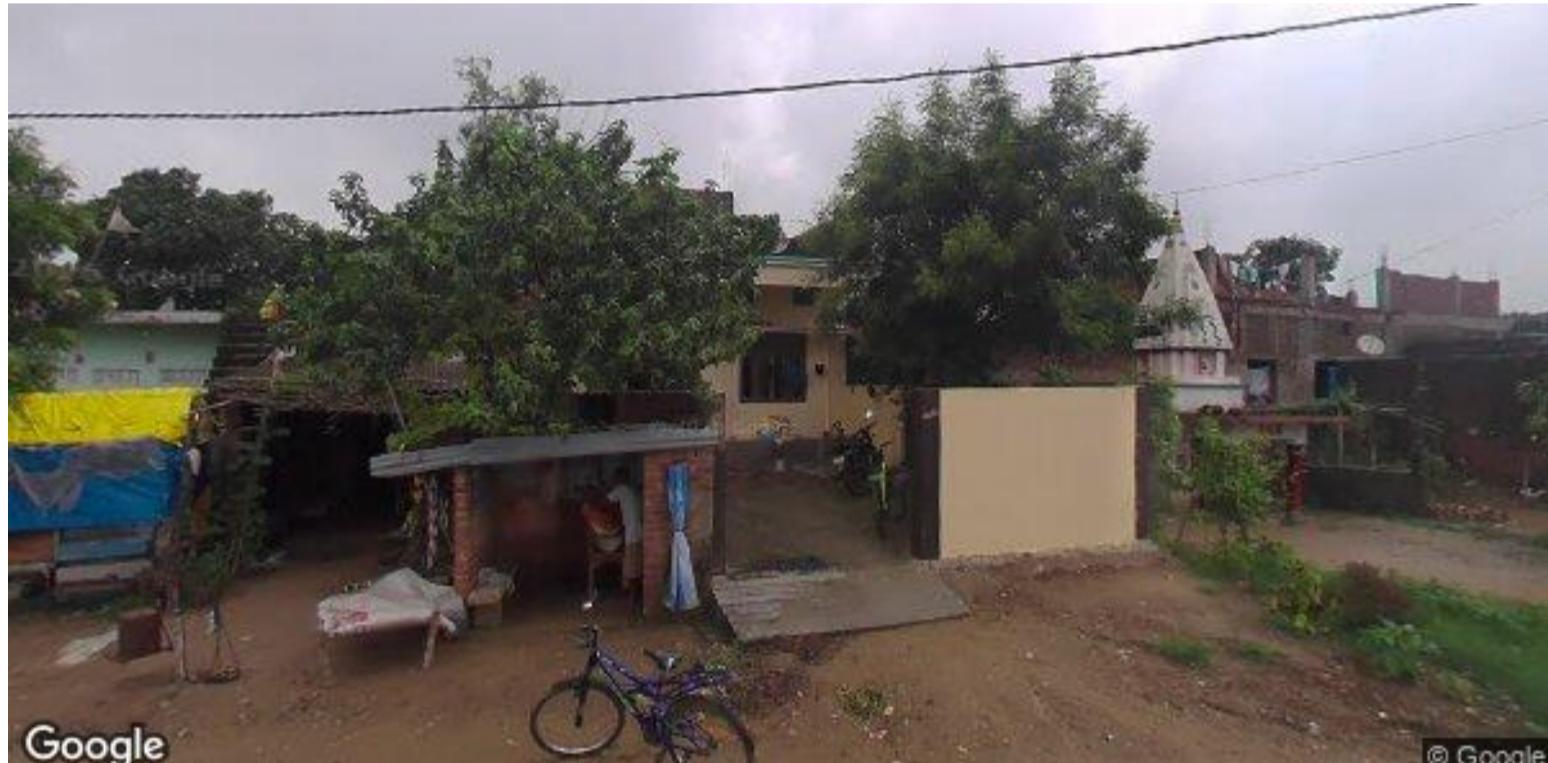
Coordinates: 27.21172, 83.21256

Risk Type: Turn

Risk Level: Medium

Speed Limit: 30 KM/Hr

Distance from Start: 71.69 km

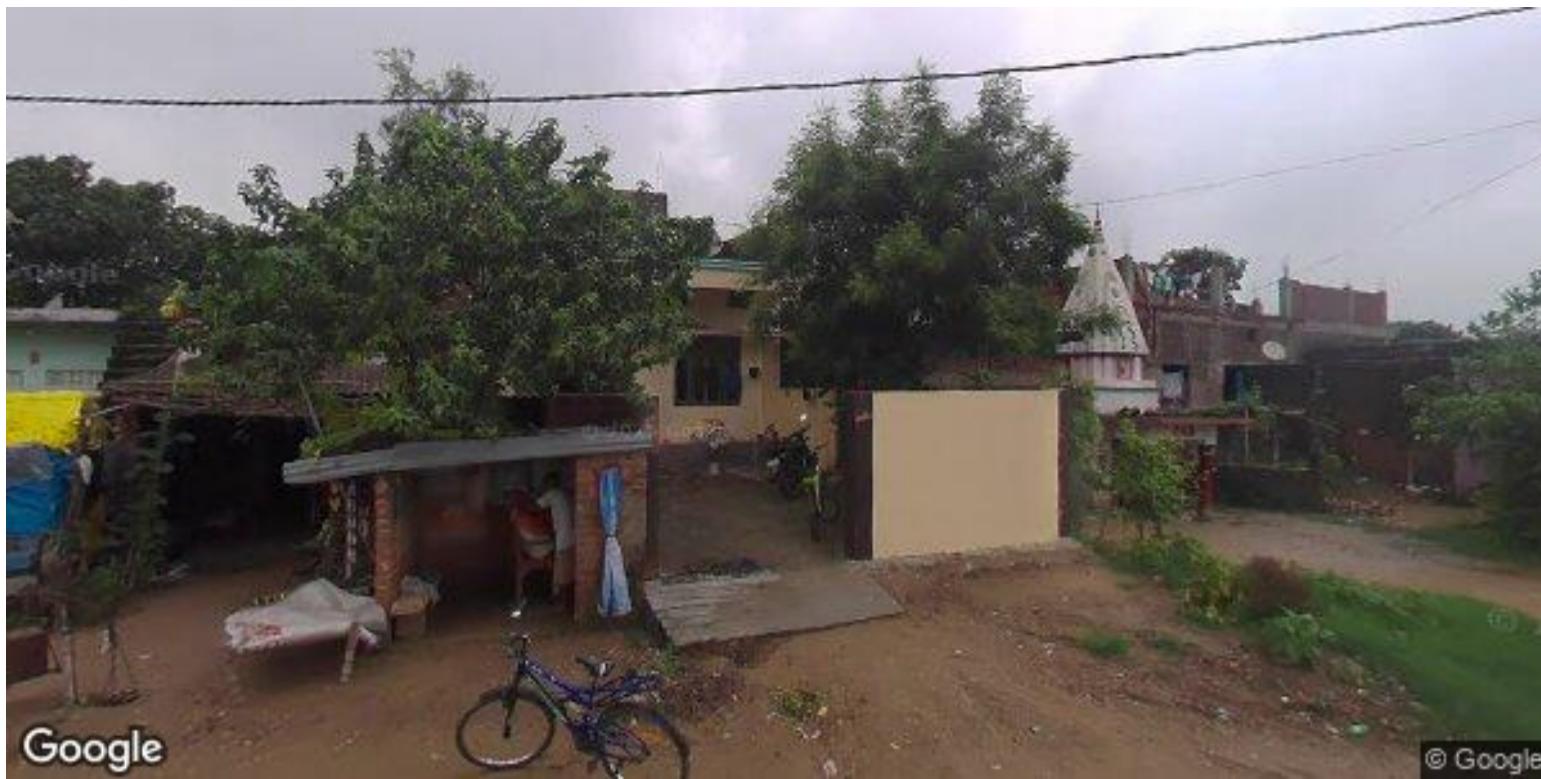
Coordinates: 27.21187, 83.21252

Risk Type: Turn

Risk Level: High

Speed Limit: 15 KM/Hr

Distance from Start: 71.72 km
