JOURNEY RISK MANAGEMENT (JRM) STUDY

Gorakhpur LPG BP to SHUKLA INDANE GAS SERVICE

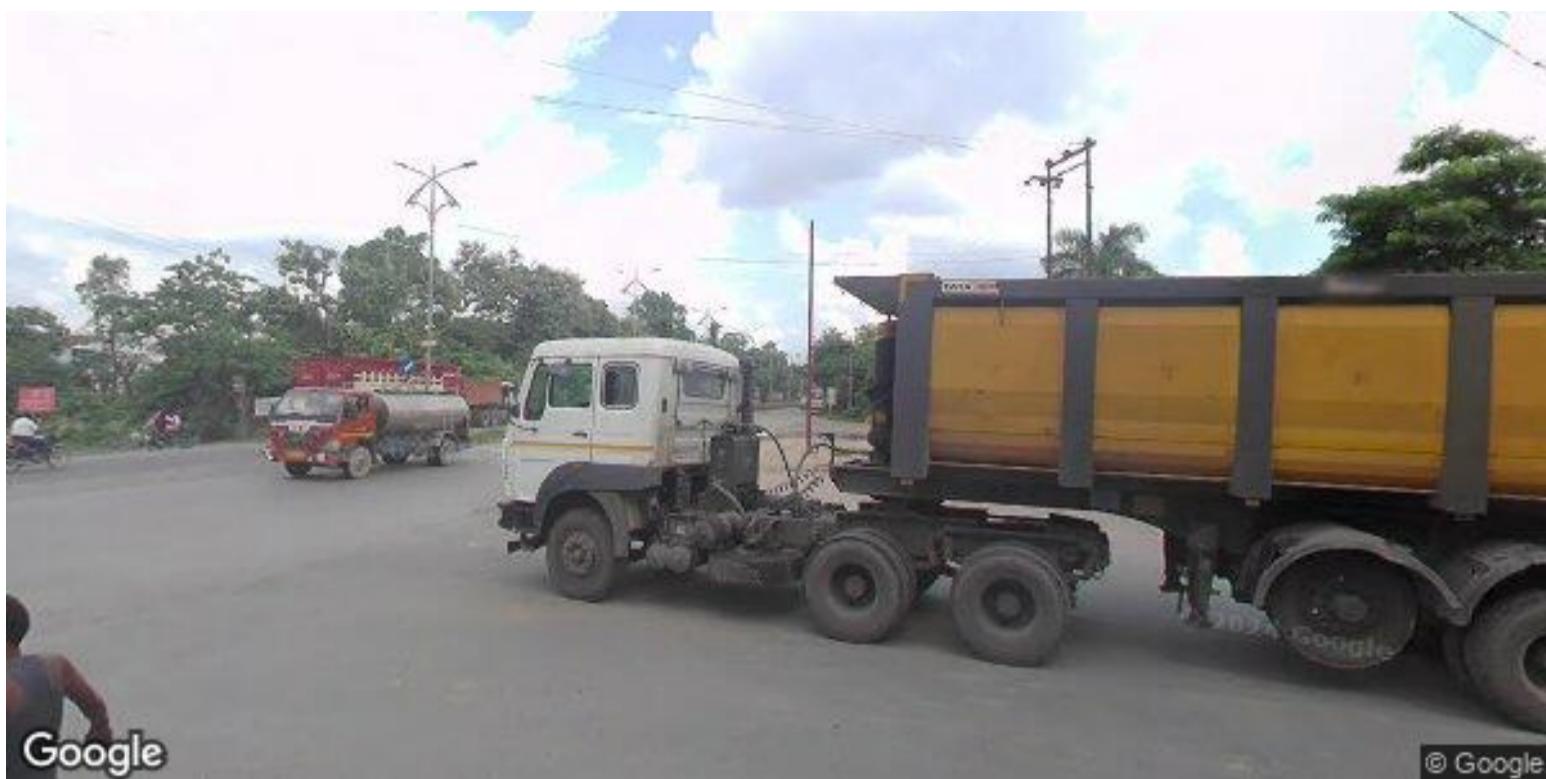
Coordinates: 26.75126, 83.22476

Risk Type: Blind Spot

Risk Level: Blind Spot

Speed Limit: 10 KM/Hr

Distance from Start: 2.17 km

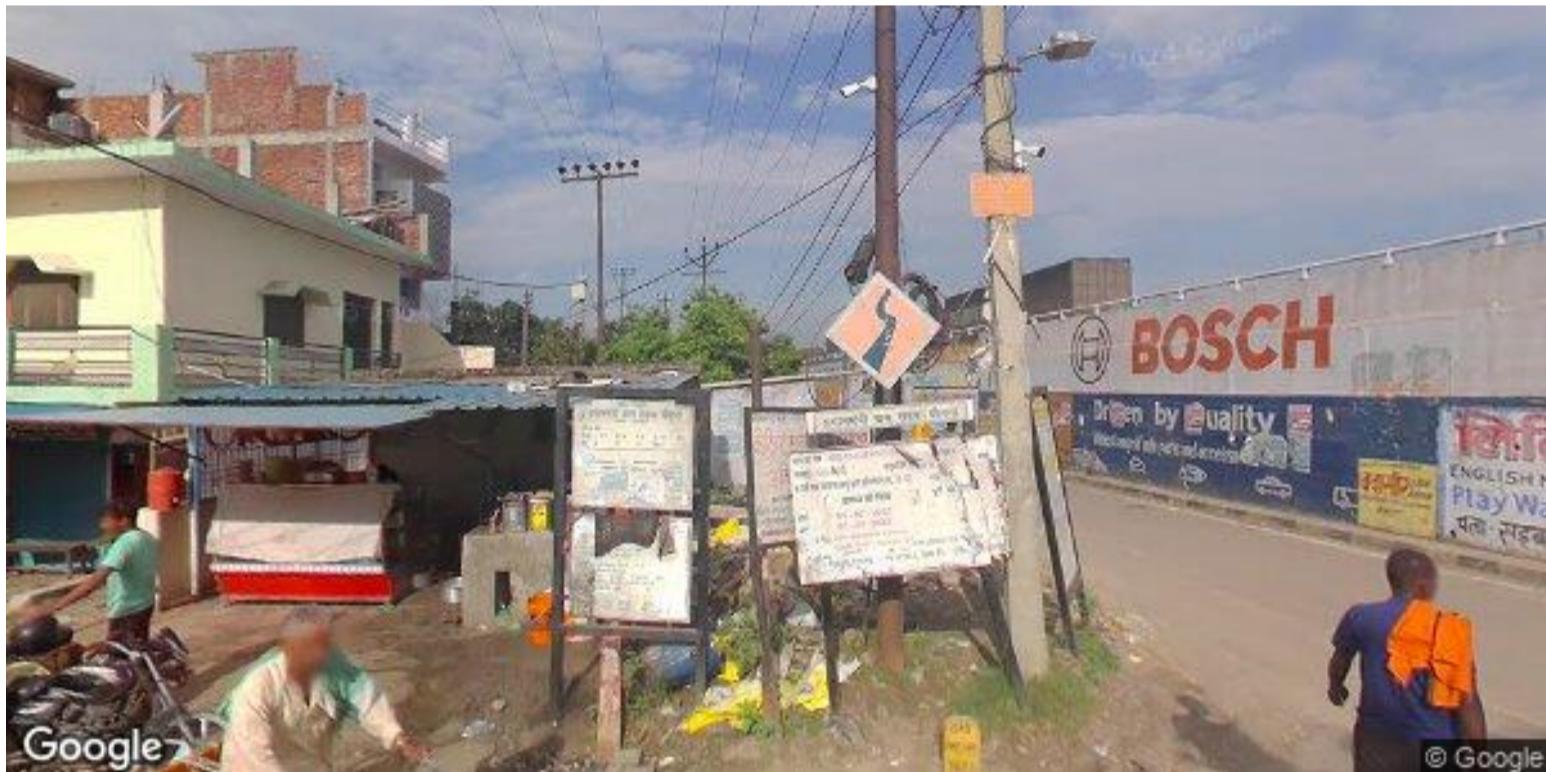
Coordinates: 26.75353, 83.20457

Risk Type: Blind Spot

Risk Level: Blind Spot

Speed Limit: 10 KM/Hr

Distance from Start: 4.23 km

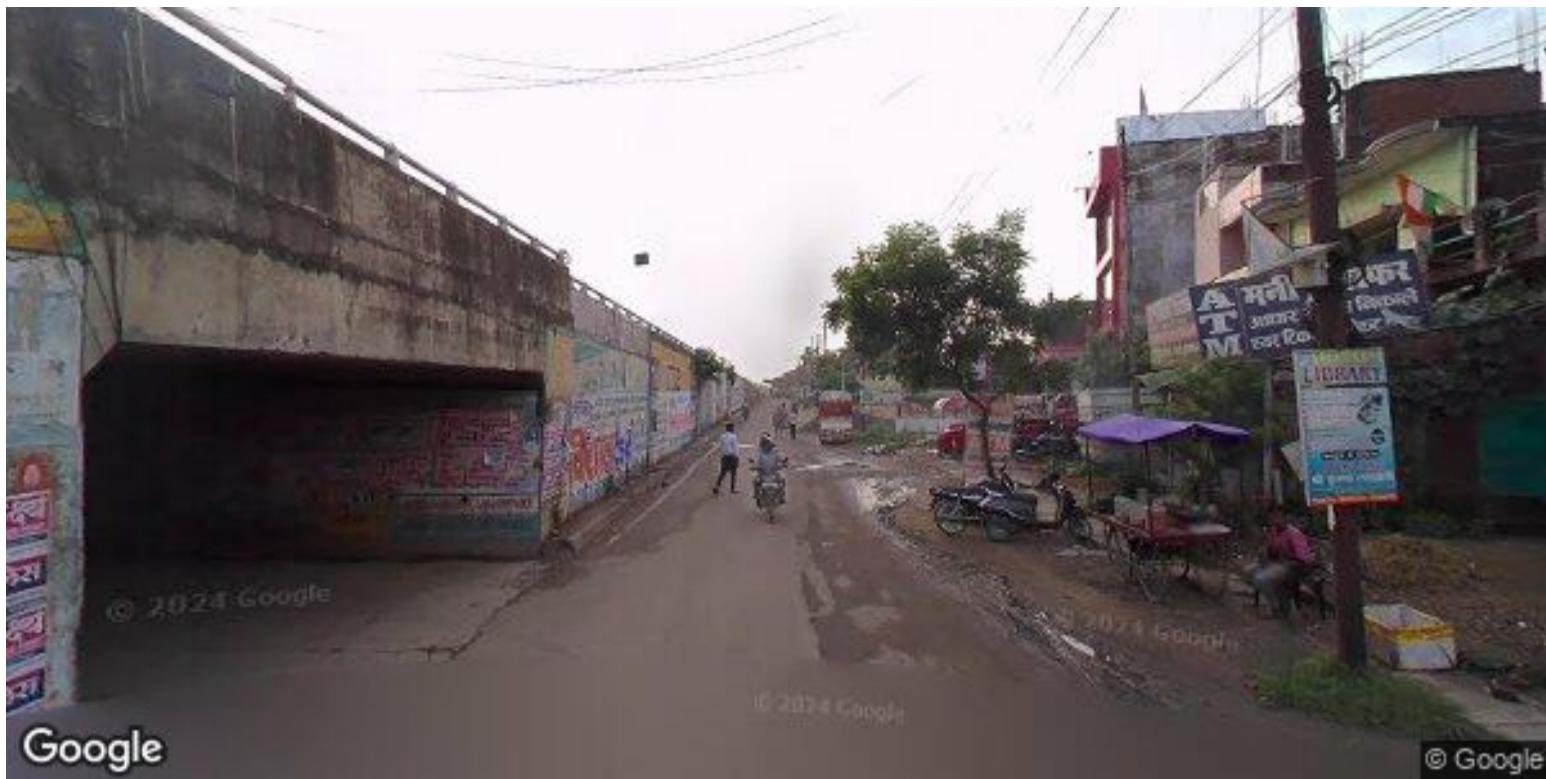
Coordinates: 26.75381, 83.20466

Risk Type: Turn

Risk Level: High

Speed Limit: 15 KM/Hr

Distance from Start: 4.30 km

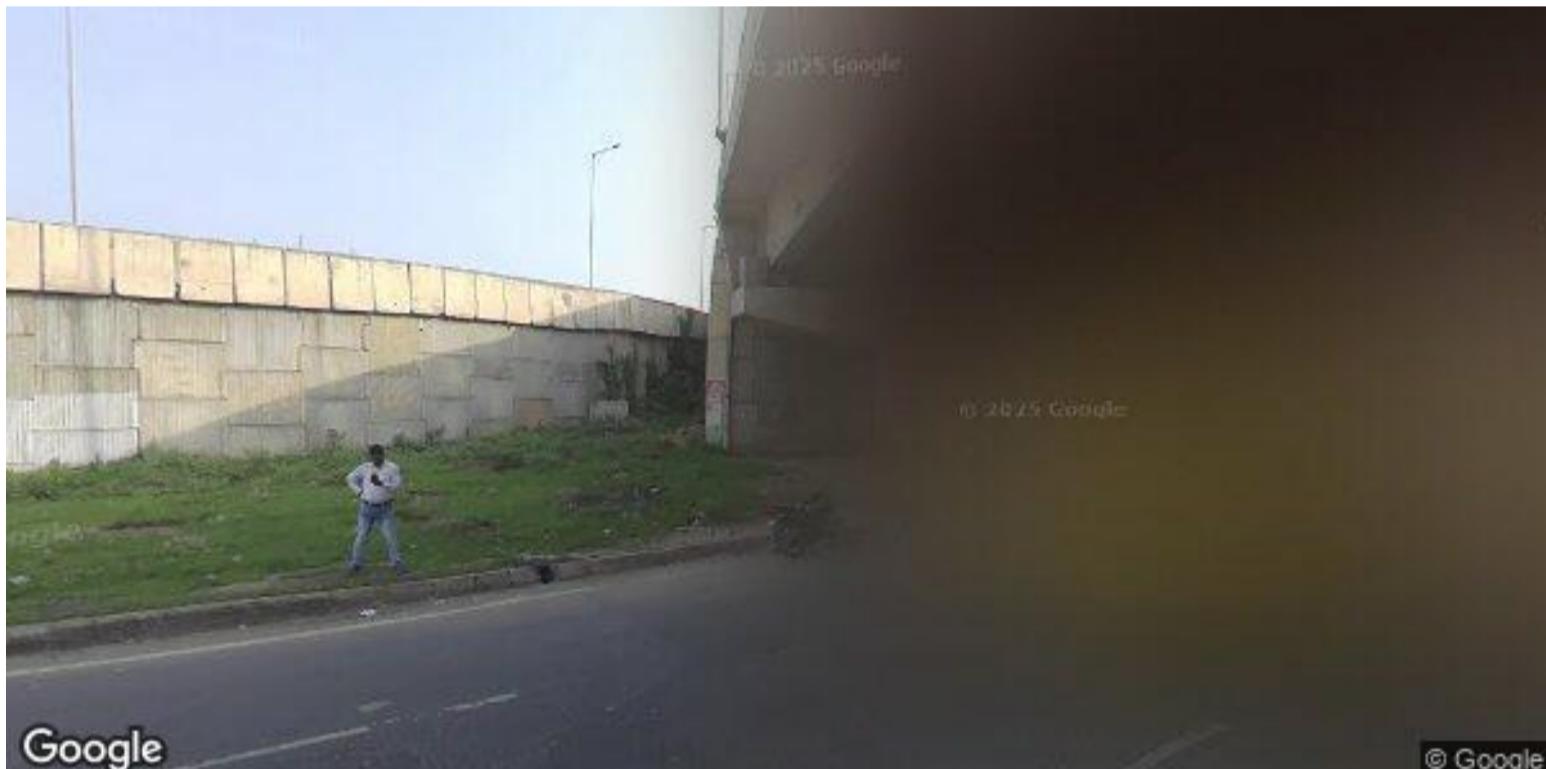
Coordinates: 26.74681, 83.25111

Risk Type: Roundabout

Risk Level: High

Speed Limit: 15 KM/Hr

Distance from Start: 8.97 km

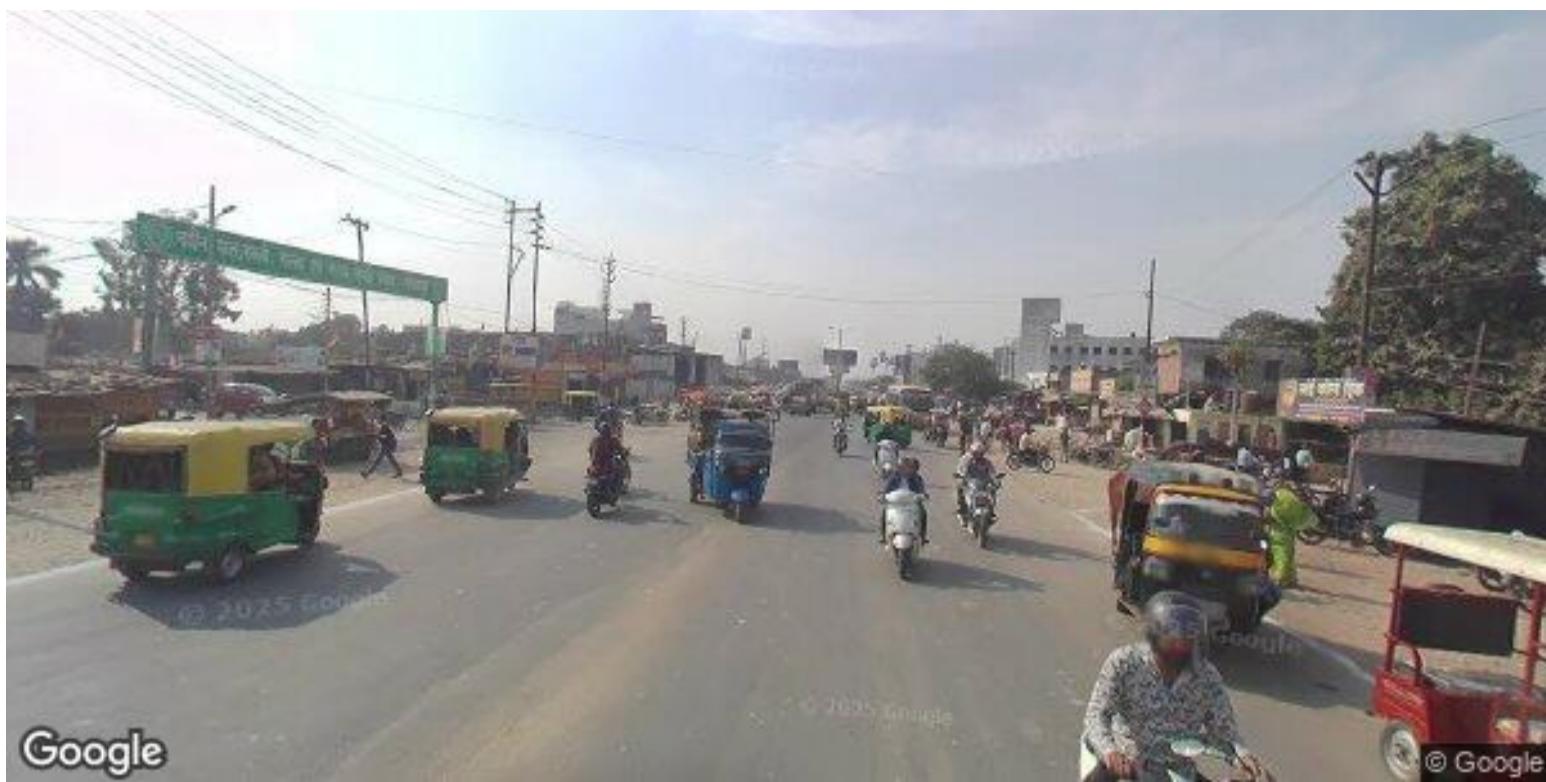
Coordinates: 26.73463, 83.36380

Risk Type: Turn

Risk Level: High

Speed Limit: 15 KM/Hr

Distance from Start: 20.70 km

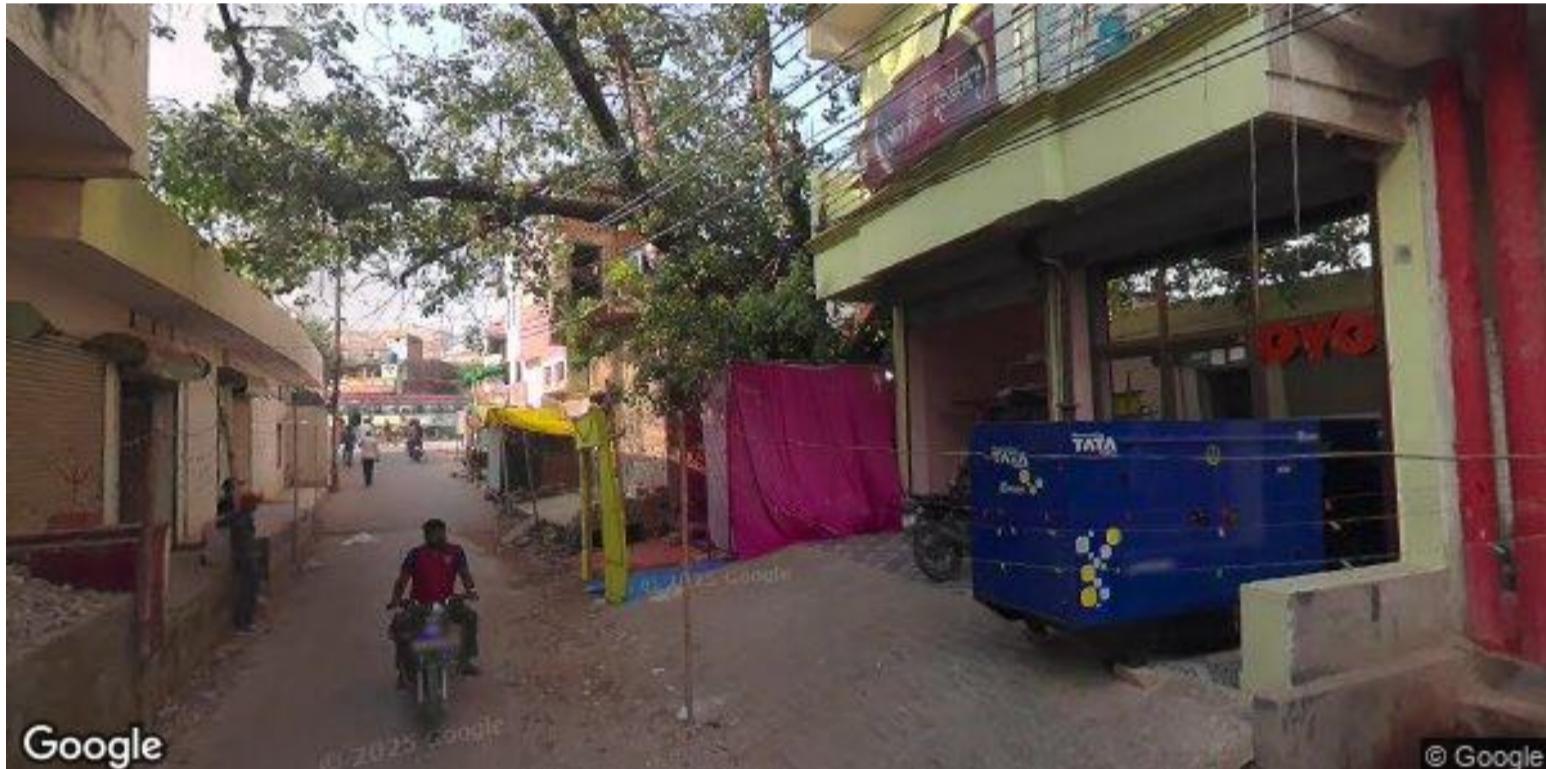
Coordinates: 26.73407, 83.36383

Risk Type: Turn

Risk Level: Medium

Speed Limit: 30 KM/Hr

Distance from Start: 20.77 km

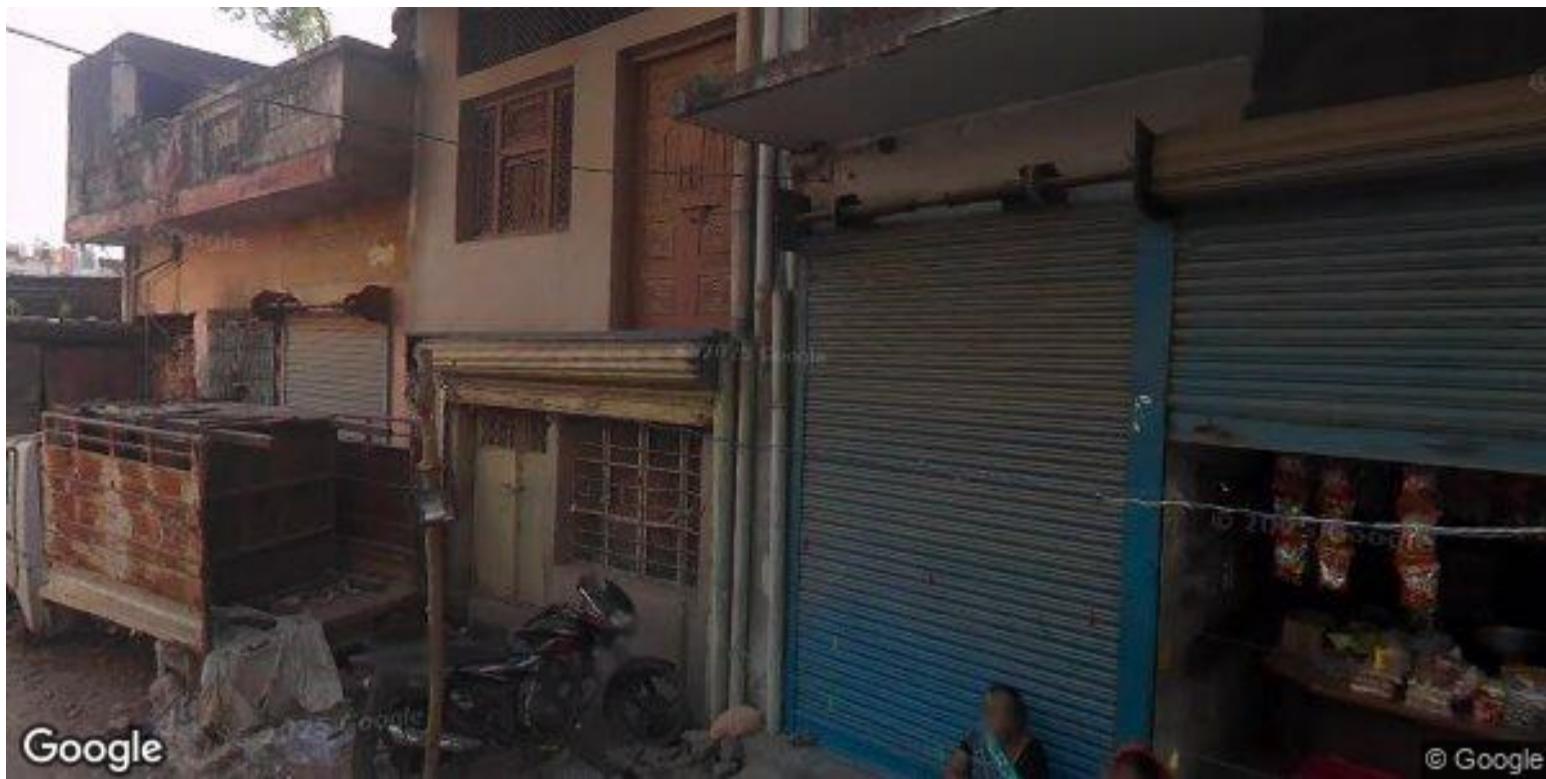
Coordinates: 26.73403, 83.36381

Risk Type: Turn

Risk Level: High

Speed Limit: 15 KM/Hr

Distance from Start: 20.78 km

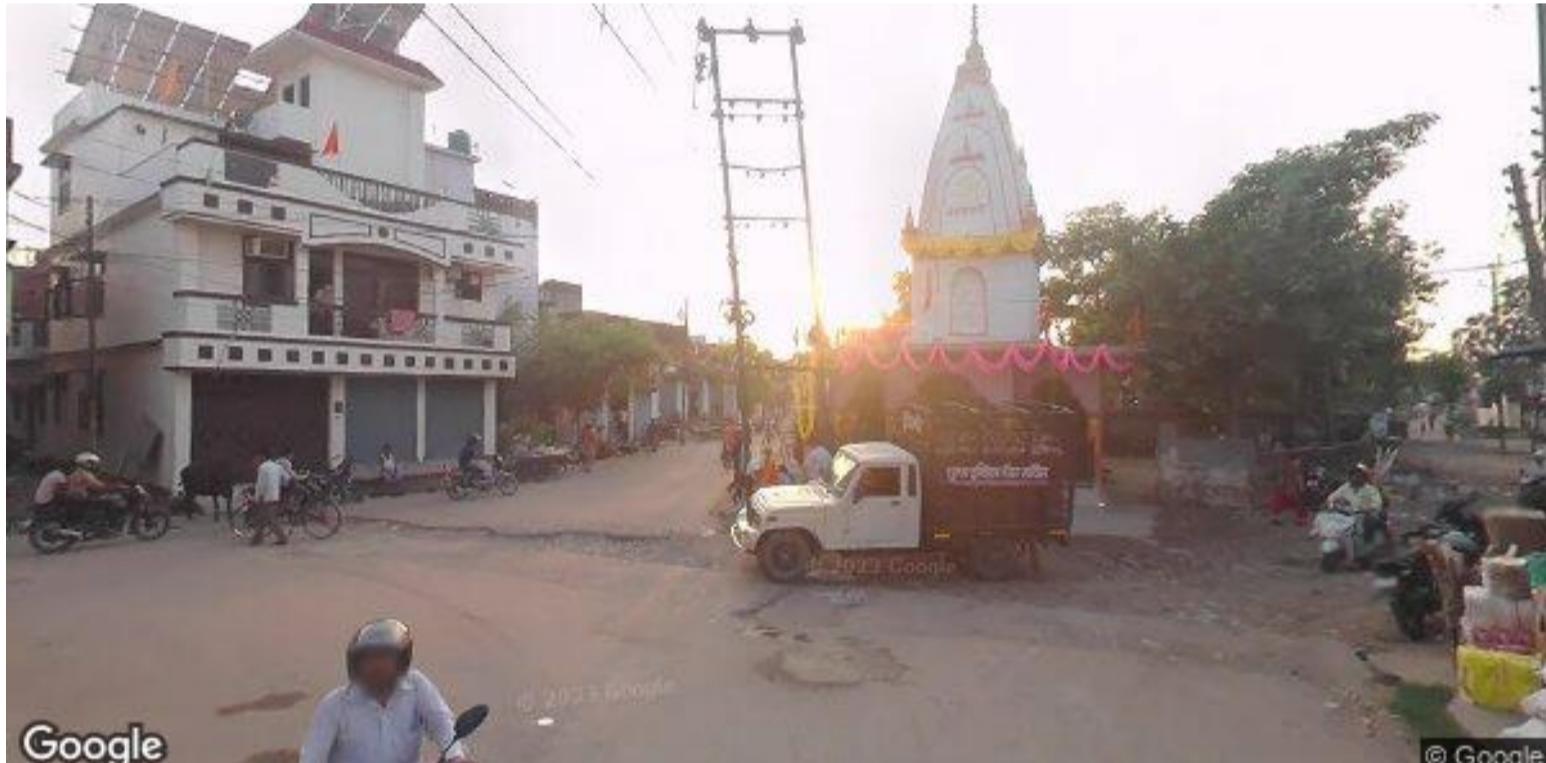
Coordinates: 26.73240, 83.36631

Risk Type: Blind Spot

Risk Level: Blind Spot

Speed Limit: 10 KM/Hr

Distance from Start: 21.08 km

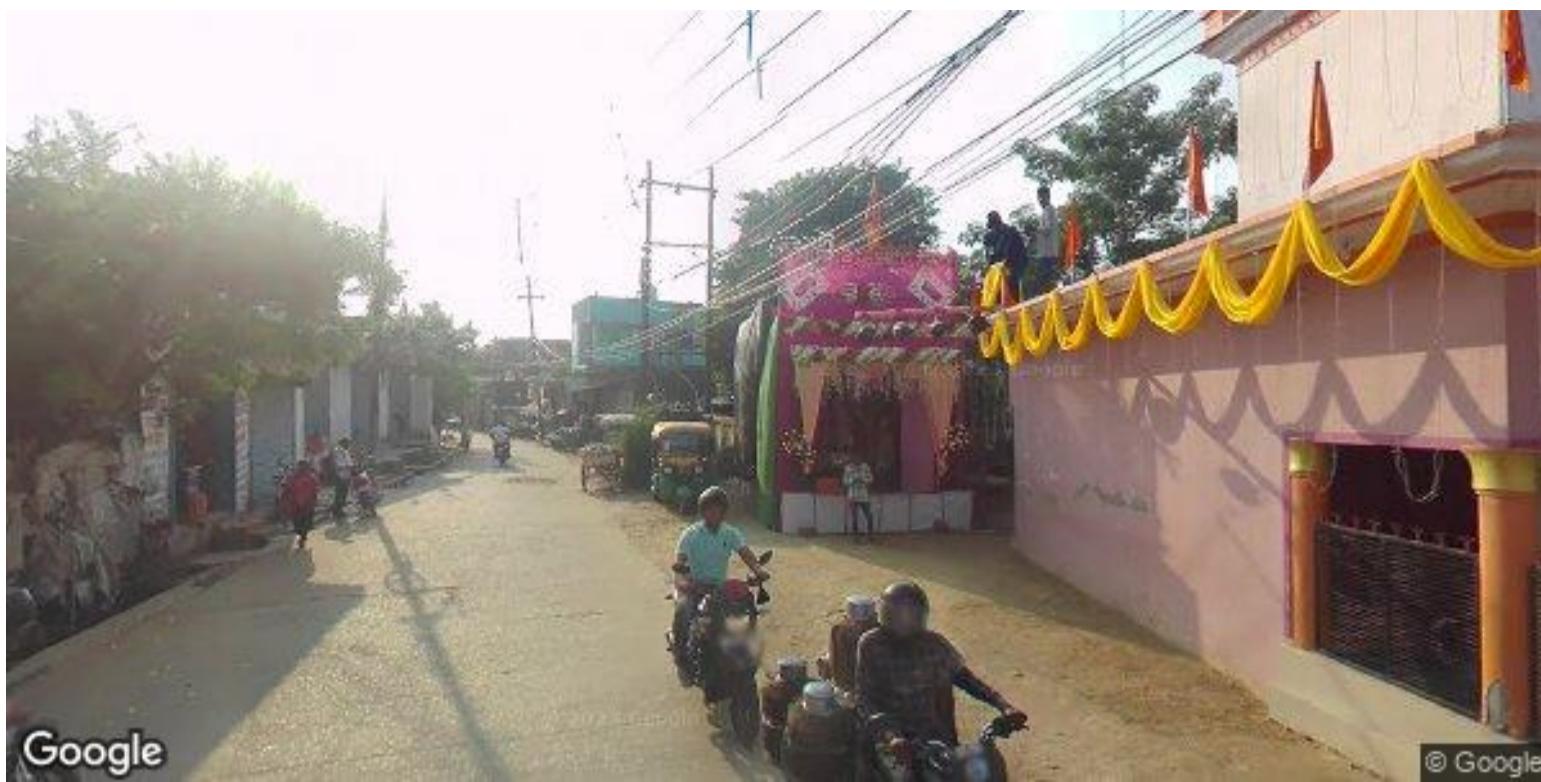
Coordinates: 26.73237, 83.36617

Risk Type: Blind Spot

Risk Level: Blind Spot

Speed Limit: 10 KM/Hr

Distance from Start: 21.10 km

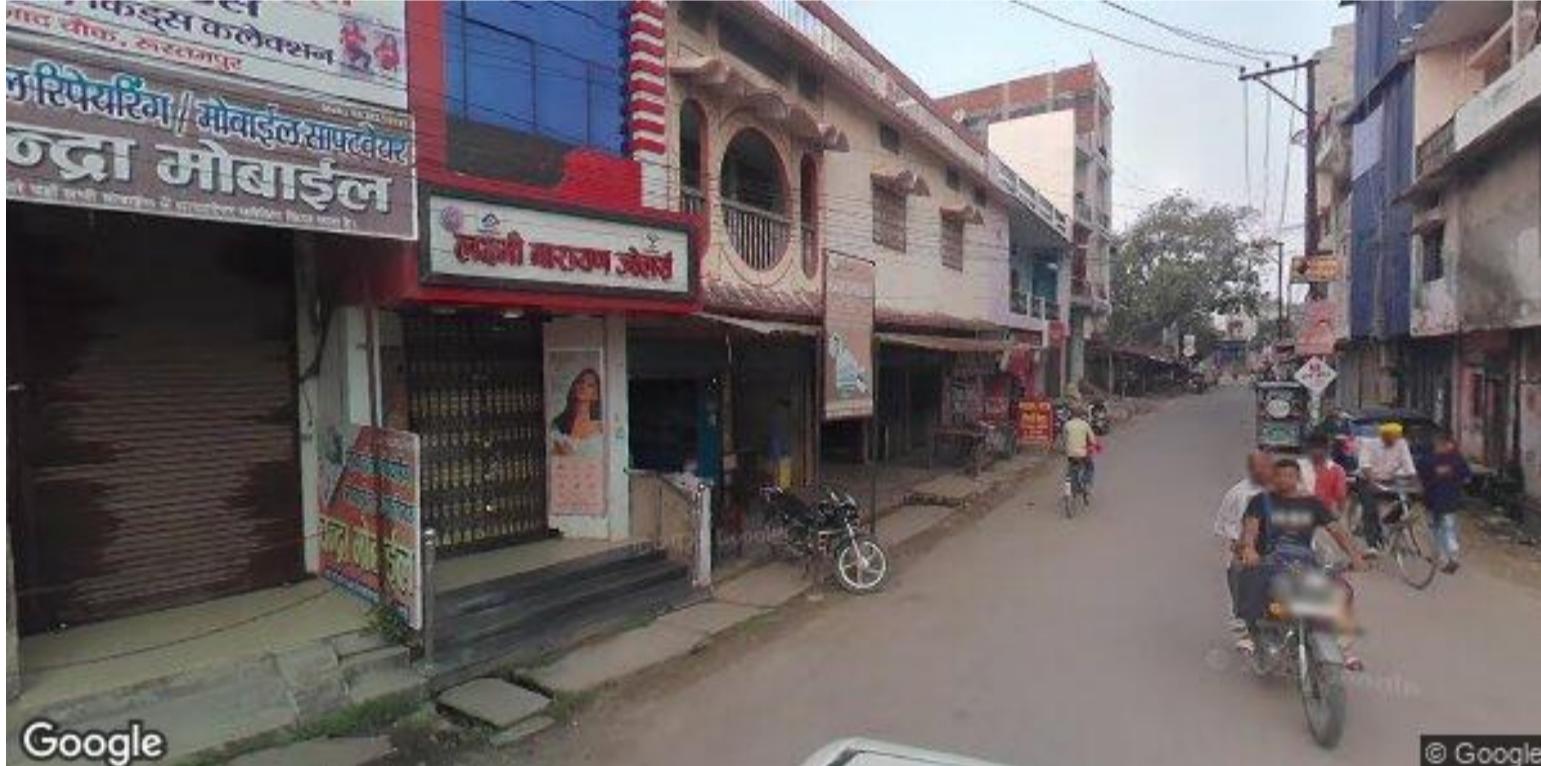
Coordinates: 26.73083, 83.36975

Risk Type: Turn

Risk Level: High

Speed Limit: 15 KM/Hr

Distance from Start: 21.51 km

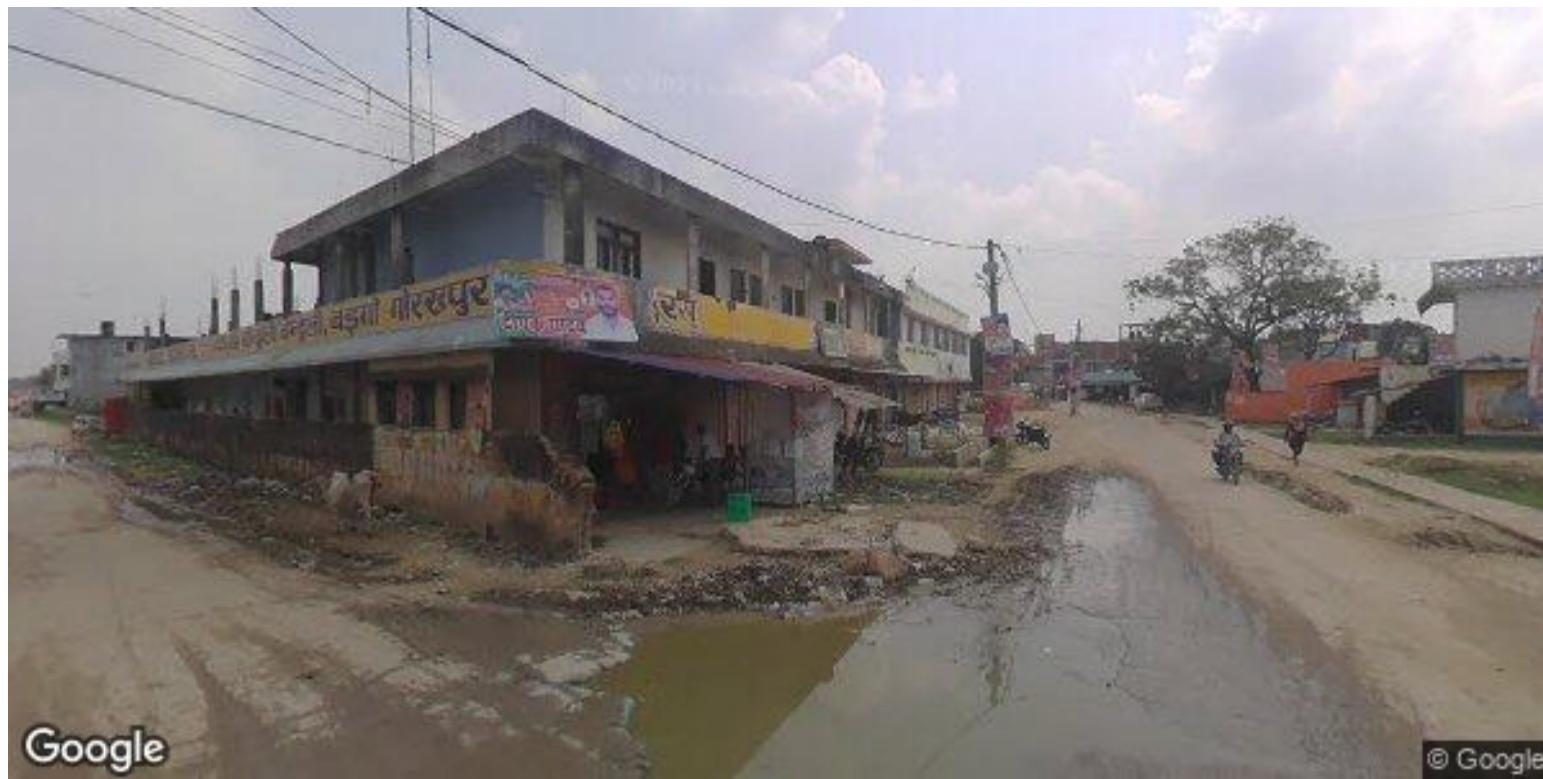
Coordinates: 26.71547, 83.37887

Risk Type: Turn

Risk Level: High

Speed Limit: 15 KM/Hr

Distance from Start: 23.47 km
