## JOURNEY RISK MANAGEMENT (JRM) STUDY

**Gorakhpur LPG BP TO ANSHI INDANE GAS SER**

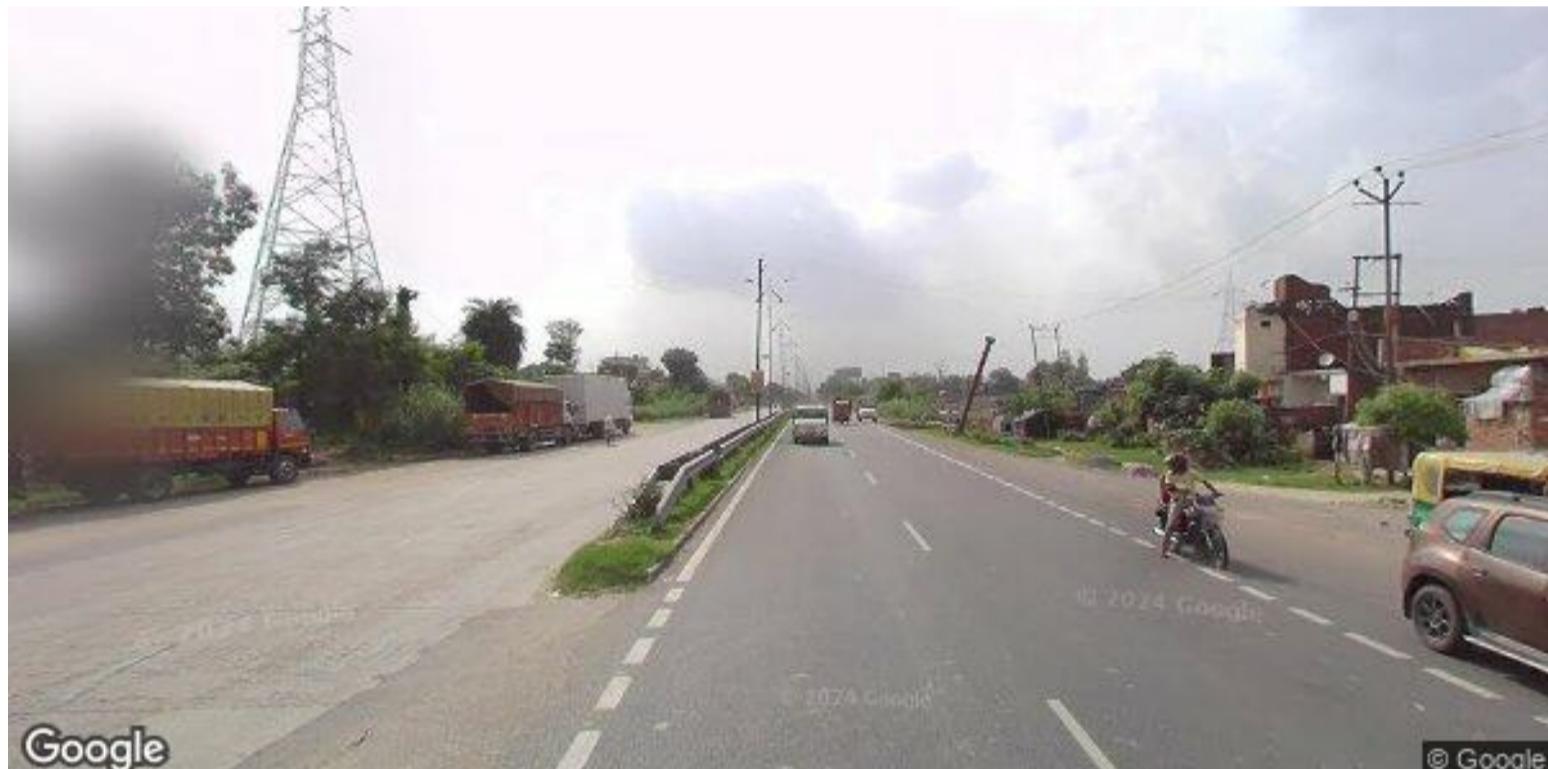
**Risk Type: U-Turn****Risk Level: High****Speed Limit: 10 KM/Hr****Distance from Start: 8.76 km****Coordinates: 26.7471208, 83.2490873**

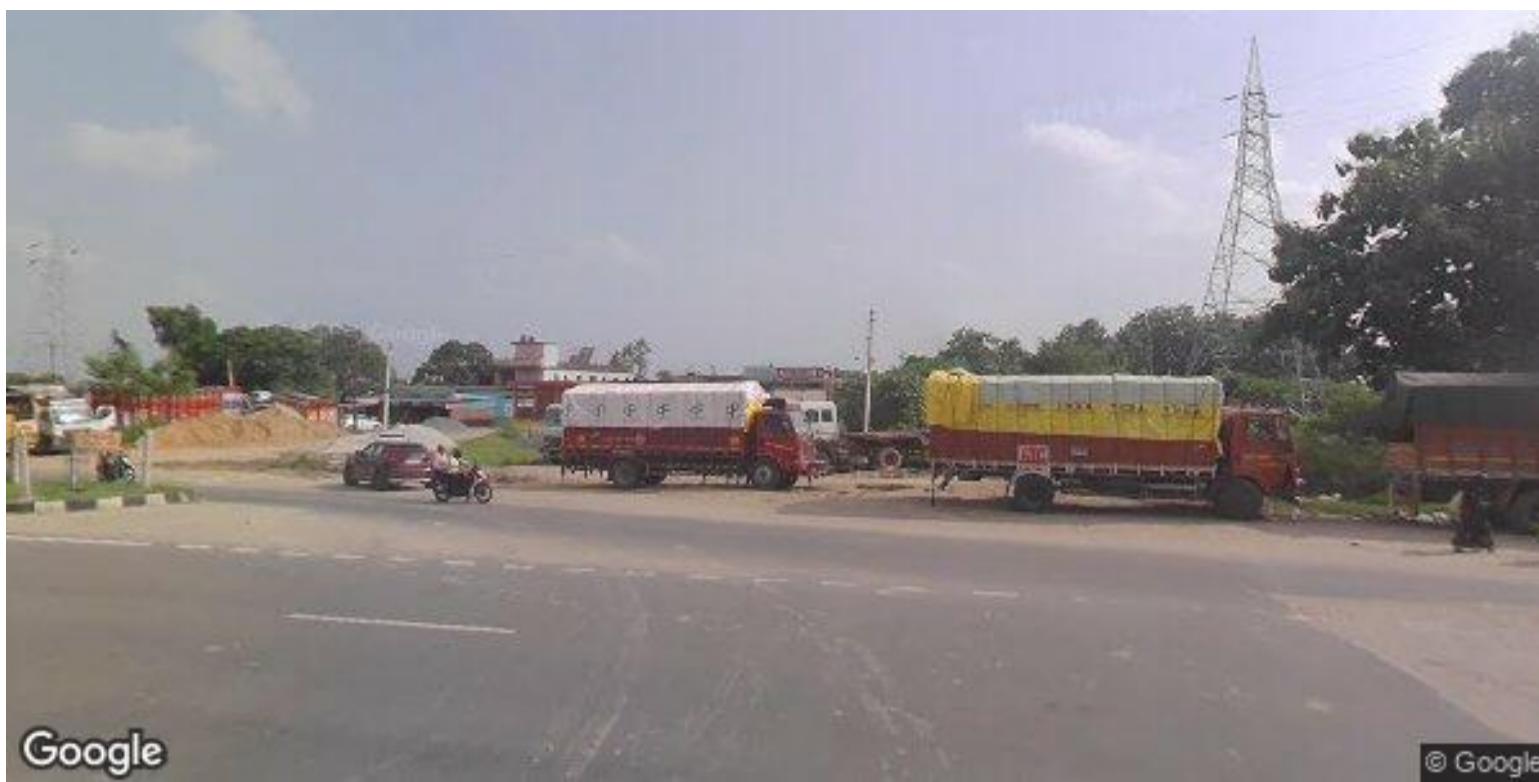
**Risk Type:** Blind Spot

**Risk Level:** Blind Spot

**Speed Limit:** 10 KM/Hr

**Distance from Start:** 8.76 km

**Coordinates:** 26.74712, 83.24909

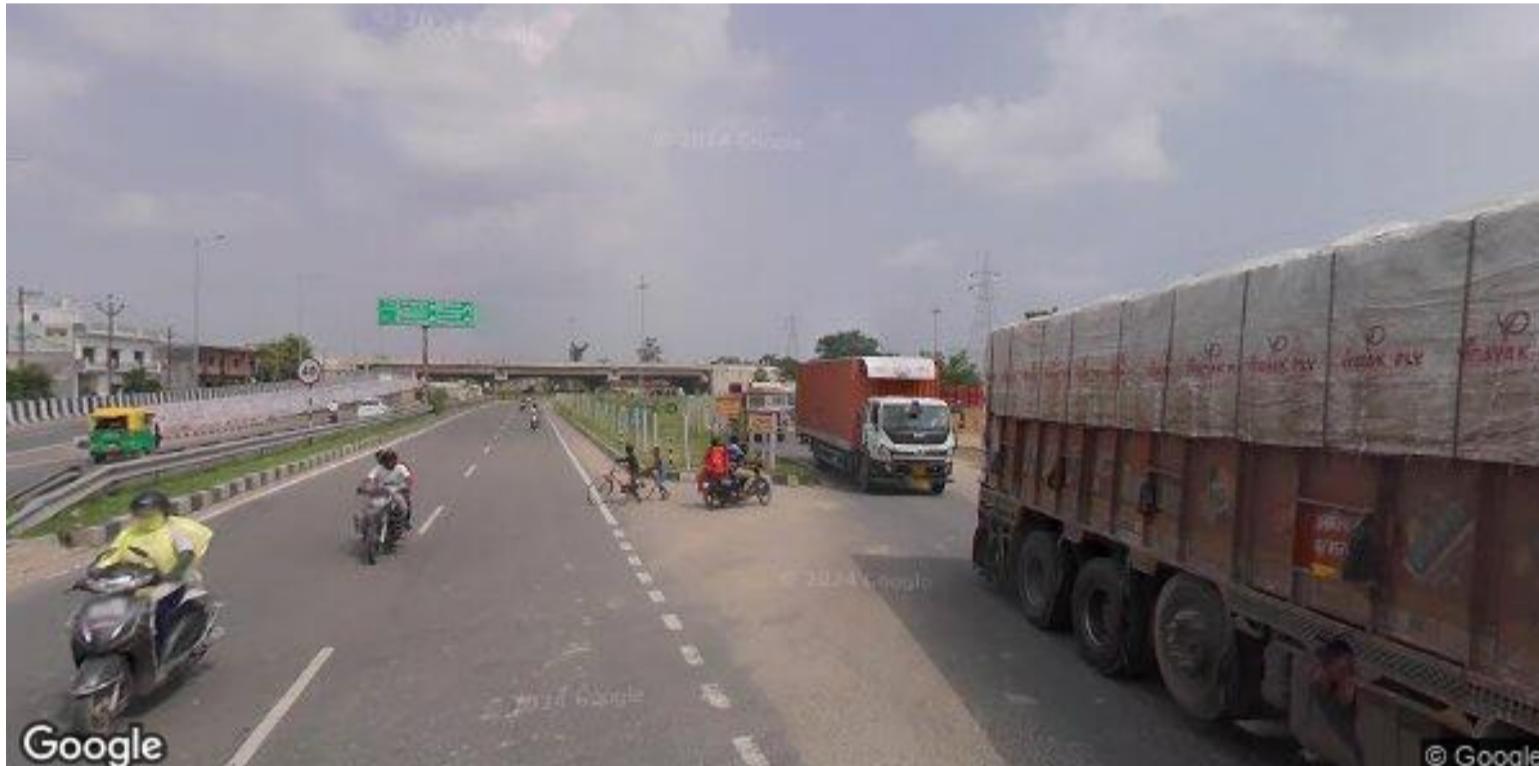
**Risk Type:** Turn

**Risk Level:** High

**Speed Limit:** 15 KM/Hr

**Distance from Start:** 8.79 km

**Coordinates:** 26.74703, 83.24907

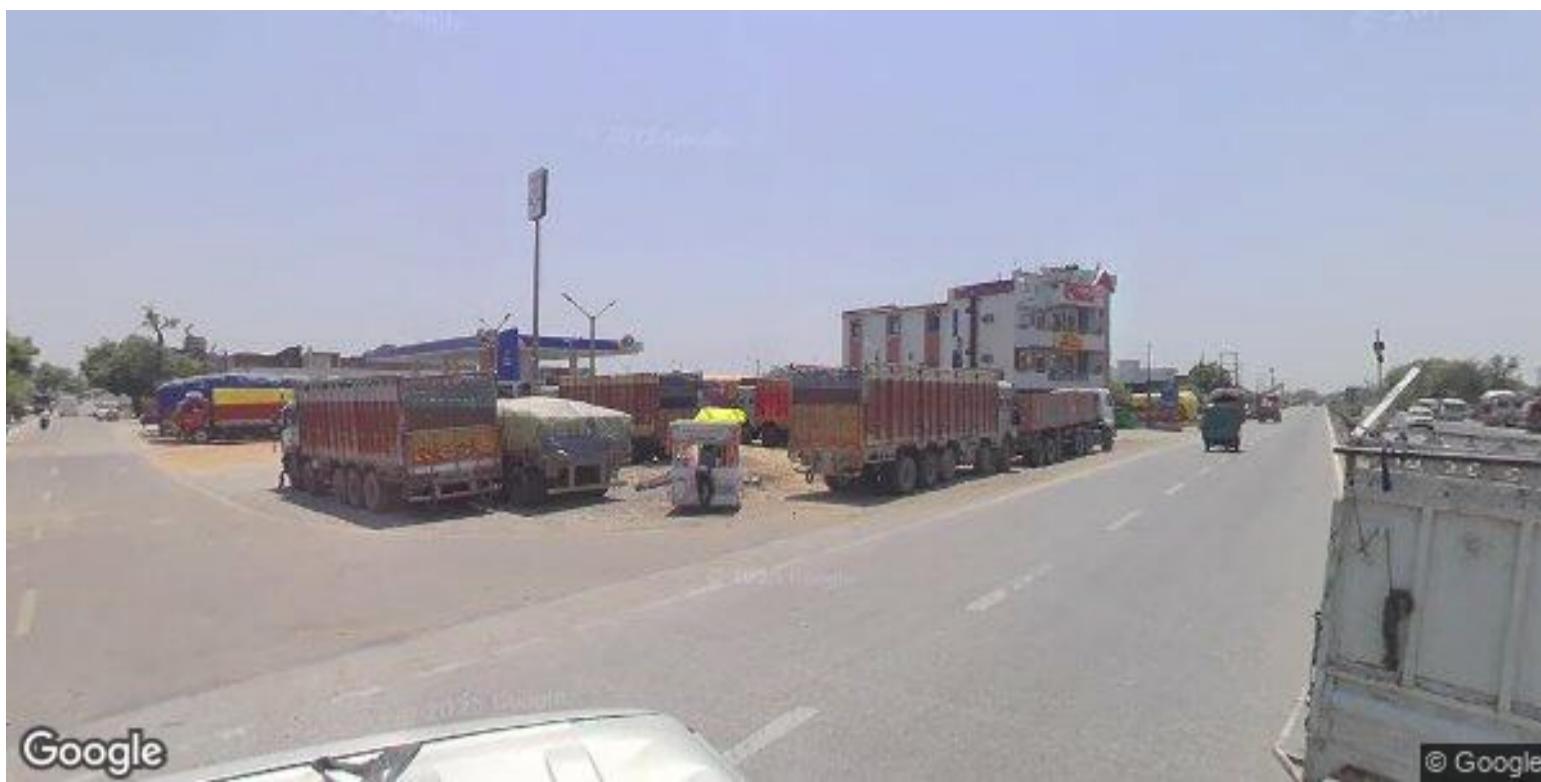
**Risk Type:** Blind Spot

**Risk Level:** Blind Spot

**Speed Limit:** 10 KM/Hr

**Distance from Start:** 59.01 km

**Coordinates:** 26.82809, 82.76755

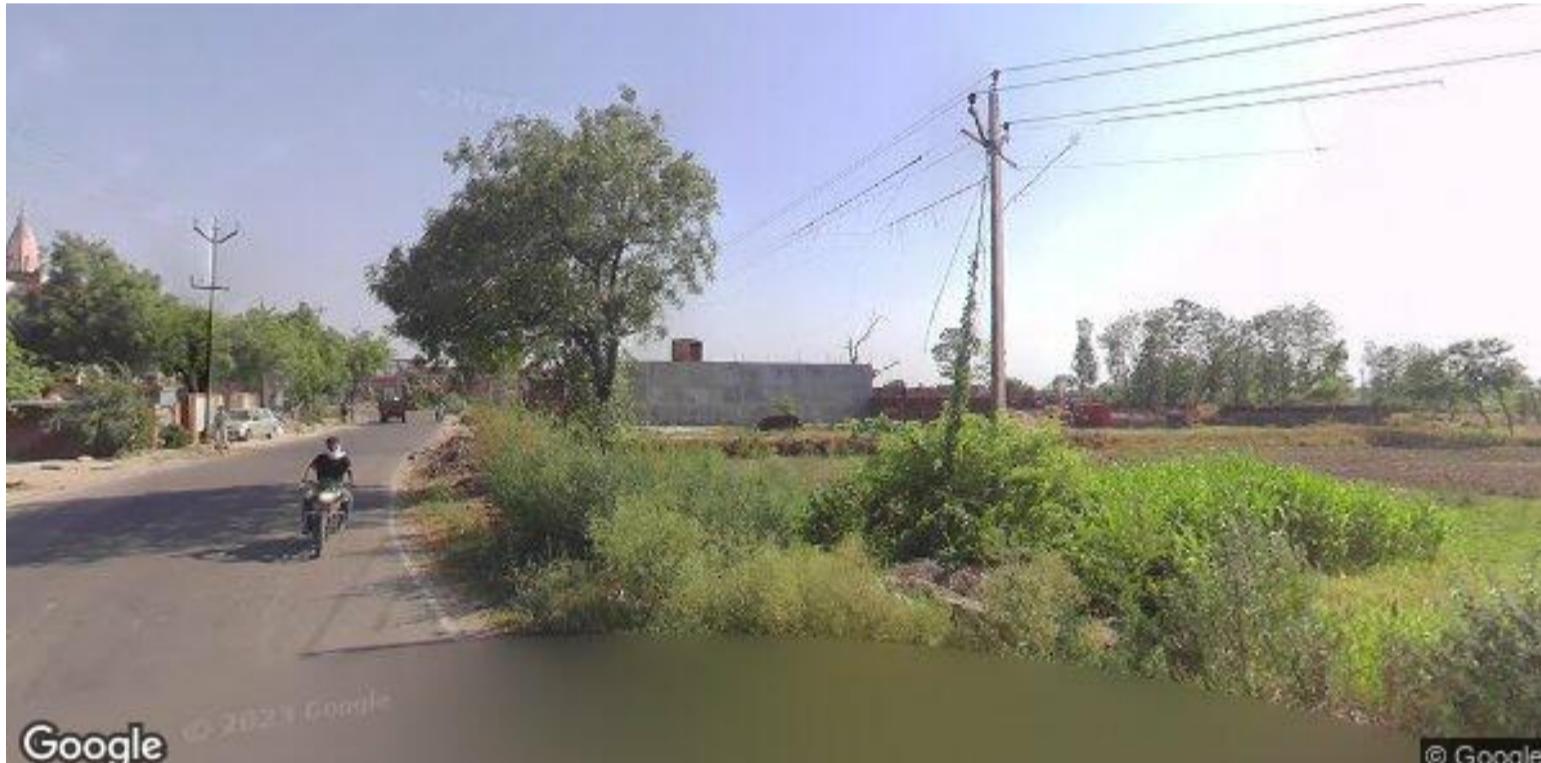
**Risk Type:** Turn

**Risk Level:** Medium

**Speed Limit:** 30 KM/Hr

**Distance from Start:** 60.41 km

**Coordinates:** 26.83965, 82.76772

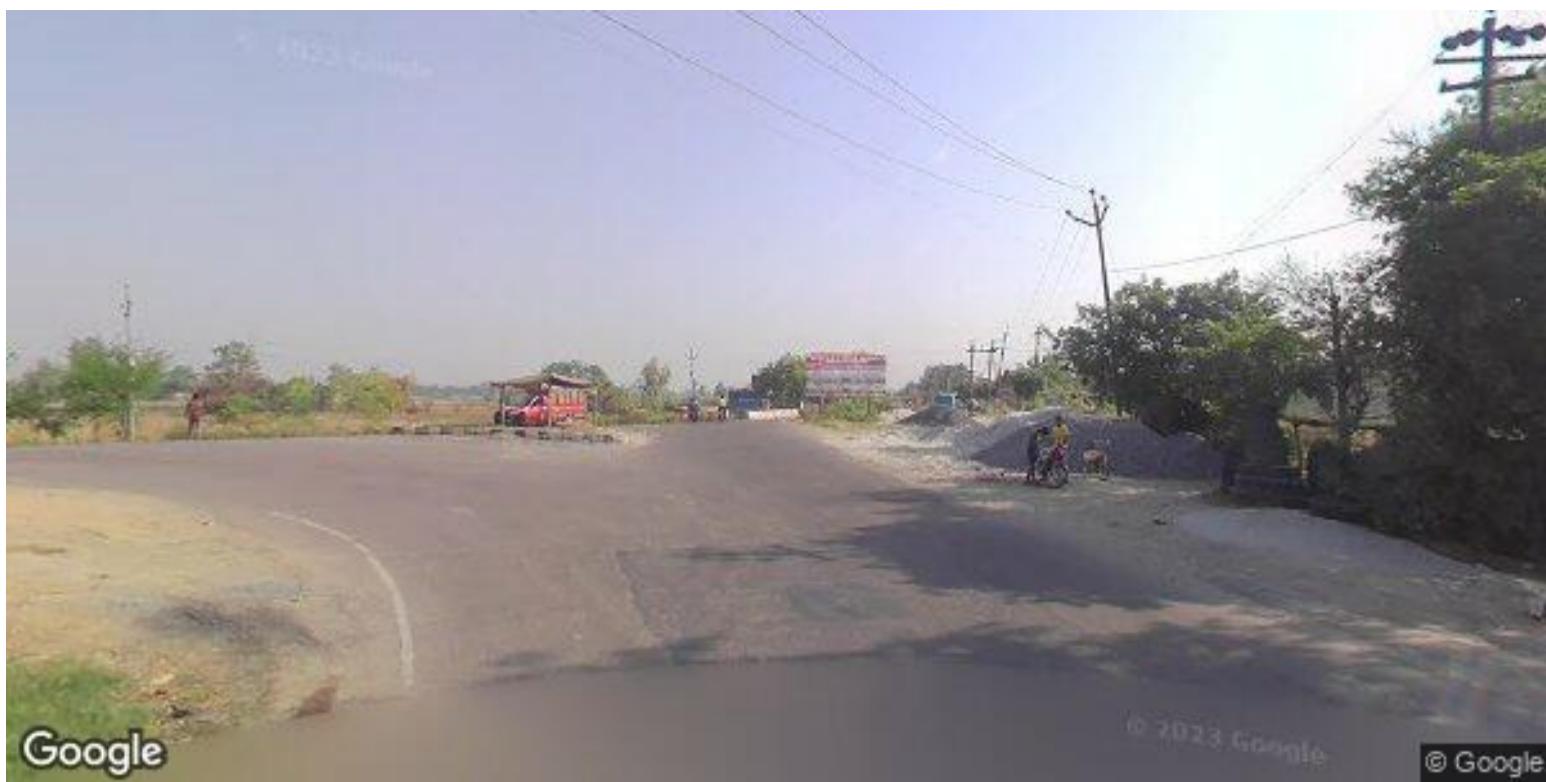
**Risk Type:** Turn**Risk Level:** Medium**Speed Limit:** 30 KM/Hr**Distance from Start:** 61.35 km**Coordinates:** 26.84763, 82.76664

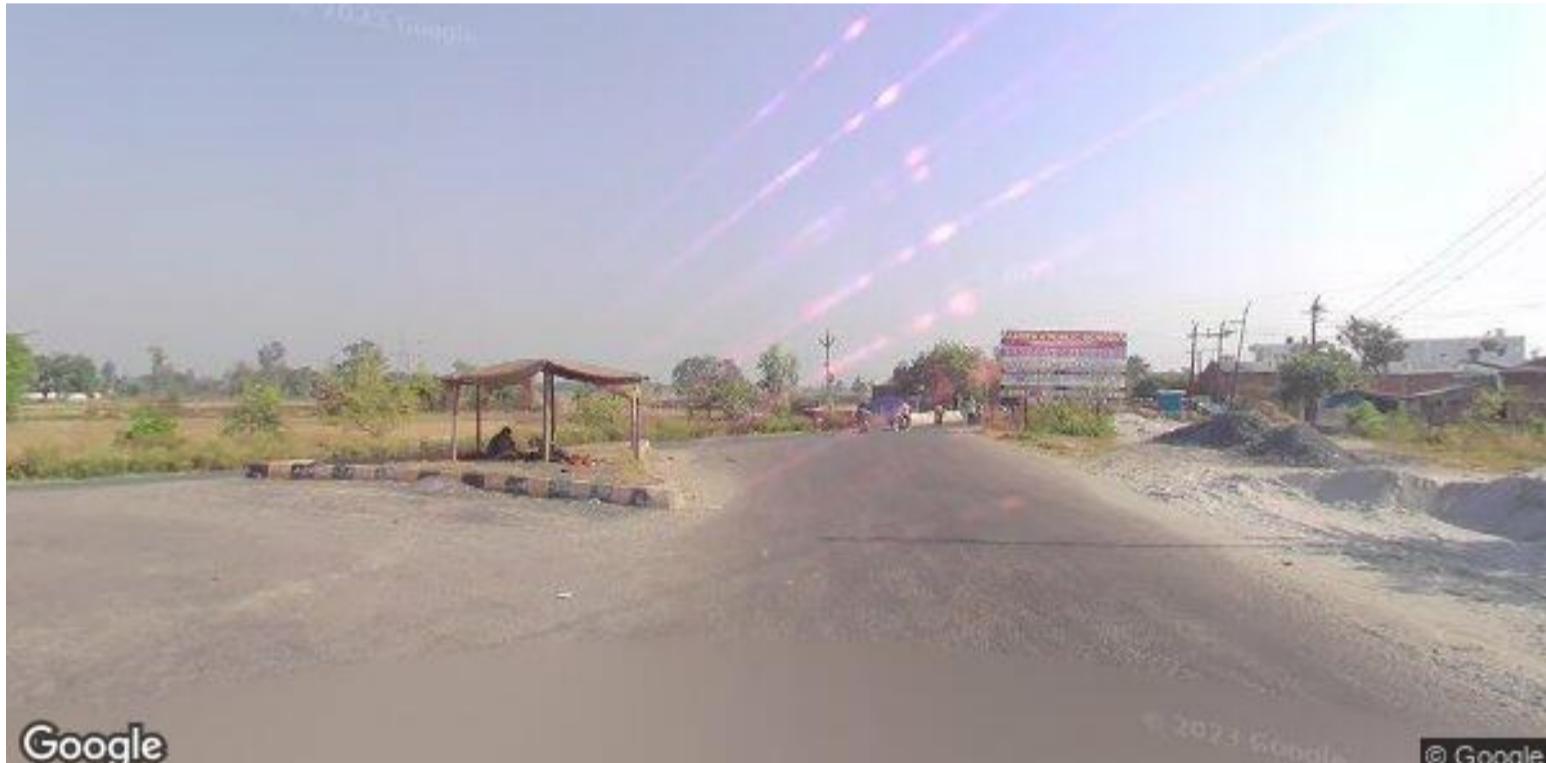
**Risk Type:** Turn**Risk Level:** High**Speed Limit:** 15 KM/Hr**Distance from Start:** 61.38 km**Coordinates:** 26.84777, 82.76661

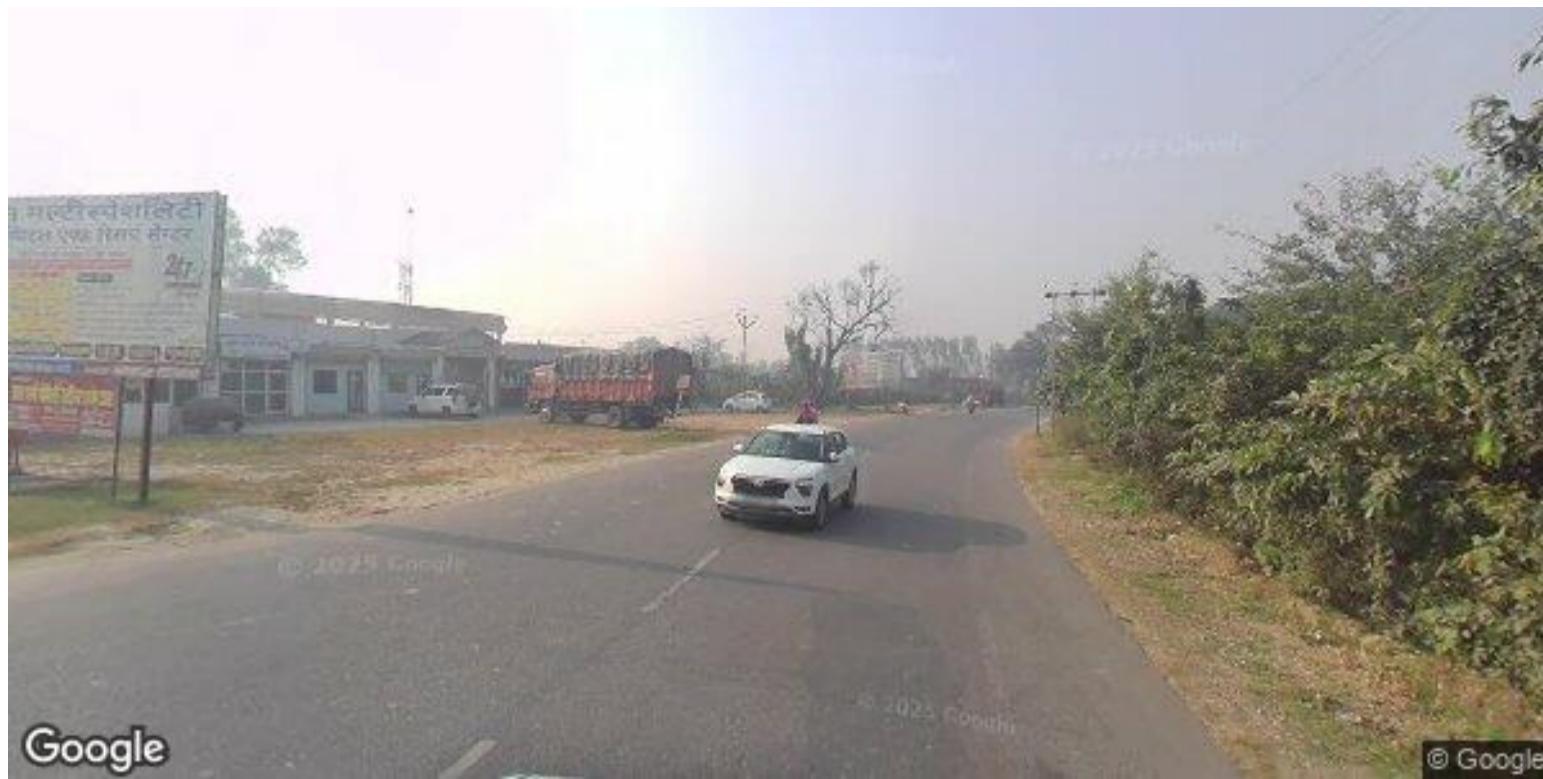
**Risk Type:** Blind Spot**Risk Level:** Blind Spot**Speed Limit:** 10 KM/Hr**Distance from Start:** 61.41 km**Coordinates:** 26.84783, 82.76633

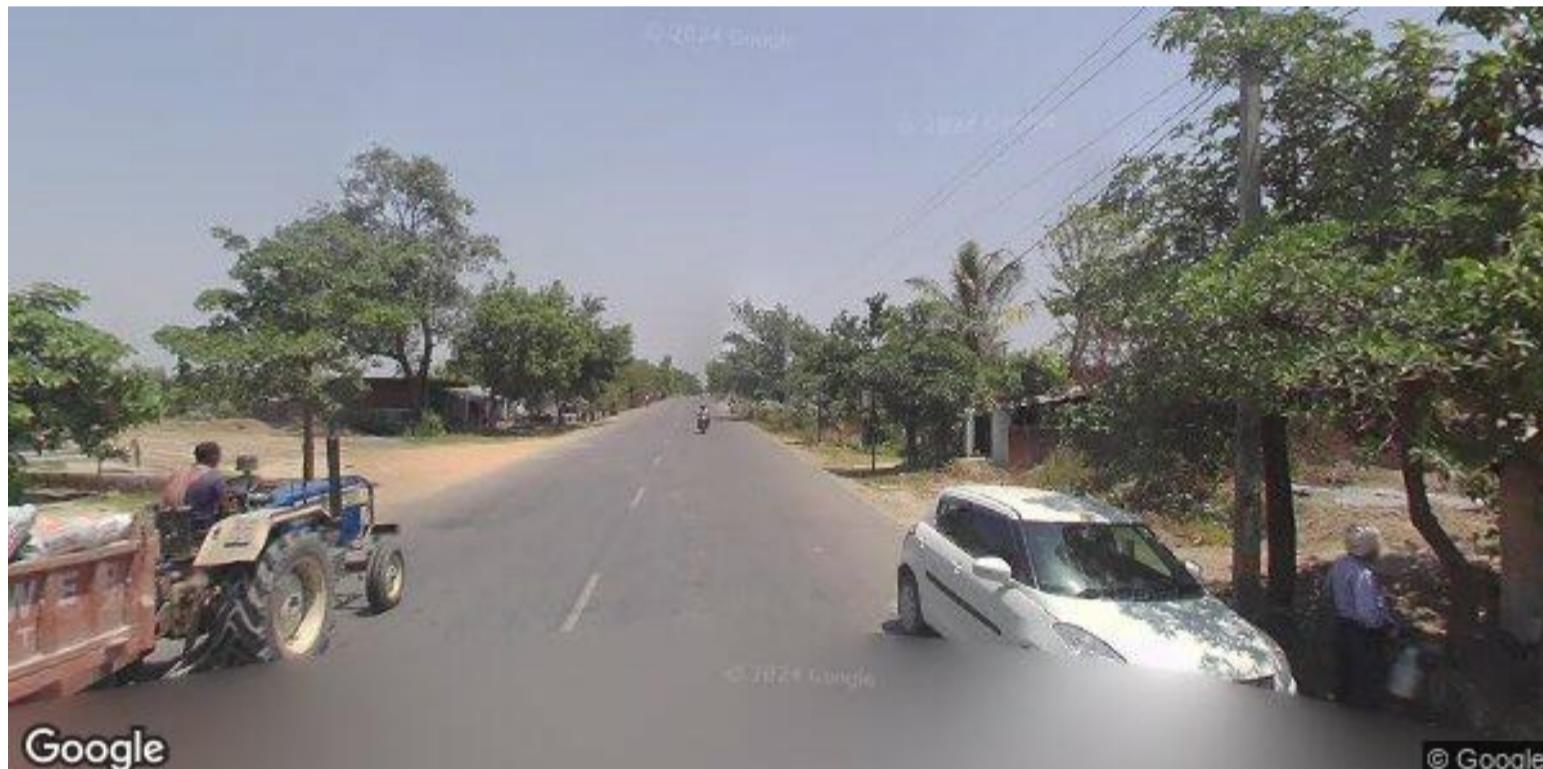
**Risk Type:** Blind Spot**Risk Level:** Blind Spot**Speed Limit:** 10 KM/Hr**Distance from Start:** 64.48 km**Coordinates:** 26.87522, 82.76558

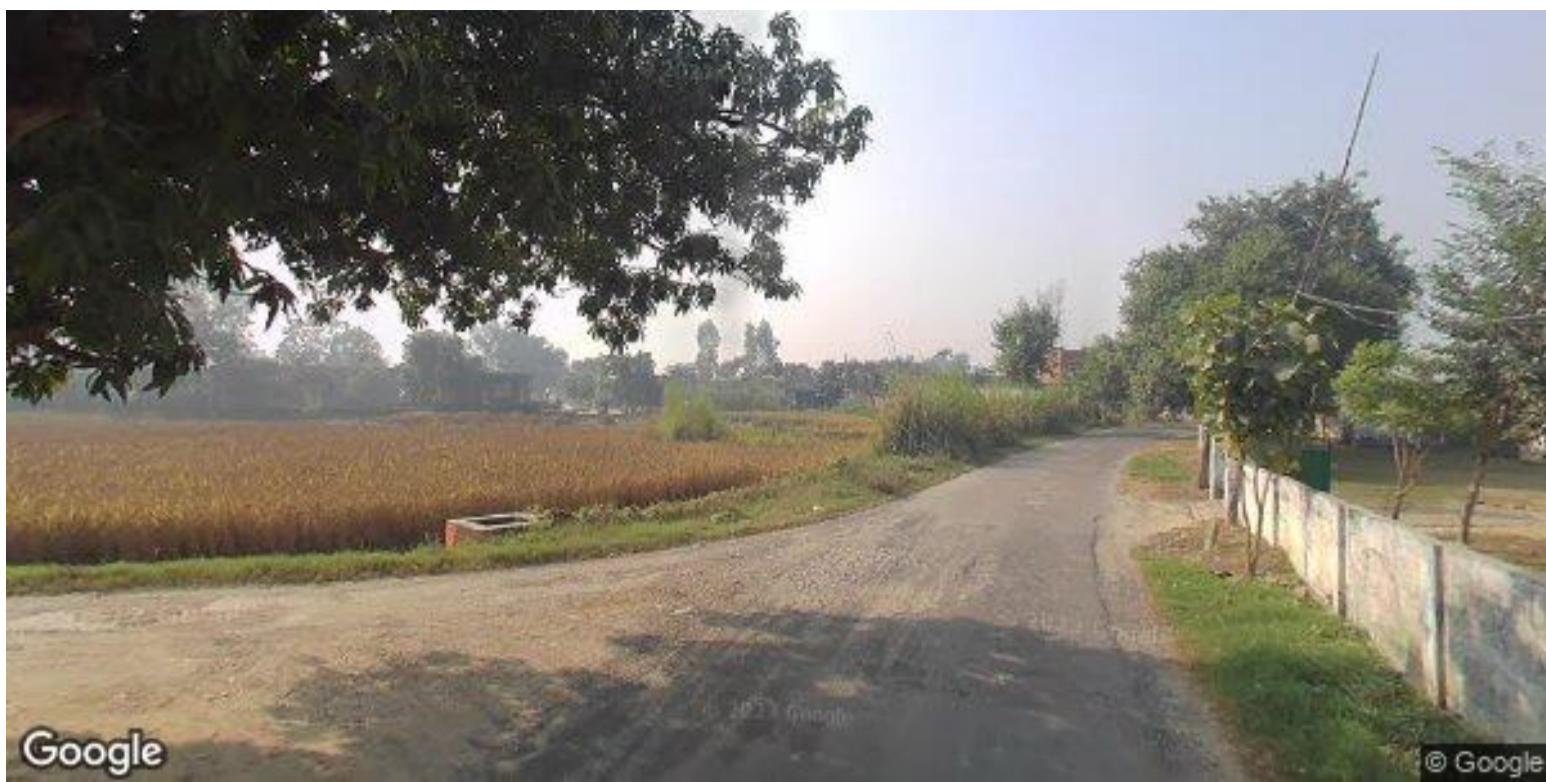
**Risk Type:** Turn

**Risk Level:** Medium

**Speed Limit:** 30 KM/Hr

**Distance from Start:** 65.20 km

**Coordinates:** 26.87383, 82.77251
