## JOURNEY RISK MANAGEMENT (JRM) STUDY

### Gorakhpur LPG BP TO SUN GAS SERVICE

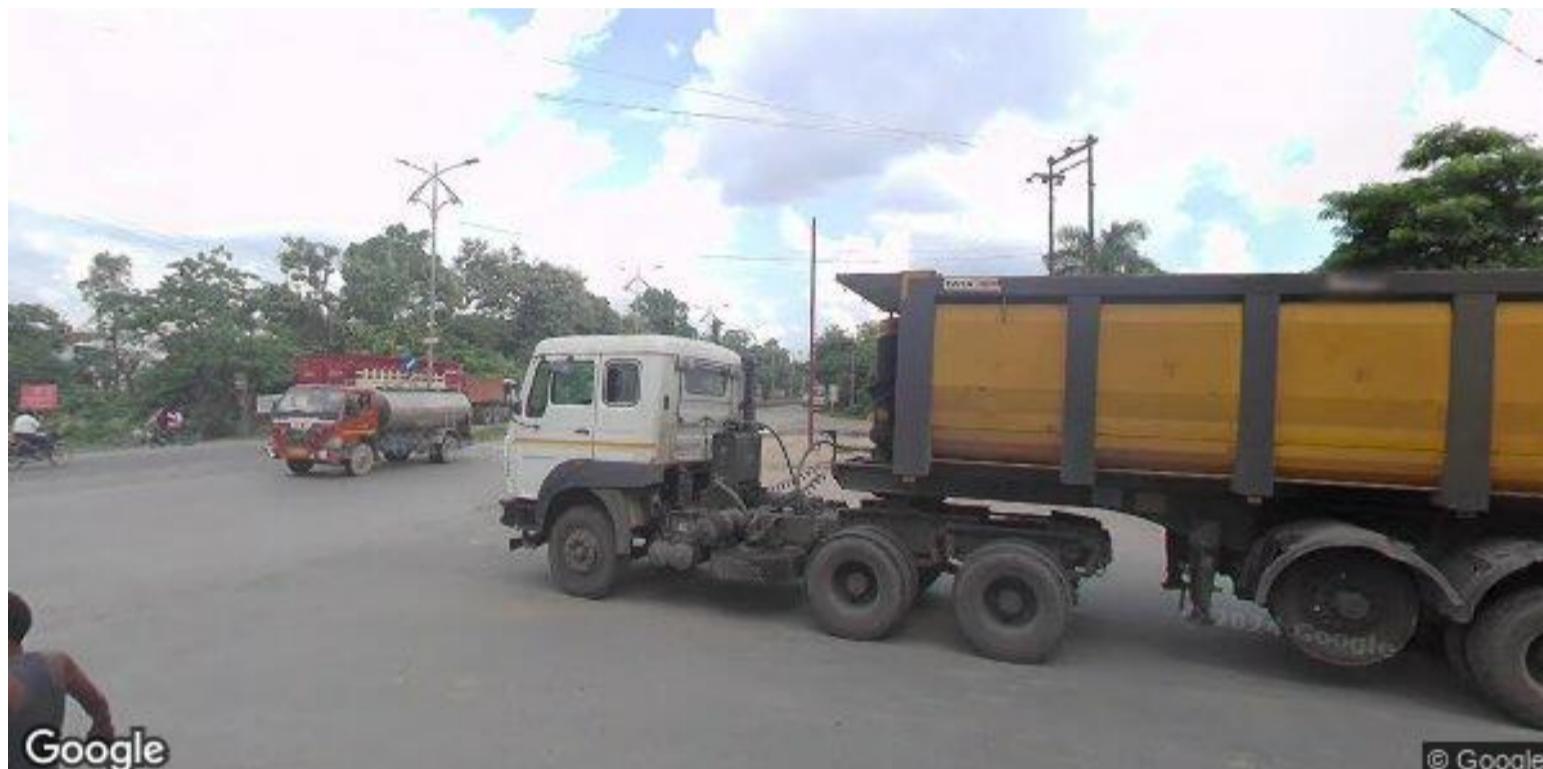
**Coordinates:** 26.75126, 83.22476

**Risk Type:** Blind Spot

**Risk Level:** Blind Spot

**Speed Limit:** 10 KM/Hr

**Distance from Start:** 2.17 km

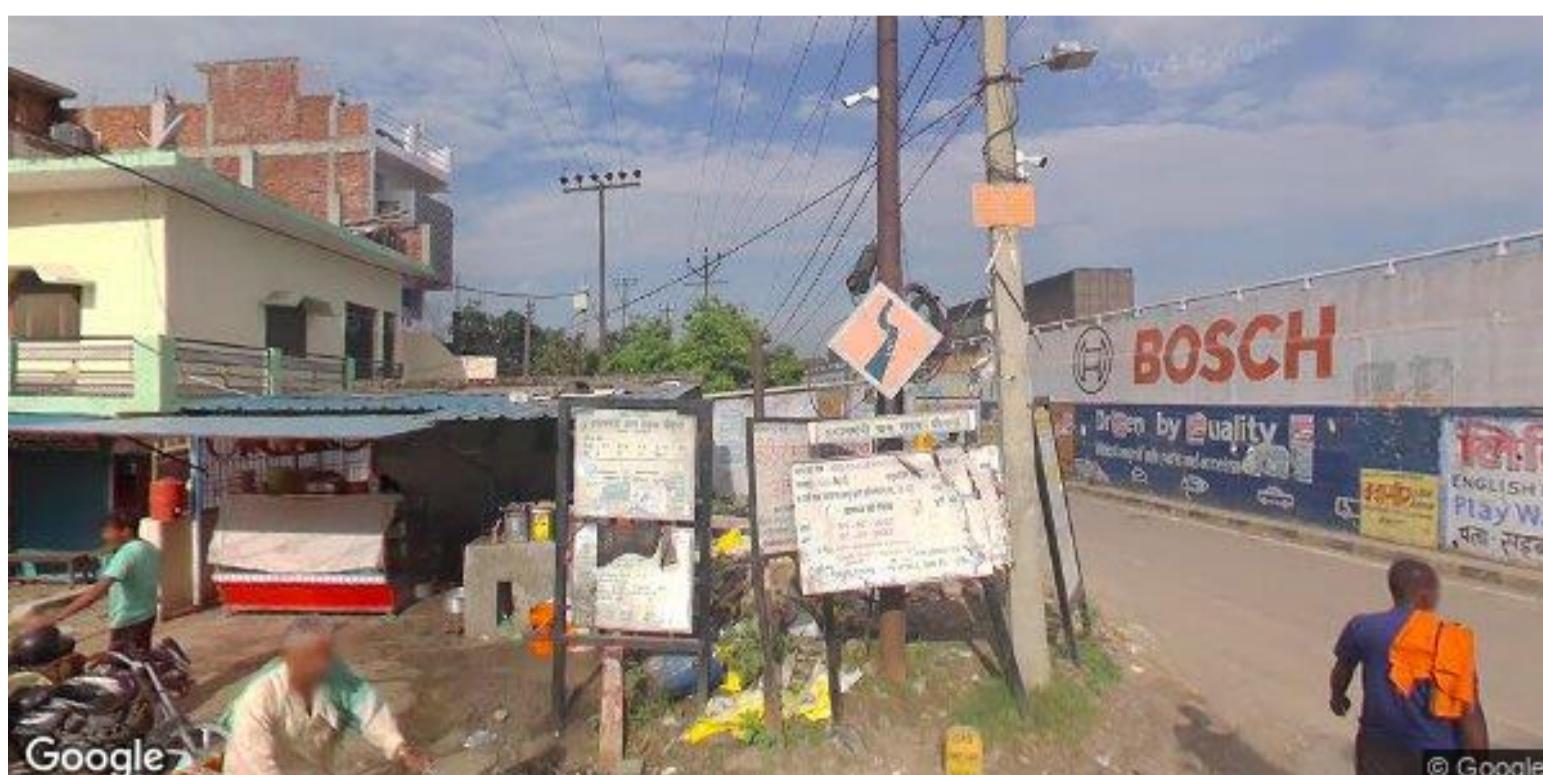
**Coordinates:** 26.75353, 83.20457

**Risk Type:** Blind Spot

**Risk Level:** Blind Spot

**Speed Limit:** 10 KM/Hr

**Distance from Start:** 4.23 km

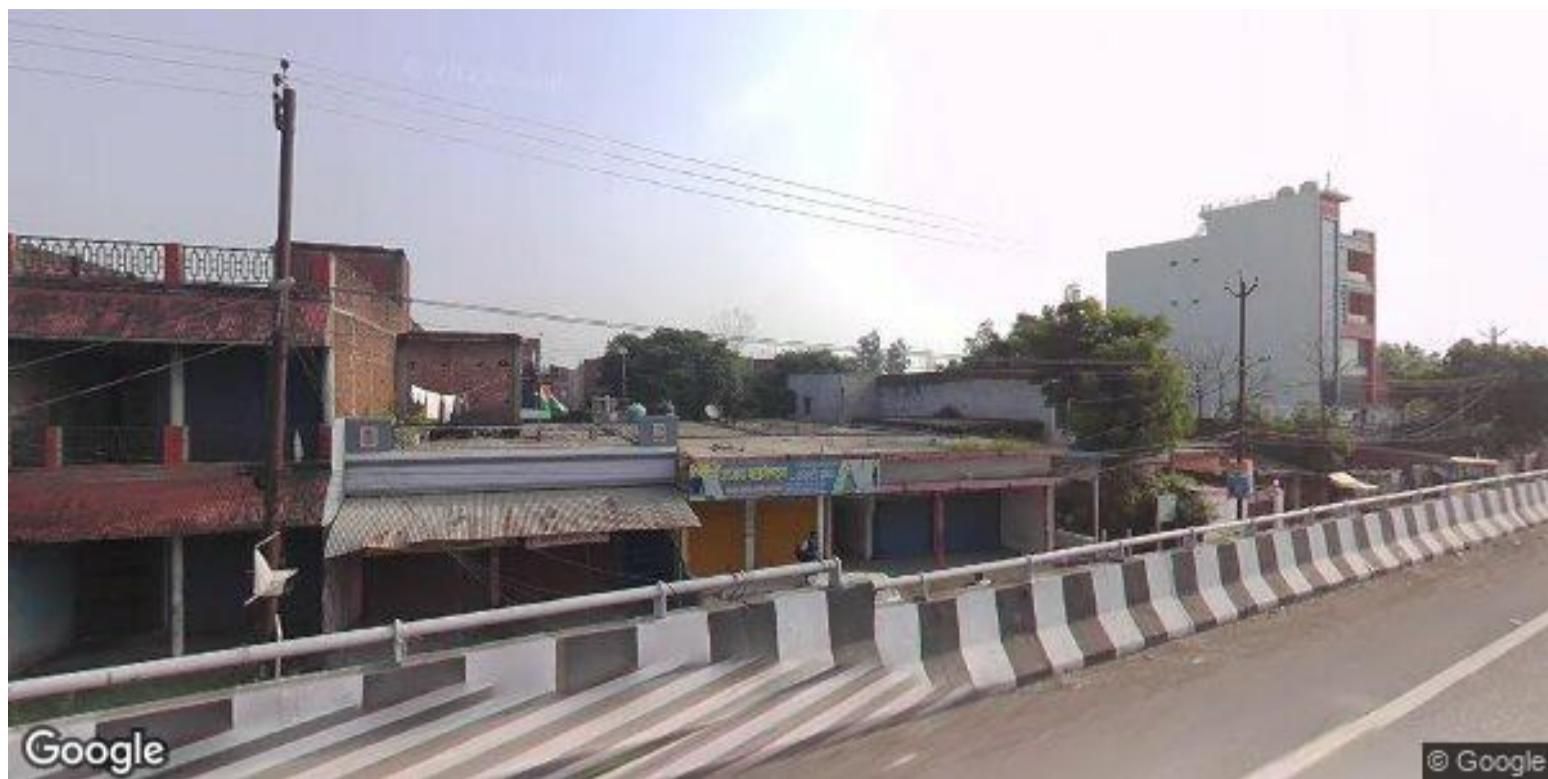
**Coordinates:** 26.75377, 83.20465

**Risk Type:** Turn

**Risk Level:** High

**Speed Limit:** 15 KM/Hr

**Distance from Start:** 4.28 km

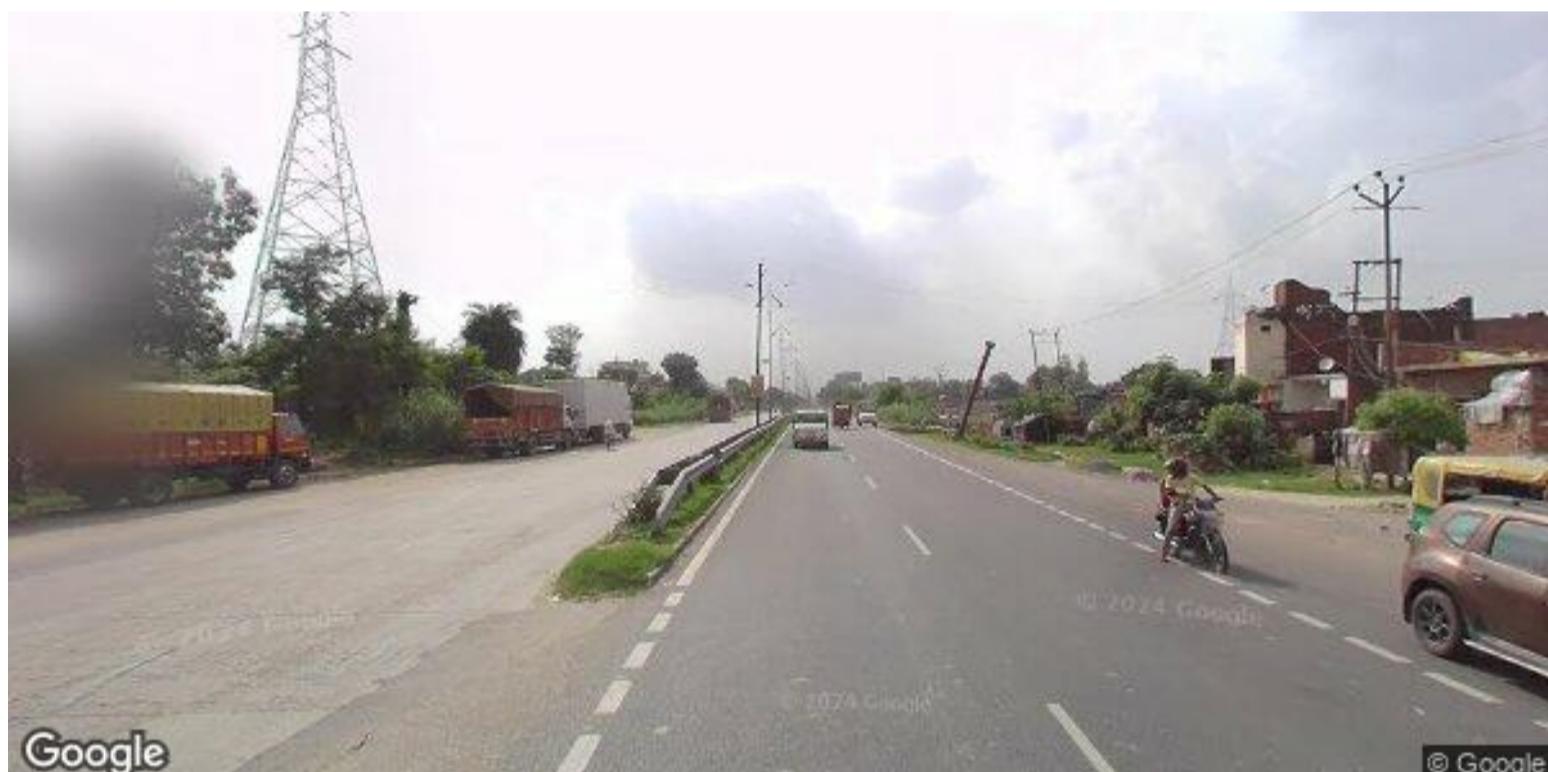
**Coordinates:** 26.7471208, 83.2490873

**Risk Type:** U-Turn

**Risk Level:** High

**Speed Limit:** 10 KM/Hr

**Distance from Start:** 8.75 km

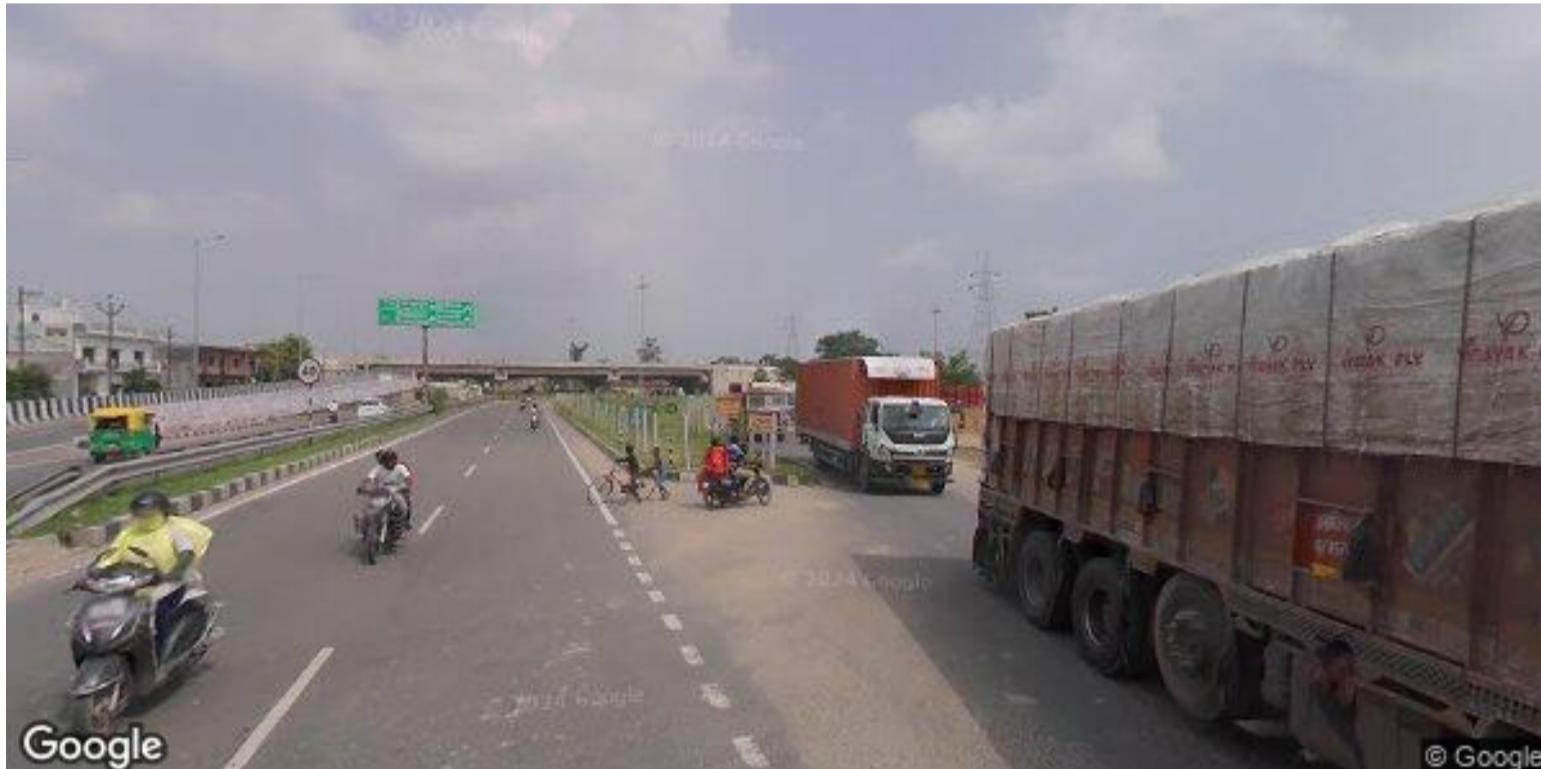
**Risk Type:** Turn**Risk Level:** High**Speed Limit:** 15 KM/Hr**Distance from Start:** 8.79 km**Coordinates:** 26.74703, 83.24907

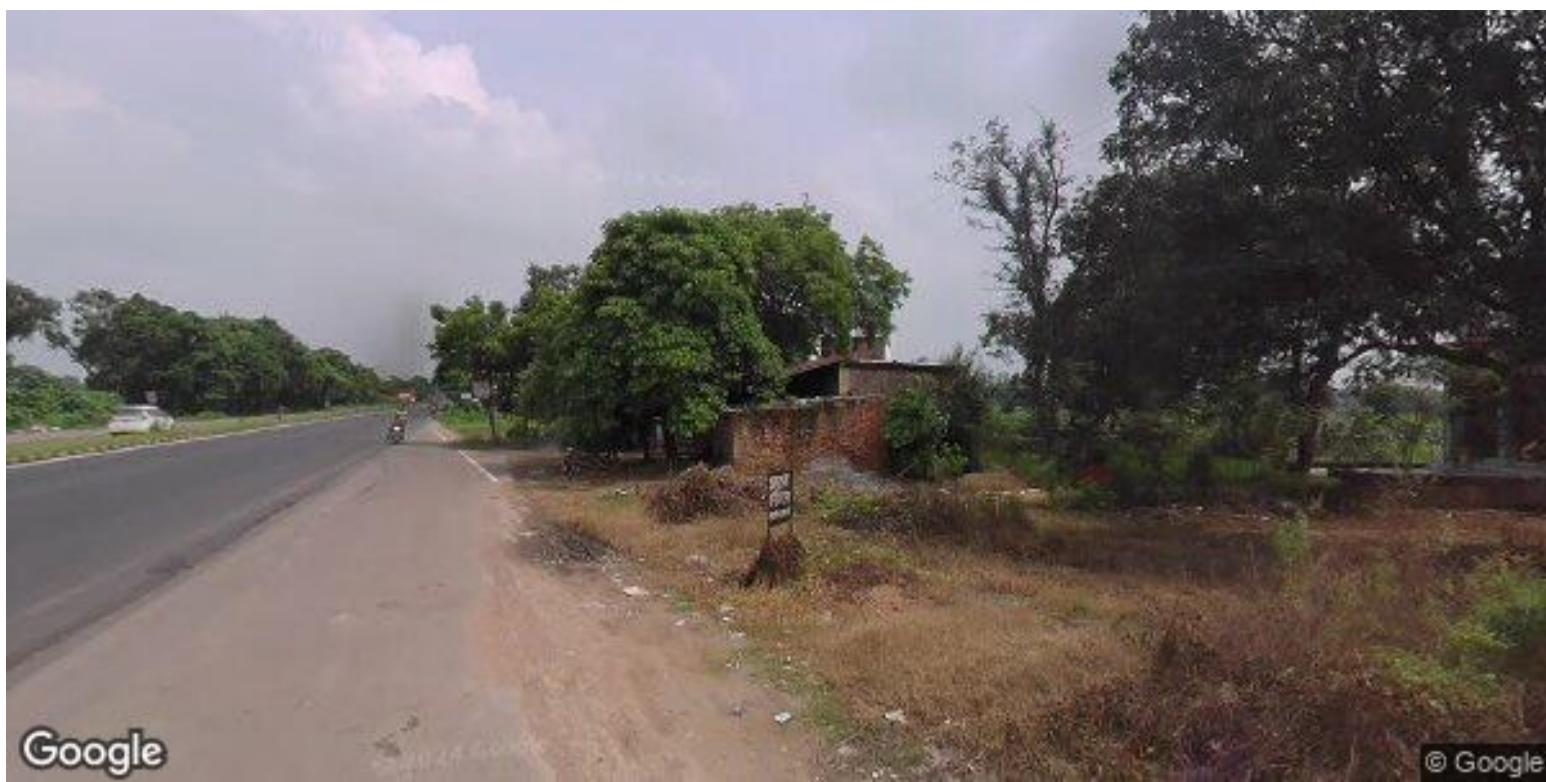
**Coordinates:** 26.76367, 82.55861

**Risk Type:** Turn

**Risk Level:** Medium

**Speed Limit:** 30 KM/Hr

**Distance from Start:** 82.67 km

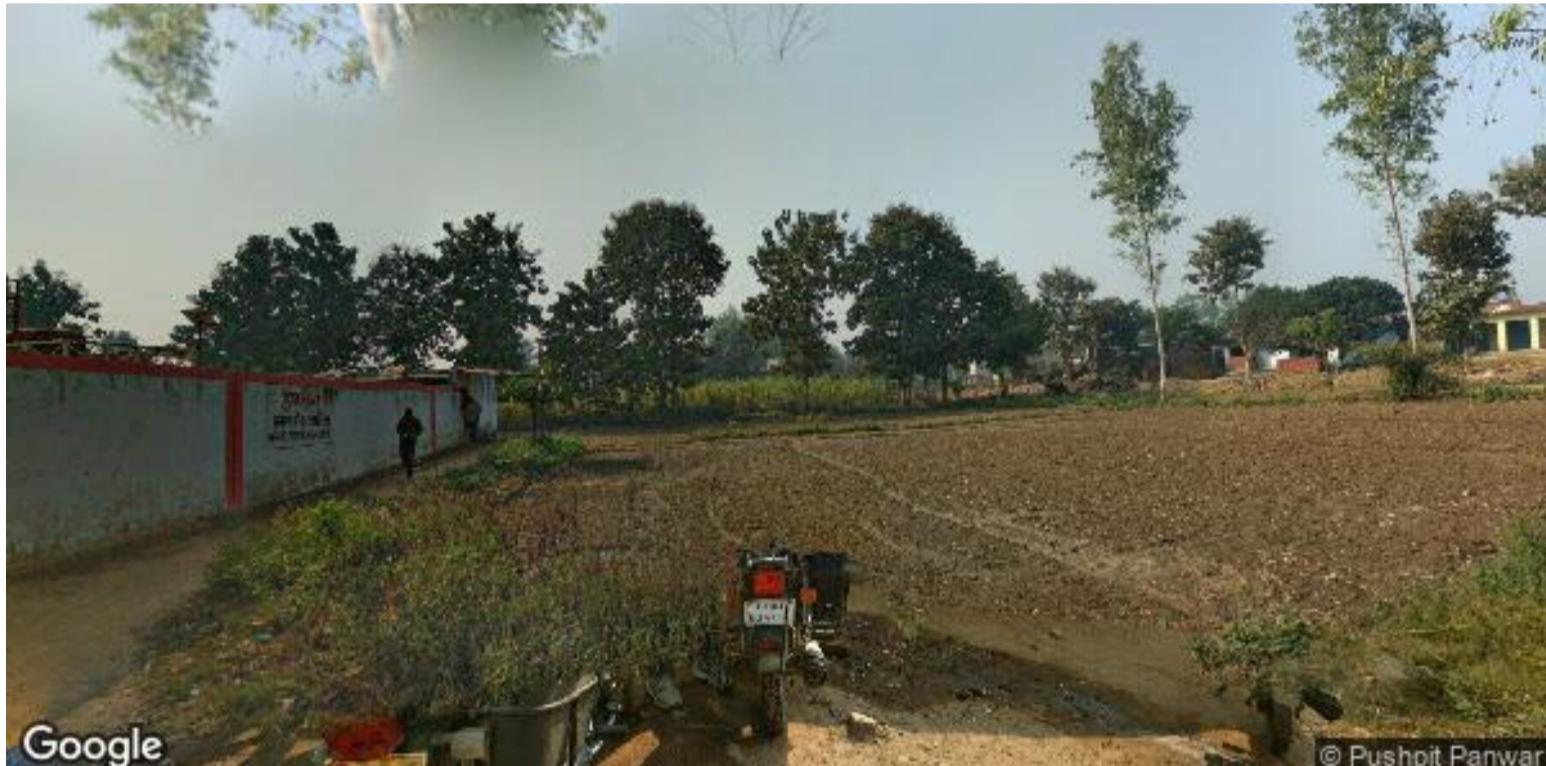
**Coordinates:** 26.77852, 82.55863

**Risk Type:** Turn

**Risk Level:** Medium

**Speed Limit:** 30 KM/Hr

**Distance from Start:** 85.84 km

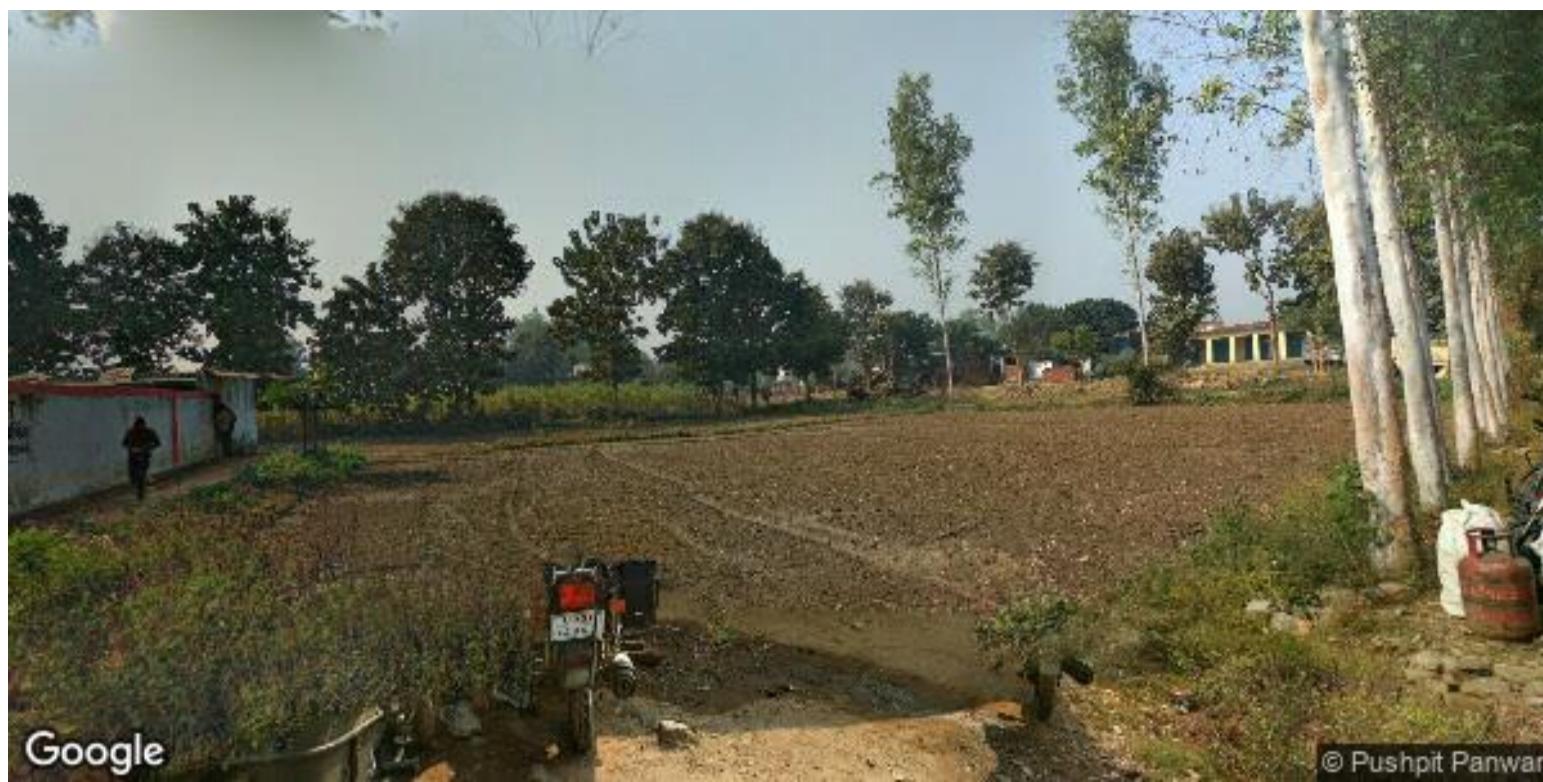
**Risk Type: Turn****Risk Level: High****Speed Limit: 15 KM/Hr****Distance from Start: 85.89 km****Coordinates: 26.77857, 82.55875**
