IndianOil

JOURNEY RISK MANAGEMENT (JRM) STUDY

Gorakhpur LPG BP to ARCHANA INDANE GAS SERVICE

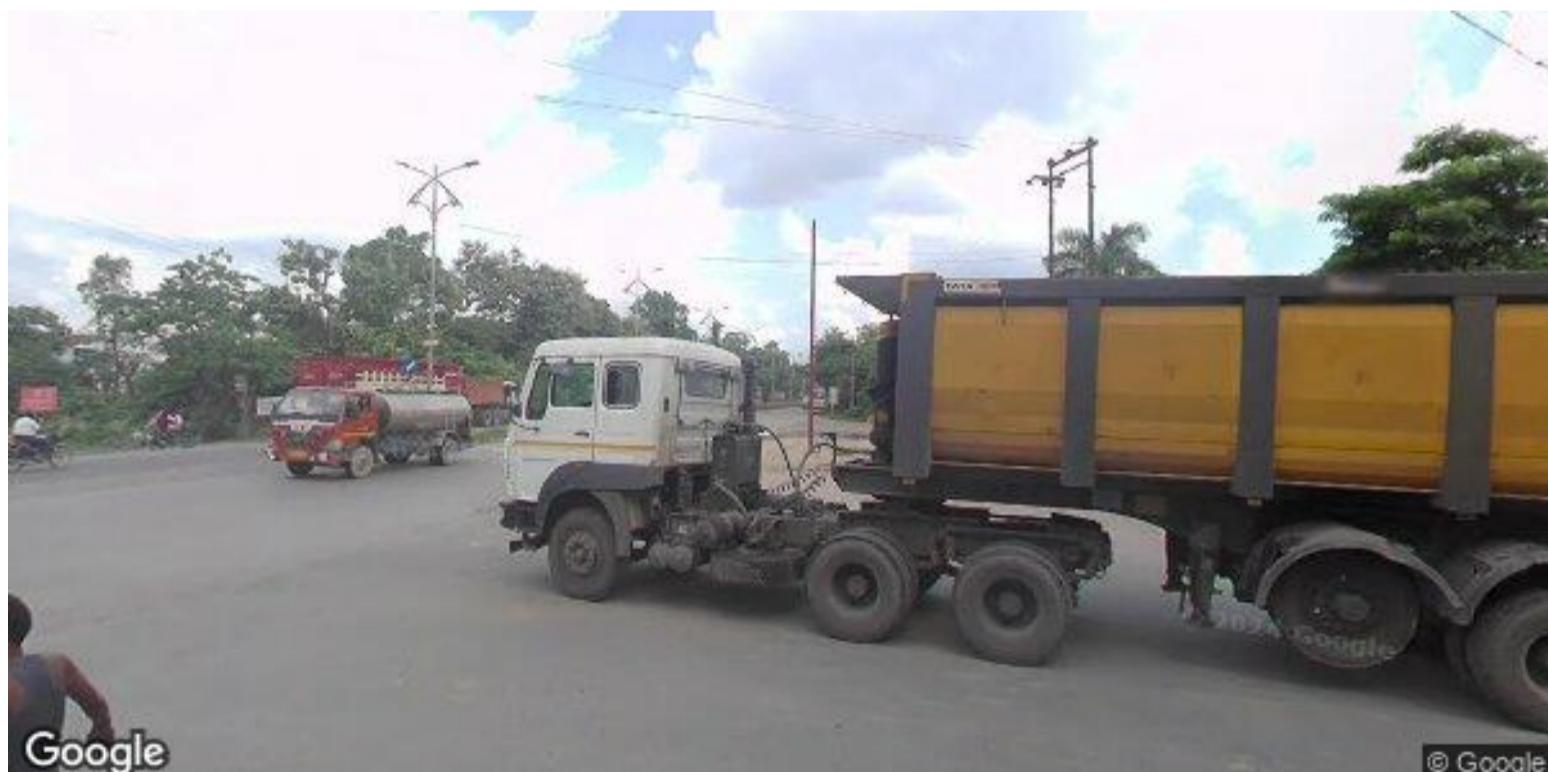
Coordinates: 26.75126, 83.22476

Risk Type: Blind Spot

Risk Level: Blind Spot

Speed Limit: 10 KM/Hr

Distance from Start: 2.17 km

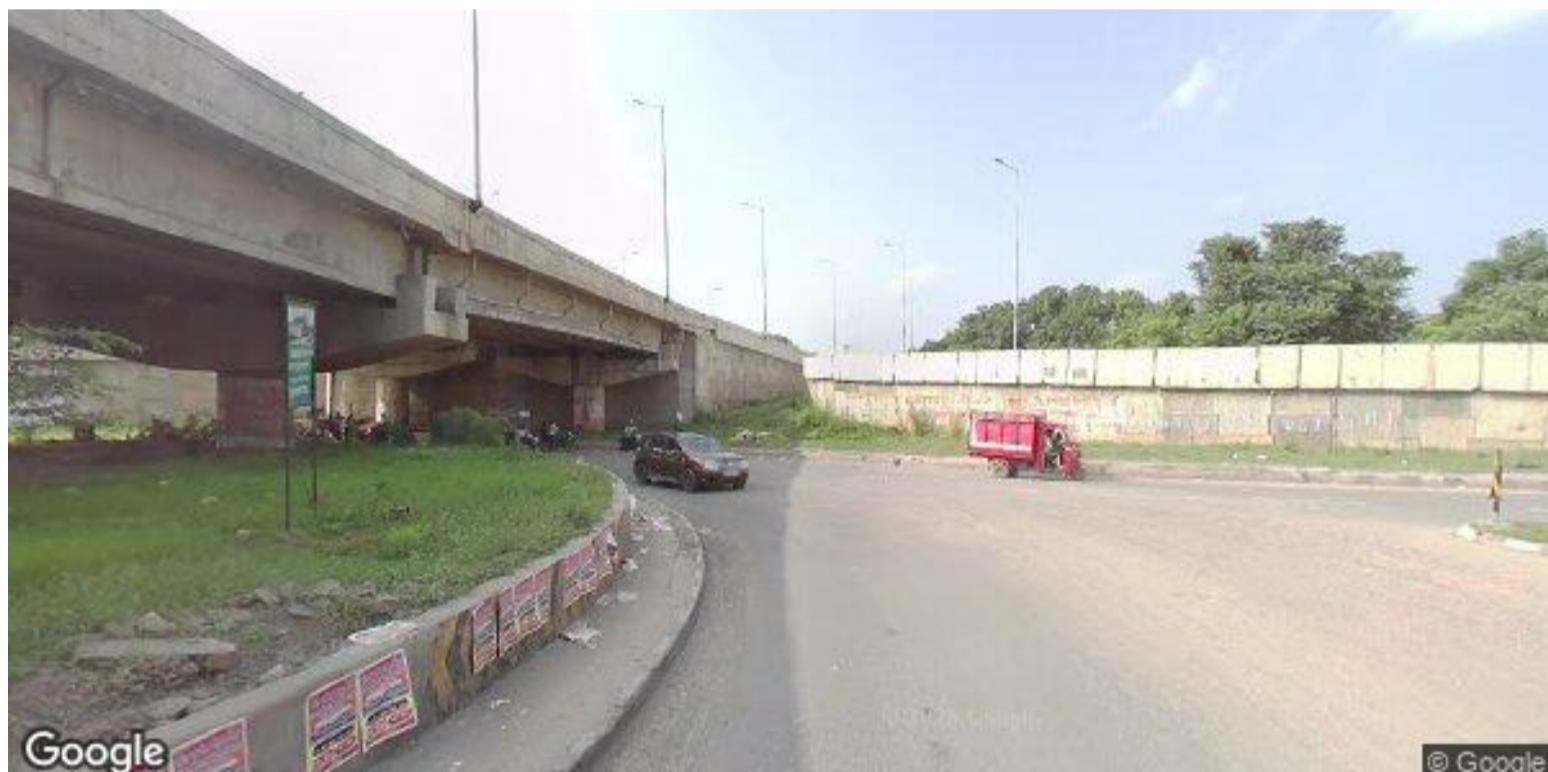
Coordinates: 26.74656, 83.25154

Risk Type: Turn

Risk Level: Medium

Speed Limit: 30 KM/Hr

Distance from Start: 9.05 km

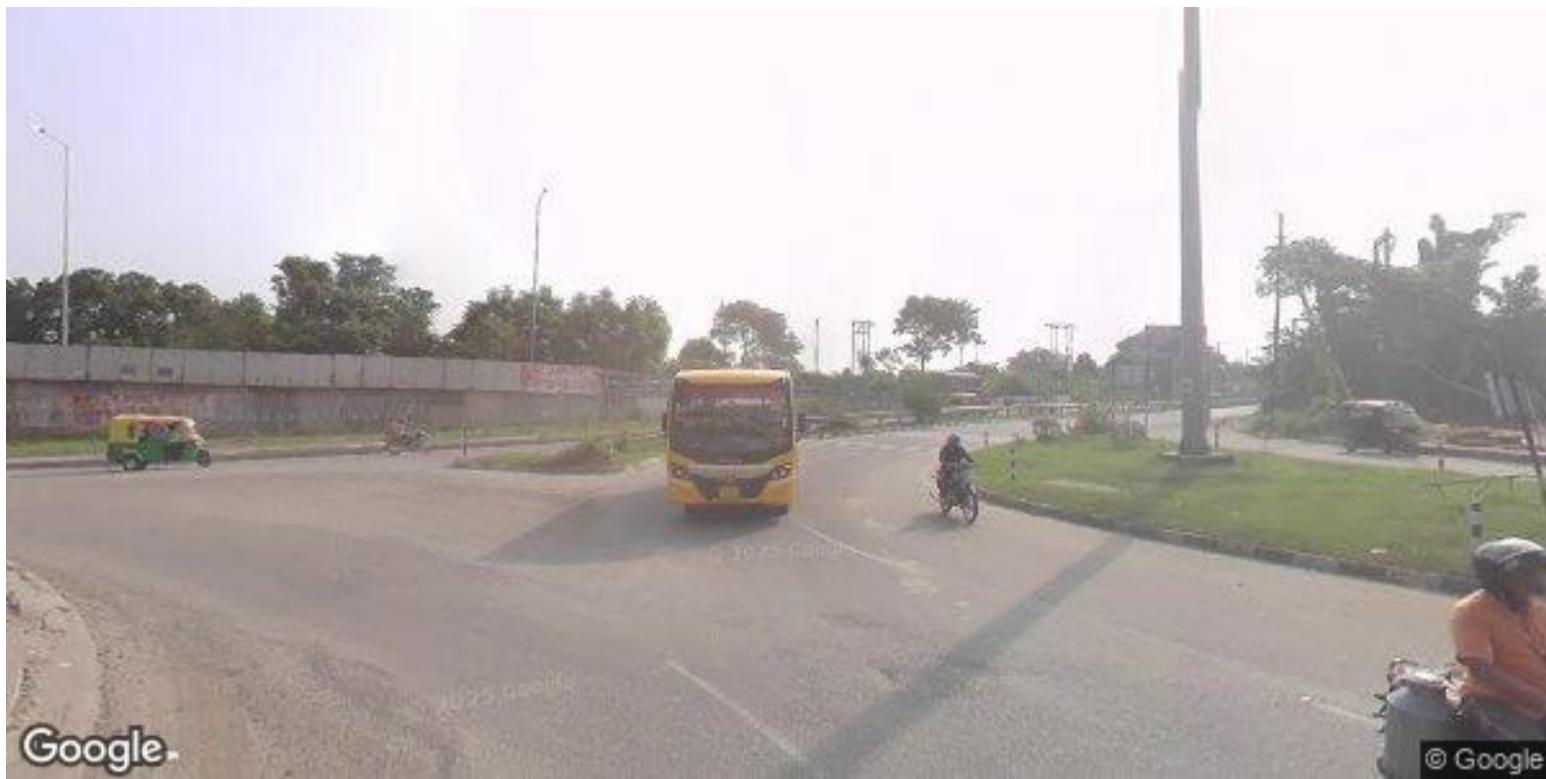
Coordinates: 26.74644, 83.25150

Risk Type: Turn

Risk Level: Medium

Speed Limit: 30 KM/Hr

Distance from Start: 9.07 km

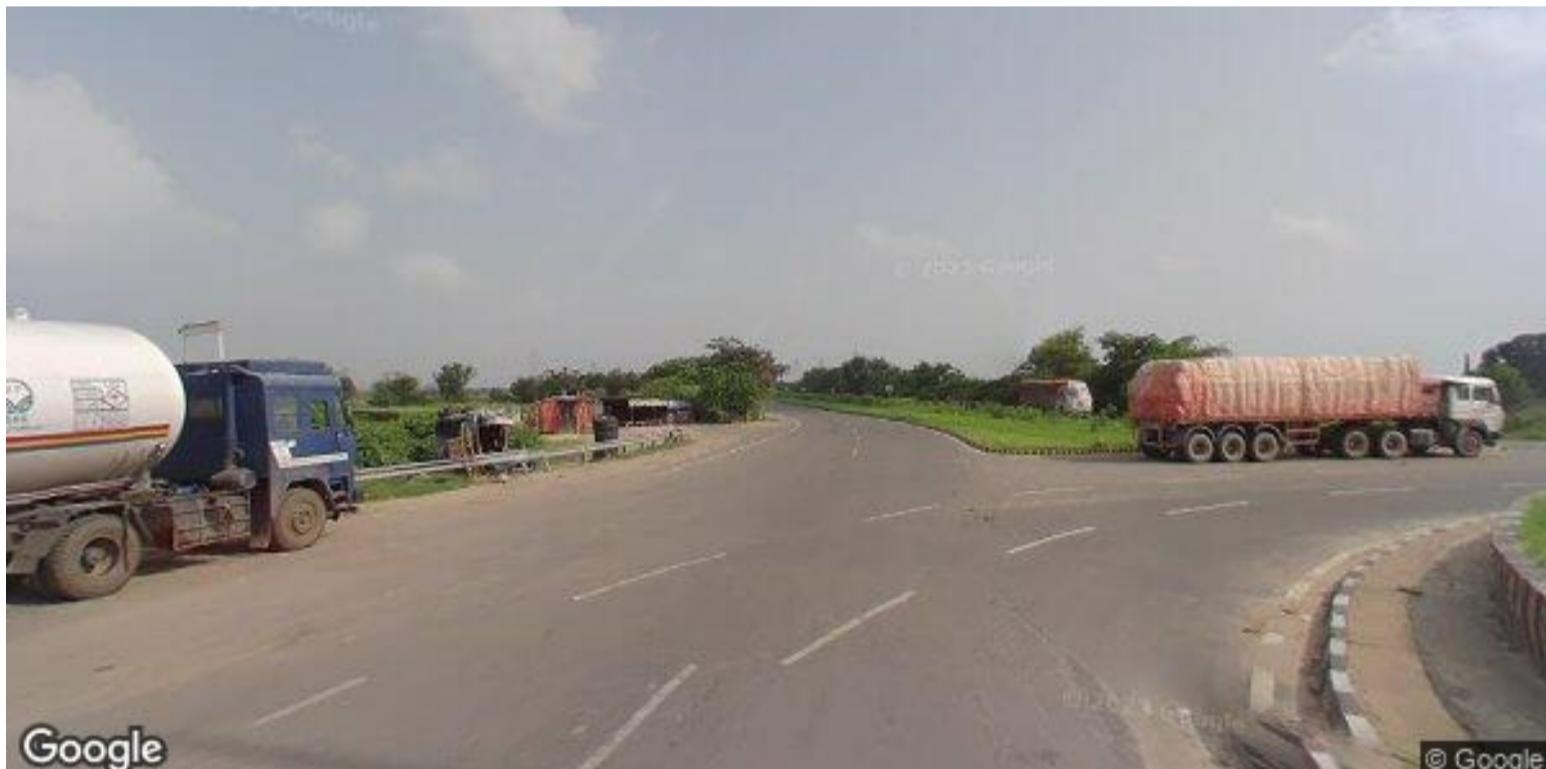
Coordinates: 26.74306, 83.25344

Risk Type: Turn

Risk Level: Medium

Speed Limit: 30 KM/Hr

Distance from Start: 9.49 km

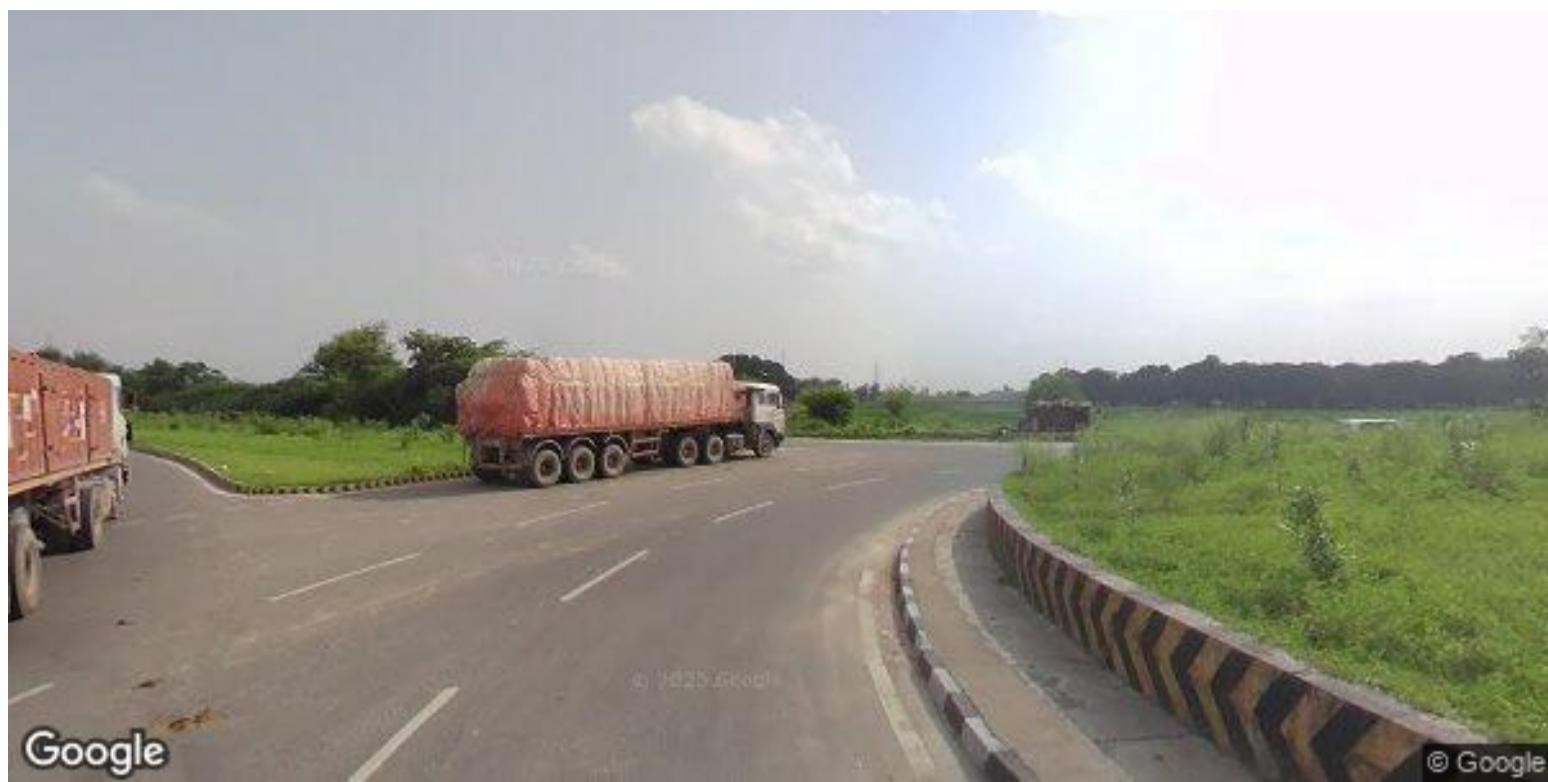
Coordinates: 26.74300, 83.25343

Risk Type: Turn

Risk Level: Medium

Speed Limit: 30 KM/Hr

Distance from Start: 9.50 km

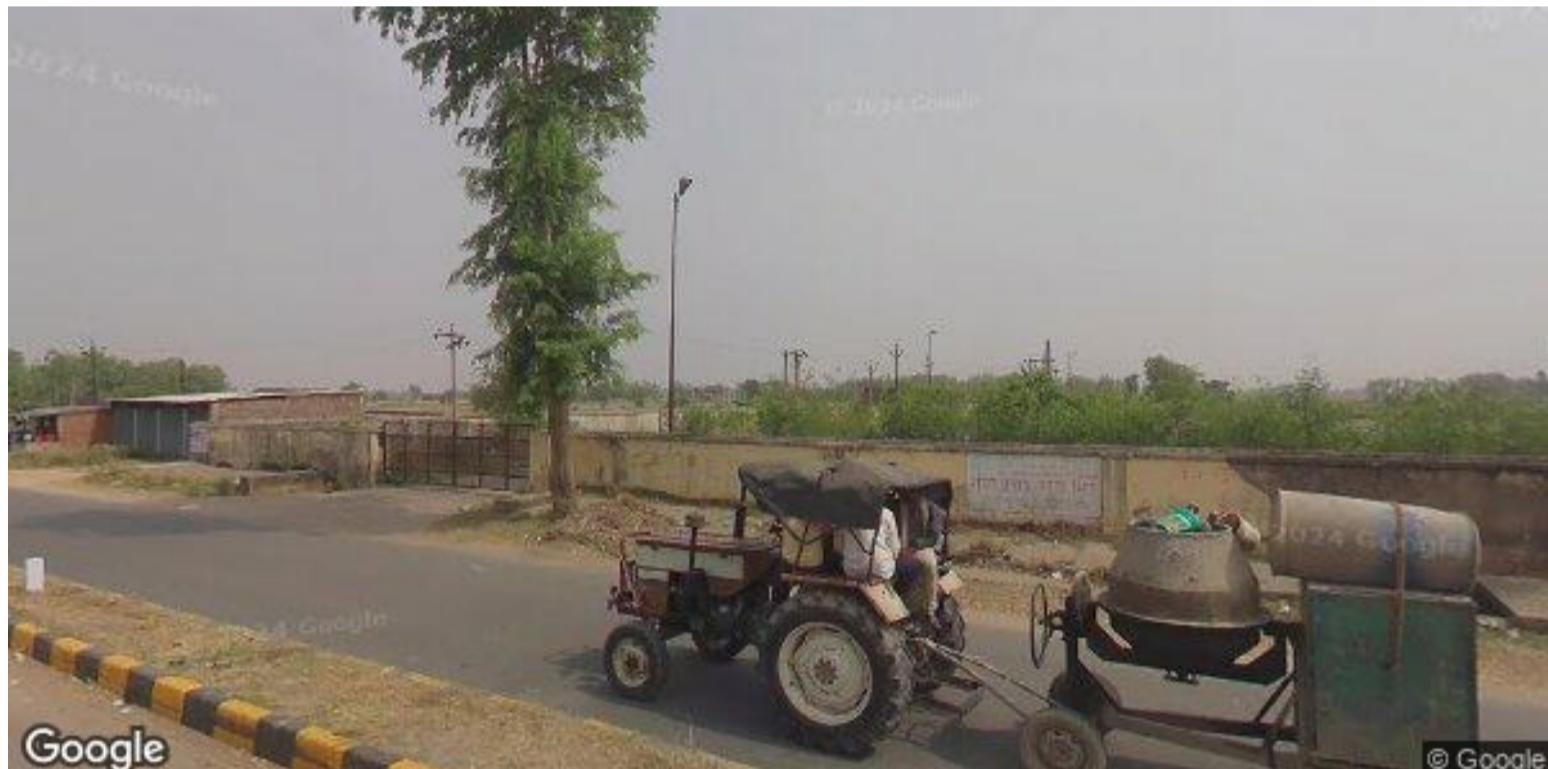
Coordinates: 26.74526, 83.53161

Risk Type: Turn

Risk Level: Medium

Speed Limit: 30 KM/Hr

Distance from Start: 41.18 km

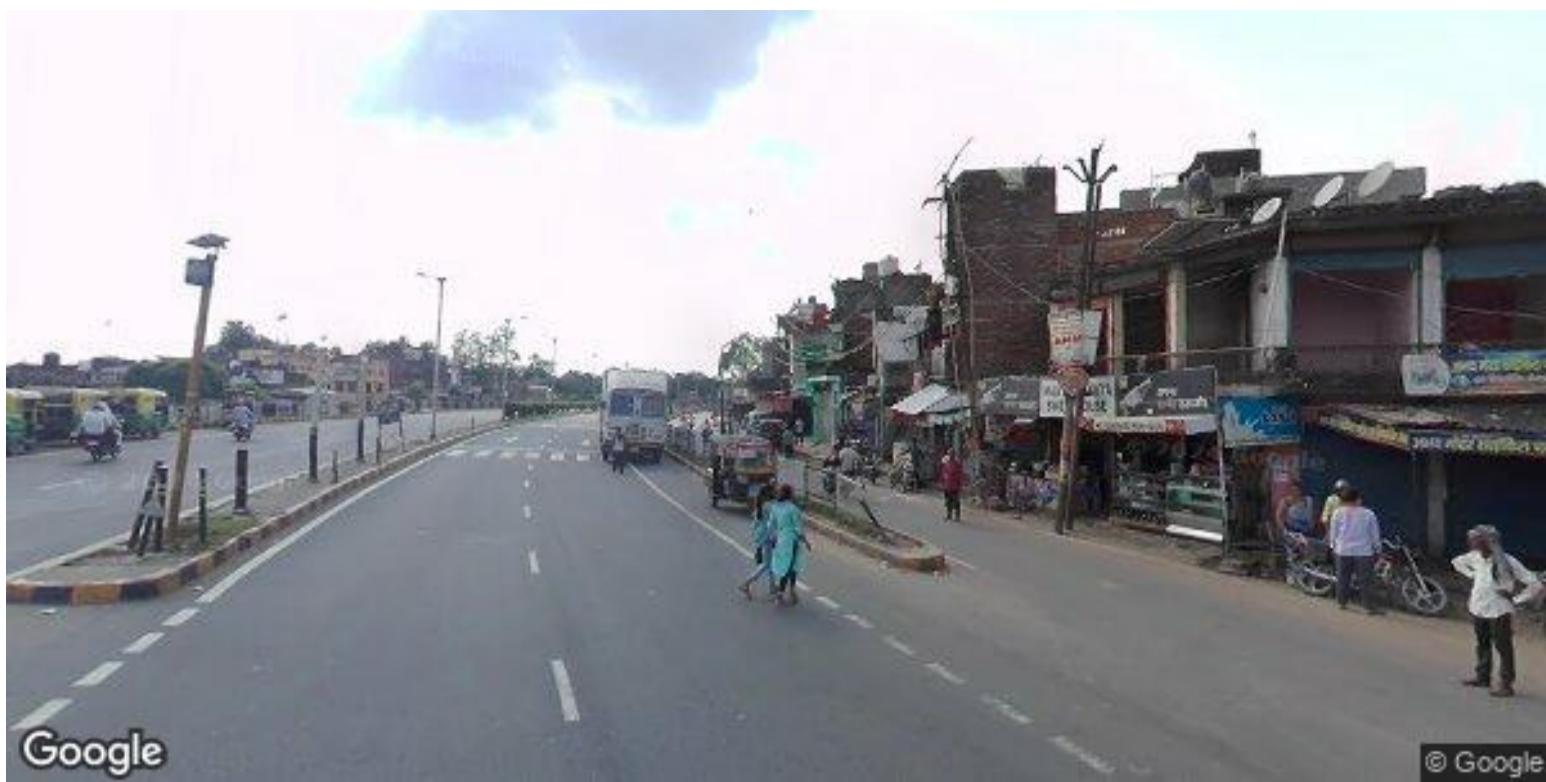
Coordinates: 26.74095, 83.73588

Risk Type: Turn

Risk Level: High

Speed Limit: 15 KM/Hr

Distance from Start: 61.59 km

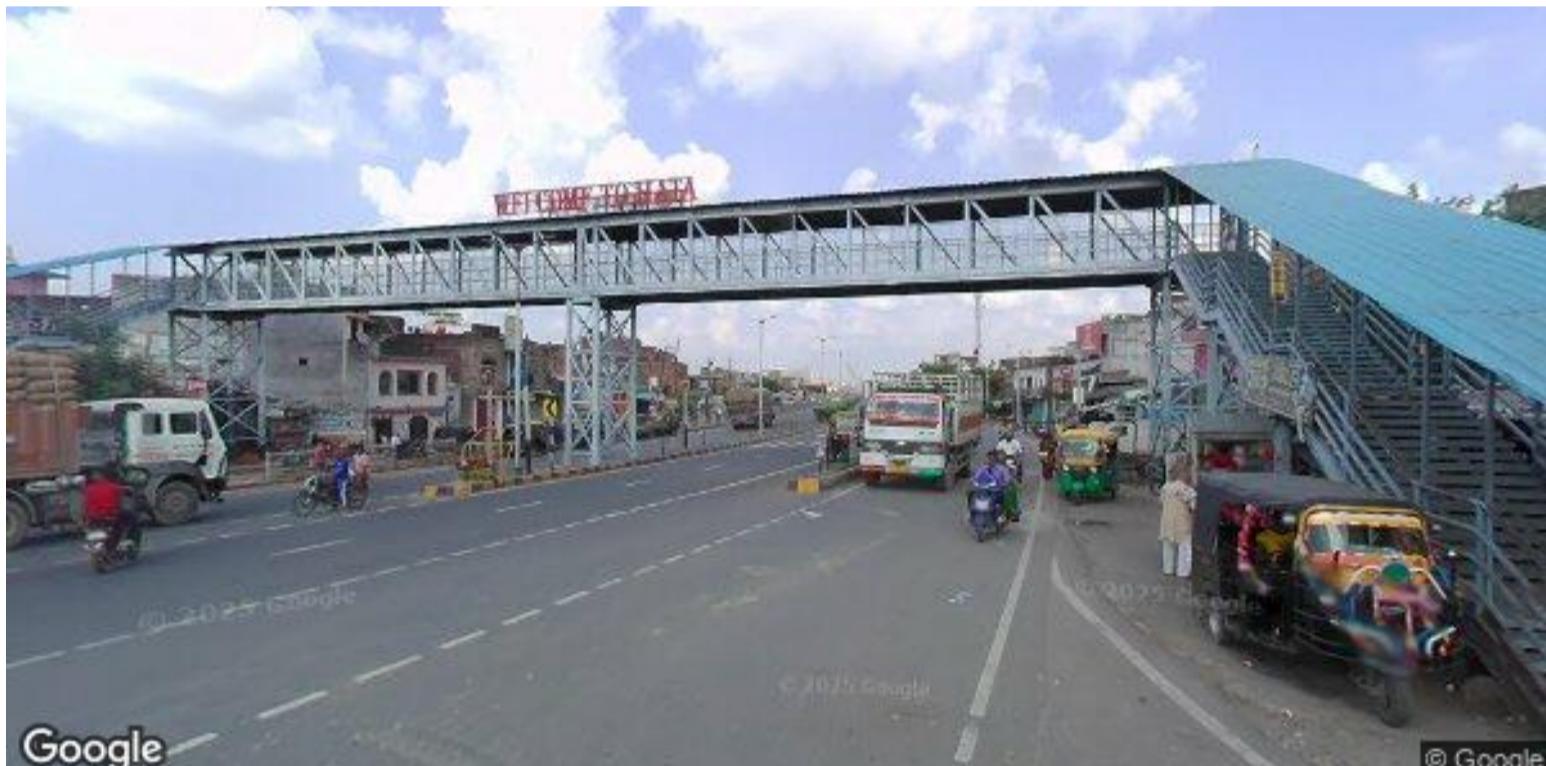
Coordinates: 26.74083, 83.73599

Risk Type: Turn

Risk Level: High

Speed Limit: 15 KM/Hr

Distance from Start: 61.61 km

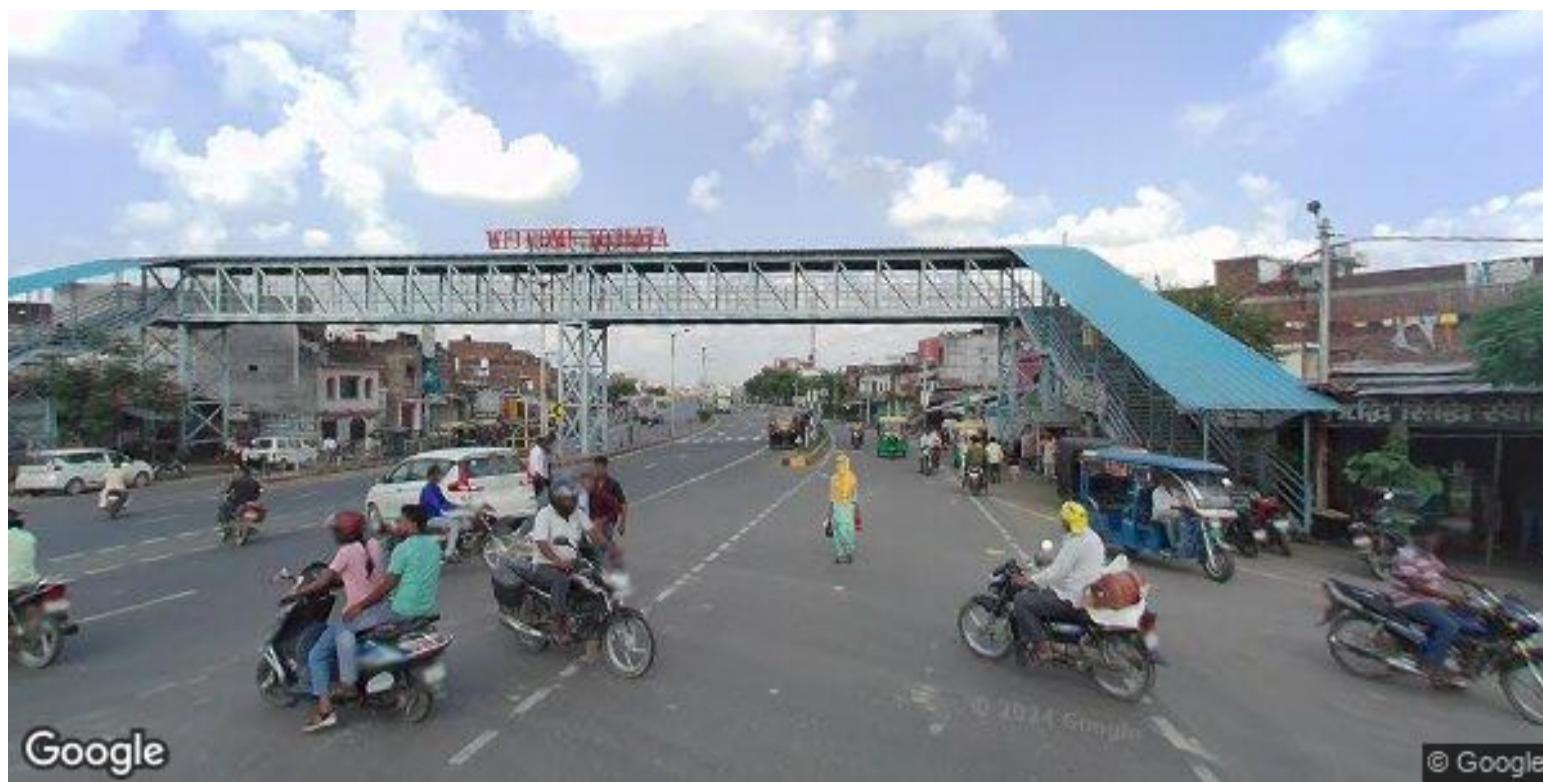
Coordinates: 26.74077, 83.73593

Risk Type: Turn

Risk Level: High

Speed Limit: 15 KM/Hr

Distance from Start: 61.61 km

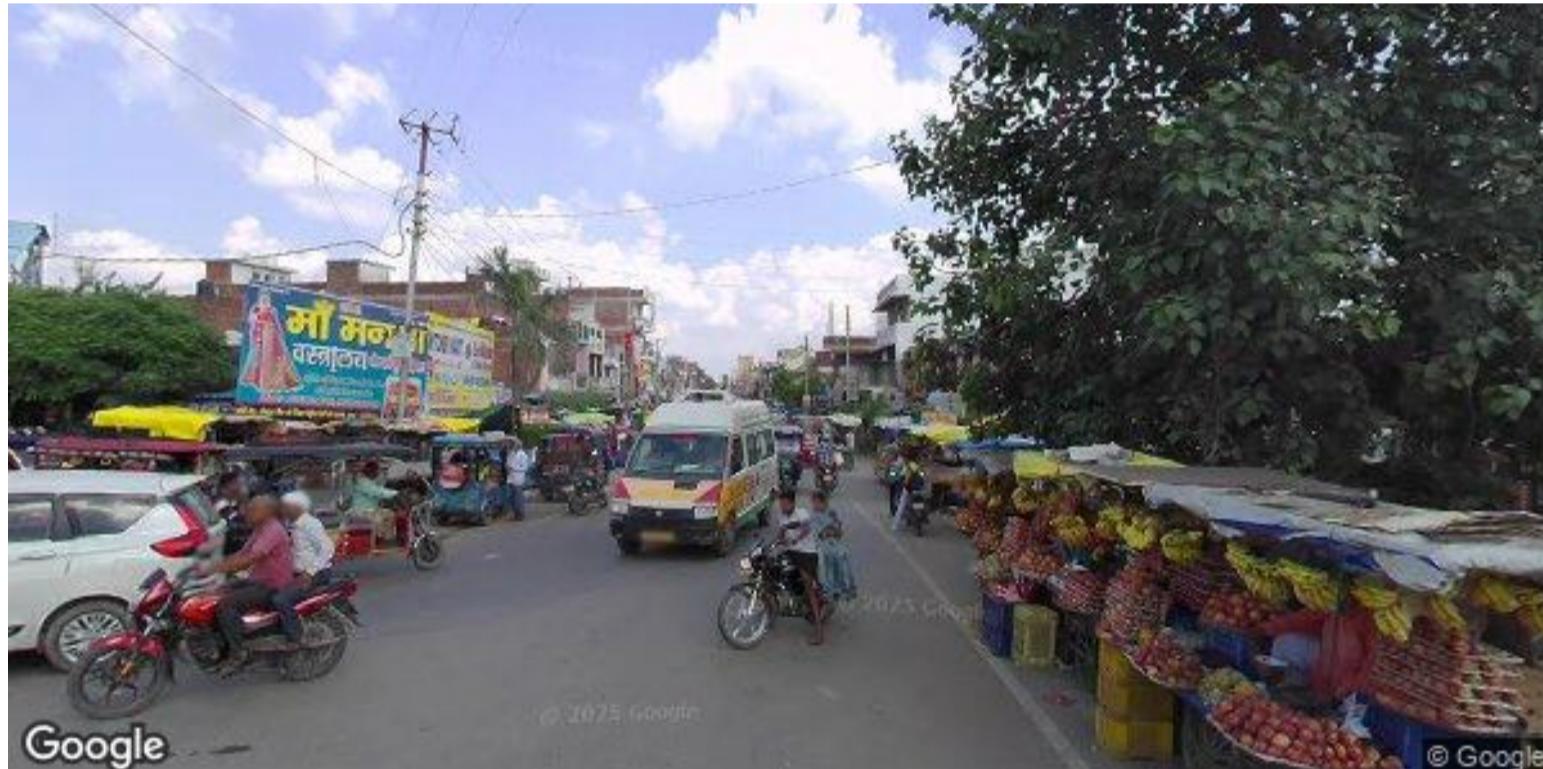
Coordinates: 26.74055, 83.73597

Risk Type: Turn

Risk Level: High

Speed Limit: 15 KM/Hr

Distance from Start: 61.64 km

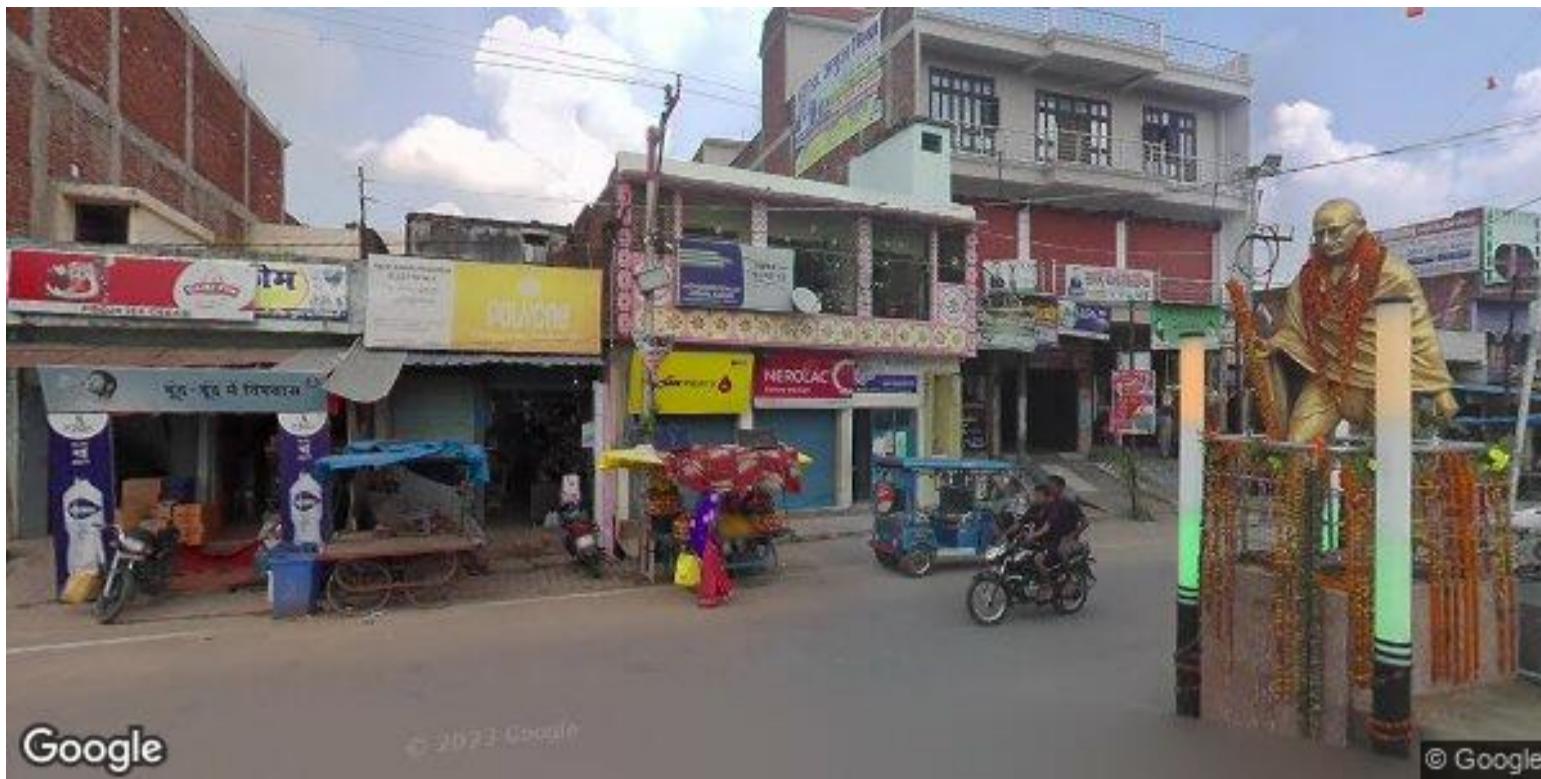
Coordinates: 26.74089, 83.73798

Risk Type: Blind Spot

Risk Level: Blind Spot

Speed Limit: 10 KM/Hr

Distance from Start: 61.81 km

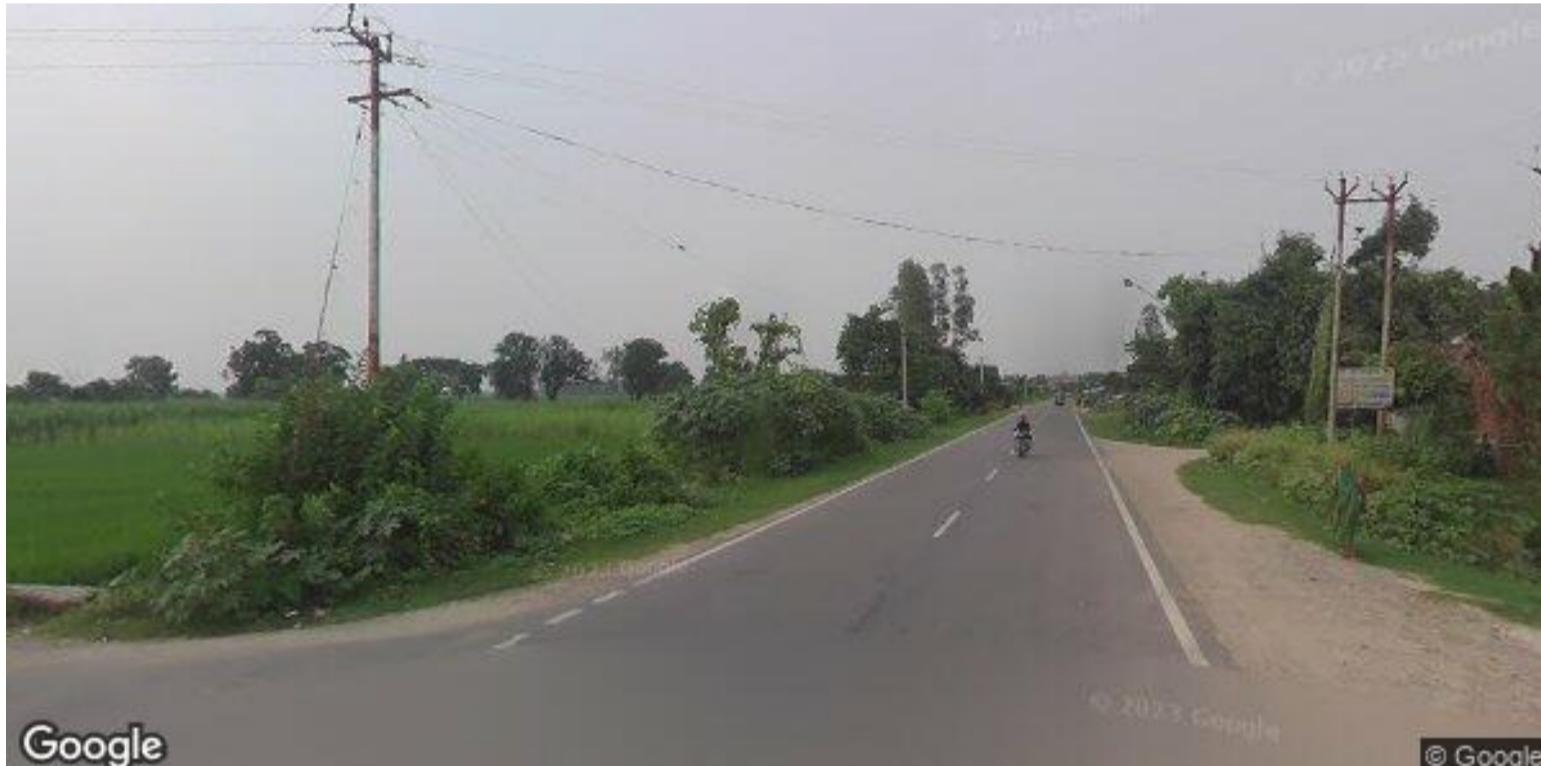
Coordinates: 26.72386, 83.72687

Risk Type: Turn

Risk Level: High

Speed Limit: 15 KM/Hr

Distance from Start: 64.03 km
