IndianOil

JOURNEY RISK MANAGEMENT (JRM) STUDY

Gorakhpur LPG BP TO KARMUA INDNAE GRAMIN

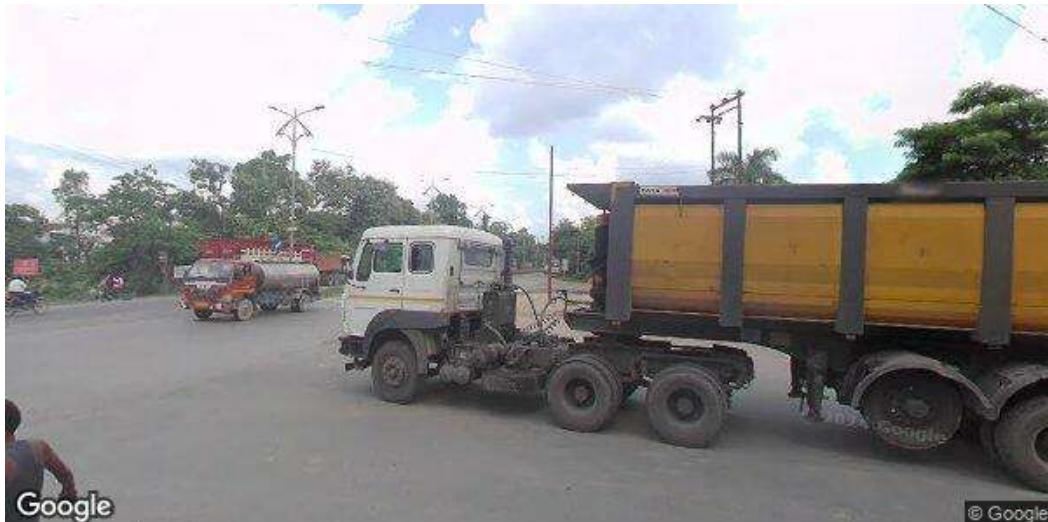
Distance from Start: 2.16 km

Risk Type: Blind Spot

Risk Level: Blind Spot

Speed Limit: 10 KM/Hr

Coordinates: 26.75126, 83.22476

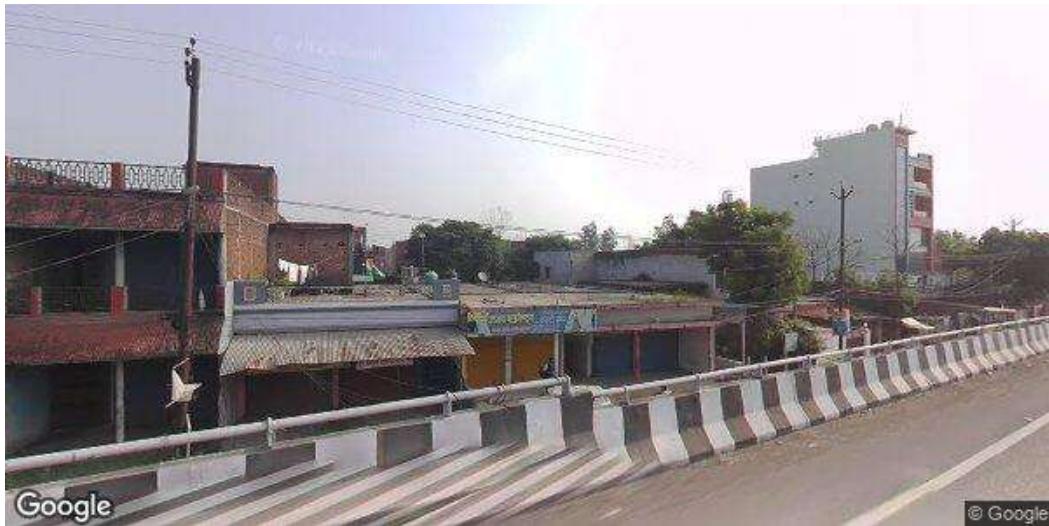
Distance from Start: 4.27 km

Risk Type: Turn

Risk Level: High

Speed Limit: 15 KM/Hr

Coordinates: 26.75377, 83.20465

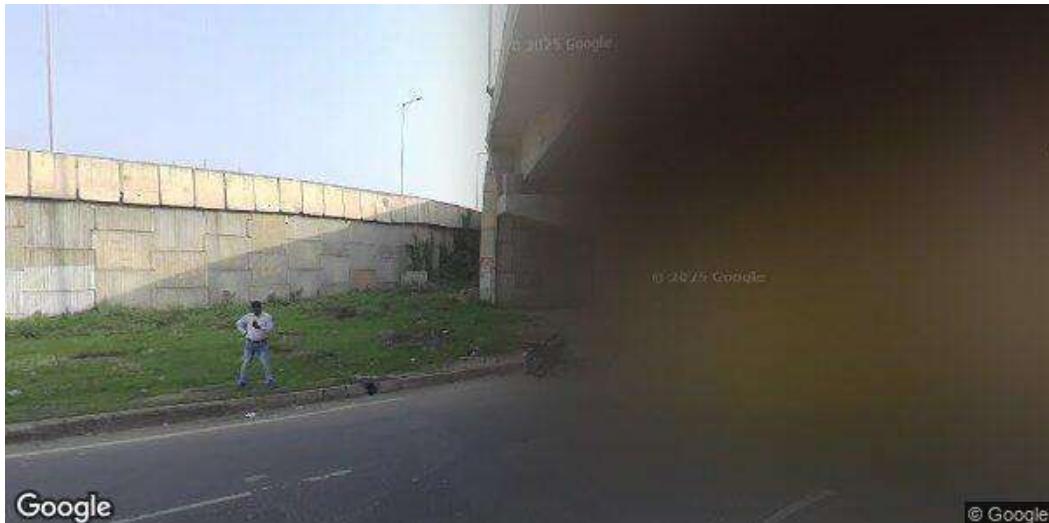
Distance from Start: 8.13 km

Risk Type: Roundabout

Risk Level: High

Speed Limit: 15 KM/Hr

Coordinates: 26.74681, 83.25111

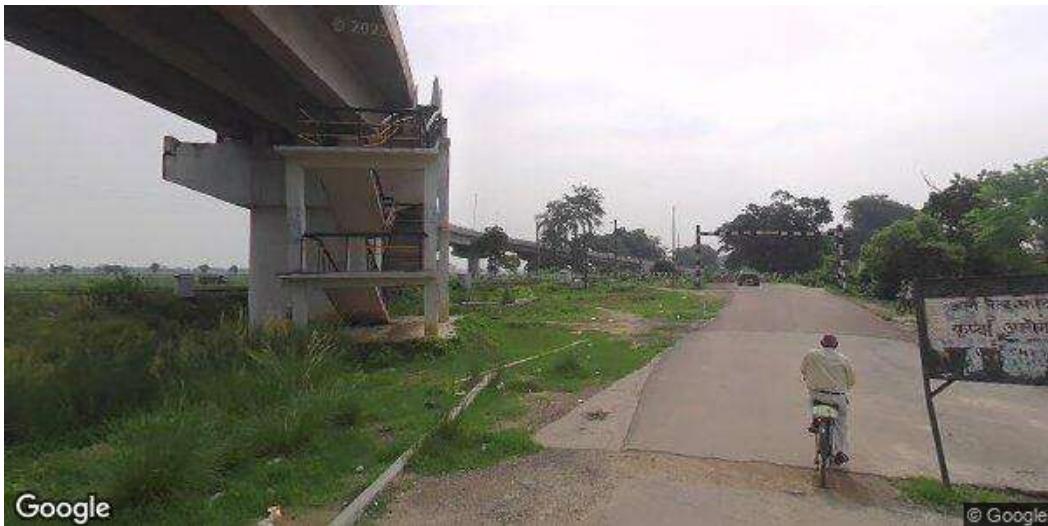
Risk Type: Turn
Risk Level: Medium
Speed Limit: 30 KM/Hr
Distance from Start: 47.38 km
Coordinates: 26.63752, 83.59723

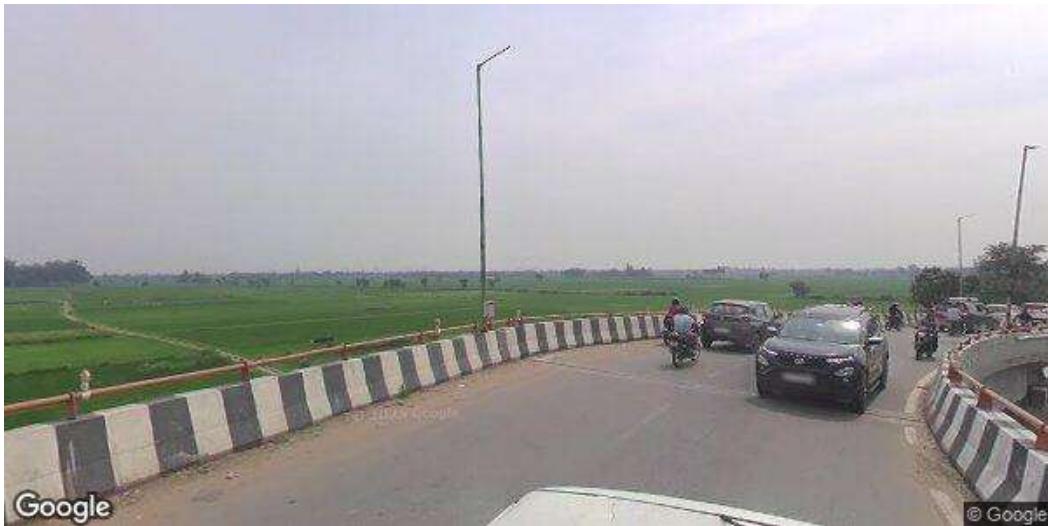
Distance from Start: 47.44 km

Risk Type: Turn

Risk Level: Medium

Speed Limit: 30 KM/Hr

Coordinates: 26.63761, 83.59795

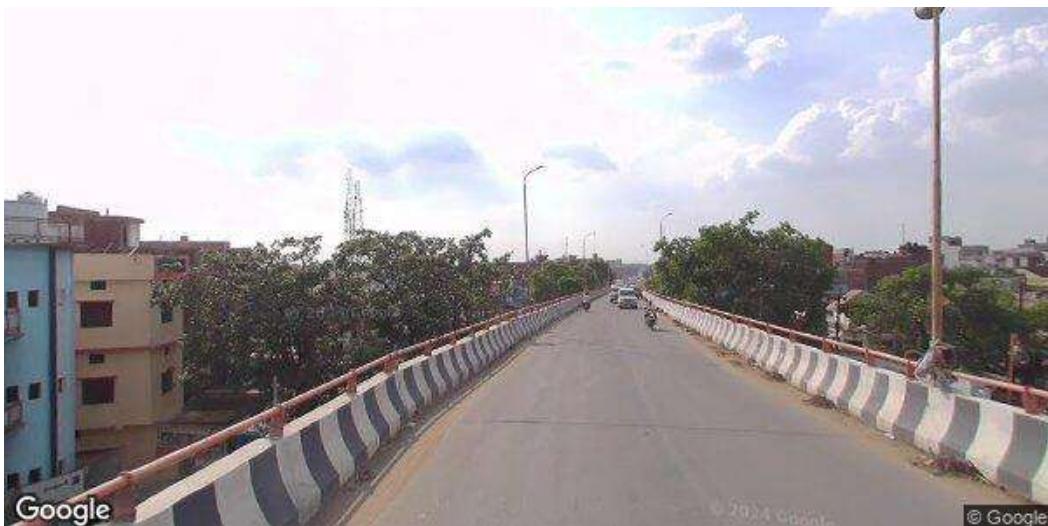
Distance from Start: 100.10 km

Risk Type: Turn

Risk Level: Medium

Speed Limit: 30 KM/Hr

Coordinates: 26.29409, 83.92225

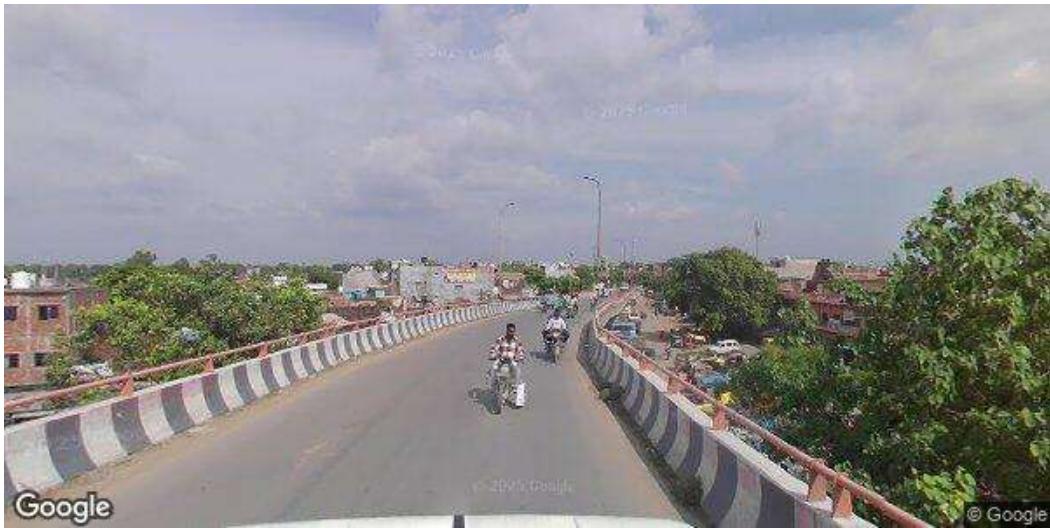
Distance from Start: 100.35 km

Risk Type: Turn

Risk Level: Medium

Speed Limit: 30 KM/Hr

Coordinates: 26.29365, 83.92376

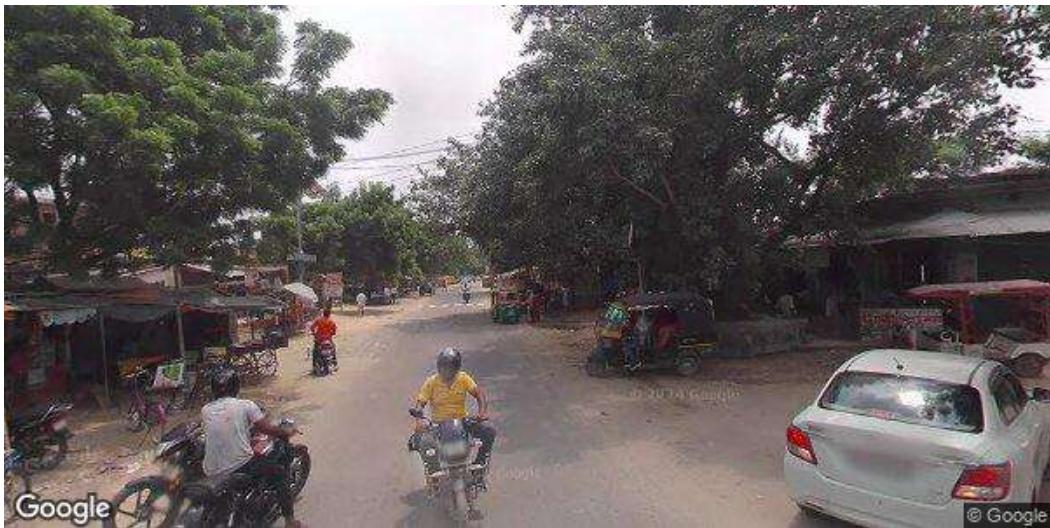
Distance from Start: 106.72 km

Risk Type: Turn

Risk Level: High

Speed Limit: 15 KM/Hr

Coordinates: 26.24874, 83.96185

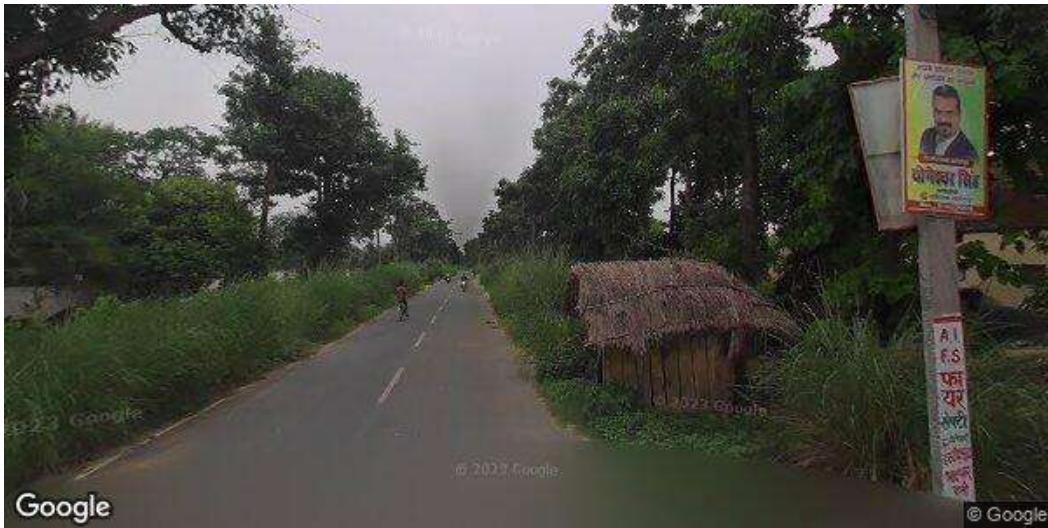
Distance from Start: 110.05 km

Risk Type: Turn

Risk Level: High

Speed Limit: 15 KM/Hr

Coordinates: 26.24285, 83.99124

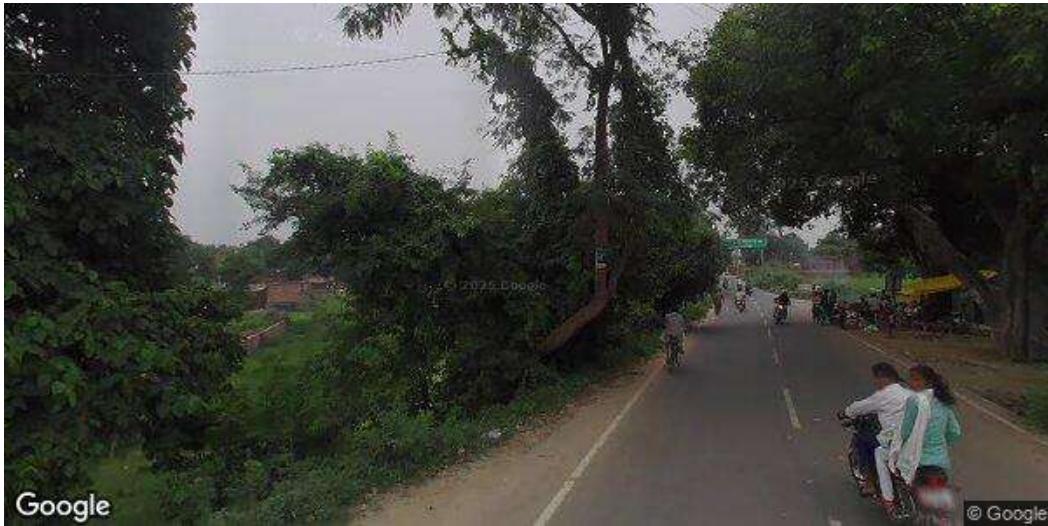
Distance from Start: 110.58 km

Risk Type: Turn

Risk Level: High

Speed Limit: 15 KM/Hr

Coordinates: 26.24736, 83.99347

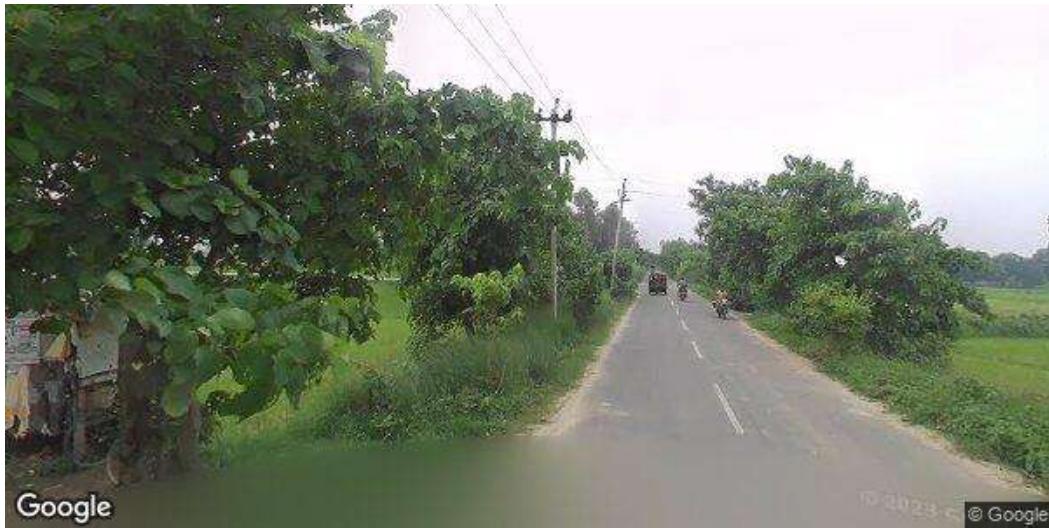
Distance from Start: 110.65 km

Risk Type: Turn

Risk Level: Medium

Speed Limit: 30 KM/Hr

Coordinates: 26.24742, 83.99388

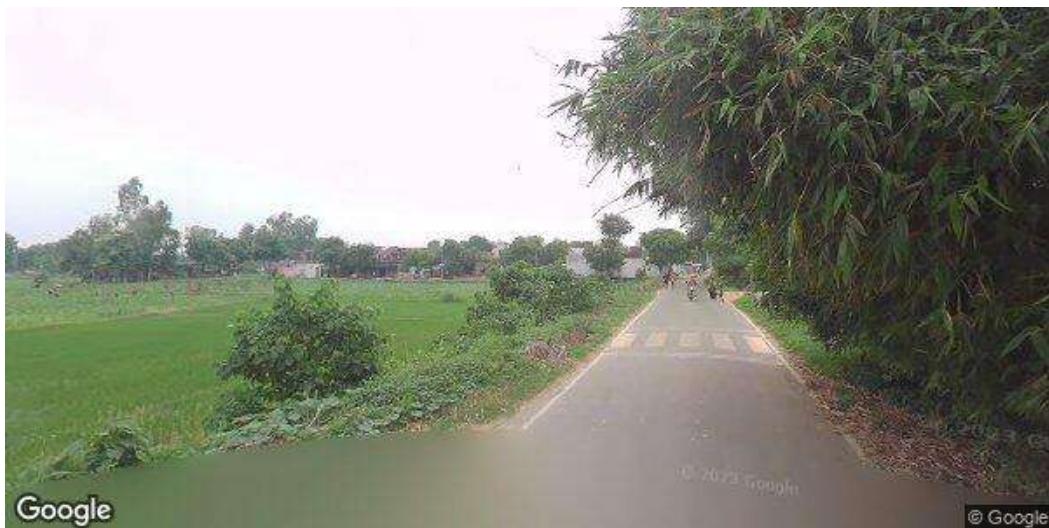
Distance from Start: 111.53 km

Risk Type: Turn

Risk Level: High

Speed Limit: 15 KM/Hr

Coordinates: 26.24386, 84.00221
